Enbridge Line 6B Pipeline Information & History Group Chairman's Factual Report

A. Accident Identification

Enbridge Energy, Limited Partnership
Line 6B
Marshall, Michigan
Crude Oil
July 25, 2010, 5:58 p.m.
DCA-10-MP-007

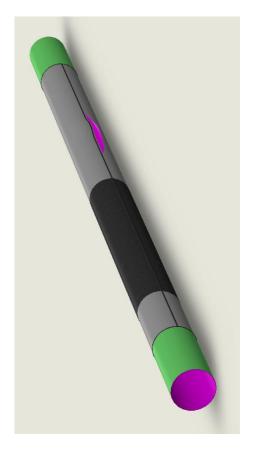
Figure 5. Drawing of the Line 6B ruptured segment, as surveyed following the rupture (right), with relative elevation differences shown.

Rupture location was at a measured elevation of approximately 910.5 feet ASL.

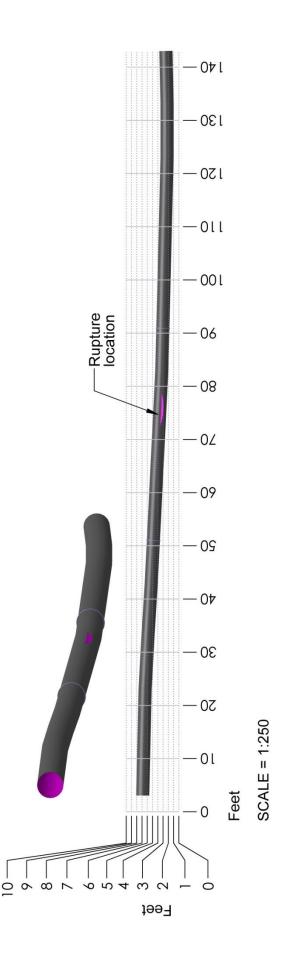
(above) ruptured segment out of trench. Polyethylene tape wrap coating (black) is only partially shown but covered the entire pipeline.
