PREPARED	NAME R. Birdseye	DATE 1-30-78	LOCKHEED - GEORGIA COMPANY A DIVISION OF LOCKHEED AIRCRAFT CORP.	PAGE	TEMP.	PERM. 4.1
CHECKED	S. K. Brown	1-30-78	TITLE FY 1977 C-130 SERVICE LIFE ANALYSIS SERVICE LIFE SUMMARY	MODEL C-130		
APPROVED	E. S. Hendrix	1-30-78		LG78ER0020 REPORT NO. Vol III

4.0 STRUCTURAL ANALYSIS LOCATIONS

B3.0 MODEL C-130A CENTER WING LOWER SURFACE WS 61

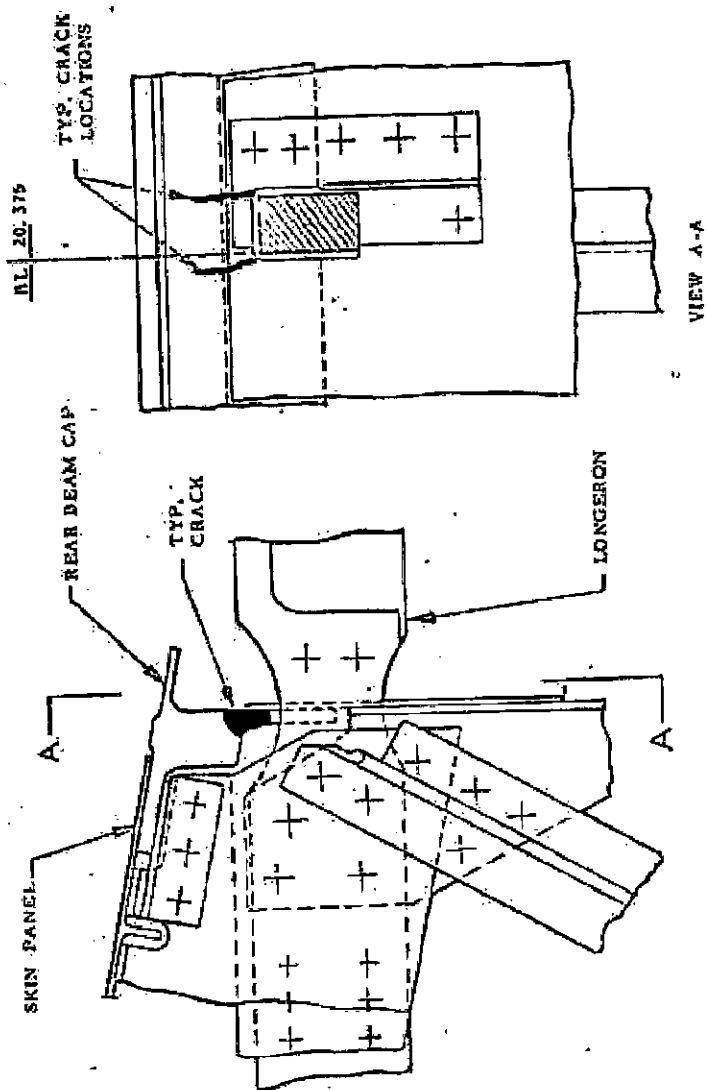
FIGURE 4.4
CENTER WING ANALYSIS LOCATIONS

C-130A UPPER REAR BEAM CAP CRACKING

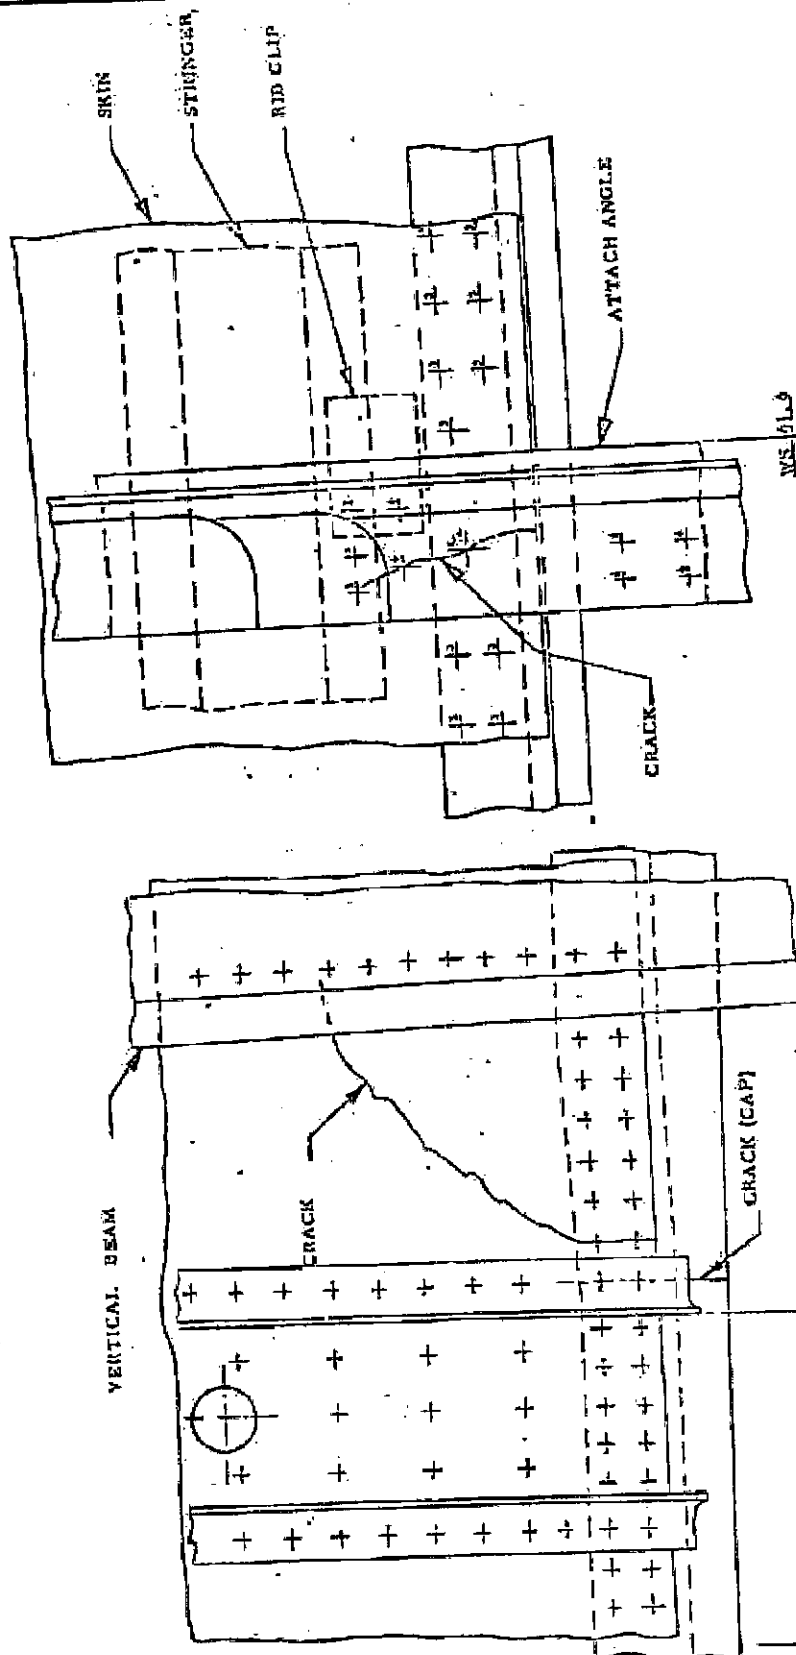
FIGURE 4.6
CENTER WING ANALYSIS LOCATIONS

Lower Skin Panels
WS 61

Lower Aft Spar Cap / Beam Web
WS 79
