HERCULESLOCKHEED-GEORGIA COMPANY
A DIVISION OF LOCKHEED CORPORATION**SERVICE BULLETIN****WING - REMOVAL OF DOUBLERS FROM CENTER WING
LOWER SURFACE, CWS 62 TO CWS 68****I. Planning Information****A. Effectivity**

382-57-55
82-557
Page 1 of 8

T.O. 1C-130-1266
DATA CODE: 0168217
9 APRIL 1987

REMOVAL OF DOUBLERS FROM CENTER WING LOWER
SURFACE CWS 82 TO CWS 68,
C-130 AIRCRAFT

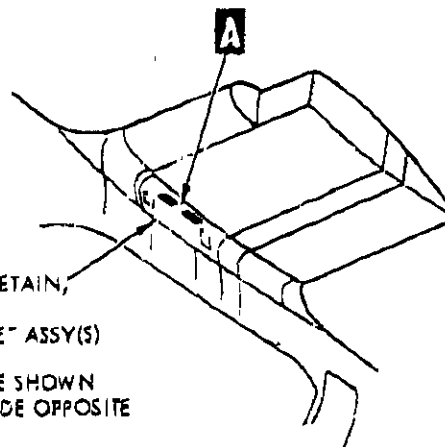
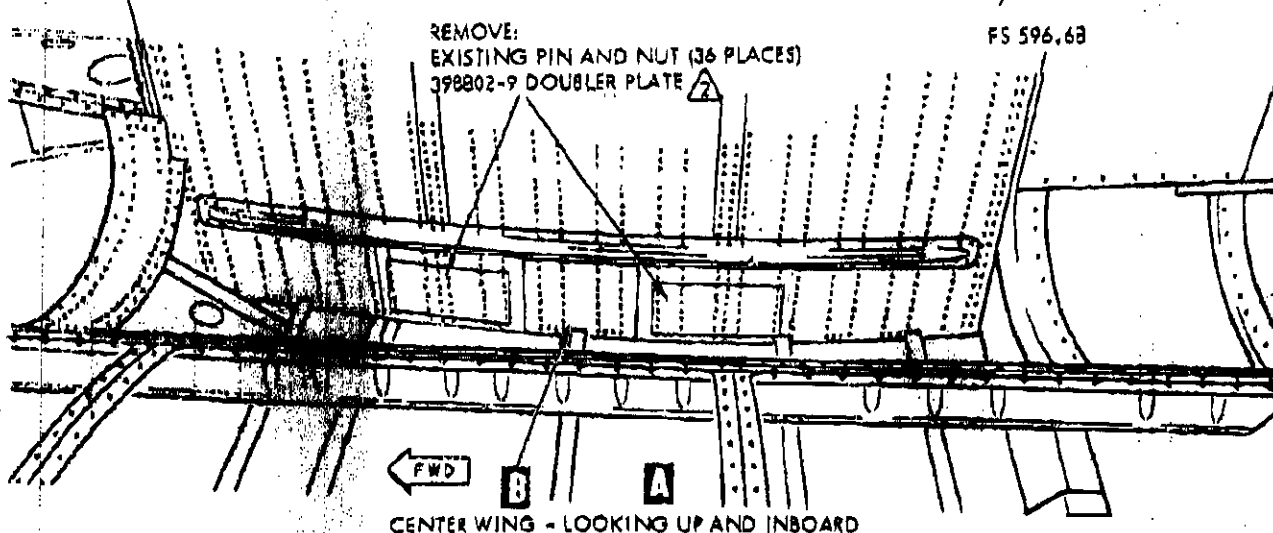
Figure 1. Removal of Doublers from Center Wing Lower Surface,
CWS 62 to CWS 68

- (1) Two external redundant doublers are presently installed on the center wing lower surface on each side of the aircraft between CWS 62 and CWS 68. These doublers have been determined to be a potential source of stress hard points and have been removed from current production aircraft. Incorporation of this modification will remove a potential source of fatigue from this area of the center wing. This modification will also make redundant one X-ray sampling inspection presently contained in SMP 515-D, Inspection Card SA-24.
- (2) This change is considered as a fatigue improvement modification and may be accomplished at the convenience of the aircraft owner/operator.

4-197. **DEFECTS:** Cracks initiate in the wing panel from fastener holes under the doublers and progress from stop drilled tracks in the wing where repair doublers have been installed.

- (1) Locate and remove the set of thirty-six taper-lok fasteners installing each 398802-9 doubler plate to wing structure and remove each 398802-9 doubler plate from the wing lower surface. (See figure 1, details A and B.)

- (4) Wet install thirty-six TL210-3-6 pins and TLN1000-3 nuts using PR1422G, Class B-2 sealant, or equivalent, at each doubler location, in accordance with instructions in the Hercules Structural Repair Manual. (See figure 1, detail B.)

- ⚠ WET INSTALL FASTENERS WITH PR1422G, CLASS B-2 SEALANT OR EQUIVALENT.
- ⚠ CLEAN SURFACES OF SEALANT RESIDUE AFTER REMOVAL OF DOUBLERS.
- ⚠ OUTLINE OF REMOVED DOUBLER PLATE SHOWN SHADED FOR REFERENCE.
