Q1036 Recorder S/N 95120161 Failure Analysis Report

Date: January 25, 2017

Location: Marion Kentucky Manufacturing Plant

Unit: Q1036 NJT Recorder S/N 95120161

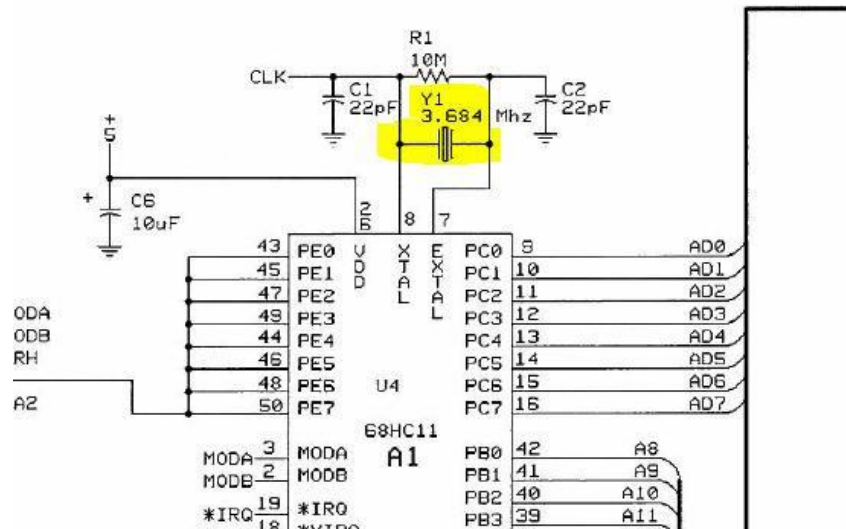
Figure 1

The power supply circuitry on the 60181 was operating as expected. The 5 VDC bus measured 4.98 VDC with minimal ripple, but it appeared as if the processor was not operating and no activity was seen on the data bus. The 3.684 MHz crystal oscillator was not operating as expected. The frequency appeared to be drifting and inconsistent. Also a very quick transitioning dip was measured on RESET line circuitry to the processor. The dip was consistently occurring approximately every 2.5 seconds.

Thinking the inconsistencies seen in the oscillator frequency could be causing the anomalies on the reset circuit, crystal oscillator reference designator Y1 (see Figure 1) was replaced.

First the Y1 crystal was replaced and a consistent frequency was now present, but the fast transitioning dip on the U4 Reset circuitry was still present and processor still appeared to be in a constant reset loop.

With a new oscillator the frequency measured was consistent and as expected, but the anomalies on the reset circuit were still present. The reset circuit has a voltage monitoring device, reference designator Q1 (see Figure 2) manufacturer part number S-80840CNY, that will force the processor to reset if low voltage is detected on the 5V bus. Thinking this might be failing it was replaced.

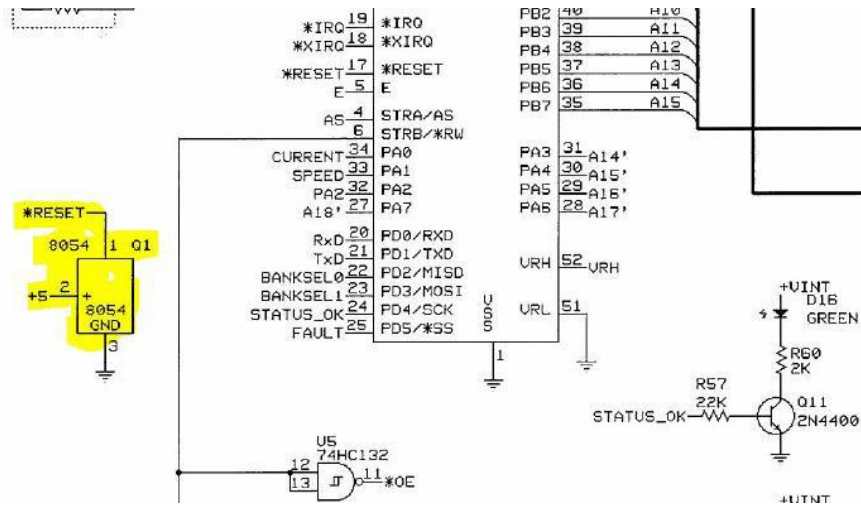
Figure 2

Replacing Q1 cleared the anomalies seen on the reset line, but the processor still did not appear to be operating and no activity was seen on the data bus. The U4 processor chip (see Figure 3) was removed from the socket and the socket was inspected for any damage.

Voltage monitor Q1 on the Reset circuit was replaced. After replacing Q1 the fast transition dip on the reset circuit was no longer present, but the unit was still not functioning.

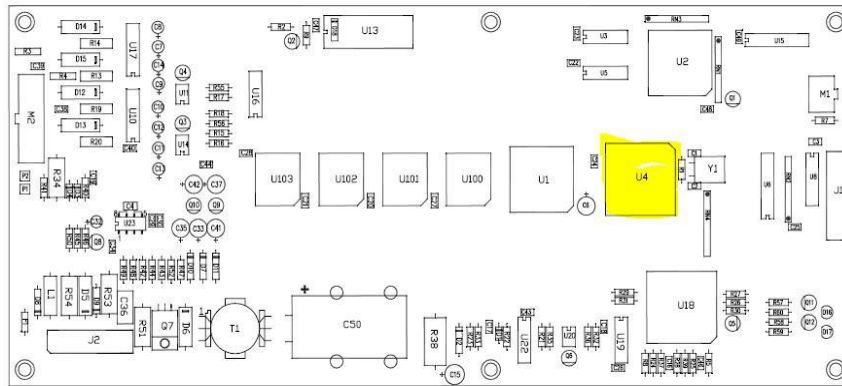
Figure 3

Several pins in the socket looked to be sprung and possibly not making good contact with the chip. A small dental pick was used to pull out the compressed or sprung pins and the processor was re-installed.

The processor IC in socket U4 was then removed and the socket was inspected closely for any signs of damage. Several pins in the socket were noticed to be compressed or sprung in the slots possibly not making good contact with the pins on the processor chip. A small dental pick was used to re-shape the deformed pins and the processor IC was re-installed. The unit still did not function.

Four problems were identified on the 60181 board. Three of the problems were corrected and it is recommended that the IC socket for U4 be replaced. We recommend the unit go through the FRR process before being sent back to the customer. The U4 socket should be replaced at this time and every external I/O connection would be tested.

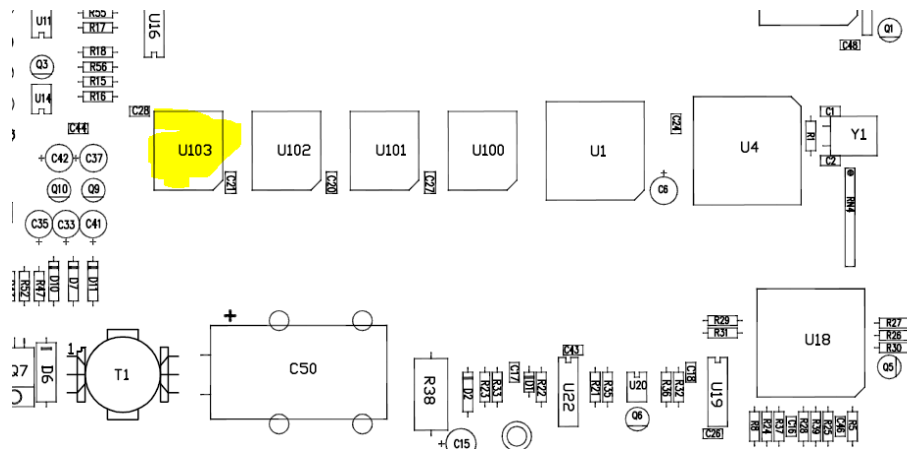
Figure 4

The board was still not functioning, so again each socket IC was replaced with the corresponding IC from the known good board. When IC U103 (see Figure 4) was replaced the unit began functioning. IC U103 is the flash memory where the recorder application software is stored.

Each socket IC was replaced one at a time with the corresponding socket IC from the known good functioning unit. By this process it was determined that the flash memory IC in U103 was bad. With original socket IC and the known good U103 IC, the unit was functioning.
