Long Island Rail Road

National Transportation Safety Board
Submission

DCA17FR009

Employee Fatality

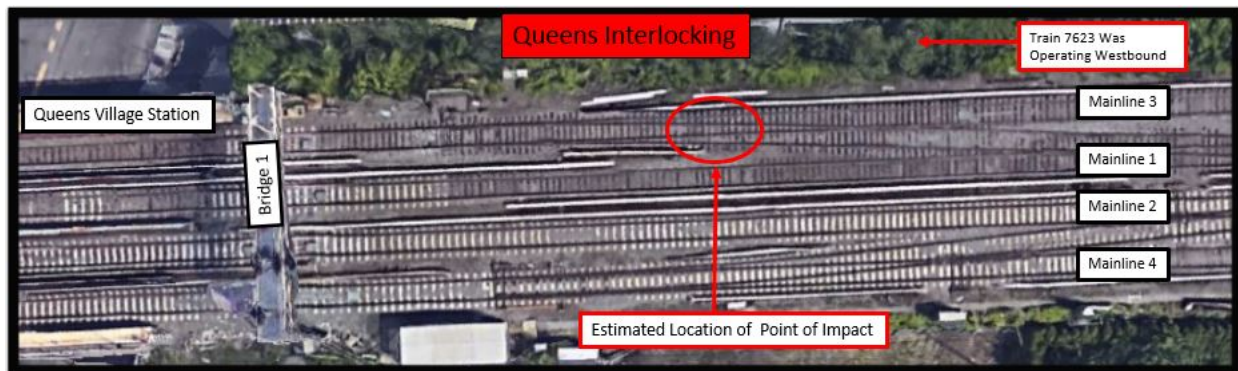
Train 7623, a 12-car consist, originated from Huntington at approximately 9:36 AM, had made a passenger stop at Merillon Avenue Station. They were scheduled to make Hillside Support Facility as the next passenger stop. Queens Interlocking consists of four mainline tracks, from north to south tracks are numbered 3,1,2,4. Belmont Yard is located south of Queens Interlocking. The east and west leg signals of the Wye are the beginning and end of the Interlocking Limits.
