Dear Fellow Suppliers,

On Jan. 9 2012, a railroad pilot was fatally injured after being struck by our J series specialty rail grinder. We would like to share our equipment upgrades with you, in efforts to help prevent similar industry accidents from occurring. You may want to review whether similar upgrades will make your machines and operations safer. If you have questions or concerns regarding this safety advisory please contact a Loram safety representative.

### Background

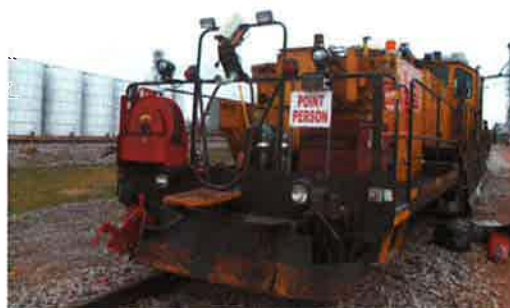
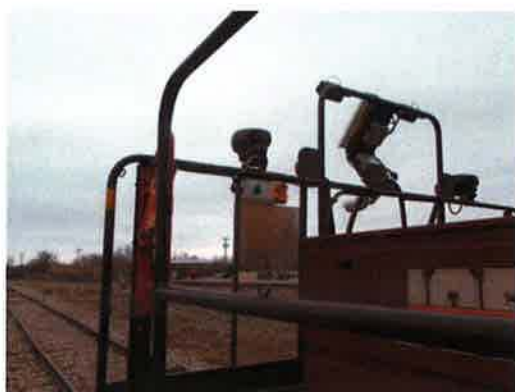
- 1) A fixed position color travel cameras at both ends of the machine. The travel camera field of view (F.O.V.) will overlap the sequence camera F.O.V. An additional monitor was installed at the operator counsel dedicated to the travel cameras.
- 2) An "Alert" horn button that is tied into the machine travel horn circuit in series with the units mounted at the 4 corner ladders.
- 3) A "Machine Stop" button that will give the point person the ability to "kill" the engine at these stations. (Tests have shown 100' stopping distance at 10 MPH and 12 feet at 3 MPH with carriages down.)
