**LYCOMING**  
A Textron Company

## Air Safety Investigation →

### Single Engine Final Report

<b>Mishap Date:</b> May 16, 2002	<b>Mishap Time (24 hr.):</b> 2154 MST
<b>Aircraft Registration:</b> N328CG	<b>Air Safety Investigator:</b> Mark W. Platt
<b>Aircraft Manufacturer:</b> Socata 2000	<b>Aircraft Model:</b> TB-21
<b>Location:</b> New River, AZ	<b>Aircraft S/N:</b> 2025
<b>On Scene</b> Yes	<b>Aircraft Damage:</b> Destroyed
<b>Examination:</b>	
<b>Federal IIC:</b> Wayne Pollack	<b>NTSB Report#:</b> LAX02FA166

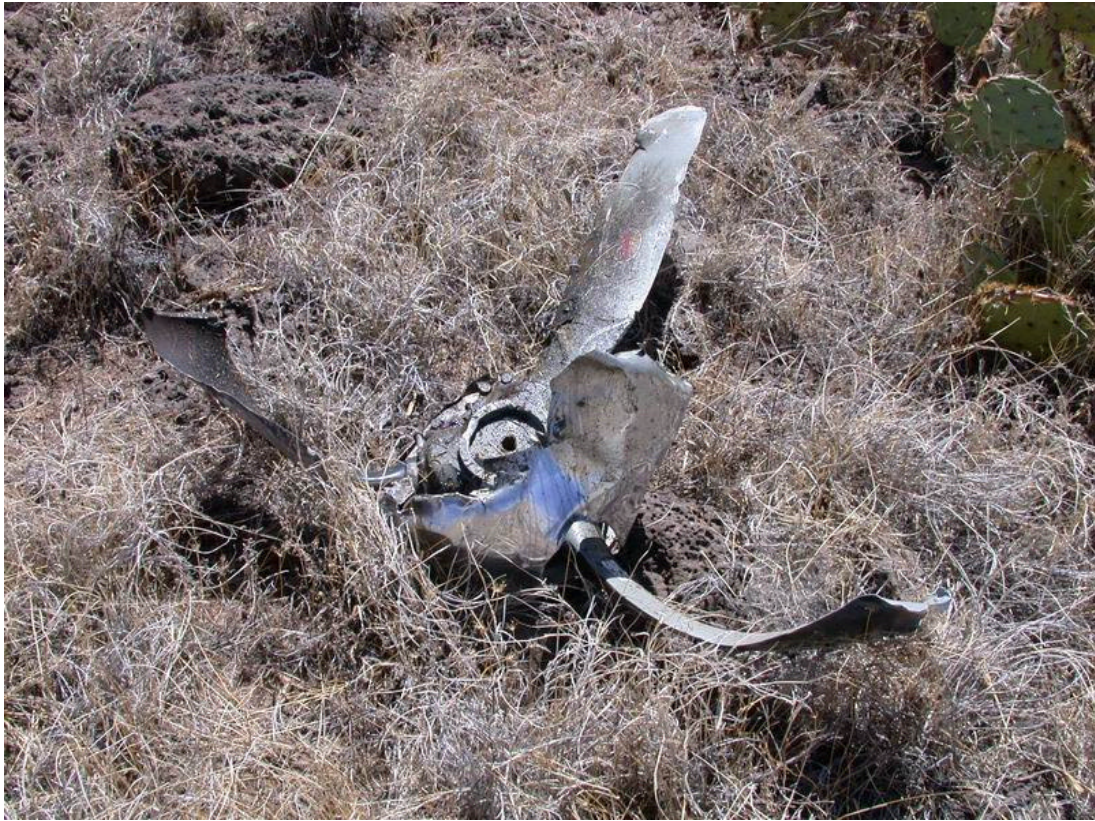
The three bladed constant speed propeller was displaced from the crankshaft flange at the mechanical attachment area of the hub. The fracture surfaces exhibited signatures consistent with overload due to the absorption of rotational energy. The spinner and dome were displaced from the propeller hub. The propeller blades remained attached to the propeller hub. In addition to significant material loss at each propeller blade tip area, the propeller blades displayed leading edge gouging, torsional twisting, chordwise striations across the cambered surface and trailing edge "S" Bending. The signatures were consistent with the absorption of rotational forces applied at the crankshaft at the time of impact. Reference photographs 74-83 for views of the subject propeller.

General view of propeller and blade damage.

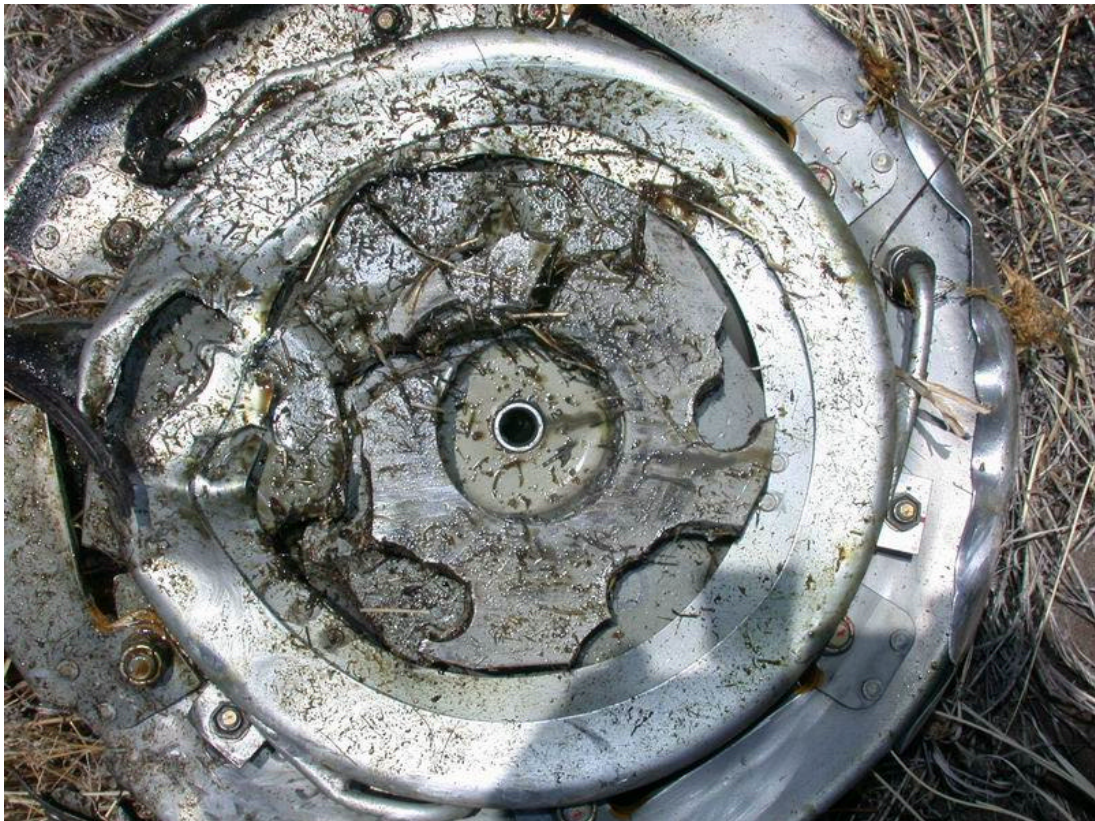
View of the mechanical attachment area of propeller hub.
