LYCOMING

Air Safety Investigation → Single Engine Examination Report

Mishap Date: Sept 8, 2012	Mishap Time (24 hr.): 1235 PDT
Aircraft Registration: N21MX	Air Safety Investigator: Mark W. Platt
Aircraft Manufacturer: Moore Edward R 2009	Aircraft Model: MXS
Location: Borrego Springs, CA	Aircraft S/N: 008
On Scene Examination: No	Aircraft Damage: Destroyed
Federal IIC: Patrick Jones	NTSB Report#: WPR12LA407

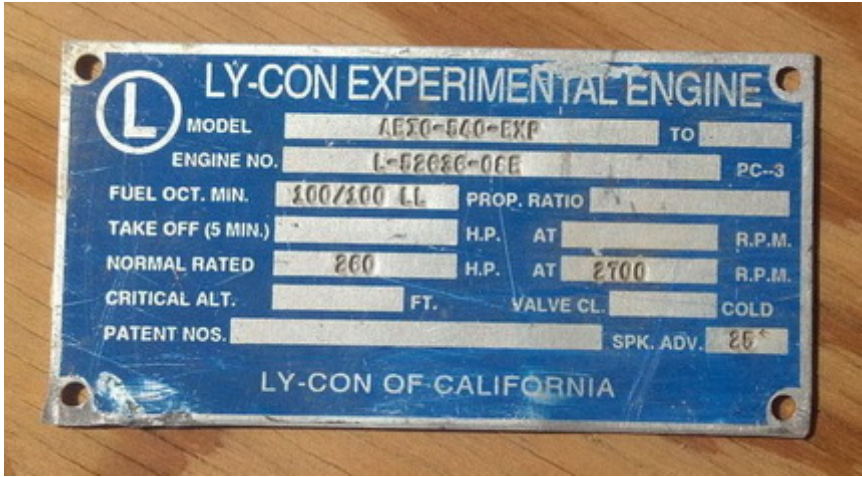
According to the engine logbook and dataplate, the subject engine is a field overhauled experimental by Lycon of Visailia, California.

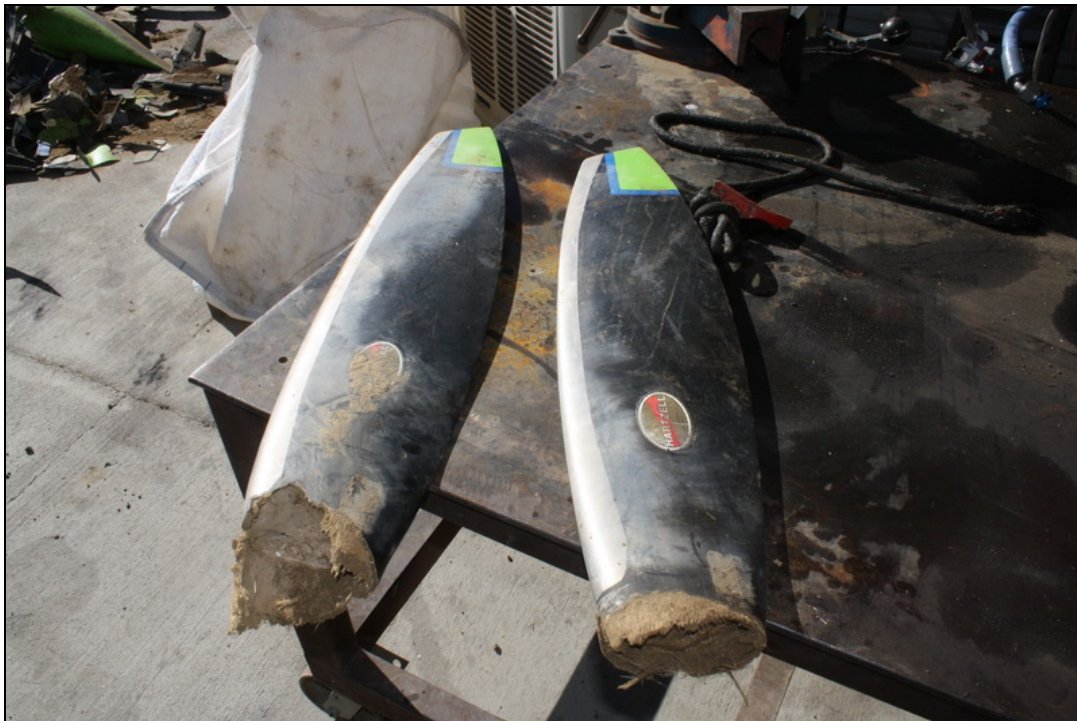
The three bladed constant speed composite propeller remained attached at the crankshaft flange. The spinner was displaced from the propeller hub. The propeller blades were displaced near the root at the propeller hub due to the absorption of impact energy. Of the three propeller blades, only two were recovered.
