**MANDATORY  
SERVICE BULLETIN**

DATE: March 10, 1978 Service Bulletin No. 412B  
(Supersedes Service Bulletin No. 412A)  
Engineering Aspects are  
FAA (DER) Approved

SUBJECT: Intake and Exhaust Valve Rocker Arm Retaining Stud

MODELS AFFECTED: O-320-H series serial numbers L-101-76 to L-2182-76 inclusive.

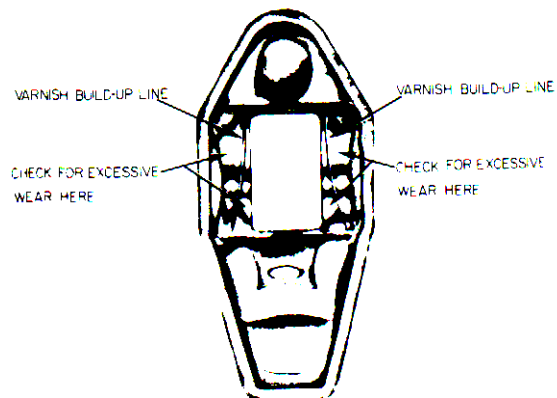
Figure 1. View Showing Interior of Rocker Arm

2. Inspect the fulcrum seating surface in the rocker arm. See figure 1. The surface will show a polish or burnishing which occurs during break-in of the engine. This is normal and not a cause for replacement. However, a developed wear step of more than .003 inch is considered excessive wear and would require replacement of the rocker arm. Do not interpret varnish build-up lines on the seating surface of the rocker arm as wear.
