MANDATORY
SERVICE BULLETIN

Service Bulletin No. 301B
(Supersedes Service Bulletin No. 301A)
Engineering Aspects are
FAA (DEER) Approved

SUBJECT: Maintenance Procedures and Service Limitations for Valves

MODELS AFFECTED: All Avco Lycoming opposed series aircraft engines.

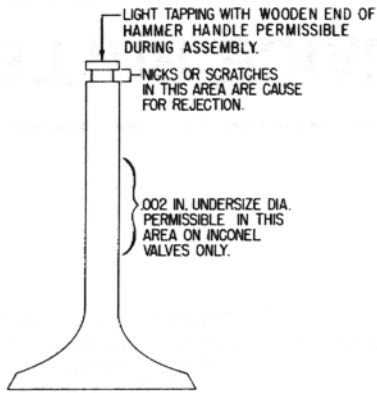
Figure 1. Diagram of Valve Showing Area for Inspection

a. Remove valves from cylinder and clean to remove carbon and examine visually for physical damage, damage due to face burning or excessive corrosion in stem to head fillet area. Valves that indicate damage of this nature must not be reused. Do not reuse valves in which stem diameters midway of valve measure less than that measured at key end; excepting inconel valves which may be .002 undersize on stem diameter as shown in figure 1.

c. After refacing, check runout of valve face. See figure 2. Total runout must not exceed .0015 inch. Do not reuse any valves that exceed this limit.

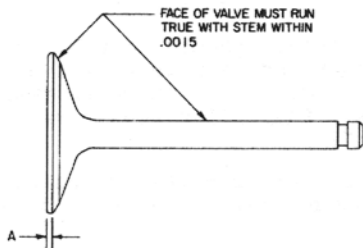
Figure 3. Section Thru Edge of Valve

d. Measure edge thickness of intake valve heads. See figure 2. If, after refacing, "A" is less than the limit shown in the following chart, the valve must not be reused.

The edge of intake valve heads are generally formed as shown in figure 3. The thickness "A" can best be measured with an optical comparator; however, it can be measured with sufficient accuracy by means of a dial indicator and a surface plate, as shown in figure 4.
