**NATIONAL TRANSPORTATION SAFETY BOARD**

**AIRFRAME AND ENGINE EXAMINATION**

**WPR12LA108**

# N367MR - Mooney M20J - Examination Report

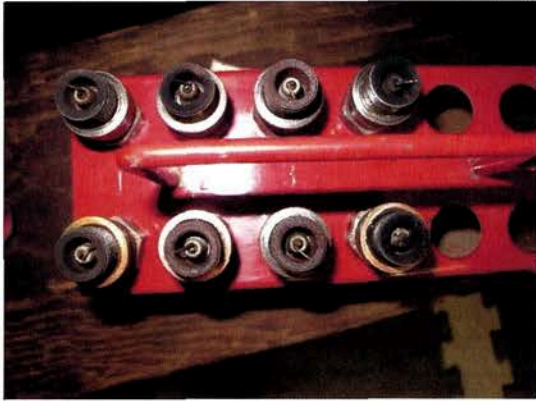
- Spark plugs were removed. Normal operating signature (NOS) except for cylinder #4 which exhibited black dust like residue residing on the top spark plug and black deposits fouling the bottom spark plug.

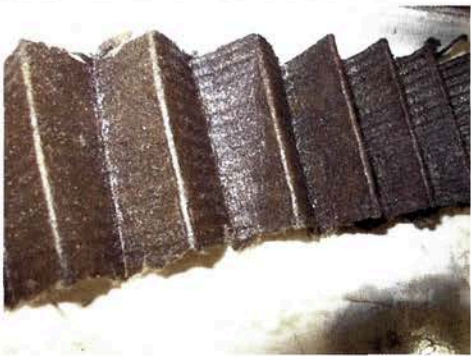
Oil filter element

- Fuel divider was disassembled. Gasket was pliable and intact. Petroleum odor was observed as well as liquid present on the plunger.
- Oil filter was safety wired and had the date, 1.31.2012, hand written on it. A wrench was used to loosen the filter and a filter cutter was used to cut open the case and examine the filter element. Portions of the filter element were black and other sections light brown/tan. Gold and black flakes were observed in the filter folds.

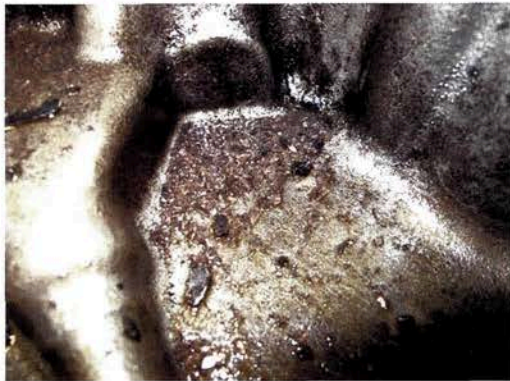
Oil sump & material found in the sump

- The oil pan was removed from the bottom of the engine. A small amount of oil was observed coating the bottom of the sump. Gold colored and black colored flakes or sand like material were observed on the bottom of the sump. No evidence of an oil leak from the oil sump gasket.

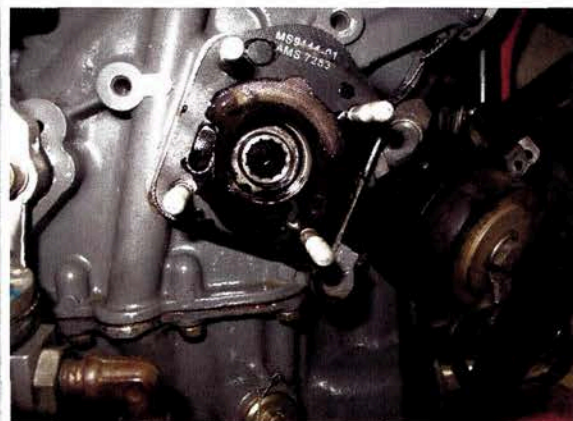
Propeller governor gasket

- Fuel lines leading to the throttle body were removed and drained fuel.
- Fuel pump was removed and drained fuel.
- The propeller governor was removed, rotated freely by hand, and the filter screen was clear of debris. The governor drained out approximately 2 oz of oil.
- The propeller gasket was a single black gasket, MS9144-01, AMS7283.

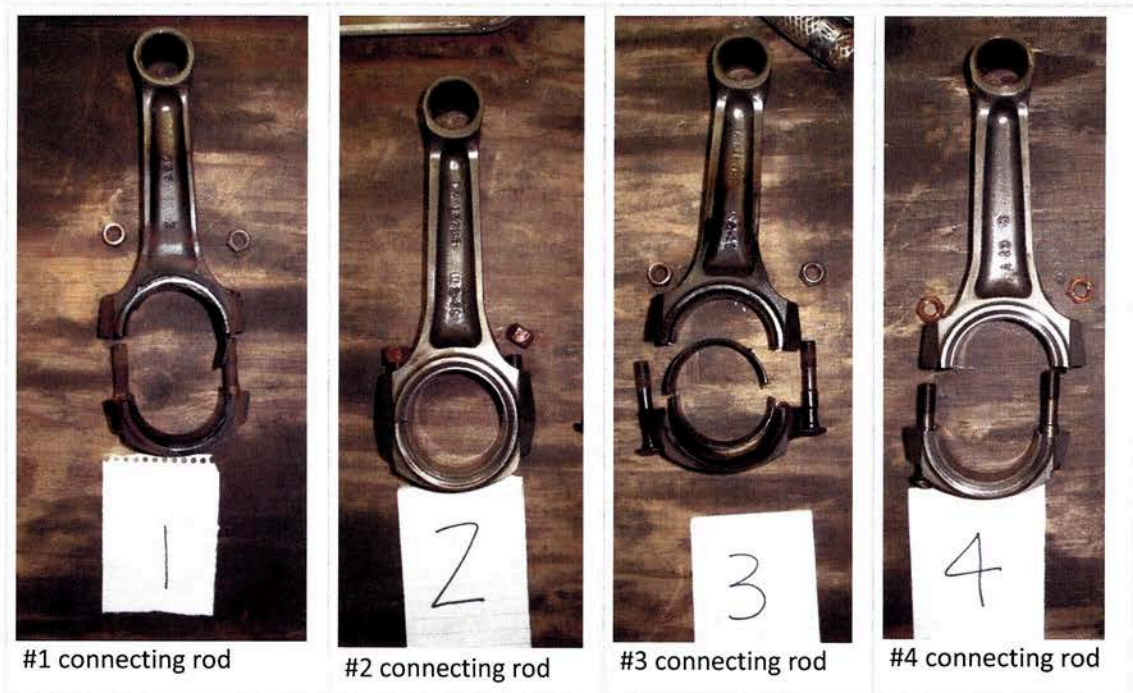
- Exhaust manifold was removed. The exhaust manifolds were dark brown/black and dull in color. The muffler was brown/black with vertical staining streaks and portions had a shiny surface.
- Valve covers were removed from all 4 cylinders. Valve rockers were coated with a light coat of oil
- The engine cylinders were removed from the engine case. All valves were seated, and no evidence of mechanical valve damage was observed. All push rods were removed and found lubricated with oil, no discoloration observed.
- The piston wrist pins were removed. Piston heads exhibited brown-white combustion deposits.
- #1 connecting rod was seized at the crankshaft bearing. Connecting rod exhibited red-brown discoloration around the base of the rod and connecting rod end cap.

- #2 connecting rod moved freely and had no discoloration.
- #3 connecting rod moved freely, and was discolored red-brown around the base and end cap.
- #4 connecting rod moved freely, and had no discoloration.

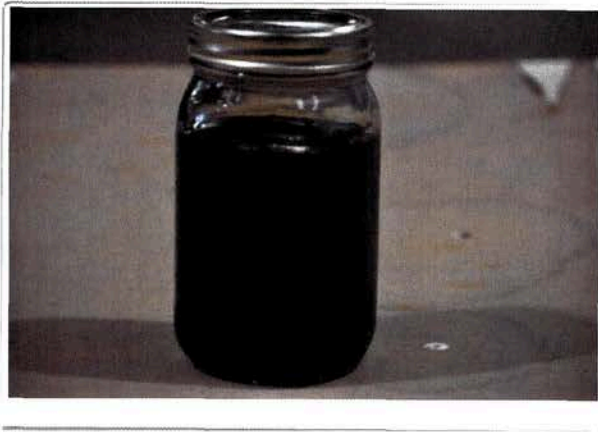
- 1) Oil collected from the oil pan, oil cooler and oil lines.
  - a. Please see attached photo for total quantity collected.
- 2) Testing the oil cooler with a small amount of air to pressurize the cooler.
  - a. We pressurized the oil cooler and then place the cooler under water to test for leaks.
  - b. No leaks were found. Oil cooler in good condition and holds pressure.
- 3) Look at the upper and lower cowling for signs of oil leak inside engine compartment.
  - a. Cowlings were dry and did not show signs of an oil leak.
