National Transportation Safety Board

Marine Accident Brief

Contact of Crane Barge *Mr Ervin*, Pushed by Towing Vessel *Kristin Alexis*, with Sunshine Bridge

Accident type	Contact	No. DCA19FM003
Vessel name	<i>Kristin Alexis</i>	
Location	Lower Mississippi River, mile 167.4, St. James Parish, about 30 miles downriver of Baton Rouge, Louisiana ¹ 30°05.86' N, 90°54.81' W	
Date	October 12, 2018	
Time	0141 central daylight time (coordinated universal time – 5 hours)	
Injuries	None	
Property damage	\$7 million est.	
Environmental damage	None	
Weather	Clear skies with visibility at 10 miles, winds north-northeast at 6 mph; air temperature 62°F, water temperature 77.5°F	
Waterway information	The Mississippi River at the Sunshine Bridge is about 2,550 feet wide, bank to bank. At the time of the accident, the river gage at Donaldsonville was at 18.37 feet, and the current was about 3 mph. (Flood stage was in effect at 27 feet.)

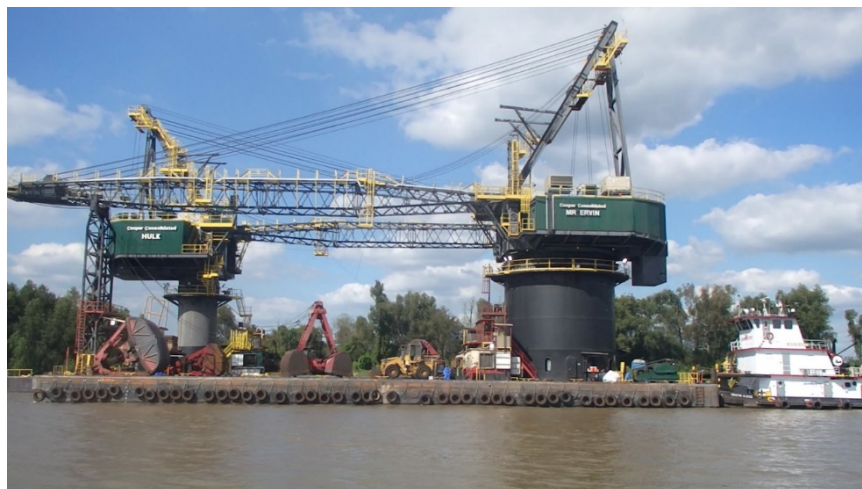
Figure 1. The *Kristin Alexis* and crane barge *Mr Ervin* configuration. (Source: US Coast Guard)

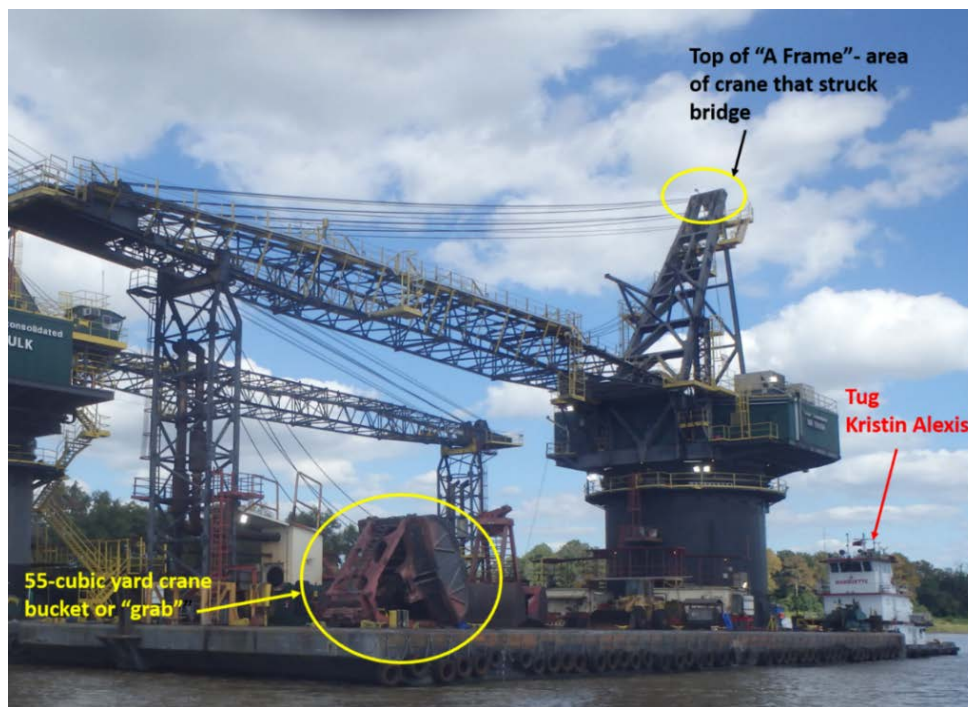
Figure 3. Photo of crane barge *Mr Ervin* faced up to the *Kristin Alexis*. (Source: Coast Guard)

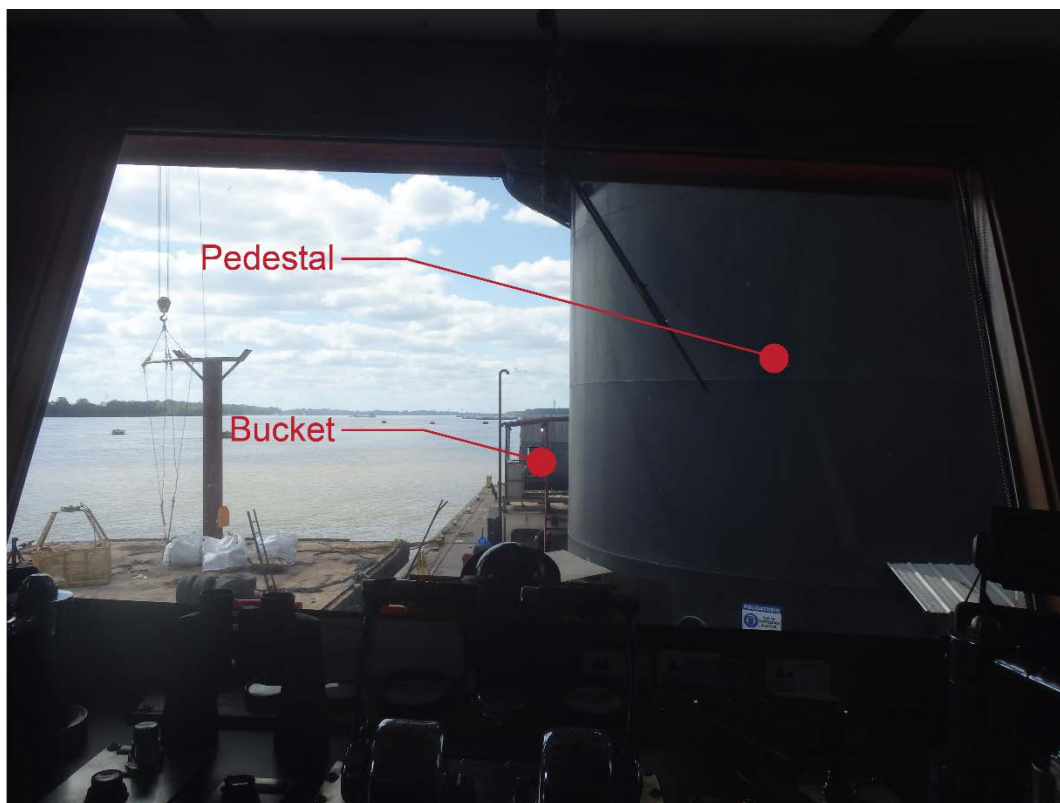
Figure 4. Forward view from the *Kristin Alexis*’ wheelhouse. The crane’s pedestal blocks most of the starboard view, while the crane bucket blocks a portion of the forward view ahead. (Source: Coast Guard)

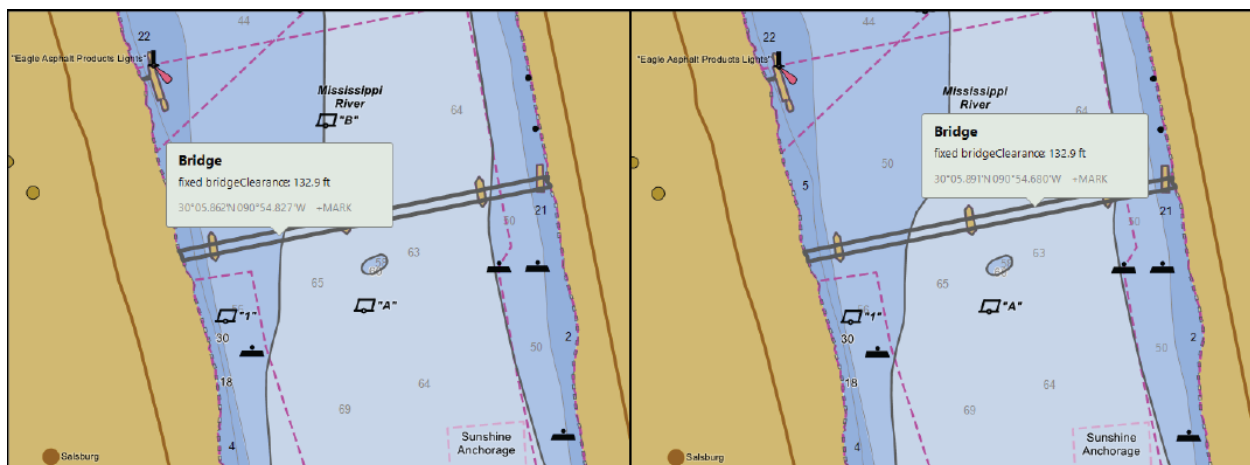
Figure 5. Vertical clearance of the Sunshine Bridge's west (left) and channel (right) spans, as indicated postaccident by the Rose Point display on board the *Kristin Alexis*, which showed the same clearance for each span (132.9 feet).

The vessel's Rose Point electronic charting system, which the crew stated they were using, provided vertical clearance information for the bridge when the cursor was placed over either span. The Rose Point provided the same vertical clearance of 132.9 feet for both the channel span and the west span. Rose Point also provided river stage information, though the pilot did not obtain this information from Rose Point or any other source at his disposal.

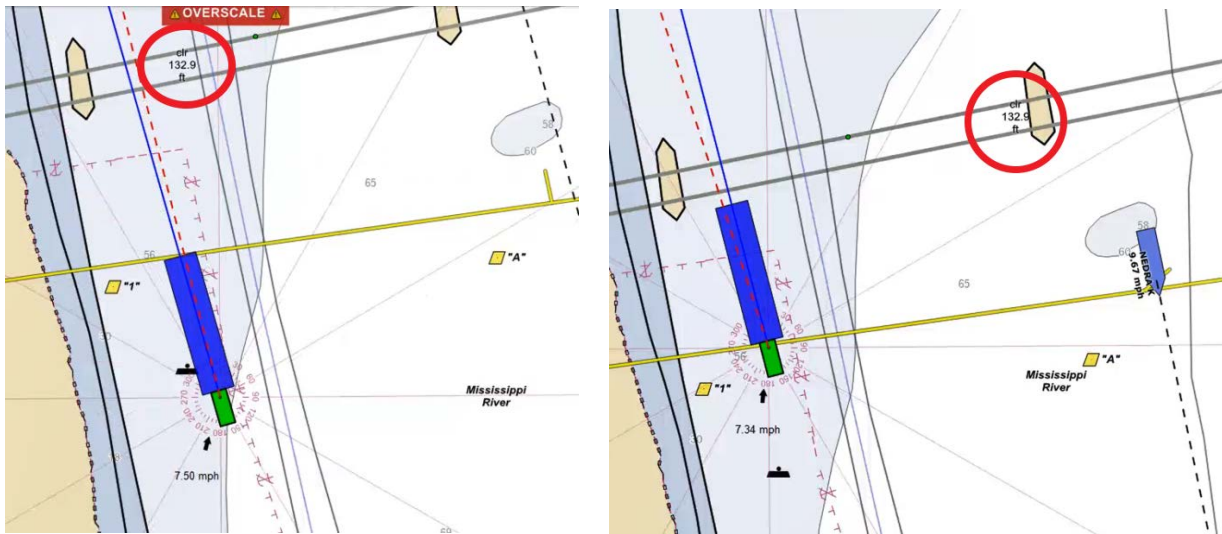
Figure 6. Screenshots of the *Kristin Alexis*' Rose Point at 0139 (left) and at 0140 (right). The vertical clearance for the Sunshine Bridge is circled in red.

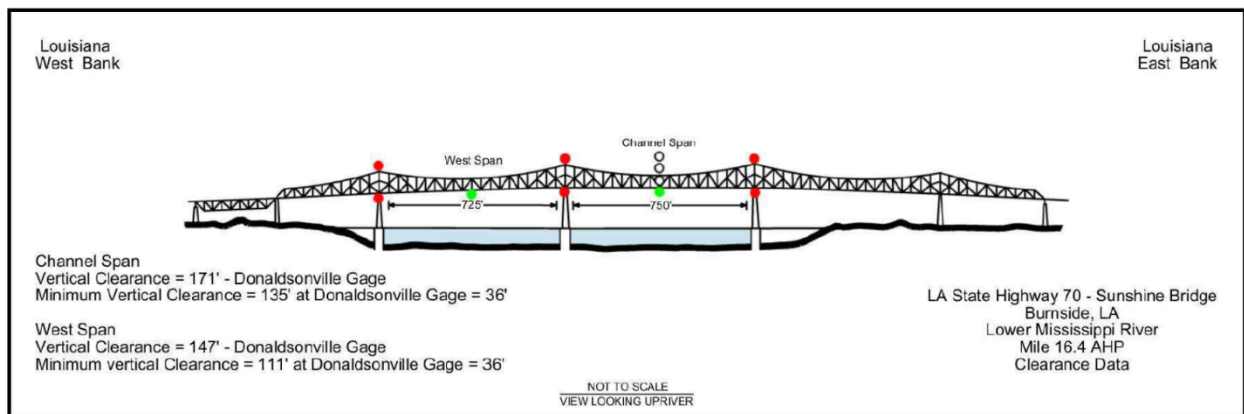
Figure 7. Sunshine Bridge span vertical clearances. The right descending bank is the west bank, and the left descending bank is the east bank. (Source: Corps of Engineers)

According to the Corps of Engineers map book, the channel span had a maximum vertical clearance of 171 feet (minus the Donaldsonville gage), and the west span had a maximum vertical clearance of 147 feet (minus the Donaldsonville gage) (see figure 7). The pilot stated that he was not using the map book.

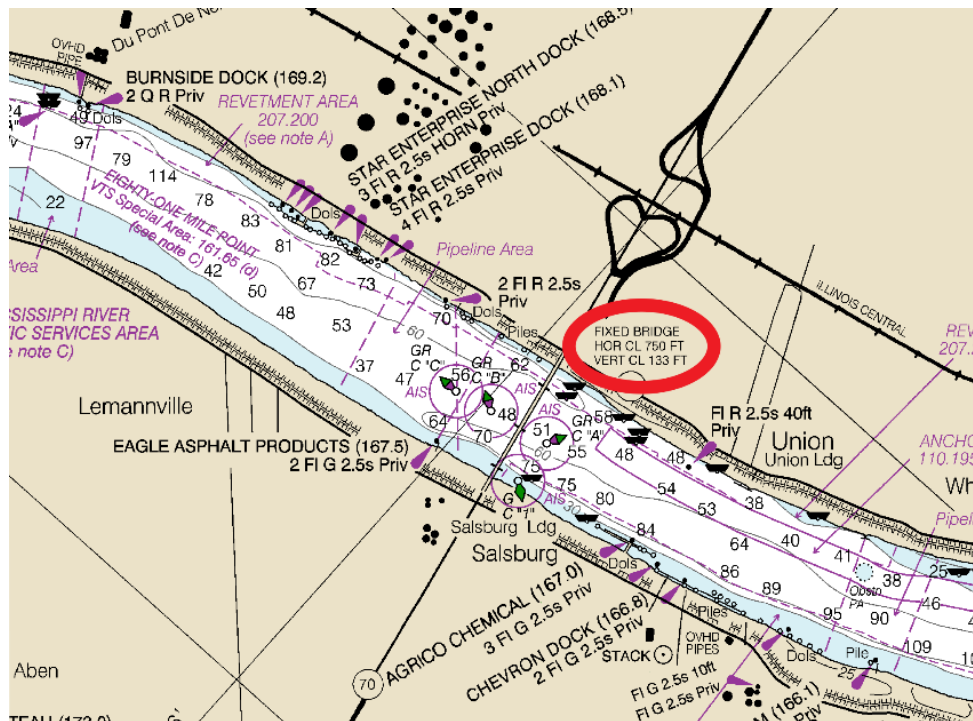
The historic bridge plans and permit data for the Sunshine Bridge showed a minimum vertical clearance of 133 feet for the channel span, based on a high-river stage at Donaldsonville of 36 feet, which occurred during the 1927 flood. The vertical clearance is noted on the left descending bank of the NOAA chart as 133 feet for the "fixed bridge," with no note on the right descending bank. Clearance data issued by the Corps of Engineers indicated a minimum vertical clearance of 135 feet for the main span and 111 feet at the west span. This minimum clearance was based on a high-river stage of 36 feet. Investigators could not determine when and by whom the clearances for the two charts were calculated, but this two-foot discrepancy may be explained by the fact that the map book measures from the highest point of the bridge span, while the NOAA chart gives the measured bridge height closer to the piers.

Figure 9. Excerpt of NOAA chart 11370 used by the crew. The vertical (133 feet) and horizontal clearances (750 feet) of the Sunshine Bridge are shown circled in red. (Source: NOAA, annotated by NTSB)

Navigational aids should provide mariners with a simple and precise way to navigate and not increase workload or cause confusion. Mariners would be better equipped with the correct information if all of the information was included on the chart and any additional data sources were clearly stated so as to "steer" the mariner to the map books, river gages, and/or other Corps of Engineers information. Given that the NOAA data (and therefore the Rose Point software that draws from it) showed only the higher clearance of the channel span of the Sunshine Bridge, the NOAA data alone did not allow for the accurate determination of the vertical clearance under the west span. Therefore, the NTSB recommends that NOAA review and update bridge data and charts to include vertical clearance information for all navigable bridge spans.

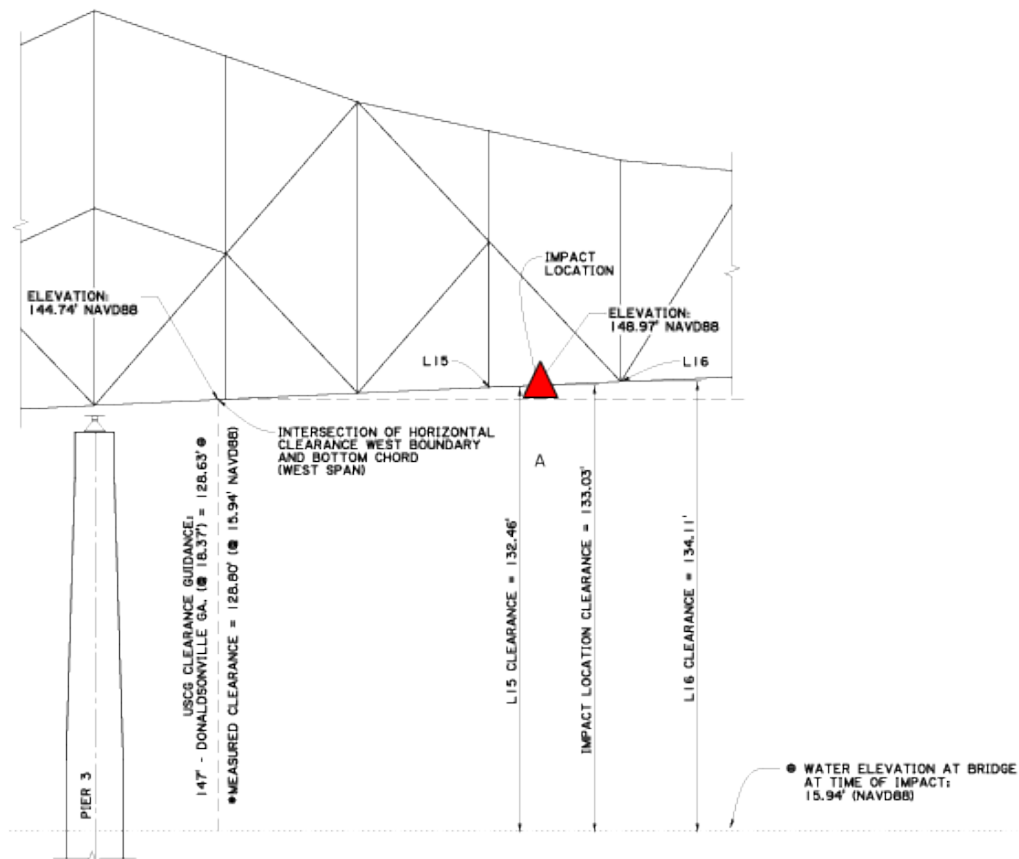
point of minimum vertical clearance for the channel span to be 16.88 feet, and for the west span to be (-)7.12 feet. As depicted in figure 10 (from the survey), the 5-percent bridge grade across the west span offered an increasing vertical clearance towards the center of the Mississippi River. At the point of impact, the survey-based vertical clearance was calculated to be 133.03 feet, indicating an actual estimated overhead clearance for the *Mr Ervin* of (-)2.72 feet.

Figure 10. Vertical clearances of the Sunshine Bridge's west span measured shortly after the accident. The impact location is marked with a red triangle. (Source: Forte and Tablada, annotated by NTSB)
