National Transportation Safety Board

Marine Accident Brief

Anchor Contact of Articulated Tug and Barge *Clyde S VanEnkevort/* *Erie Trader* with Underwater Cables and Pipelines

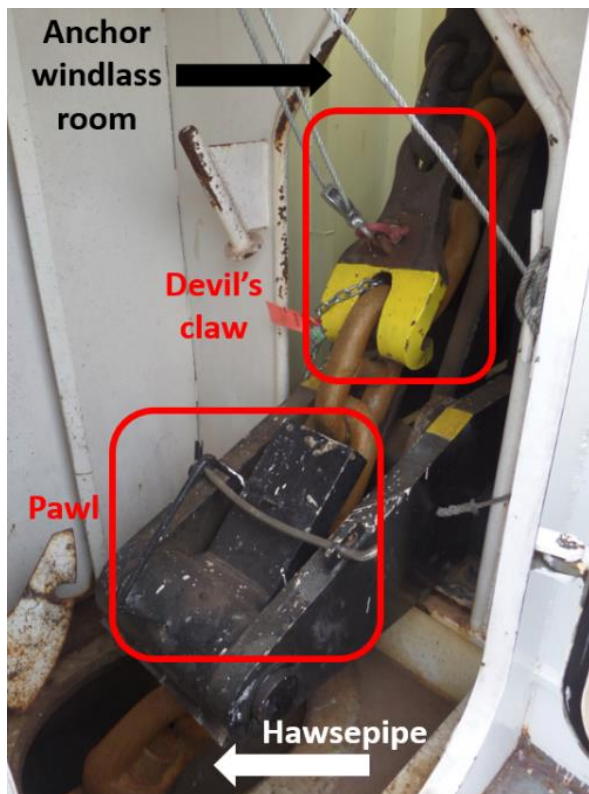
Postaccident photo of the starboard anchor's devil's claw and pawl in the secured and stowed (home) position.

The condition of the starboard pawl, devil's claw, and wildcat indicated that the anchor had been intentionally cleared and had not let go due to any failure of those components. In addition, no problems were apparent with the wildcat or windlass motor, given that the crewmembers could immediately retrieve the anchor once they found it paid out.

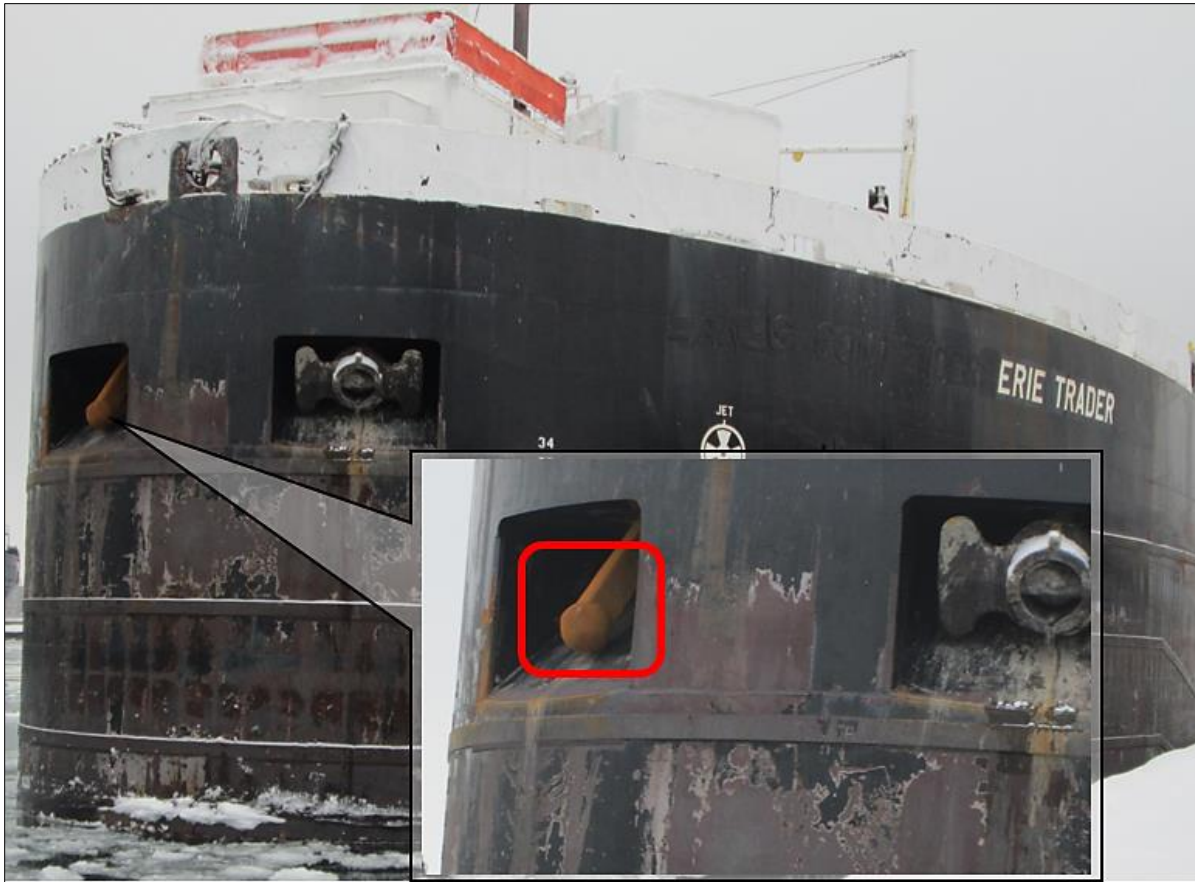
The bow of barge *Erie Trader* after the accident. An inset highlights the remnant shank of the starboard anchor in the anchor pocket. (Photo by Coast Guard)

The marine casualty report that the vessel captain submitted on April 6, 2018 stated that “the starboard-side anchor was not secured properly and released without anyone’s knowledge at an unknown place and time.”

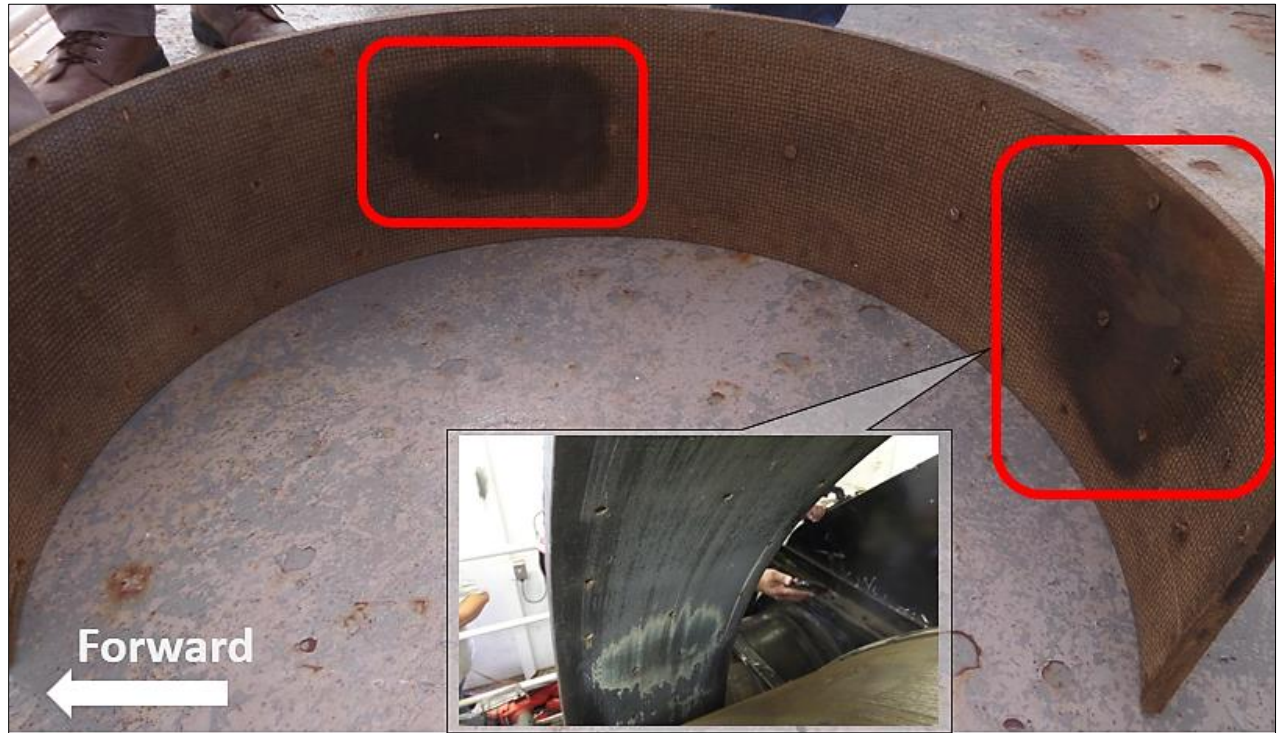
On May 4, in the port of Toledo, Ohio, investigators and party representatives witnessed the disassembly and replacement of both the upper and lower section of the starboard anchor brake band liners. At the request of the vessel owner, an attending technician from CME supervised the process. The lower brake band liner appeared to have been in place for the life of the vessel, and frictional wear was uniform along the surface. When the upper brake band liner was removed, it had only minimal wear due to its new condition, and much of the liner surface had no visible friction or notable surface contact. However, near the top of the liner and at the aft end were notable uneven friction marks. Friction marks also appeared at the forward end of the liner near the edge and on the brake band inner surface. In addition, paint was burned from the surface in both places as well as at the forward end.

Photo of the upper brake band liner for the starboard anchor. Highlighted in red are the friction marks on the liner. The inset shows the paint worn from heat accumulation through the liner aft section of the upper band.

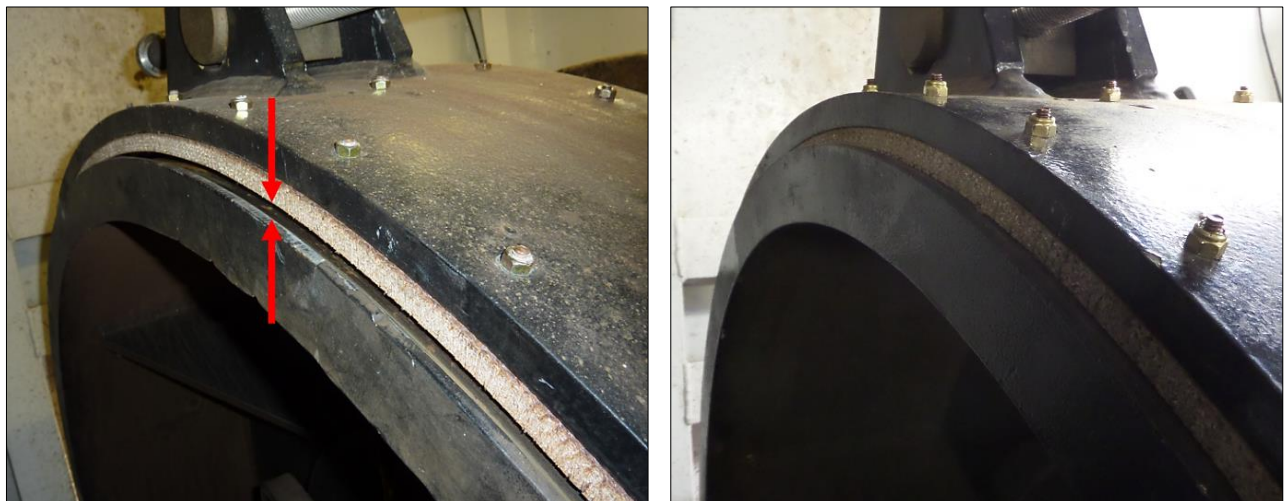
On April 9 in Silver Bay, investigators boarded the vessel and visually examined the starboard anchor assembly. When the brake was applied, a noticeable gap—about 0.3-inch wide—was observed at the top section of the brake band. The pawl, devil’s claw, brake, wildcat, handwheel, and main shaft on the starboard windlass had no visible signs of damage.

Left: Postaccident photo of the starboard anchor windlass' upper brake band liner with the brake closed. The red arrows highlight the gap at the top between the drum and liner. Right: Photo of the upper brake band liner with the brake closed after the CME technician supervised the installation and adjustment. Note the lack of gap between the brake band liner and the drum.

Although anchor windlass brakes are not intended to hold an anchor and chain indefinitely during the dynamic conditions that vessels typically encounter on voyages, a properly adjusted brake should have had ample holding capacity for the weight of the *Erie Trader's* anchor and chain. However, during the postaccident teardown and replacement of the *Erie Trader's* starboard anchor windlass brake-band liners, the brake band had to be adjusted to ensure proper contact between the liner and drum with the brake activated. Based on the friction contact pattern on the upper liner, it is likely that the chief engineer and crew who replaced the top liner did not properly adjust the brake band. The brake band liner and hardware were replaced without the training, supervision, or instructions to properly carry out the task and ensure appropriate adjustments. Aside from the improperly adjusted band, investigators found no other defects in the anchor assembly.

According to CME's field service report, "upon inspection at winch, noticed brake band was out of adjustment." CME noted no problems with the anchor windlass assembly and, after the adjustment, the anchor was tested with satisfactory results.
