Fire On Board US Small Passenger Vessel *Island Lady*
Pithlachascotee River Near Port Richey, Florida
January 14, 2018

NTSB/MAR-18/02
PB2019-100203

Marine Accident Report

Abstract: This report discusses the fire that destroyed the small passenger vessel *Island Lady* on January 14, 2018, at the mouth of the Pithlachascotee River near Port Richey, Florida. The vessel, with 53 people on board, was on a scheduled transit to an offshore casino boat, the *Tropical Breeze I*, located about 9 miles offshore in the Gulf of Mexico.

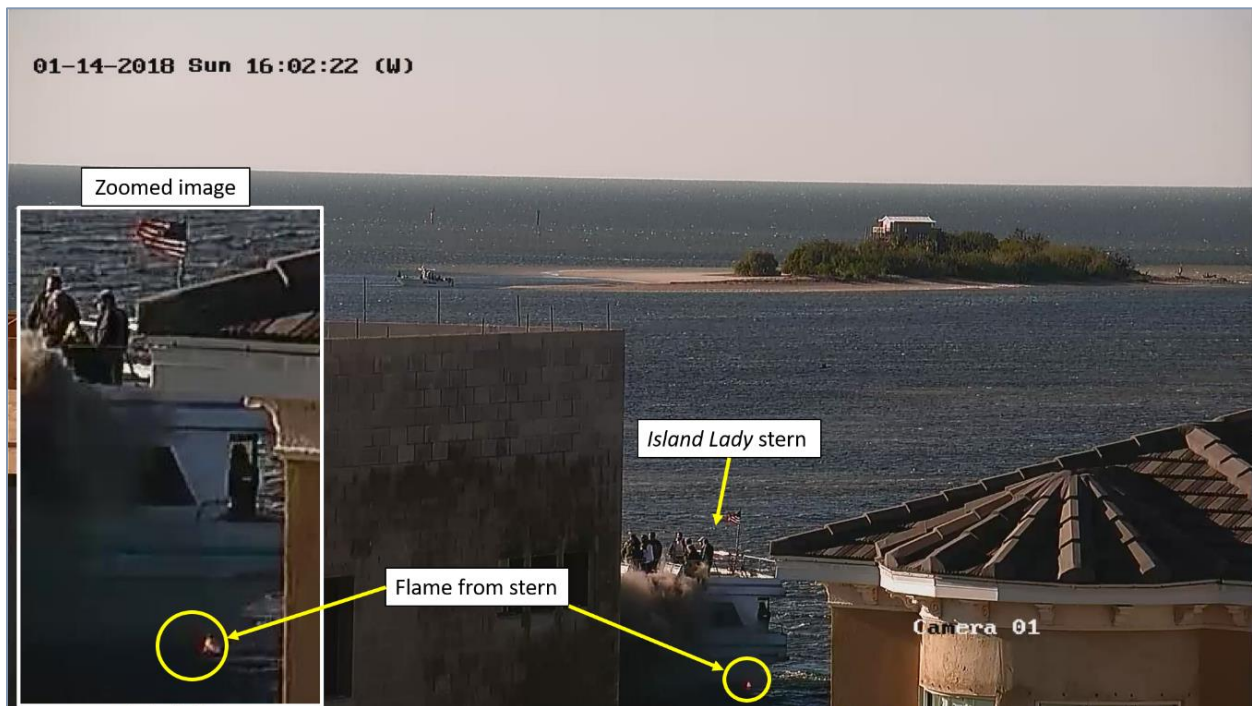
About 1553, the *Island Lady* was returning toward the harbor at a speed of about 8 knots. The captain was using the starboard engine for propulsion; the port engine remained in neutral, running at idle speed. The smoke was increasing, turning thicker and also brown/gray in color. After the vessel turned back toward the harbor and transited toward the east, the north winds blew the thickening smoke across the vessel’s beam, and the smoke billowed off the starboard side. As a result, the crewmembers were unable to pinpoint the precise location from where the smoke emanated. The shoreside video surveillance camera recorded the billowing smoke as well as flames emanating from the port exhaust opening on the stern (figure 5). At this point, no other flames were visible.

Figure 5. Still image from home surveillance video footage, with the stern of the *Island Lady* visible between two houses. Fire emanating from the port side of the stern is circled in yellow. (Video footage provided by witness)

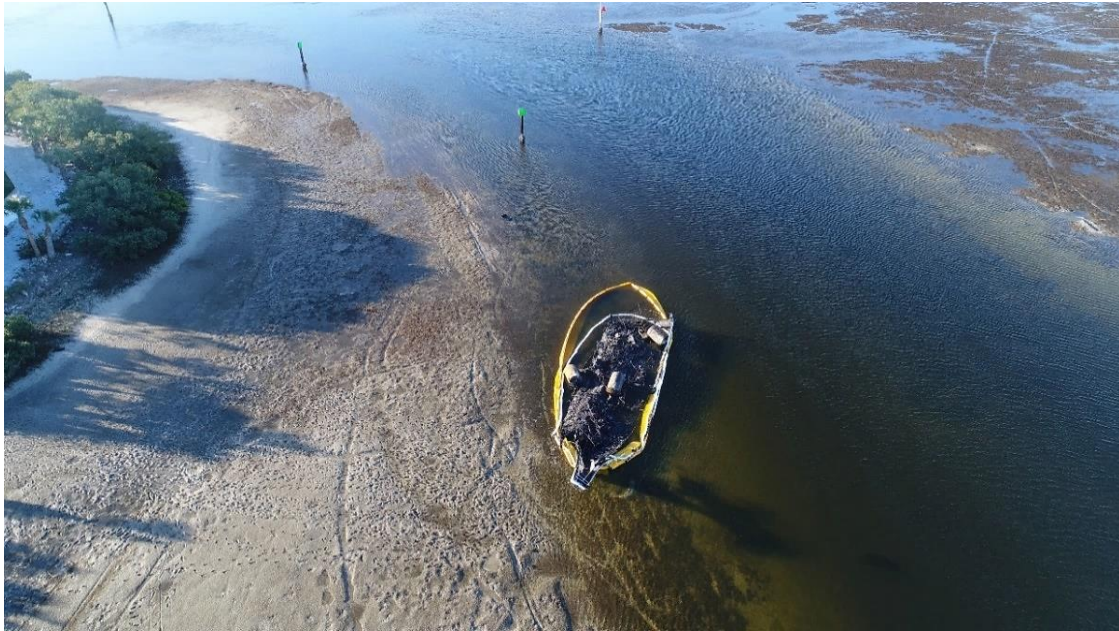
The *Island Lady*, insured for \$450,000, was declared a constructive total loss, as everything above the waterline was destroyed (figures 7 and 8). The only remains were the two fire-damaged engines, two damaged generators, remnants of various piping systems and valves, railings around the vessel, deck chairs, and three cylindrical fuel tanks.

Figure 7. Remnants of the *Island Lady* seen from above. (Photo by Titan Marine & Environmental)

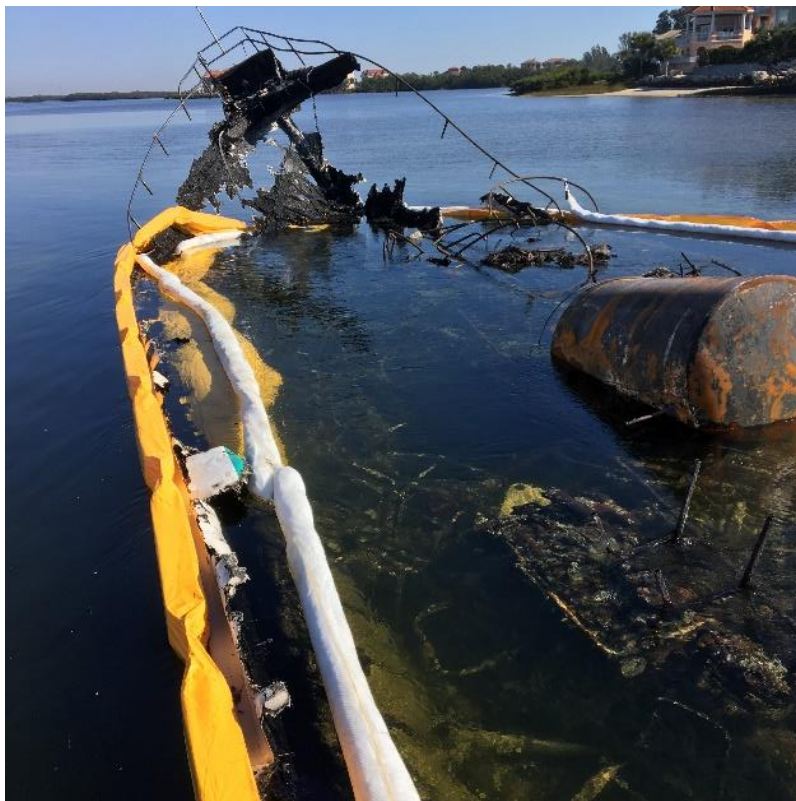
Figure 8. Looking toward the *Island Lady*'s destroyed bow.

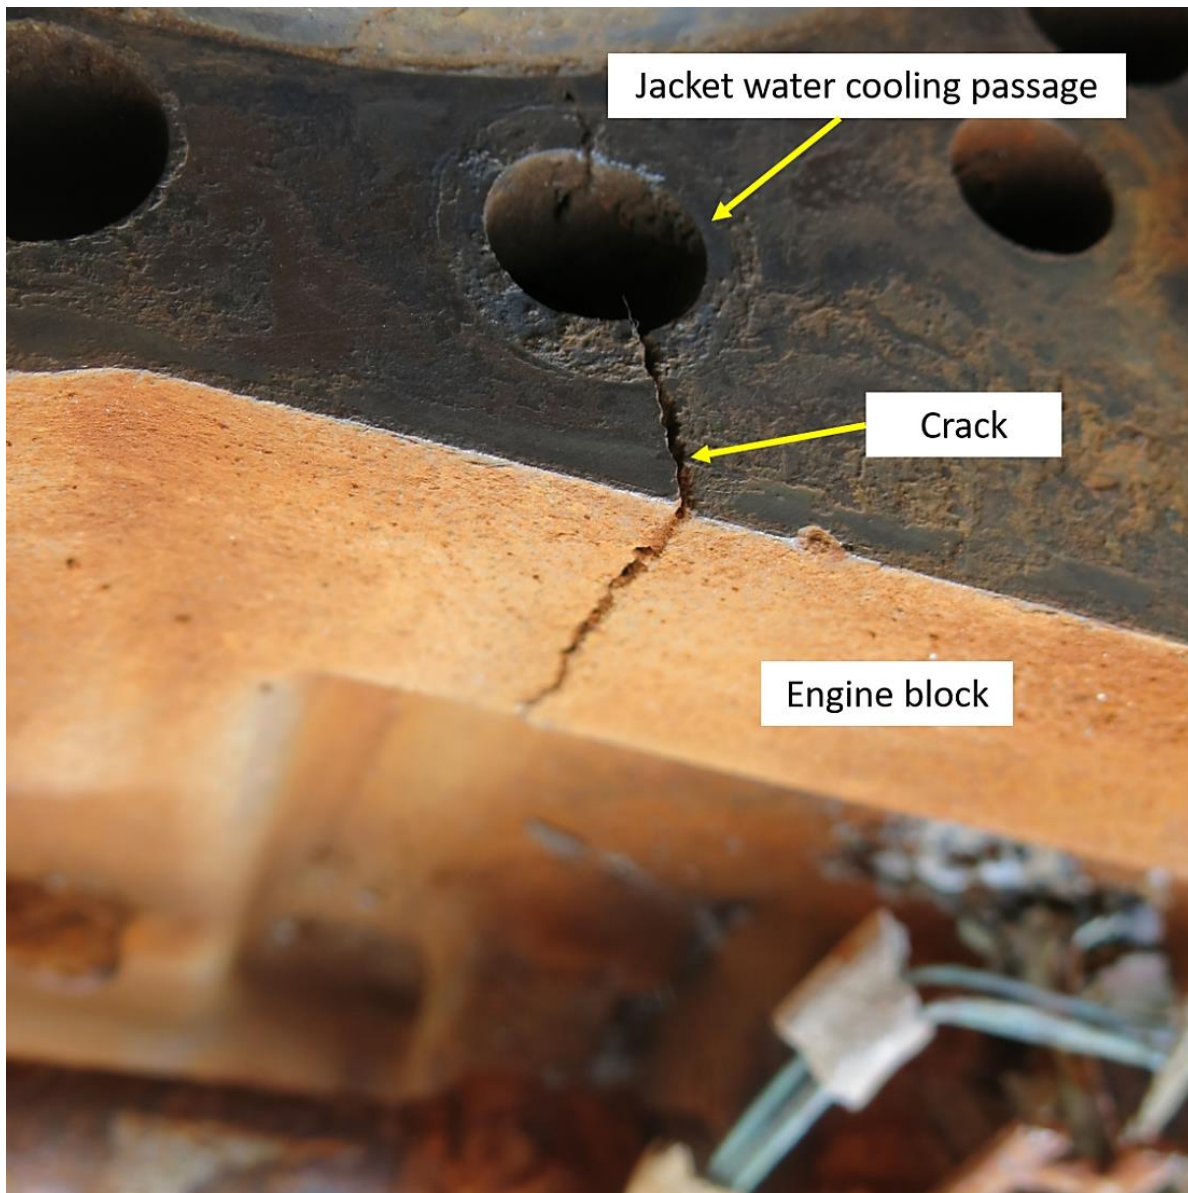
A service technician and a service manager from Ring Power—an authorized service company for Caterpillar—disassembled the port engine. A crack was discovered between the 4th and 5th cylinder on the port engine’s inboard side (figure 10). The crack was visible starting at the

no. 5 cylinder's liner through the cooling water passage and about 8 inches down the side of the block.⁸

Figure 10. Close-up of postaccident crack in the block between cylinders 4 and 5 on the *Island Lady's* port main engine.

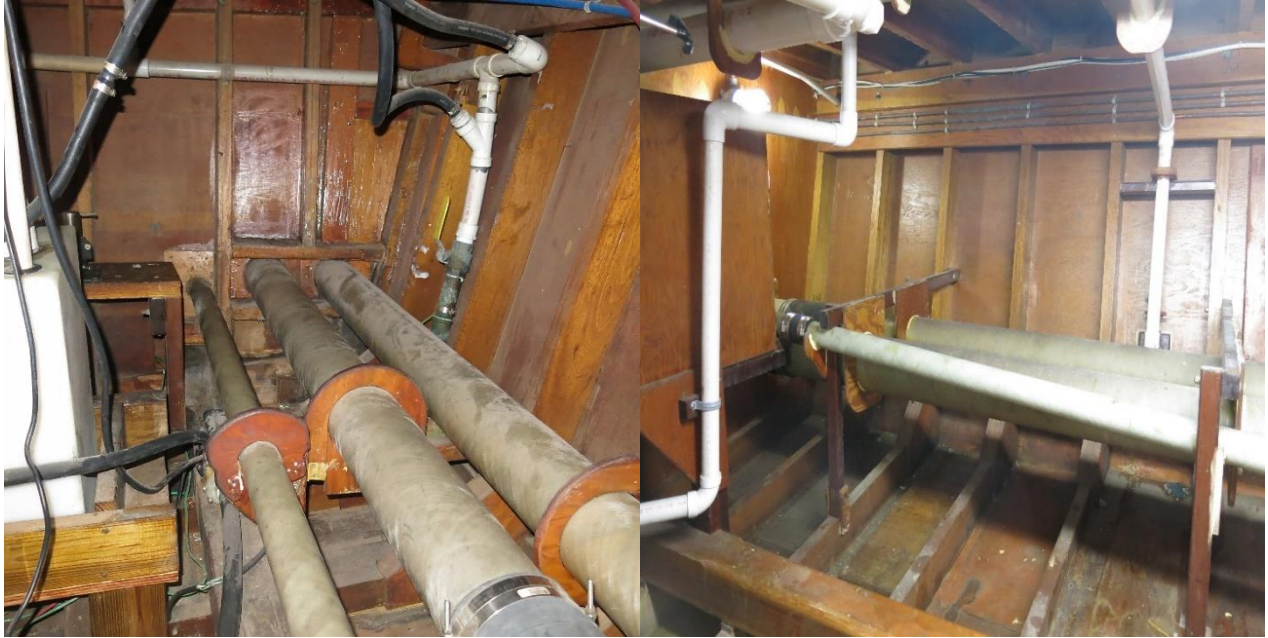
The exhaust tubes were constructed of fiberglass and connected with rubber joints. According to the vessel specifications obtained from the original owner, the original exhaust tubing was Vernatube, which was a resin-impregnated glass filament-wound tubing. The manufacturer stated that the original tubing was made exclusively with a fire-retardant resin formulated for high-temperature applications. However, Tropical Breeze Casino had since replaced some or all of this tubing: For example; according to March 2017 maintenance records, the company purchased and installed 22 feet of 8-inch exhaust tubing and 22 clamps, and the July 2017 maintenance records noted replacement of a leaking exhaust tube in the lazarette. Investigators obtained the purchase receipt to determine the properties of the replacement tubing. The tubing was Novaflex marine hard-wall water exhaust tubing, which the manufacturer stated met standards for marine wet-exhaust applications.

Figure 15. Engine exhaust tubes transiting through the lazarette spaces on board vessels constructed similarly to the *Island Lady*.

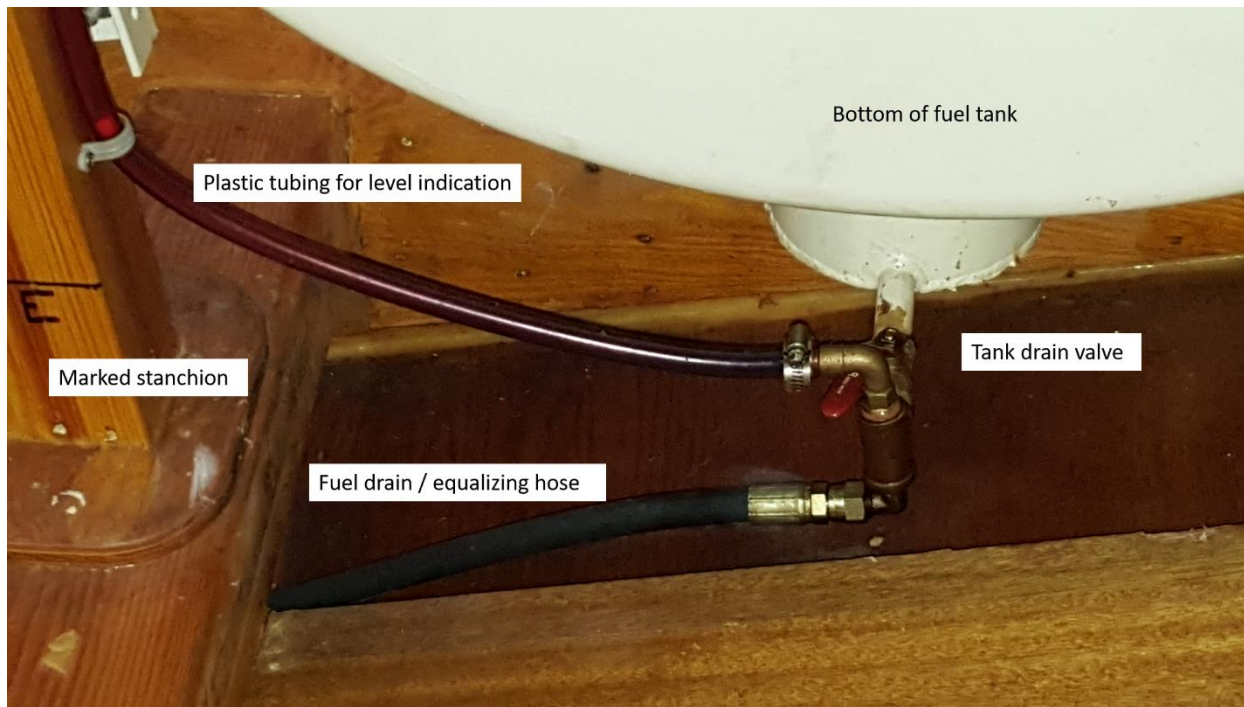
In accordance with Title 46 *CFR* 182.440 (a)(7), "tubular gauge glasses, if fitted to diesel fuel tanks, must be of heat[-]resistant materials, adequately protected from mechanical damage, and provided at the tank connections with devices that will automatically close in the event of rupture of the gauge or gauge lines." In March 2017, during a Coast Guard vessel examination of the *Island Lady*, the inspector found the fuel valves in the open position and photographed them (figure 16). The inspector told the crew to close the valves and he later looked for the regulation

about appropriate tubing material and automatic shutoff valves. He was unable to find the regulation and did not document the finding in the Coast Guard inspection report.

Figure 16. The *Island Lady's* fuel tank drain valve and plastic tubing to fuel-level indicator. (Image provided by the Coast Guard.)

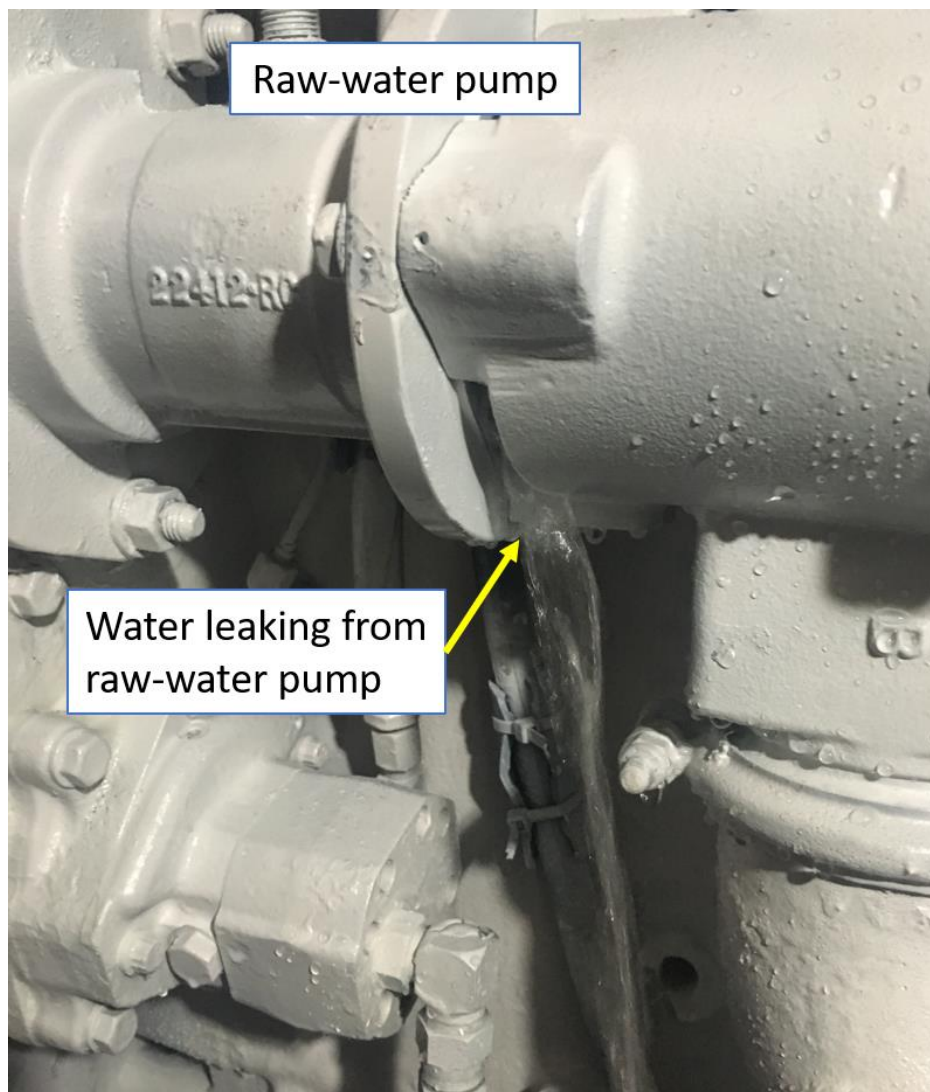
According to the monthly maintenance reports, the impellers of the raw-water pumps for both main engines were replaced in May 2017. No records were available to show the number of hours or days of operation on the impellers. Investigators obtained photos, taken by the engineer in connection with the replacement, of water leaking from the pump housing (figure 22) and of one of the old pump housings and rubber impellers before replacement (figure 23). At least six of the 12 vanes were missing from that impeller.

Figure 22. Water leaking from the *Island Lady's* raw-water pump before its May 2017 replacement, photographed by the engineer.

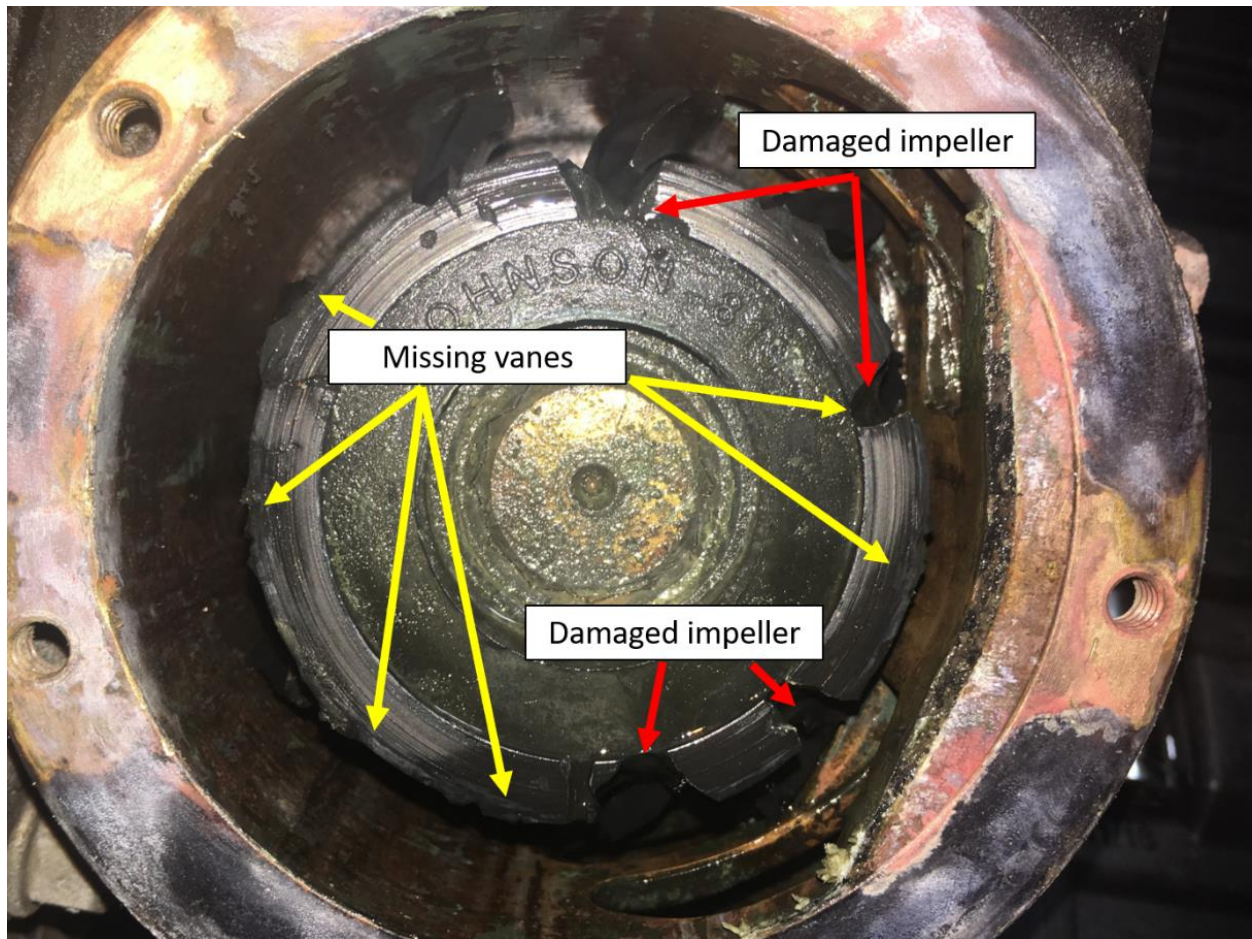
Figure 23. Raw-water pump housing and impeller from the *Island Lady* during the components' May 2017 replacement, photographed by the engineer.

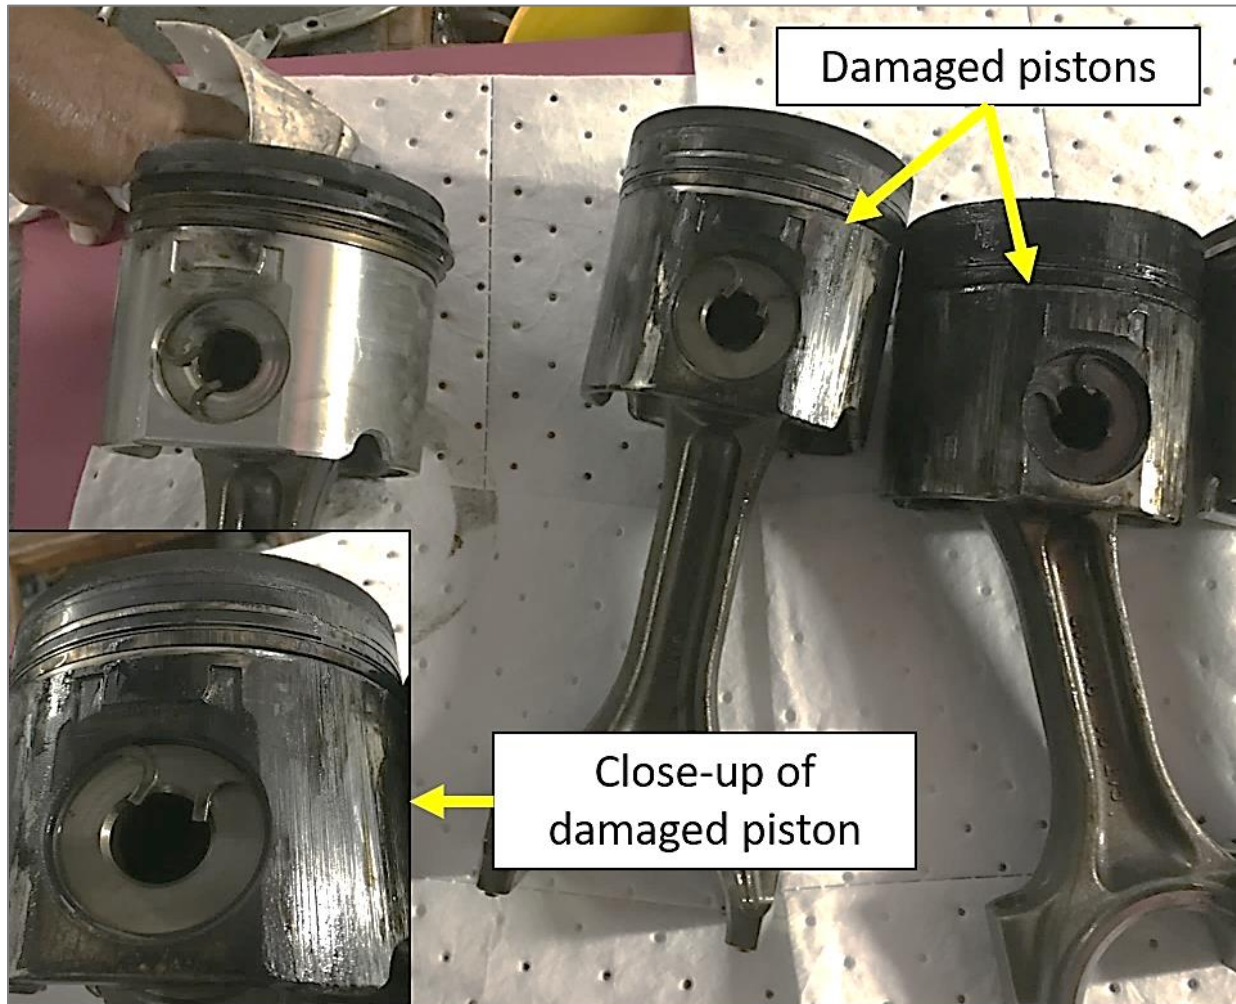
is operated with scored pistons, unburned fuel and the pressurized products of combustion are more likely to enter into the crankcase.

Figure 25. Removed pistons from the *Island Lady's* starboard engine during March 2017 overhaul, photographed by the engineer. The piston in the upper left shows no damage; the remaining pistons are scored.

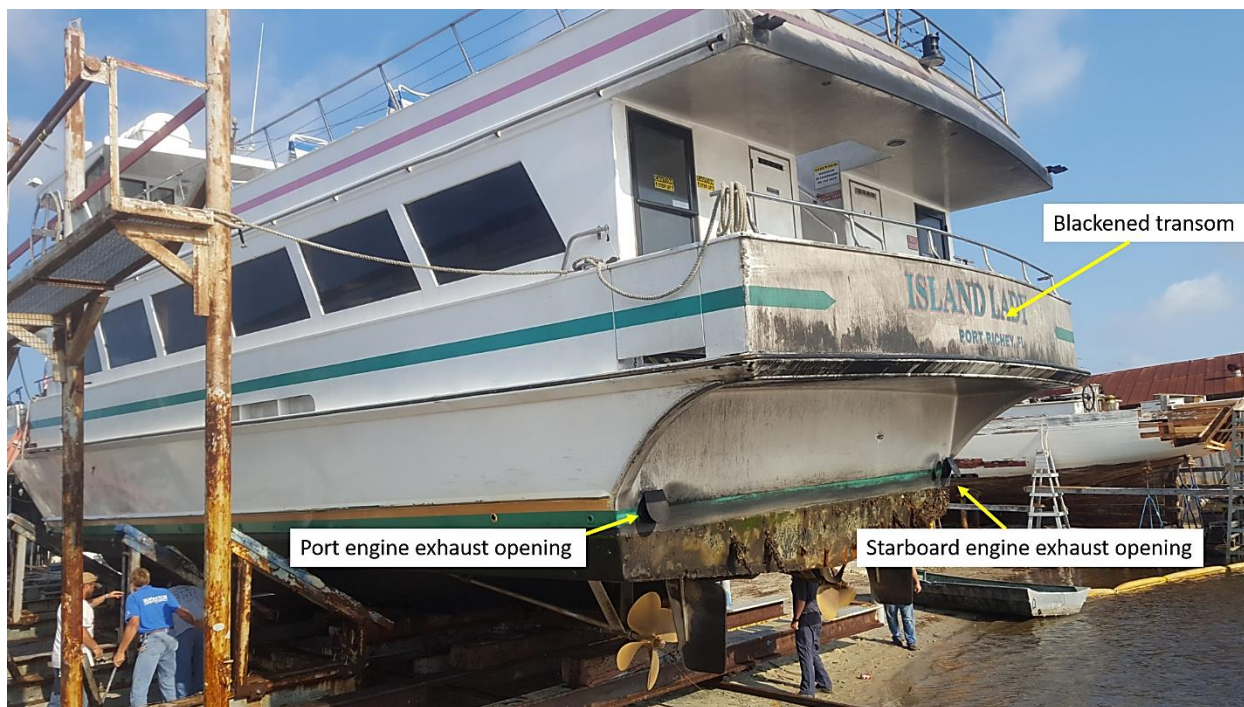
¹⁹ The Coast Guard noted some hull delamination near the propeller, a non-standard electrical cable on the water heater, and a missing flame shield on a generator fuel strainer.

Figure 26. Stern of the *Island Lady* while in drydock April 2017. (Photo by Coast Guard)
