HN-237
EN-79
NN-007

SERVICE BULLETIN

DATE: 26 SEPTEMBER 1994
PAGE 1 OF 6

FIREWALL FUEL FITTING MODIFICATION

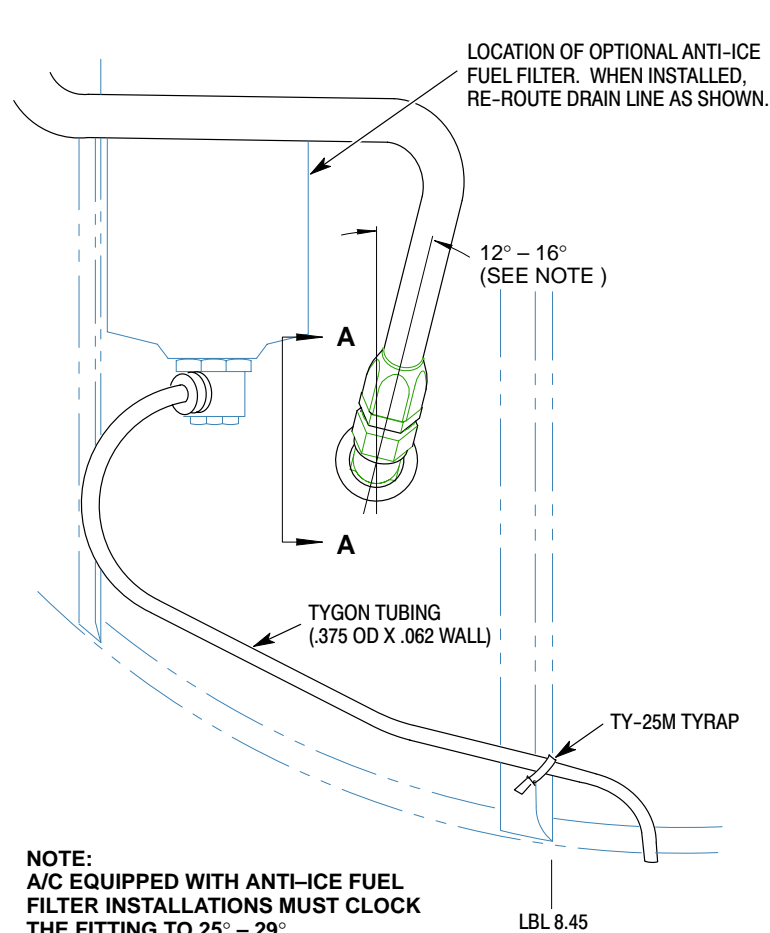
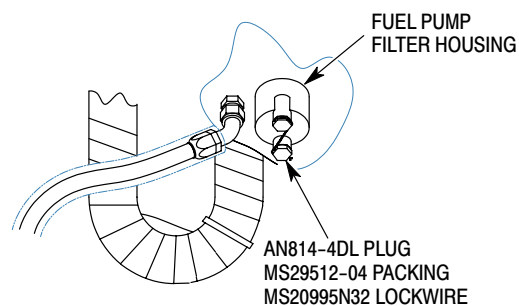
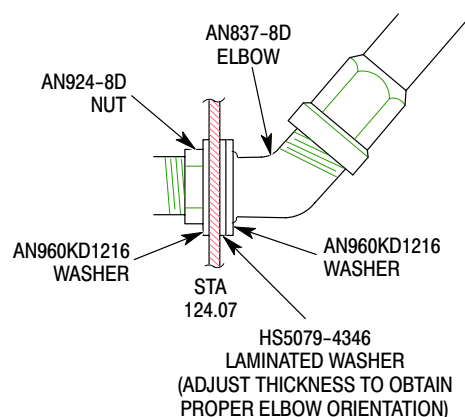
Figure 1. Firewall Fuel Fitting Modification (Installation).

MDHI has received reports from the field of the station 124 firewall fuel fitting interfering with the landing gear brace. As a result, there is a possibility of the fuel fitting becoming damaged, thus creating a potential for fuel leakage. Therefore, MDHI is requiring all operators to modify their aircraft according to procedures contained in this Notice.

- (3). Install AN924-8D (nut), (2) AN960KD1216 (washers), HS5079-4346 (laminated washer) and AN837-8D (elbow) as shown in Figure 1.
- (4). Ensure that AN837-8D is clocked 12° to 16° (25° to 29° for fuel systems equipped with anti-ice fuel filter installations) inboard as shown in Figure 1.

- (5). Reassemble fuel cell lacing per the HMI Vol. I, Section 28-00-00.
- (6). Re-install hoses to the AN837-8D fitting (see Figure 1). Torque hoses per the HMI-CSP-2, Vol. I, Section 28-00-00.

- (7). Install AN814-4DL plug, MS29512-04 packing and MS20995N32 lockwire to engine fuel pump housing 369A8100-507 configurations only at location shown in Figure 1.
- (8). Re-fuel aircraft per servicing instructions contained in the Handbook of Maintenance Instructions (HMI).
