NTSB ID: WPR12LA407

Subject: N21MX MXS Wreckage Inspection and Findings

Location: Aircraft Recovery Services (ARS) , Pearblossom, CA

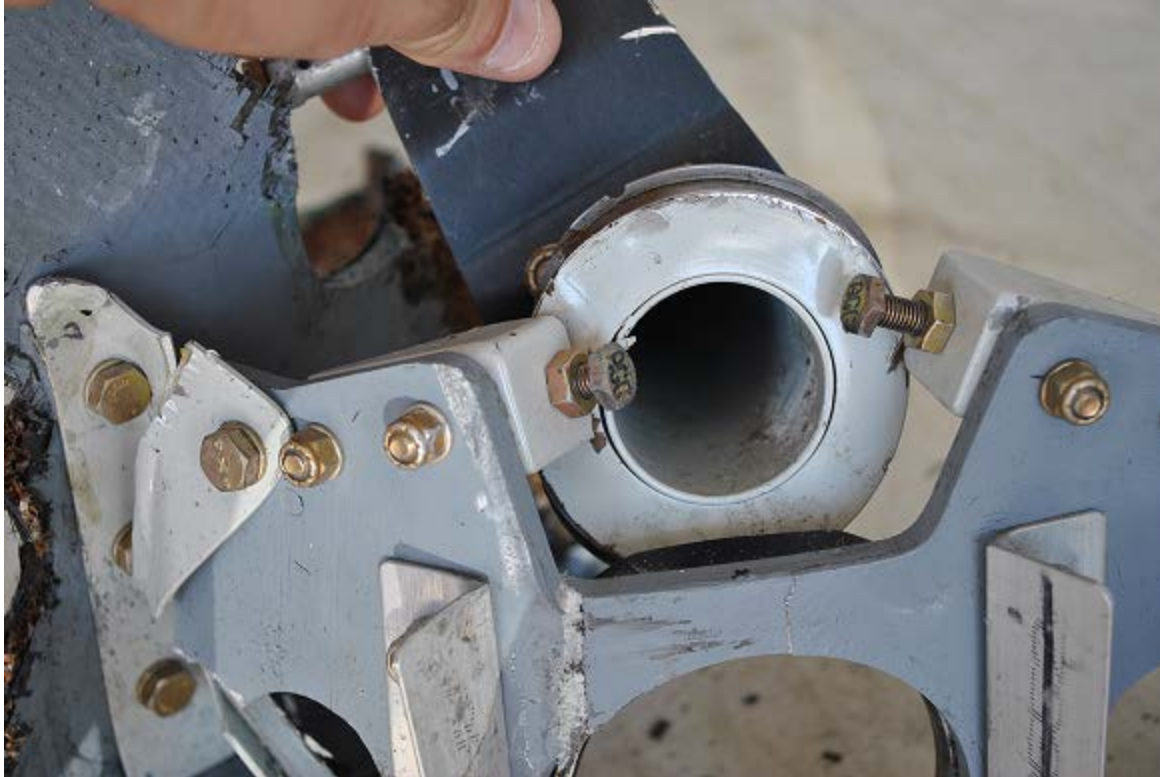
Prior to impact, the torque tube was dislodged from the forward torque tube bearing. The torque tube assembly controls the ailerons and elevator. Failure of this component in this manner would result in the pilot's inability to control the aircraft in pitch and roll.

The forward torque tube bearing had been installed on N21MX in a manner inconsistent with the design of the MXS aircraft. The correct placement of the forward and aft torque tube bearings ensures proper operation and retention of the torque tube assembly.

Shown above is the position of torque tube assembly/ front torque tube bearing assembly at impact. Reference witness marks on forward face of torque tube with aileron stop brackets. Reference aluminum used to attach bearing assembly to airframe. Reference aluminum extruded channel added as stiffener to either side of bearing.

Furthermore, to ensure no potential for field modifications is present, MX Aircraft will release an inspection procedure for owners of MXS aircraft to perform a visual inspection to verify that the correct installation of the torque tube bearings exists. MX Aircraft will contact each owner and record the results of the inspections for NTSB review.

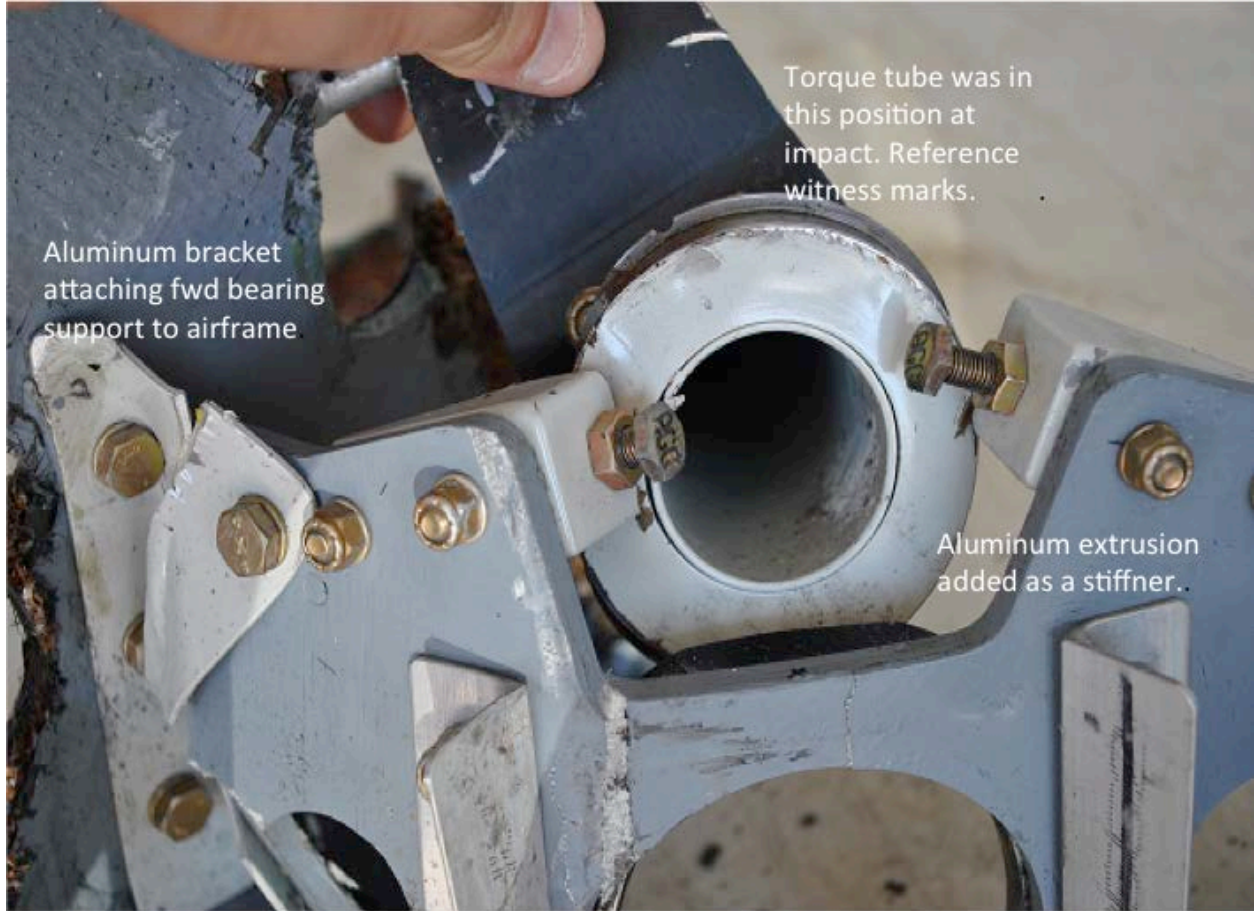
Torque tube was in this position at impact. Reference witness marks.

Aluminum bracket attaching fwd bearing support to airframe

Aluminum extrusion added as a stiffener.
