Installation of Upper/Lower Bolts on MLG Uplock Assembly

ATLANTIC
SOUTHEAST
AIRLINES™

ALERT BULLETIN

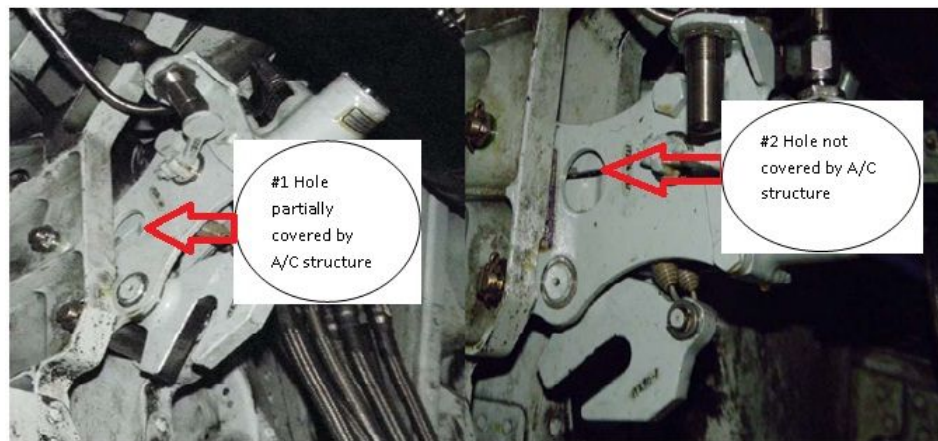
Synopsis It has been discovered that the upper bolt of the MLG uplock can be installed improperly.

Bombardier released AOM 1307 to notify operators of this event. See the below figure.

#1 - Bolt installed through the Airframe Structure and MLG Uplock.

#2 - Bolt not installed through the MLG Uplock, but Airframe Structure only.

Action Required When installing a MLG uplock assembly, ensure that you follow the AMM TASK 32-32-05-400-801 and/or Bombardier Task Card precisely.
