## Continental Motors, Inc. Magneto Analysis Report

| Engine Model: | Lycoming IO-540-K1B5 | Engine S/N: | L-15134-48A C (converted) | |
| Aircraft Make/Model: | Piper PA-32-300 | Aircraft S/N: | 32-40641 | Registration N4267R |

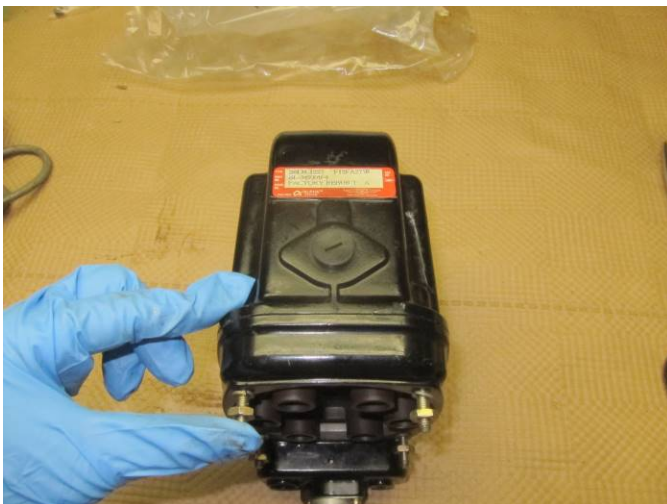
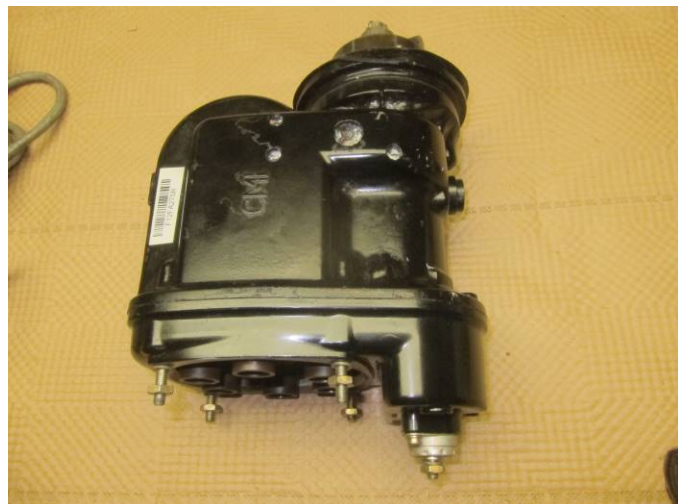
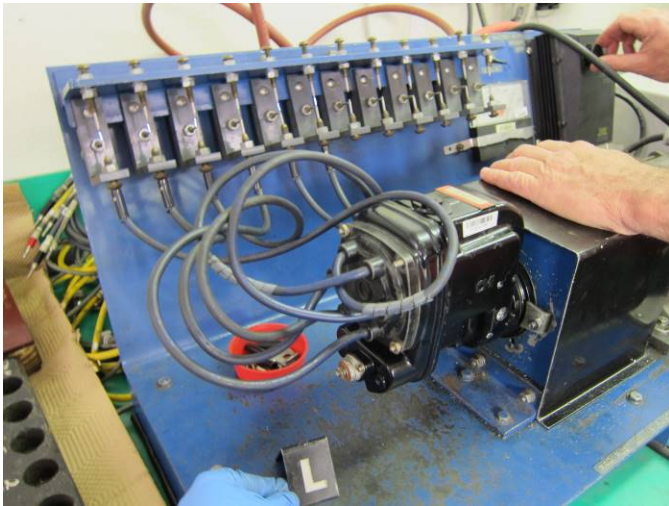
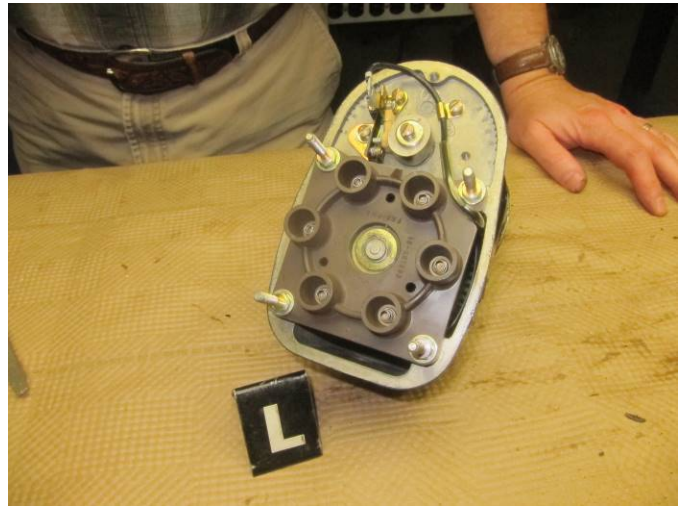
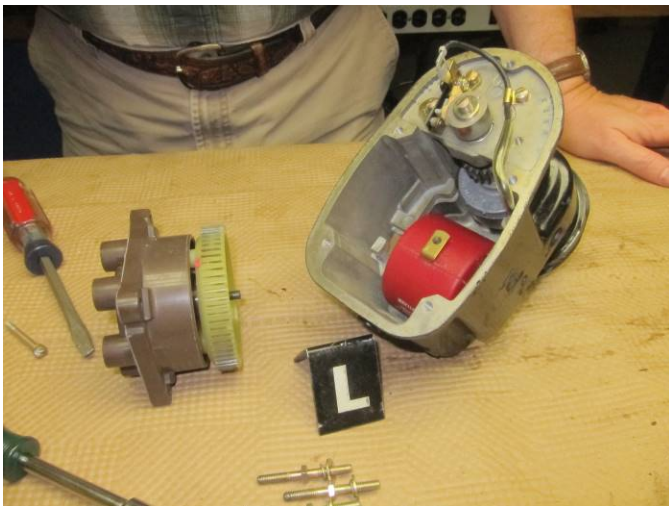
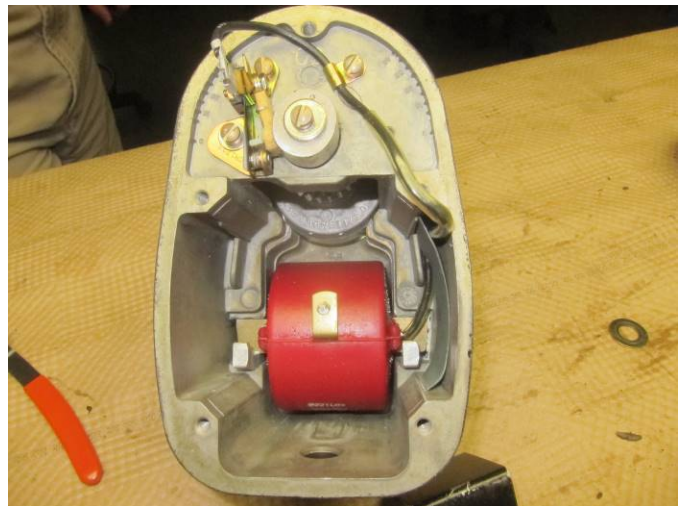
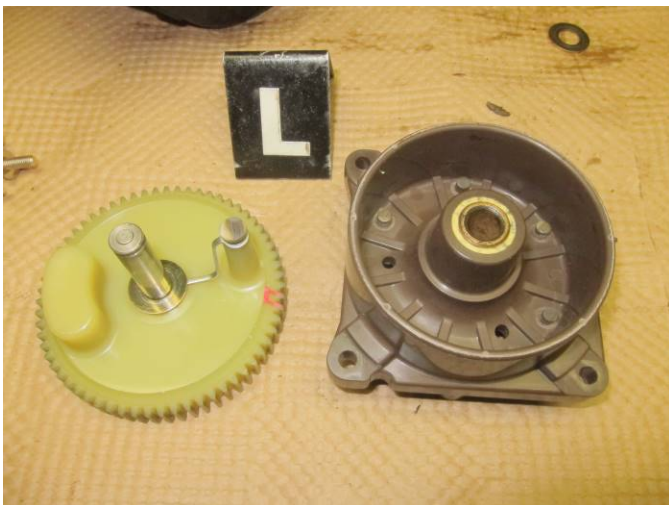
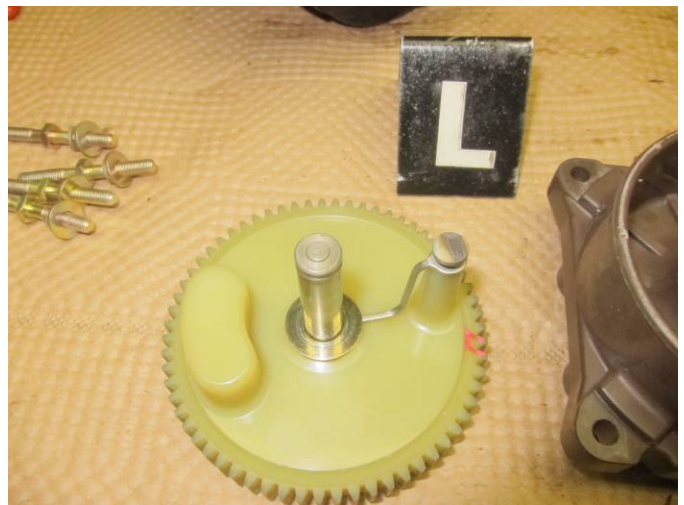
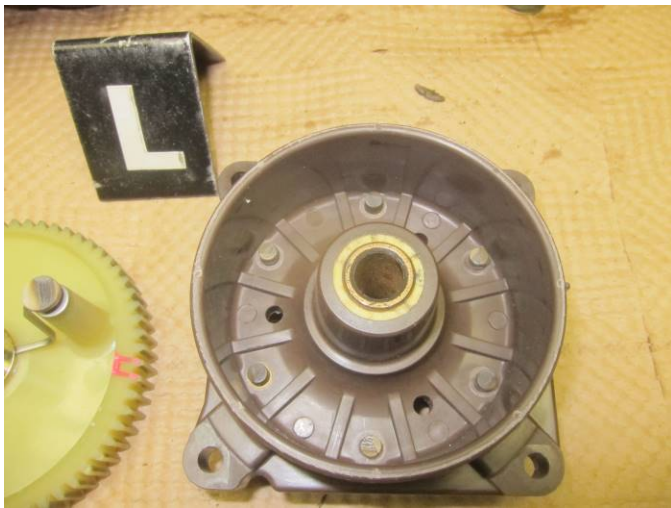
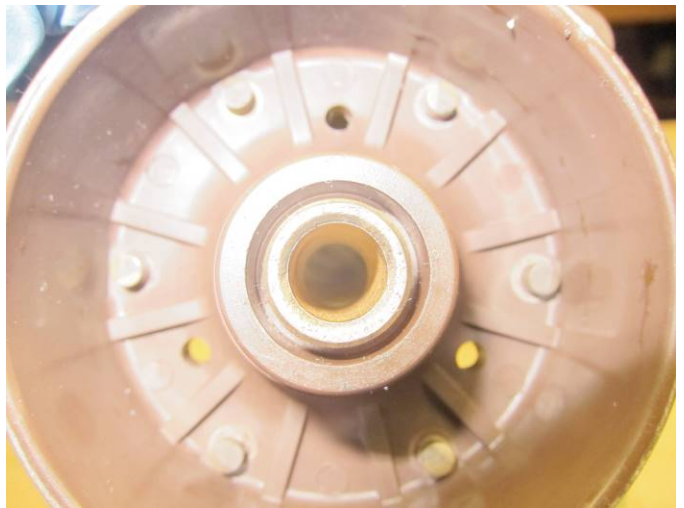
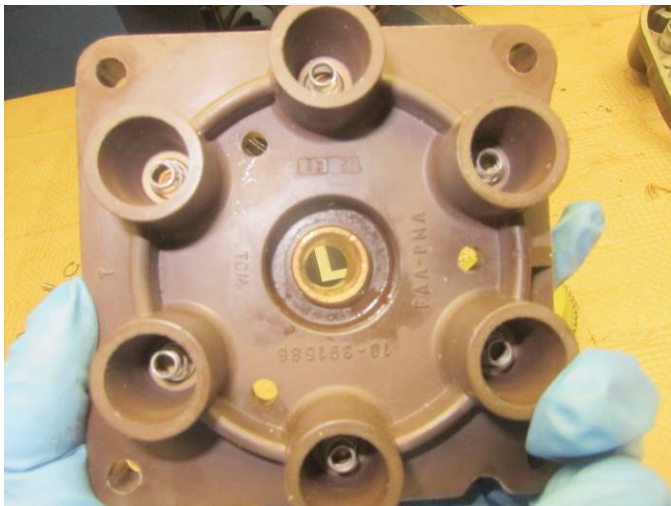
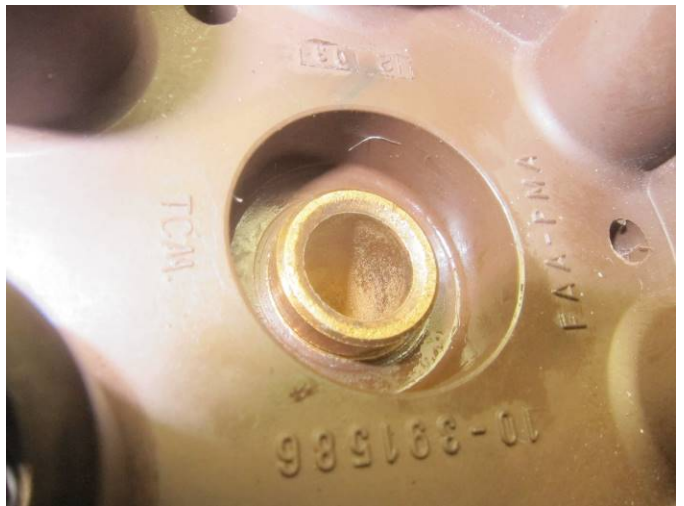
### LEFT MAGNETO:

The left magneto's internal timing was checked using a magneto timing light and visually examining the distributor gear position through the timing port. The internal timing was correct. The magneto was placed on a test bench and each lead produced a spark across a 7mm gap throughout all operating speeds. The impulse coupling functioned properly.

The magneto was disassembled to examine the distributor gear. Examination of the distributor gear while the axle was installed in the distributor block bushing revealed no discernable radial or axial play. There were no anomalies noted with the left magneto's internal components.

The date stamp of the left magneto's distributor block indicated that it was from the third batch from 2012. The date stamp on the left magneto's distributor gear was from 2012.

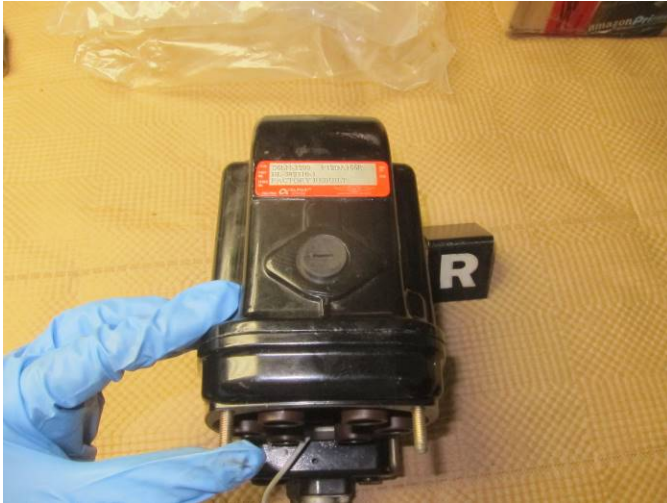
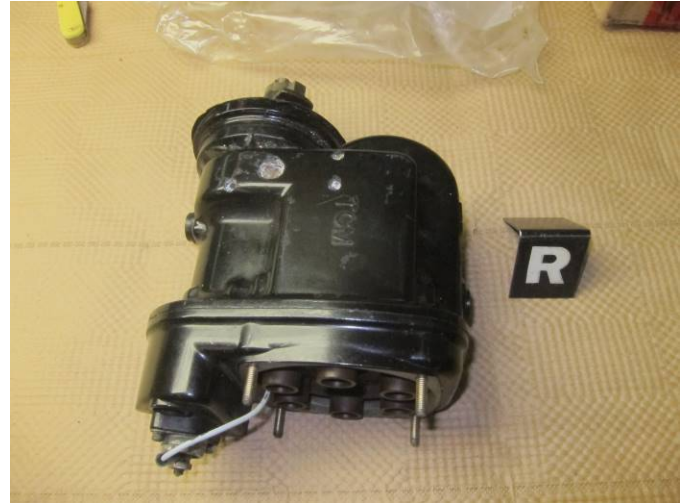
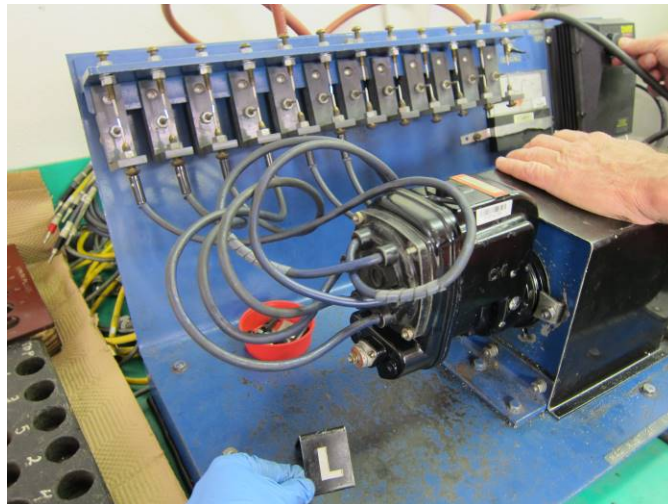
The right magneto's internal timing was checked using a magneto timing light and visually examining the distributor gear position through the timing port. The internal timing was trailing by three distributor gear teeth. The magneto was placed on a test bench and each lead produced a spark across a 7mm gap throughout all operating speeds and in firing order.

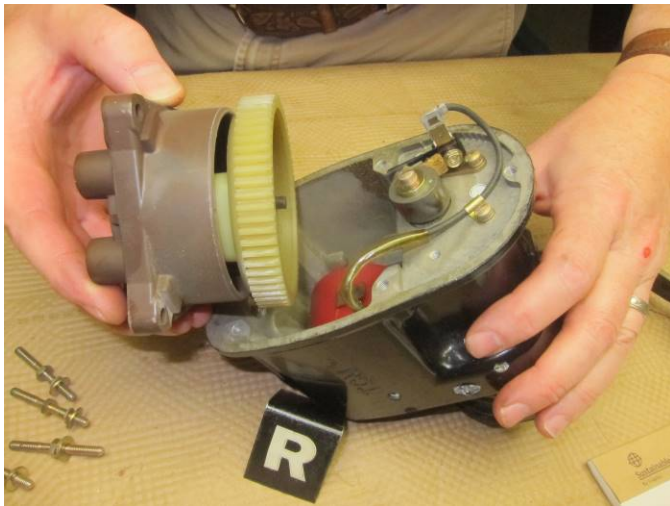
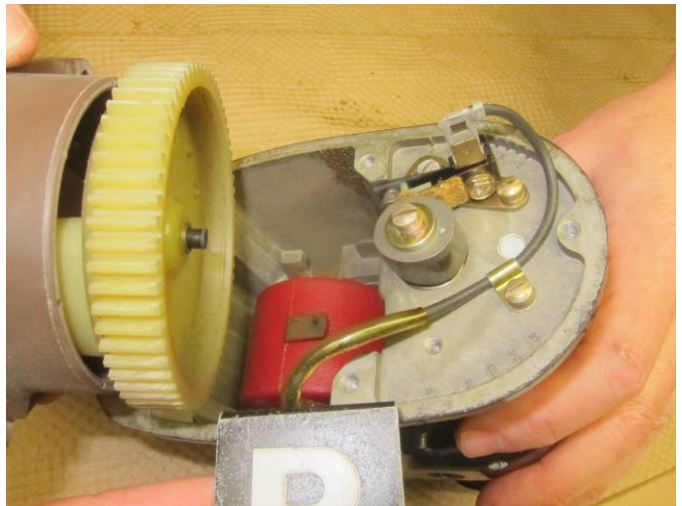
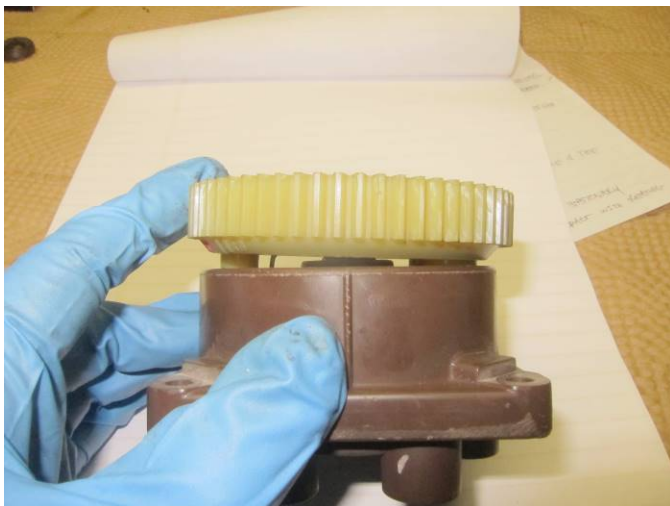
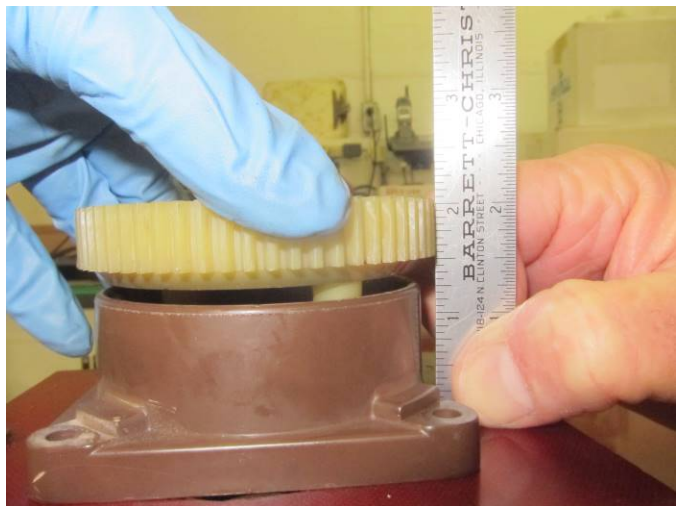
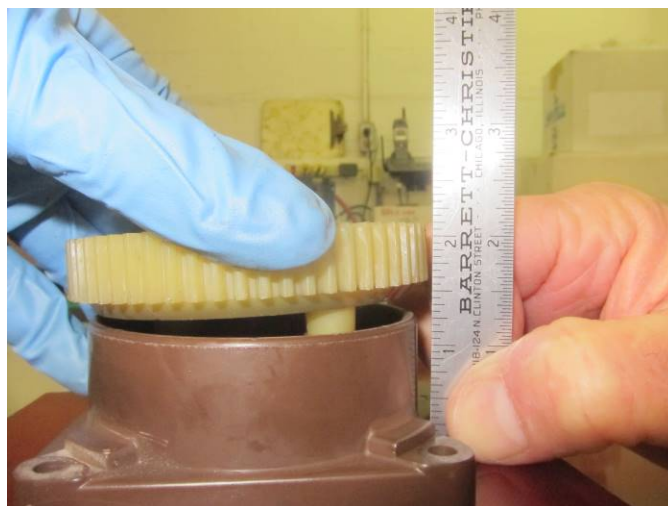
The magneto was disassembled to examine the distributor gear. Examination of the distributor gear while the axle was installed in the distributor block bushing revealed there was a significant angular displacement between the gear and the block.

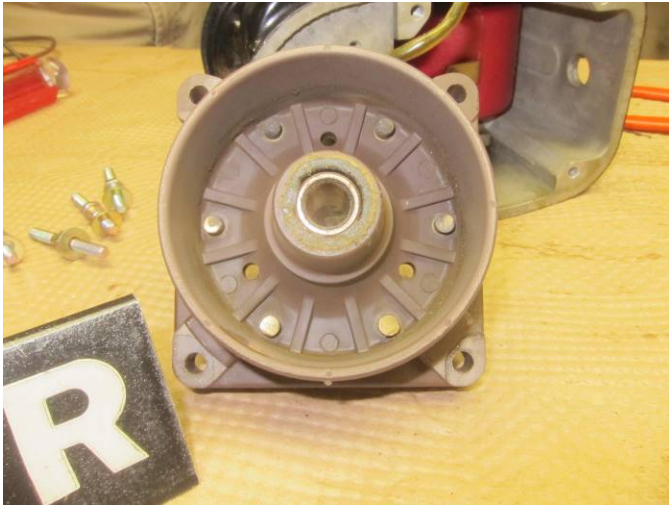
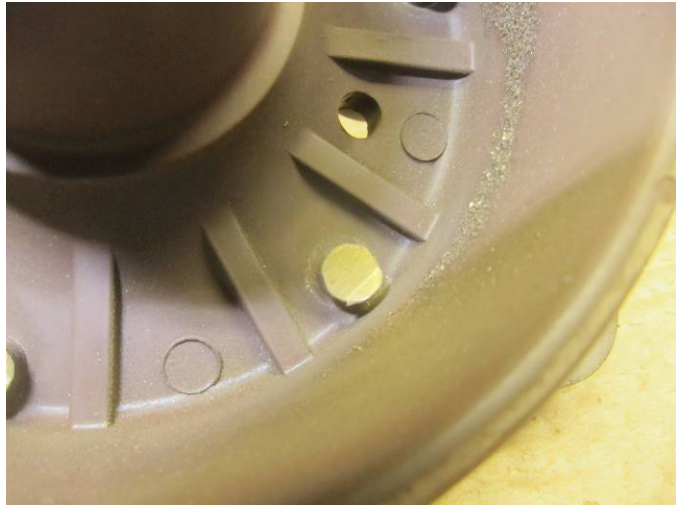
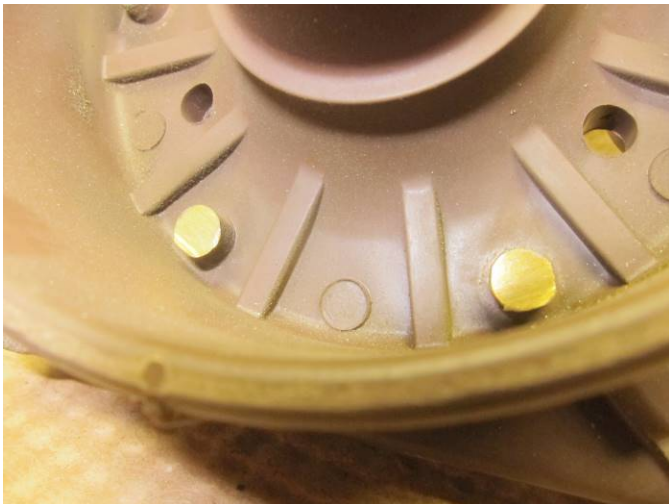
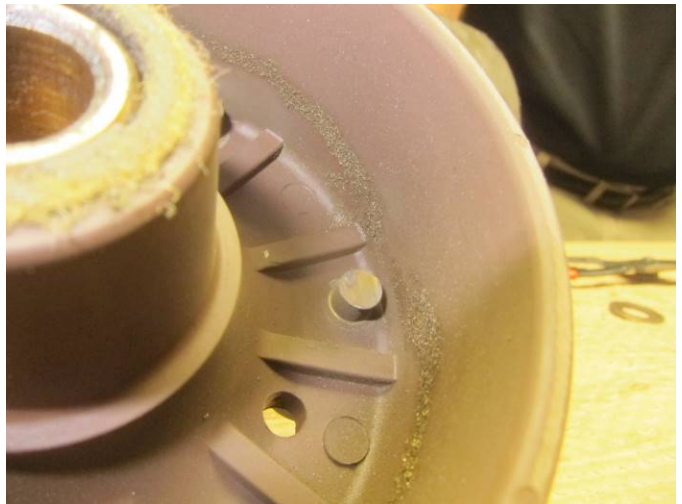
The distributor gear was removed from the distributor block. Four of the six fixed electrodes were mechanically damaged and some of the material had been shaved off of the electrodes. Some brass shavings/chips were found on the inside circumference of the distributor block.

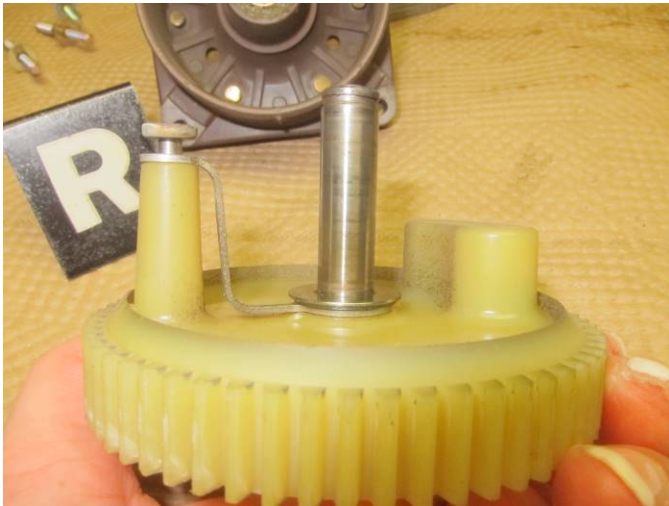
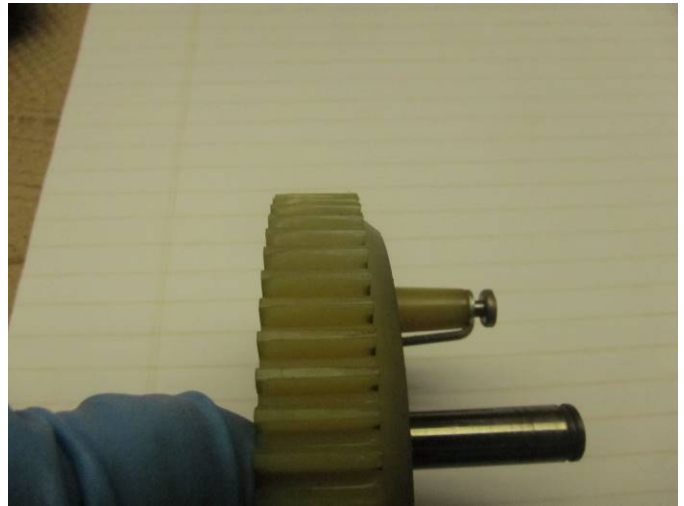
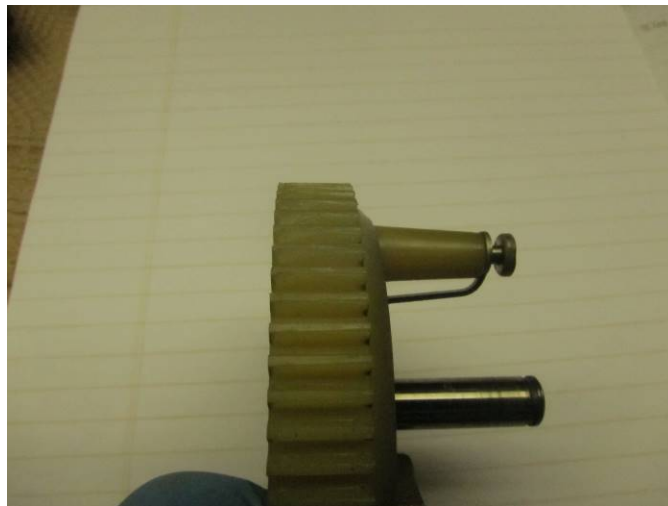
The distributor gear teeth displayed a worn condition on the carbon-brush-end of the gear. A number of the distributor gear teeth apexes displayed mechanical deformation damage consistent with imprints left from the drive gear teeth.

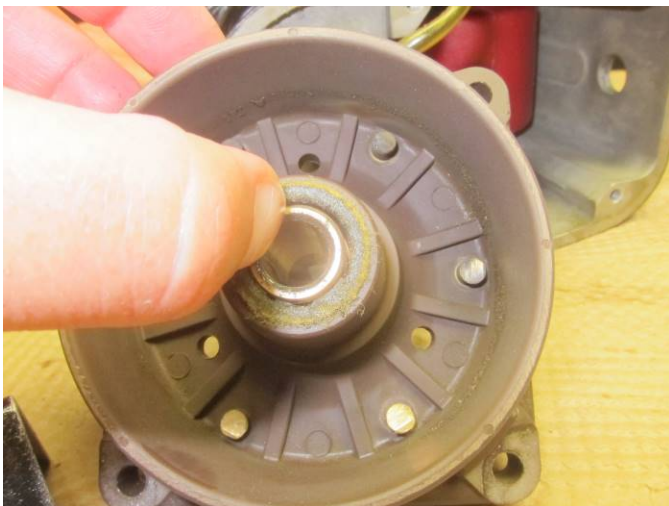
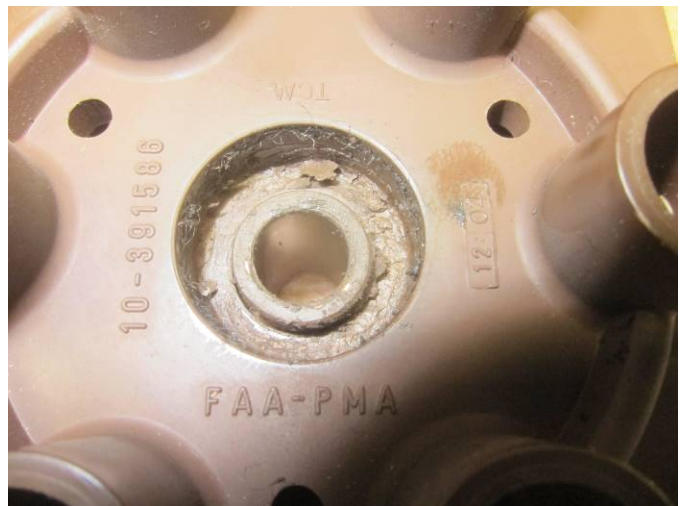
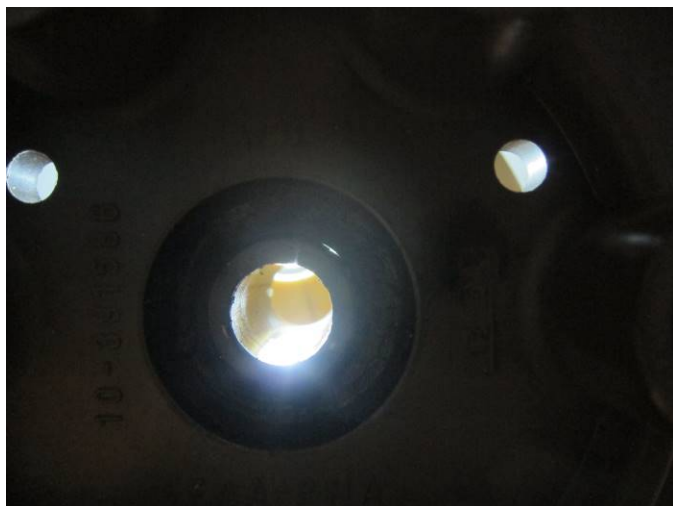
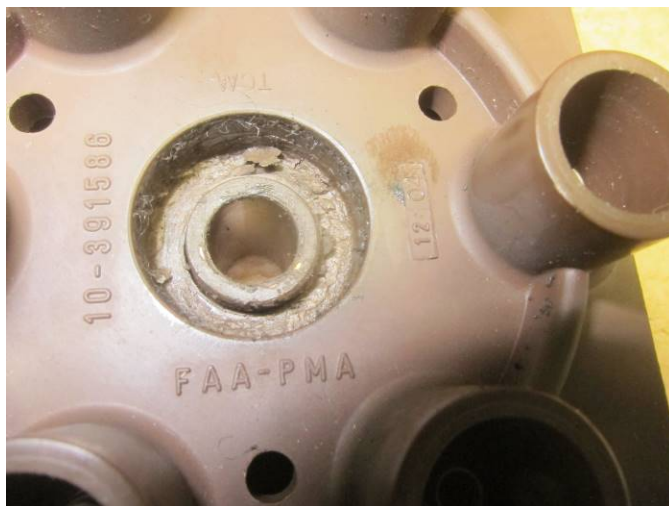
Examination of the distributor block revealed that the bushing, in which the distributor gear axle rides and which is normally molded into the block, was loose. Visible gaps were noted between the bushing and the housing and fragmented block material was noted under the felt strip and felt washer.

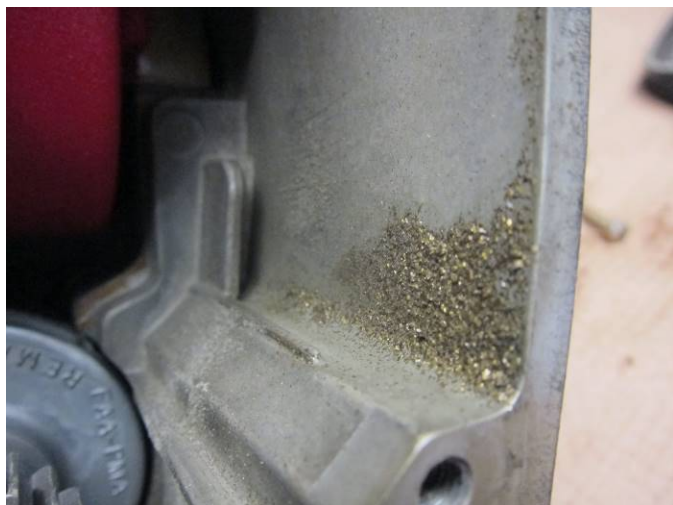
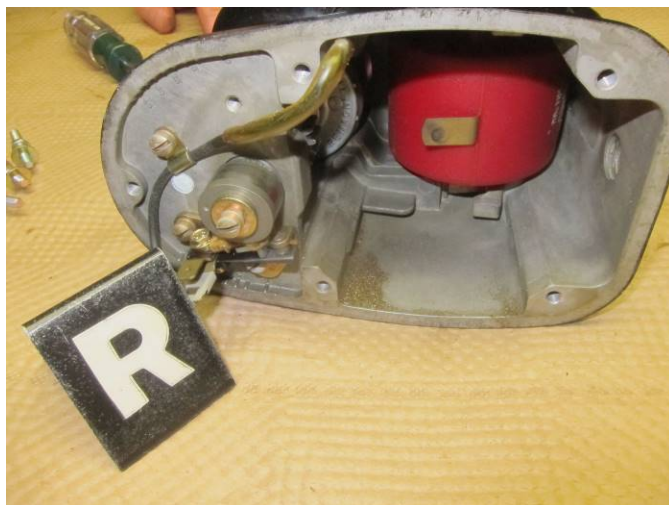
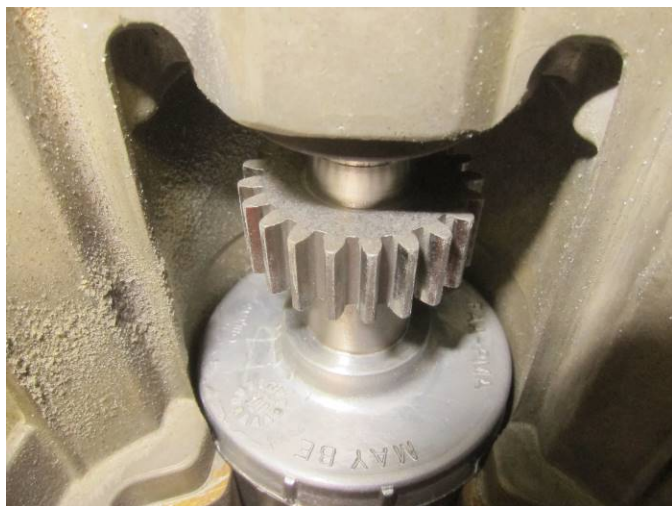
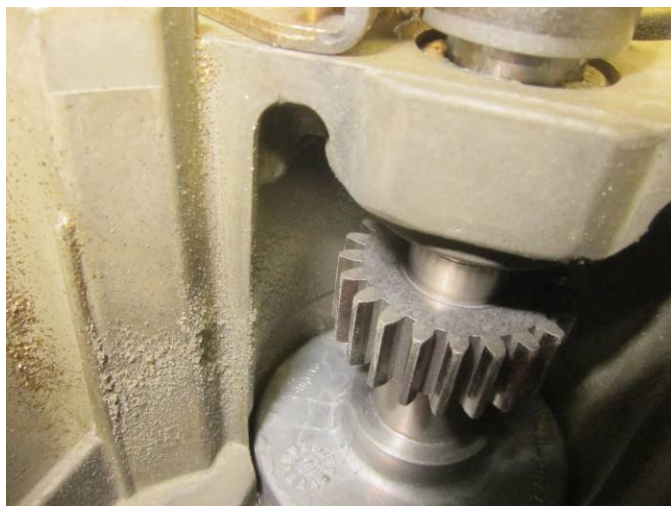
The magneto housing contained brass shavings/chips consistent with the material that had been removed from fixed electrodes. The drive gear was intact and did not display any discernable axial or radial play. A pale dust was noted on the magneto housing around the drive gear. The pale dust was consistent with material worn from the carbon-brush-end of the distributor gear teeth.
