NATIONAL TRANSPORTATION SAFETY BOARD

MAGNETO EXAMINATION FIELD NOTES

Location: Morrisville, New York
Date: September 20, 2015
Time: 1251 EDT
Aircraft: N22721, Cessna 150H

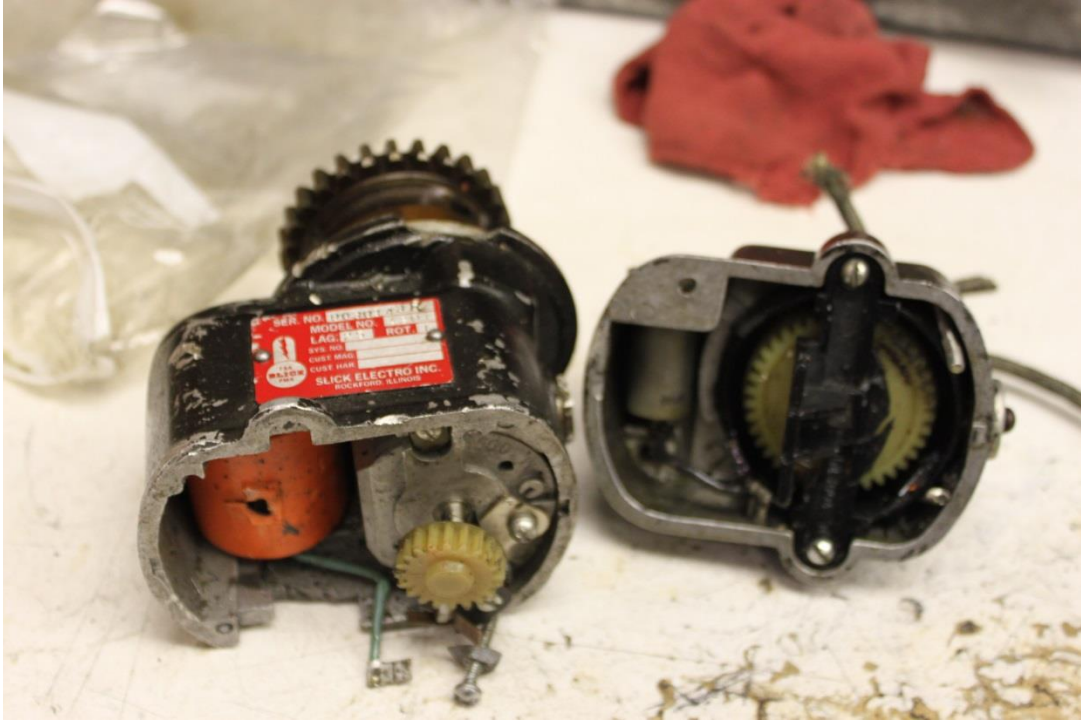
The magneto was placed on a bench as received for examination ([Figure 1](#)). Impact damage precluded operational testing of the magneto assembly. Examination revealed the mount flange of the frame was broken in one place. An impulse coupling was installed and felt satisfactory during hand rotation of the rotor. The spring of the impulse coupling was removed and the spring was not broken ([Figure 2](#)). The rotor shaft was bent but the rotor gear remained installed; no teeth of the rotor gear were missing and the rotor was tightly installed to the shaft ([Figure 3](#)). The coil remained installed in the frame by the 2 coil wedges, but the coil tab was broken off ([Figure 4](#)). The black colored wire from the coil remained securely attached to the frame, and the green colored wire from the coil was separated from the contact points (done during field investigation). The primary and secondary resistance of the coil measured 0.7 and 14,000 Ohms, respectively (Primary specification is 0.50 to 1.2 Ohms and Secondary specification is 13,000 to 20,500 Ohms). The distributor housing was separated but the capacitor remained secured to the distributor housing. The distributor gear and block remained secured to the distributor housing and the support bar was in-place but broken ([Figure 5](#)). Examination of the distributor gear revealed no missing teeth and the electrode remained tightly secured with no abnormal wear noted ([Figure 6](#)). The carbon brush remained installed but was fractured. The distributor block electrodes were satisfactory, and check of the distributor block and support bar for carbon tracing using a high tension tester was negative. The points were tightly installed and were misaligned. Slight pitting and normal wear of the point surfaces was noted. The capacitor was electrically tested and found to read 0.369 microfarads (MFD); specification is 0.35 MFD plus or 10 percent when tested at 400 volts DC ([Figure 7](#)).

Figure 1: Left Magneto As First Viewed

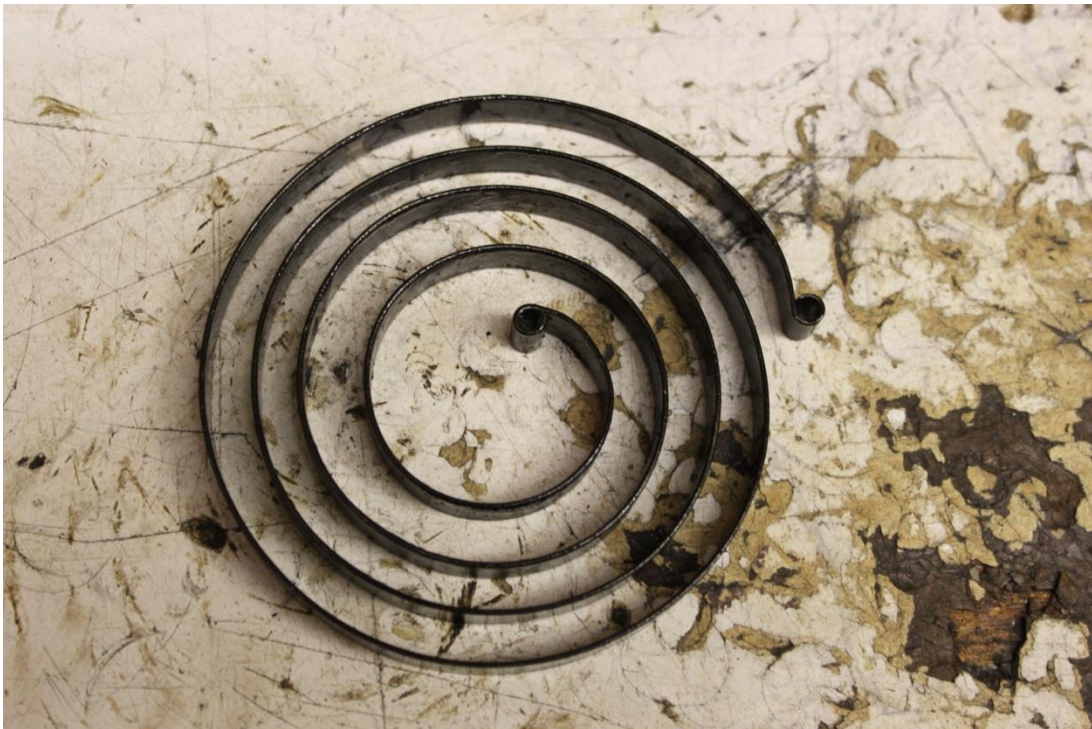
Figure 2: Left Magneto Impulse Coupling Spring

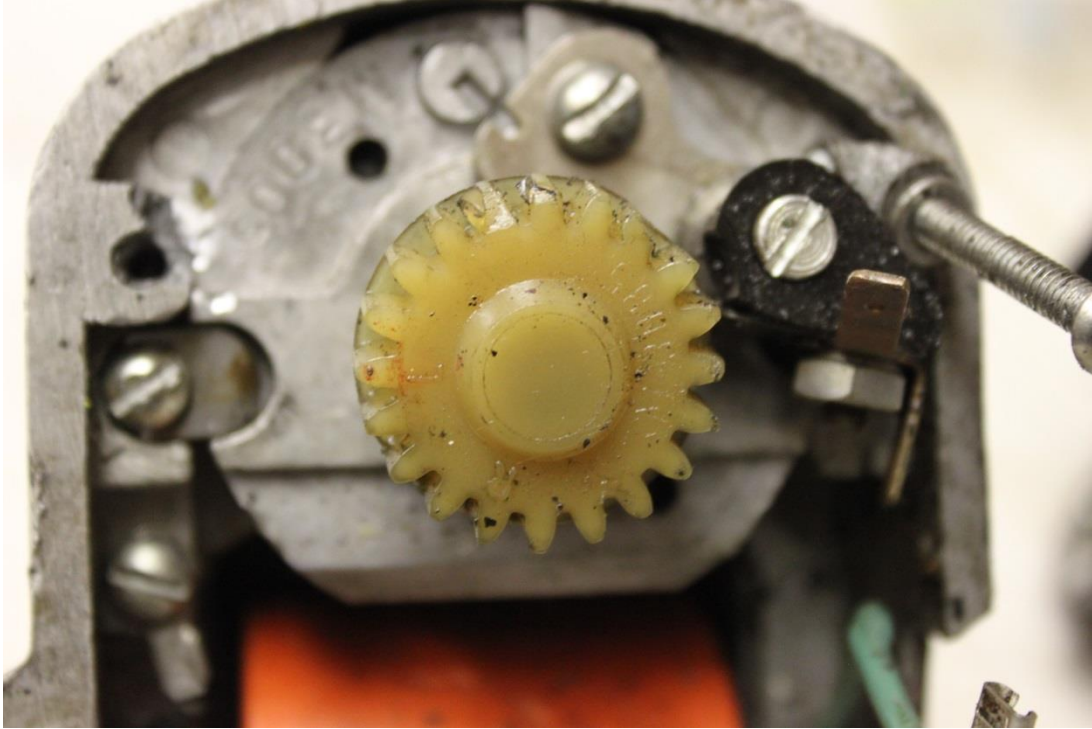
Figure 3: Left Magneto Rotor Gear

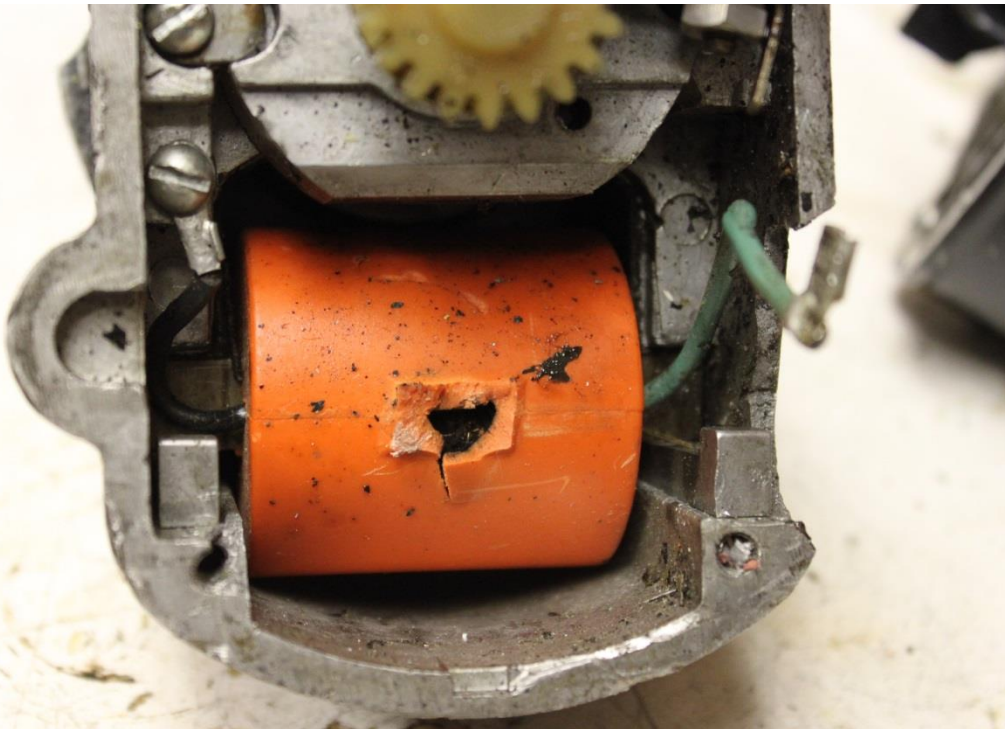
Figure 4: Left Magneto Coil

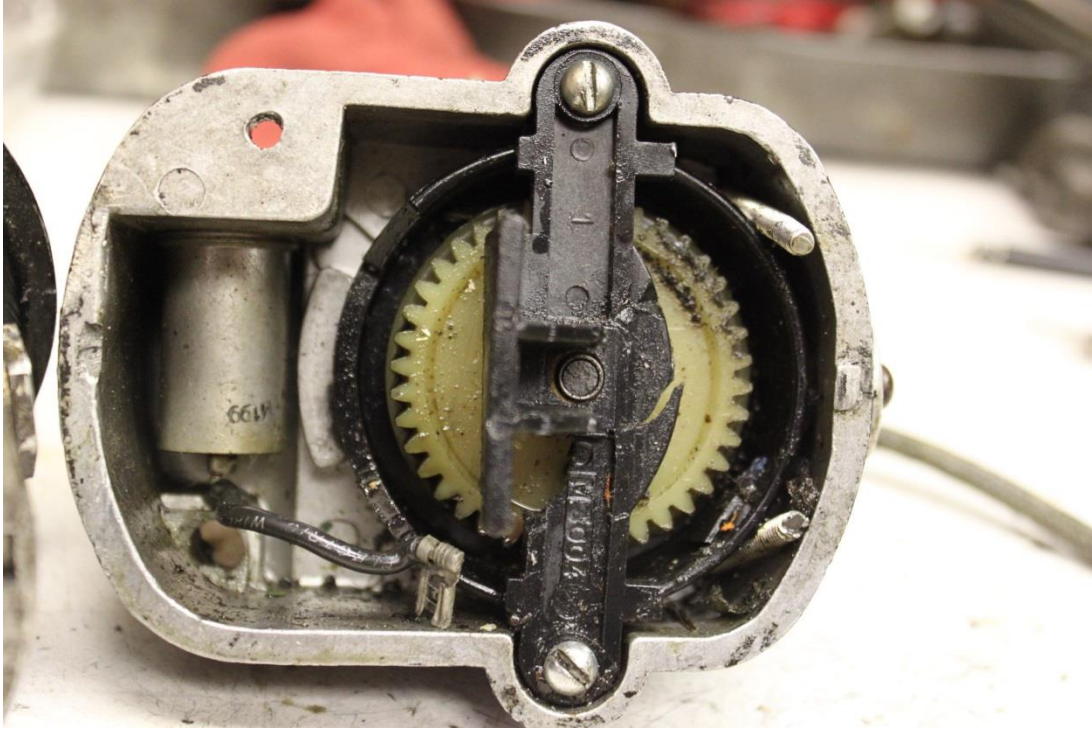
Figure 5: Left Magneto Distributor Housing

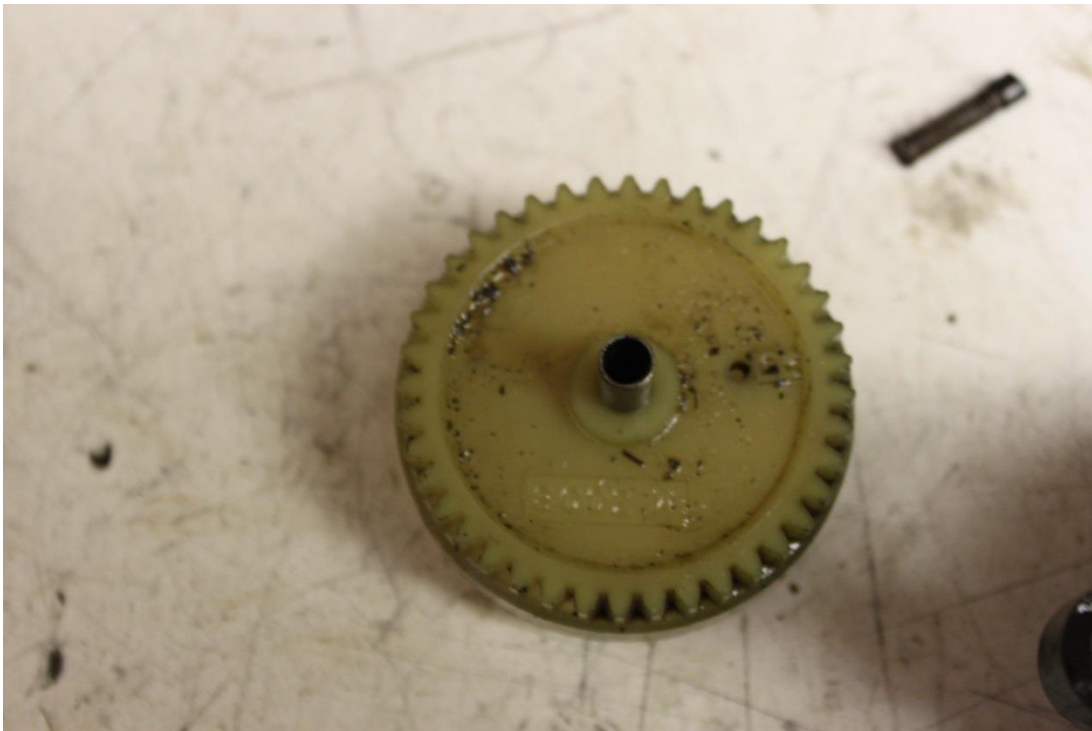
Figure 6: Left Magneto Distributor Gear

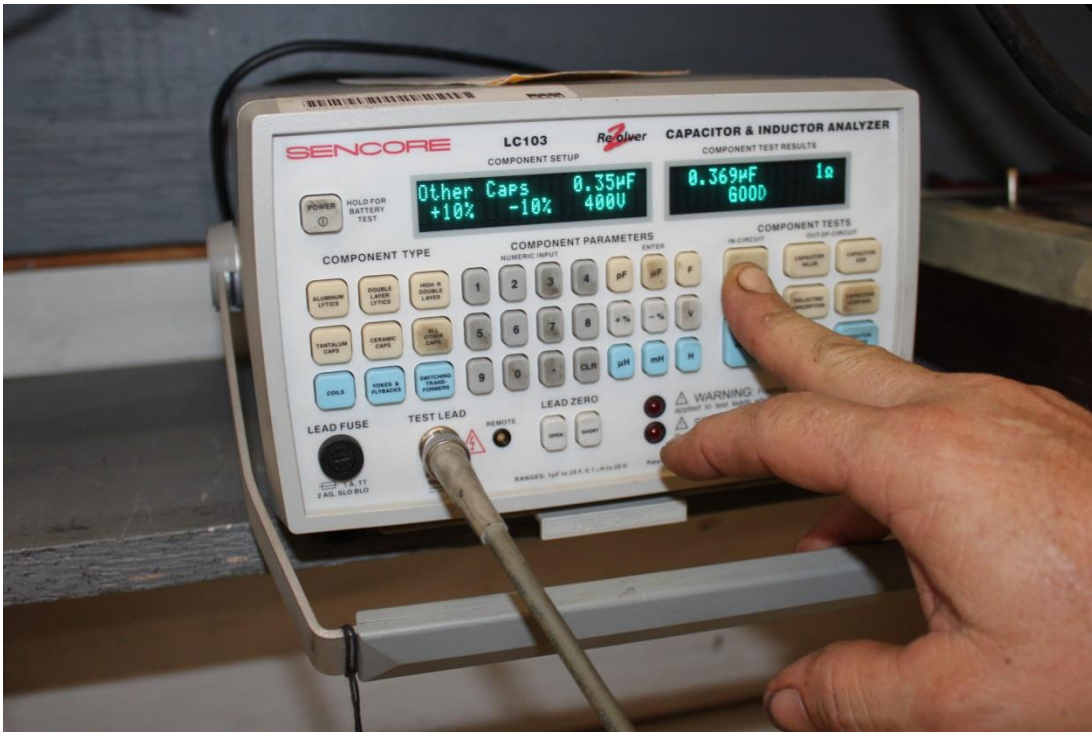
Figure 7: Test Results of Left Capacitor

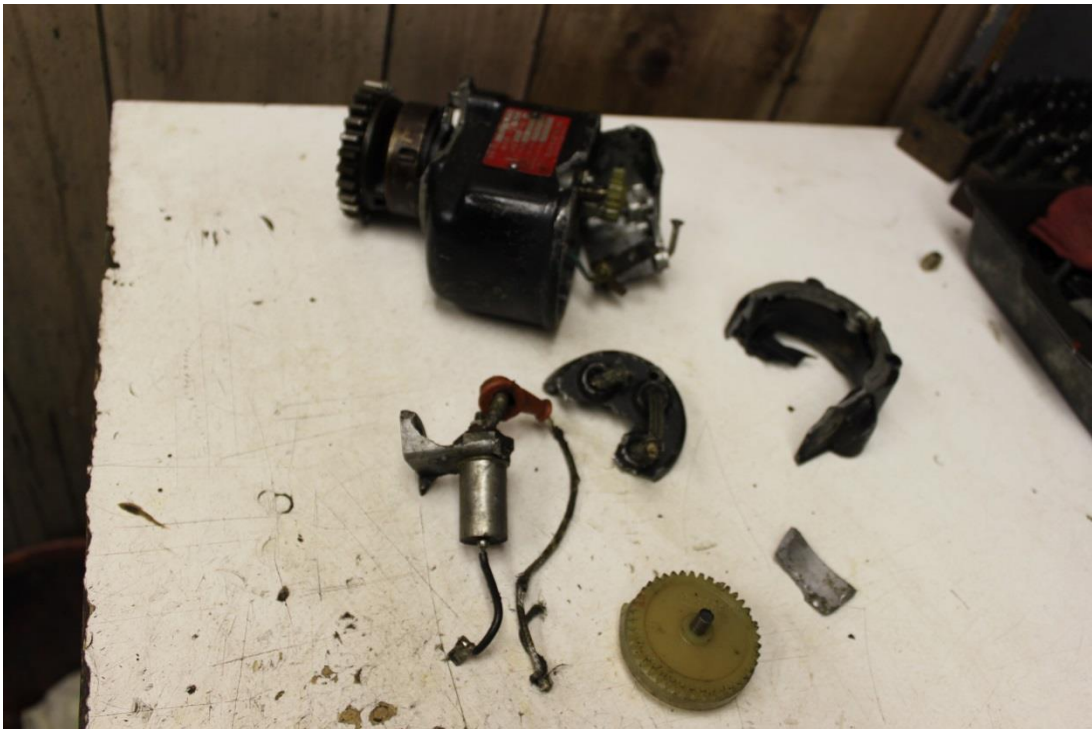
The magneto was placed on a bench as received for examination ([Figure 8](#)). Impact damage precluded operational testing of the magneto assembly. Examination revealed the mount flange of the frame was broken in 3 areas. An impulse coupling was installed and felt stiff initially during hand rotation of the rotor, but felt satisfactory after continued rotation of the rotor. The spring of the impulse coupling was removed and the spring was not broken ([Figure 9](#)). The distributor housing was fractured into 3 pieces and the capacitor/condenser was separated from the distributor housing. The rotor gear remained tightly installed to the rotor shaft but the rotor gear exhibited impact damage; no teeth of the rotor gear were missing ([Figure 10](#)). The coil remained installed in the frame by the 2 coil wedges, but the coil tab which exhibited normal wear was bent ([Figure 11](#)). The black colored wire of the coil remained securely attached to the frame, while the green colored wire remained attached to the contact points; the tab exhibited normal wear. The primary and secondary resistance of the coil measured 0.7 and 16,000 Ohms, respectively (Primary specification is 0.50 to 1.2 Ohms and Secondary specification is 13,000 to 20,500 Ohms). The distributor block was missing/not located, and the distributor gear was impact damaged ([Figure 12](#)). Examination of the separated distributor gear revealed it was impact damaged but there were no missing teeth; several of the teeth exhibited impact damage. The electrode remained tightly secured with no abnormal wear noted ([Figure 13](#)). The carbon brush remained installed but was fractured; the spring was not fractured ([Figure 14](#)). The contact points were broken and pitting was noted on the contact of the moveable side of the contact points. Normal wear of the contact points was noted. The capacitor was electrically tested and tested 0.344 microfarads (MFD); specification is 0.35 MFD plus or 10 percent when tested at 400 volts DC ([Figure 15](#)). The coil and housing were retained for additional testing at temperature at the manufacturer's facility.

Figure 8: Right Magneto as First Viewed

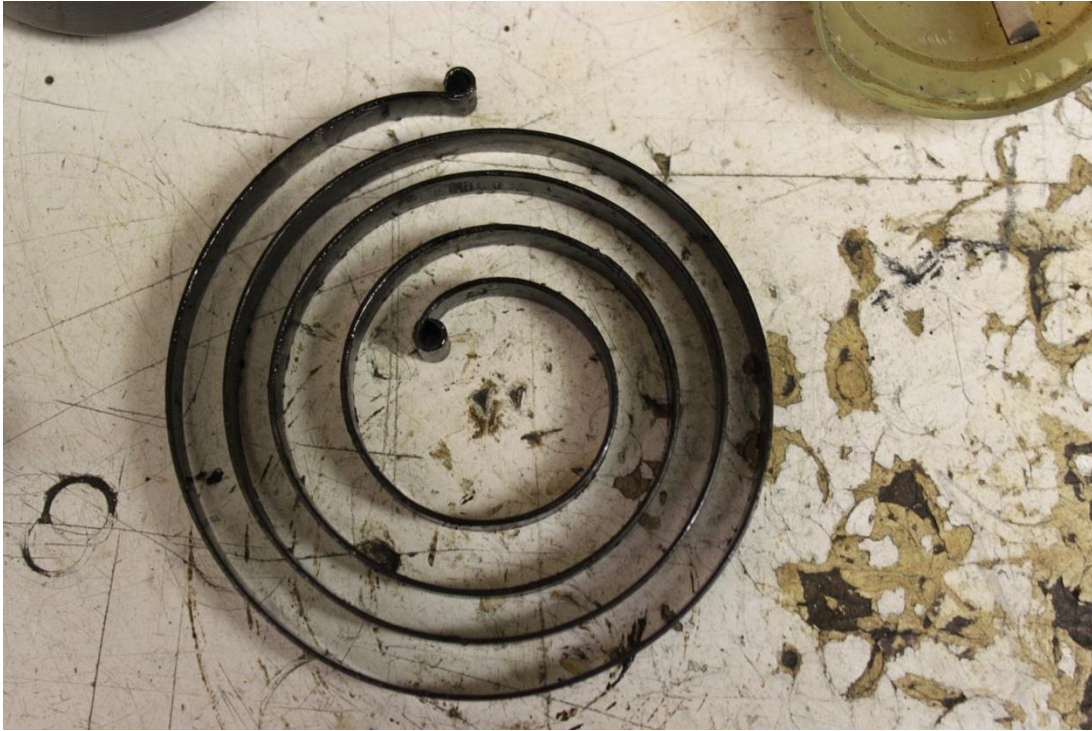
Figure 9: Right Magneto Impulse Coupling Spring

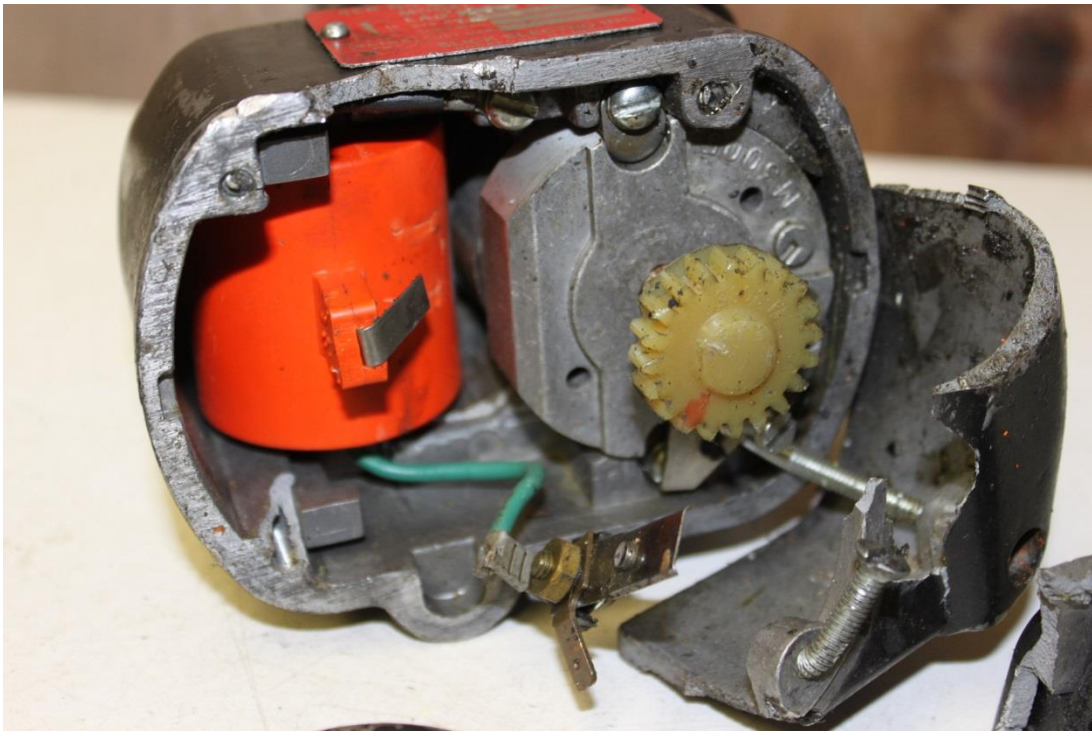
Figure 10: Right Magneto Coil, Housing, and Rotor Gear

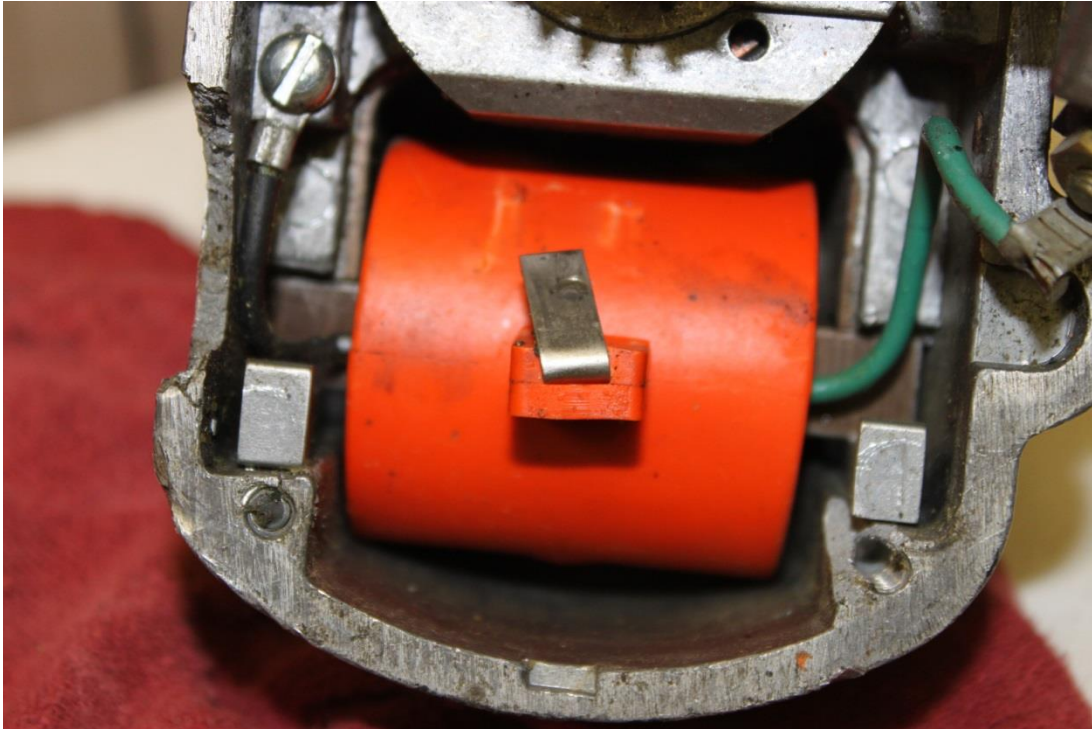
Figure 11: Right Magneto Coil Tab

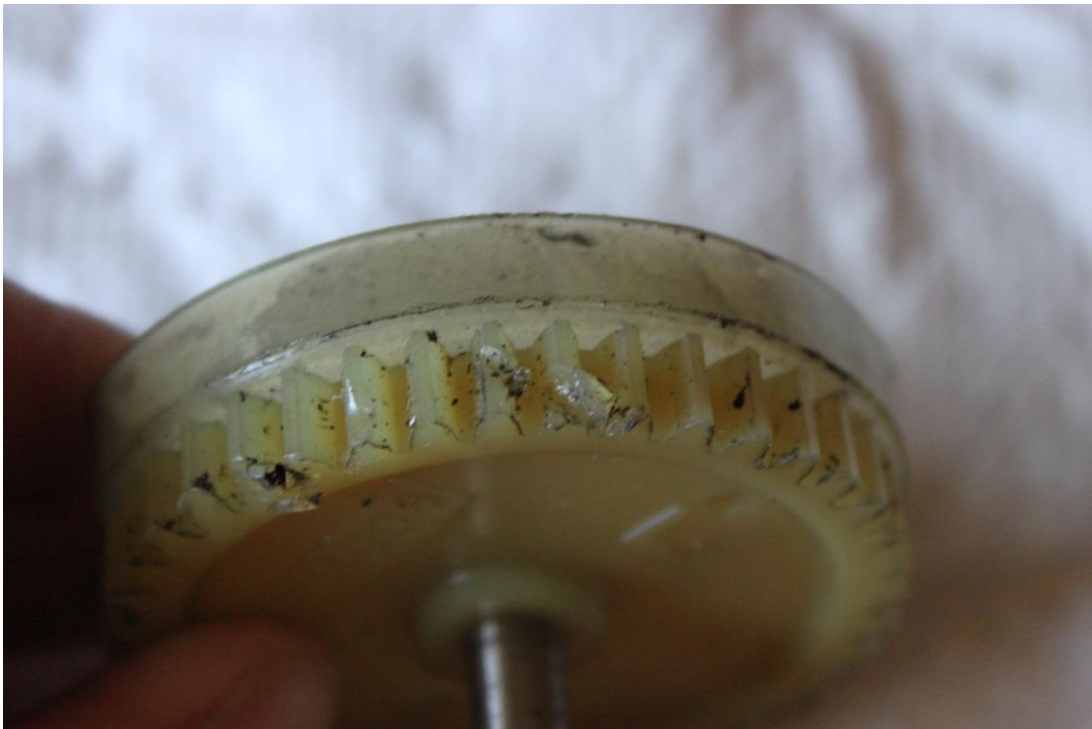
Figure 12: Right Magneto Distributor Gear

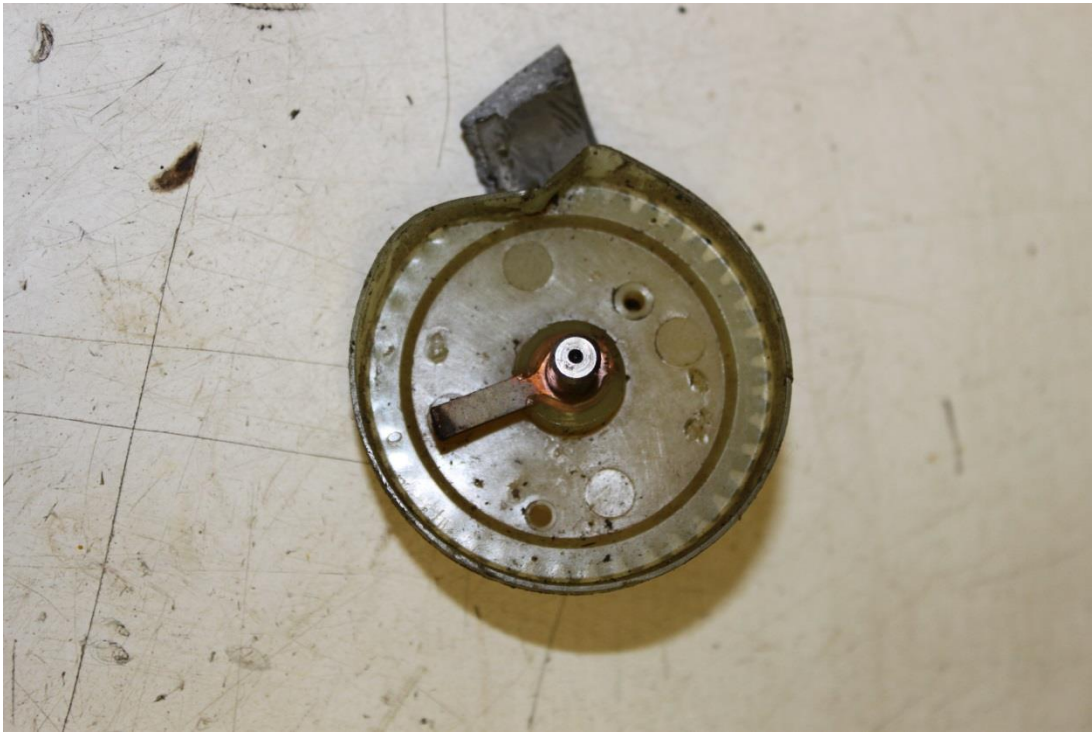
Figure 13: Right Magneto Distributor Gear and Electrode

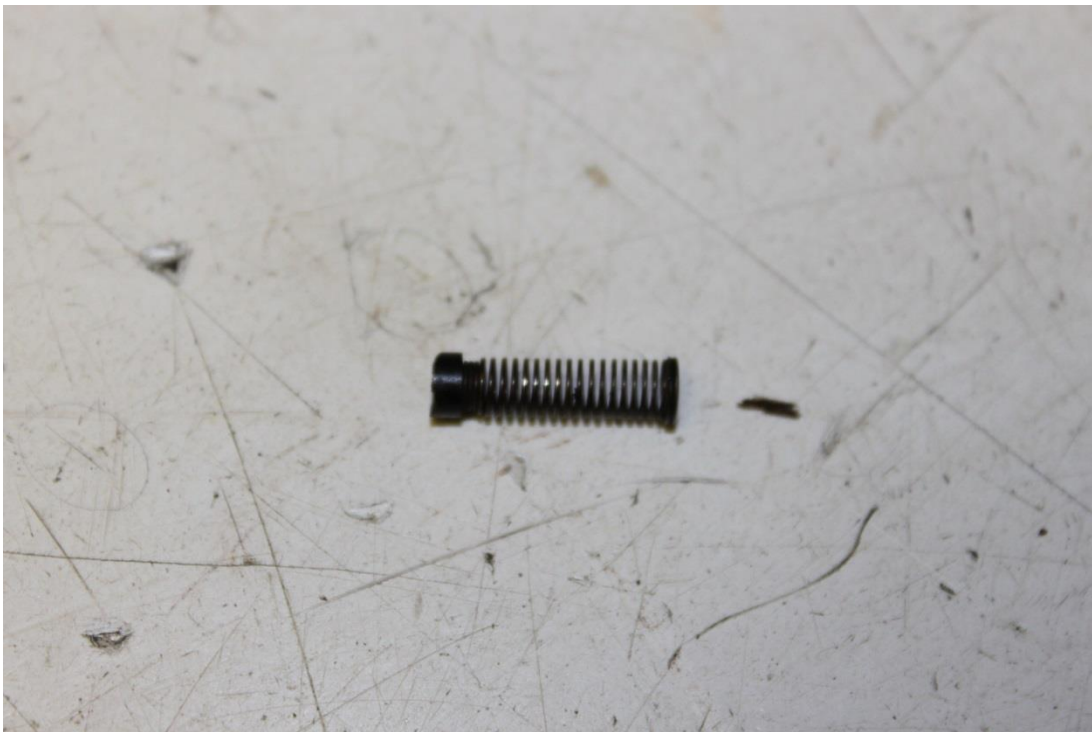
Figure 14: Right Magneto Carbon Brush and Spring

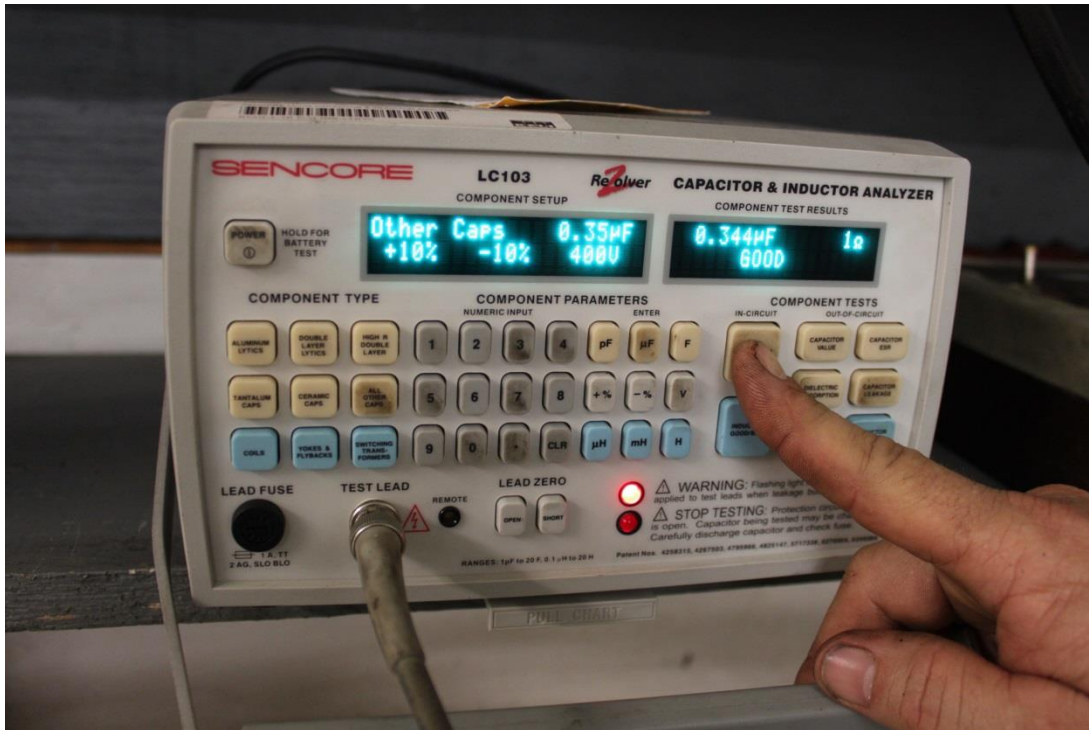
Figure 15: Test Results of Right Capacitor
