**NATIONAL TRANSPORTATION SAFETY BOARD
Office of Aviation Safety**

**MAINTENANCE GROUP CHAIRMAN'S FACTUAL
DCA12MA020**

Operator: Sundance Helicopters, Inc.
Location: Henderson, NV
Date: December 7, 2011
Time: 1630 Pacific standard time
Aircraft: N37SH, Eurocopter AS-350B2

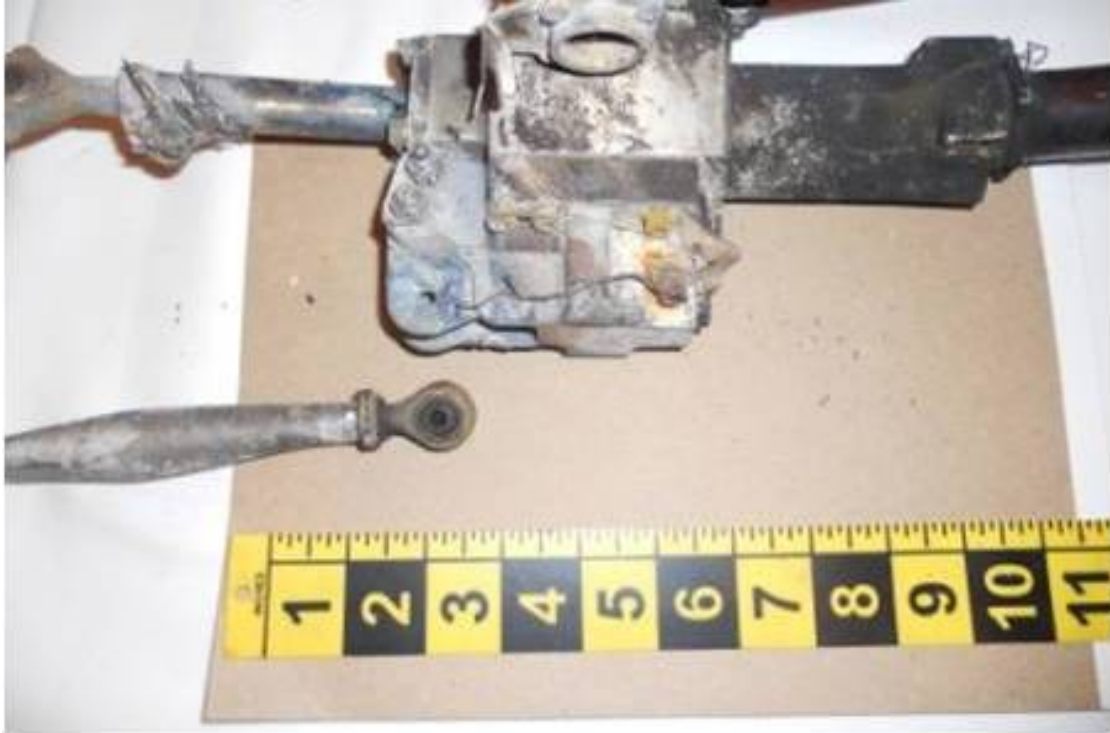
Photo 1. Fore/Aft Servo and Input Rod

During the initial wreckage examination at the accident site, the Airworthiness Group identified that the fore/aft servo input rod was not connected to the fore/aft servo (See Photo 1 and Figure 3). The input rod is normally secured using a bolt, washer, and lock nut. The assembly is then safetied using a cotter pin. During the on scene portion of the investigation, the hardware that secures the input rod to the fore/aft servo was not found. Additional information regarding the full wreckage examination can be found in the Airworthiness Group Chairman's Factual Report.

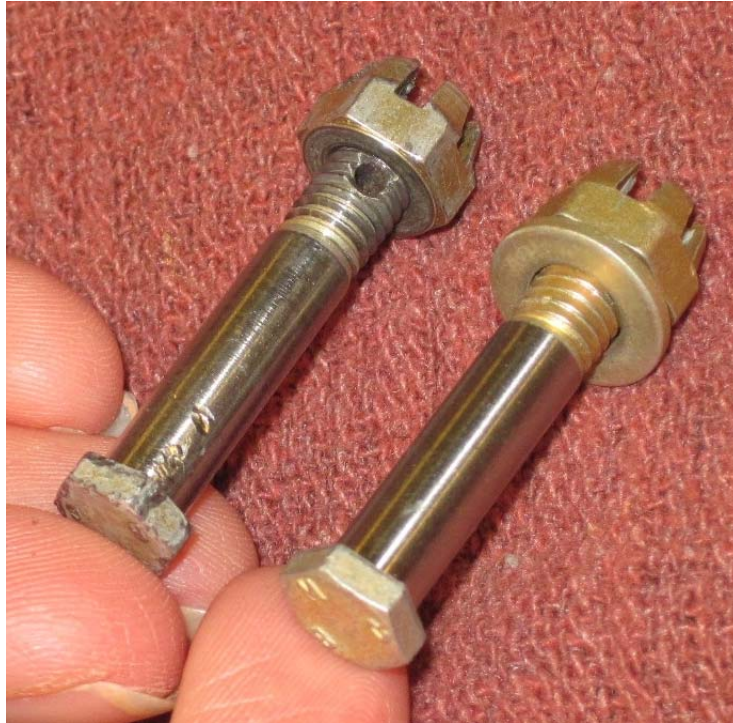
Photo 2. Old and New Bolts

Of the unairworthy hardware identified, two bolts and nuts were retained by the NTSB Airworthiness Group. These were from the fore/aft servos on helicopters N351WM and N340SH. Both of the bolts contained wear markings on the shank that rendered them unairworthy. The nut for N340SH had no locking capability, and the nut for N351WM was serviceable. According to Sundance Helicopters, a new bolt for N351WM was installed at an aircraft total time of 12,210.9 hours in November of 2008. At the time of removal, the total hours on N351WM were 16,415 hours, indicating that the bolt had been installed for 4,204.1 hours. There were no records of replacement for the hardware on N340SH. At the time of removal, the total hours on N340SH were 7,308 hours. In 2009, Sundance implemented a record policy to require recording when the bolt and nut are replaced. However, this is not a standard industry requirement. There is no requirement by the manufacturer to replace the nut when the bolt is replaced.^{6 7}

⁶ Following the accident, Sundance required that all lock nuts be replaced following removal.
