LOG BOOK #1

MAINTENANCE RECORD

Learjet 35
S/N 35-060

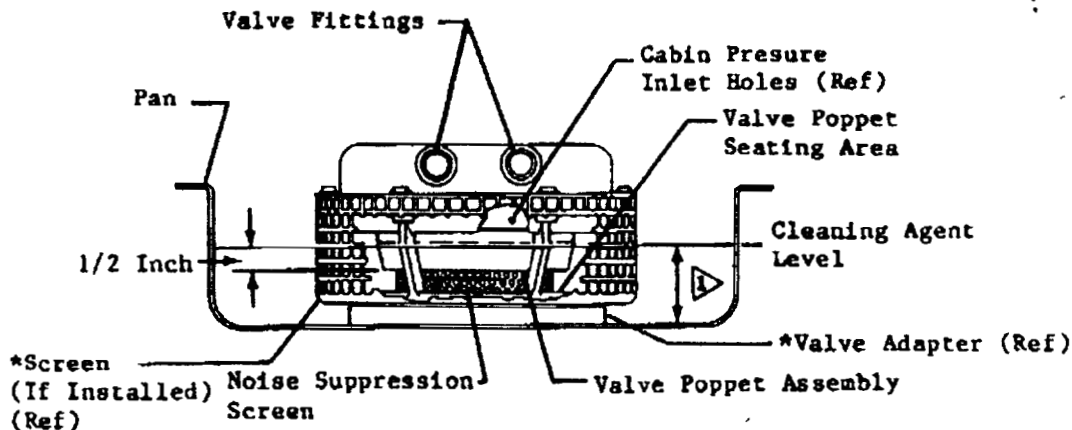
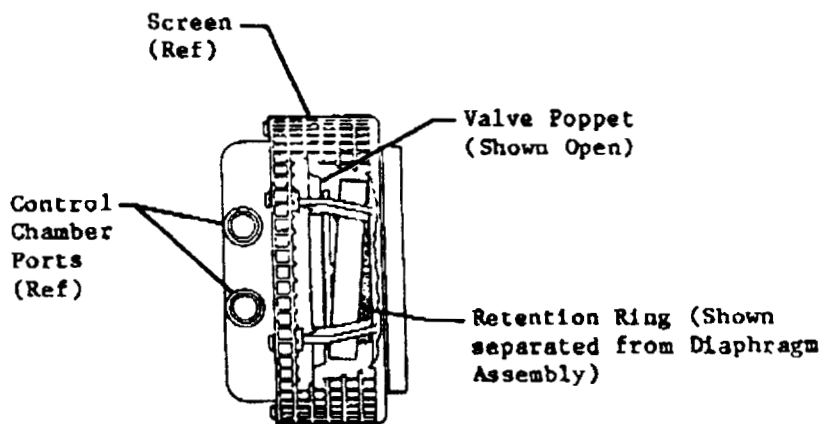
Cabin Air Exhaust Control Valve Cleaning
Figure 202

WARNING: DEFECTIVE VALVE ASSEMBLY SHOWN. DO NOT INSTALL VALVE ASSEMBLY IN THIS CONDITION.
