NATIONAL TRANSPORTATION SAFETY BOARD
WASHINGTON, D.C.

SERVICE BULLETIN 747-28A-2092

NO: 747-28A2092
DATE: February 12, 1979
REVISION 1: April 27, 1979

SUBJECT: MAIN FUEL TANK PUMP WIRING INSPECTION, REWORK,
AND MODIFICATION

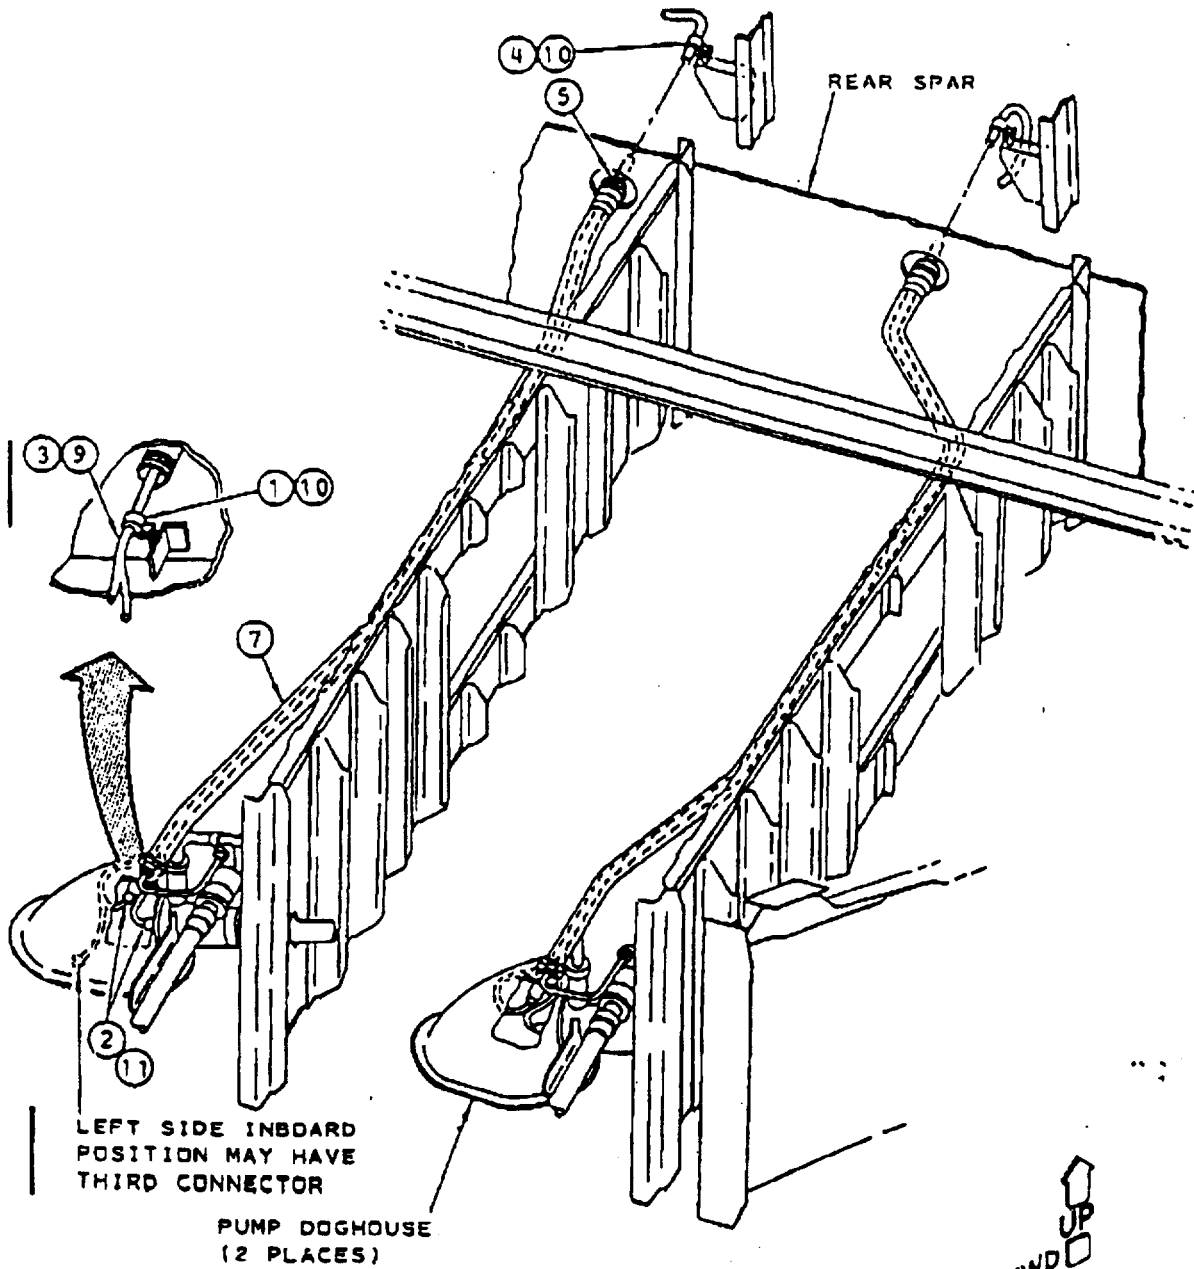
FIGURE 1. WIRE BUNDLE INSPECTION AND REWORK

DETAIL I
LEFT WING INSTALLATION SHOWN
RIGHT WING OPPOSITE

- ④ Remove bundle from clamp on rear side of rear spar (inboards located at approximately WS692 and outboards at WS711).

- ⑤ Pull bundle out of conduit from rear side of rear spar. Tie off pull cord at doghouse end so it will not be inadvertently drawn through. Remove any wire ties that served as a manufacturing facility and were inadvertently left installed on the wire bundle.

- ⑥ NOT SHOWN - Clean wires using approved solvents (Ref: 747 Wiring Diagram Manual Chapter 20). Inspect wires for burn damage or chafing. Repair or replace damaged or chafed wire as applicable (Ref: 747 Wiring Diagram Manual Chapter 20).

- ⑦ If electrical arcing or burning is evident the conduit should be inspected, and replaced if necessary.

- ⑧ Tie wire bundle and encase in two concentric teflon sleeves; Size #4 inner; Size #0 outer per Figure 2.

- ⑨ Reinstall tied double-sleeved wire bundle in conduit using pull cord. Detach pull cord.

- ⑩ Reinstall clamps, ensuring sleeving is under clamps.

- ⑪ Reinstall connectors on wire bundle and make continuity check (Ref: 747 Wiring Diagram Manual Subjects 28-22-31 and 28-22-32).
