EXHIBIT NO. 11K

NATIONAL TRANSPORTATION SAFETY BOARD
WASHINGTON, D.C.

SERVICE BULLETIN 747-28A-2194

SUBJECT: FUEL - DISTRIBUTION - FUEL BOOST AND OVERRIDE/JETTISON PUMPS - INSPECTION

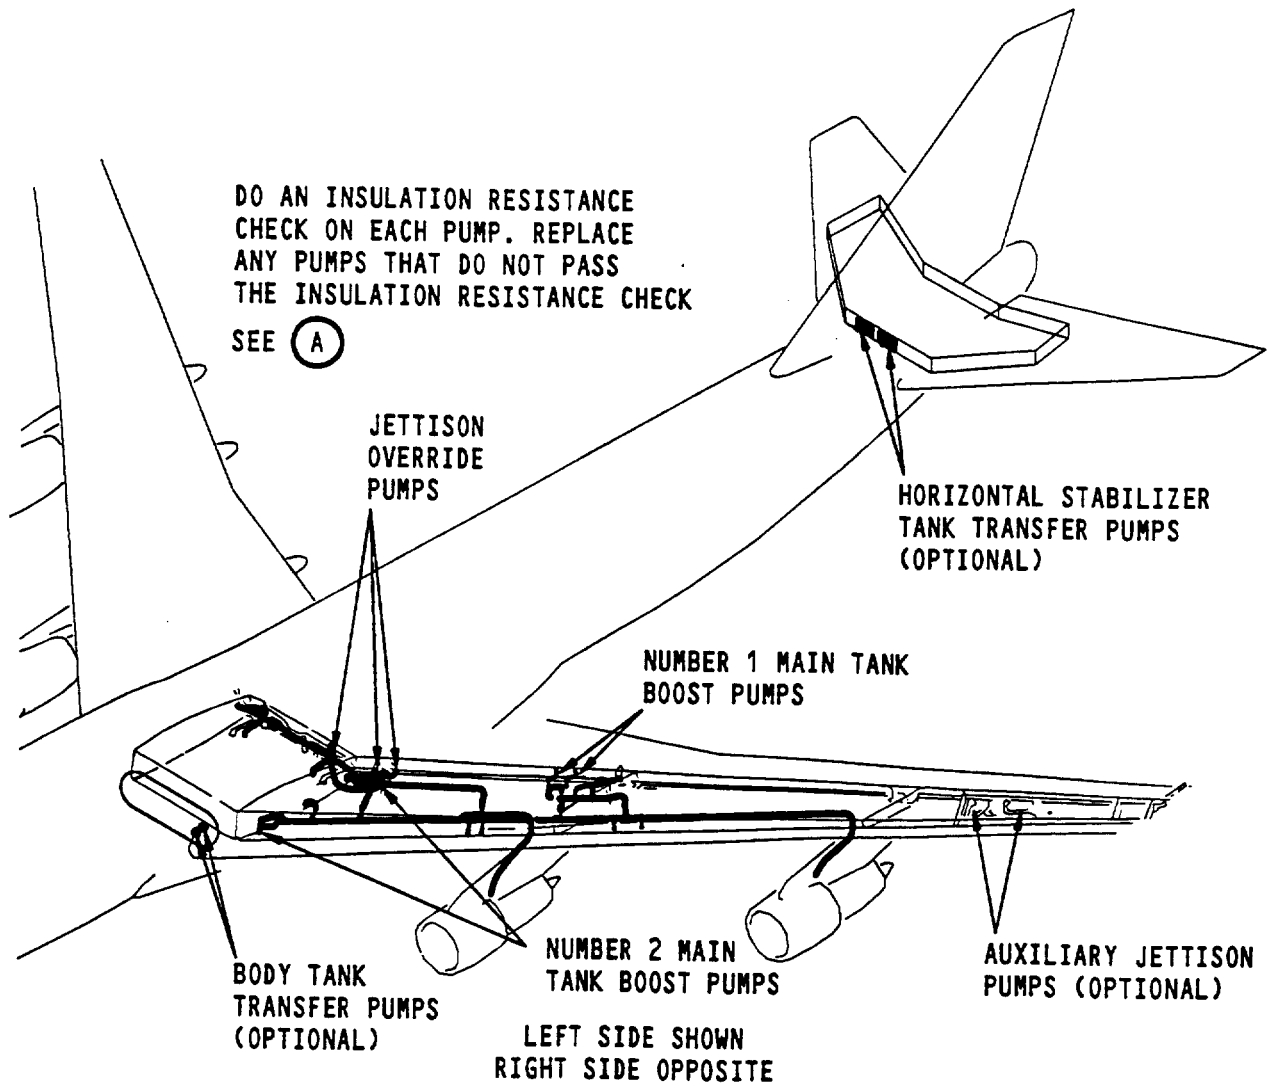
FIGURE 1. AIRPLANE FUEL PUMP INSPECTION

- F. Do a visual inspection of the wire terminal assembly, the electrical connector and the wire insulation on the fuel pump.
- 1. Examine the pump for the following conditions:

- a. Signs of a fuel leak
 - b. Signs of heat discoloration
- NOTE:** Clean the cap as given in Boeing Standard Wiring Practices Manual 20-60-01 after the inspection for heat discoloration.

- c. Signs of bulges, bent flanges, broken screw, medium to heavy corrosion damage (as specified in the 747 Corrosion Prevention Manual Subject 20-40-00, Part I, General Information - Corrosion Removal Techniques, Paragraph 3.A), etc.

- 2. If the results of the visual examination of the fuel pump are:
 - a. None of the conditions in paragraph F.1 are found, go to paragraph G.
 - b. One or more of the conditions in paragraph F.1 are found,

- 1) Replace the fuel pump.
 - 2) Go to paragraph G.
- G. Do an insulation test of the fuel pump.
- 1. Disconnect the electrical connector of the fuel pump.

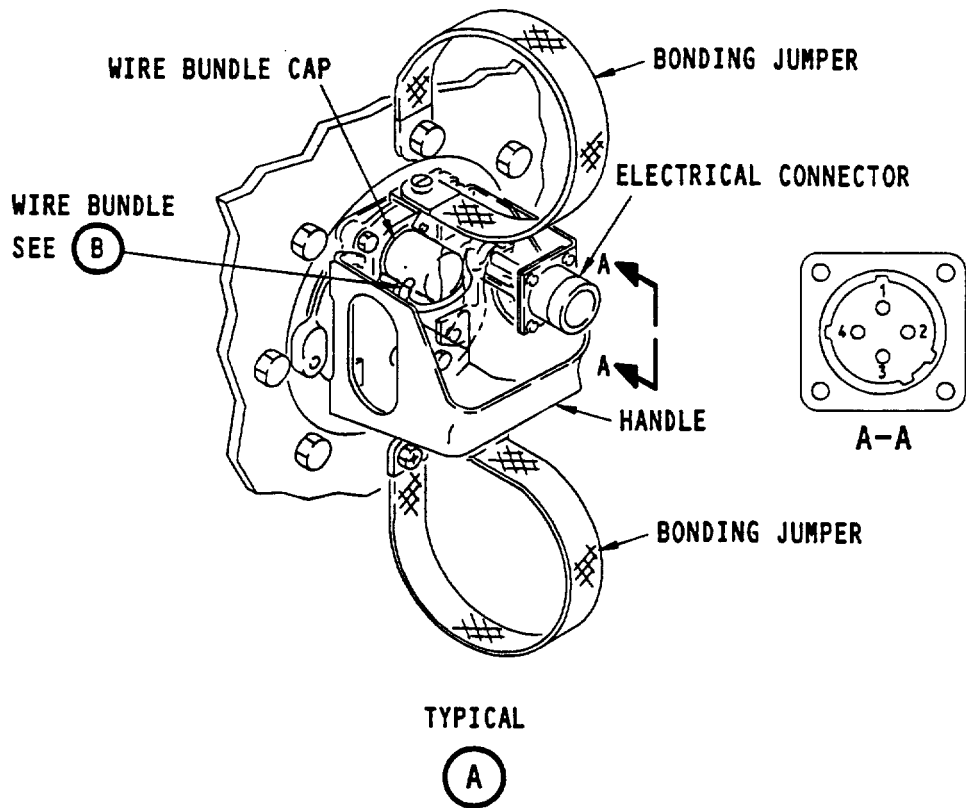
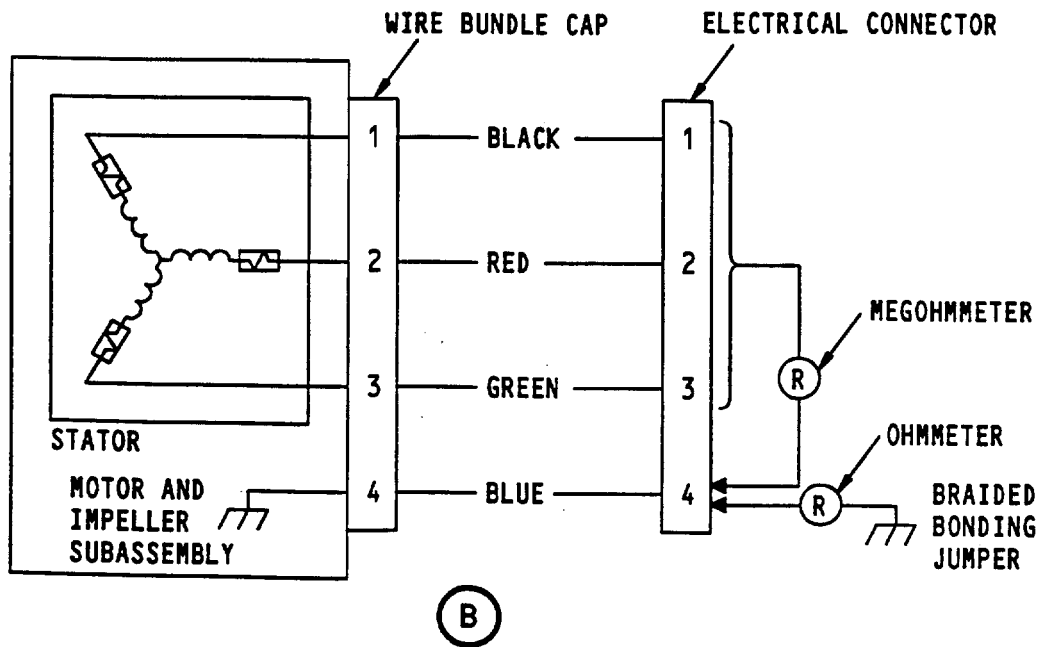
FIGURE 1. AIRPLANE FUEL PUMP INSPECTION

- b. If each resistance measured between pin 4 and pins 1, 2 and 3 is equal to or greater than 1 megohm, go to paragraph G.6.
 - c. If any resistance measured between pin 4 and pins 1, 2 and 3 is less than 1 megohm, replace the fuel pump. Go to paragraph G.2 and do the insulation resistance test on the replacement fuel pump.

- c. If any resistance measured between pin 4 and pins 1, 2 and 3 is below 1 megohm, replace the fuel pump. For pumps that have an insulation resistance from 1 to 5 megohms, it is recommended that the pump be replaced. If the pump is not replaced, do this test on the pump at every A-check or an equivalent time. If the pump was replaced go to paragraph G.2 and do the insulation resistance test on the replacement fuel pump. If the pump was not replaced go to Paragraph G.8.
