SERVICE BULLETIN 747-57-2253

SERVICE BULLETIN

NUMBER: 747-57-2253

SUBJECT: WINGS - CENTER SECTION - SECONDARY FUEL BARRIER INSPECTION AND REPAIR

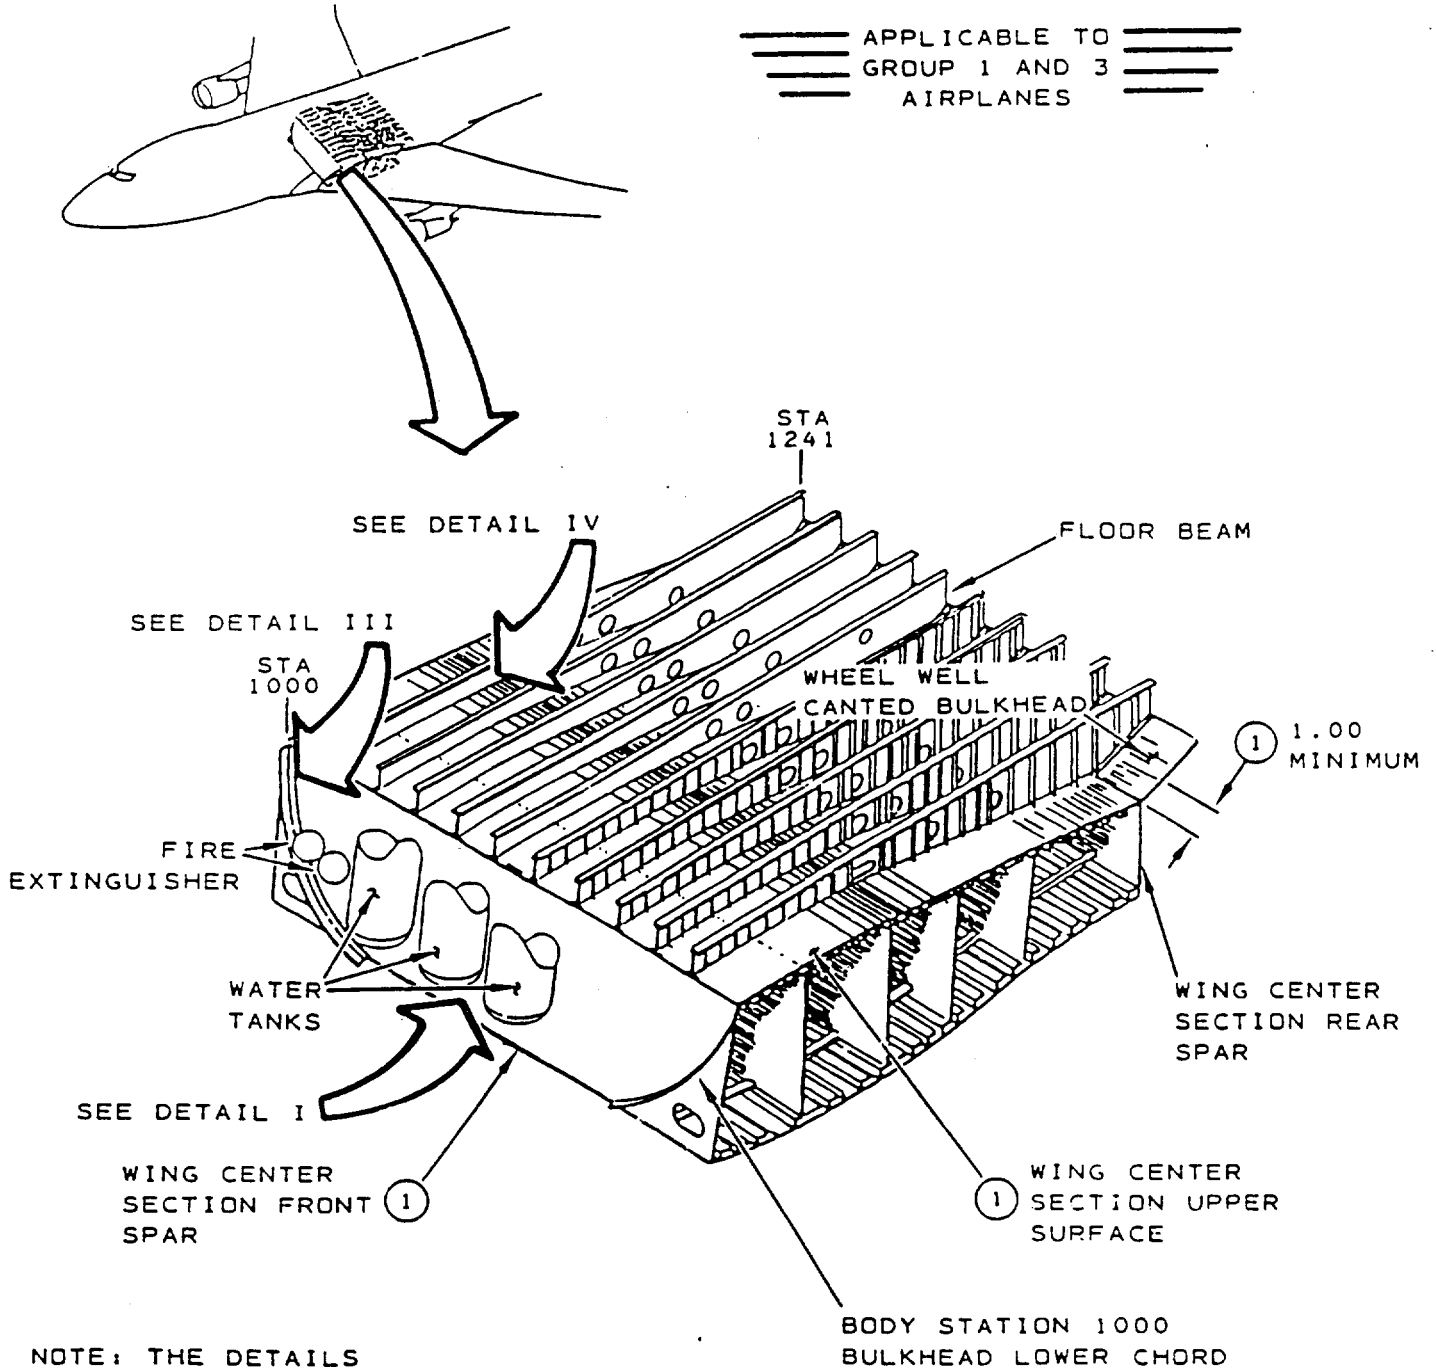
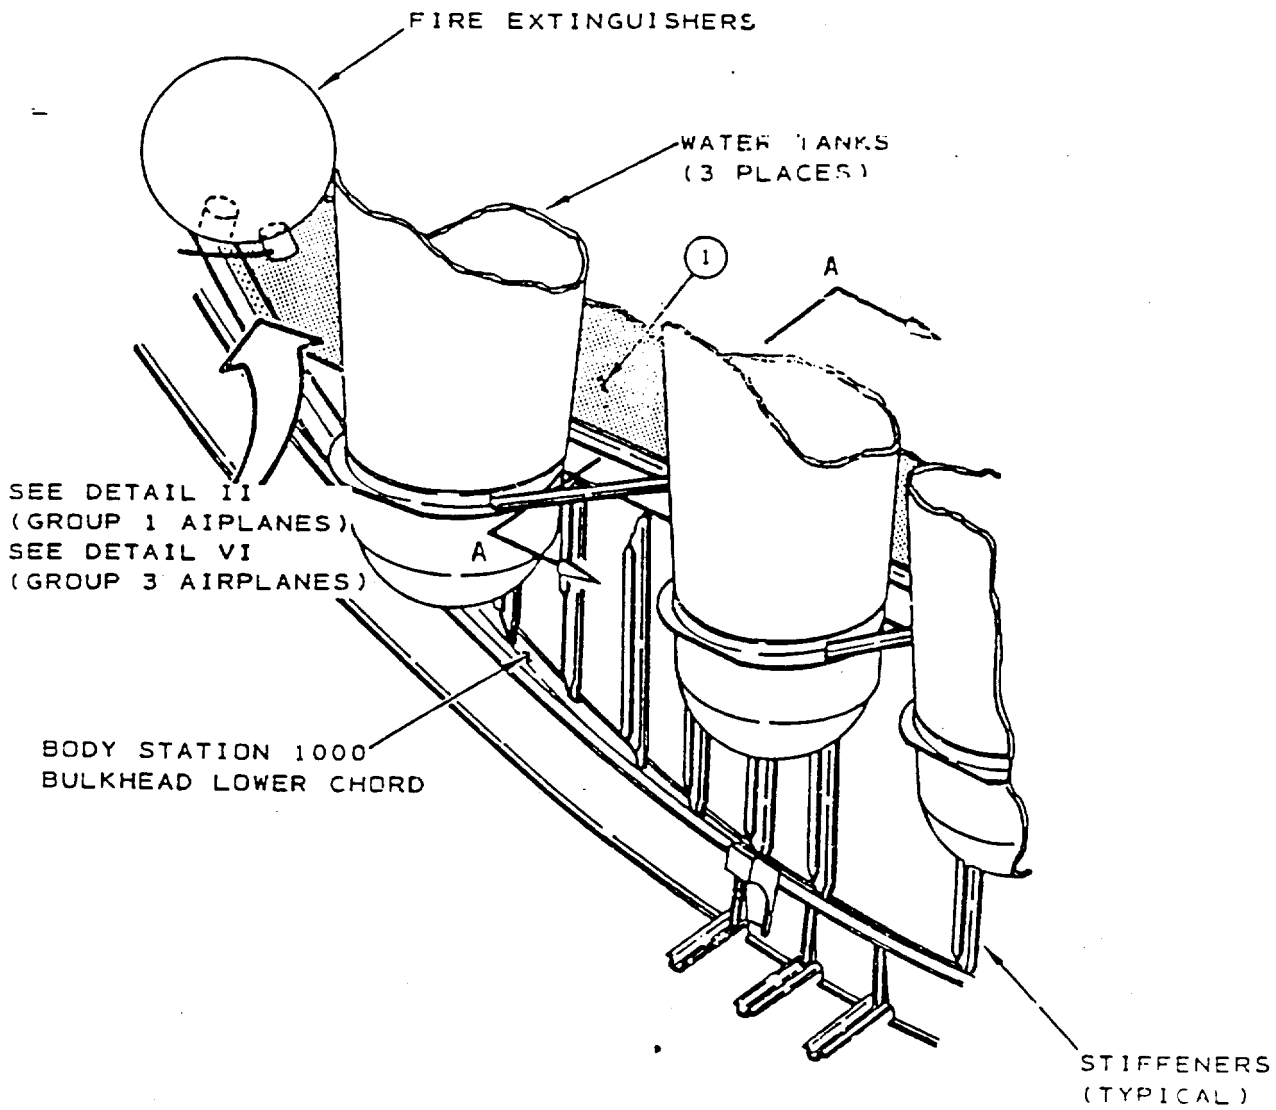
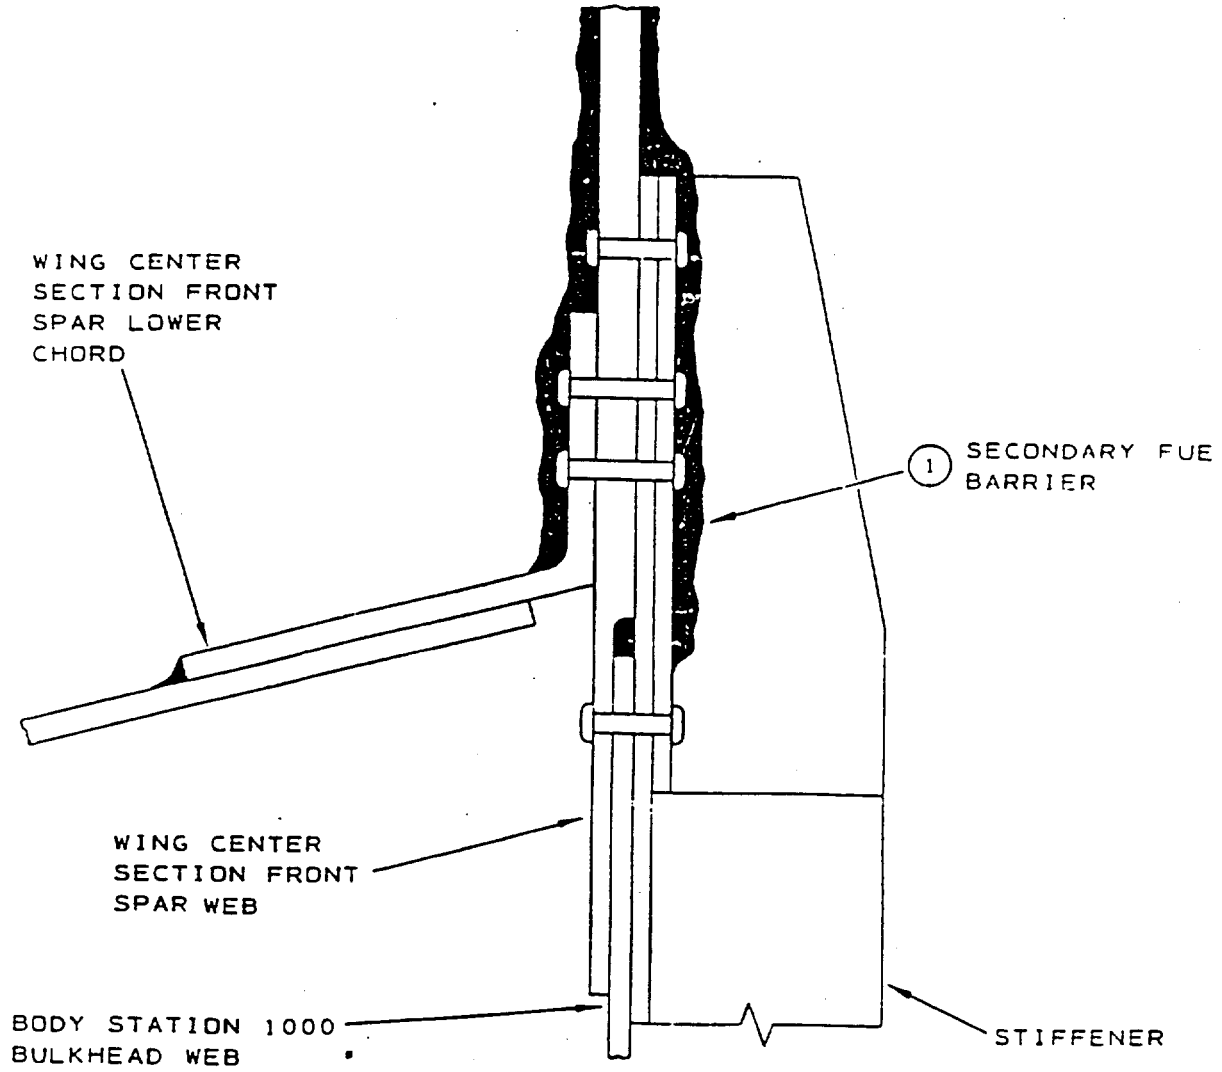
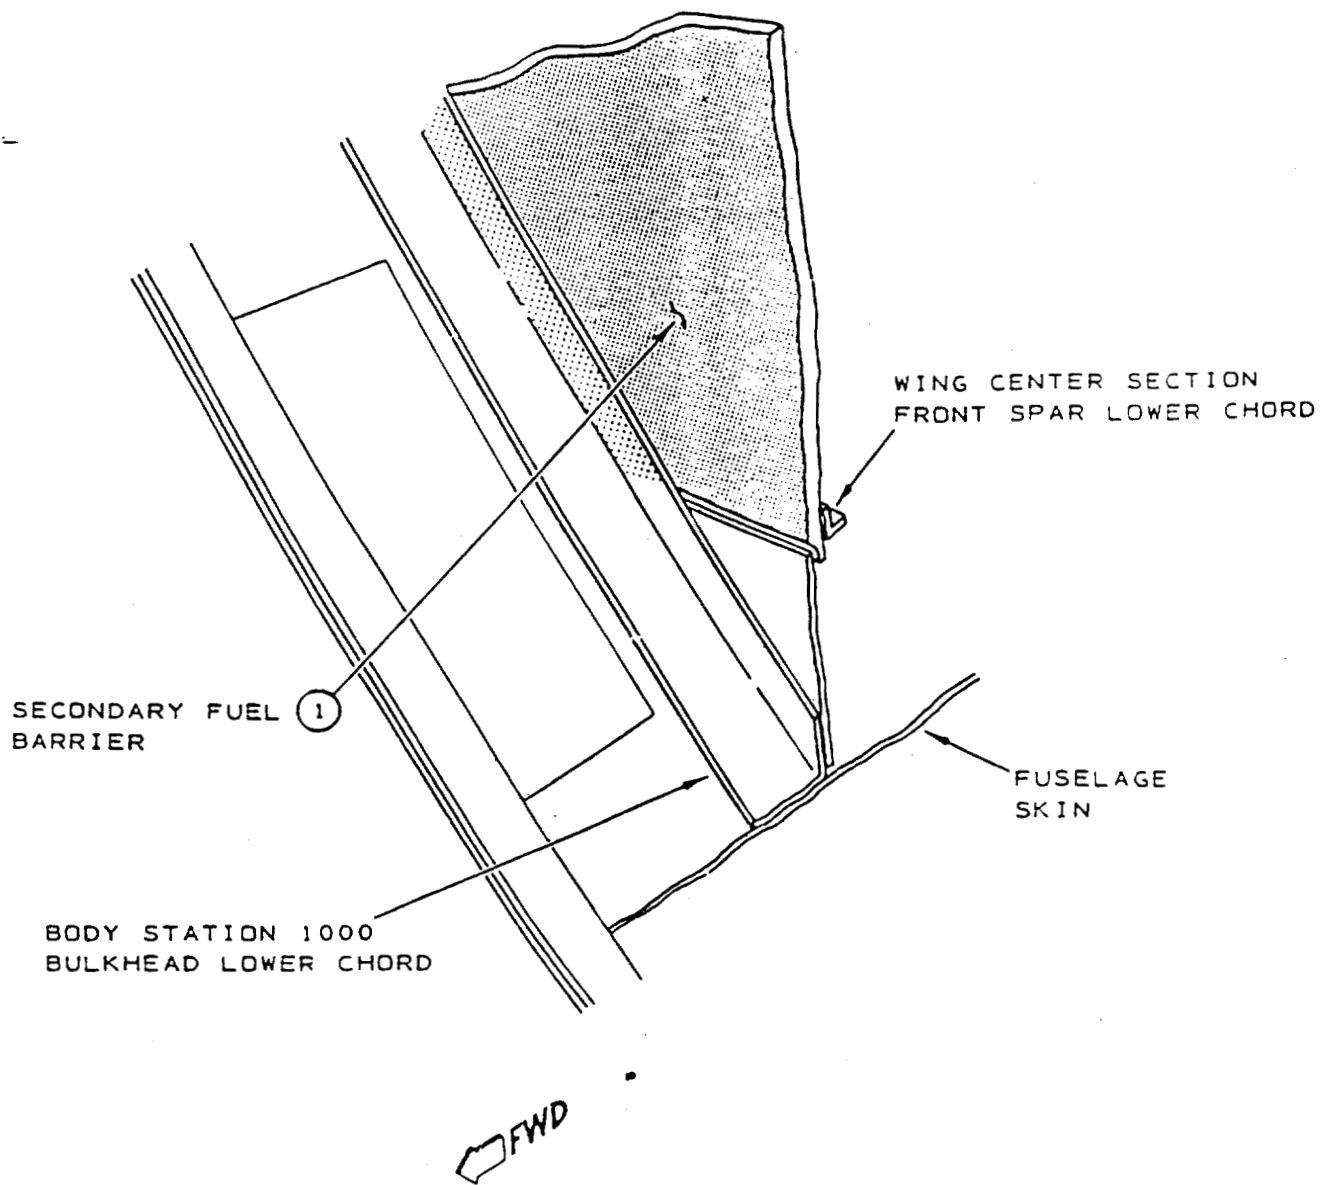
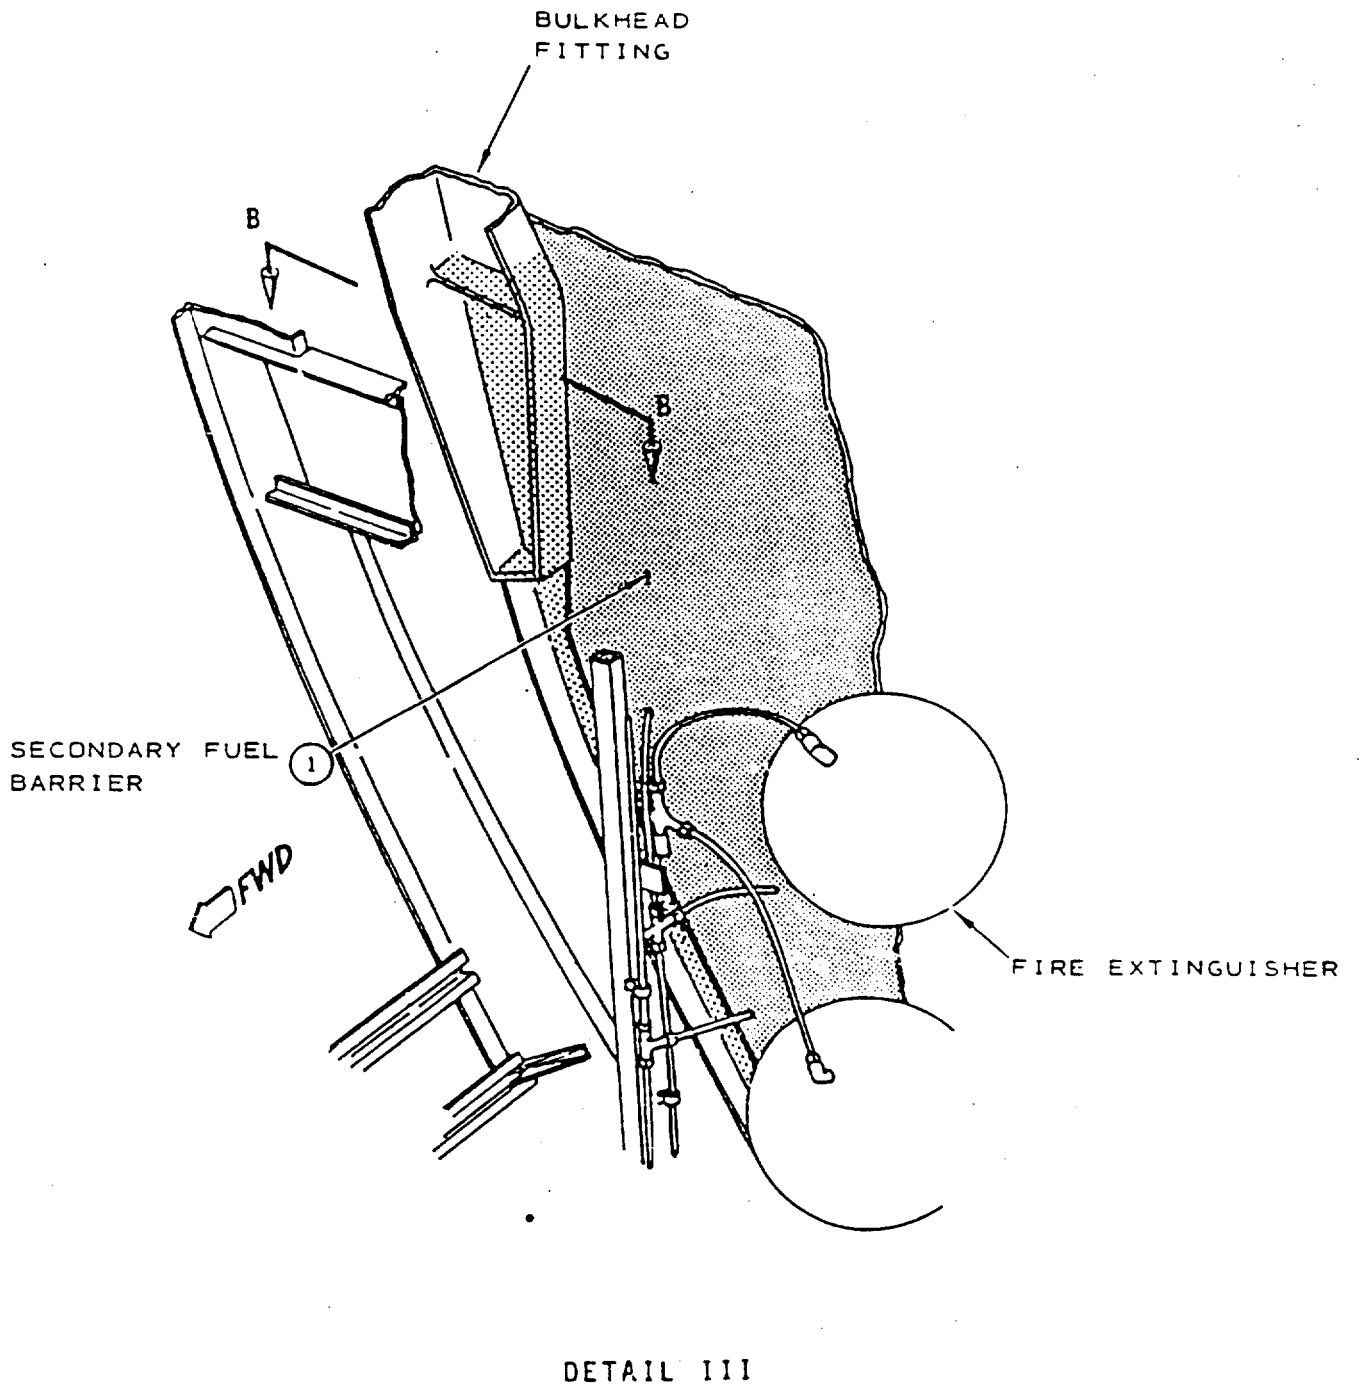
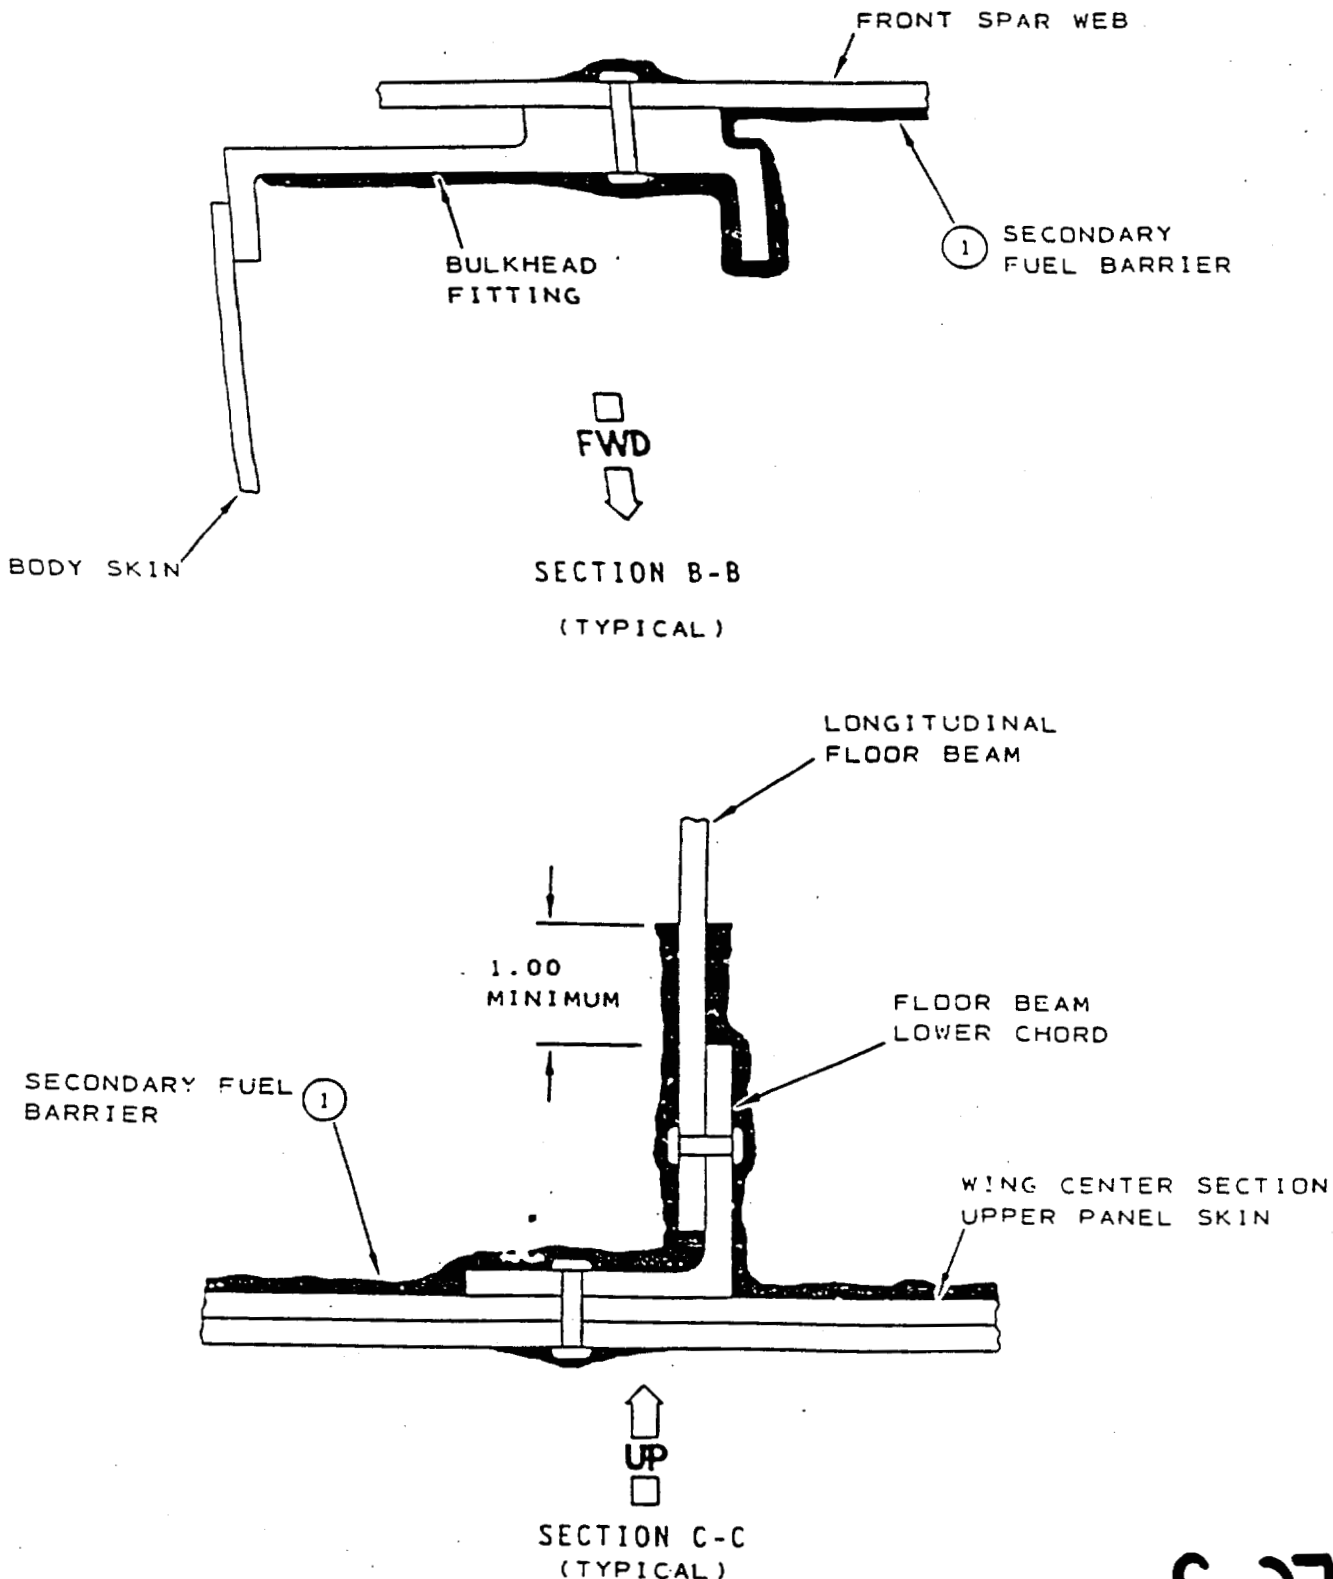
FIGURE 4. SECONDARY FUEL BARRIER INSPECTION AND REPAIR - GROUP 1 AND 3 AIRPLANES

- ① Perform a close visual inspection of the exterior surface of the wing center section front spar and upper surface to determine whether the secondary fuel barrier (sealant BMS 5-81) meets the following requirements:

NOTES: 1. The secondary fuel barrier may be identified by it's glossy finish, clear to brownish hue, and rubber like texture.

2. Particular attention should be paid to areas around fasteners, brackets, and structural joints.

- a. The secondary fuel barrier should have complete coverage (with no breaks or openings) of all structure on the front spar and upper surface which is in contact or directly adjacent to the wing center section fuel.

- b. On the front spar, the secondary fuel barrier should extend a minimum of one inch forward of front spar of stiffeners, fittings, chords and brackets.

- c. On the front spar, the secondary fuel barrier should cover the web flange of the Body Station (BS) 1000 bulkhead lower chord (see Detail II).
- d. On the front spar, the secondary fuel barrier should cover the bulkhead fitting at BS 1000 up to the outboard flange at fillet (see Detail III).

- e. On the wing center section upper surface, the barrier should extend a minimum of one inch above the longitudinal floor beam lower chord (see Section C-C).

- f. On the wing center section upper surface, the coating should extend a minimum of one inch onto the wheel well canted bulkhead.
- g. On the wing center section upper surface, the barrier should extend a minimum of one inch above the horizontal flange of the side of body plus chord and stub frame brackets (see Detail V).

- h. On Group 3 airplanes, the secondary fuel barrier should extend at least 3.0 inches forward of the front spar at the bathtub fitting at Stringer S-38 (see Detail VI).

Repair areas where secondary fuel barrier is missing or damaged with sealant BMS 5-81 per Process Data pages or operator's comparable procedure.

NOTE: Use of a borescope is recommended for areas which are covered by tubing, ducting, insulation blankets or wire bundles. However, if additional access is needed for inspection or repair, accomplish the following as needed:

- ② Optional - Insert 3/8 inch outside diameter nylon tube under stub frame, leaving 0.50-0.75 inch length of tube extending beyond each side of the fitting. Temporarily plug the tube during sealant injection.
- ③ Clean area per Process Data pages and inject sealant BMS 5-26 under all stub fittings (stub frame) and fair into fillet seal. Provide a ramp to allow water to drain around fitting.
- ④ Clean area per Process Data pages and inject sealant BMS 5-26 under forward three stub frame fittings on each side of airplanes and fair into fillet seal.
- ⑤ Apply secondary fuel barrier sealant BMS 5-81 and overlap at least one inch onto existing barrier per Process Data pages or operator's comparable procedure.

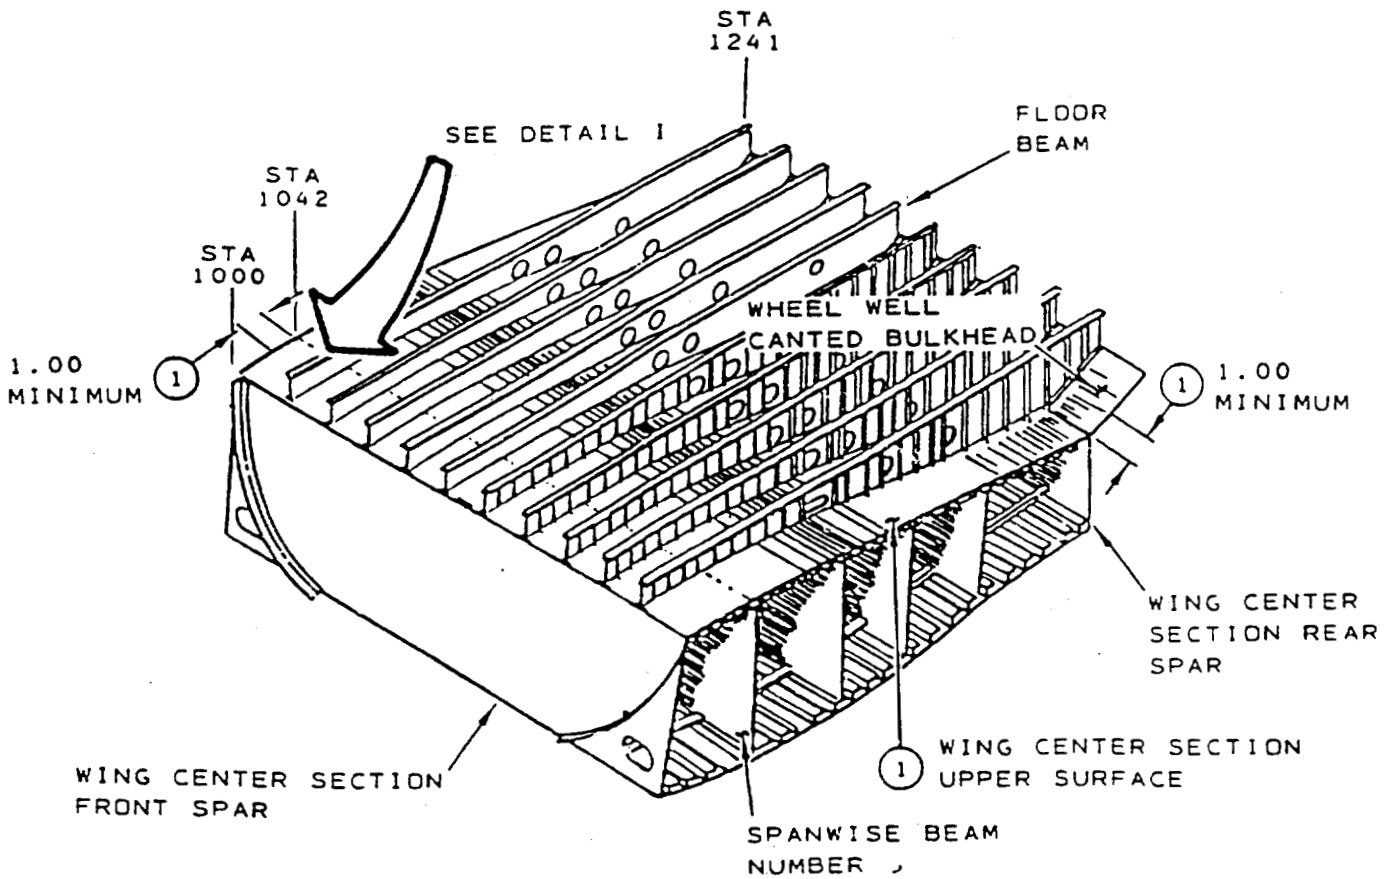
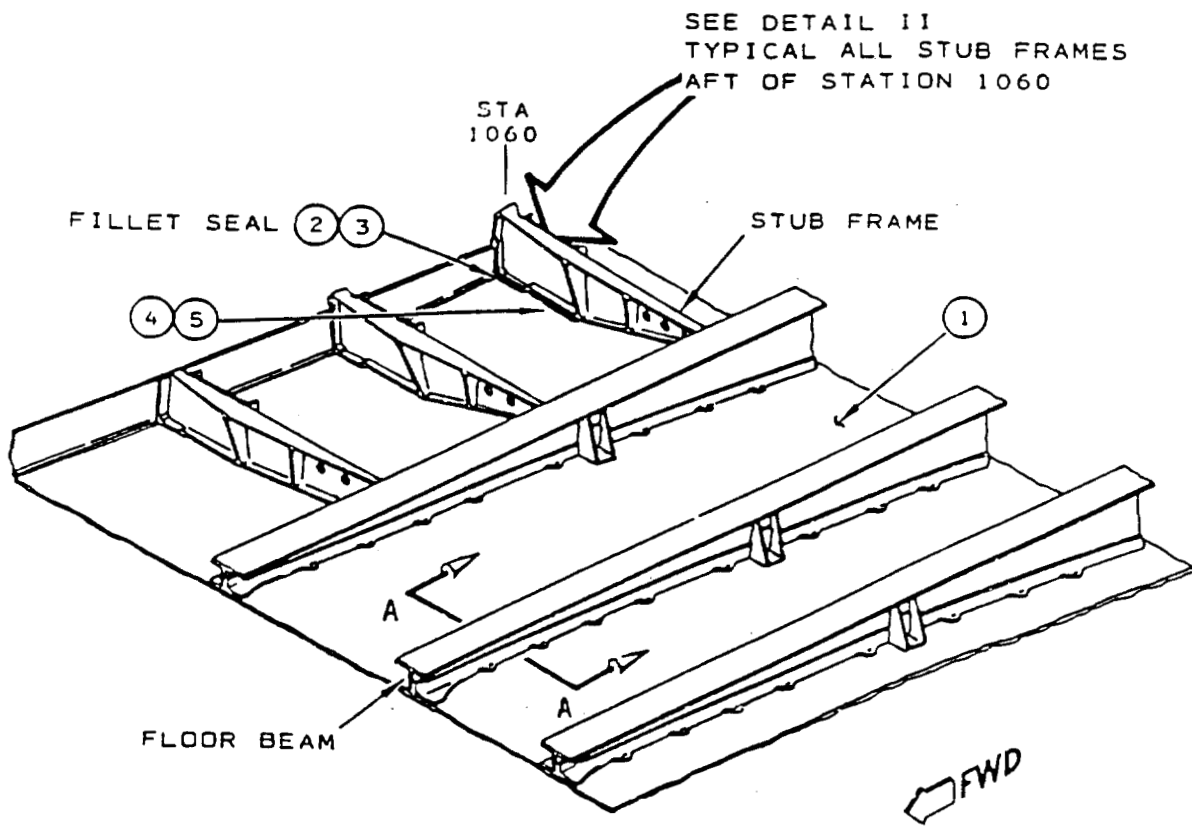
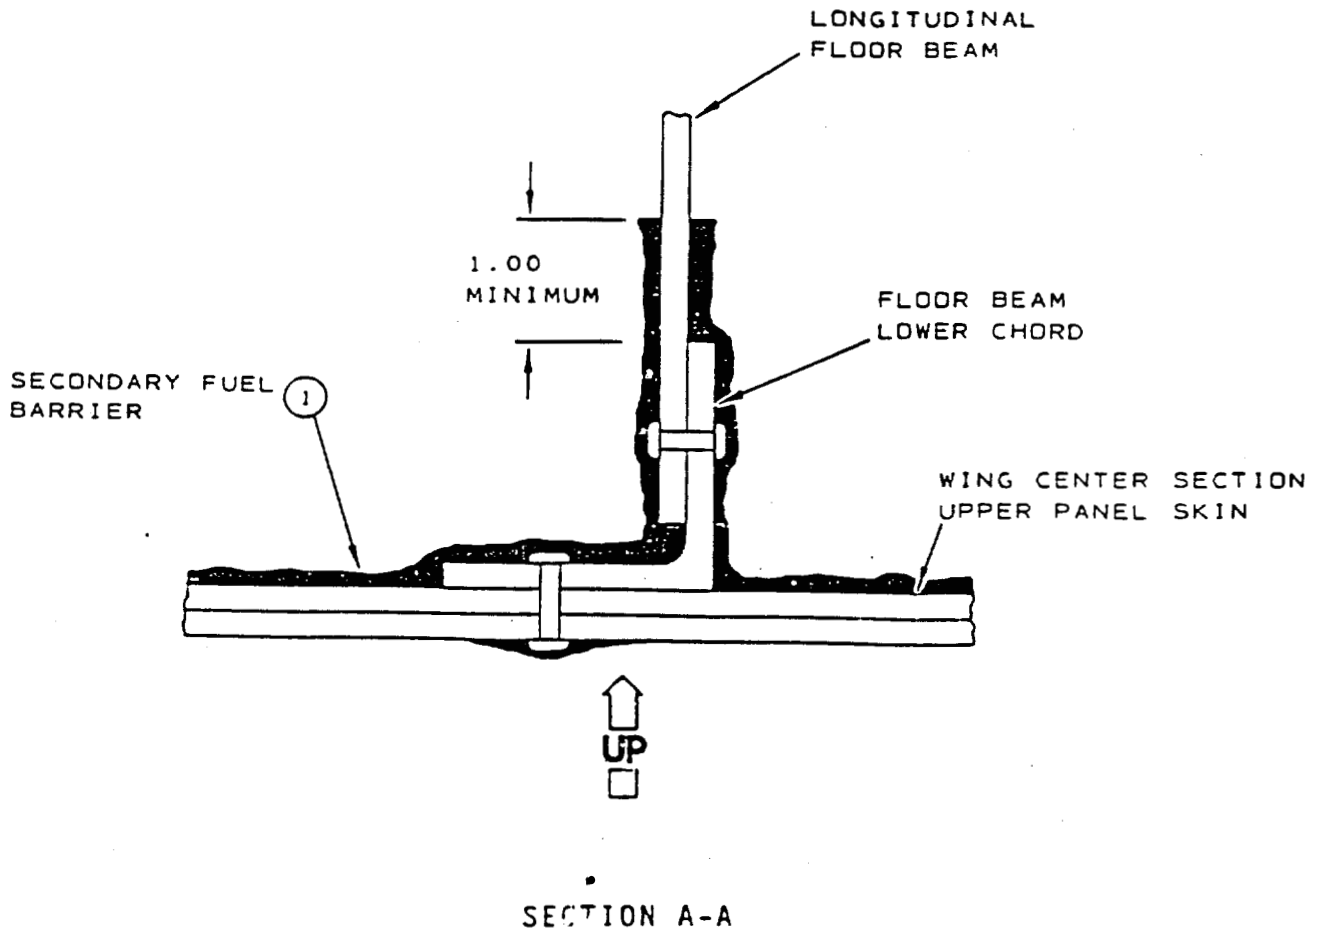
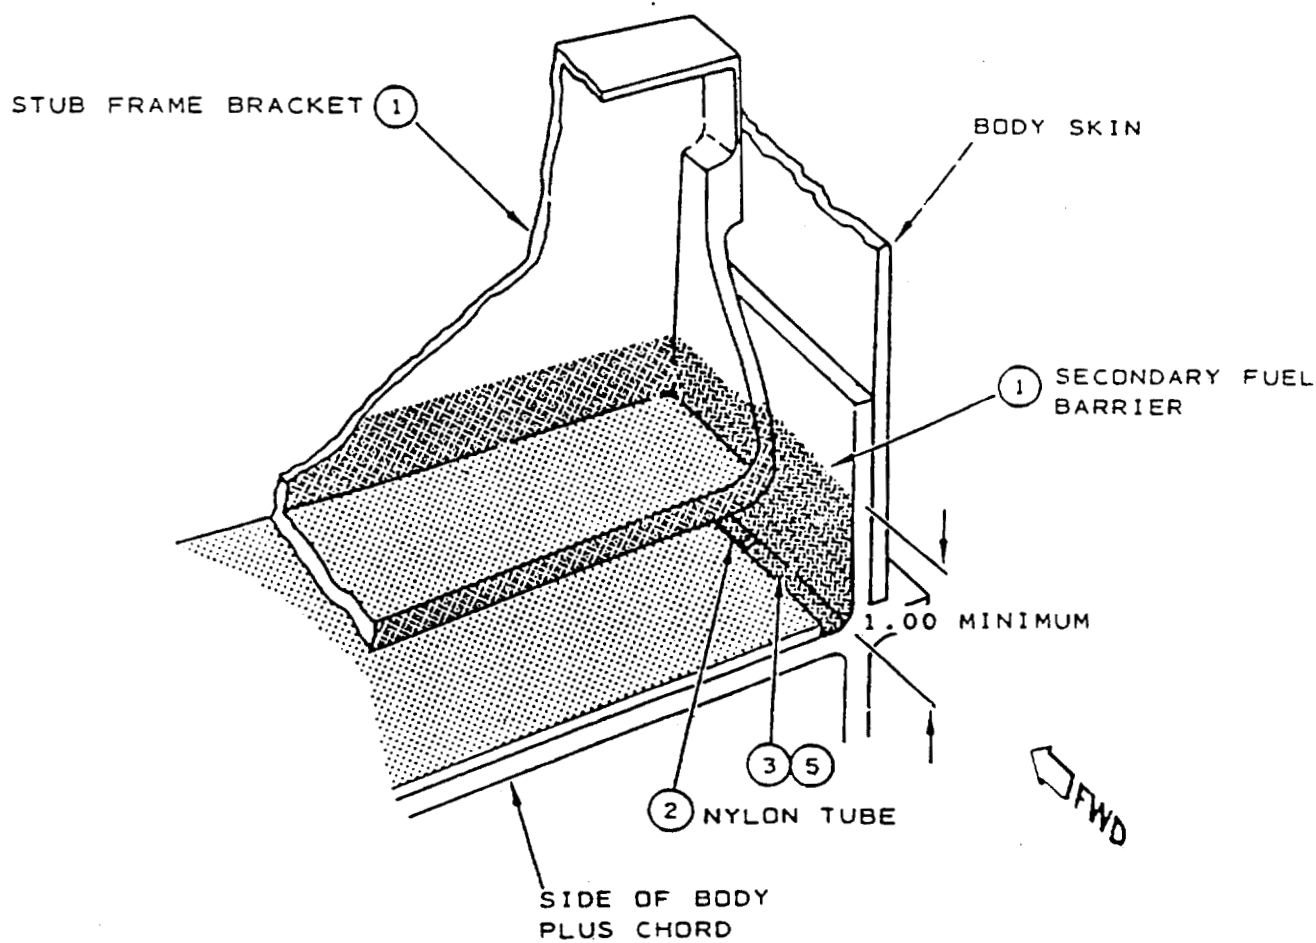
FIGURE 5. SECONDARY FUEL BARRIER INSPECTION AND REPAIR - GROUP 2 AIRPLANES

Perform a close visual inspection of the exterior surface of the wing center section upper surface to determine whether the secondary fuel barrier (sealant BMS 5-81) meets the following requirements:

NOTES: 1. The secondary fuel barrier may be identified by its glossy finish, clear to brownish hue, and rubber like texture.

2. Particular attention should be paid to areas around fasteners, brackets, and structural joints.

- a. The secondary fuel barrier should have complete coverage (with no breaks or openings) of all structure of the upper surface which is in contact or directly adjacent to the wing center section fuel.
- b. On the wing center section upper surface, the barrier should extend a minimum of one inch above the longitudinal floor beam lower chord (see Section A-A).
- c. On the wing center section upper surface, the coating should extend a minimum of one inch onto the wheel well canted bulkhead.
- d. On the wing center section upper surface, the barrier should extend a minimum of one inch above the horizontal flange of the side of body plus chord and stub frame brackets (see Detail II).
- e. On the wing center section upper surface, the coating should extend a minimum of one inch forward of spanwise beam number 3.

Repair areas where secondary fuel barrier is missing or damaged with sealant BMS 5-81 per Process Data pages or operator's comparable procedure.

NOTE: Use of a borescope is recommended for areas which are covered by tubing, ducting, insulation blankets or wire bundles. However, if additional access is needed for inspection or repair, accomplish the following as needed:

- 2 Optional - Insert 3/8 inch outside diameter nylon tube under stub frame, leaving 0.50-0.75 inch length of tube extending beyond each side of the fitting. Temporarily plug the tube during sealant injection.
- 3 Clean area per Process Data pages and inject sealant BMS 5-26 under the stub fitting (stub frame) and fair into fillet seal. Provide a ramp to allow water to drain around fitting.
- 4 Clean area per Process Data pages and inject sealant BMS 5-26 under the aft stub frame fitting on each side of airplane and fair into fillet seal.
- 5 Apply secondary fuel barrier sealant BMS 5-81 and overlap at least one inch onto existing barrier per Process Data pages or operator's comparable procedure.
