# NATIONAL TRANSPORTATION SAFETY BOARD

## Group Chairman's Factual Report

### Maintenance Records Group Chairman's Report

WPR10FA371

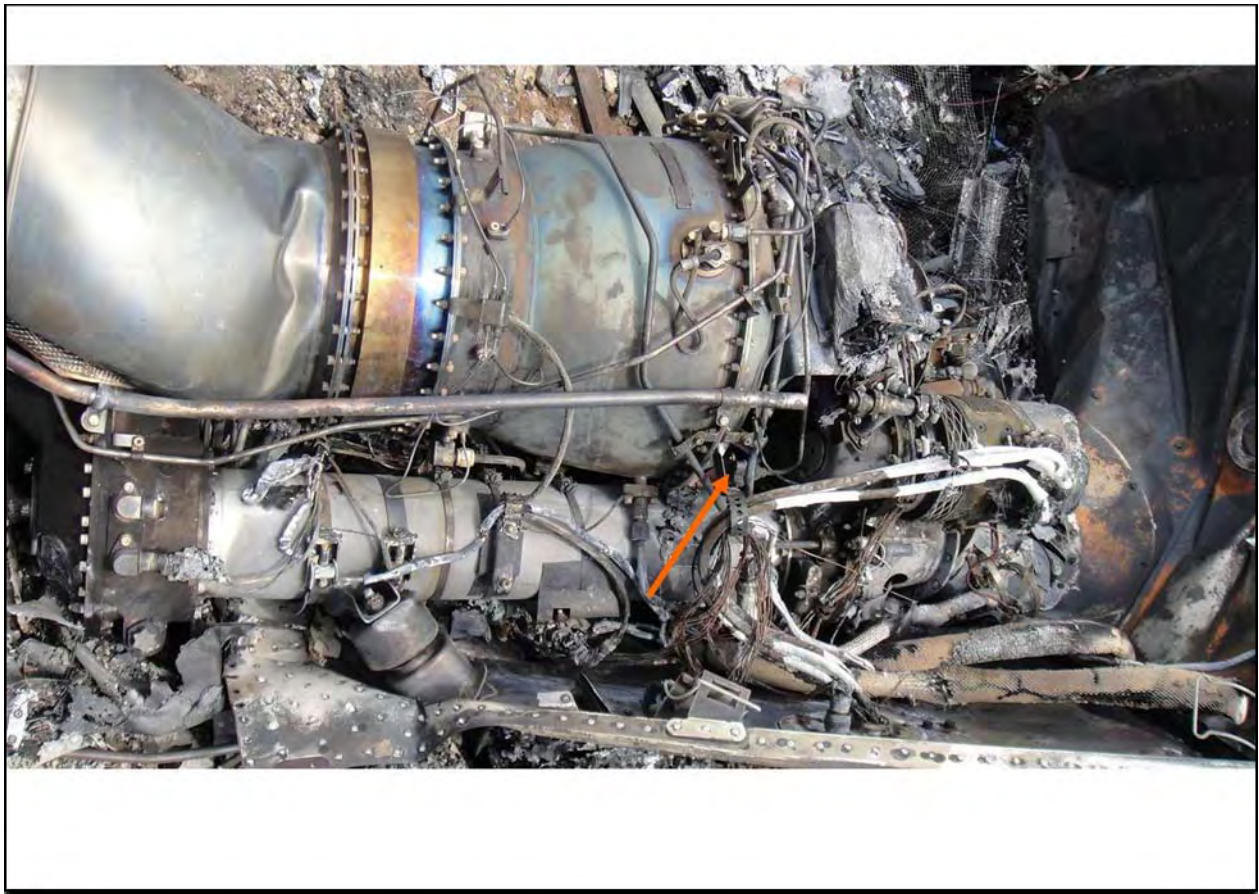
Examination of the helicopter at the accident site showed that the fuel union was not attached at its fitting to the engine compressor module (See Photo 1. Engine at Accident Site and Photo 2. Fuel Inlet Union at Attach Point). According to a Turbomeca representative, if this fuel line becomes disconnected, fuel starvation to the engine occurs.

**Photo 1. Engine at Accident Site (red arrow points to jet union)**

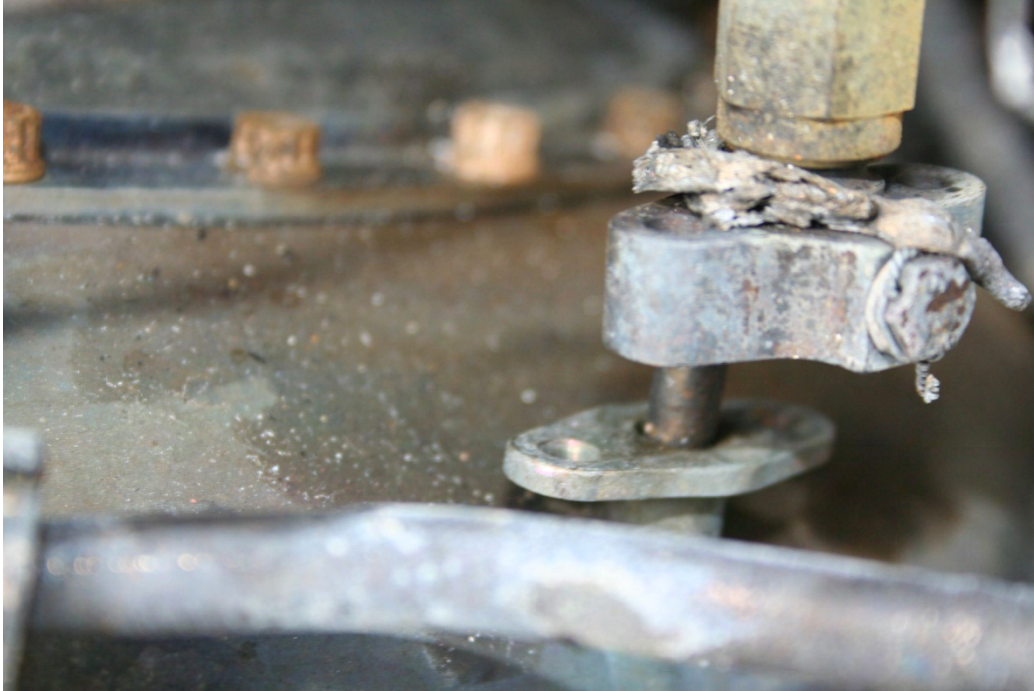
**Photo 2. Fuel Inlet Union at Attach Point**

External examination of the engine at the accident site revealed that the fuel inlet union, located on the lower right-hand-side of the engine, had become detached from the boss on the compressor case. The fuel supply line remained attached to the union and to the hydro-mechanical unit (HMU). The intermediate gasket was located in the fuselage debris, directly below the union. The remaining wreckage and ground area were extensively examined utilizing a

series of magnets and sifting grates, but did not reveal the presence of the two five-point bolts and self locking nuts for mounting the union to the compressor case flange." Figure 1 shows a view of the fuel inlet union, its associated hardware, and its attach point to the engine. Photo 3 shows an exemplar fuel inlet union as it should be installed.
