1. Serviceable part tag for prop blade PN RFC11M1-6A SN 861398
2. United Technologies-Hamilton Standard Shop Traveler for prop blade PN RFC11M1-6A SN 861398 overhaul, 3/16/93
3. Ultrasonic shear wave inspection sheet for prop blade PN RFC11M1-6A SN 861398
4. Hamilton Standard letter to FAA, dated August 23, 1995, detailing Rock Hill repair to prop blade PN RFC11M1-6A SN 861398
5. FAA Form 8130-3 for prop blade PN RFC11M1-6A SN 861398
6. Atlantic Southeast Airlines EMB-120 Line Check checklist for ASA EMB-120 airplane 256, dated August 20, 1995

In response to your request for the work package of propeller blade P/N RFC11M1-6A, S/N 861398, I have enclosed a repair report with record of work attachment references. The report is arranged in chronological order, with references to the applicable record of work attachment for each repair.

Customer: Atlantic Southeast Airlines
Blade Part Number: RFC11M1-6A
Blade Serial Number: 861398
Blade Total Time: 12,129.75 Hrs.
Time Since Major Insp. 2,775.80 Hrs.
Reason For Return: Failed Ultrasonic Inspection AD 94-09-06, on 5-19-94
(Attachment #1 & #2)

OVERHAUL/REPAIR REPORT

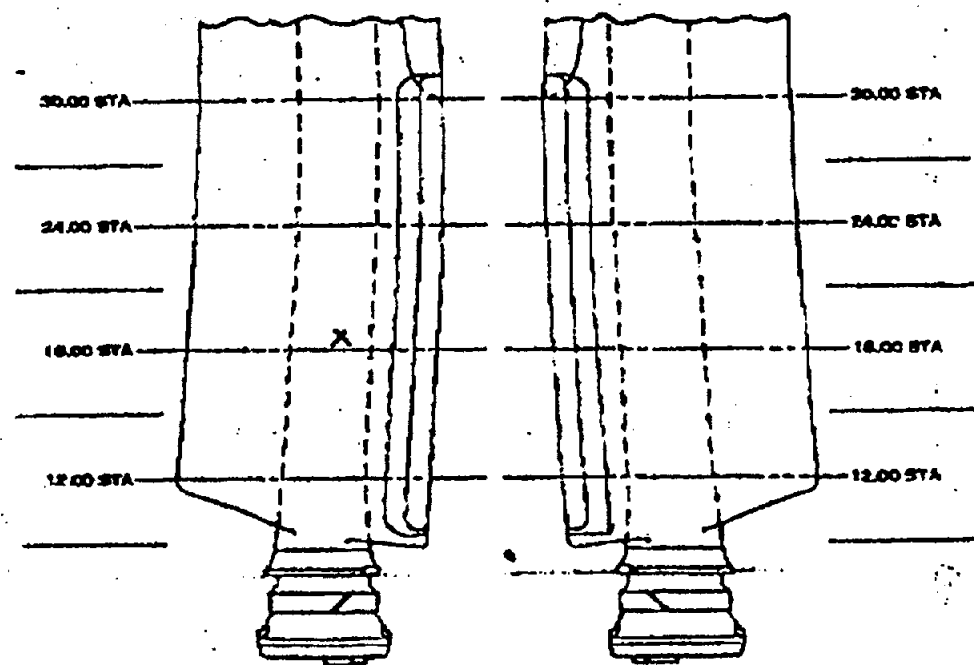
BLADE STATUS: PASS _____ FAIL *33DB Reference*

FACE SIDE CAMBER SIDE
Rejectable Indication at Station Marker 18 3/4 on Face Side, 60% FSH

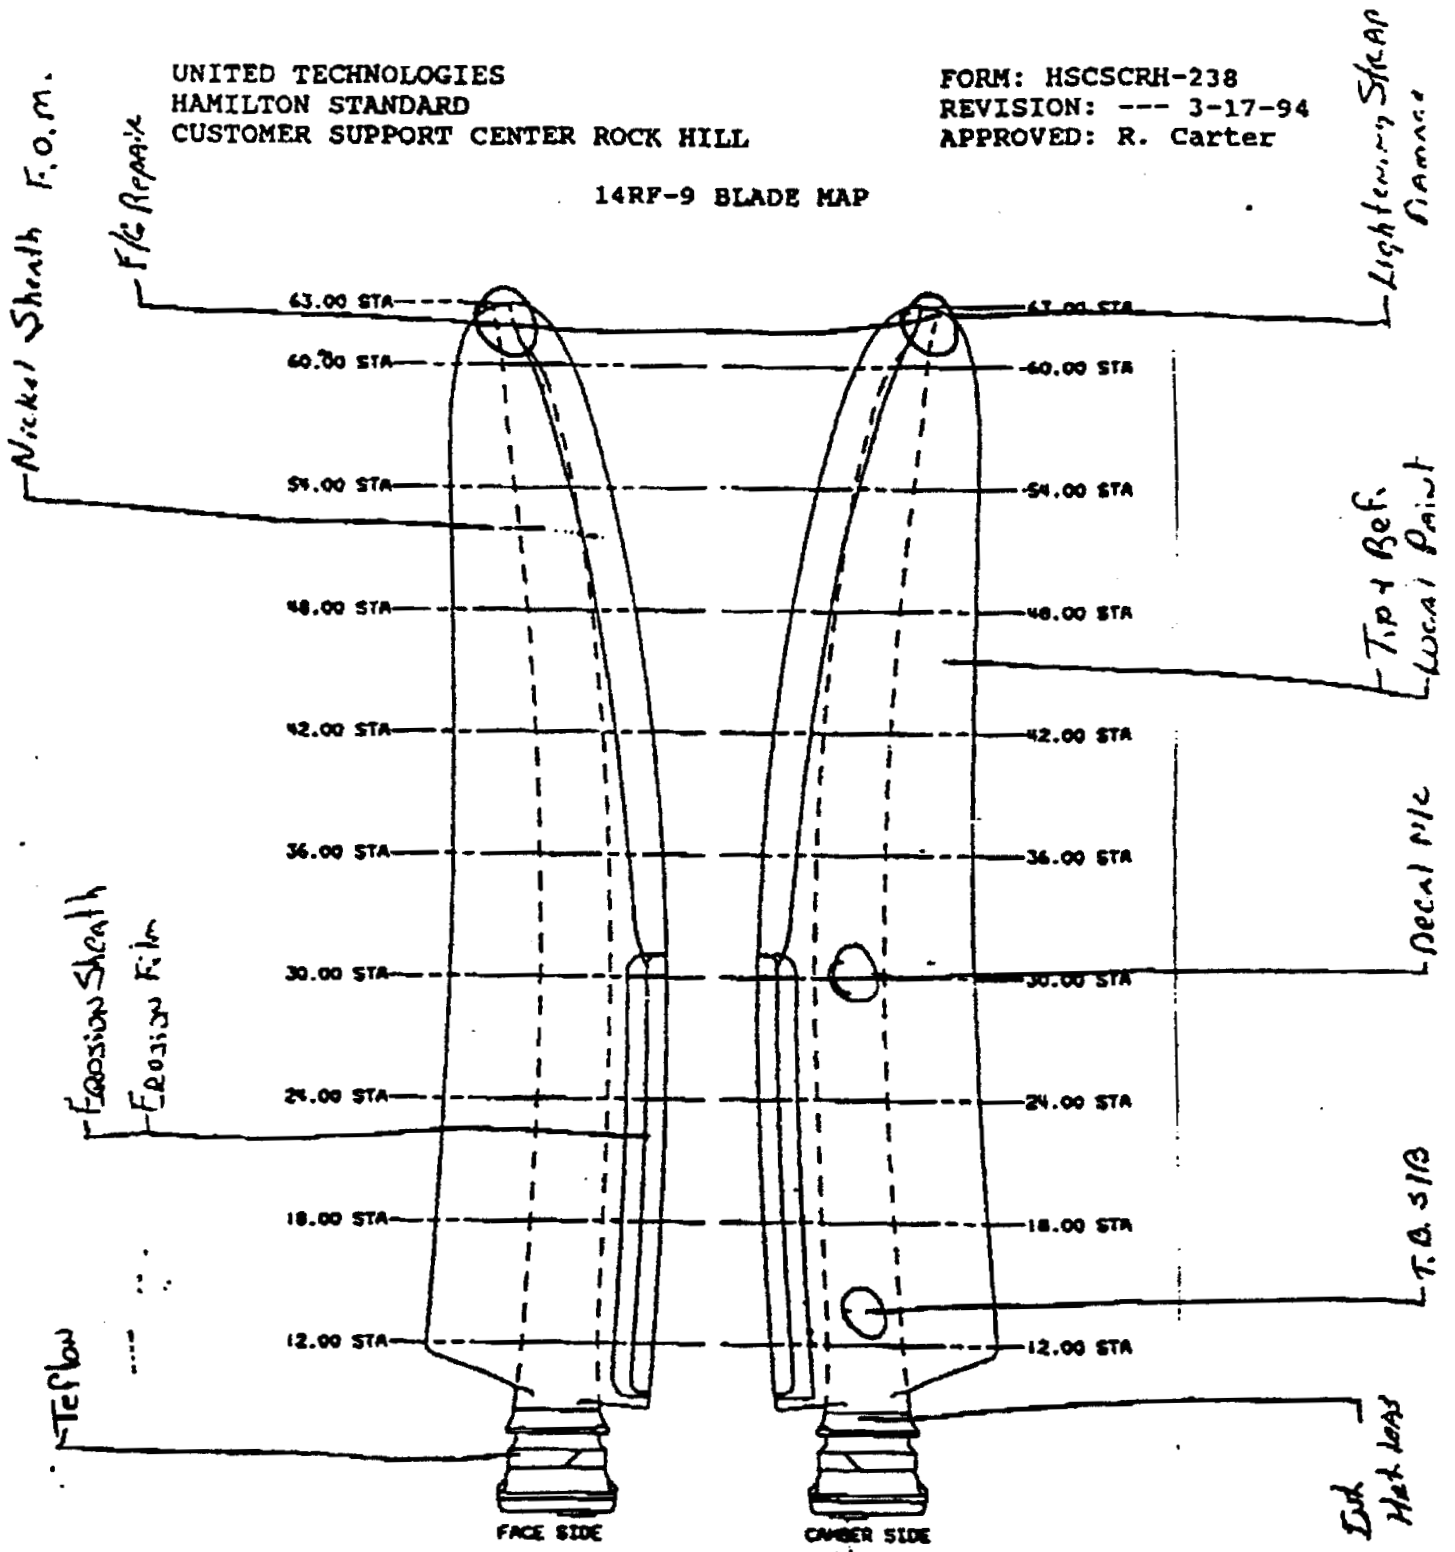
14RF-9 BLADE MAP

Watt 24d1
Watt 4148
SN# 861398

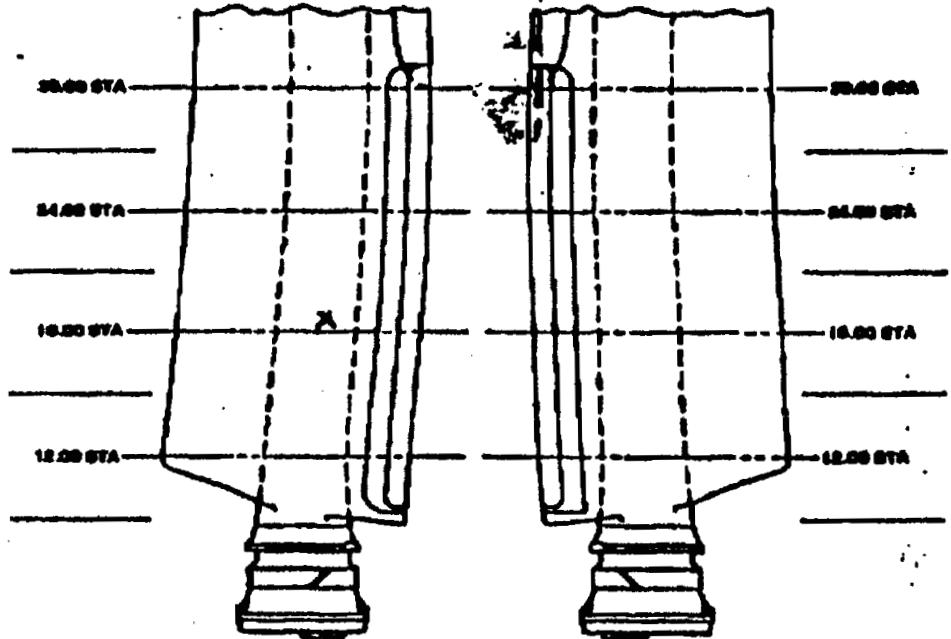
Attachment 2

BLADE STATUS: PASS _____ FAIL
