PPG Aerospace Transparencies ***Failure Analysis Report***

June 17, 2019

RE: Evaluation of a Left Hand Window for Pilatus; Part Number NP172121-5; S/N 01120H6846; CA136394

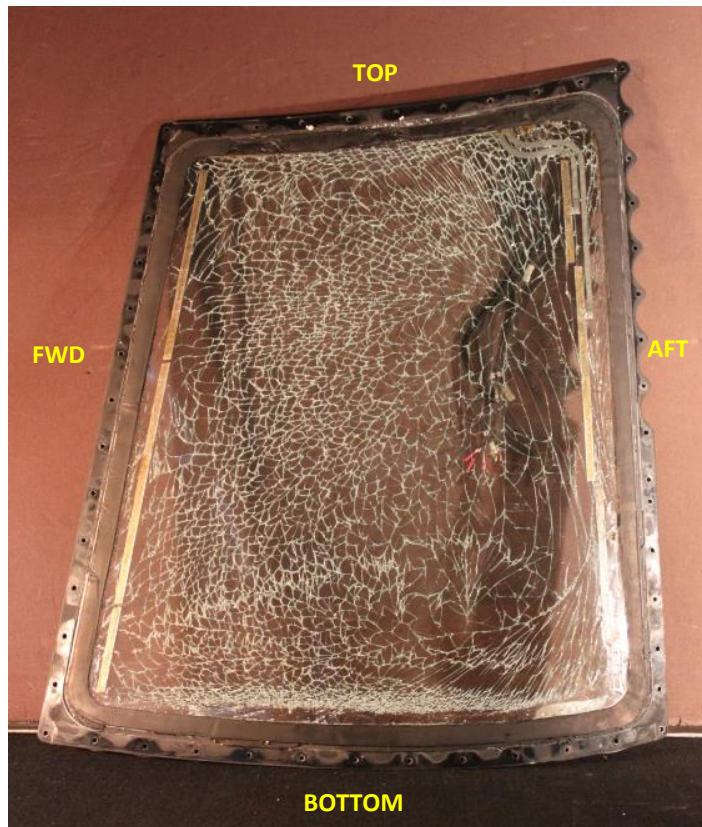
Figure A: Inboard Overall View

Figure A: Outboard overall view of the window as received.

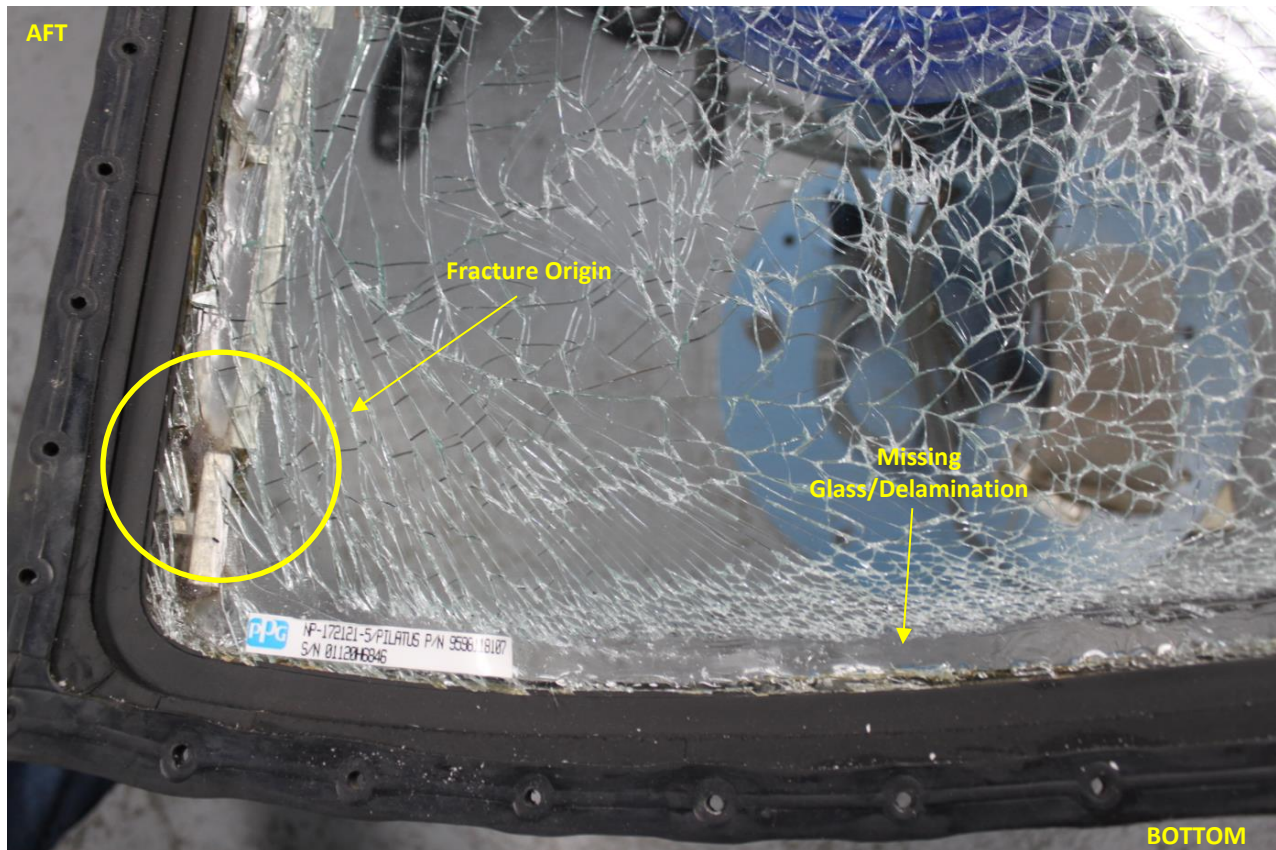
Figure C: Fracture Location

- Anti-static coating – open
- The inboard glass ply failed with the fracture origin location along the aft bottom edge (see Figure C). Arcing visible at bus bar location with black discoloration.

- Heavy delamination/moisture ingress was visible along bottom/aft edges. Missing glass from inboard ply along the bottom/aft edges made determining the failure origin impossible, but likely became disbanded from windshield after breakage due to delamination issue.

Figure C: Inboard view of the window at fracture origin location. Inner glass ply was missing along bottom/aft edges around fracture origin, so exact failure origin location was unable to be determined. Delamination present.

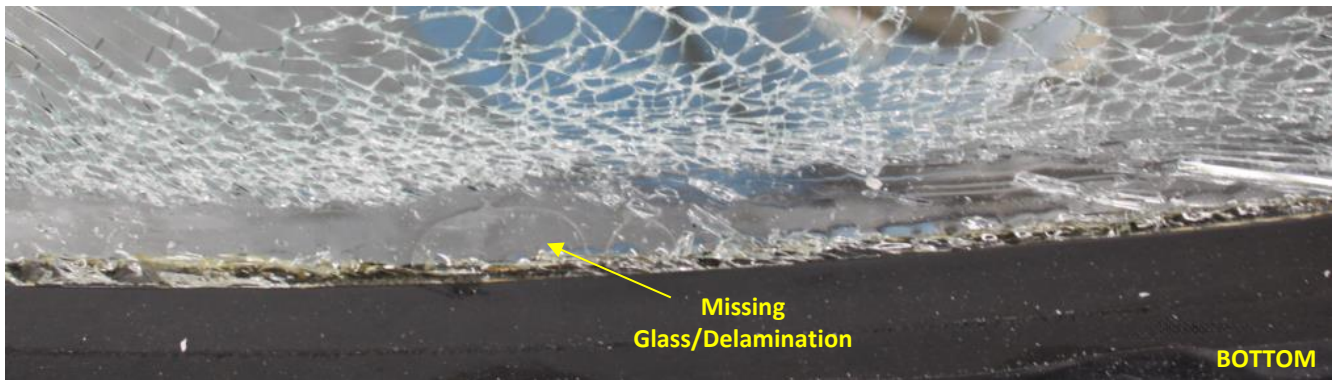
Figure D: Close-up View of Delamination

Figure D: Close-up view of delamination present along edge of windshield.

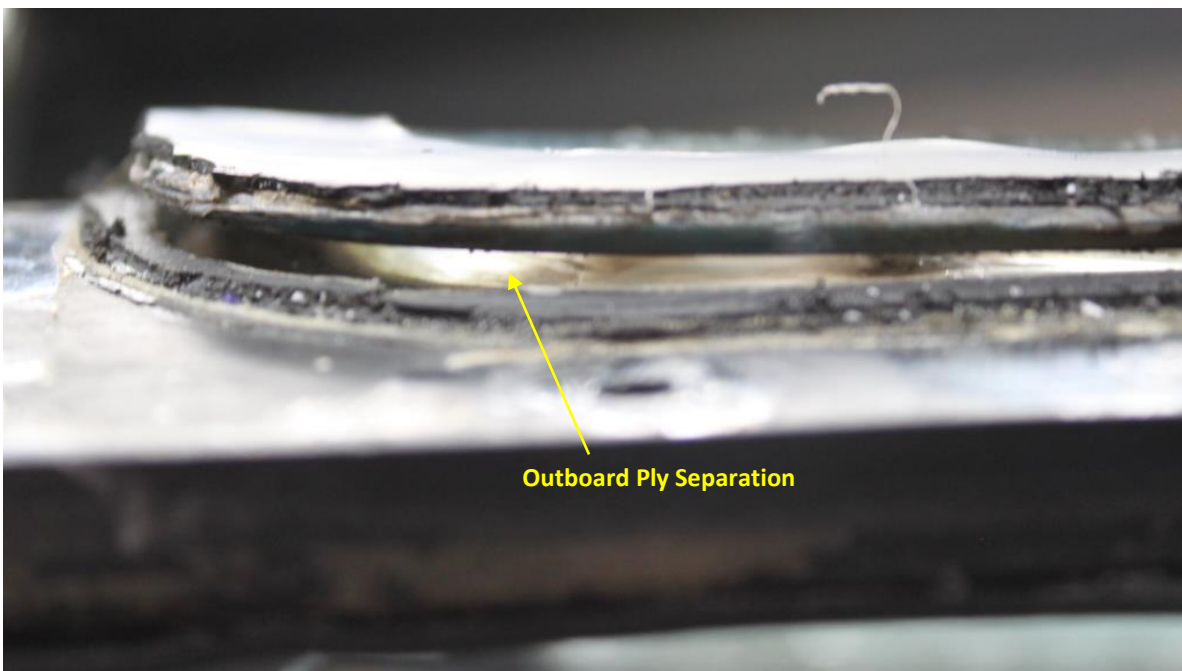
Figure E: Close-up View of Detached Outboard Ply

- Moisture seal removed around entire periphery of window to reveal that ~80% of fiberglass straps had been removed during maintenance practices. Combination of missing straps and heavy delamination caused the outboard ply to become detached from the edge attachment.

Figure E: Close-up view of aft-bottom edge of windshield where outboard ply was separated from edge attachment.

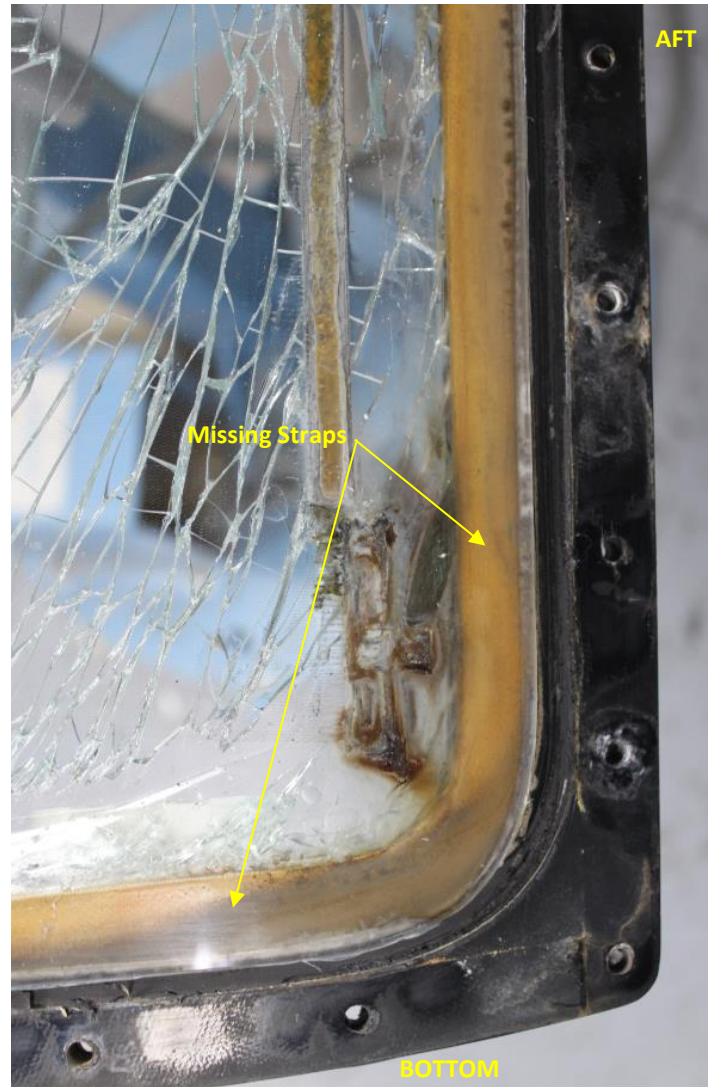
Figure F: Outboard View – No Fiberglass Straps

Figure F: Outboard view of windshield at fracture origin. No fiberglass straps present.

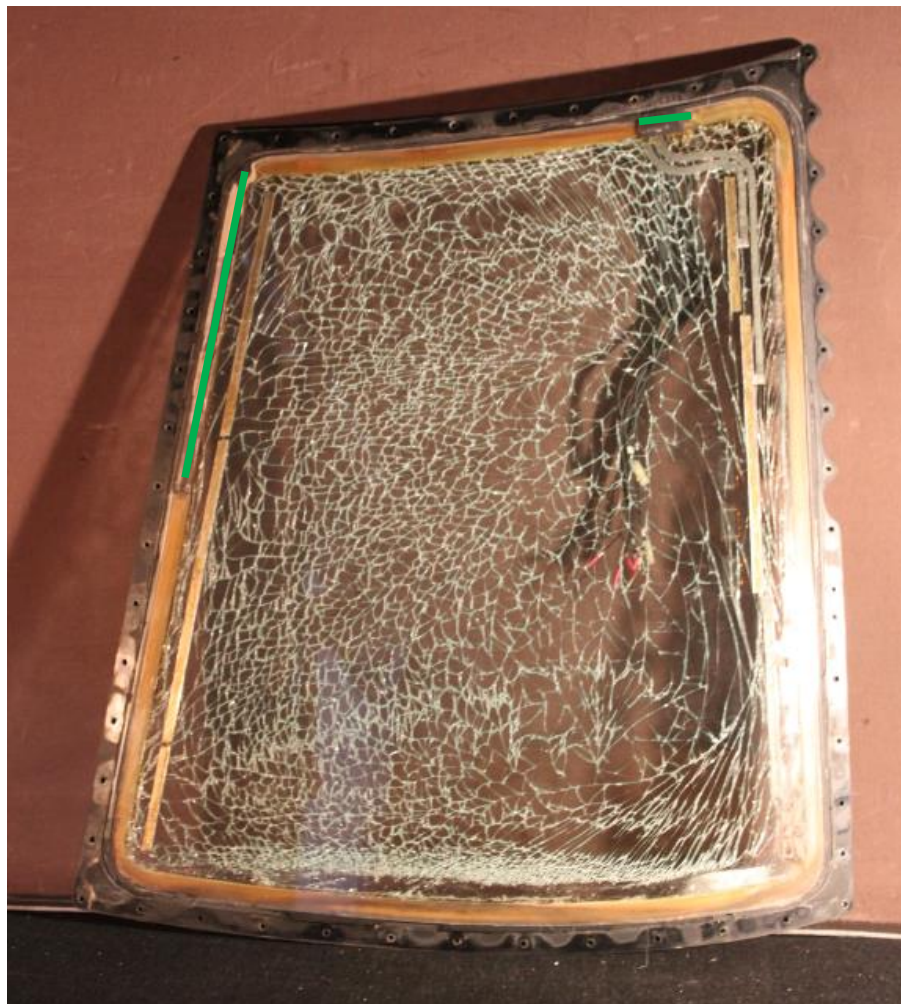
Figure G: Outboard Overall View – Remaining Strap Locations

Figure G: Outboard view of windshield to highlight where remaining fiberglass straps remain. ~80% of straps had been removed. Green lines below highlight the areas of remaining strap – all other areas have the strap removed.
