**SERVICE BULLETIN #9**

**SUBJECT:** Flaperon hanger rib  
**TO:** KITFOX MODEL I, II, III owners  
**FROM:** Denney Aircraft Company

**Attached Drawing D28002 Wing Rib Reinforcement**

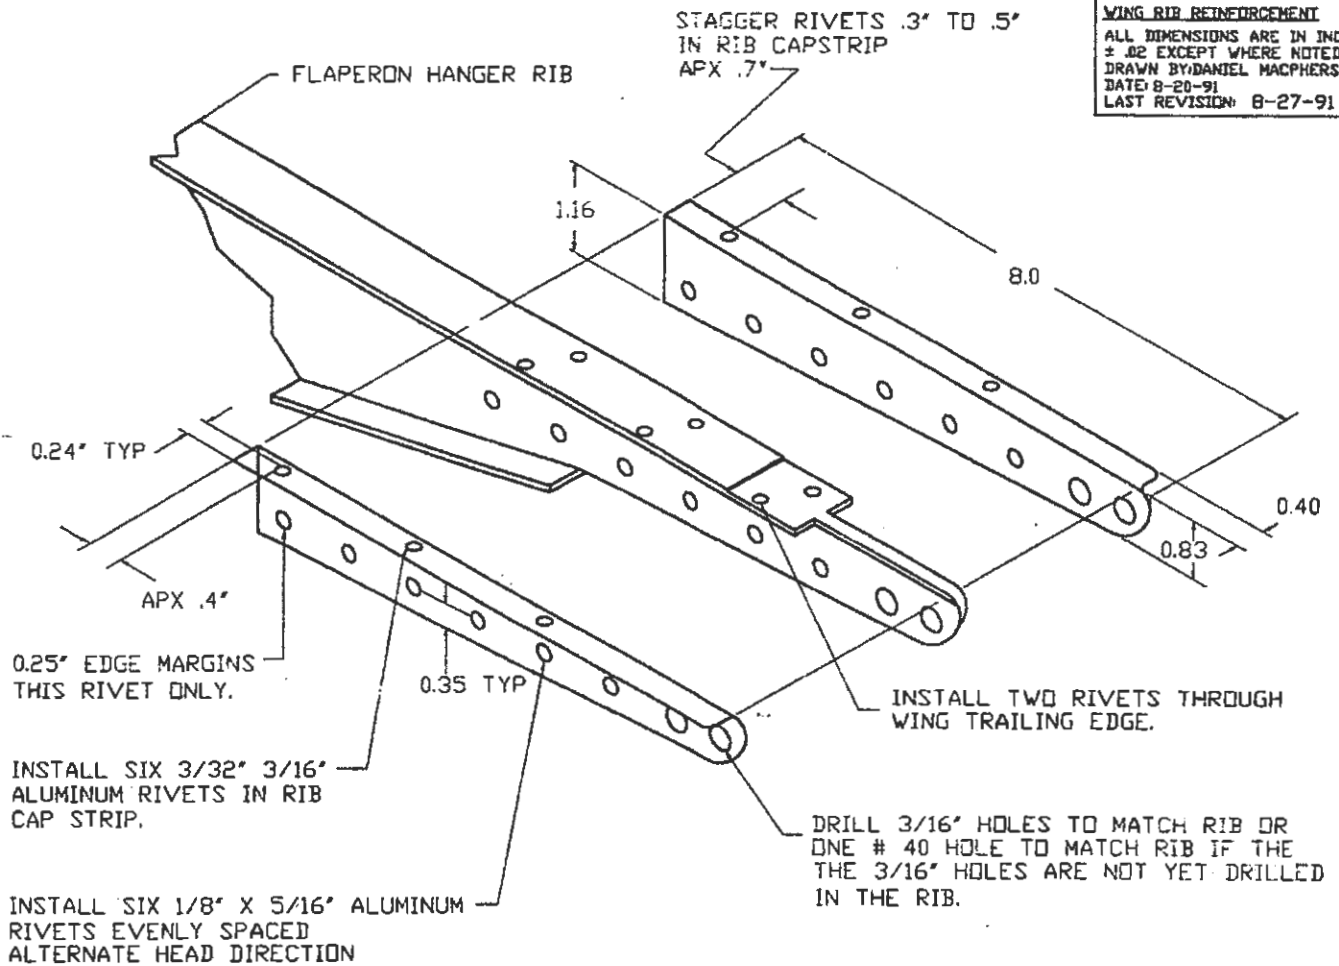
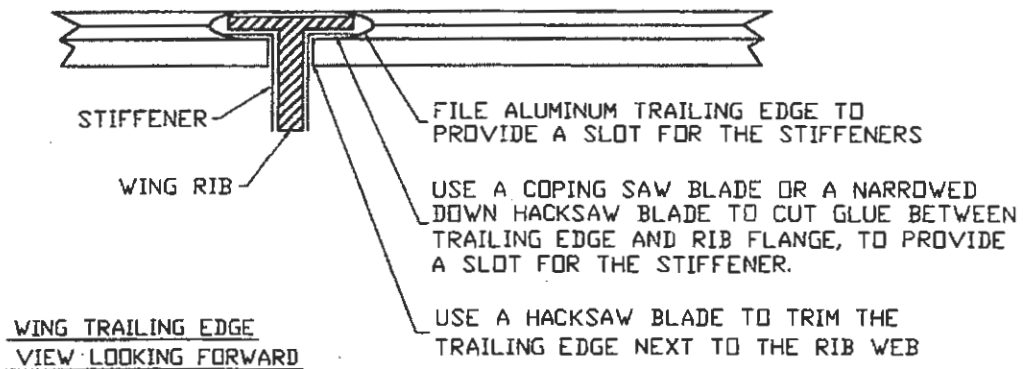
D28002

There have been two cases of Kitfox flaperon hanger rib failure documented in the United Kingdom. In both cases the failure appeared to be from side load overstress. Both aircraft had been in recent prior ground accidents. One was in an automobile accident while being transported on a trailer. The other mishap involved a nose-over upon landing. In both cases it is very likely that there were excessive side loads placed on the flaperon hangers which could have contributed to the subsequent failures. In the latter case the failure occurred on the ground during a period of engine operation at very low RPM's including engine operation on one cylinder, which caused the entire aircraft to shake violently. There was no personal injury to any persons in either case.

We have designed and tested reinforcements for the flaperon hanger ribs that can be readily fitted to Kitfox wings under construction or retro fitted to wings already completed. These modified ribs will withstand up to 150 lbs side load each when in reality the load will most likely be spread over the 5 hanger ribs. FAR 23 requires a side load capability of 12G's and 24 G's normal to the plane of the control surface. The flaperon with the Denney Aircraft mass balance weighs 7 pounds so you can see that it will withstand a side load of over 21 G's with the modification. We also tested standard un-modified ribs and they withstood 90 lbs of side load (12G's). In essence they met the Part 23 requirement for side loads without the reinforcement.

To meet the requirements of FAR 23 for in-plane loads of 24 G's the reinforcement must be installed on the two outboard ribs. (This assumes you have positioned your Denney Aircraft Co supplied mass-balance in the prescribed position near the outboard end of the flaperon). You should also install the reinforcement on each inboard rib to compensate for slack in the bearing or failure of the fuselage/turtledeck support bearing. If you desire to reinforce all ten flaperon hanger ribs that is ok but not necessary UNLESS you have installed the rod type mass-balance inserted in the leading edge of the flaperon as some have done in the U.K. If you have used the rod-type mass balance method then you should reinforce all 10 flaperon hanger ribs.

The reinforcements consist of left and right .025" 2024-T3 aluminum angles riveted to each side of each flaperon hanger rib end. Each angle is 8 inches long and tapers from a depth of 1.2 inches to .8 inches with a flange of .4 inch. This flange fits flush against the bottom of the rib capstrip. The reinforcement angles are fastened to the tail of each hanger rib with 6 each 1/8 inch x 5/16 inch long blind "POP" rivets. Each aluminum angle is also riveted to the rib capstrip with 3 each 3/32 inch x 3/16 inch rivets. The builder will have to round the ends of each reinforcement angle to match the rib. He can at his option apply FSA-2 structural adhesive or the equivalent to the mating surfaces for increased joint strength. If this is done the reinforcement angle should be cleaned with acetone or MEK and rough sanded with 100 grit sandpaper.

To retrofit the reinforcement strips to a wing that is already covered, you will have to slit the fabric from the trailing edge about 8 inches forward along the centerline of the bottom of the hanger rib. Slit the fabric along the trailing edge about 6 inches on each side of the rib. Then you can pull the flap of fabric back away from the rib so you can drill rivet holes and install the reinforcement angles.

To repair the fabric you will have to remove the paint and dope down to bare fabric with Stits reducer, MEK, or other suitable solvent. Then use fabric tape to cover the slits and use Stits Poly-Tac, Poly-Brush, and Poly-Spray to attach and coat the tapes. Heat-shrink the patches and repaired areas to restore tautness to those areas. Repaint.
