WRECKAGE AND IMPACT

The Safety Board investigator-in-charge performed an on-scene wreckage documentation the day following the accident followed by the initial examination.

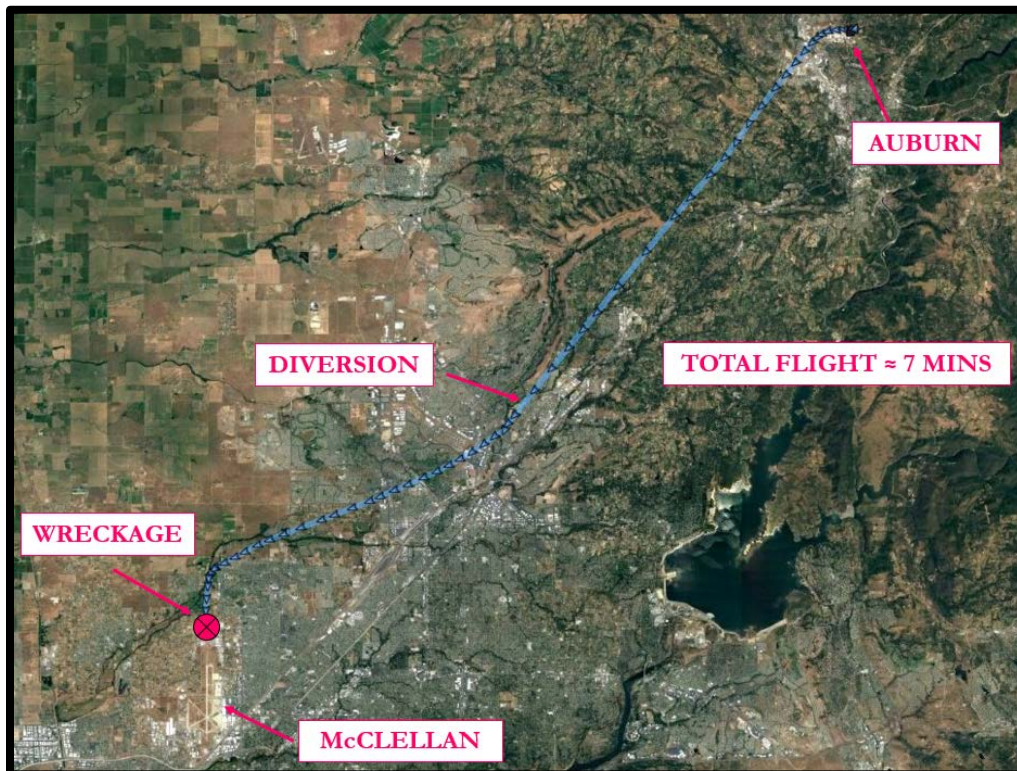
Figure 3: Accident Flight Recorded in the Handheld GPS with Diversion to McClellan

Located in the wreckage was a Garmin GPSMAP 396, battery-powered portable GPS receiver. The unit stores date, route-of-flight, and flight-time information; all recorded data is stored in non-volatile memory. Recorded data plots were recovered for the time frame that matched the anticipated flight track of the airplane departing from Auburn. The track indicated that the airplane departed from runway 25 about 1455. After becoming airborne, the airplane climbed and headed toward San Carlos on a heading of about 220 degrees. At 1459:28, with the airplane about 6,800 ft msl, the airplane began a gradual descent and shifted to a 240-degree heading. The airplane continued in the direction while cruising between about 215-200 kts until 1502:02 when the airplane made a left turn to adjoin the final approach leg to runway 16 at McClellan Airfield.

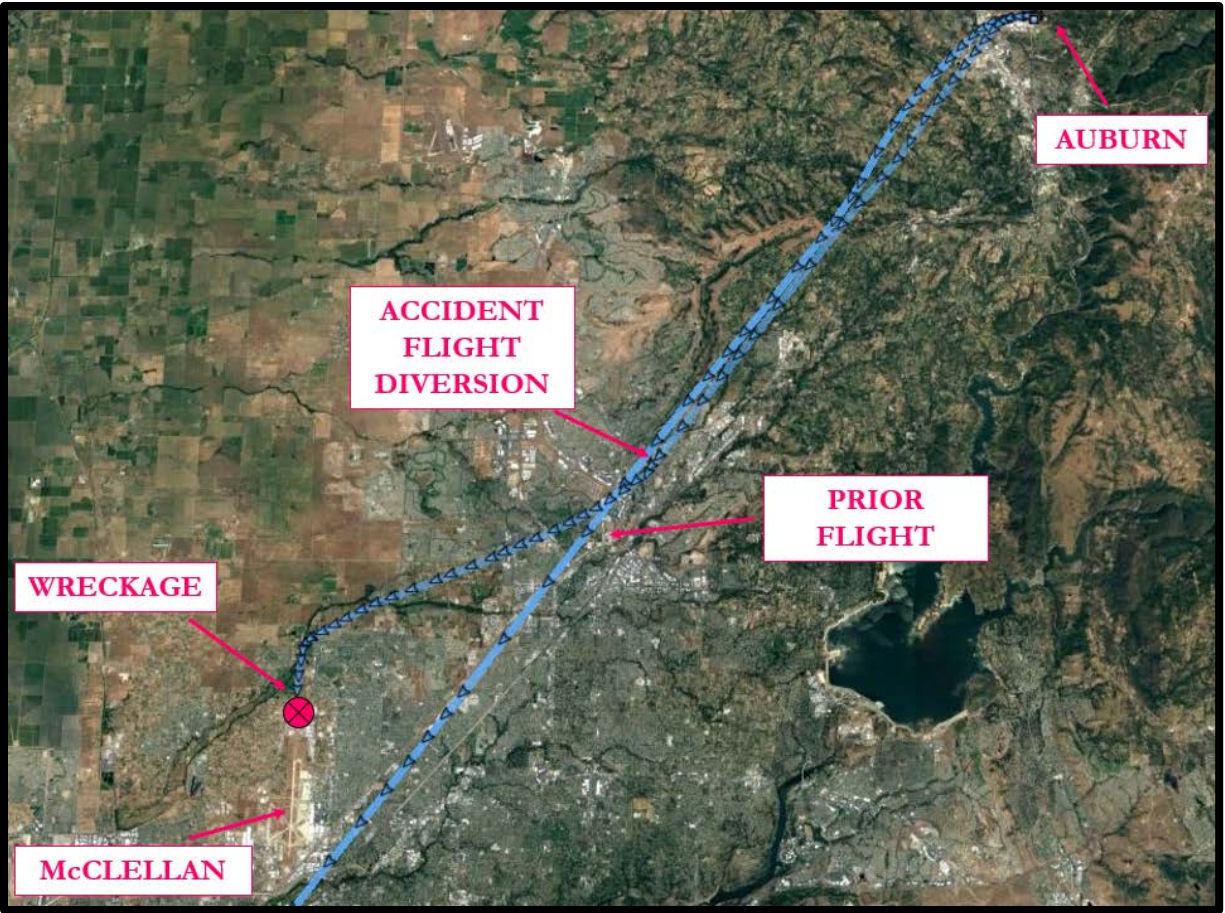
Figure 5: Accident Flight Compared to Prior Flight with Same Flight Plan

A comparison was made between the accident flight and a prior flight from Auburn to San Carlos. Lateral and perpendicular distances were measured between the prior flight path, and compared to the accident. Comparing the flight paths revealed that the accident flight was similar in speed and altitude gain until reaching the diversion point.

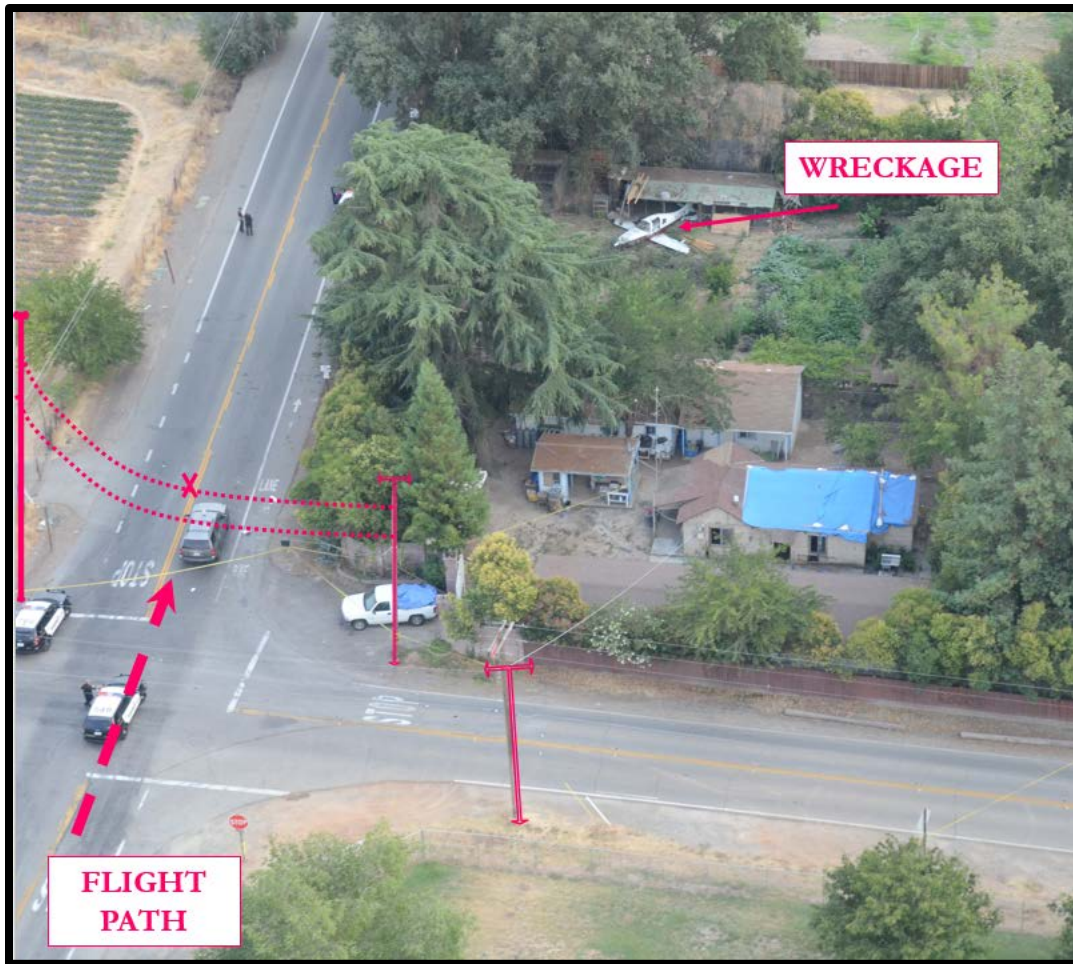
Figure 10: Wreckage Relative to Impacted Powerlines

The accident site was in a back yard of a residence located on the corner of U street (east-west oriented) and 28th street (north-south oriented). Powerlines were located 190 ft north of the wreckage with two support structures (wood poles) on both sides of 28th street (the south side of U street), at a distance of 73 ft apart. The lines had been separated from the west structure attach fittings (35-ft high) but remained attached to the east structure (about 55 ft high). The upper powerline had several bends in the center area consistent with the airplane having made contact with the wire. Situated on the level terrain, the airplane came to rest in upright with the nose oriented on an about 100-degree magnetic bearing. The main wreckage, which consisted of a majority of the airframe and engine, was located about 1.3 nm from the edge of the runway 16 at McClellan. The global positioning satellite (GPS) coordinates for the main wreckage were approximately 38 degrees 42 minutes and 14.35 seconds north latitude and 121 degrees 24 minutes and 6.28 seconds west longitude, at an elevation of about 70 ft mean sea level (msl).

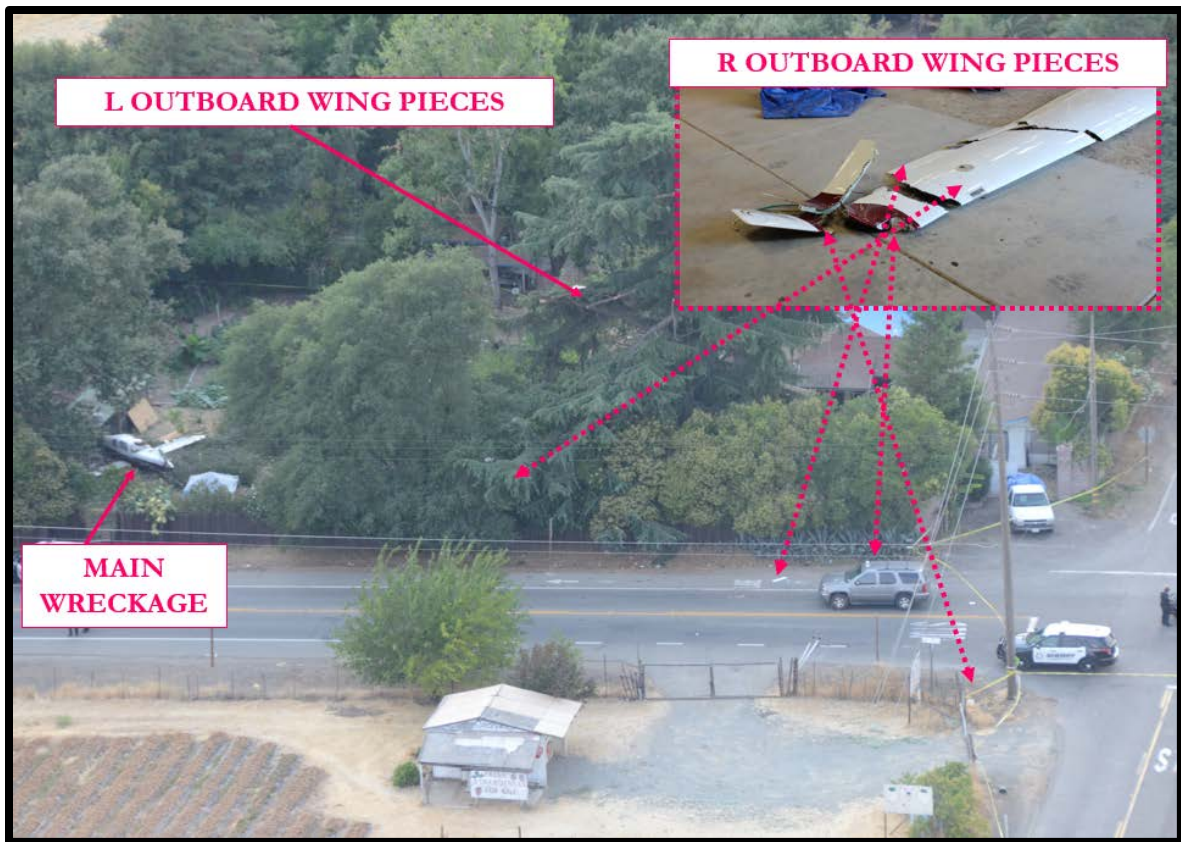
Figure 13: Debris Field Highlighting Right Wing Pieces

The inboard portion of the right wing (measuring about 7 feet and 4 inches) remained attached to the wing root; fuel was seeping out at the attached points. The outboard portion of the wing was located on top of the shed, below the first impacted tree; the fuel cap remained secured. The right flap remained attached to the wing and the inboard 4 inches of aileron was attached. The remainder of the aileron was separated into 2 pieces, the inboard piece was found in the shed area in the outboard piece was located at the beginning of the debris field adjacent to the right-wing tip on the west side of the road. The right wing tip was fragmented into three major pieces: the end tip was found on the east side of the road; the midsection was found on the west side of the road where fragmented pieces of green/blue lens were scattered in the dirt; in the remained with the outboard portion of the right wing near the shed area.

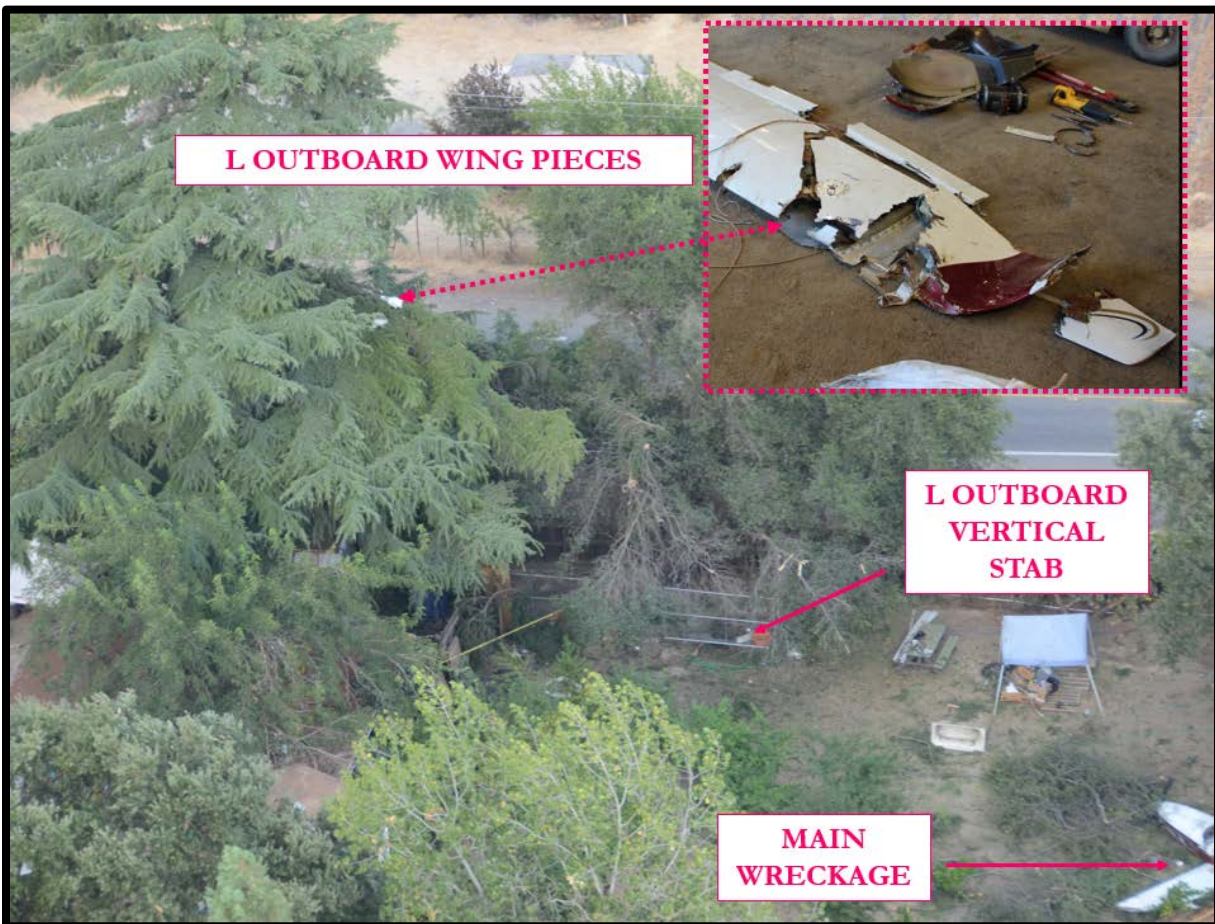
Figure 14: Debris Field Highlighting Left Wing Pieces

The left inboard 11 feet and 7 inches of the wing remained attached to the airframe at the wing root. The flap was still attached at its respective hinges. The aileron was separated into two sections, one of which remained attached to the wing and the outboard portion was found in the shed area. The outboard portion of the left-wing was severely fragmented and found along the debris field. A larger section of the upper wing (which included the fuel cap) was located in the canopy of the tree branches along with the pilot tube. The left wing tip was found in the shed area and the bracket that affixes the lens to the wingtip was located near the main wreckage.

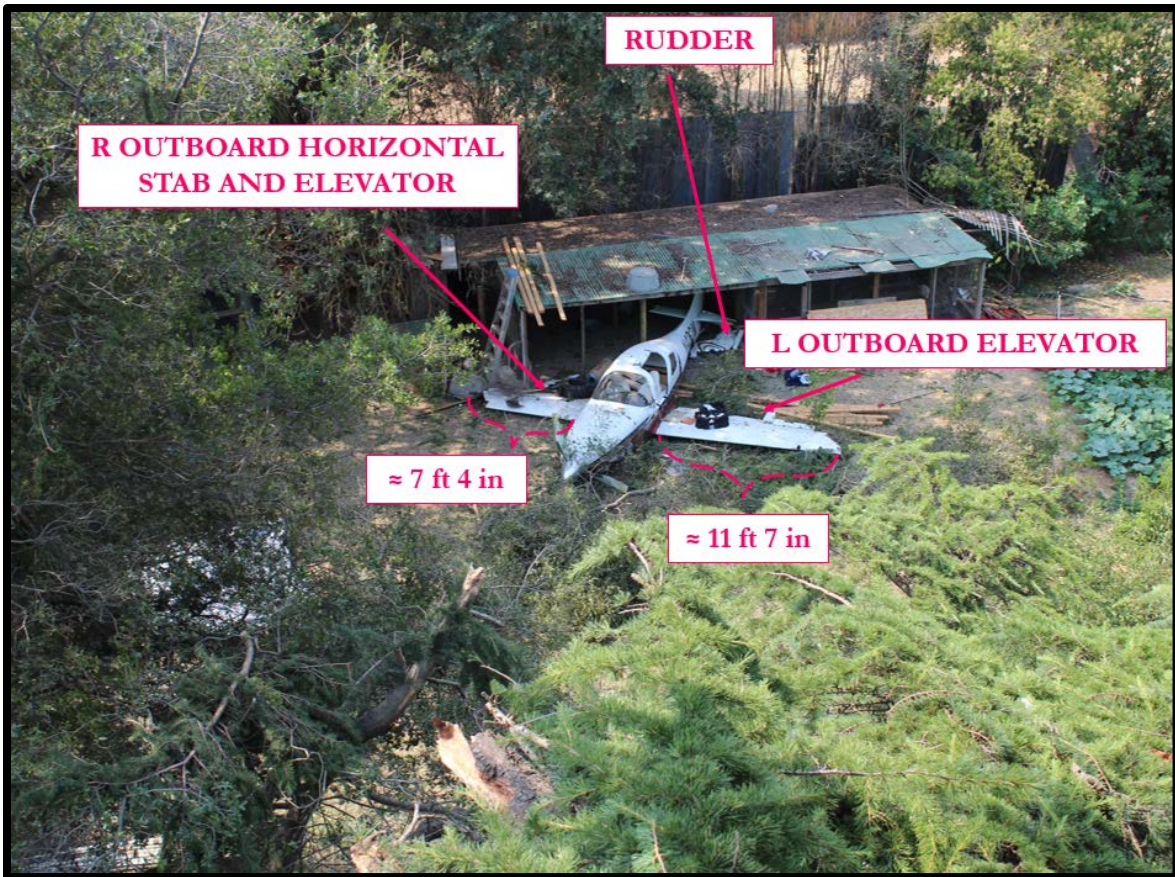
Figure 15: Main Wreckage

The engine's upper cowling was intact and no evidence of soot or oil; the bottom cowling had suffered crush deformation. The landing gear were physically in the retracted position and the selector handle was "down."

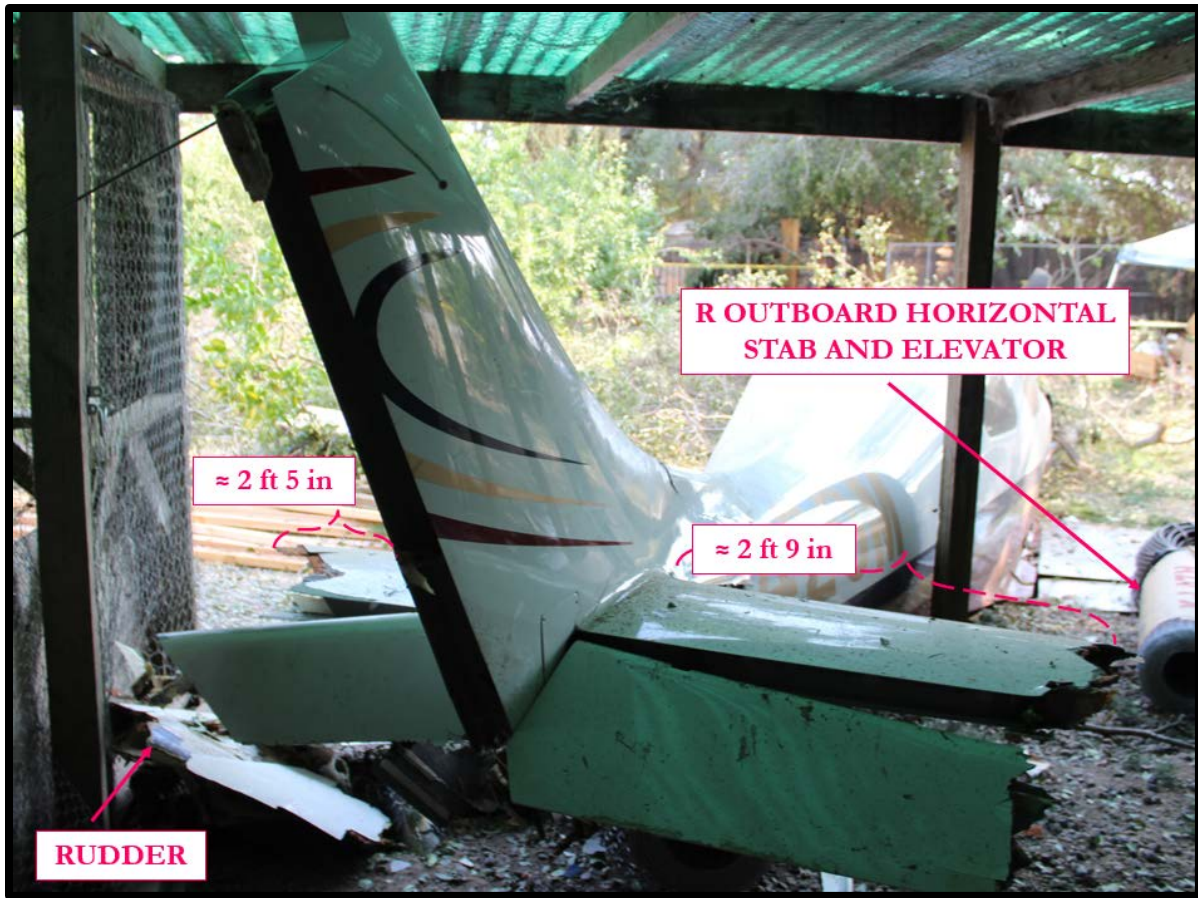
Figure 16: Tail Section

The inboard portions of the horizontal stabilizers and elevators remained attached to the empennage. The right outboard portion of the horizontal stabilizer and elevator were found under the right wing of the main wreckage. The left outboard horizontal stabilizer was found in the debris field between the first-impacted tree and the main wreckage. The left outboard elevator was found under the left-wing. The rudder had separated from its attached points and located in the main wreckage under the inboard portion of the left horizontal stabilizer.

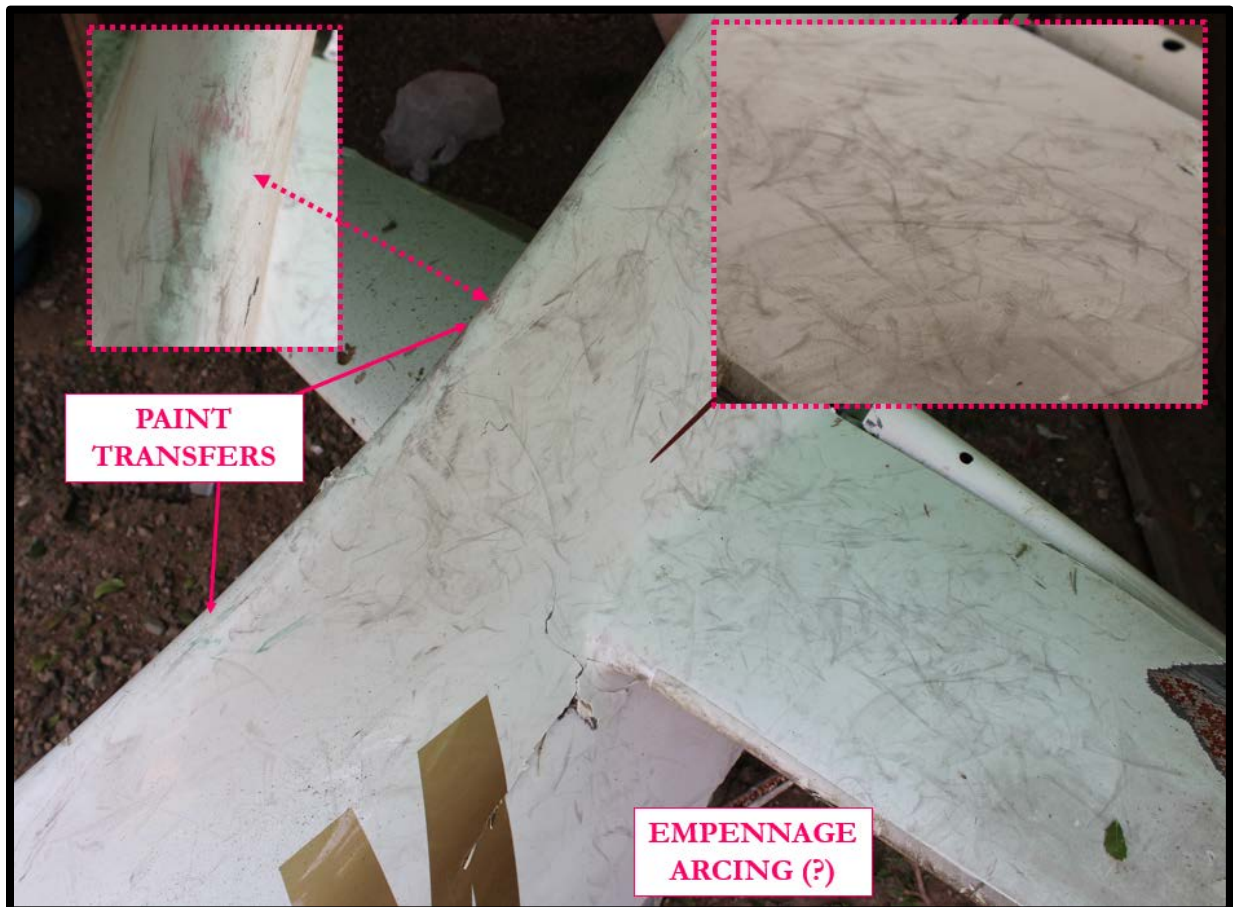
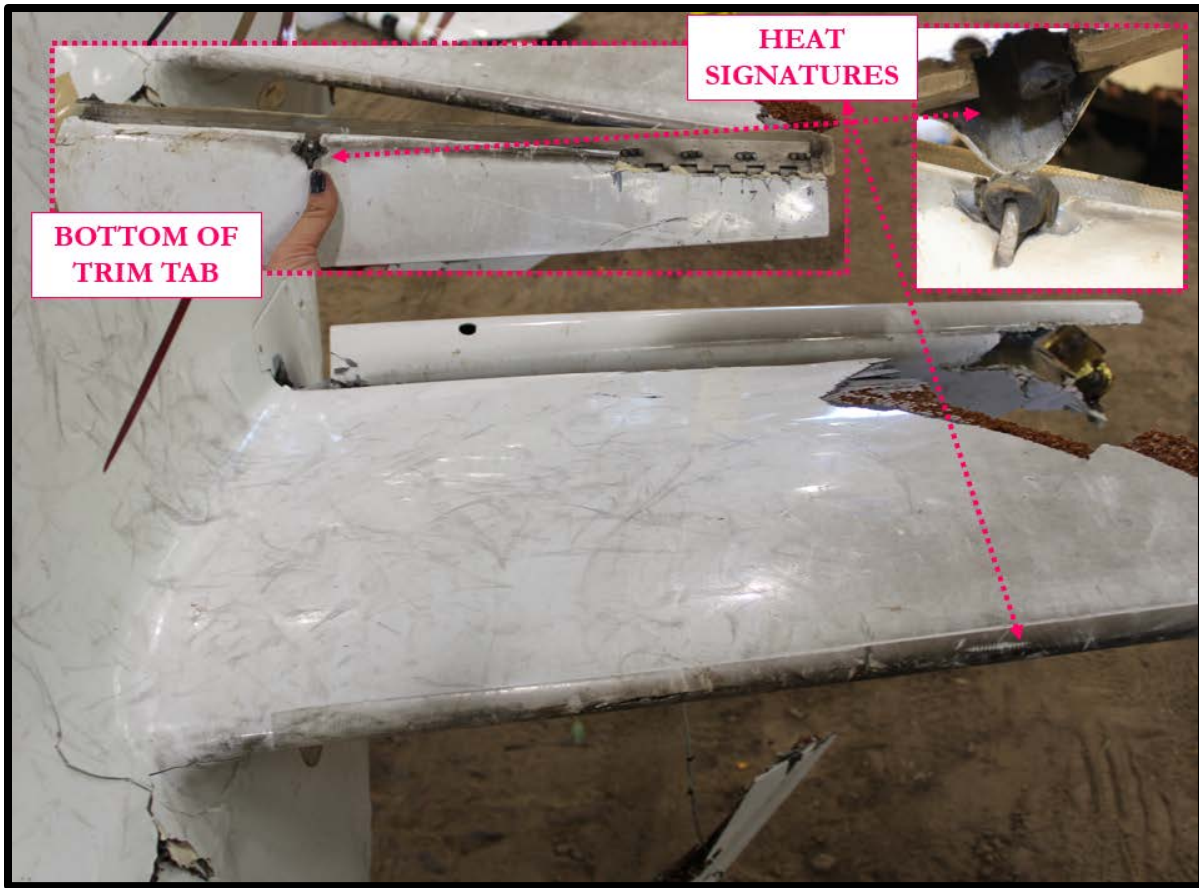
Figure 17: Markings on Empennage

On the top of the tailfin, where the empennage transitions into the vertical stabilizer, there were numerous black/grey marks and smudges. The markings measured about 1 to 2 inches in length and increased in intensity moving toward the outboard section of the left horizontal stabilizer; there were additionally blue and red paint transfer marks at the spine. The leading edge of the stabilizer was darker grey/black in color and blistered/cracked at the leading-edge tape. The dark coloration continued at to the leading edge of the elevator in the trim tab at a concentration of black at the bottom leading-edge. The attached fittings of the elevator trim tab were black and had an appearance of sustaining thermal damage. According to the NTSB materials lab experts, the signatures could be indicative of electrical arcing of the e-glass composite airframe as it contacted a high-tension power line.

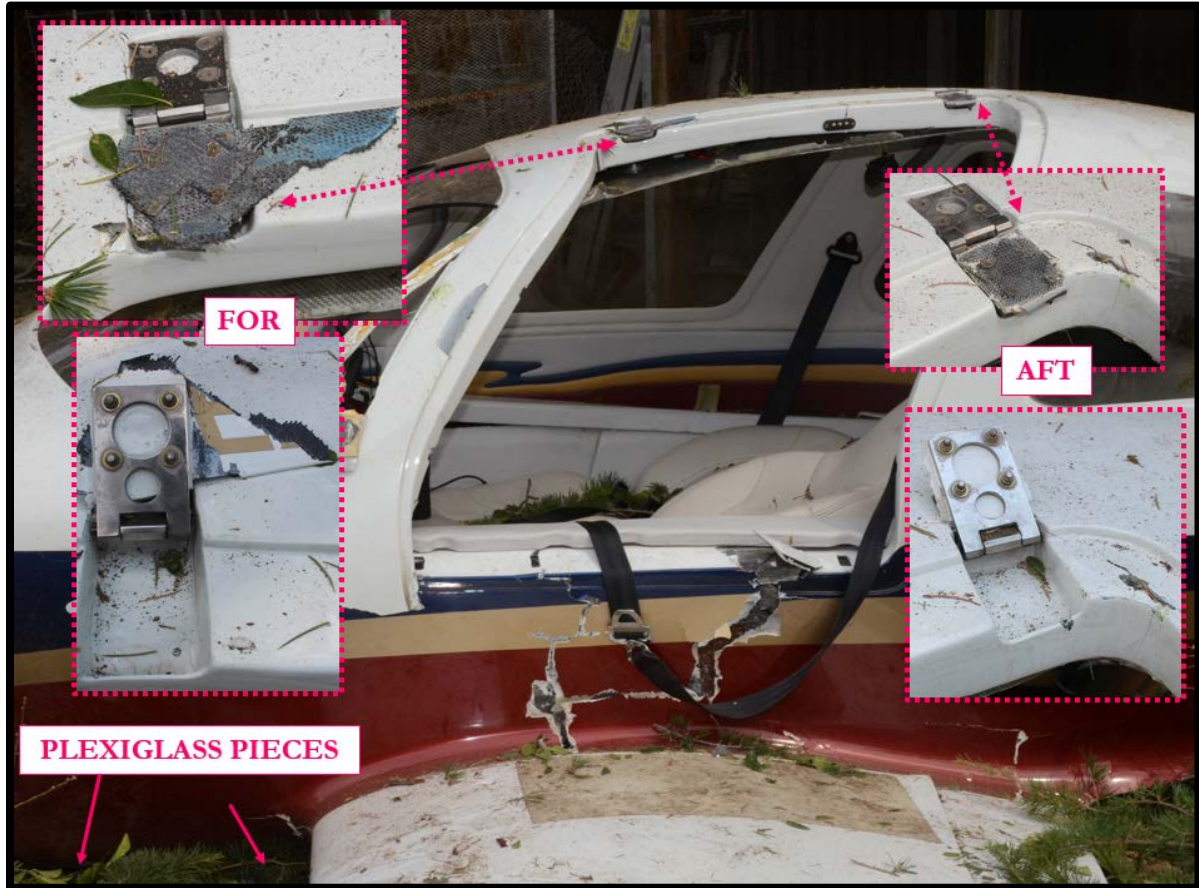
Figure 19: Accident Airplane Door Hinges

The door was not located. The door actuator hinge was located in the cockpit.

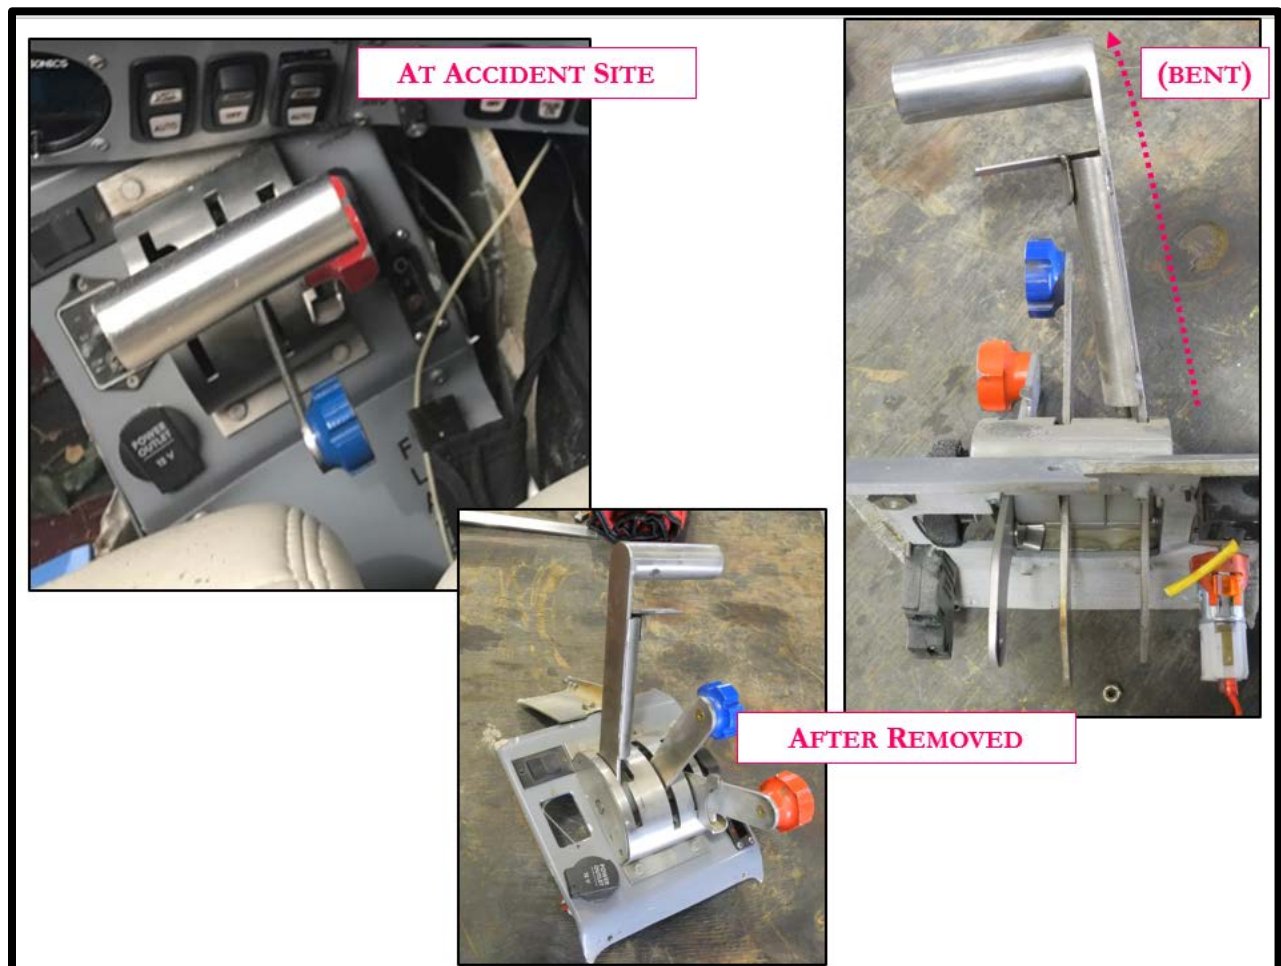
Figure 21: Throttle Quadrant

The airframe remained relatively intact and there was only minor crush damage to the cockpit. The throttle was between mid and full throttle (not in the emergency detent); the propeller lever was at feather and the condition lever mid-range. The throttle quadrant retention clip was displaced and the throttle lever was slightly bent. It is unknown if the clip displacement was a result of the cockpit deformation at impact.

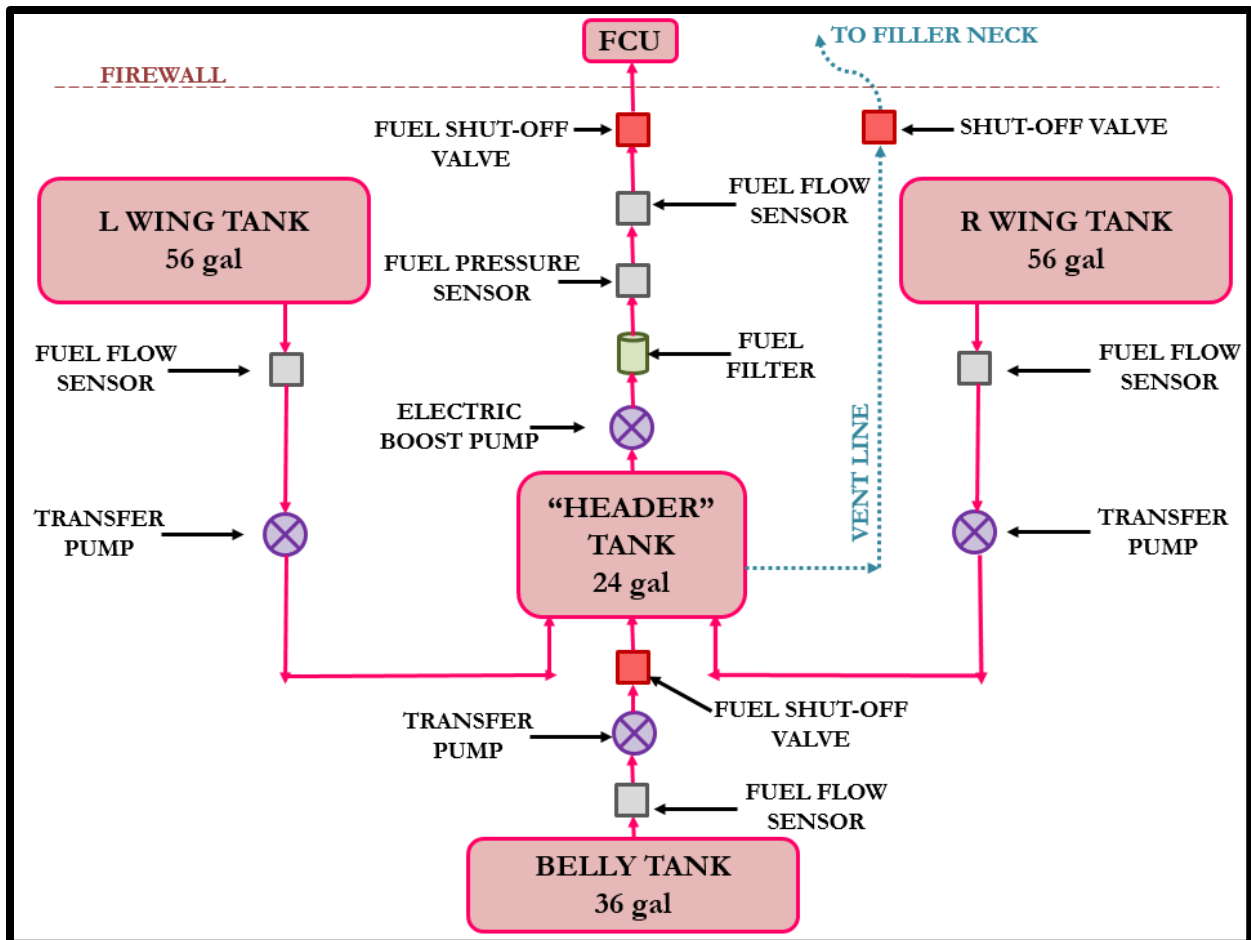
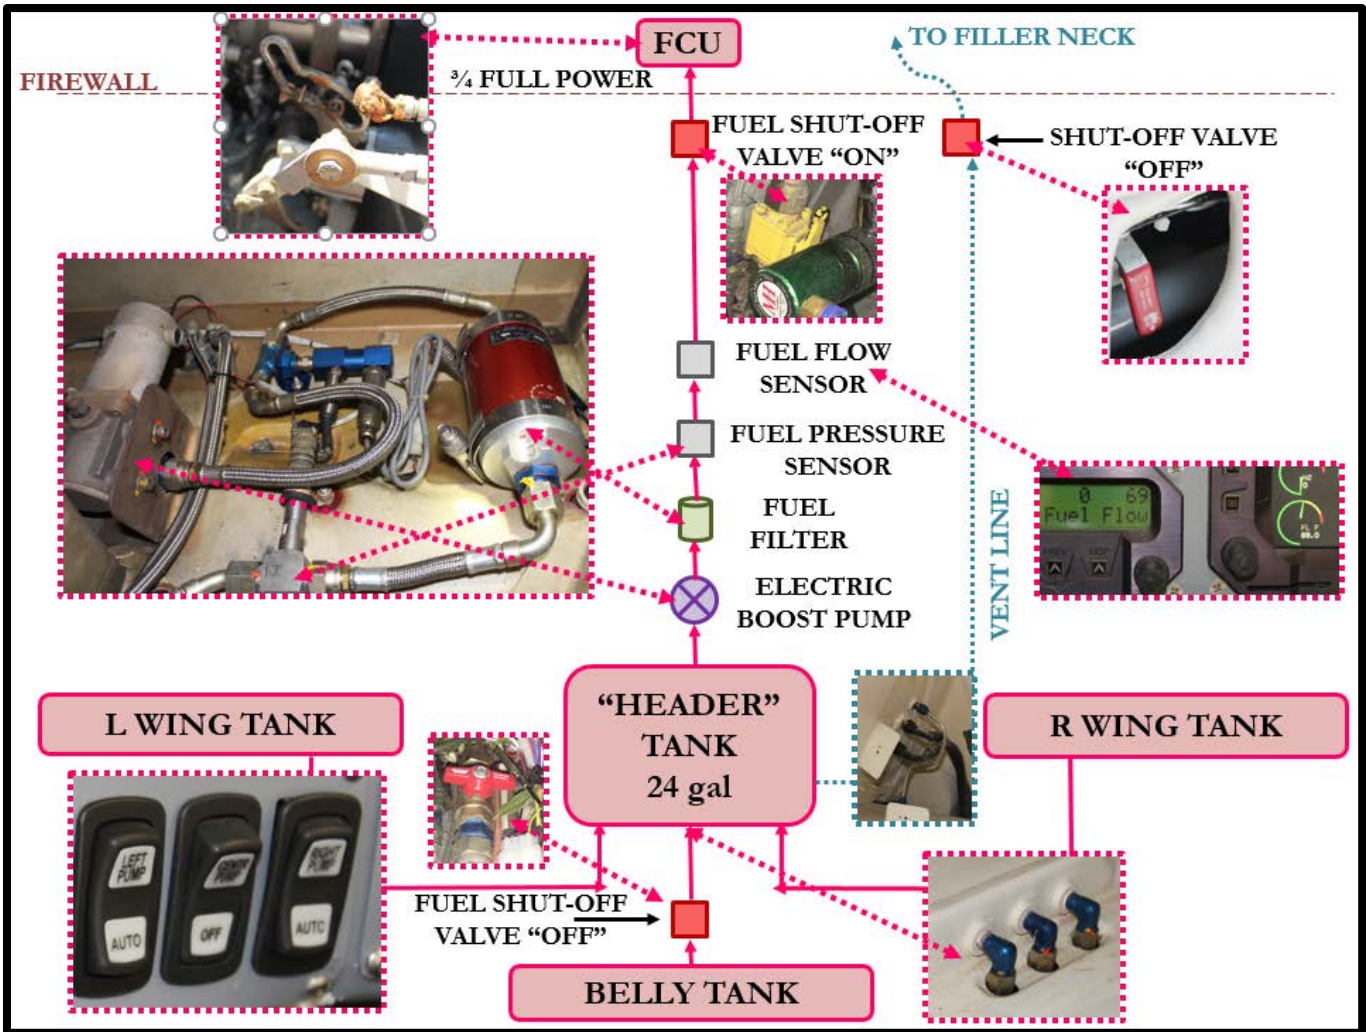
Figure 25: Fuel System

The fuel system consisted of two 56-gallon wing tanks and a 36-gallon belly tank that all fed into a 24-gallon header tank. From the header tank there was an electric boost pump where the fuel was fed through a fuel filter and continued by the fuel pressure sensor and then the fuel flow sensor to the fuel control unit (FCU), meaning the pressure and flow displayed on the instrument panel were based on what the pressure header tank was supplying to the FCU. The header tank had a vent line.

The fuel pressure remained relatively stable through the flight. Immediately after the accident, the left and right fuel pumps were selected to “auto” and the center pump was selected to “off.” During a post accident examination of the fuel system, the fuel line was detached from the fuel control unit (FCU) and the system was activated. Upon activation of the boost pump, about 20 gallons of fluid was pumped from the header tank at a recorded fuel flow of about 70 gallons per hour.

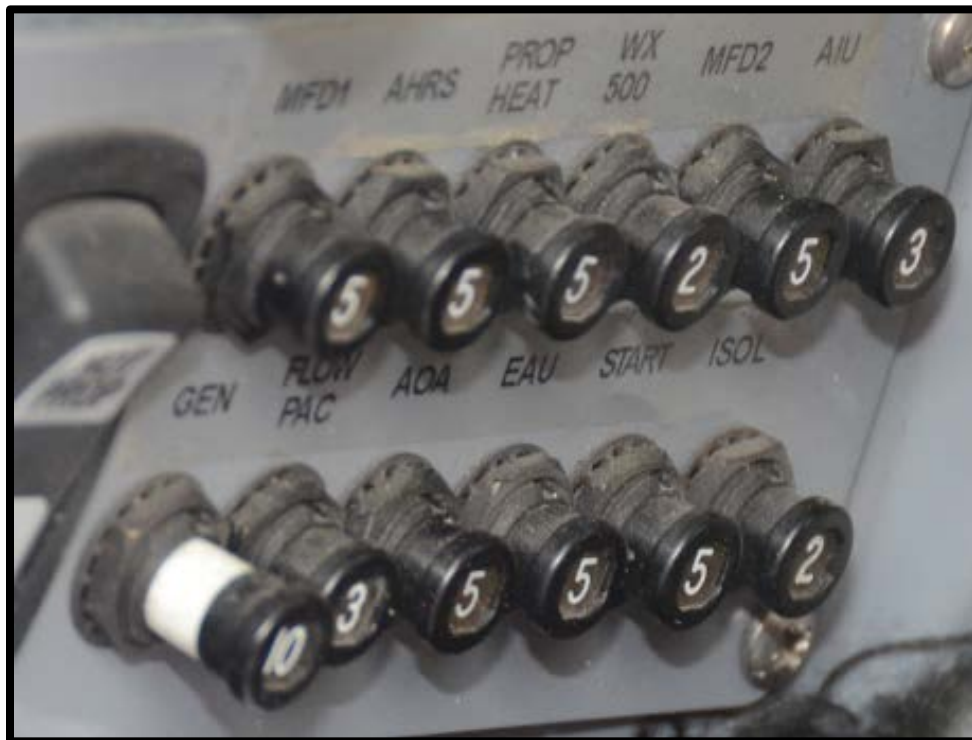
Figure 27: Generator Circuit Breaker

The generator switch was selected to “on” and the generator circuit breaker was out. The air conditioner switch was “on.”
