National Transportation Safety Board

Marine Accident Brief

Capsizing and Sinking of the Fishing Vessel *Christopher's Joy*

Accident no.	DCA14LM020
Vessel name	<i>Christopher's Joy</i>
Accident type	Capsizing and sinking
Location	Gulf of Mexico, near Southwest Pass, Louisiana 28°49.52' N, 089°24.22' W
Date, time	September 23, 2014 Capsizing about 1430 central daylight time, sinking about 2057 (coordinated universal time - 5 hours)
Injuries	2 injuries, 2 fatalities
Damage	Loss of vessel, valued at \$460,000
Environmental damage	Unknown quantity of diesel fuel and oil on board
Weather	Winds northeast 16 knots with gusts 17-19 knots, air temperature 80° F, tide 1.15 ft above mean lower low water and falling, current northeast 2-3 knots, visibility 10 miles, wave heights 2.7 feet
Waterway information	North central Gulf of Mexico, populated by numerous offshore production platforms and drilling rigs

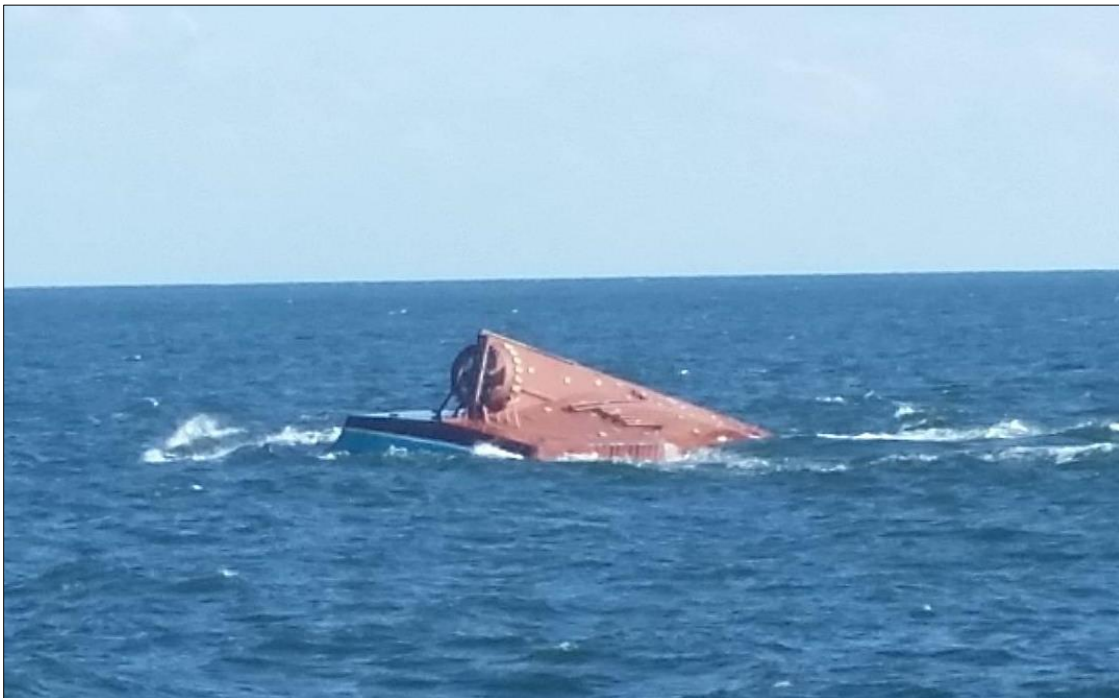
**Stern of *Christopher's Joy* after the two surviving crewmembers were rescued.
(Photo by crewmembers on board the supply boat *Miss Anna*)**
