Enbridge Incorporated
Hazardous Liquid Pipeline Rupture and Release
Marshall, Michigan
July 25, 2010

NTSB/PAR-12/01
PB2012-916501

Pipeline Accident Report

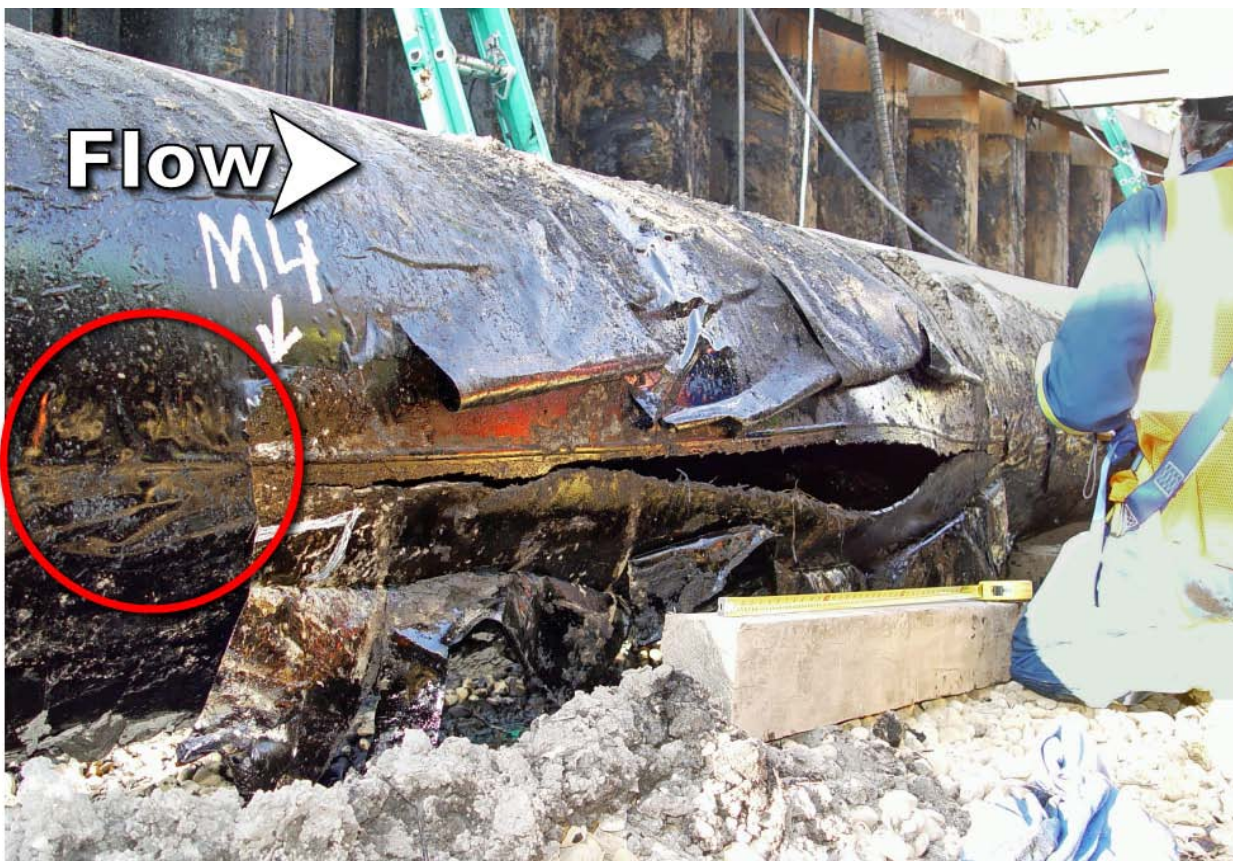
The fracture in the ruptured segment measured 6 feet 8.25 inches long and up to 5.32 inches wide. (See figure 2.) External corrosion was present along the longitudinal weld seam and in areas where the adhesive bond between the pipe and its protective polyethylene tape coating had deteriorated (disbonded). The coating was wrinkled and had separated from the pipe surface as shown in the red circle in figure 2.

Figure 2. The ruptured segment of Line 6B in the trench following the July 25, 2010, rupture. The fracture face measured about 6 feet 8.25 inches long and was 5.32 inches wide at the widest opening. The fracture ran just below the seam weld that was oriented just below the 3 o'clock position. A red circle shows a location where the coating was wrinkled and had separated from the pipe surface.

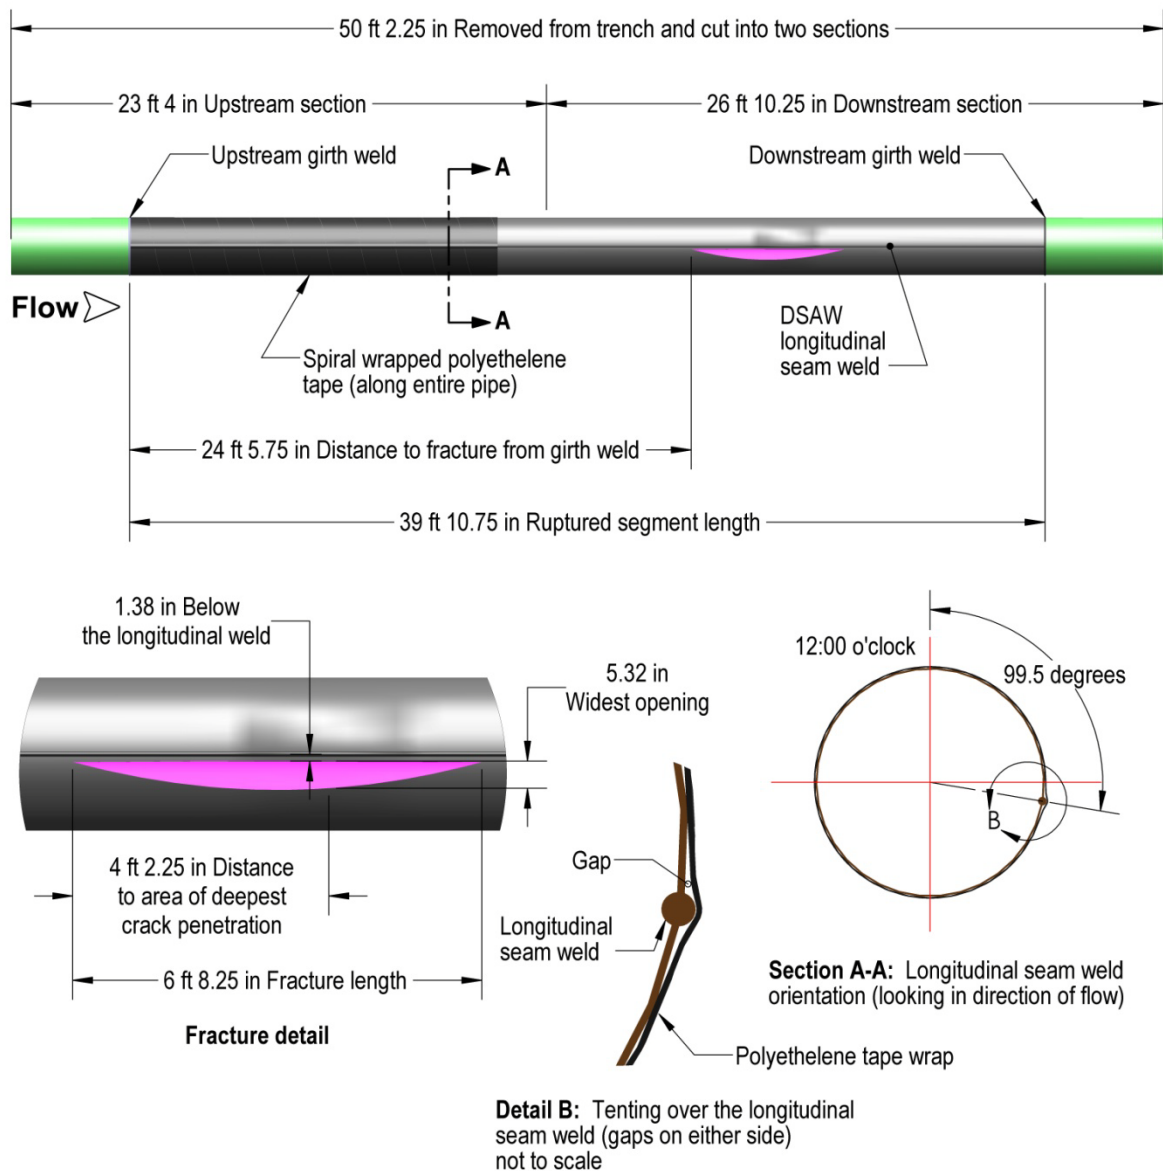
The ruptured pipe segment was 39 feet 10.75 inches long. The longitudinal seam was oriented at 99.5° clockwise.⁴³ A 50-foot length of pipe that included the rupture was removed and cut into two sections for shipping to the NTSB's Materials Laboratory for examination. The upstream section measured 23 feet 4 inches. The downstream section measured 26 feet 10.25 inches. (See figure 11.)

Figure 11. Line 6B ruptured segment showing upstream and downstream sections used for Materials Laboratory examination. Detail B shows tented coating over the longitudinal seam weld.

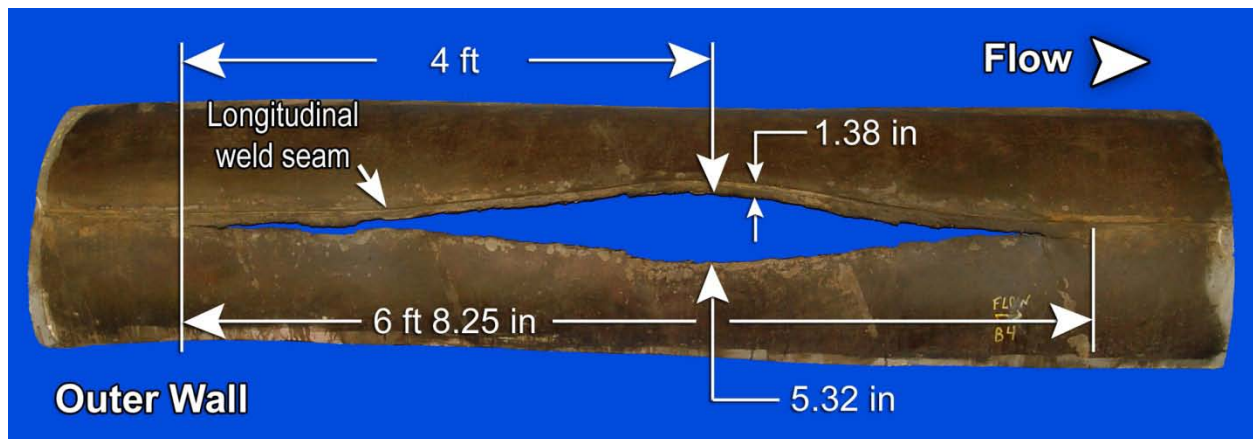
The fracture measured 6 feet 8.25 inches in length with the upstream end of the fracture located 24 feet 5.75 inches away from the upstream girth weld. The widest point along the fracture measured 5.32 inches and was about 4 feet from the upstream end of the rupture. The upper fracture face at the widest opening was measured at 1.38 inches below the longitudinal seam weld away from the heat-affected zone, with this offset ranging from 0.5 to 1.5 inches below the longitudinal weld seam for the length of the fracture face. (See figure 12.)

Figure 12. The outside surface of the pipe looking at the fracture area cut for lab examination.

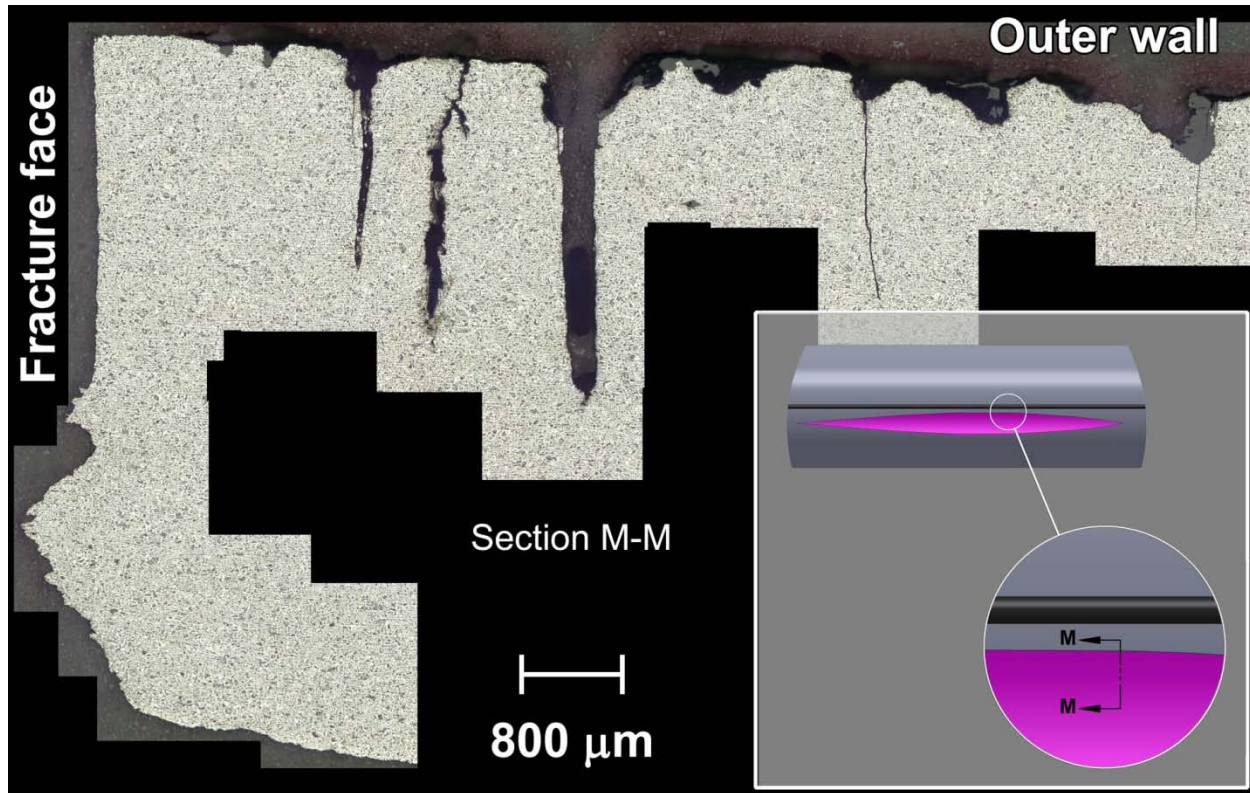
A cross-section through the fracture was prepared as shown in figure 15. The preexisting crack portion of the fracture showed a transgranular⁴⁹ fracture path with limited crack branching, consistent with near-neutral pH SCC or corrosion fatigue. Multiple closely spaced and parallel secondary cracks (with transgranular propagation paths and limited crack branching) emanated from corrosion pits on the outside wall near the fracture face, also consistent with corrosion fatigue or near-neutral pH SCC. The deepest secondary crack extended through about 43 percent of the wall thickness.

Figure 15. Transverse section through the top of the fracture showing multiple parallel cracks emanating from corrosion pits on the outside surface.

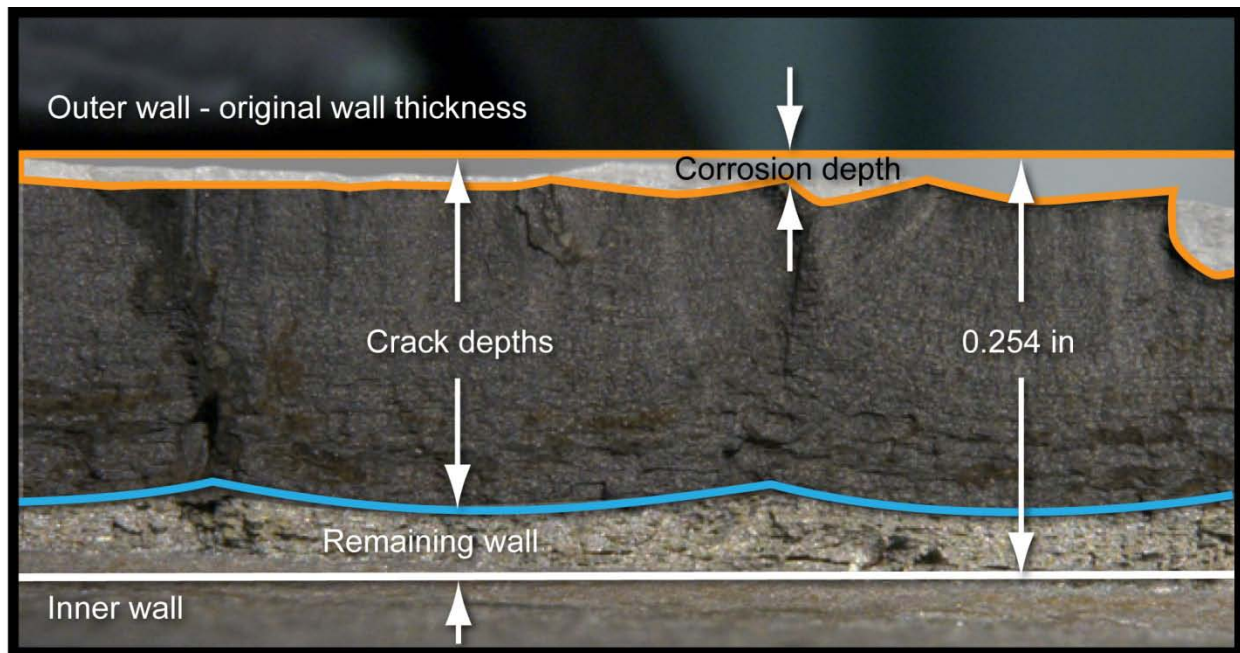
Figure 16. Lab measurements of crack and corrosion depths along the fracture face measured from images similar to figure 14 near area of deepest penetration (about 344 inches from upstream girth weld).
