NATIONAL TRANSPORTATION SAFETY BOARD

MATERIALS LABORATORY FACTUAL REPORT

Report No. 15-067

Place : Valhalla, New York
Date : February 3, 2015
Vehicle : Metro-North Train No. 659
NTSB No. : DCA15MR006
Investigator : Dana Sanzo O-RPH

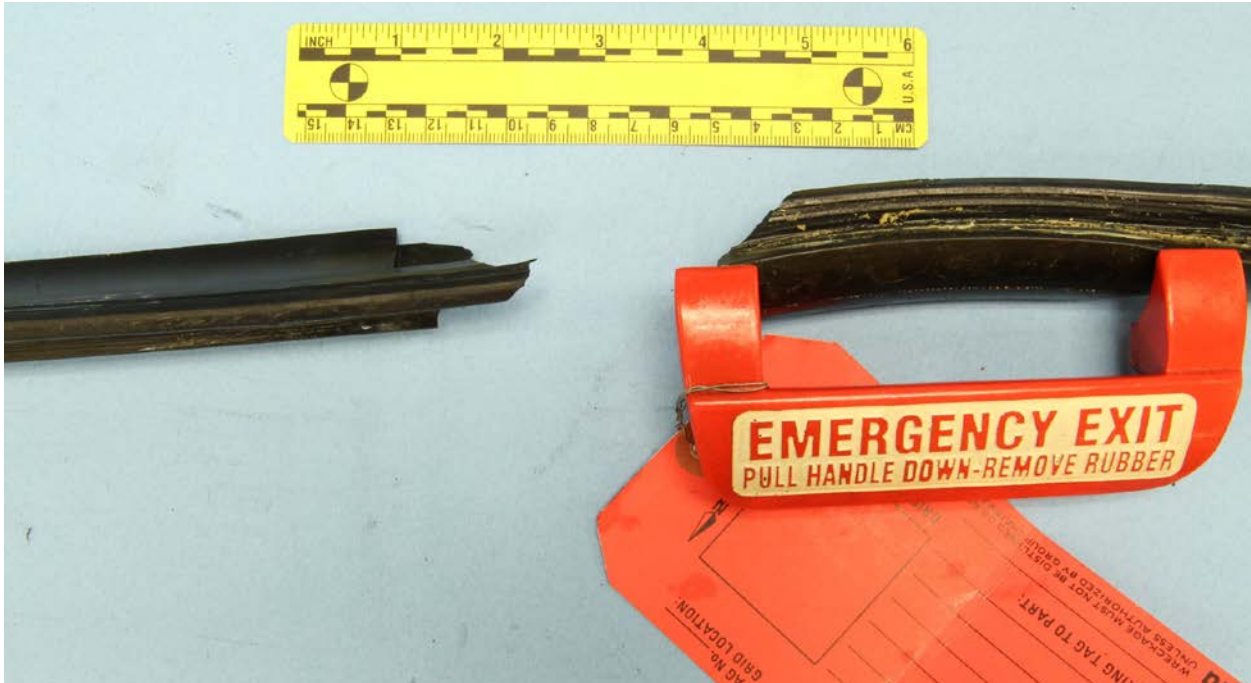
All of the tears originated where the emergency pull handles were attached to the zip strip. An exemplar of a full thickness tear is shown in Figure 3 and a partial thickness tear is shown in Figure 4. The aluminum pull handles were attached by wires molded into the zip strip. There was a designed narrowing of the zip strip thickness and molded cutouts in the area of the handles as shown in Figure 5. A complete damage description of each zip strip is found below.

- #4174 L9: Two handled zip strip. Handle 1 had a full thickness tear on the left and a partial thickness tear that was 0.39 inches in length on the right. Handle 2 had a partial thickness tear that was 0.54 inches in length and was intact on the right.

Figure 3. Photograph of full thickness (separation) tear (#4174 L9).

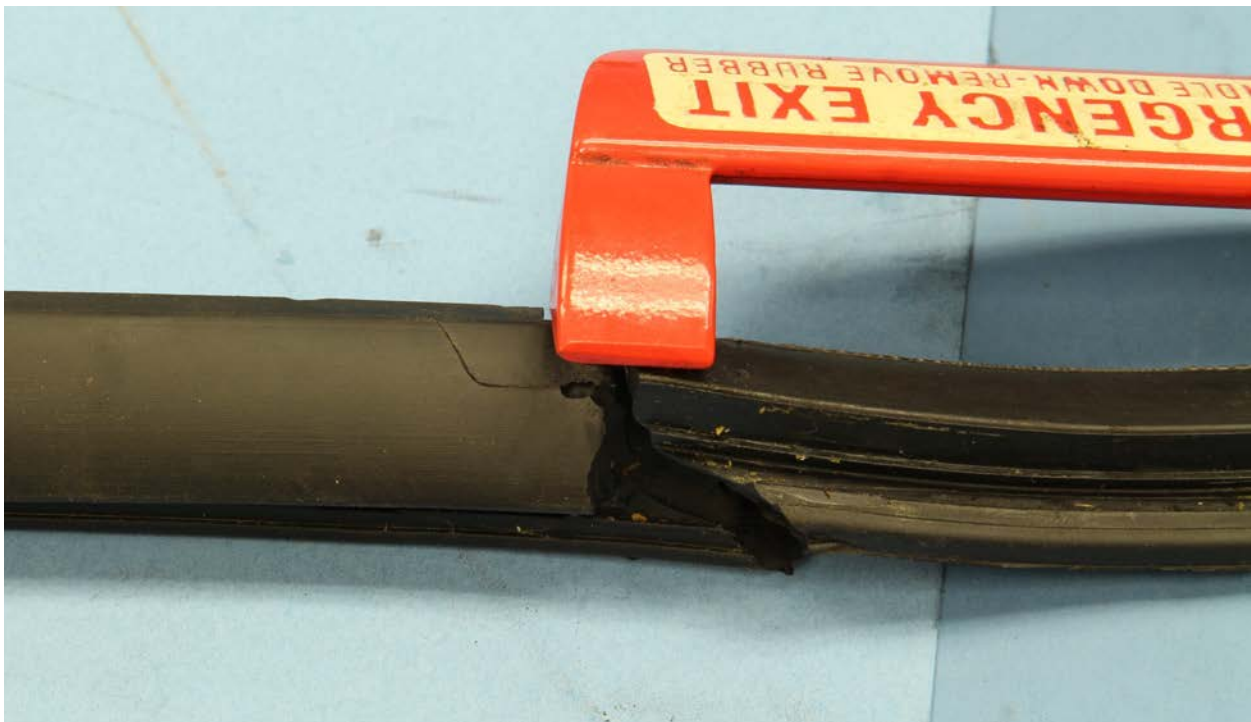
-
- #4196 R1: Single-handled zip strip. Zip strip on left side of handle had a partial thickness tear that was 0.50 inches in length. Right side of handle had a partial thickness tear that was 0.50 inches in length.

Figure 4. Photograph of partial thickness tear (#4196 R1).

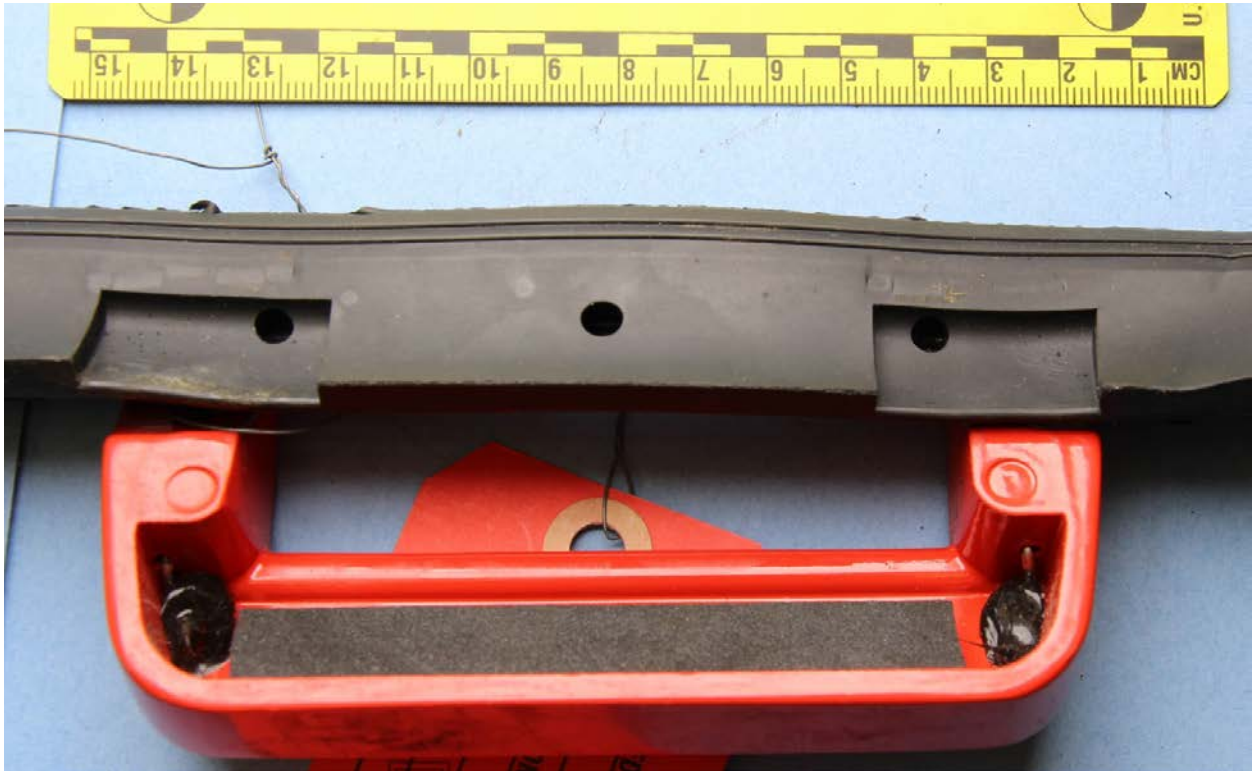
Figure 5. Photograph of molded cutouts in handle area of zip strip.

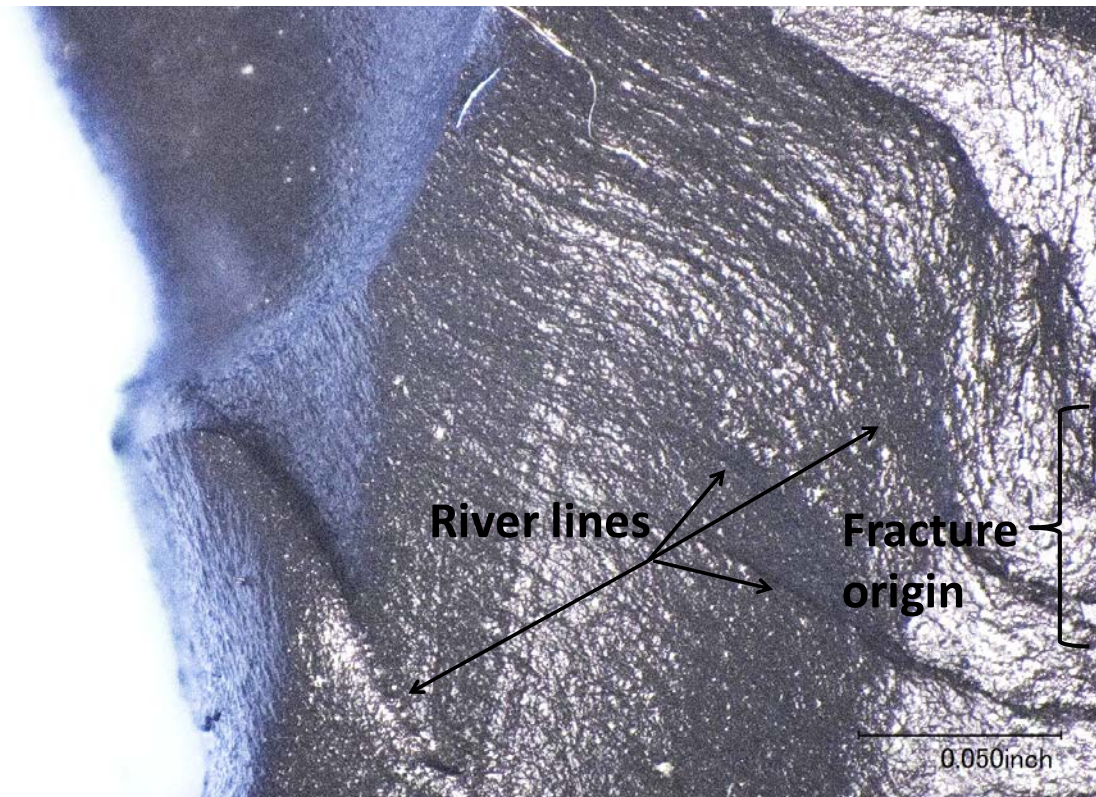
The fracture features of the tears were visually examined using a 5x-50x stereo zoom microscope. The tear surface on all the damaged zip strips exhibited hackle or river lines that oriented in the direction of the tear and originated in the area of the handle attachment wires as shown in Figure 6. There were narrowing and shear patterns on the ends of the complete fractures as shown in Figure 7. These fracture patterns are consistent with overstress. None of the zip strips exhibited visible indicators of age or environmental-related degradation.

Figure 6. Close-up photograph of fracture/tear surface.

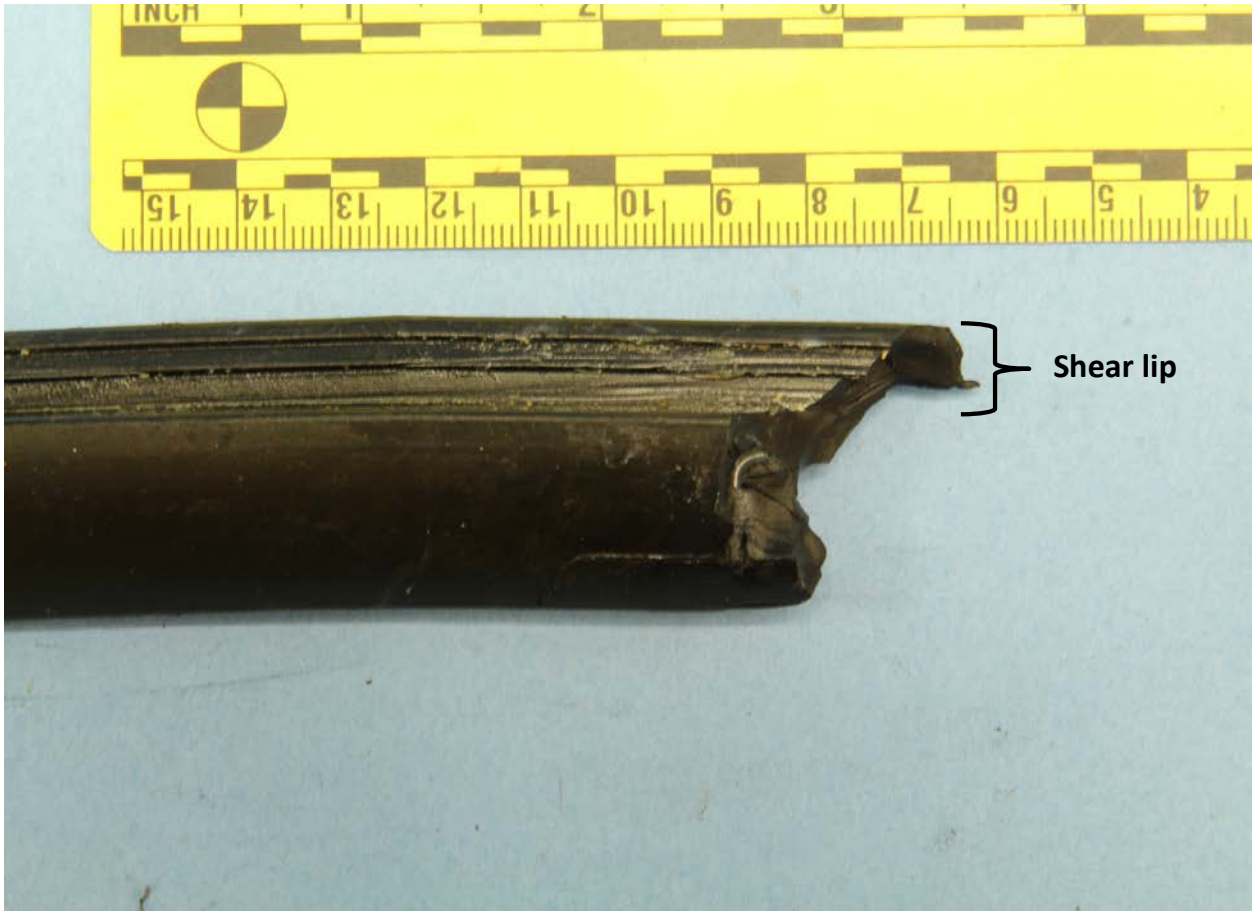
Figure 7. Close-up photograph of shear lip pattern.
