NATIONAL TRANSPORTATION SAFETY BOARD

MATERIALS LABORATORY ANNOTATED PHOTOGRAPHS

Report No. 82-032A

Place : Minneapolis, Minnesota
Date : August 1, 2007
Vehicle : I35W Highway Bridge
NTSB No. : HWY07MH024
Investigator : Mark Bagnard

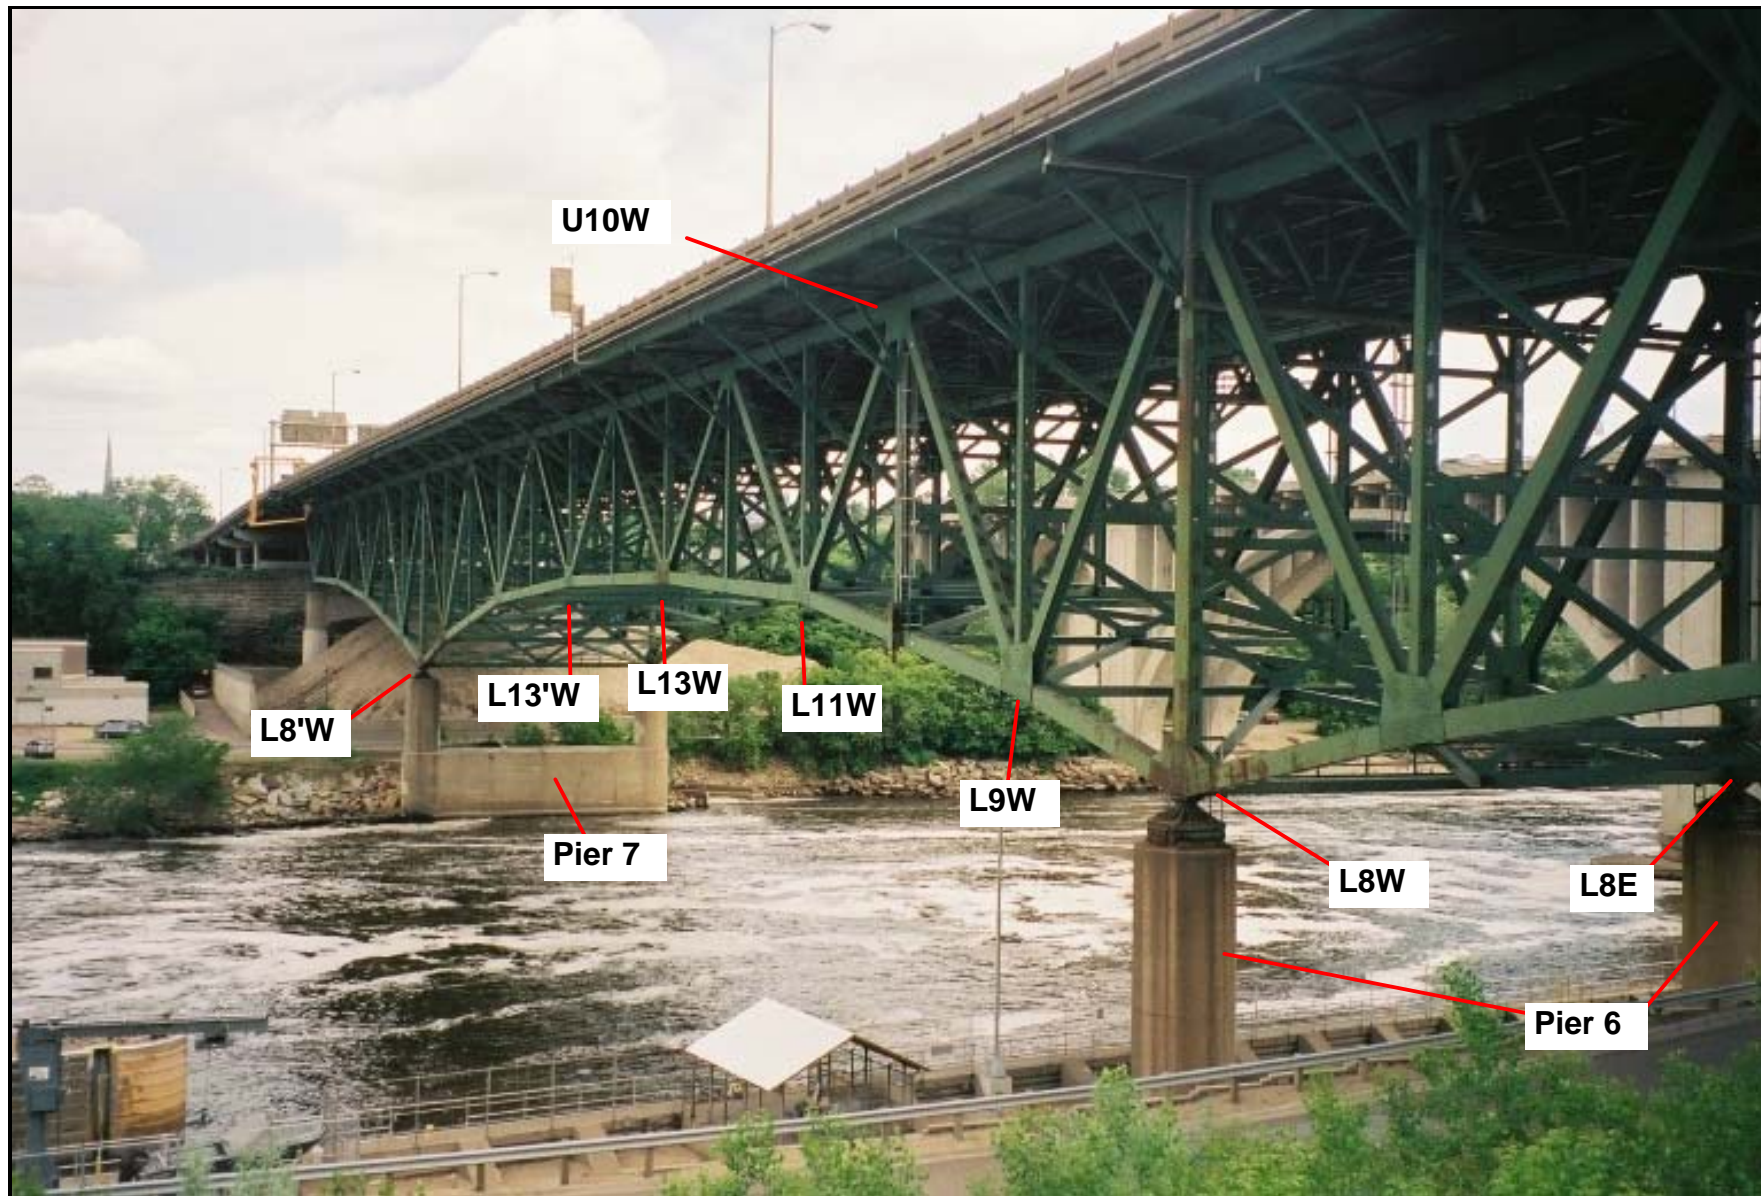
Figure 1. Overall view of the center span of the deck truss portion of the bridge before the collapse. View is looking north and slightly east, and key nodes have been labeled, as described in the Structural Investigation Group Chairman Factual Report.

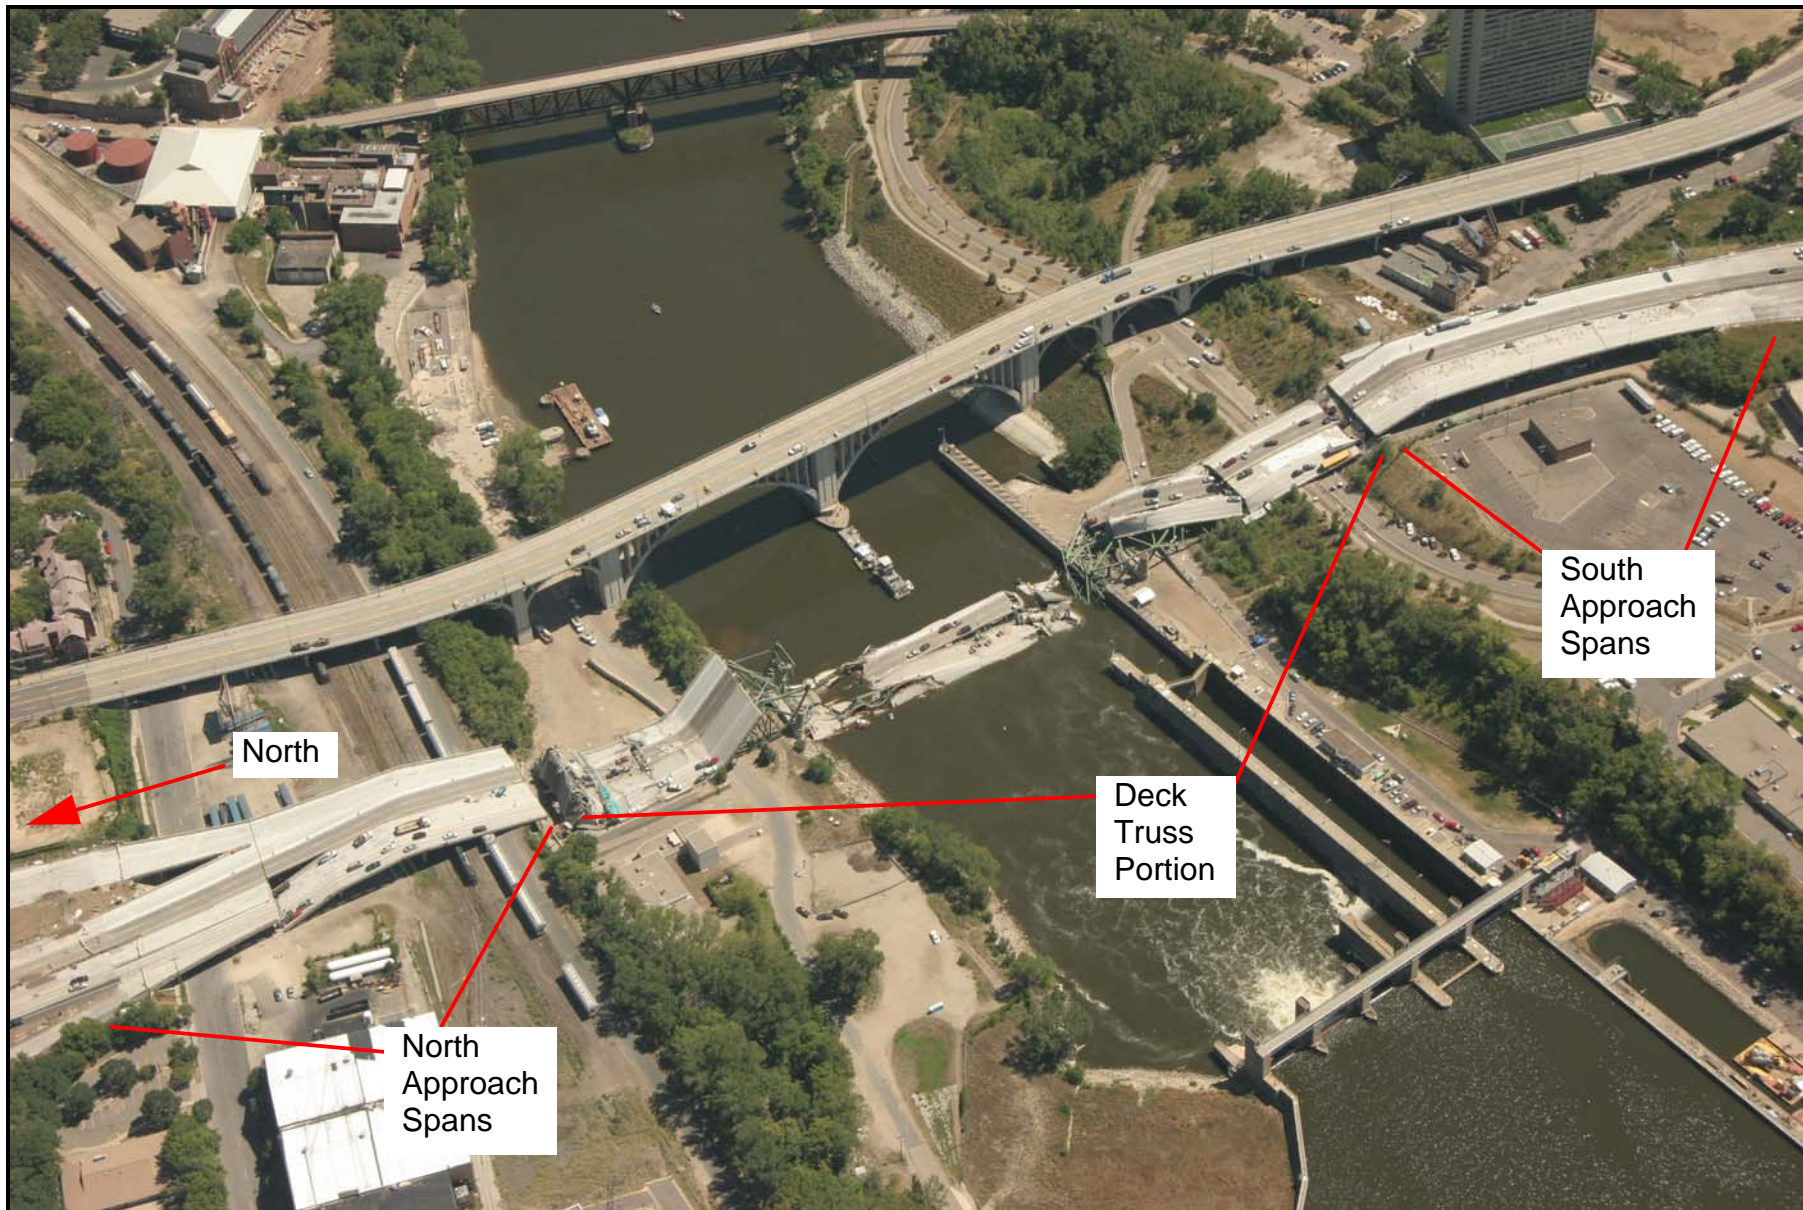
Figure 2. Overall view of the bridge after the collapse. Direction of viewing is east and slightly south.

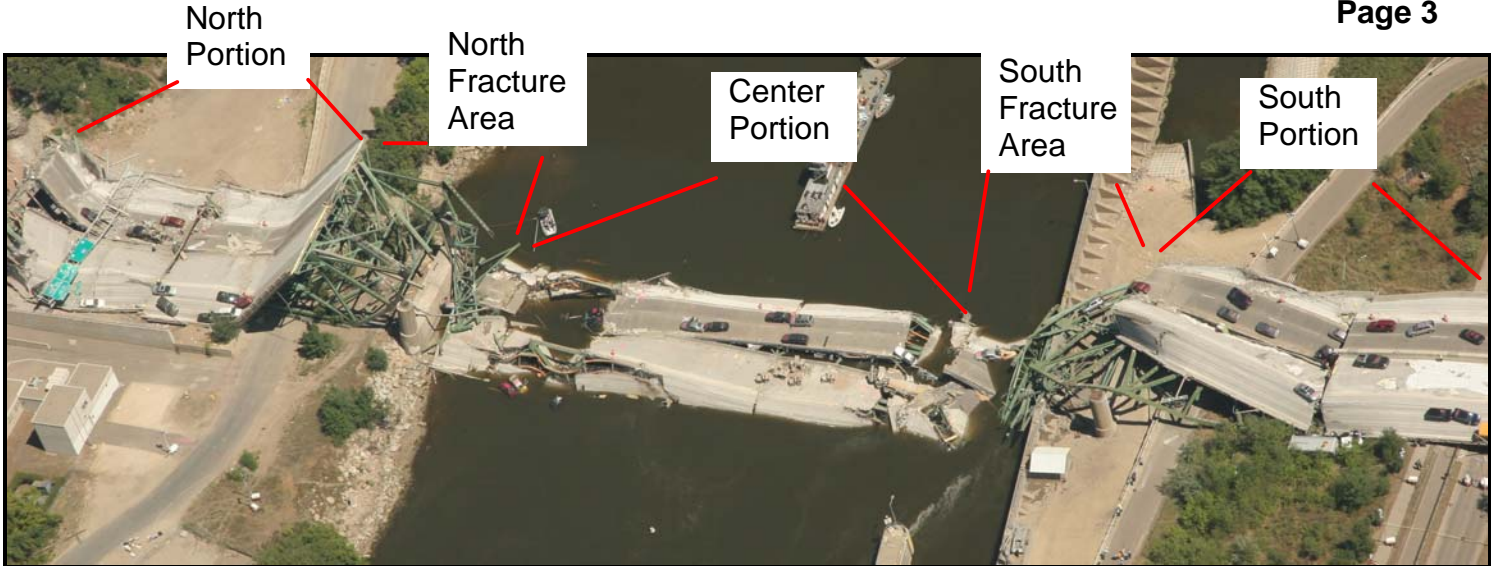
Figure 3. Overall view of the collapsed deck truss portion of the bridge, with the South and North Fracture Areas and the south, center, and north portions indicated. View is looking east.

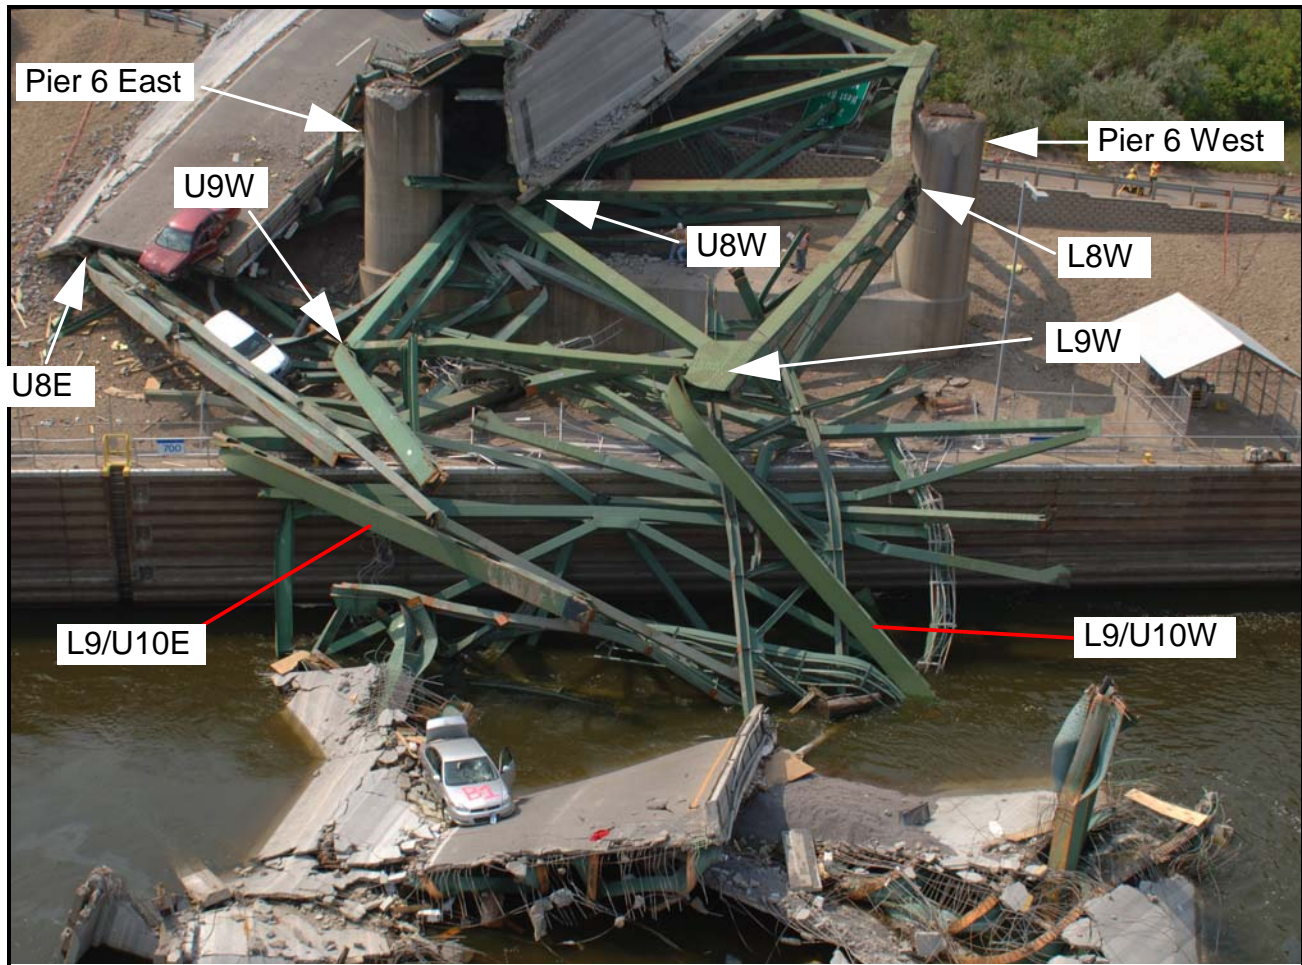
Figure 4. View of the South Fracture Area and the south portion of the deck truss adjacent to the river, viewed looking south.

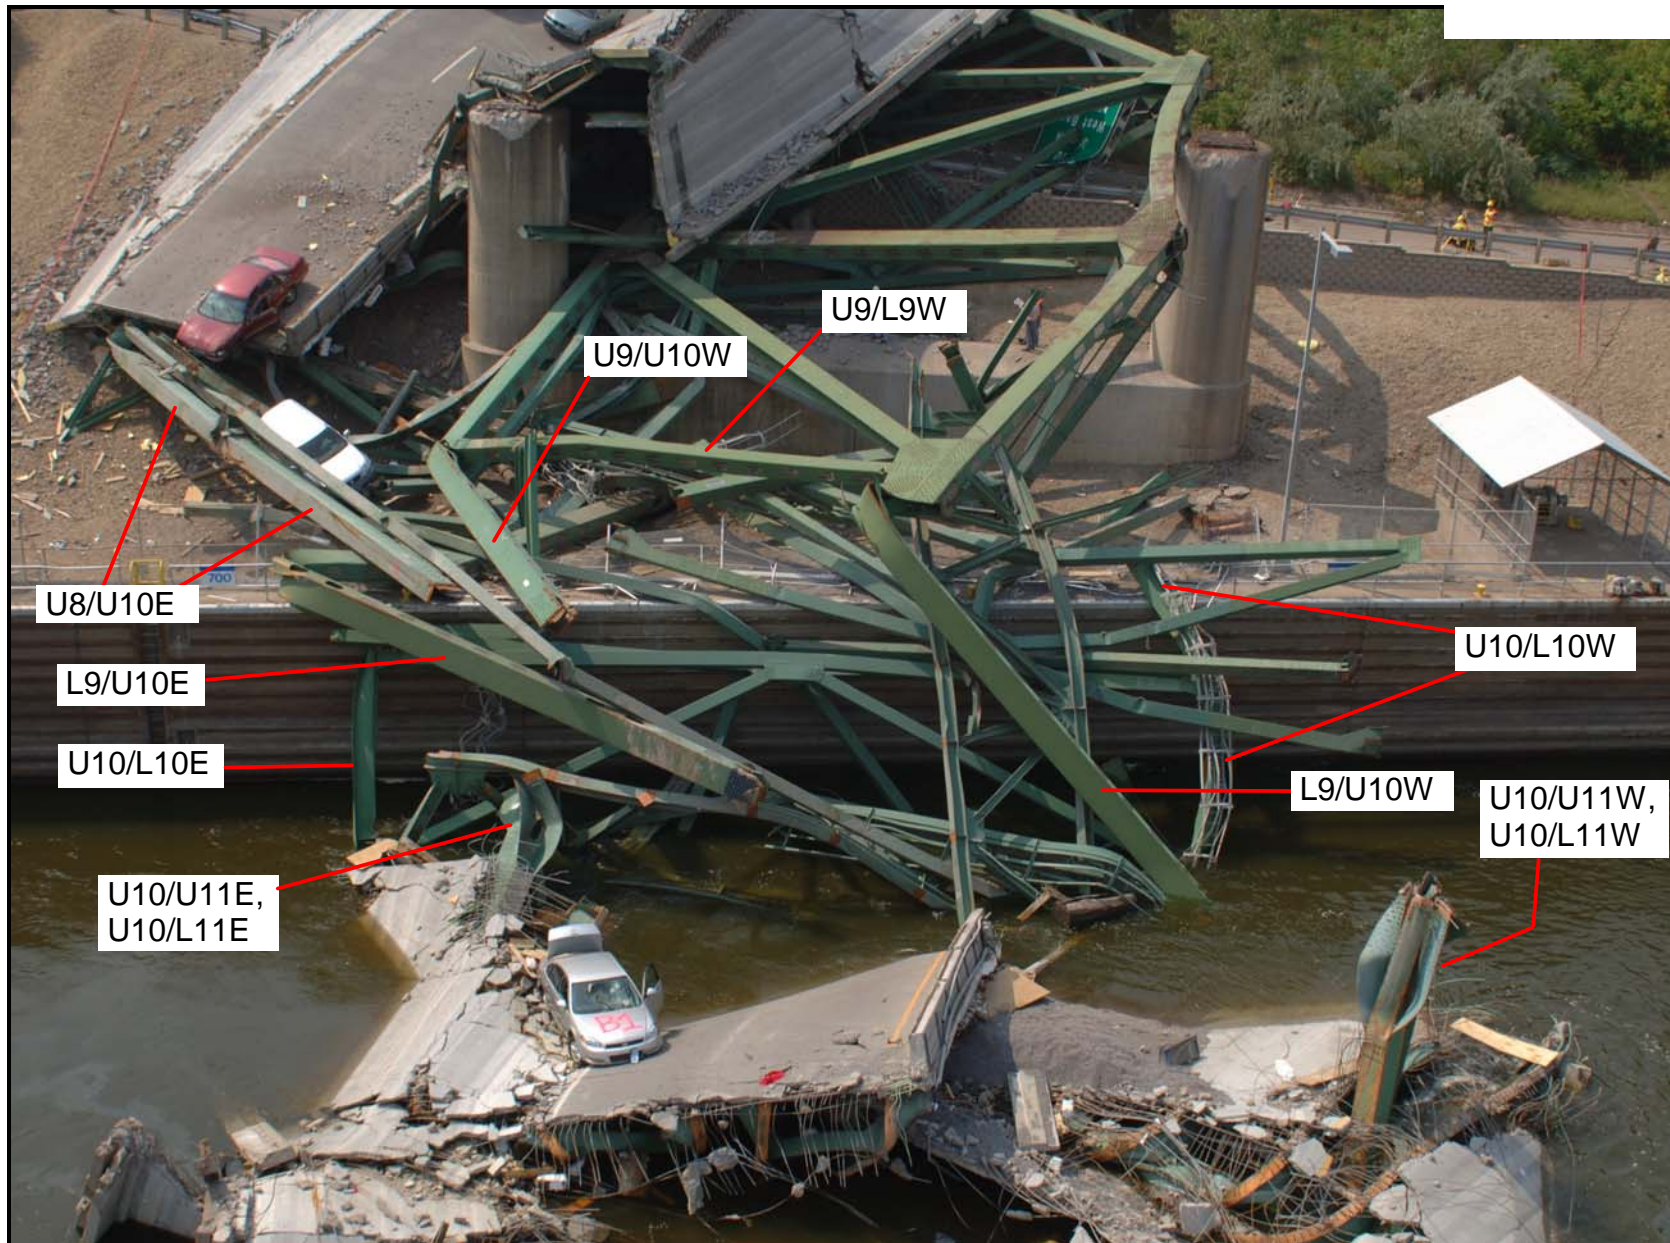
Figure 5. (Repeated photograph from figure 4.) View of the South Fracture Area and the south portion of the deck truss adjacent to the river, viewed looking south. Main truss members that separated from their nodes in the South Fracture Area as well as other main truss members are identified.

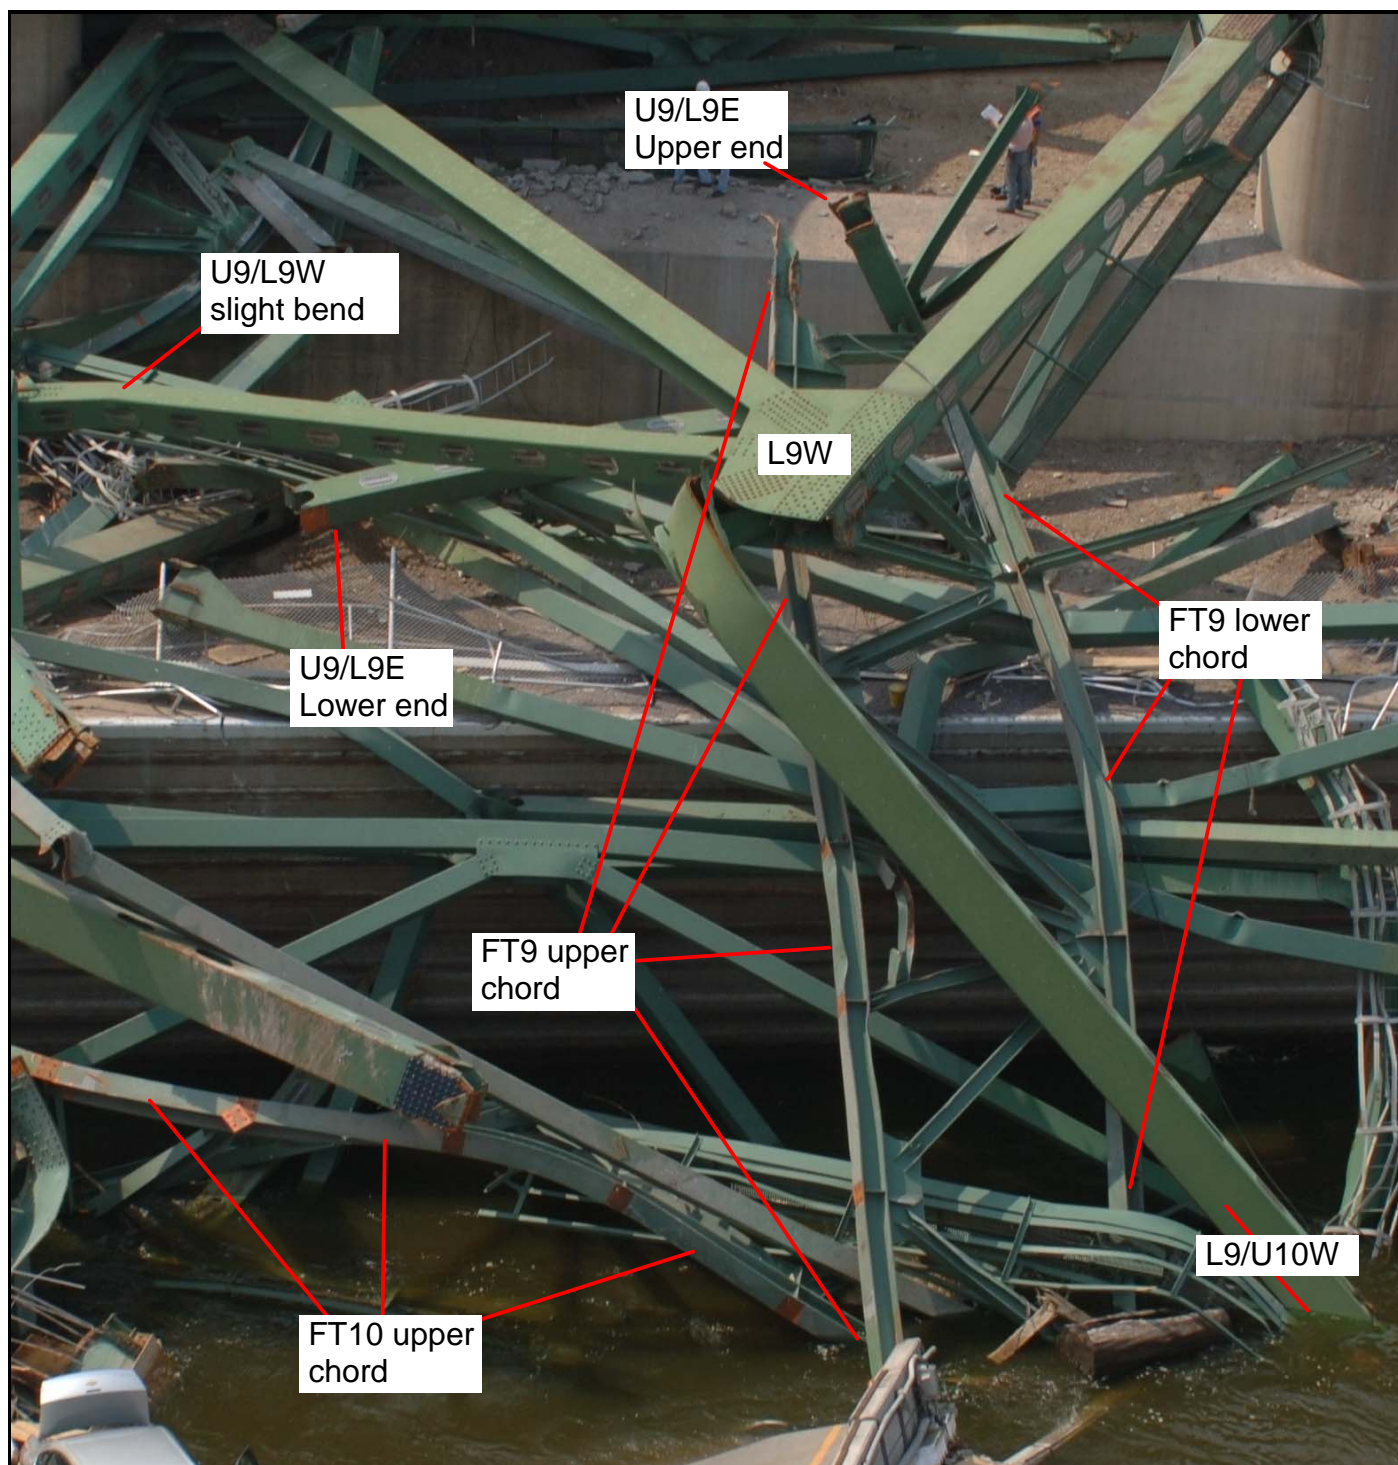
Figure 6. Enlarged portion of the photograph in figure 5. This area primarily shows the location of floor truss 9 (FT9) and vertical U9/L9E, which remained attached to the floor truss.

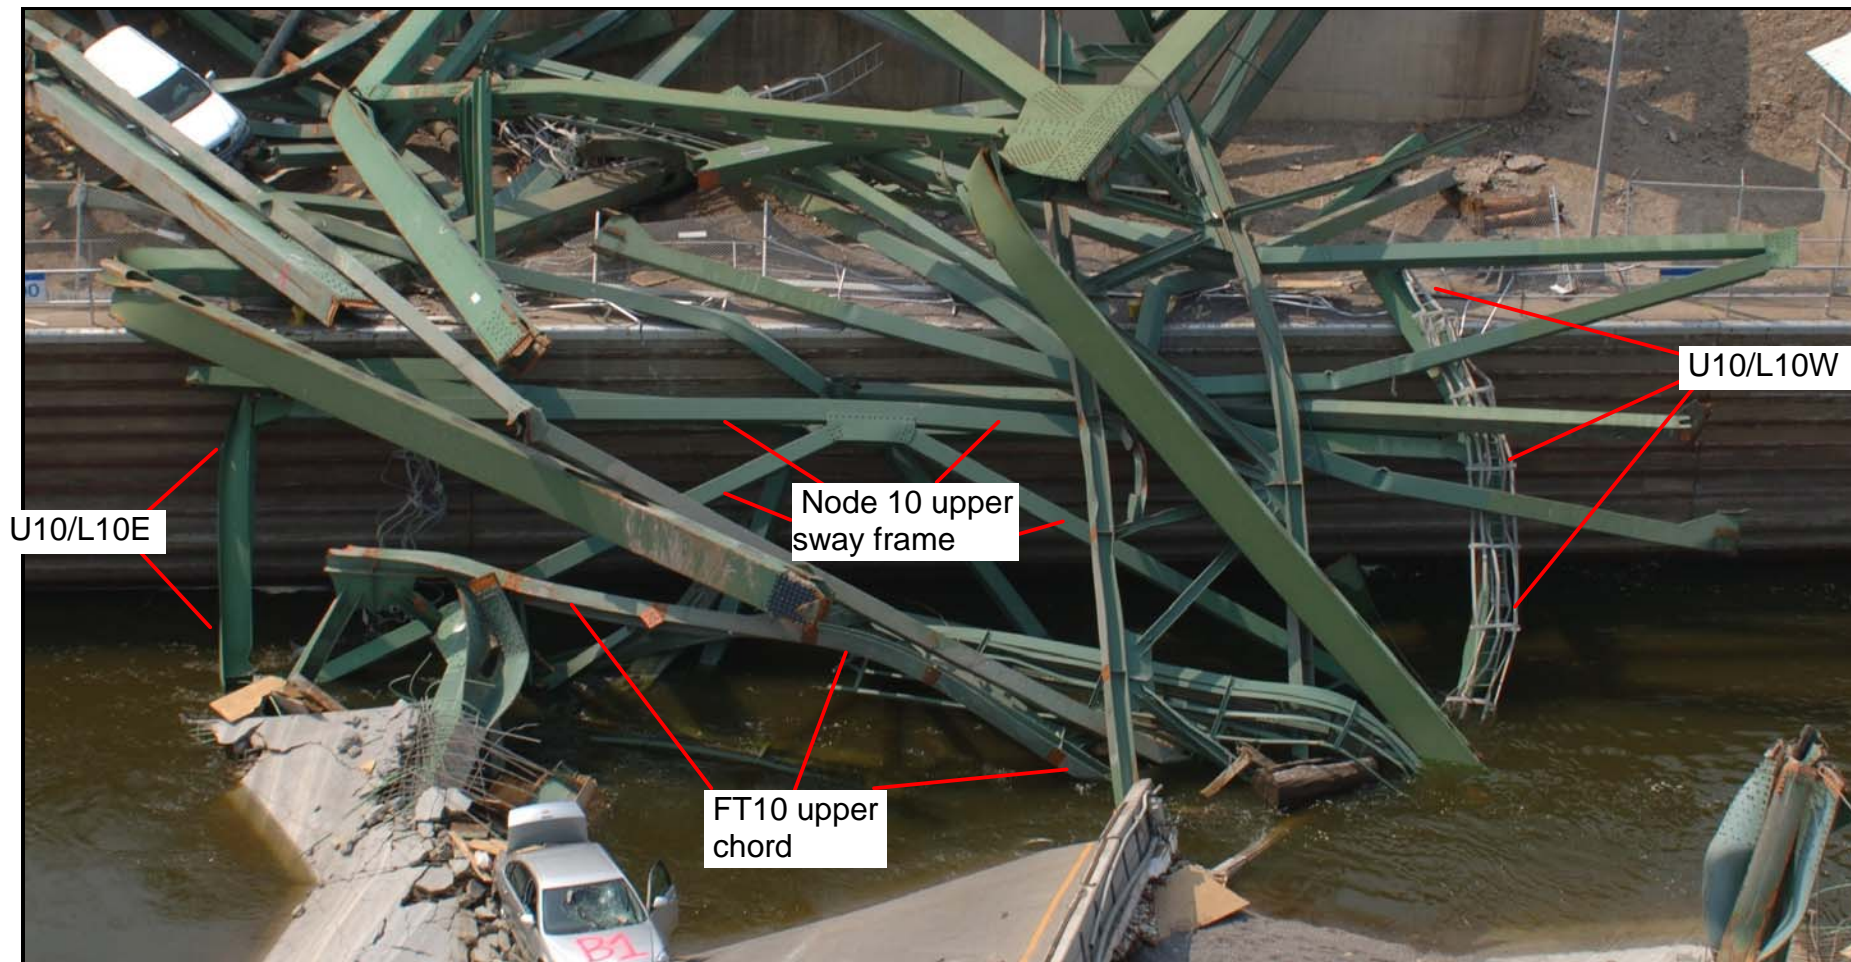
Figure 7. Enlarged portion of the photograph in figure 5. This area primarily shows the location of floor truss 10 (FT10) and verticals U10/L10 East and West, which remained attached to the lower chord of the floor truss.

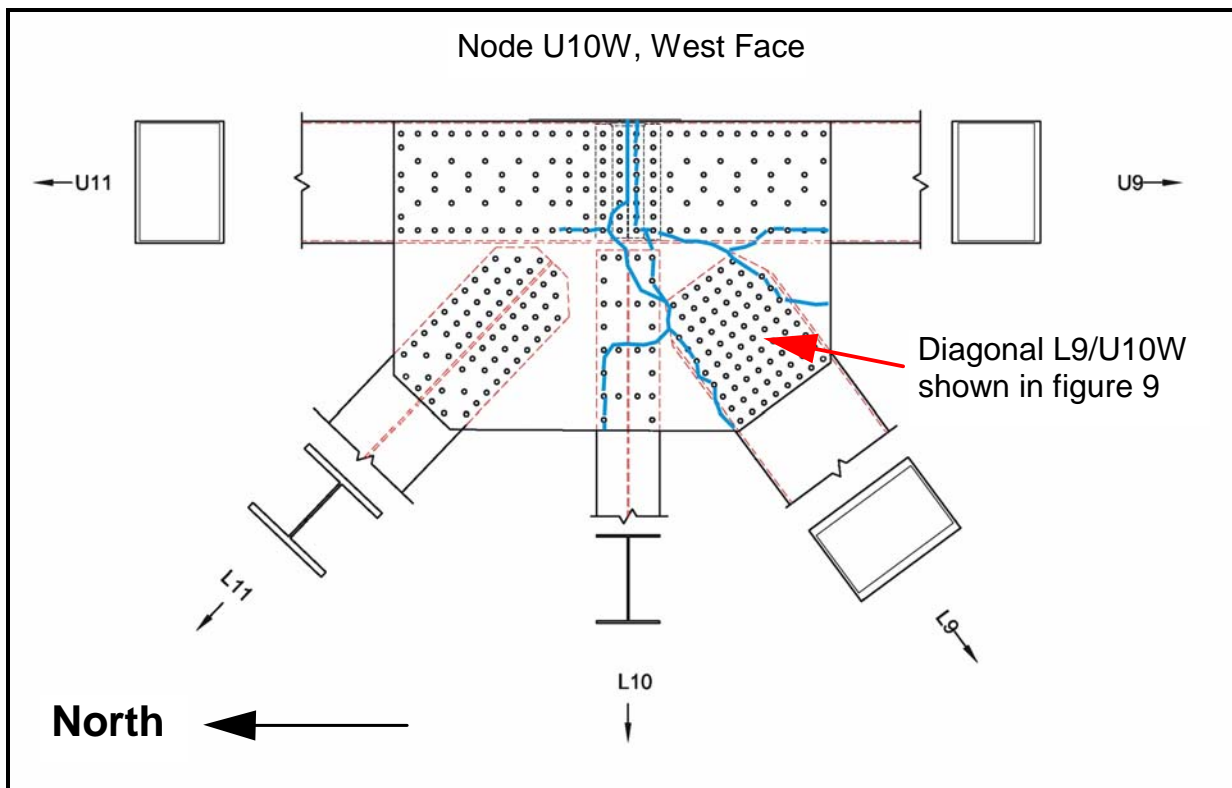
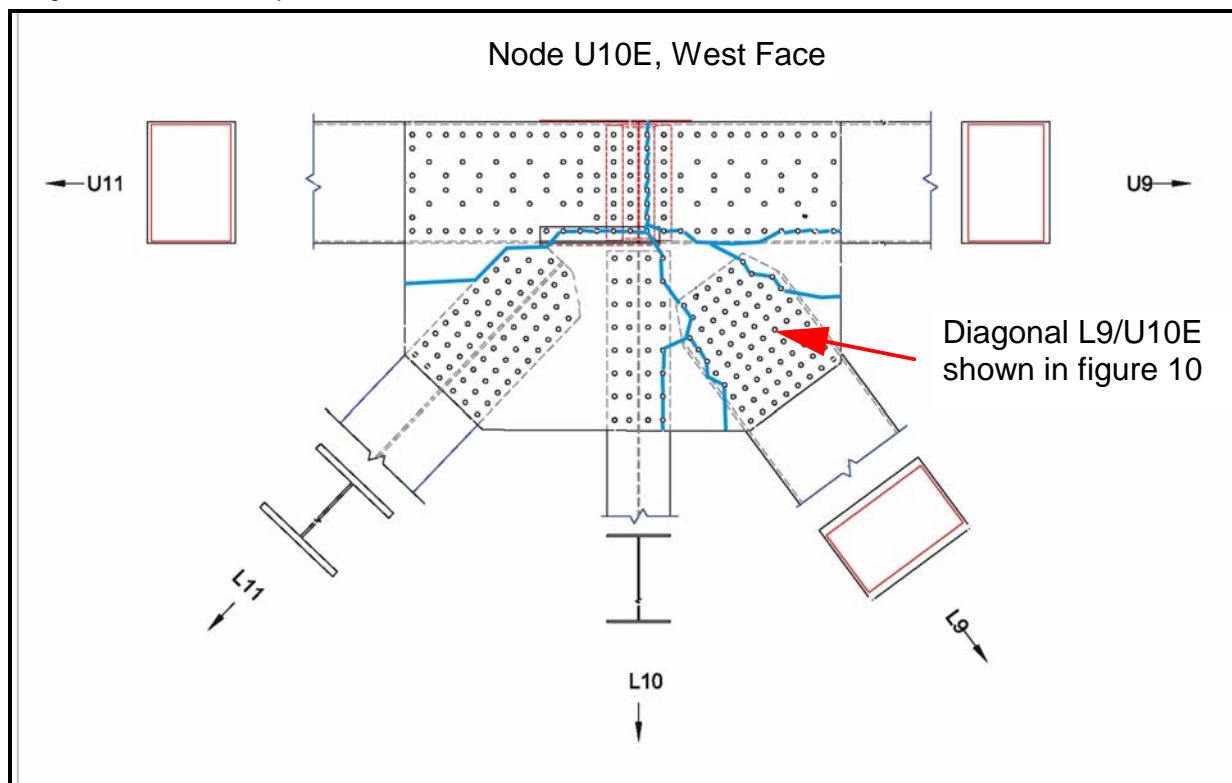
Figure 8A. Drawings of the U10 East and West nodes showing the fracture locations (blue lines) of the west gusset plates.

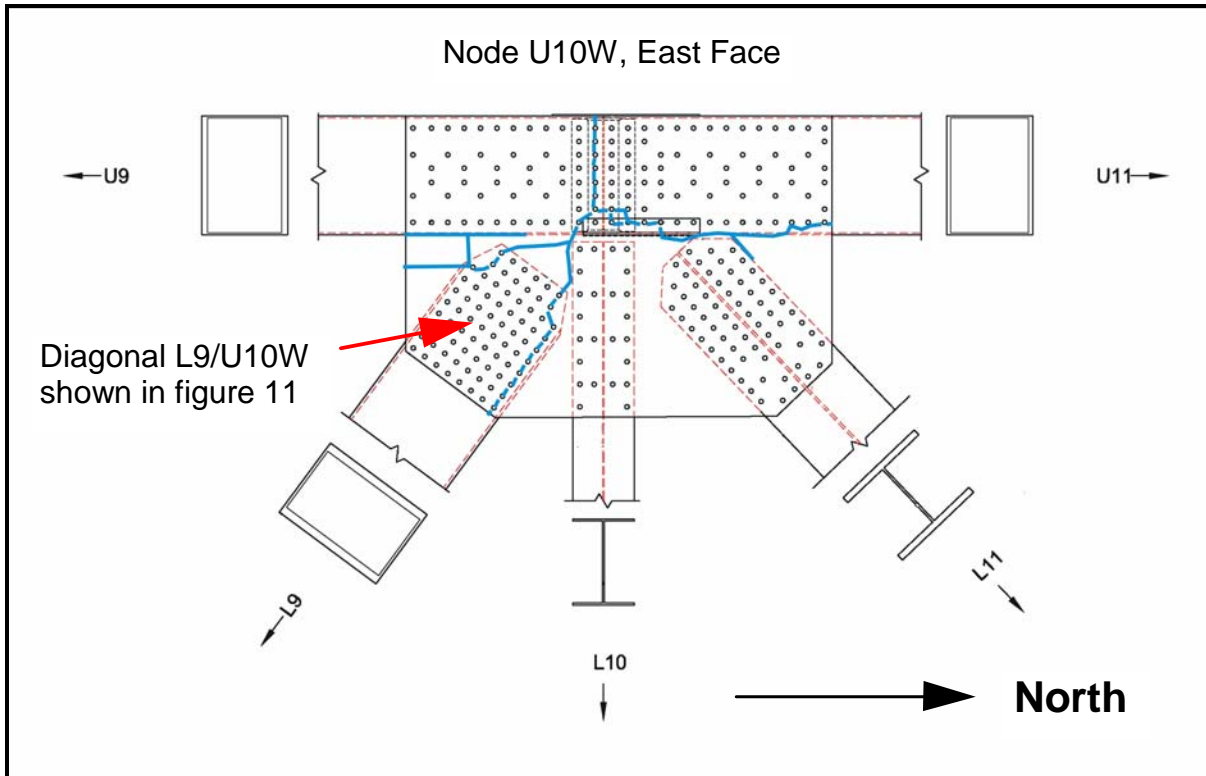
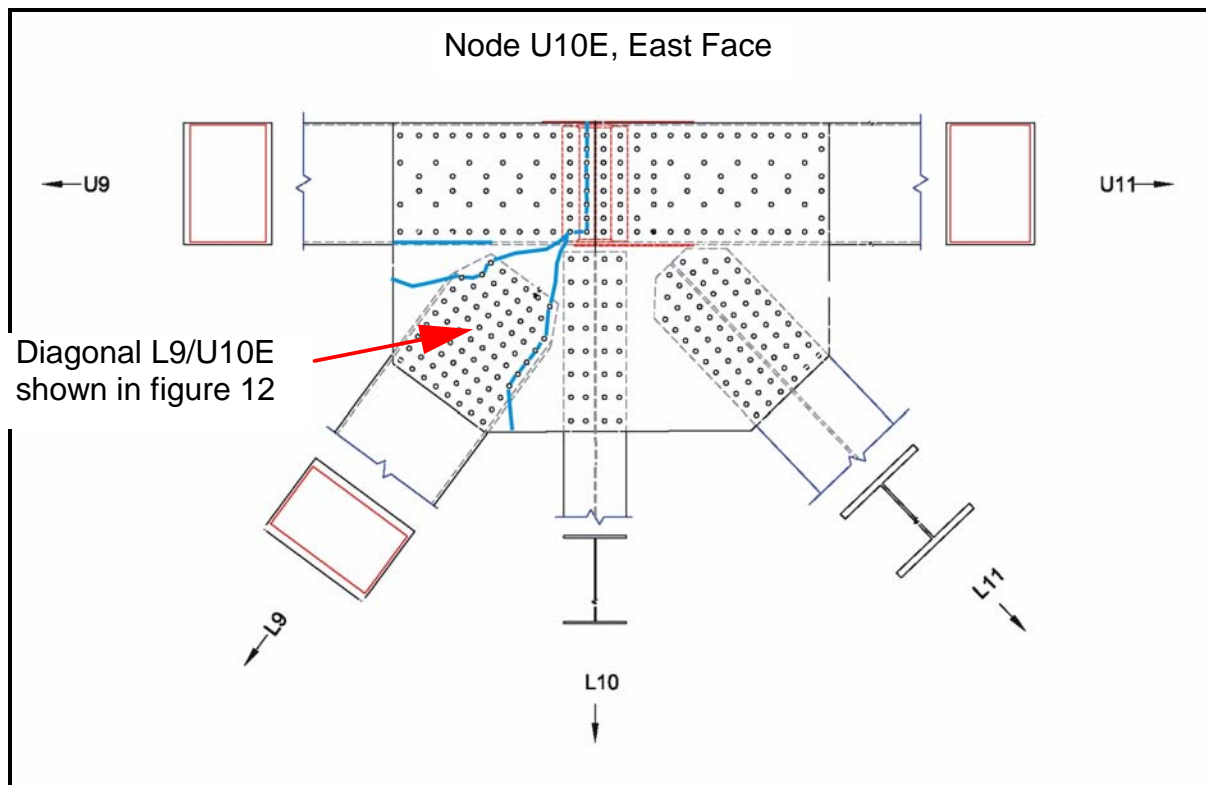
Figure 8B. Drawings of the U10 East and West nodes showing the fracture locations (blue lines) of the east gusset plates.

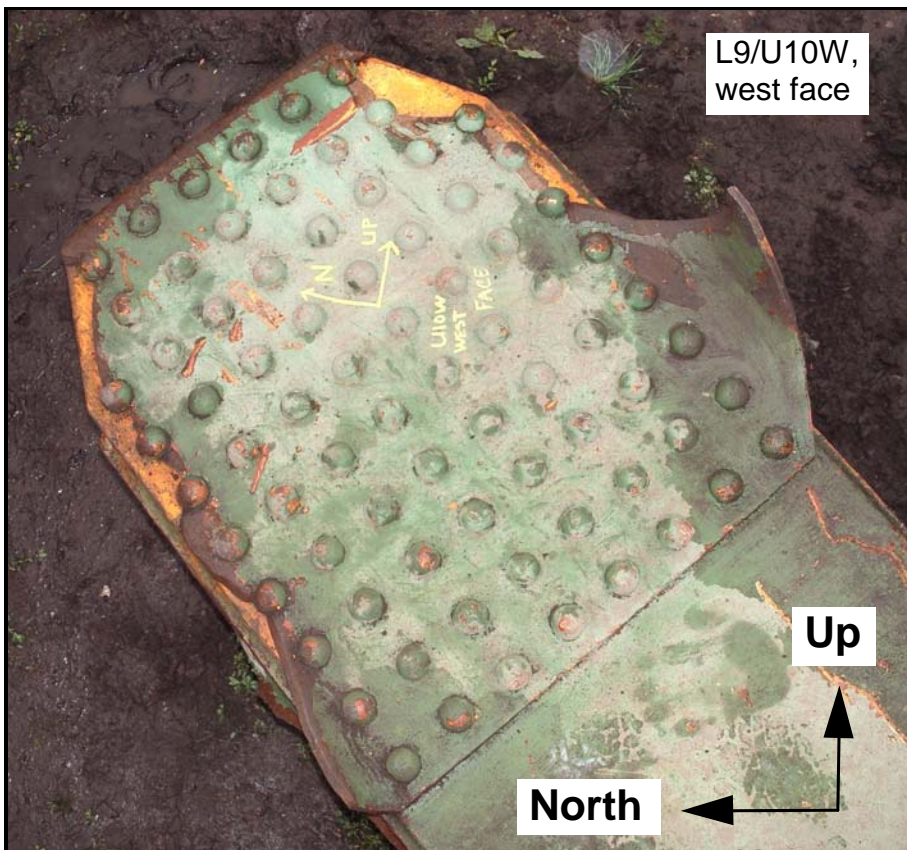
Figure 9. Photograph of the portion of the U10W west gusset plate attached to the U10W end of diagonal L9/U10W. The V-shaped tip portion of the plate above the end of the diagonal has been folded under the west side plate of the diagonal. Compare to figure 8A. Also see figure 13.

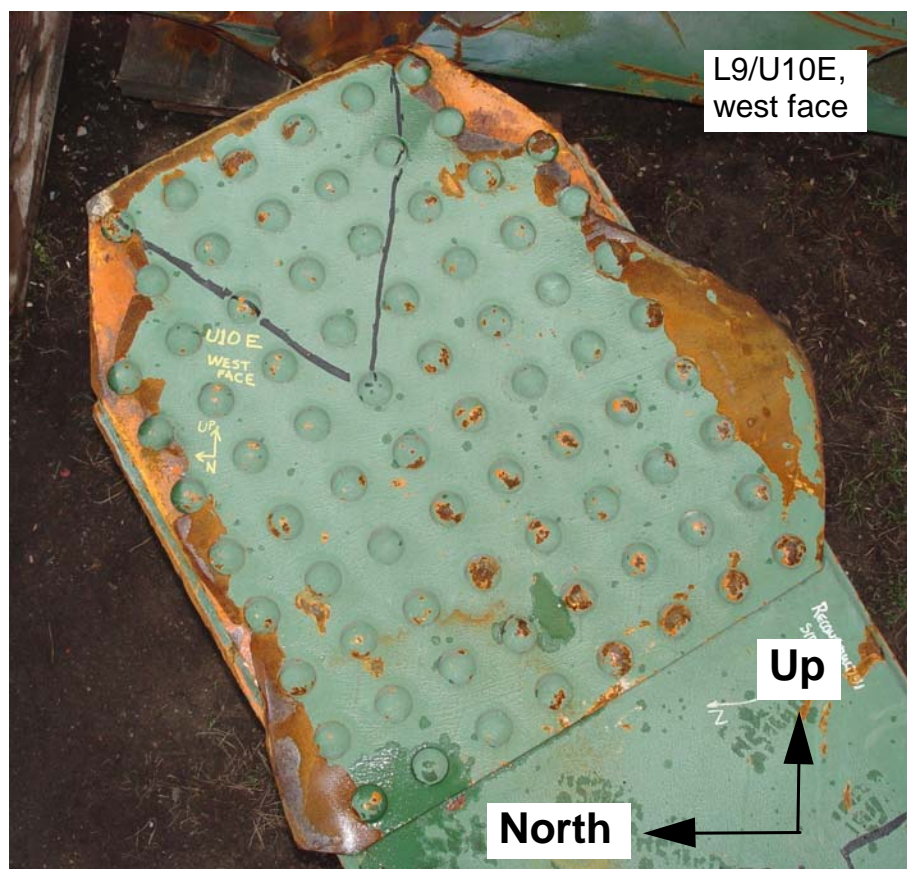
Figure 10. Photograph of the portion of the U10E west gusset plate attached to the U10E end of diagonal L9/U10E. The V-shaped tip portion of the plate above the end of the diagonal has been folded under the west side plate of the diagonal. The black lines drawn on the visible face show the location of the V-shaped tip portion on the other side of the west side plate. Compare to figure 8A.

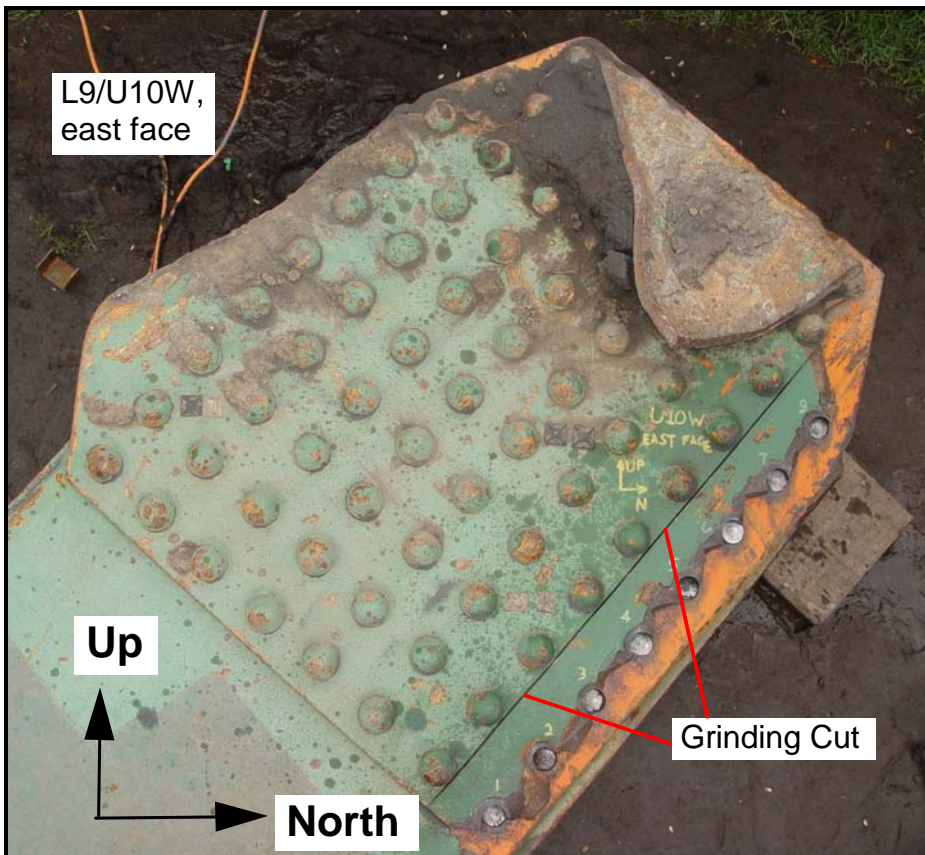
Figure 11. Photograph of the portion of the U10W east gusset plate attached to the U10W end of diagonal L9/U10W. The V-shaped tip portion of the plate above the end of the diagonal has been folded back over the east side plate of the diagonal. Compare to figure 8B. The grinding cut adjacent to the edge of the diagonal was made in preparation for removal of a fractured portion of the gusset plate. Also see figure 13.

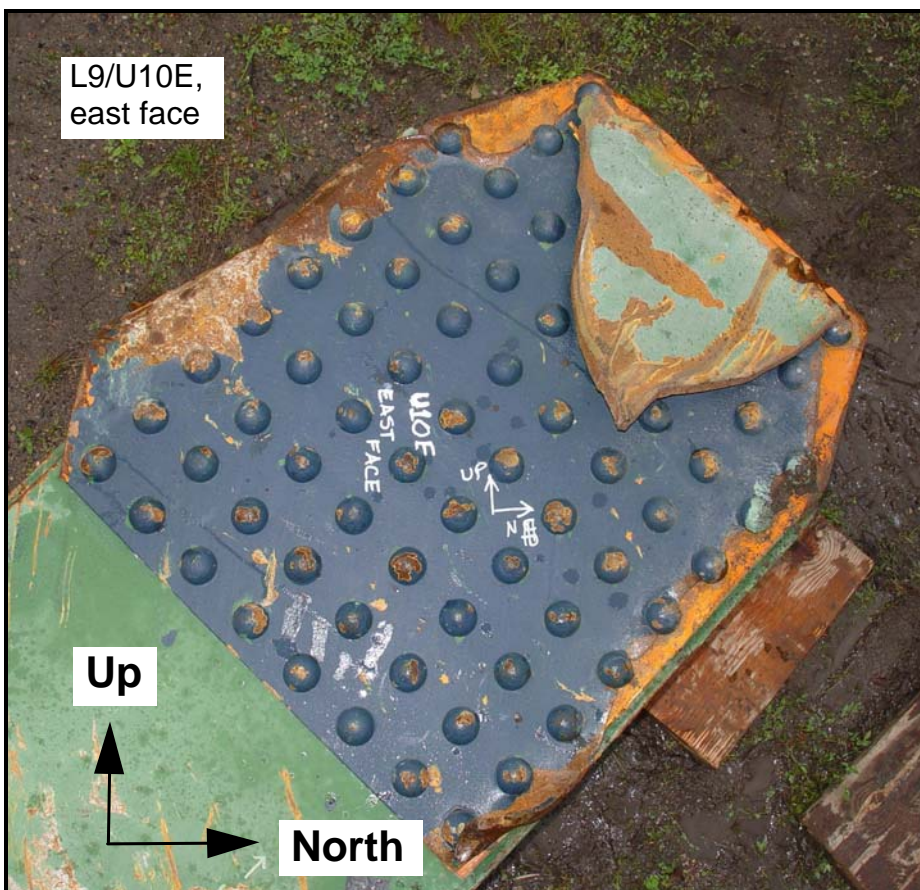
Figure 12. Photograph of the portion of the U10E east gusset plate attached to the U10E end of diagonal L9/U10E. The V-shaped tip portion of the plate above the end of the diagonal has been folded back over the east side plate of the diagonal. Compare to figure 8B.

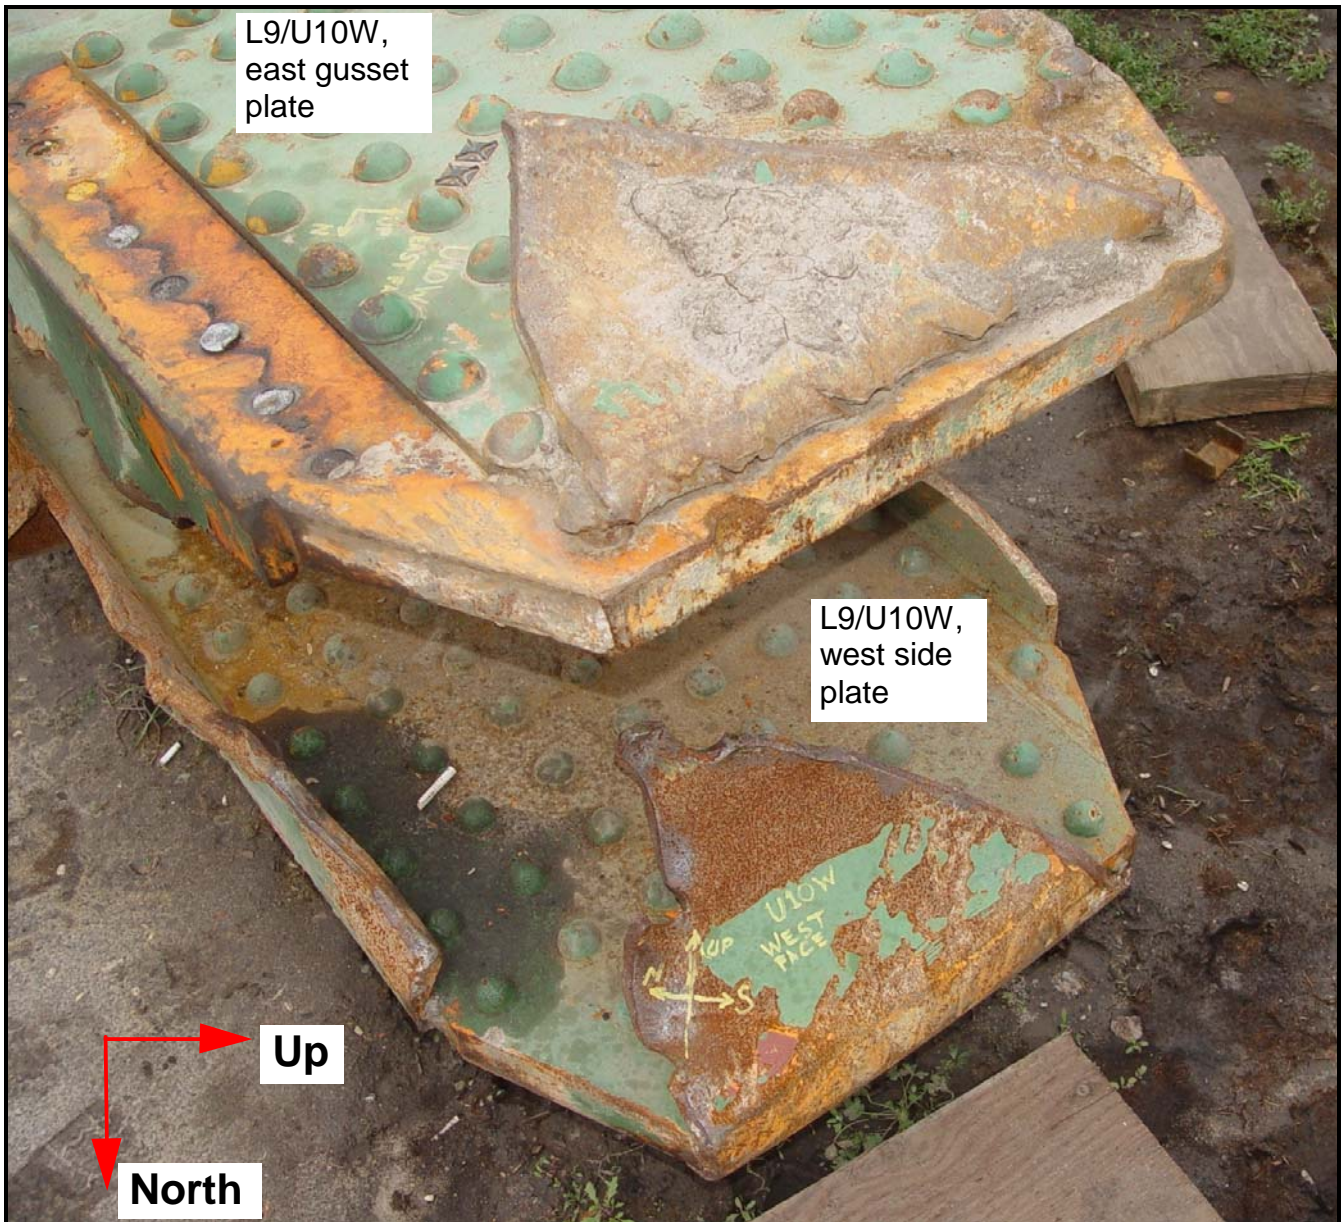
Figure 13. Photograph of the upper (U10W) end of diagonal L9/U10W showing the V-shaped tips of the gusset plates folded to the east. Photograph taken after removal of a piece of the east gusset plate for laboratory examination. The north, south, and up directions marked on the west gusset plate are oriented for the folded piece of the plate.
