NATIONAL TRANSPORTATION SAFETY BOARD

MATERIALS LABORATORY ANNOTATED PHOTOGRAPHS

Report No. 82-032A

Place : Minneapolis, Minnesota
Date : August 1, 2007
Vehicle : I35W Highway Bridge
NTSB No. : HWY07MH024
Investigator : Mark Bagnard

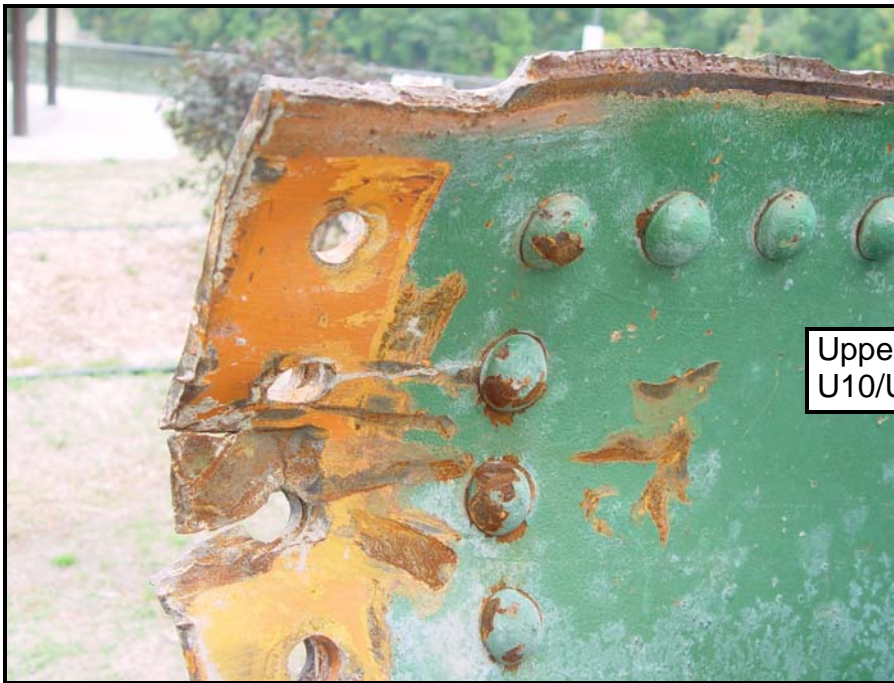
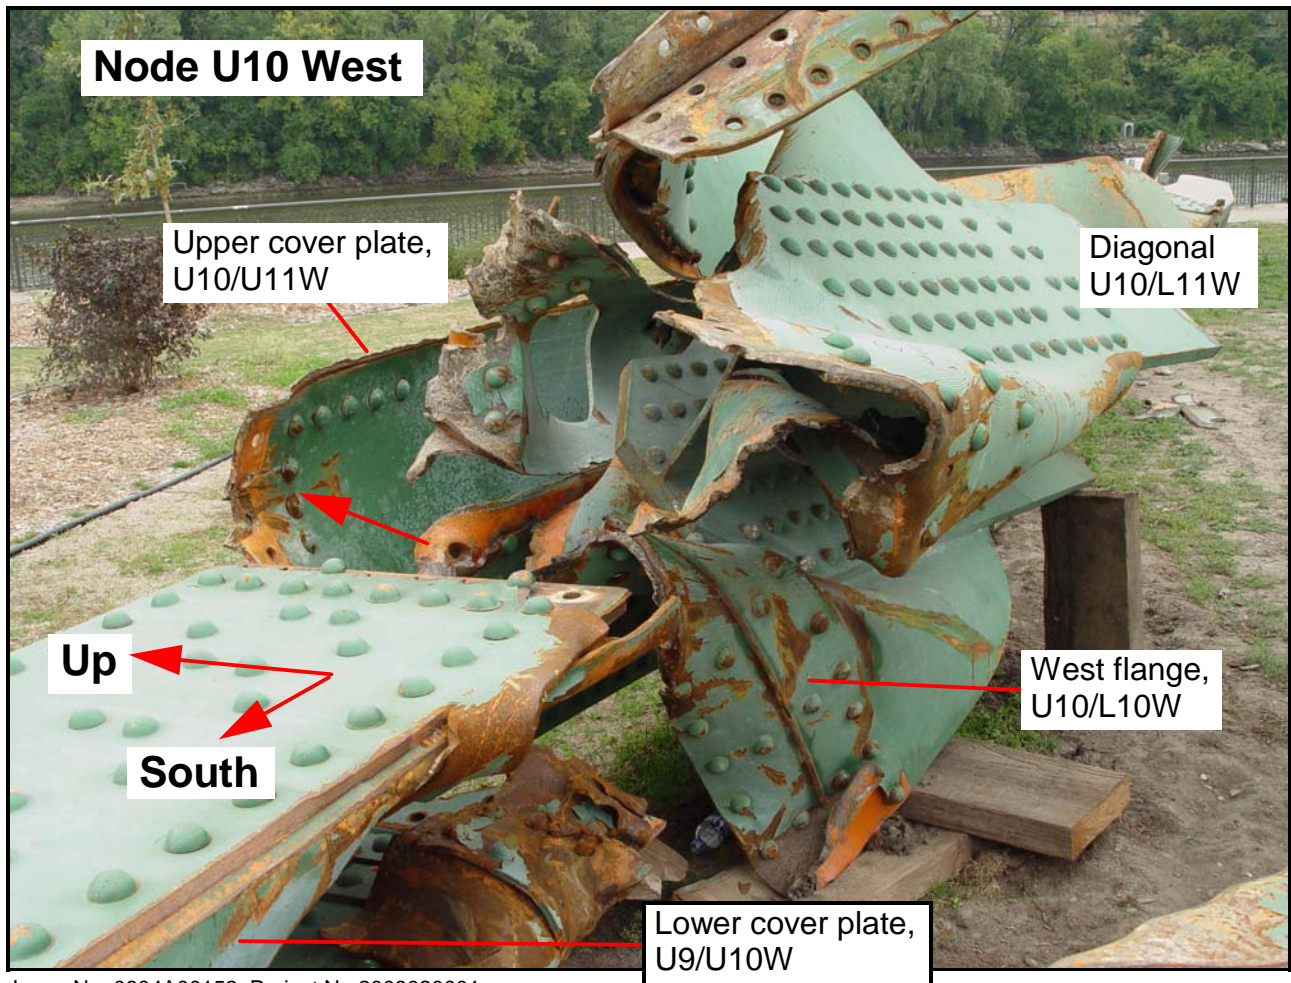
Figure 14. Lower photograph shows an overall view of the pieces from node U10 West, with an arrow indicating an impact mark visible on the lower surface of the upper cover plate of U10/U11W. The deformed west flange of vertical U10/L10W is also indicated. Upper photograph shows a closer view of the impact mark.

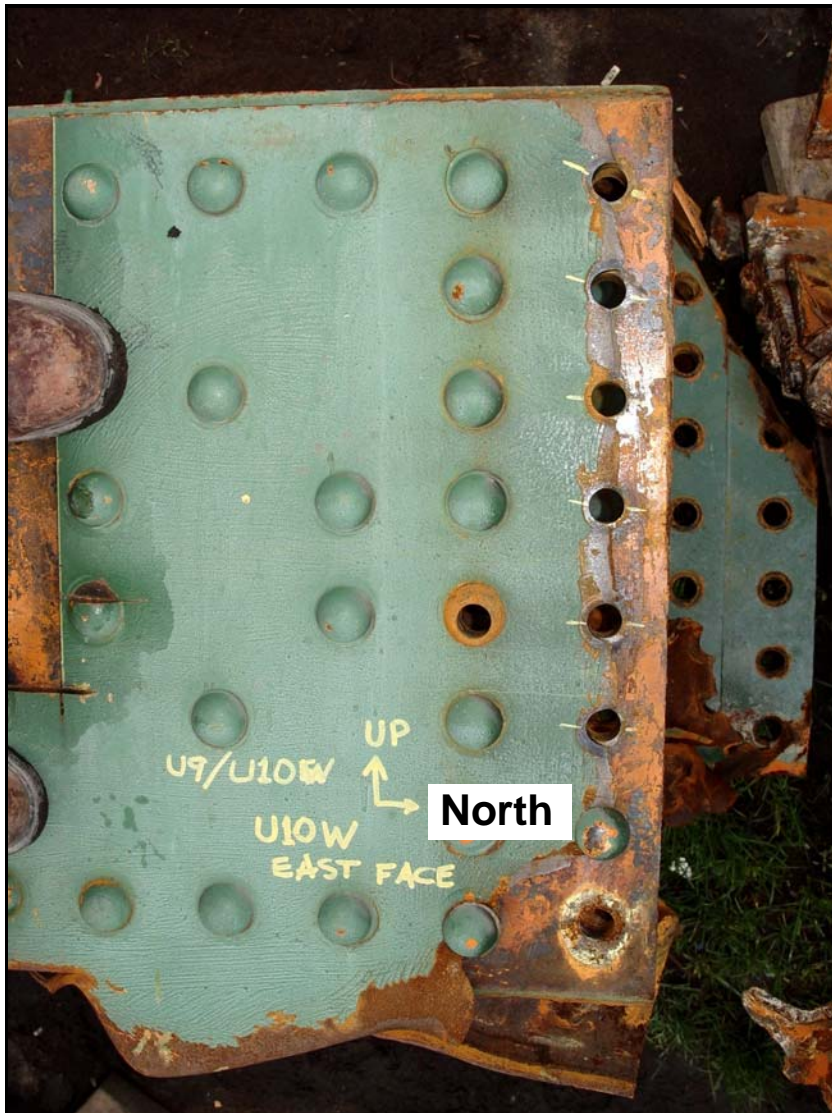
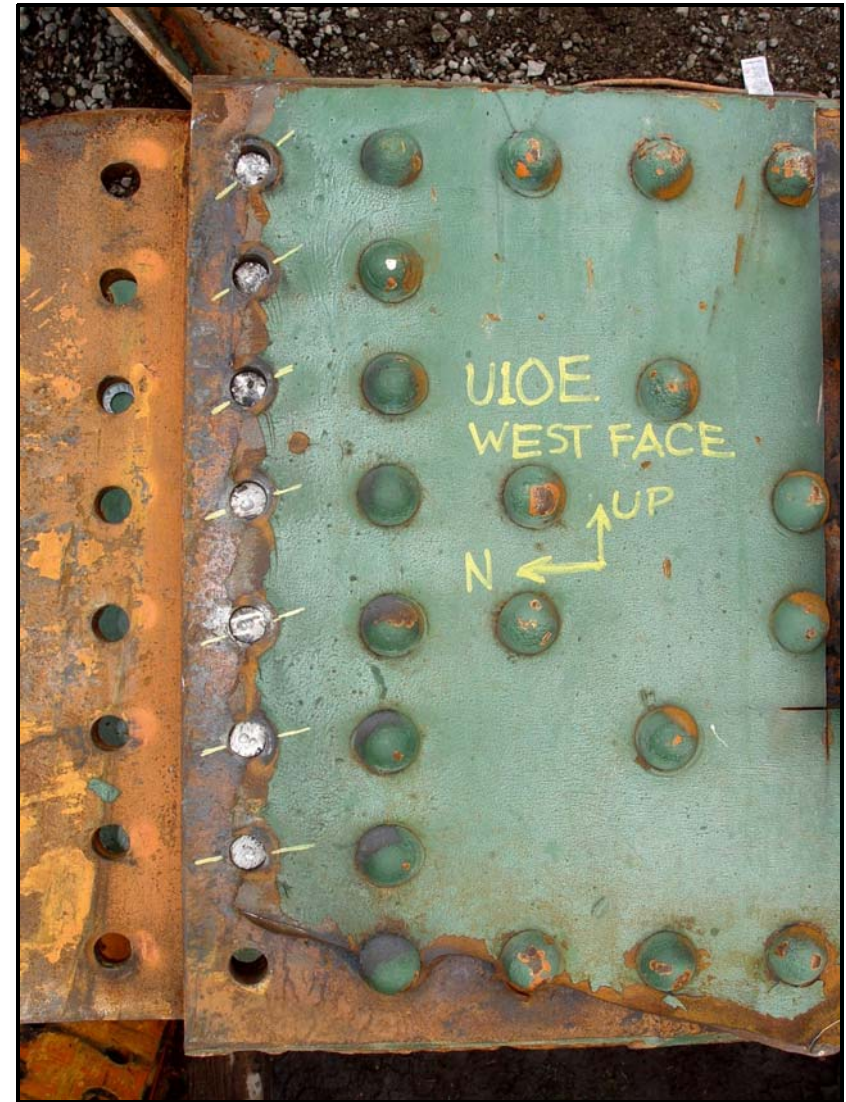
Figure 15. View of the deformation pattern associated with the node U10 gusset plate fractures at the upper chord. The left photograph shows the east gusset plate of node U10W, and the right photograph shows the west gusset plate of node U10E (after grinding off the heads of the rivets adjacent to the fracture). Markings that indicate the tensile loading direction have been added through the rivet holes adjacent to the fracture.

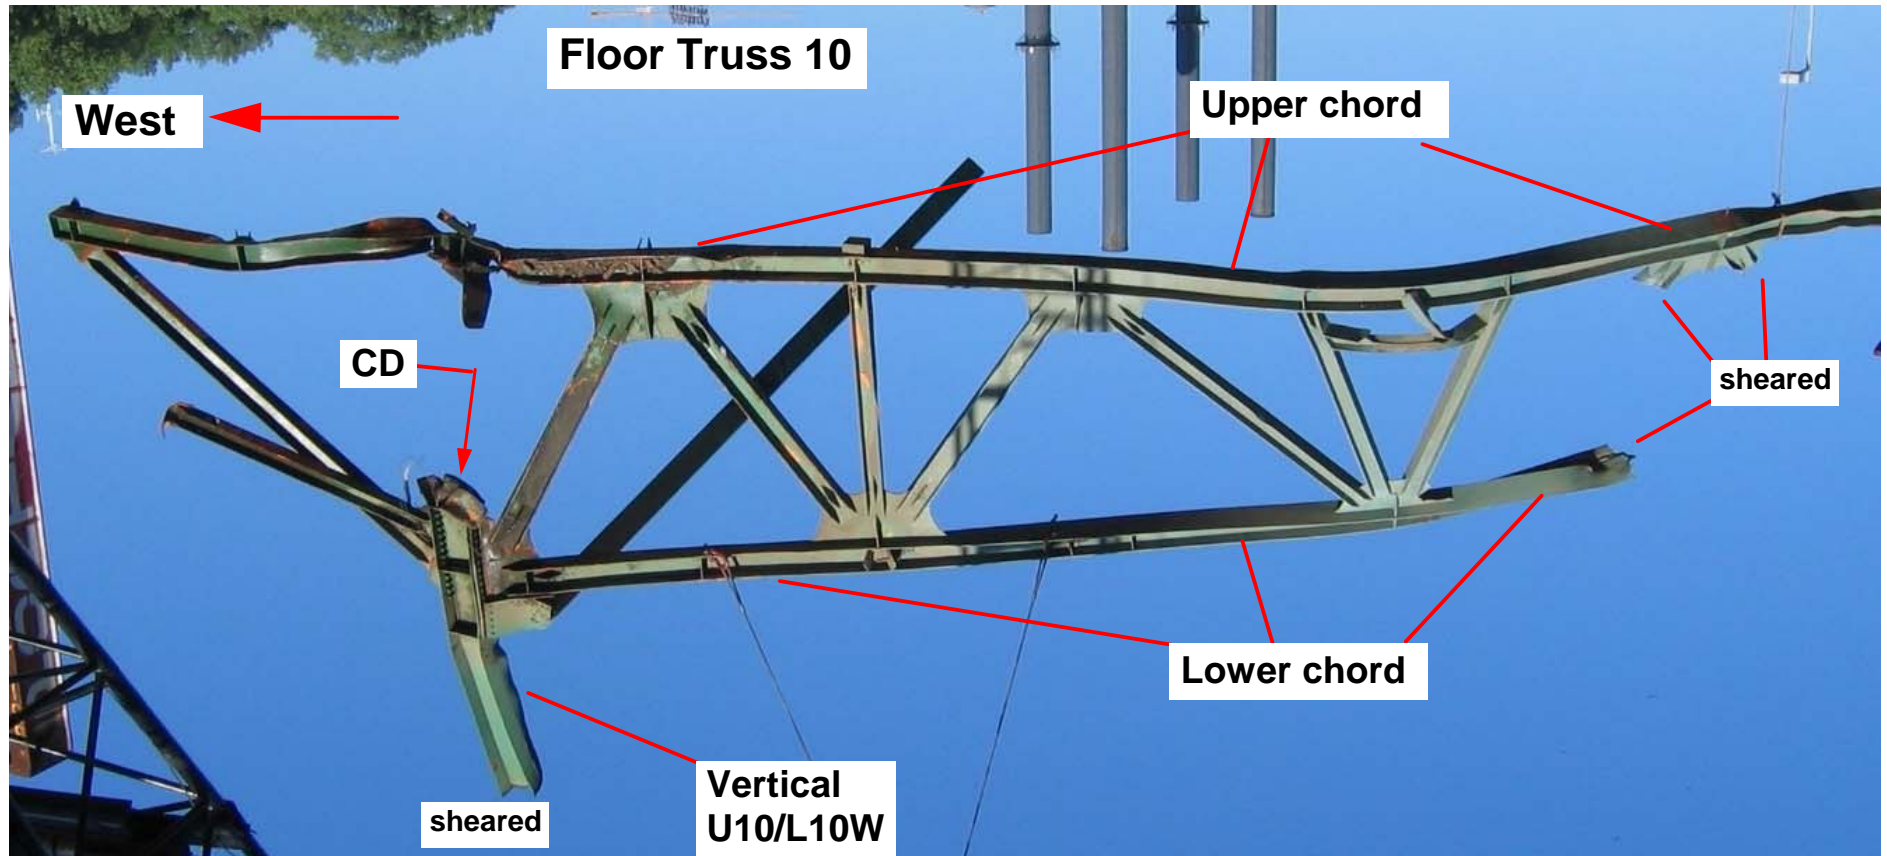
Figure 16. West and central portion of floor truss 10 as it was being removed from the river. The photograph has been turned upside down from the way it was taken to show the floor truss in its normal orientation, viewed looking north. Arrow "CD" indicates severe compression damage to the portion of vertical U10/L10 West above the lower chord of the floor truss. Ends sheared during the recovery process are also indicated.

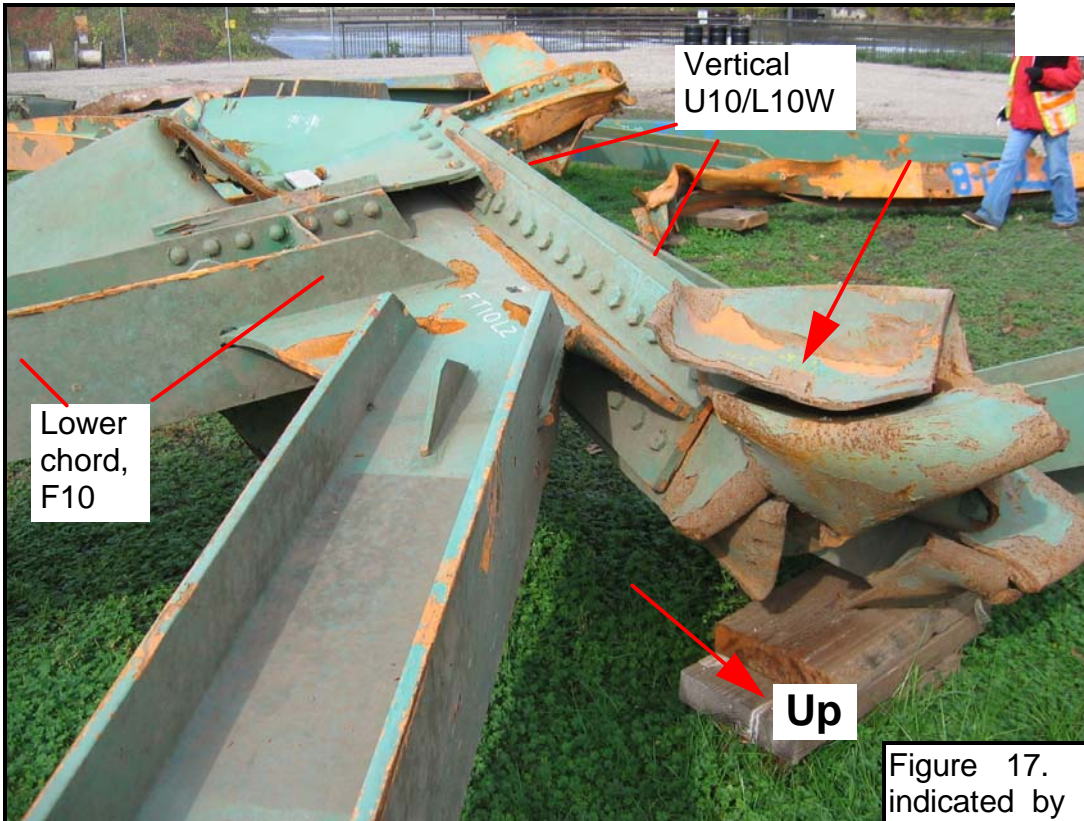
Figure 17. View of the area indicated by arrow "CD" in figure 16, showing the compression damage to the portion of U10/L10 West above the lower chord of floor truss 10. The arrow indicates the impact mark where diagonal L9/U10W contacted the upper end of the web of the vertical.

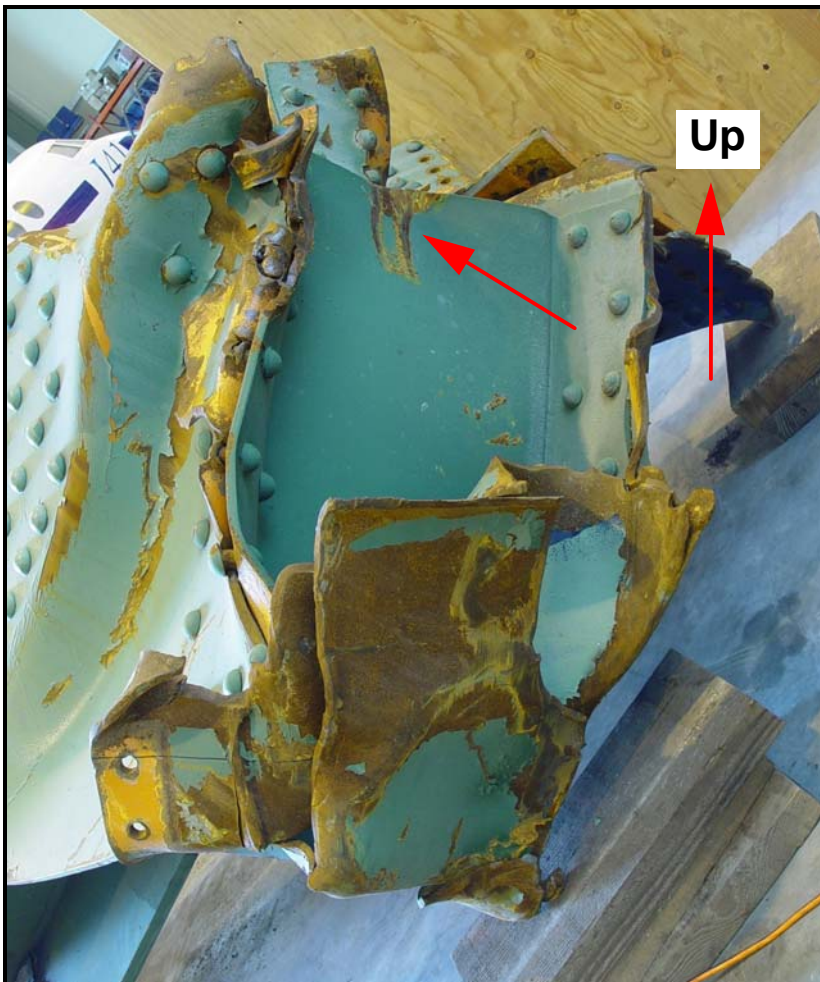
Figure 18. View of the main portion of node U10 East, showing the folding and compression damage on the web of the vertical. The arrow indicates the impact mark where diagonal L9/U10 East contacted the upper end of the web of the vertical.

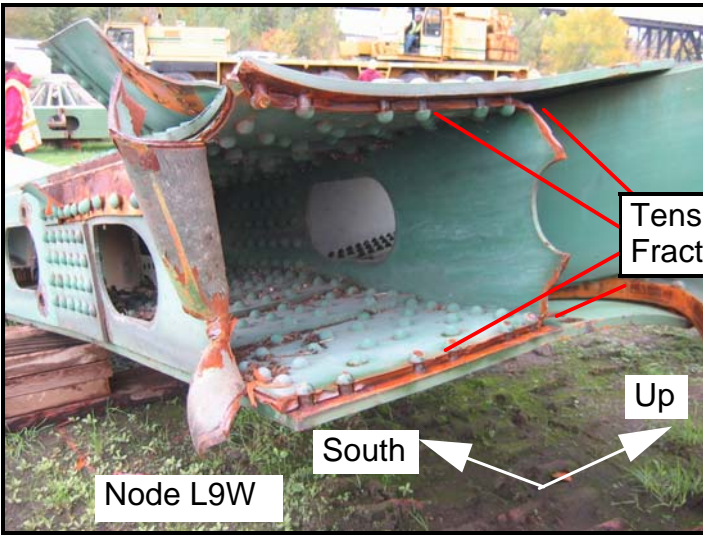
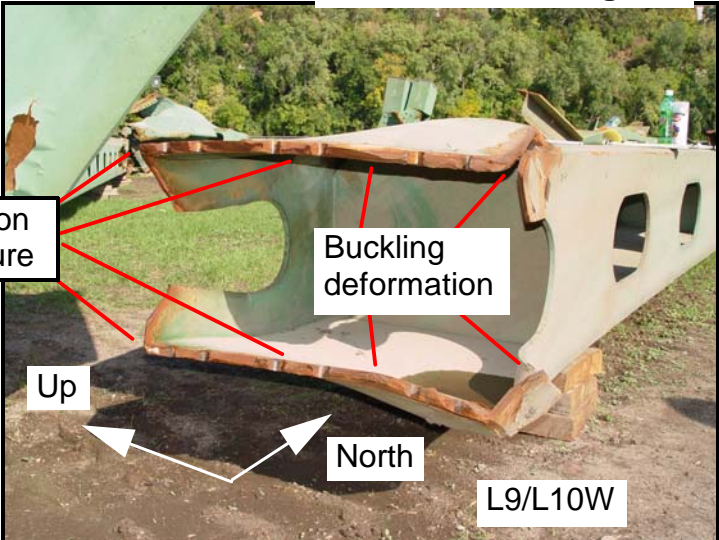
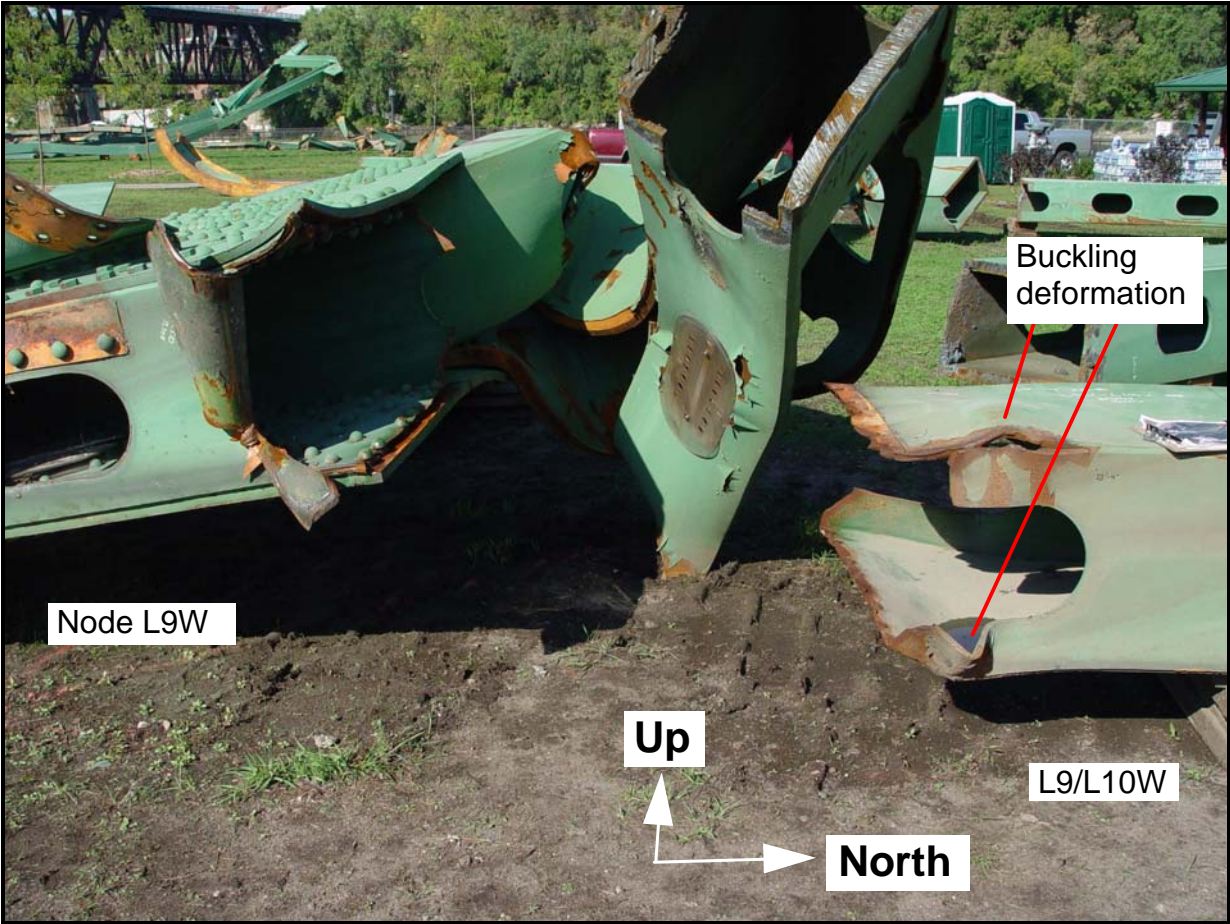
Figure 19. Node L9W and lower chord member L9/L10W showing the fracture area in the lower chord. Lower photograph looking mainly up, upper right photograph looking mainly north, and upper left photograph looking mainly south. Tension fracture areas and compression buckling deformation areas are noted.

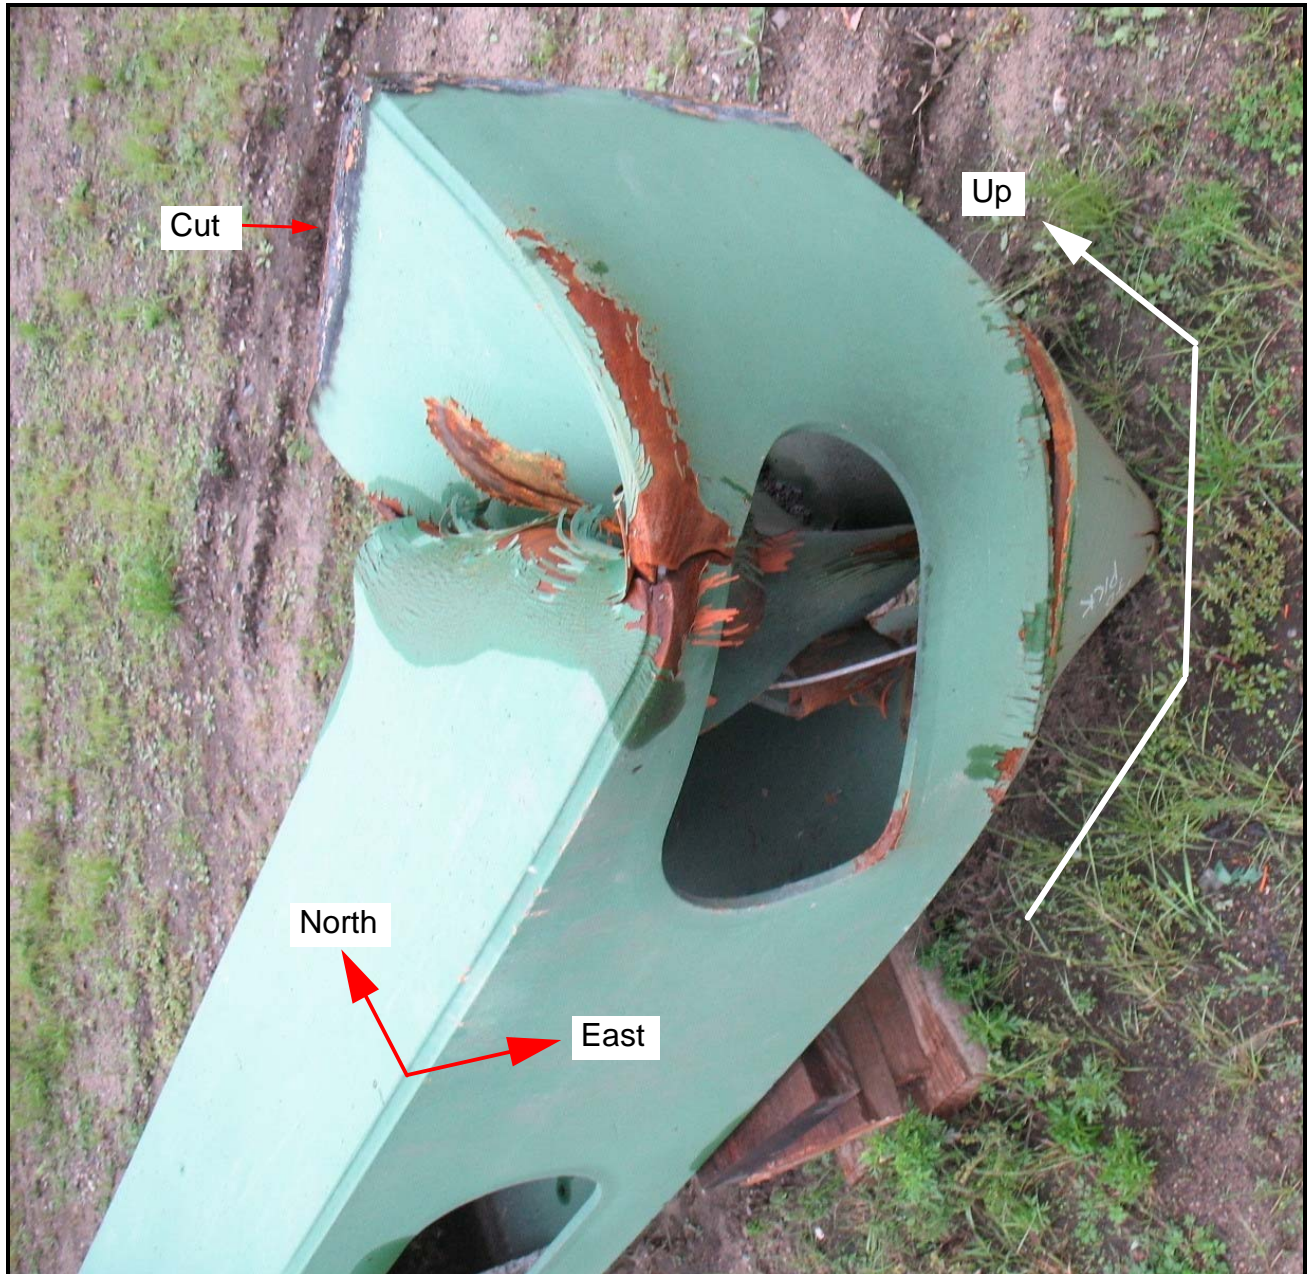
Figure 20. Vertical member U9/L9 East showing the bent area below the floor truss lower chord. The member was cut at the indicated location during the removal process.

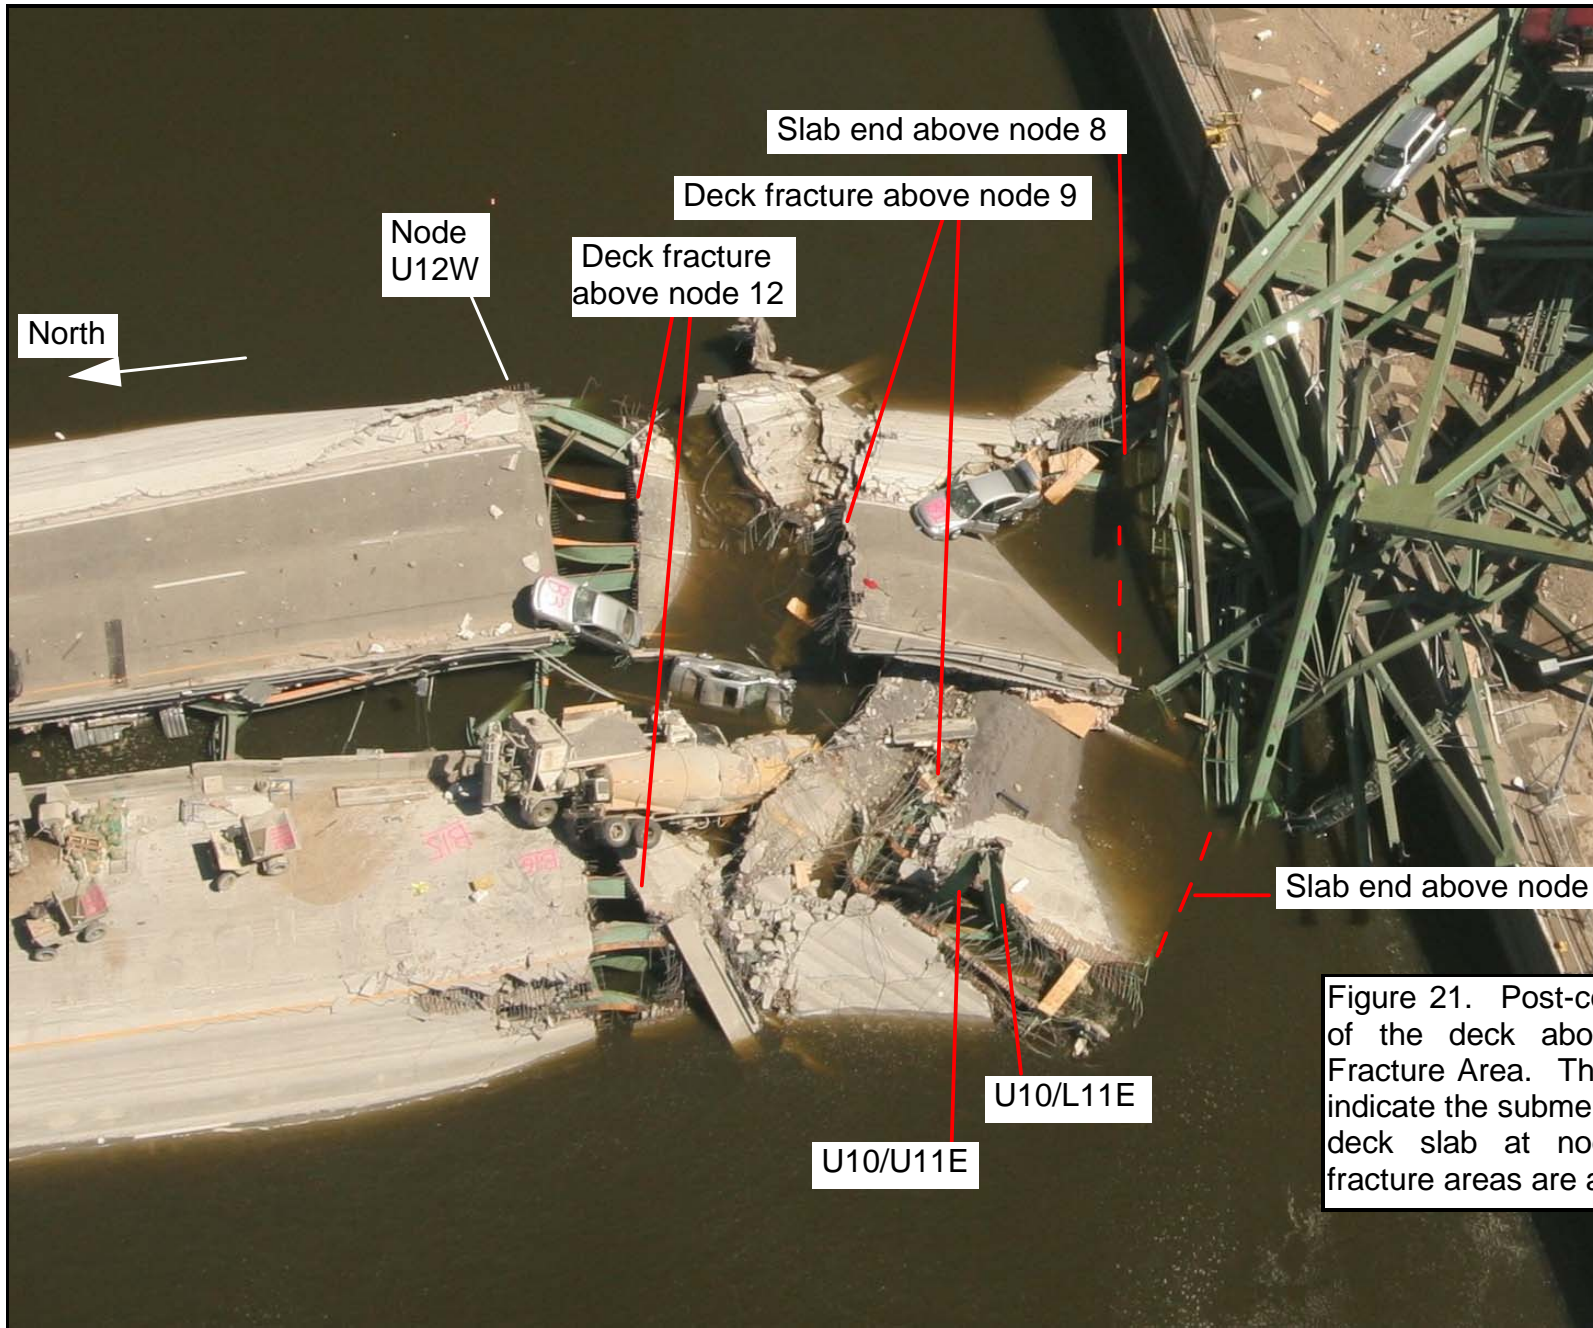
Figure 21. Post-collapse position of the deck above the South Fracture Area. The dashed lines indicate the submerged end of the deck slab at node 8. Deck fracture areas are also indicated.

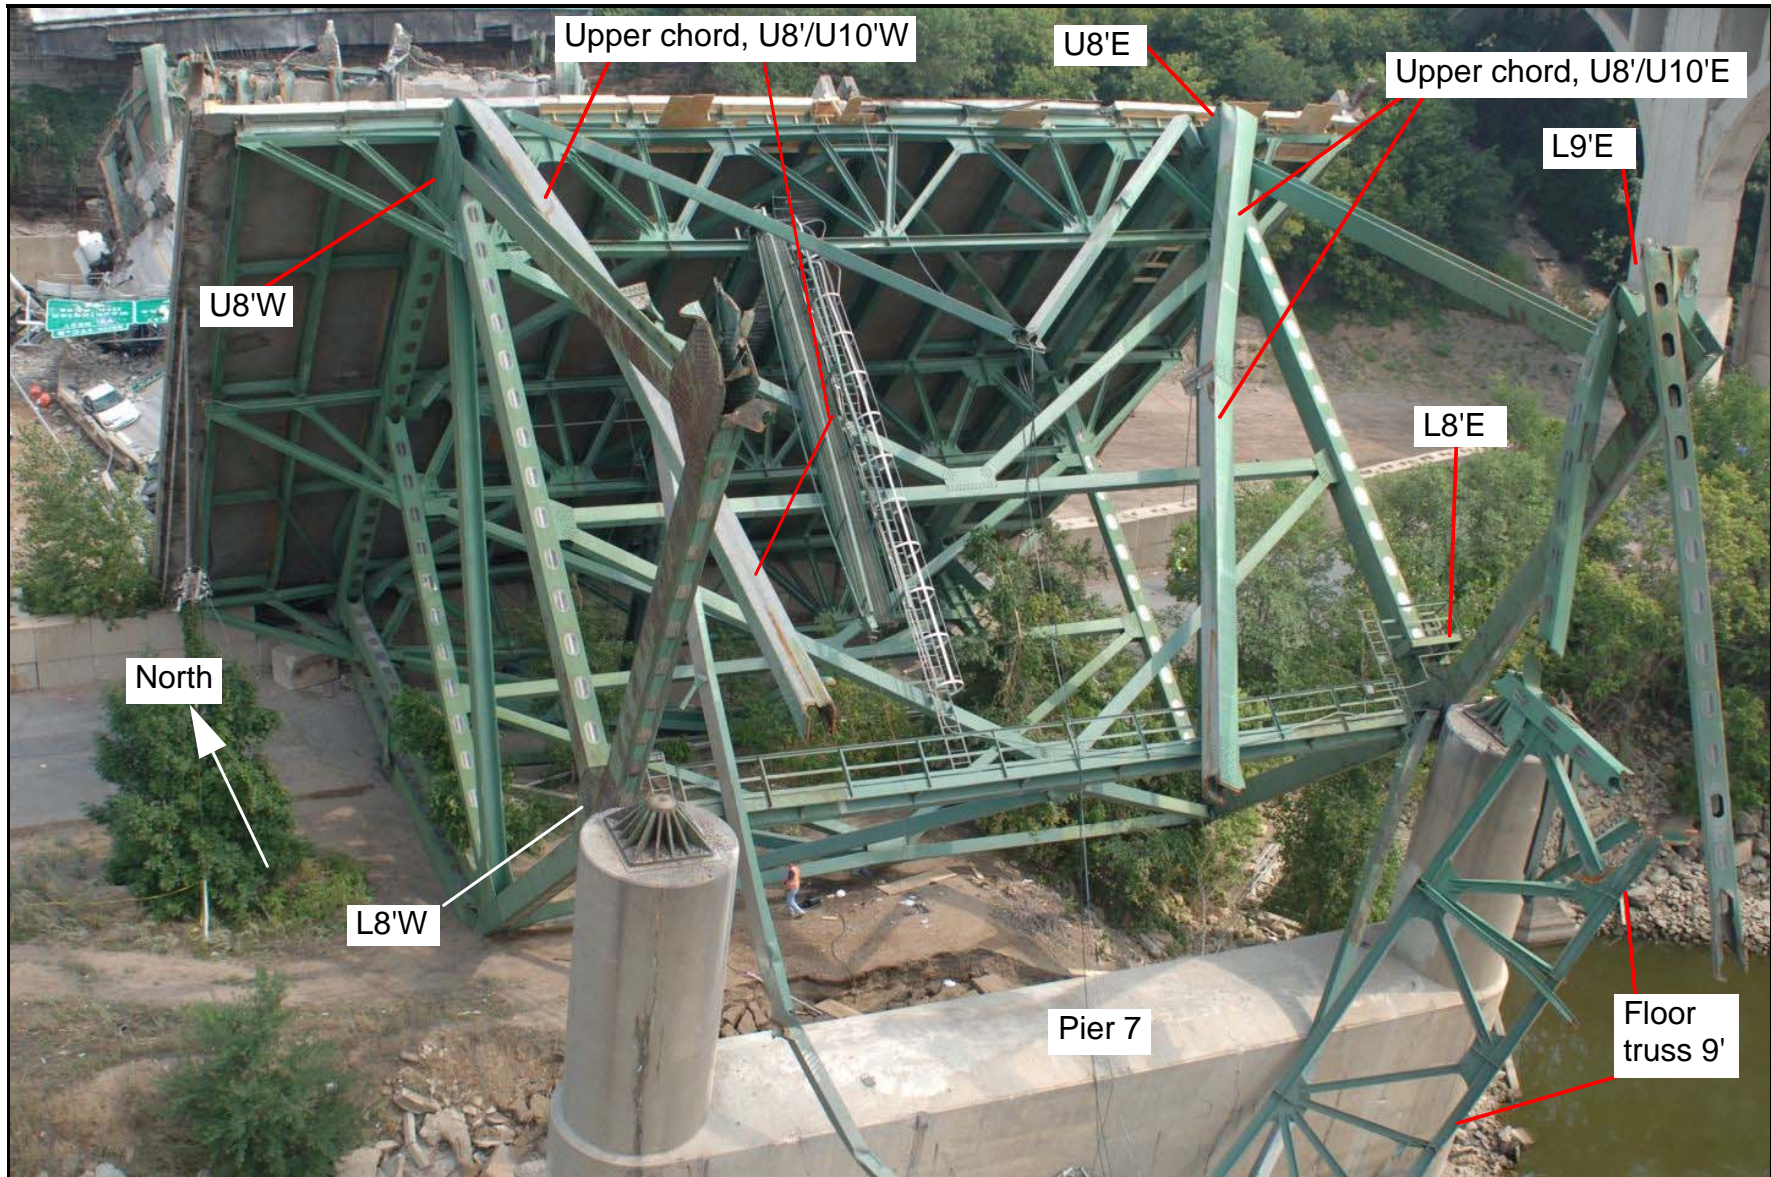
Figure 22. Overall view of a large portion of the deck truss above and north of pier 7 that rotated to the north as a rigid body. View is looking north and slightly east and shows most of the fractured members in the North Fracture Area.

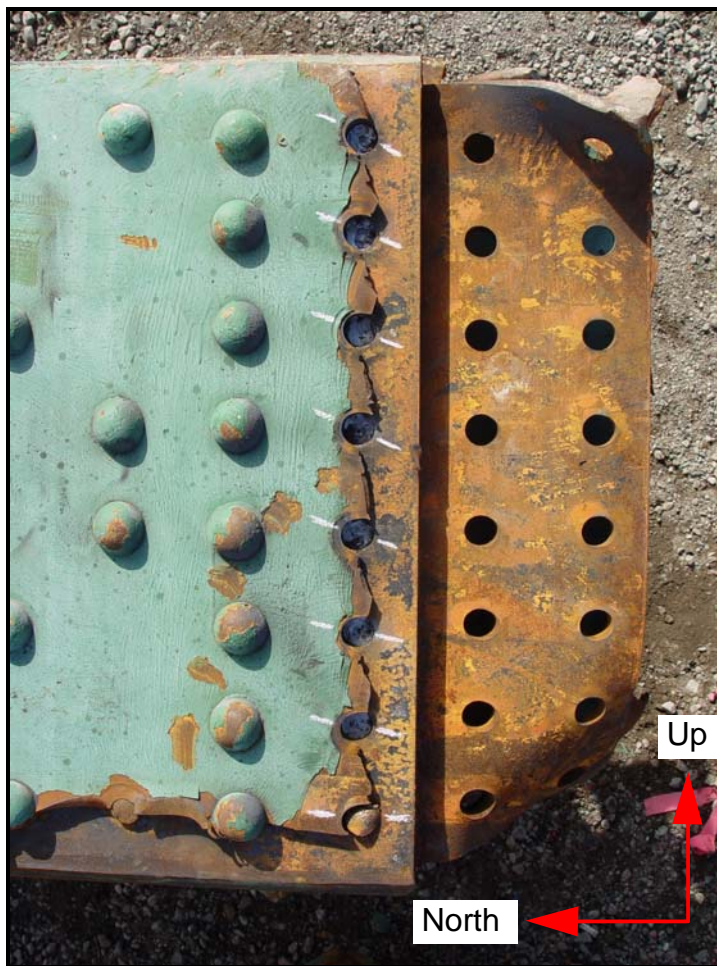
Figure 24. View of the deformation pattern associated with the fracture in the west gusset plate at node U10' East in the area of the upper chord (after grinding off the heads of the rivets adjacent to the fracture). Markings that indicate the tensile loading direction have been added through the rivet holes adjacent to the fracture. Compare to the left photograph in figure 15.

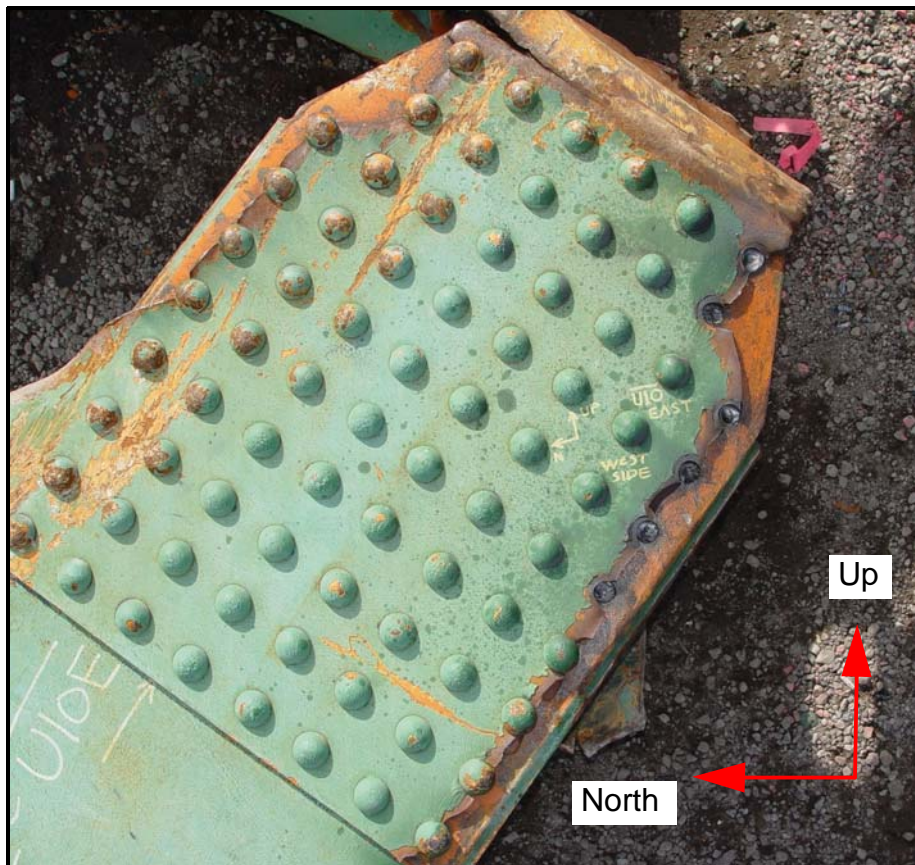
Figure 23. Fractured and deformed west gusset plate on node U10' East.

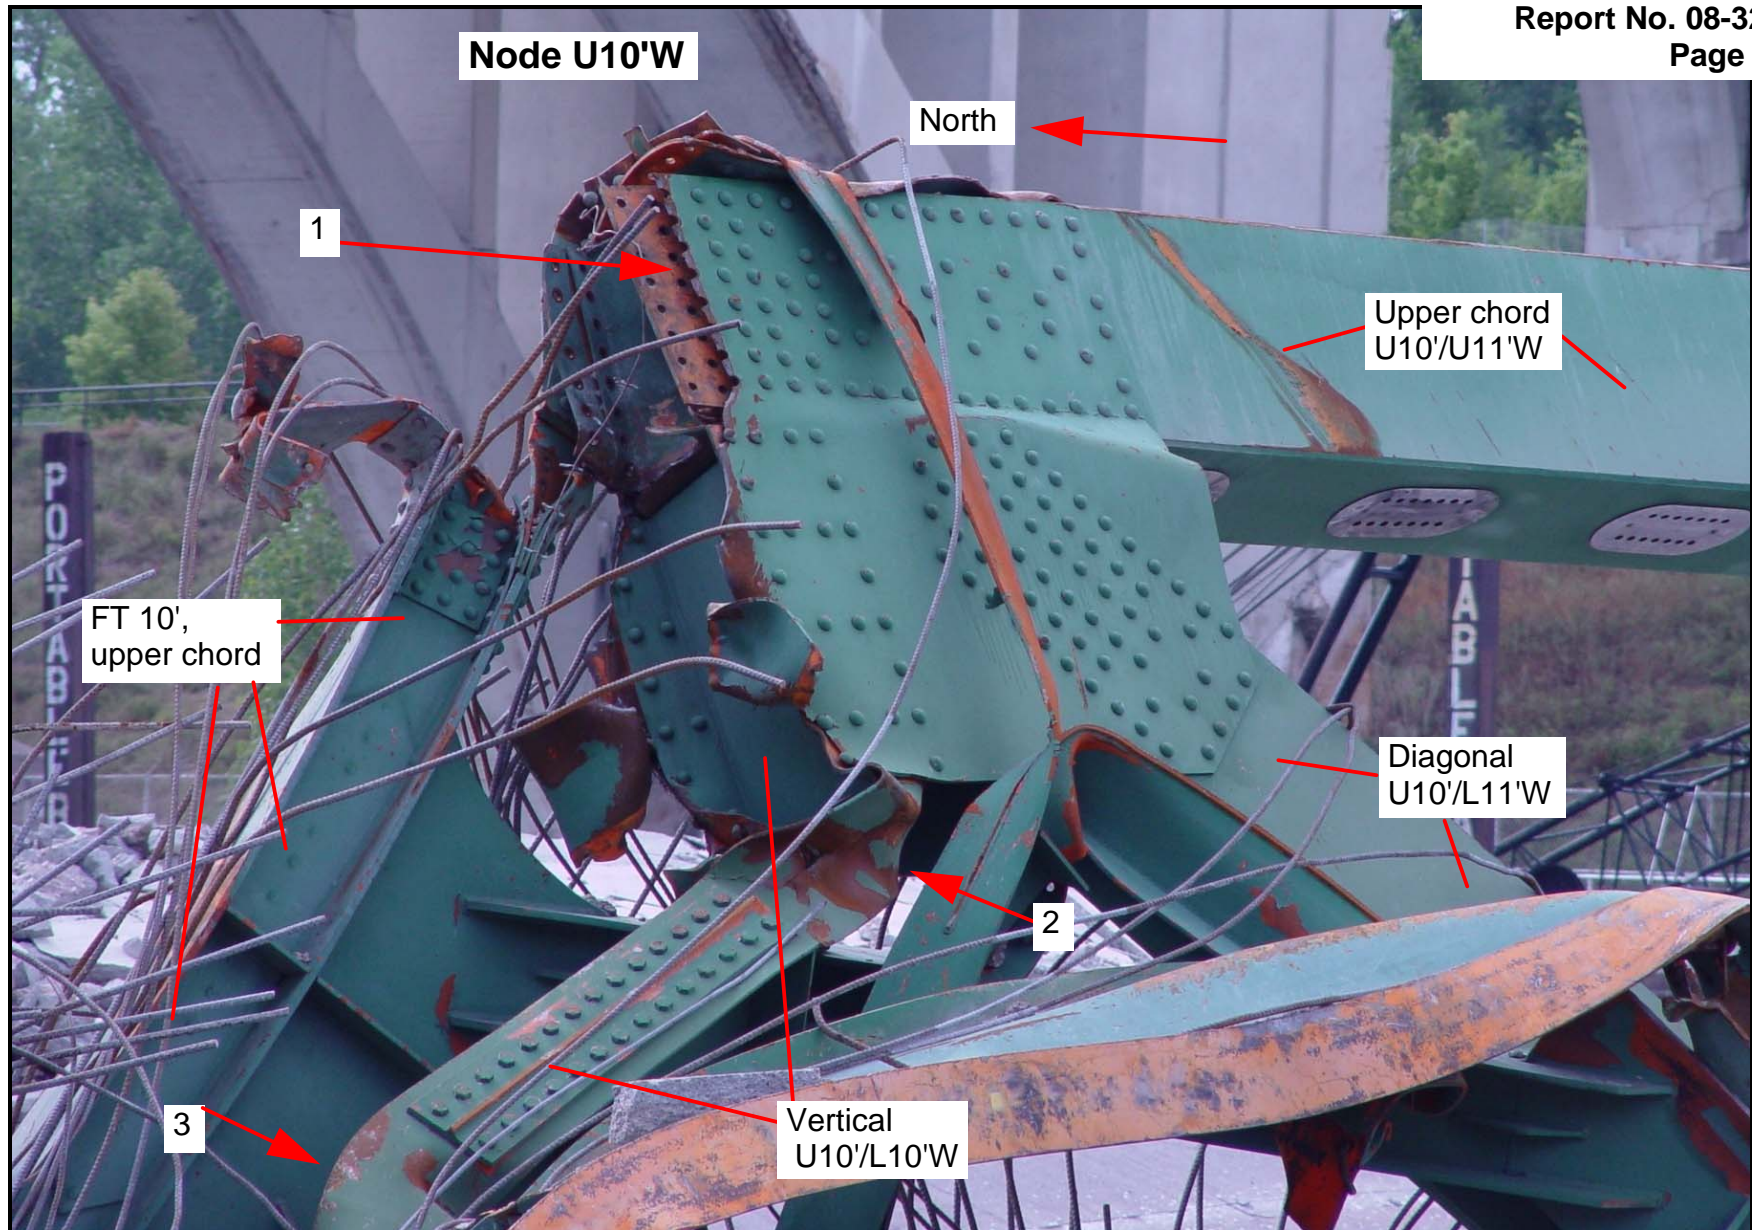
Figure 25. Overall view of the west side of main portion of node U10' West in the post-collapse position. Arrow "1" indicates the fracture in the gusset plate through the upper chord. Arrows "2" and "3" indicate bending/buckling damage in vertical U10'/L10' West.

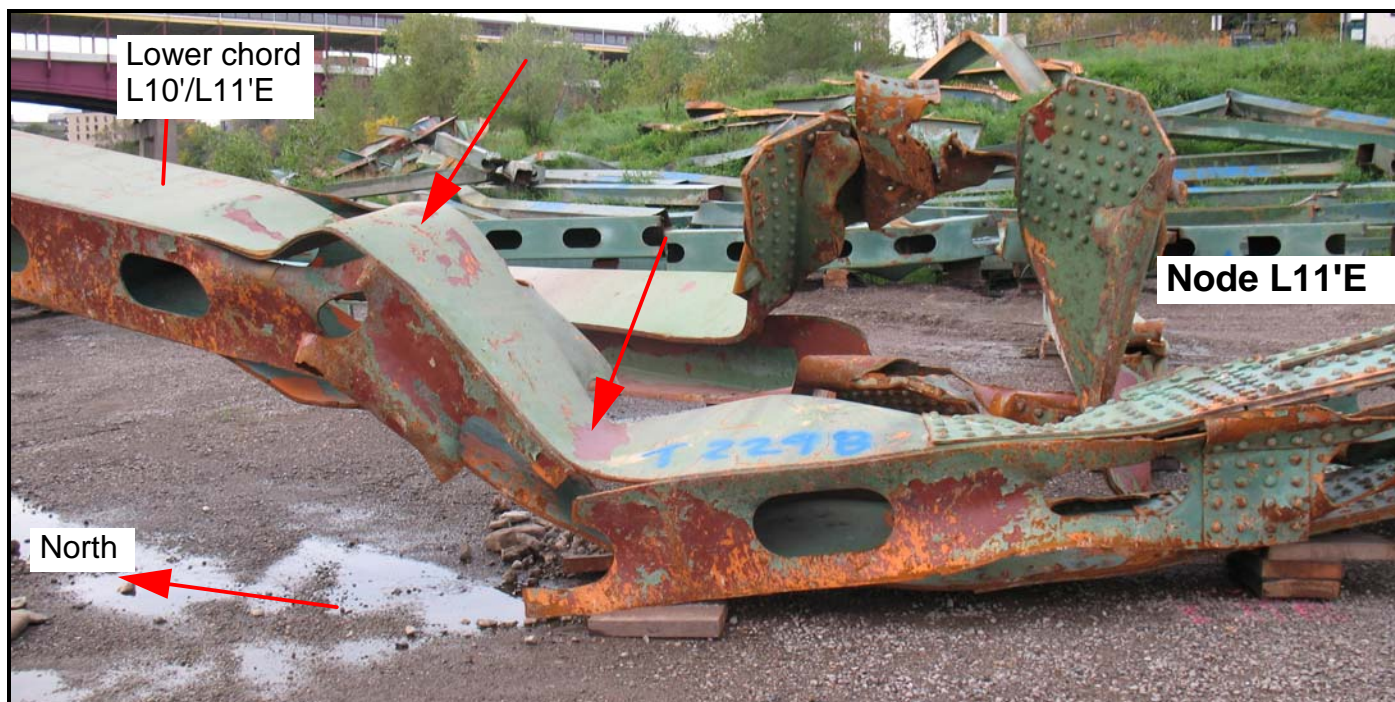
Figure 26. View of lower chord member L10'/L11'E adjacent to node L11' East, showing the compression buckling deformation in the area indicated by the arrows. Direction of view is mainly looking up.

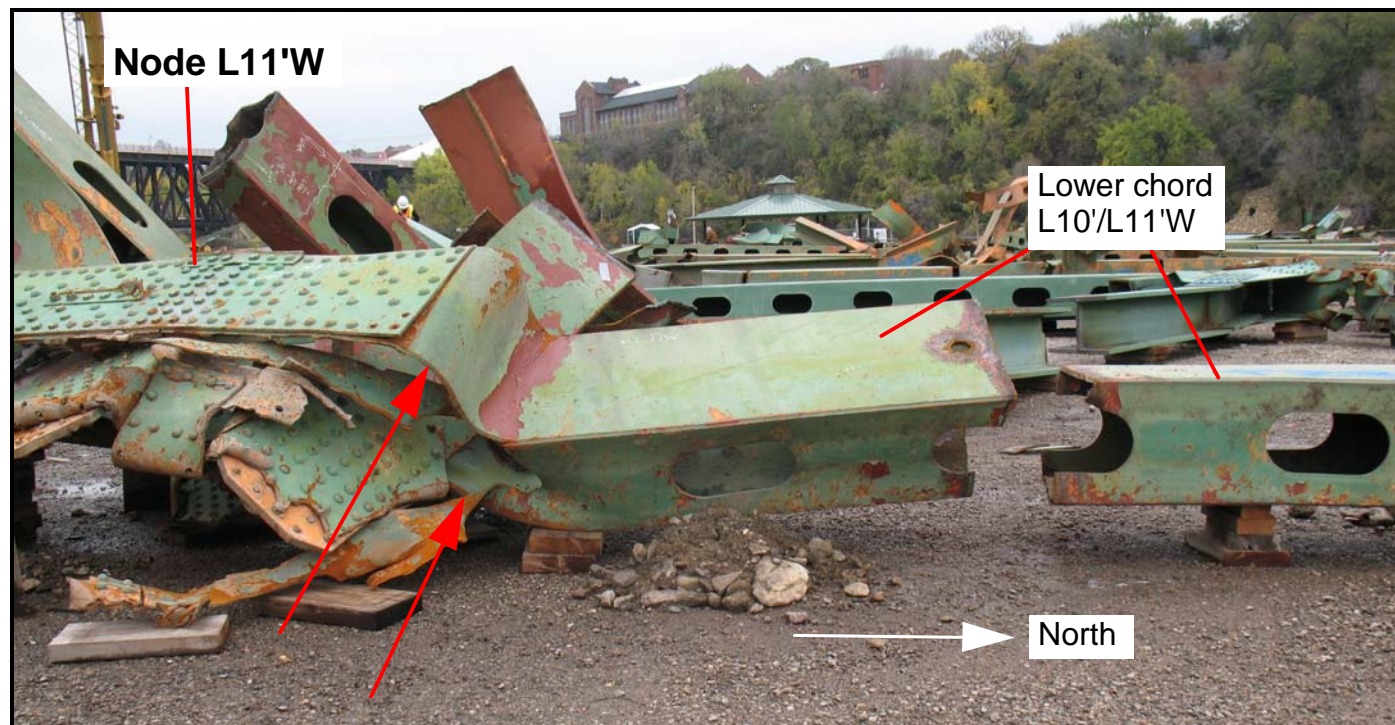
Figure 27. View of lower chord member L10'/L11'W adjacent to node L11' West, showing the compression buckling deformation in the area indicated by the arrows. Direction of view is mainly looking up.
