NATIONAL TRANSPORTATION SAFETY BOARD

MATERIALS LABORATORY ANNOTATED PHOTOGRAPHS

Report No. 82-032A

Place : Minneapolis, Minnesota
Date : August 1, 2007
Vehicle : I35W Highway Bridge
NTSB No. : HWY07MH024
Investigator : Mark Bagnard

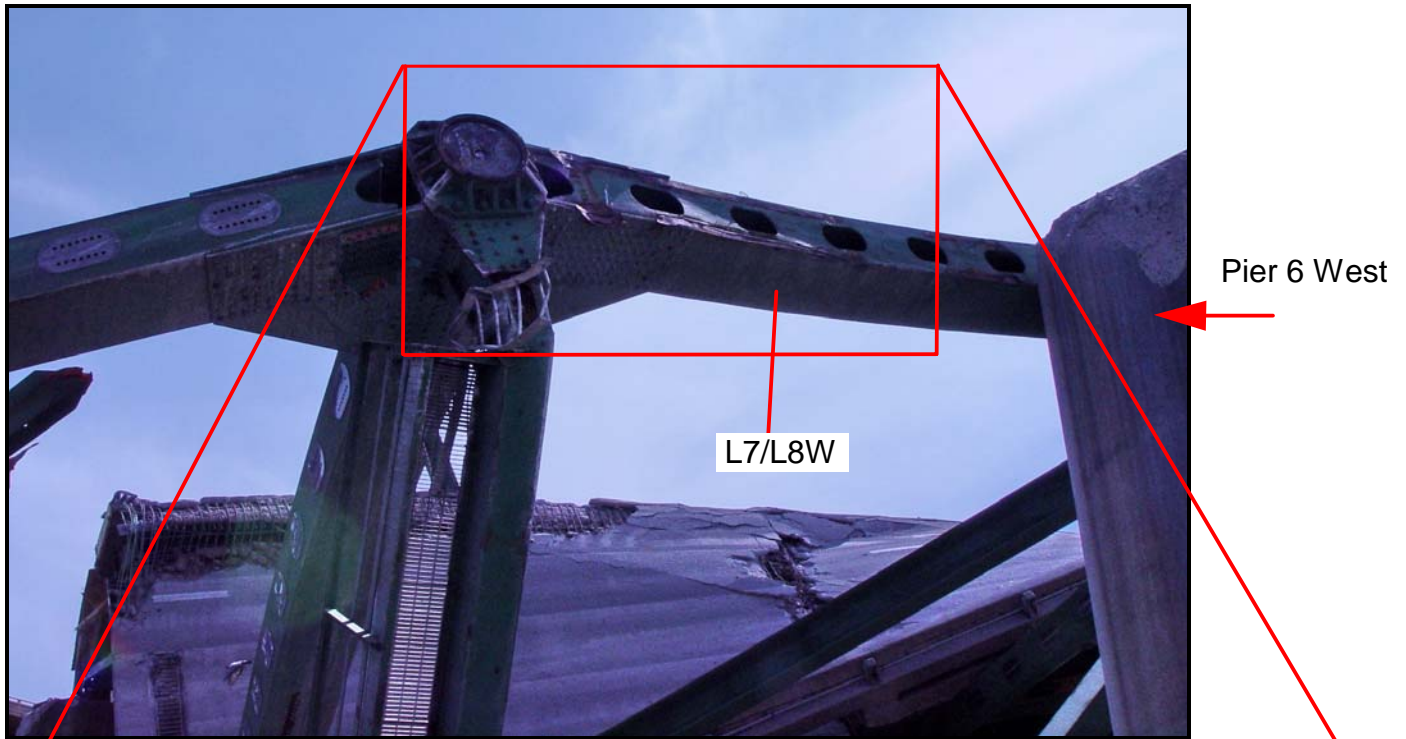
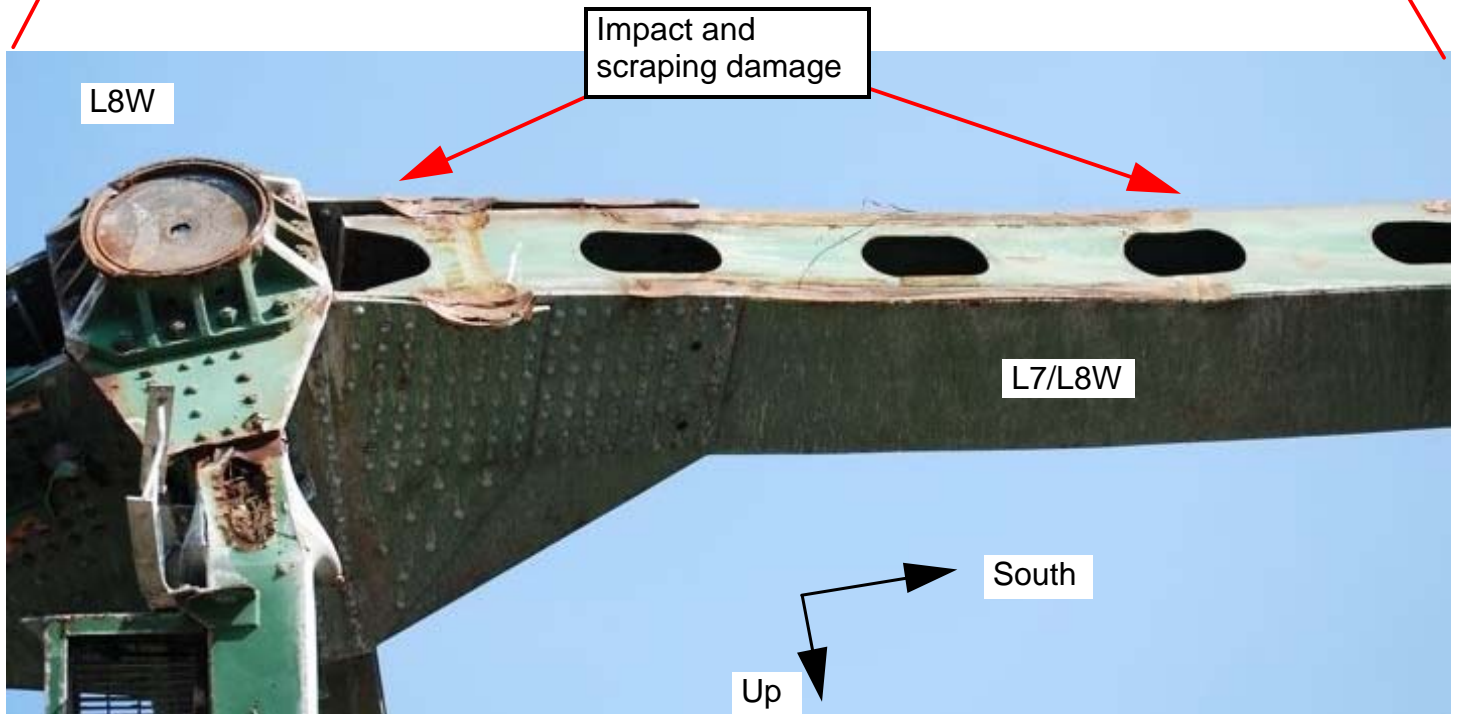
Figure 28. View of the lower surface of node L8 West and lower chord member L7/L8W before removal from the accident site, showing the impact and scraping damage on the lower chord.

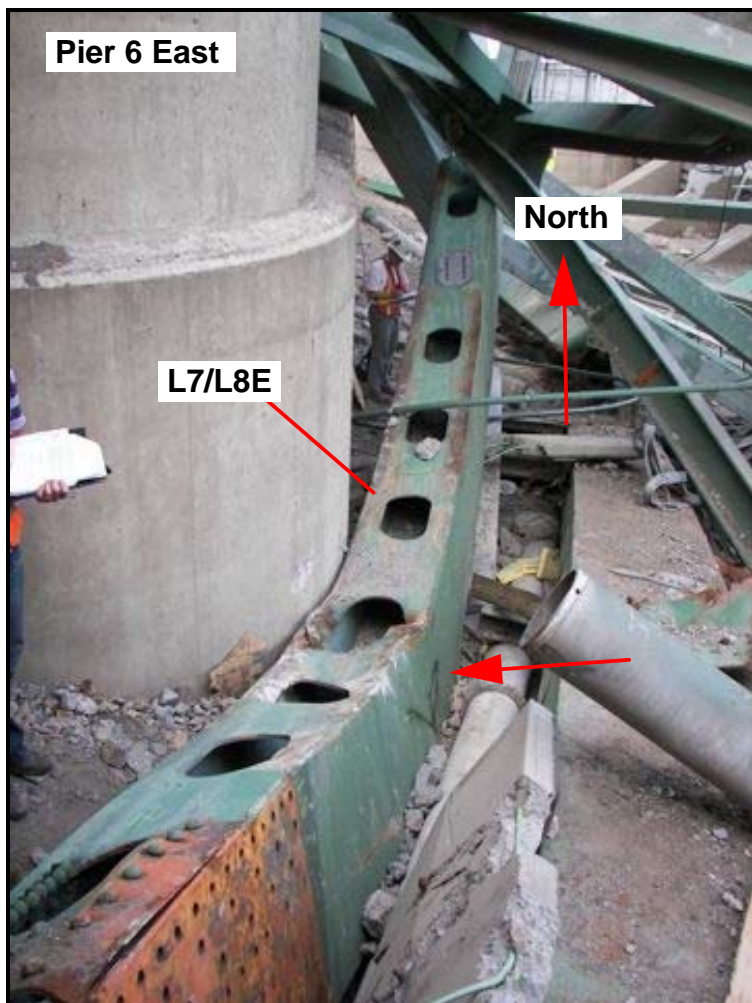
Figure 29. View of the lower side of lower chord member L7/L8E showing the scraping damage from contact with the pier and bearings at pier 6. View is looking north along the member, but west geographically. The unlabeled arrow indicates the partial fracture shown in figure 30.

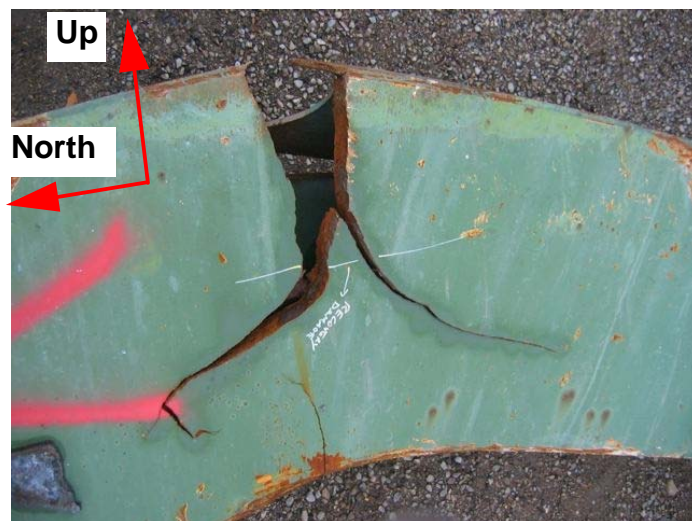
Figure 30. View of the partial fracture in lower chord member L7/L8E.

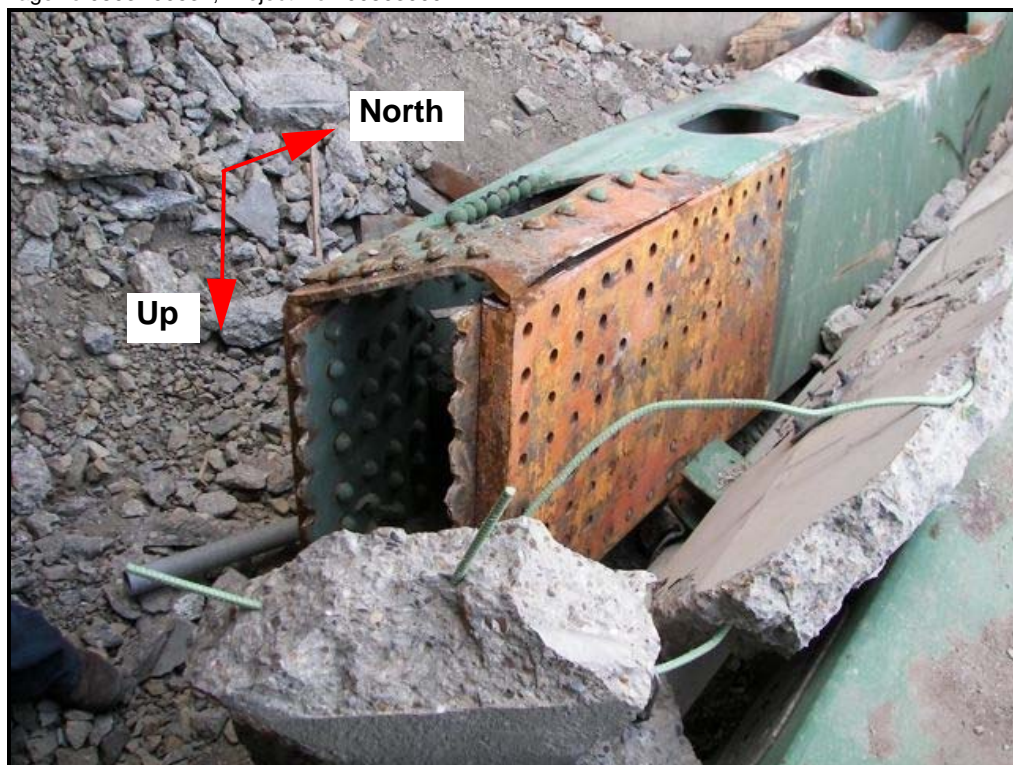
Figure 31. View of the L7E end of lower chord member L7/L8E in its post-collapse position, showing the locations of sheared rivets between the side plate of the lower chord and the gusset plate at node L7 East.

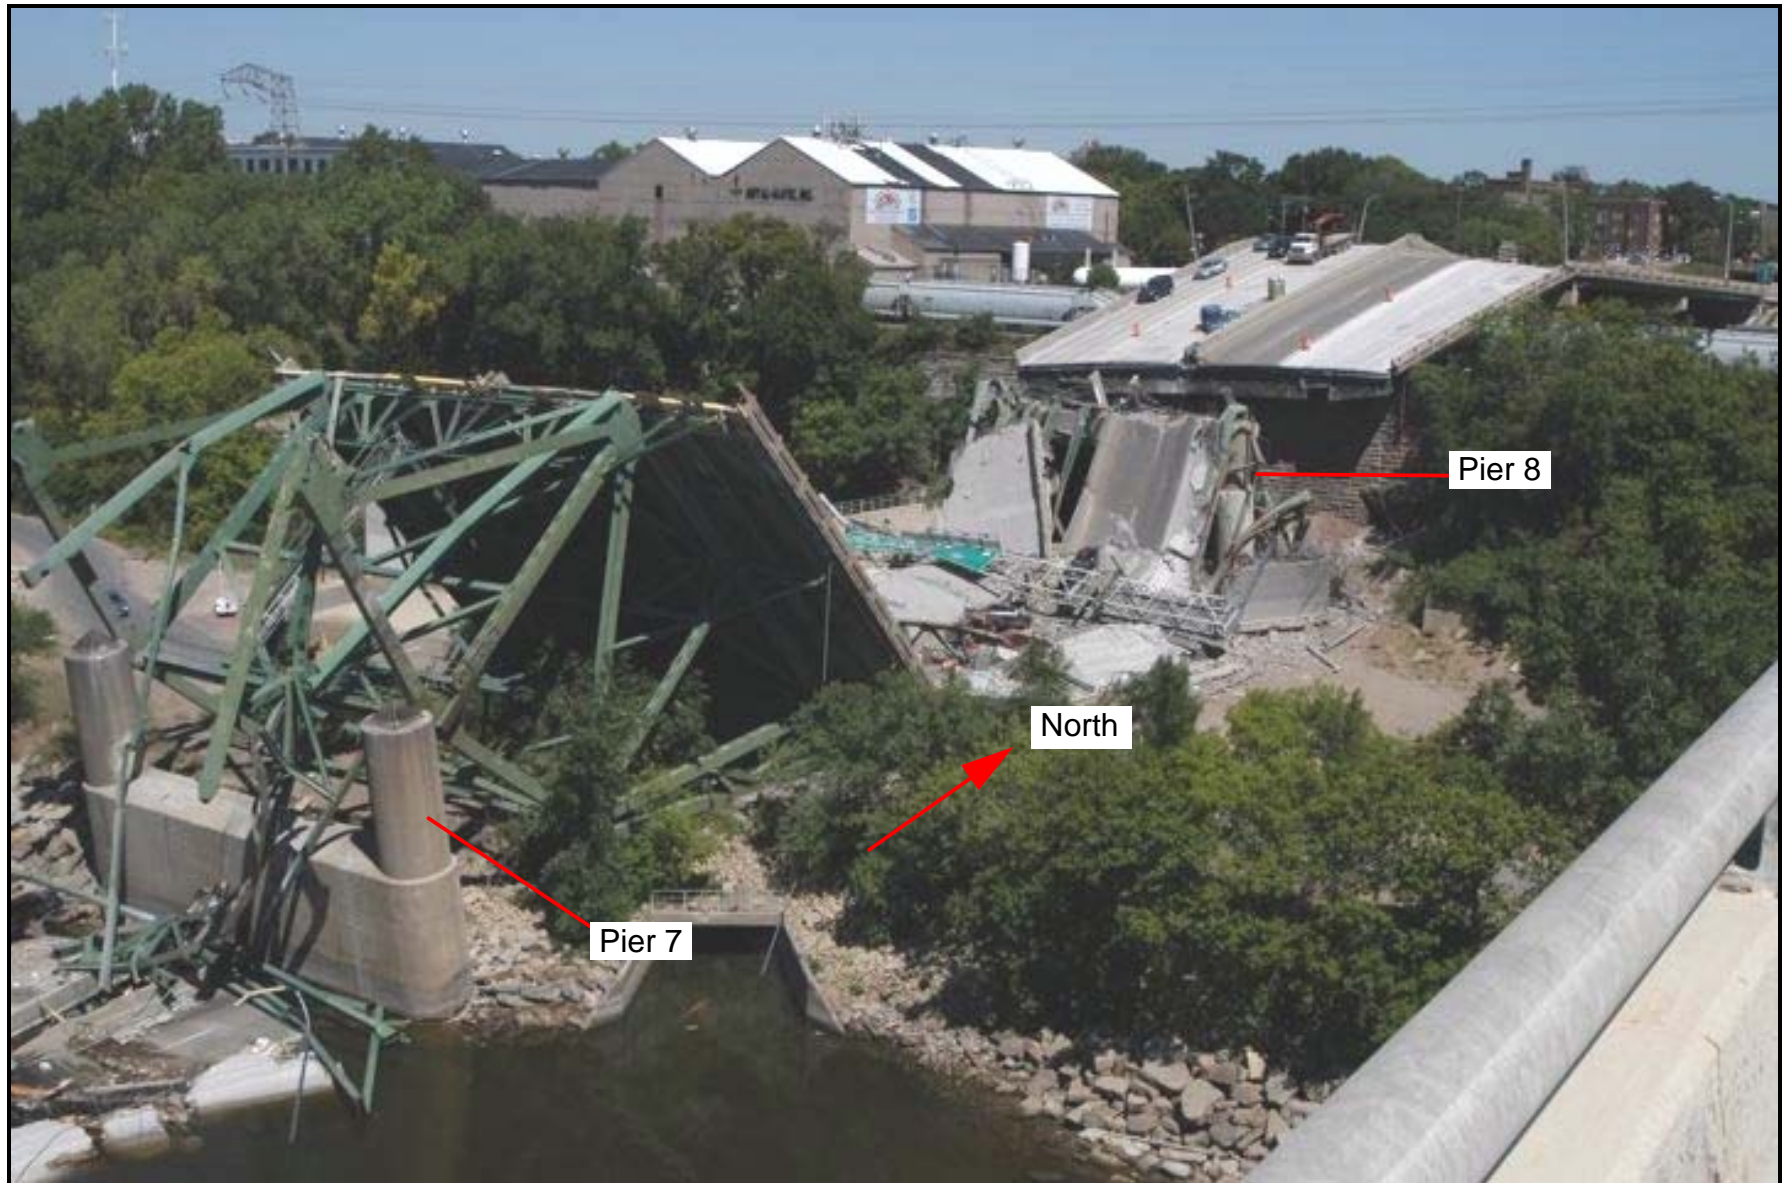
Figure 32. Overall view of the north portion of the deck truss after the collapse. View is looking northwest.

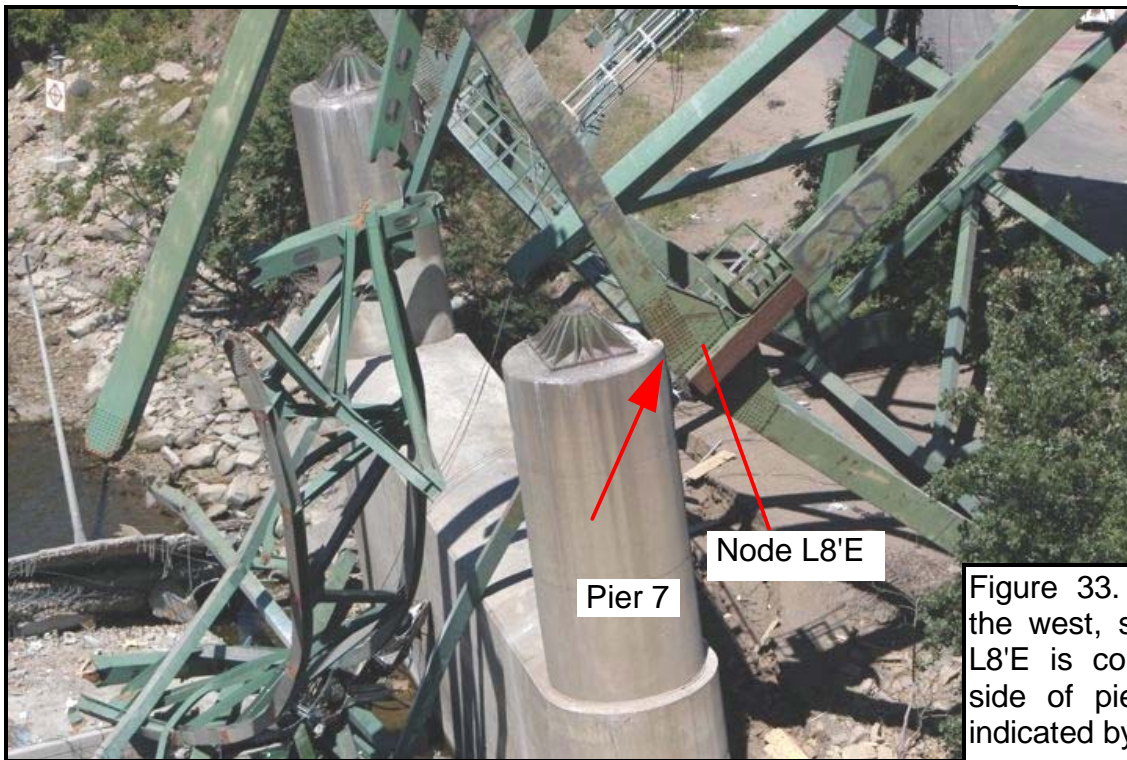
Figure 33. View looking to the west, showing how node L8'E is contacting the north side of pier 7, at the area indicated by the arrow.

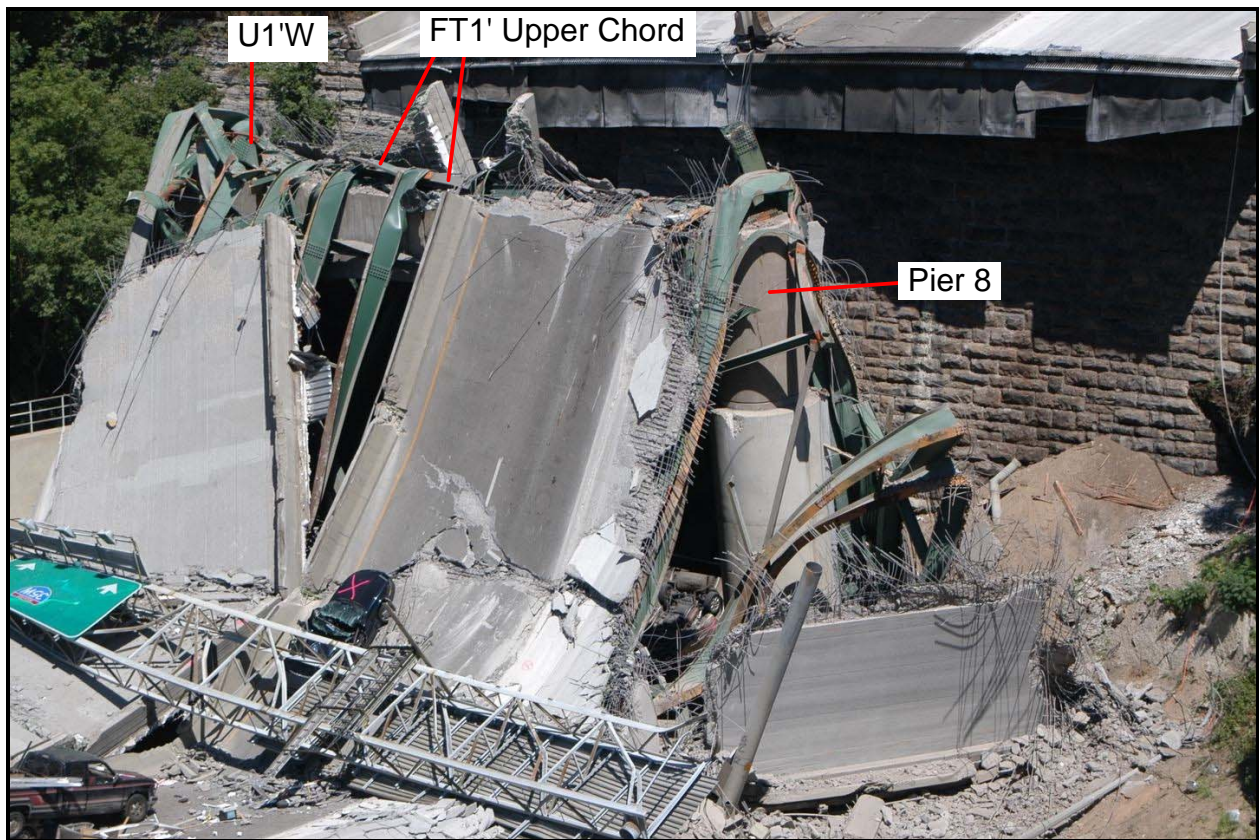
Figure 34. Deck truss at pier 8 after the collapse. The upper chord of FT1' and a portion of node U1' West are indicated. View is looking northwest. The unsupported southern end of the north approach spans is visible at the top of the photograph.

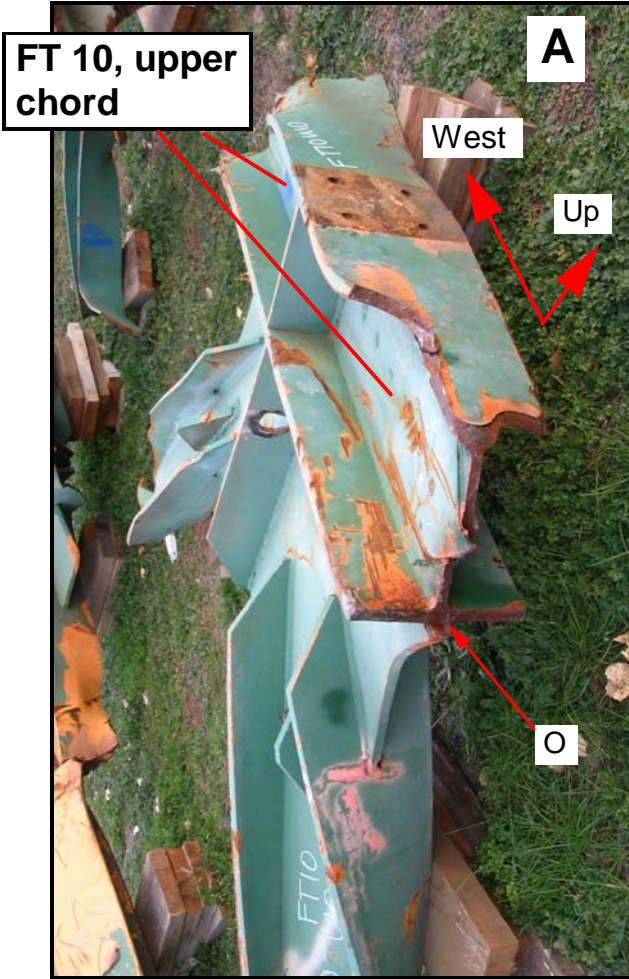
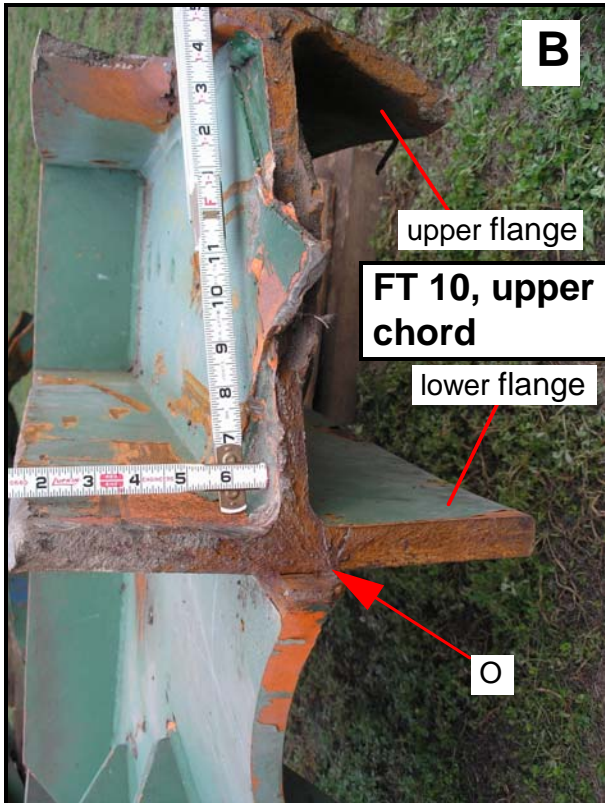
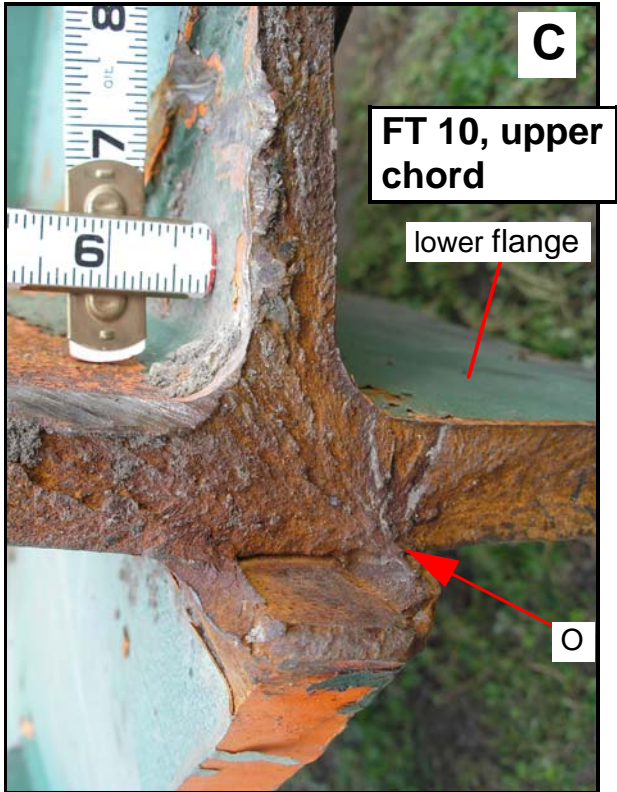
Figure 35. Fracture in the upper chord of FT 10 near node U10 East. All views are looking primarily west. Overall view in photograph A, closer view of the fracture in photograph B, and closer view of the origin area in photograph C. Arrow "O" indicates the origin area.
