NATIONAL TRANSPORTATION SAFETY BOARD

MATERIALS LABORATORY FACTUAL REPORT

Report No. 07-119

Place : Minneapolis, Minnesota
Date : August 1, 2007
Vehicle : I35W Highway Bridge
NTSB No. : HWY07MH024
Investigator : Gary Van Etten

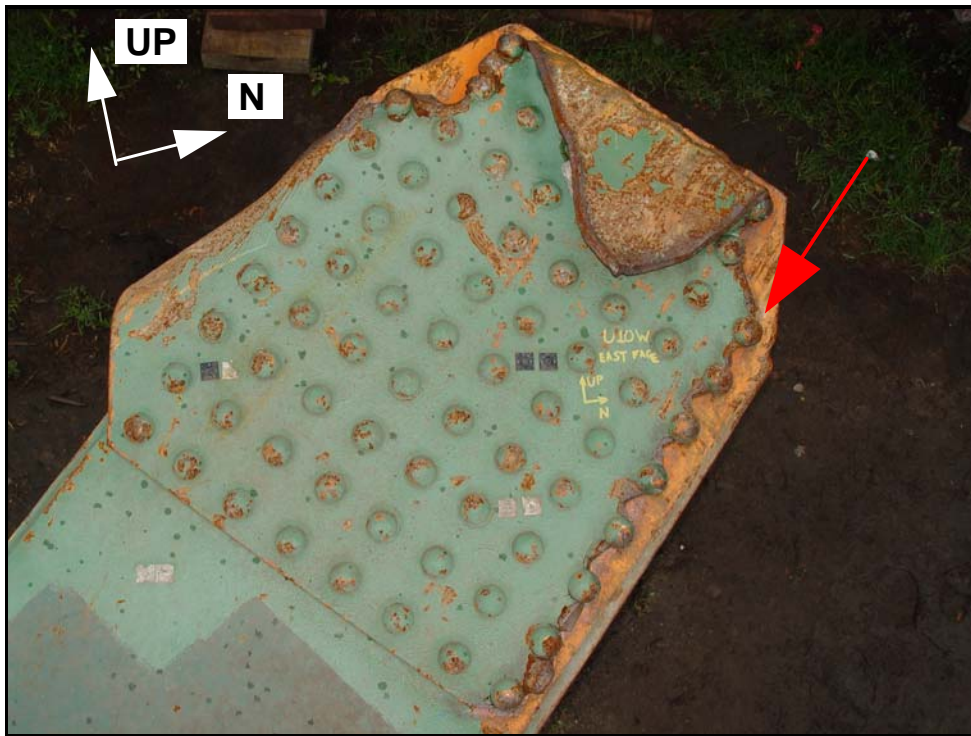
The portion of the east gusset plate of node U10W received for laboratory examination was cut from a larger piece of this gusset plate, which was attached to the U10W end of diagonal L9/U10W. The larger piece was held to the diagonal with rivets, as shown in figure 1. The east gusset plate was fractured along the lower/north row of rivet holes for the rivets attaching the gusset plate to the upper end of the diagonal as well as elsewhere around the end of the diagonal. The rivet heads from along the lower/north edge of the rivet pattern were ground off, and the rivet shanks were partially punched through. The plate was also cut adjacent to the next row of rivets. Figure 2 shows the larger piece of the plate after removal of the rivet heads and after most of the cut had been made. After the cut was completed, the piece of the gusset plate containing the fracture was removed from other structure and sent to the NTSB Materials Laboratory for examination.

Figure 1. Overall view of the piece of the east gusset plate at node U10W attached to the U10W end of diagonal L9/U10. The arrow indicates the lower/north row of rivets.

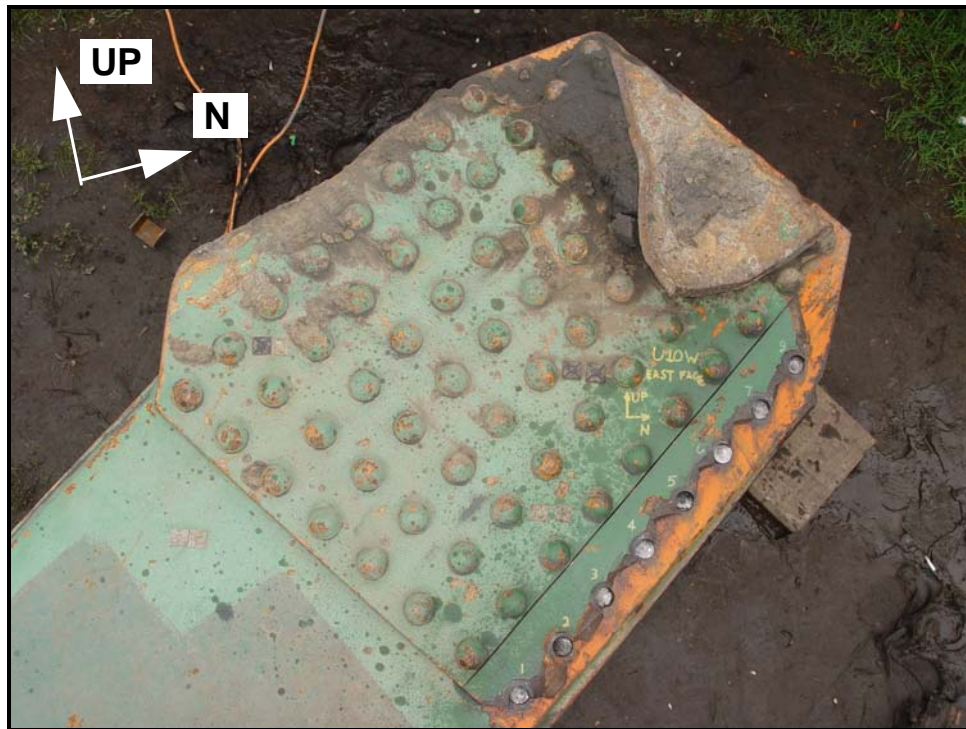
Figure 2. Overall view of the piece of the east gusset plate at node U10W attached to the U10W end of diagonal L9/U10W after removal of the rivet heads from the lower/north row of rivets and cutting adjacent to the next rivet line.

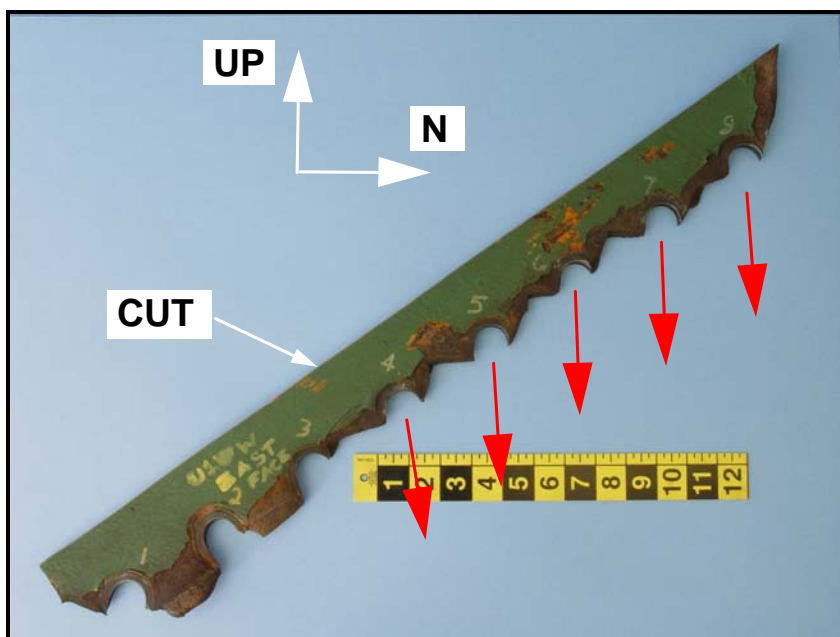
Figure 3 shows the gusset plate piece received in the laboratory. The cut location is identified. The rivet holes had been labeled on-site, starting with 1 at the lower/south end and ending with rivet hole 8 near the upper/north end.

The gusset plate piece had minor residual bending deformation along its length from rivet hole 6 to its upper end. All fractures in the gusset plate piece were typical of ductile overstress fracture. There was no noticeable out-of-plane deformation adjacent to the fracture between rivet holes 3 and 7. Figure 4 shows the fracture in this area. Below rivet hole 3 the plate was bent away from the east side plate of the diagonal, and the plate fracture ligaments between rivet holes 1 and 2 and between holes 2 and 3 were twisted.

Figure 3. Overall view of the portion of the gusset plate removed from the east gusset plate of node U10W. Arrows indicate load directions associated with the fracture at rivet holes 4 through 8.

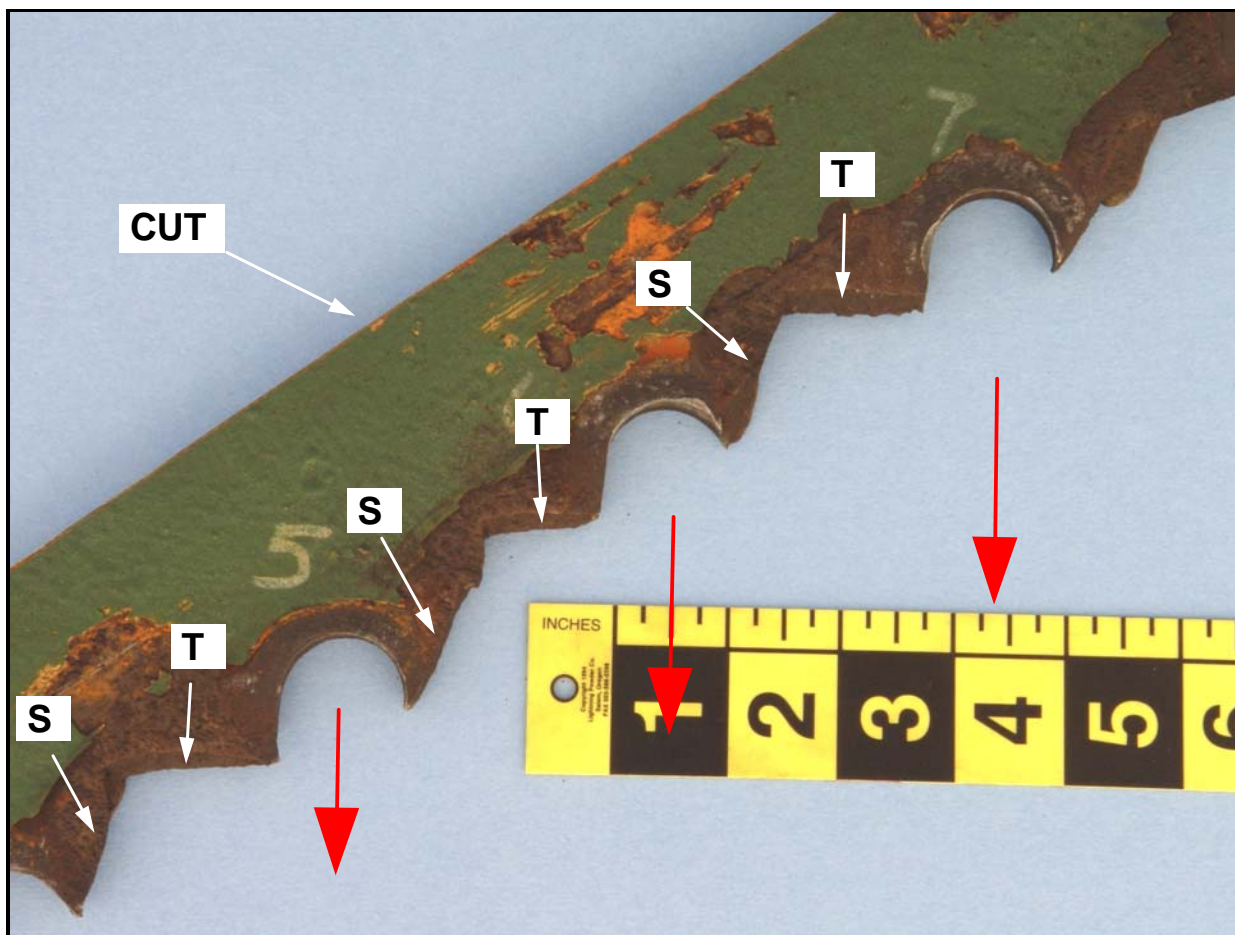
Above hole 7 the gusset plate was also bent away from the east side plate of the diagonal, slightly between holes 7 and 8 and more noticeably above hole 8. The plate showed significant necking deformation adjacent to the fracture ligaments, especially the tensile fracture areas as described below.

As can be seen in figure 4, from hole 3 to hole 8, the fracture profile between the holes had a step-like pattern, with a horizontal ligament and a vertical ligament. The vertical ligaments intersected the lower rivet holes tangentially, indicative of fracture under shear stresses, and the horizontal ligaments intersected the rivet holes perpendicularly, indicative of fracture under tensile stresses. Based on the deformation patterns associated with the fracture, the tensile load directions associated with the fracture from hole 3 to hole 8 was nearly vertical, approximately perpendicular to the tensile fracture ligaments, and varied slightly from hole to hole. Arrows in figure 3 and 4 indicate tensile load directions. Significant tensile elongation of the tensile fracture ligaments was noted.

Figure 4. Fracture between holes 4 and 7. Arrows "T" indicate tensile fracture areas, and arrows "S" indicate shear fracture areas in the fracture ligaments between adjacent rivet holes. Tensile loading directions are indicated by unlabeled arrows.
