NATIONAL TRANSPORTATION SAFETY BOARD

MATERIALS LABORATORY FACTUAL REPORT

Report No. 08-004

Place : Minneapolis, Minnesota
Date : August 1, 2007
Vehicle : I-35W Bridge 9340
NTSB No. : HWY07MH024
Investigator : Mark Bagnard

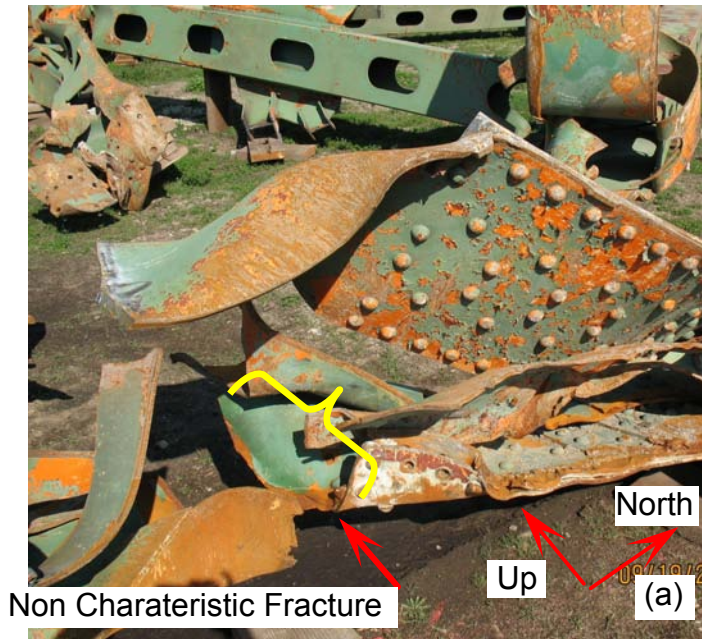
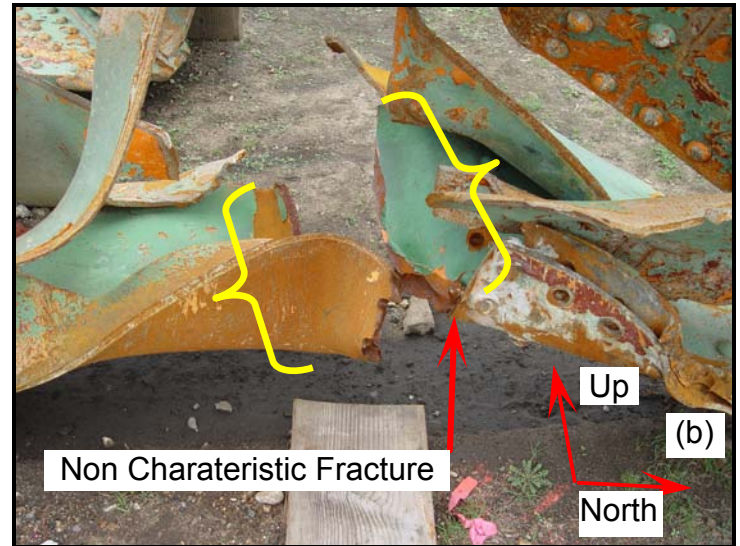
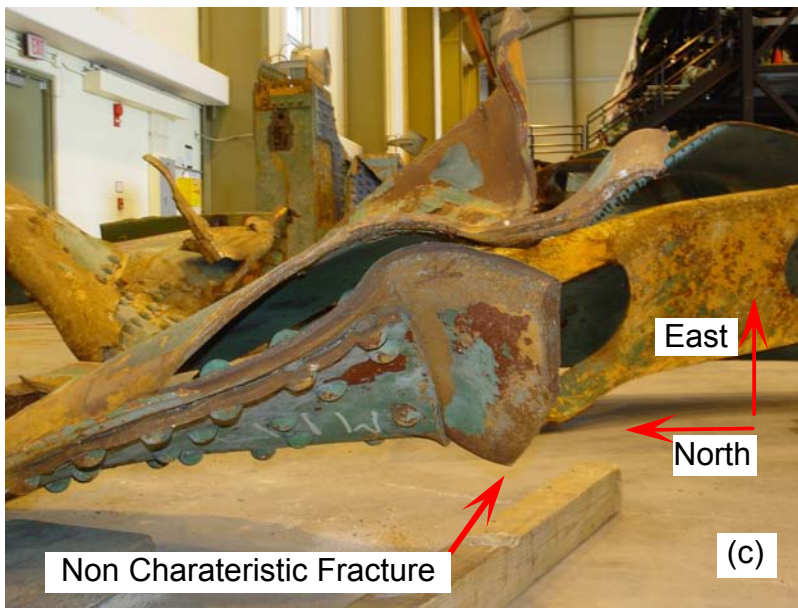
On scene examination found that the 15/16 inch thick west side plate (often referred to as a web) of member L10/L11W was vertically fractured near the southern edge of the west gusset plate of L11W node. The gusset plate and side plate were heavily deformed and damaged in the fracture area. Figure 1 displays several views of the L10/L11W west plate fracture with items of interest indicated. Some damage was established to be post fracture as indicated by contact marks or differences noted on either side of the fracture. The upper portion of the member side plate contained a large "S" bend indicative of compression buckling that extended across the fracture location (see figure 1 (c)).

Figure 1--Several views of the fracture (yellow brackets) through the as-recovered west side plate from member L10/L11W with the location of the non charateristic fracture region identified.

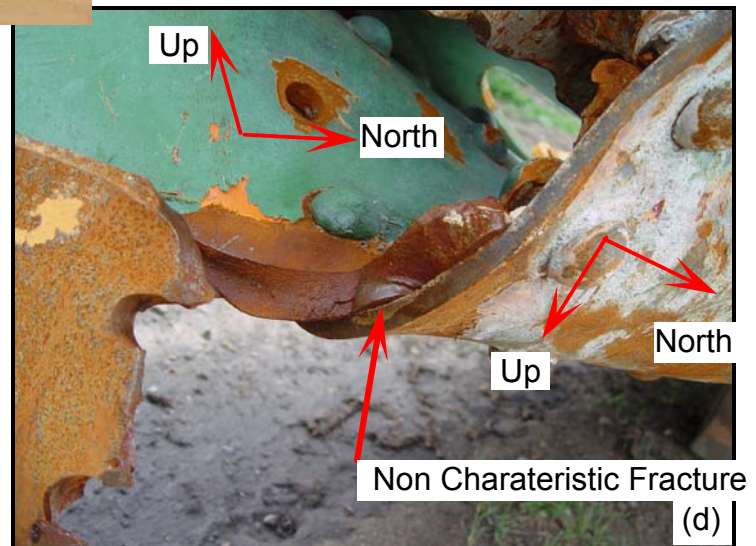
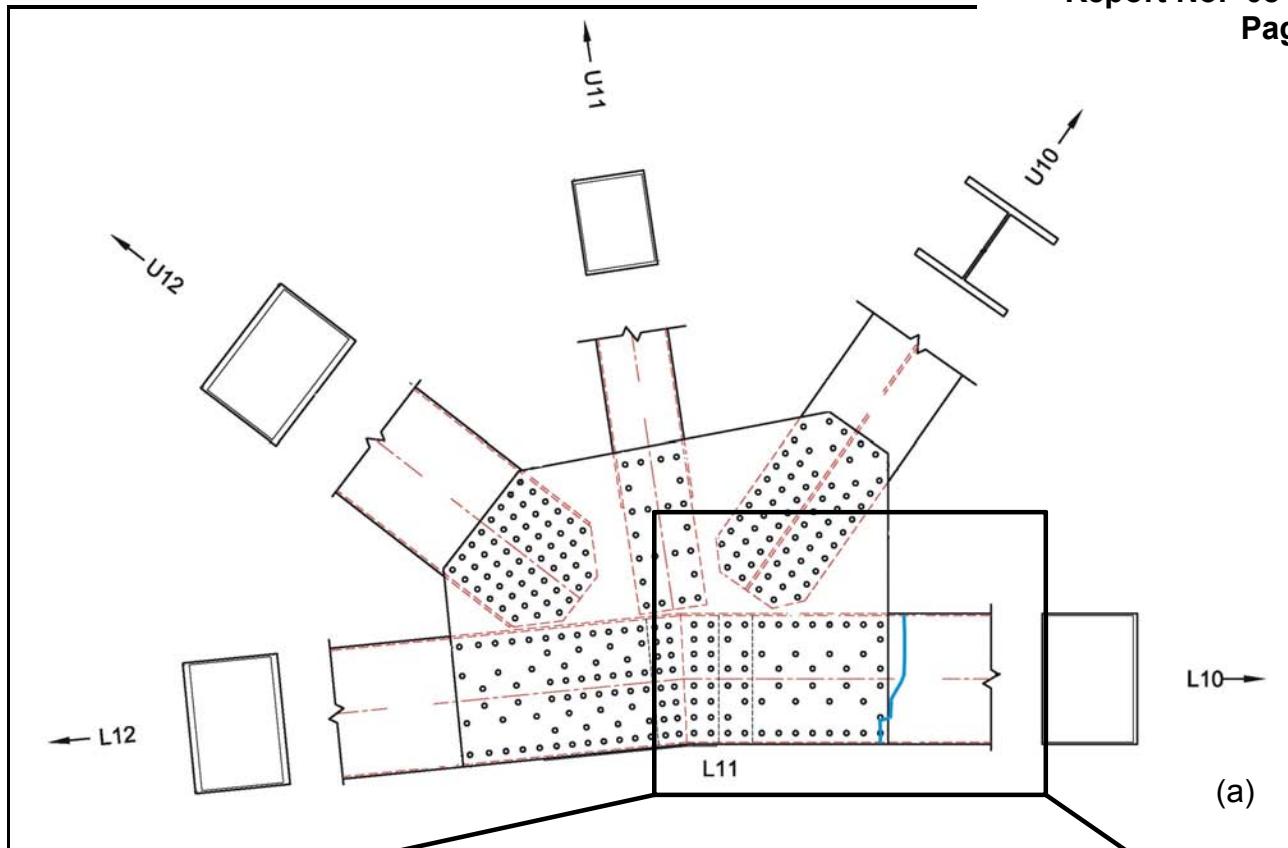
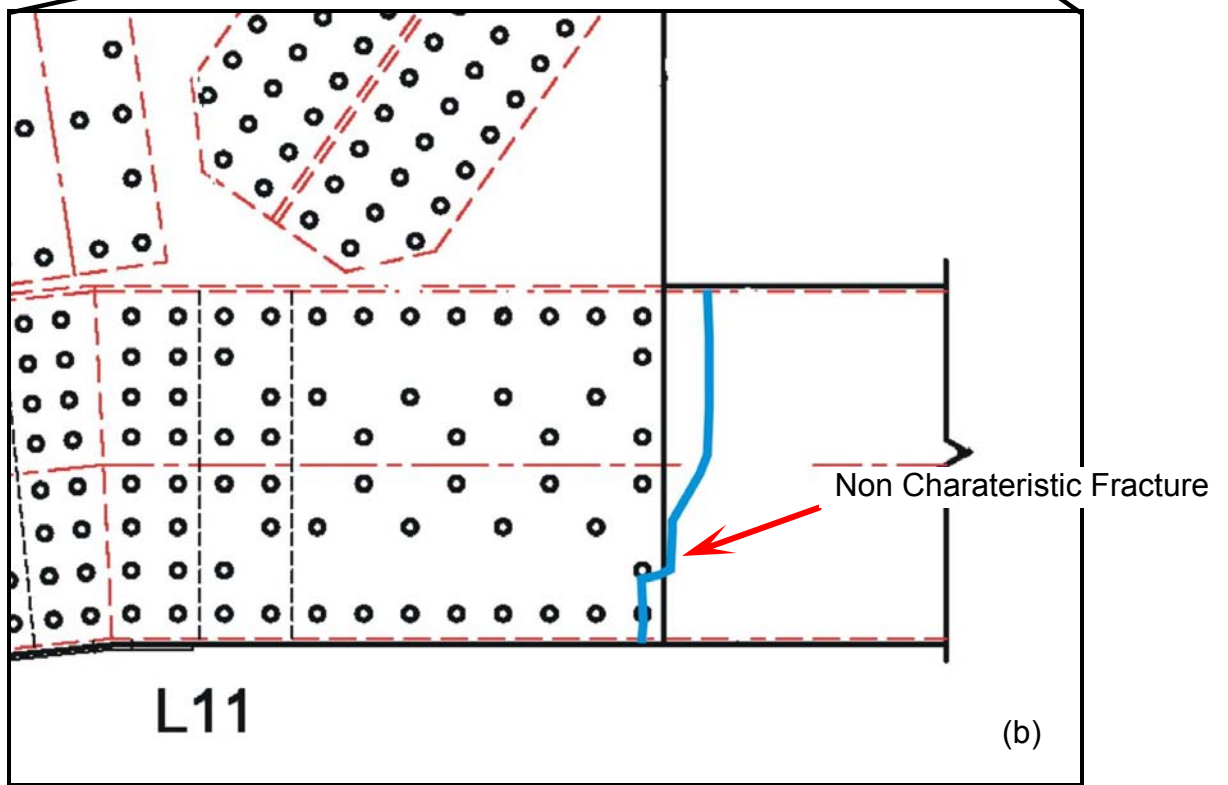
The majority of the fracture in the side plate displayed brittle features with chevron markings indicating propagation from the lower region of the plate upward. The brittle portion of the fracture initiated at a smooth textured, 1 ½ inch long, semi-elliptical region of the fracture that had non-characteristic features (features not typical of brittle or ductile fracture). This region was located approximately 9 inches above the lower edge of the member, approximately in line with the 3rd horizontal row of gusset to member rivets (counting from the lower edge of the member). Below this area the fracture was ductile with deformation indicative of in-plane tension loading and passed through the southern most rivet holes of the first two rivet rows. Figure 2 contains illustrations showing the approximate fracture location on the west plate of the member with the location of the non-characteristic fracture indicated.

Figure 2--Illustration of the fracture path in the west side plate of member L10-L11W. Approximate fracture path shown in undeformed member. Entire node in (a) and fracture area in (b) viewed looking east at the west face of node L11W. The approximate location of the non-characteristic fracture is denoted in (b).

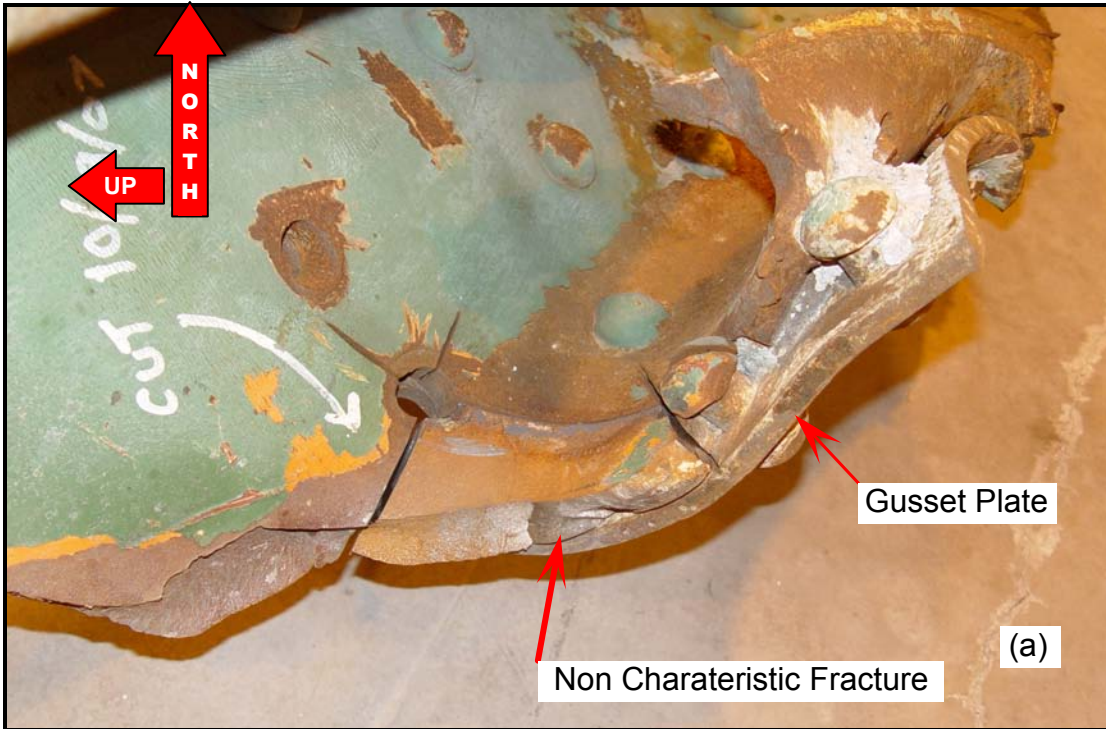
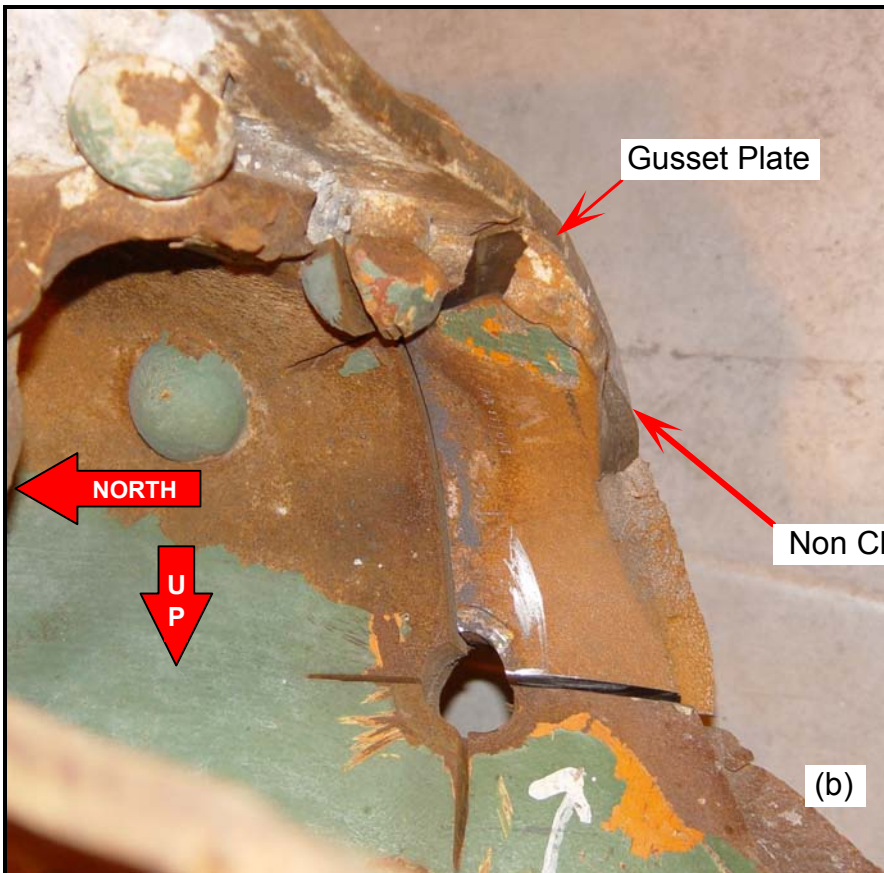
Both faces of the side plate fracture were partially obscured with red rust deposits when recovered and were sprayed with clear lacquer to reduce further degradation. The north face of the side plate fracture had less damage than the south face of the fracture. A trapezoidal shaped piece was cut from north side fracture of the west side plate of L10/L11W containing the non-characteristic fracture area and portions of the surrounding fracture for detailed examination at the NTSB Materials Laboratory. The removed section is shown in figure 3 placed in its original location in the west plate.

Figure 3--Two views of the west side plate with the removed section in place. View (a) looking generally north and west, view (b) generally west.

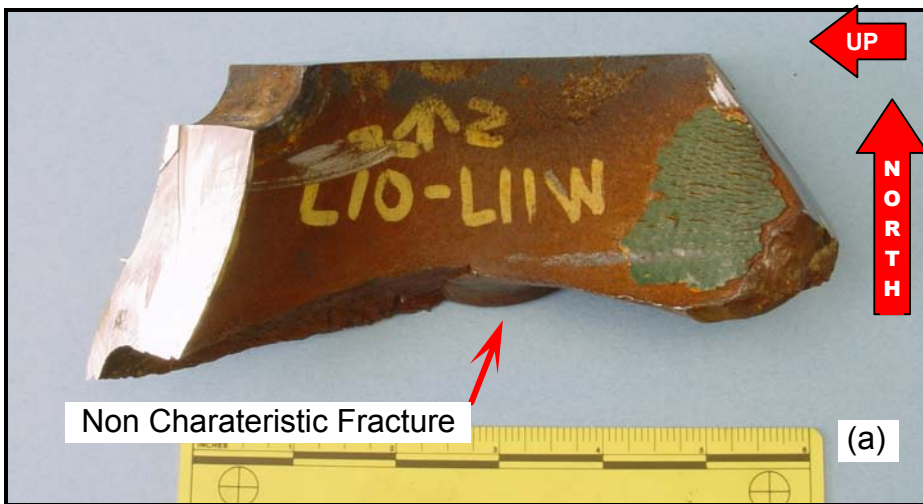
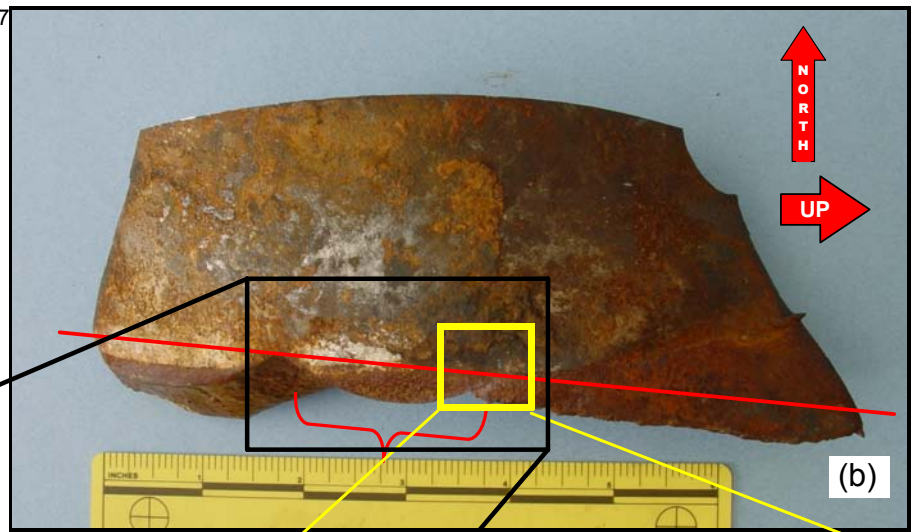
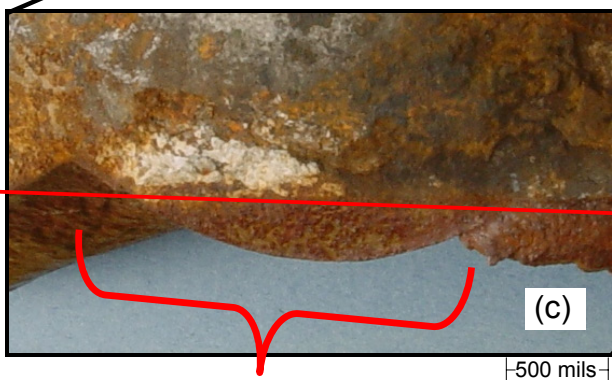
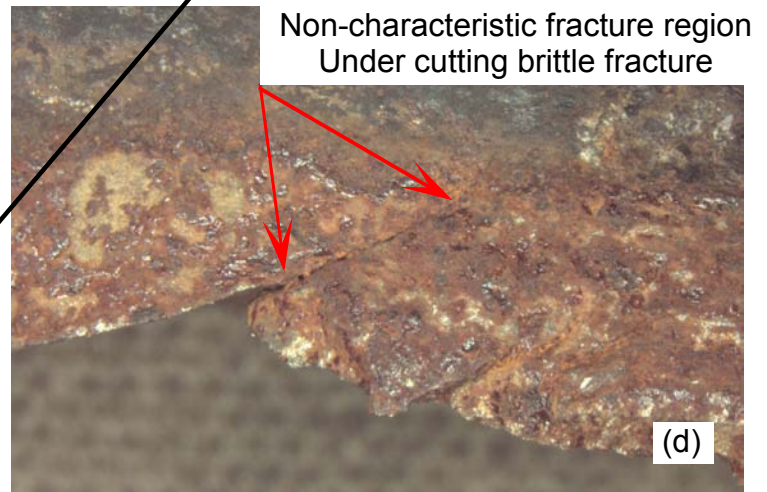
Figure 4 displays the east and west faces of the removed piece with the approximate southern edge of the west side gusset plate denoted by the red lines on views (b) and (c). The piece was cleaned with acetone to remove the lacquer and loosely adherent deposits and further cleaned with soap and water and by repeated applications and removal of acetate tape.

A visual examination of the main portion of the north face revealed that the non-characteristic fracture area extended slightly south of the south edge of the gusset plate. Because the area was curved in the vertical direction similar to a parenthesis “)” facing north the upper and lower ends were slightly north of the south edge of the gusset plate. The upper end of the area also under cut the brittle fracture region as shown in figure 4 (d) and was not exposed on the fracture face.

Figure 4--Views of the east (a) and west (b) faces of the piece removed from L10/L11W, with enlargements of the west face showing the profile of the bracketed non characteristic feature (c) and the feature undercutting the brittle fracture (d).

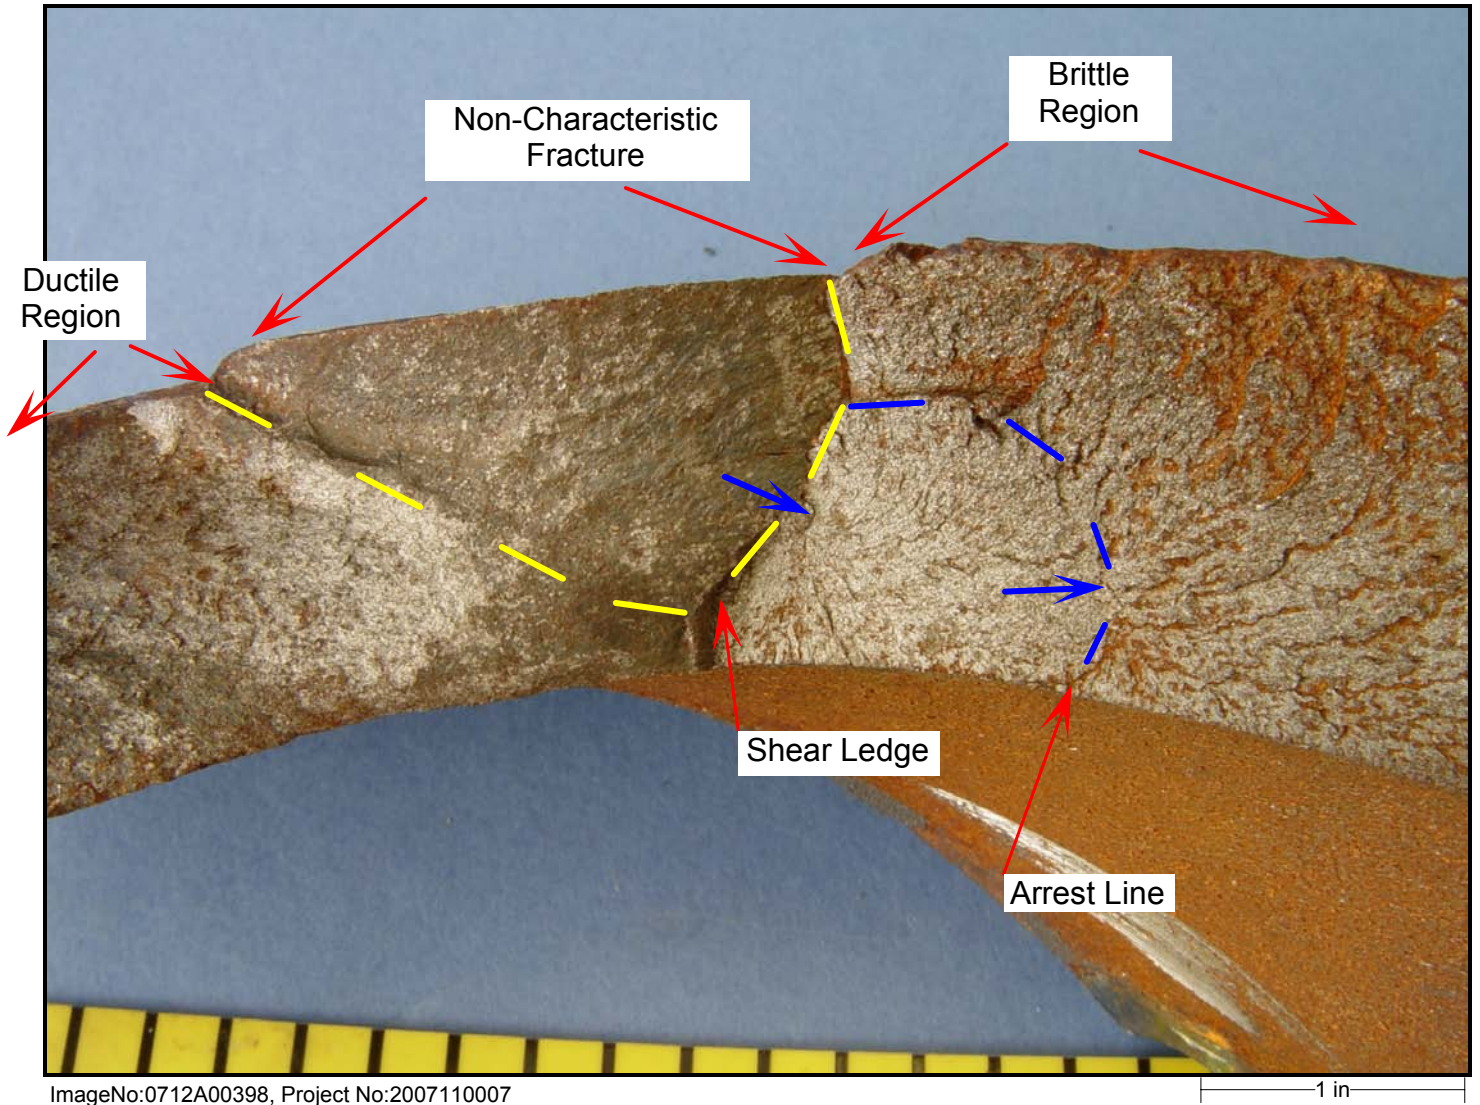
Optical viewing of the cleaned north fracture face revealed three distinct regions, as indicated in figure 5. The non-characteristic fracture area had a characteristic brittle fracture region above it and a characteristic ductile fracture region below it. The non-characteristic fracture area, outlined in yellow on figure 5, was darker in appearance than the regions on either side. It was relatively smooth and roughly triangular or semi-elliptical in shape. The feature penetrated about 0.75 inch into the 15/16 inch side plate and was about 1.5 inch long measured vertically on the west face of the plate.

The plane of the non-characteristic fracture area was generally normal to the surface of the side plate. Where as, the brittle fracture region was tilted to the normal such that on the north fracture face, the western edge of the brittle fracture overlaid the non-characteristic fracture area (shown as the crack in the surface in figure 5 (d)) and undercut the area at the eastern edge. The undercut portion of the non-characteristic fracture area was broken away on the northern fracture face leaving a shear ledge at the interface, as indicated in figure 5.

Figure 5--The cleaned north fracture with the three regions and other features identified.

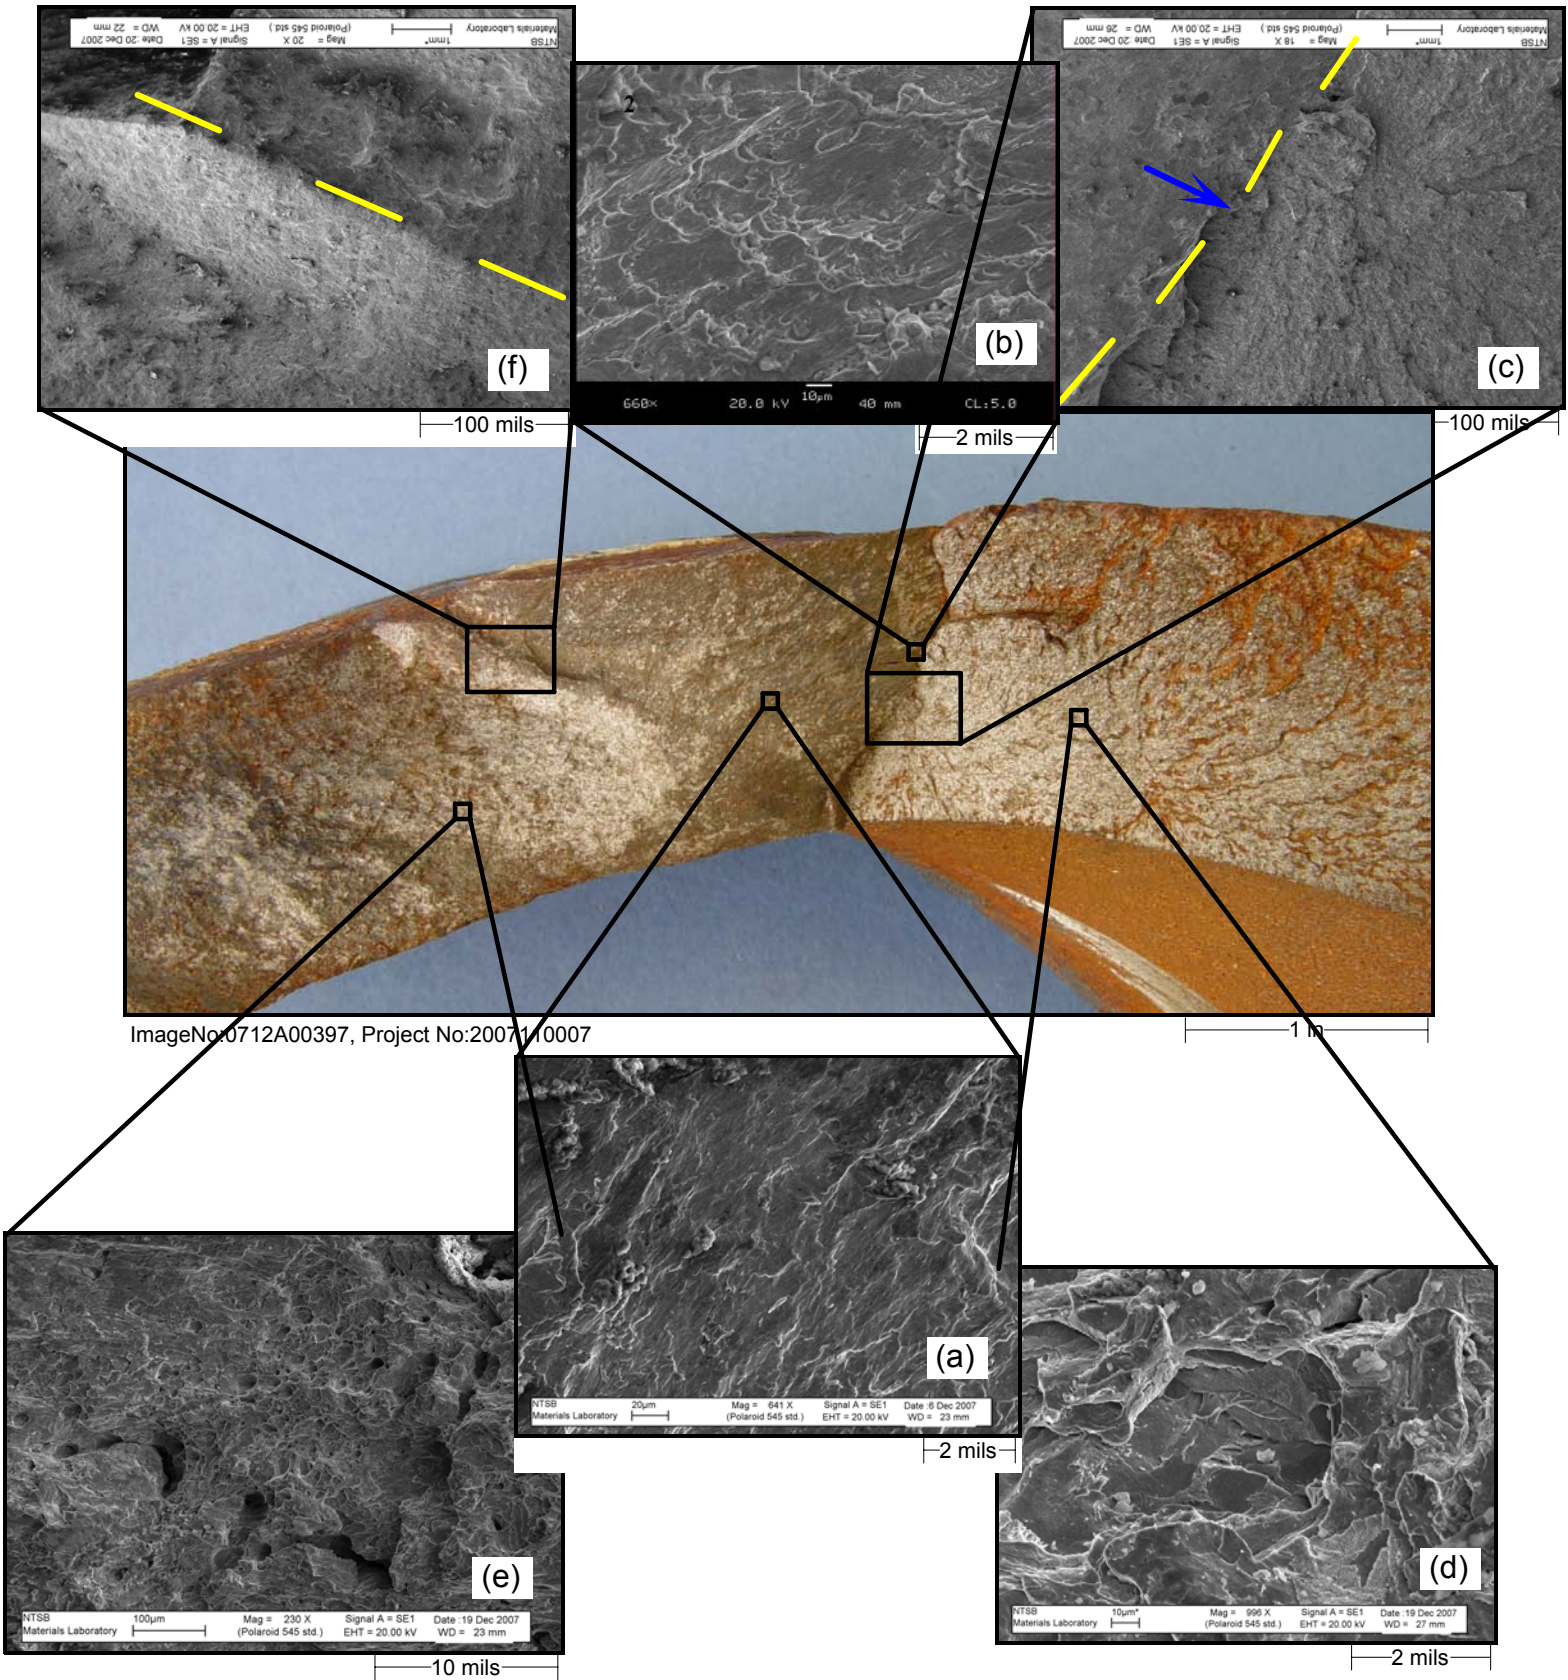
Close optical and scanning electron microscope (SEM) inspections confirmed an oxidized surface with nondescript fracture features on the surface of the area. At higher magnifications the majority of the area appeared to have an undulating surface consistent with fracture face recontact damage, as shown in figure 6 (a). Isolated areas with the appearance of ductile shear dimples were found near the periphery of the non-characteristic region, as shown in figure 6 (b).

Figure 6--Optical view of the fracture with SEM satellite views showing features in the indicated areas. Larger SEM views are displayed in the following pages.

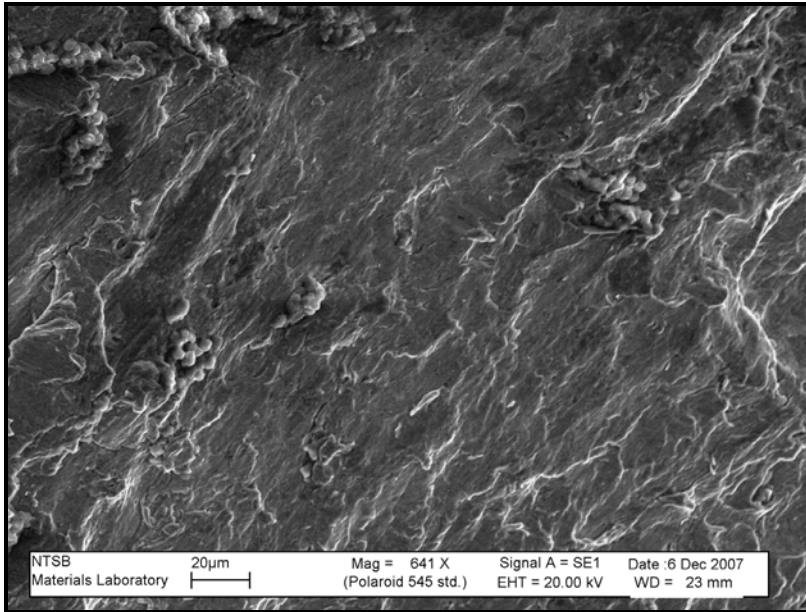
Figure 6 (a)--SEM view of the surface of the nondescript feature.

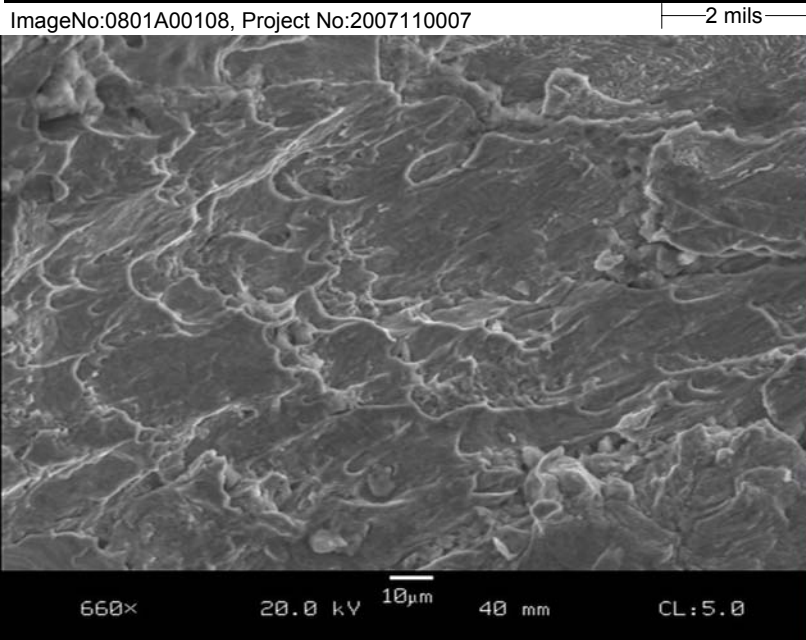
Figure 6 (b)--SEM view from the non-characteristic area show the appearance of ductile shear dimples.

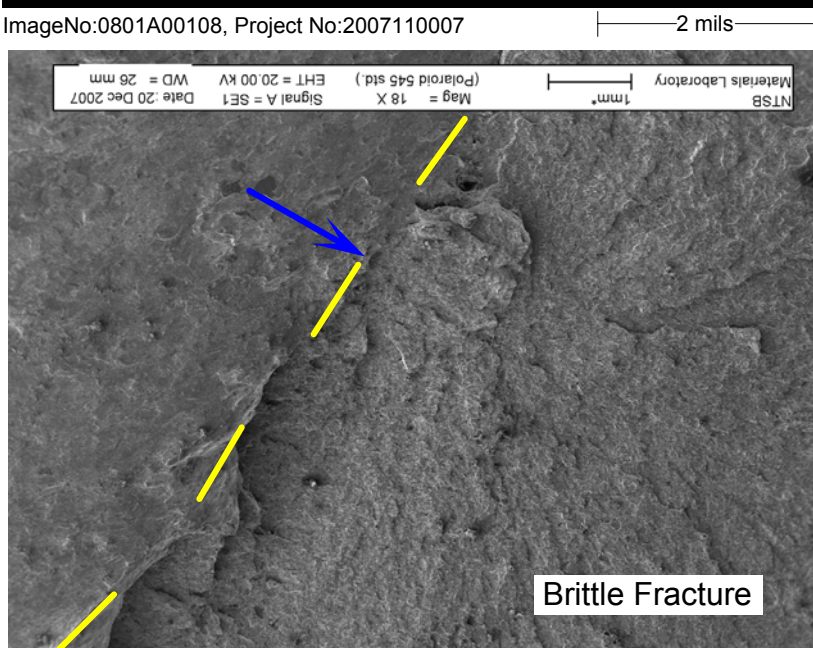
The brittle fracture region above the non-characteristic fracture area displayed chevrons, fracture traces and a rough, faceted surface typical of brittle fracture in steels. The fracture features indicated that the brittle fracture initiated in the middle of the plate at the edge of the non-characteristic fracture area and propagated vertically upward (left-most blue arrow in figure 5, and figure 6(c)). A curved line (dashed blue line in figure 5) was visible in the brittle region about 1 inch above the initiation, indicating a momentary arrest of the fracture before re-initiation (right-most blue arrow in figure 5) and propagating upward through the remaining plate section. At higher SEM magnifications, the fracture surface was predominately transgranular cleavage with small isolated areas of ductile dimples, as shown in figure 6 (d)

Figure 6 (c)--SEM view showing the initiation (arrow) of the brittle fracture at the edge (dashed line) of the nondescript feature.

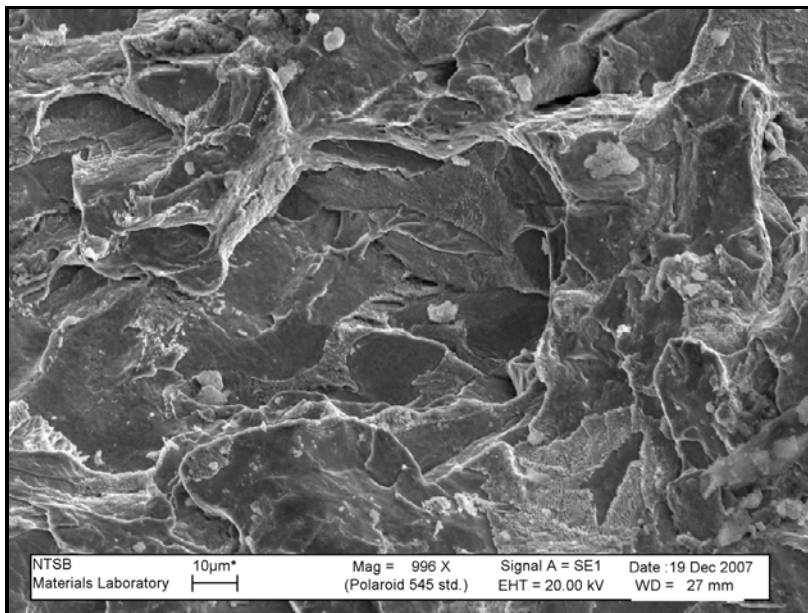
Figure 6 (d)--Typical cleavage features in the brittle region.

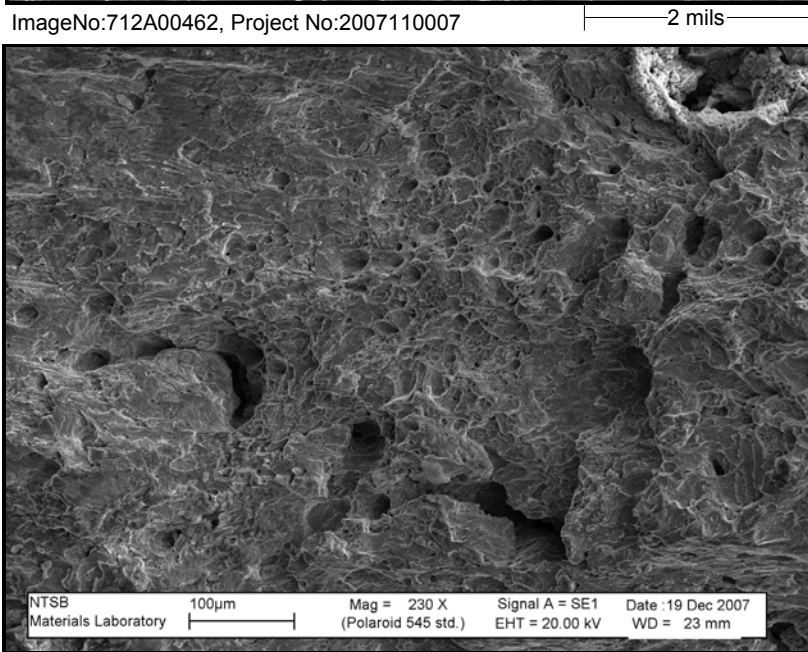
The ductile region below the non-characteristic fracture area had a relatively rough matte gray surface typical of ductile overstress fractures in steel. SEM viewing revealed ductile dimples, as show in figure 6 (e) The overall plane of the ductile fracture was slightly offset to the non-characteristic fracture area and made an abrupt transition to intersect the non-characteristic fracture area as shown in figure 6 (f).

Figure 6 (e)--Typical ductile dimples in the ductile overstress region.

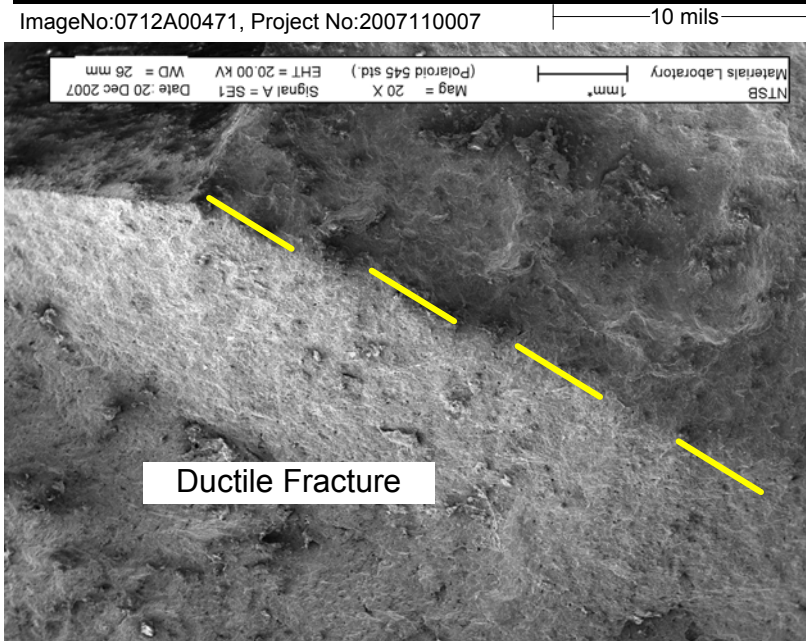
Figure 6 (f)--The abrupt transition from the ductile fracture, left, to the nondescript feature, right. Intersection indicated by the dashed line.

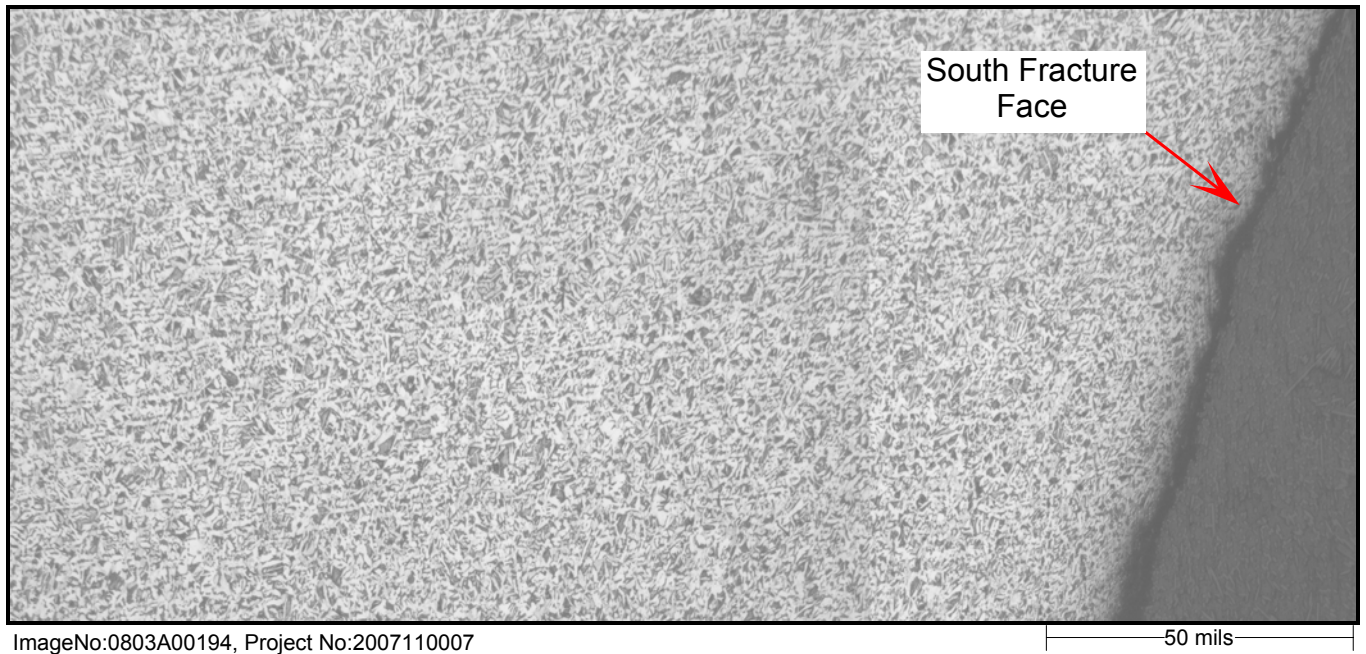
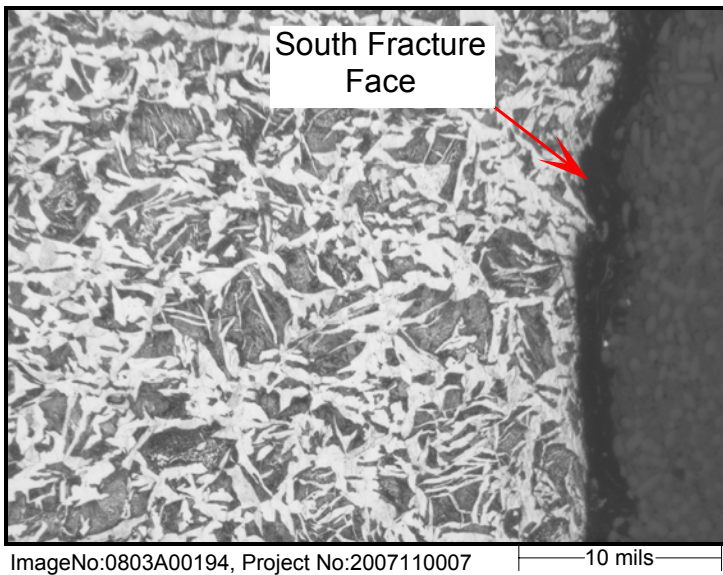
Two metallographic cross sections were cut longitudinally through the west side plate of member L10/L11W. One was through the non-characteristic fracture region of the south side fracture. The other was located about 1 inch north of the fracture face, in line with the non-characteristic fracture region. When polished and 2% Nital¹ etched a slightly banded microstructure of ferrite and pearlite was revealed consistent with rolled low carbon steel, as shown in figure 7. The indicated rolling direction was in the north-south orientation of the member. The microstructure was consistent through out the specimens with no indications of surface decarburization or other anomalies such as welding.

Figure 7--The microstructure of the west plate adjacent to the south side of the non-characteristic fracture. Normal rolled ferrite and pearlite microstructure throughout.
