# NATIONAL TRANSPORTATION SAFETY BOARD

MATERIALS LABORATORY FACTUAL REPORT

Report No. 08-031

Place : Minneapolis, Minnesota  
Date : August 1, 2007  
Vehicle : I35W Highway Bridge  
NTSB No. : HWY07MH024  
Investigator : Mark Bagnard

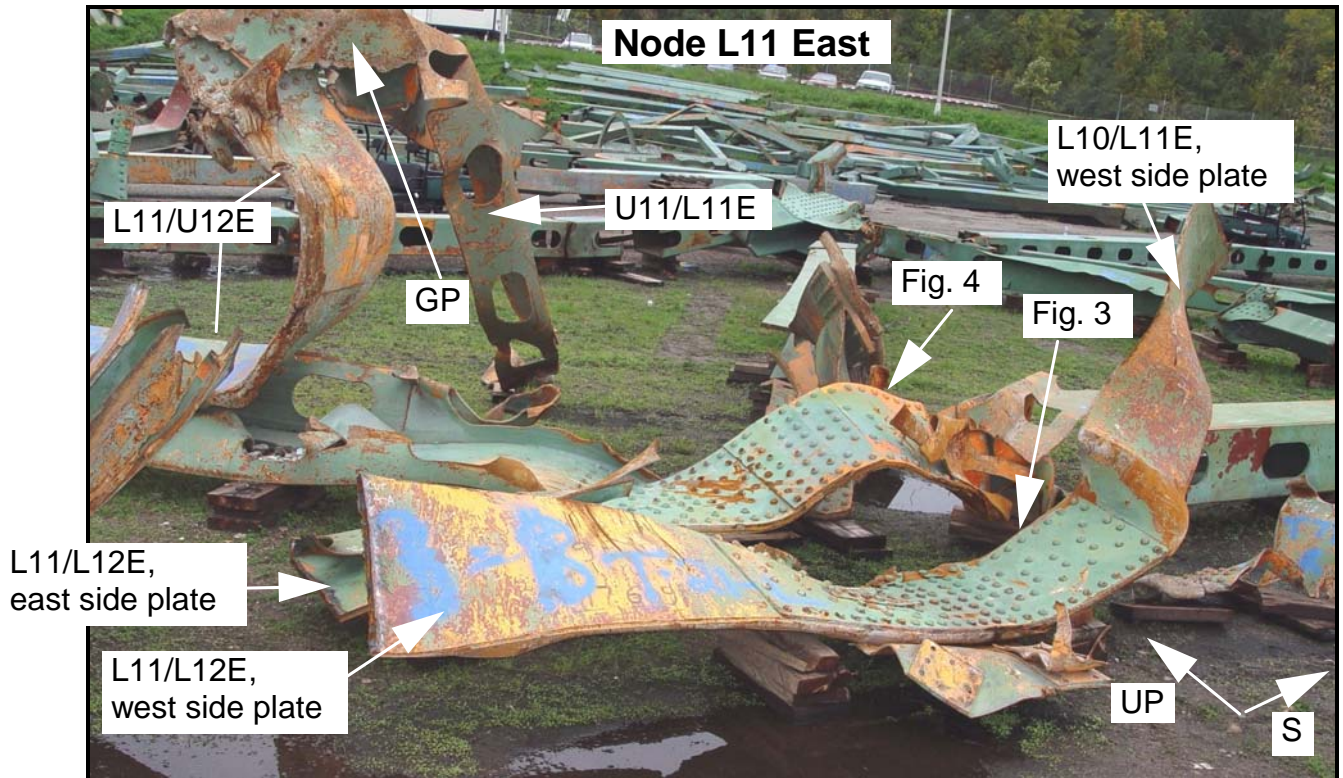
Both the east and west side plates of the lower chord members (L10/L11E and L11/L12E) remained attached to each other through intact portions of the gusset plates at node L11 East (see figure 1), but fractures in the gusset plates separated the diagonals (U10/L11E and L11/U12E) and the vertical (U11/L11E) from the lower chord members.

penetrating on the outside of the remainder of the node. The west gusset plate in the area between the compression diagonal and the vertical was not fractured, as can be seen in the upper left corner of figure 1, and this gusset plate remained attached to the west side plate of the vertical.

Figure 1. Overall view at Bohemian Flats showing the side plates of lower chord members L10/L11E and L11/L12E at node L11E. The diagonals and the vertical at this node are also visible. Arrow "GP" indicates a portion of the west gusset plate that was intact between the vertical U11/L11E and the compression diagonal L11/U12E.

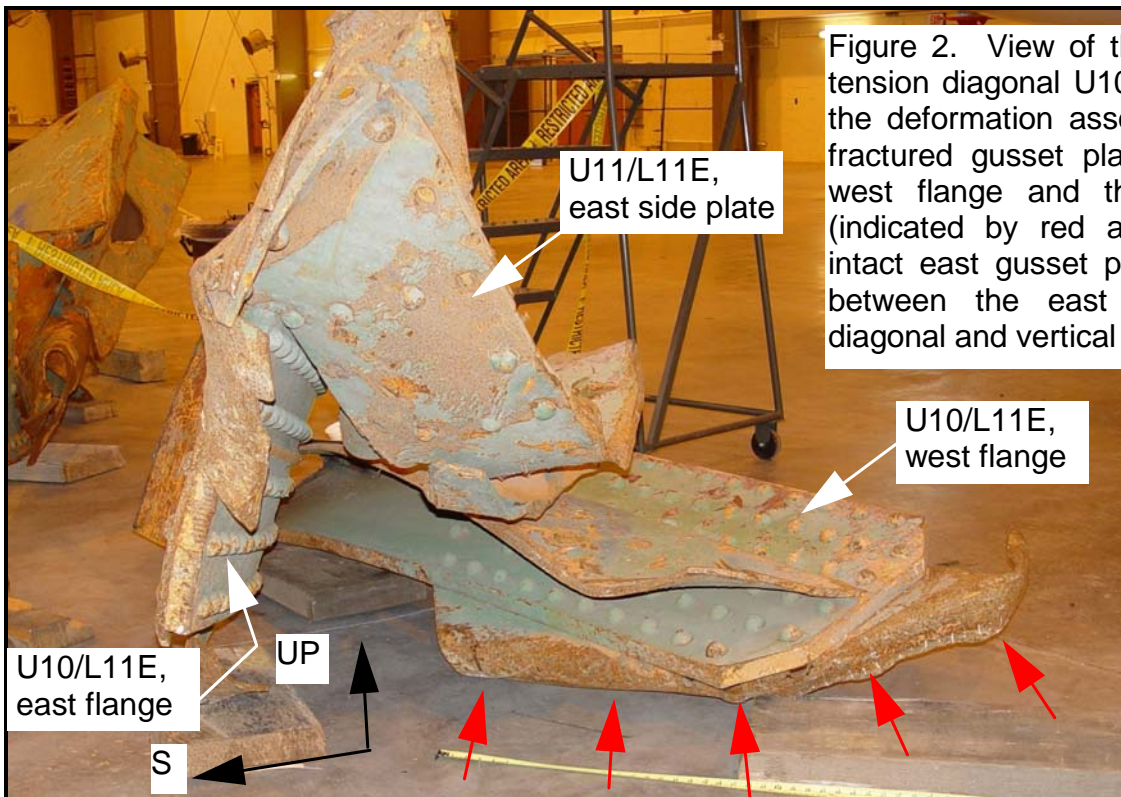
- The east gusset plate in the area between the tension diagonal and the lower chord was fractured, with part of the fracture through the line of corrosion at the top of the lower chord. The plate above the fracture folded to the west over the lower end of the east flange of the diagonal, and the plate below the fracture was pulled to the east away from the east side plate (see figure 4). Deformation patterns associated with the gusset plates in the area between the tension diagonal U10/L11E and the lower chord member clearly indicated that the diagonal translated east relative to the lower chord before the gusset plate fractured. The east gusset plate was largely intact in the area between the tension diagonal and vertical member U11/L11E (visible on the left side of figure 2).

Figure 2. View of the lower end of tension diagonal U10/L11E, showing the deformation associated with the fractured gusset plate between the west flange and the lower chord (indicated by red arrows) and the intact east gusset plate in the area between the east flange of the diagonal and vertical U11/L11E.

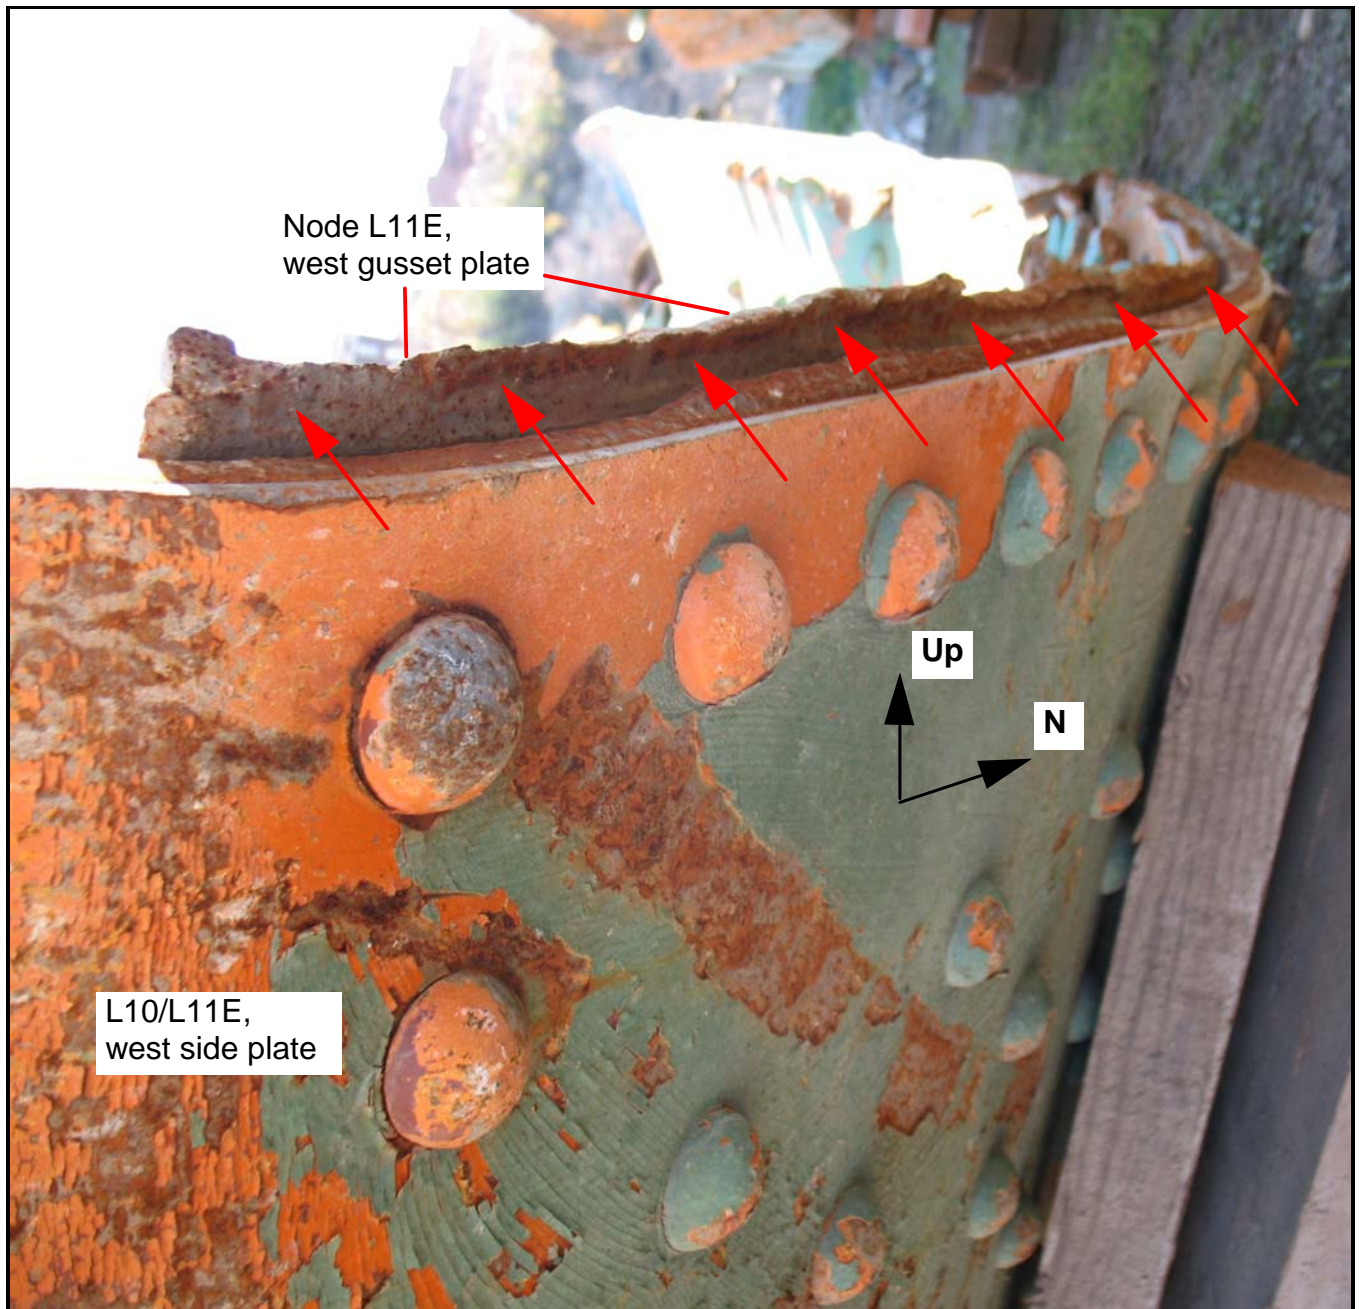
- The west gusset plate in the area between the tension diagonal and the lower chord was fractured partially along a line of corrosion at the upper edge of the lower chord. The portion of the west gusset plate below the fracture was folded to the east over the top of the lower chord, and the portion of the plate above the fracture was folded to the west away from the west flange of the U10/L11 East diagonal (see figure 2). Figure 3 shows the line of corrosion in the west gusset plate adjacent to and just below the fracture between the tension diagonal and the lower chord.

Figure 3. Arrows indicate a line of corrosion in the west gusset plate of node L11E, in the area between the tension diagonal U10/L11E and the lower chord L11/L11E. This area mates with the area indicated by the red arrows in figure 2, and the "Fig. 3" arrow in figure 1 indicates the area shown in this photograph.

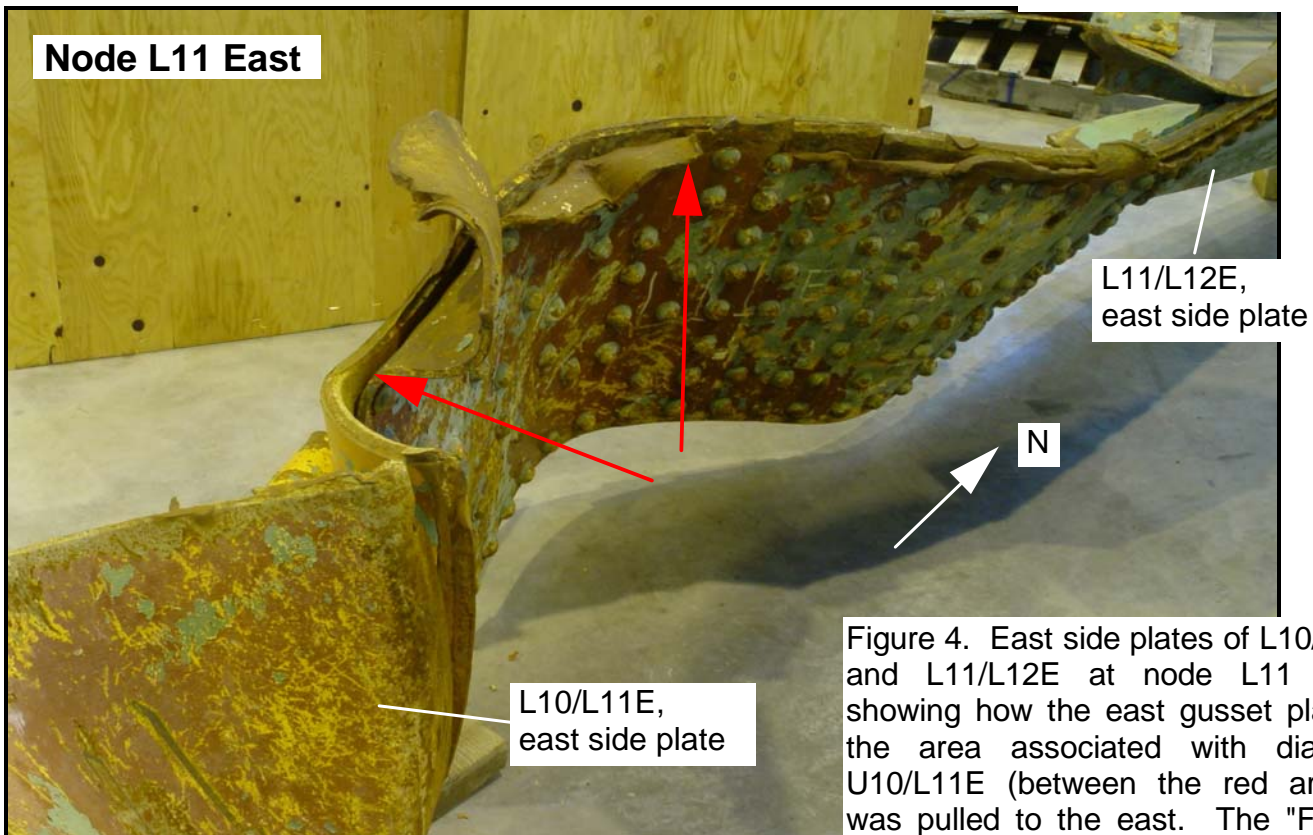
Figure 4. East side plates of L10/L11E and L11/L12E at node L11 East, showing how the east gusset plate in the area associated with diagonal U10/L11E (between the red arrows) was pulled to the east. The "Fig. 4" arrow in figure 1 indicates the direction of viewing in this photograph.

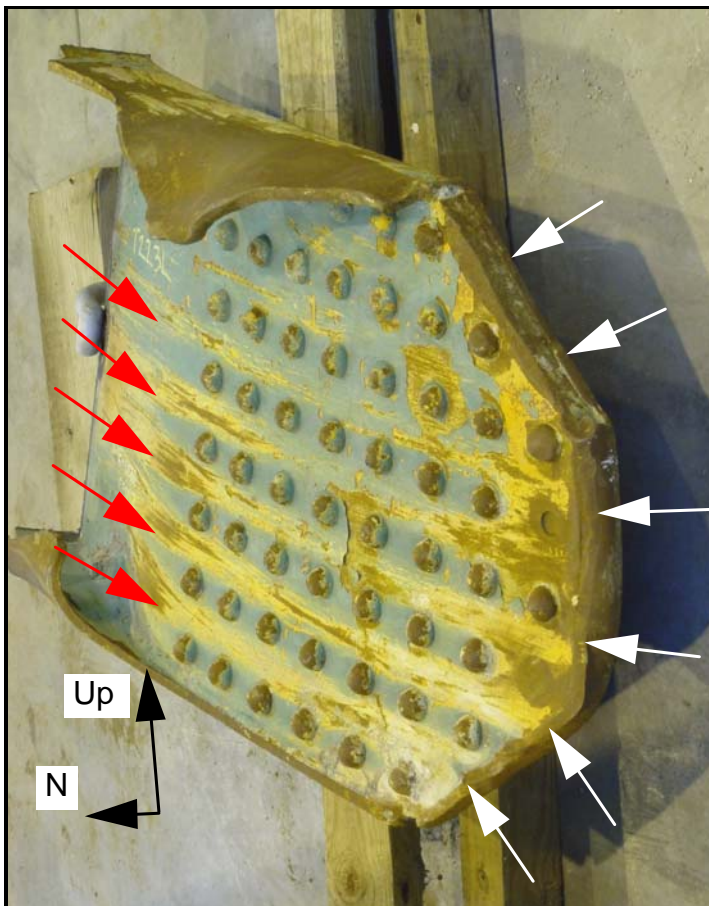
The lower (L11E) ends of both side plates of compression diagonal L11/U12E were split from each other and curled outward, away from the node. Examination of the gusset plate fractures and deformation between this compression diagonal and lower chord L11/L12E showed that the gusset plates were folded over the lower ends of the compression diagonal side plates and that there was scraping damage on the inside surfaces of the side plates. Figure 5 shows the scraping pattern on the inside of the east side plate of the compression diagonal and the gusset plate folded over the end of the side plate, consistent with the side plate passing on the outside of the node. Damage patterns on the lower end of the compression diagonal and the associated areas of the gusset plates indicated that the lower end of the diagonal split apart, with the side plates

Figure 5. Inside surface of the lower (L11E) end of the east side plate of compression diagonal L11/U12E, showing scraping marks on the inside surface (red arrows) and the east gusset plate folded over the lower end of the side plate (white arrows).

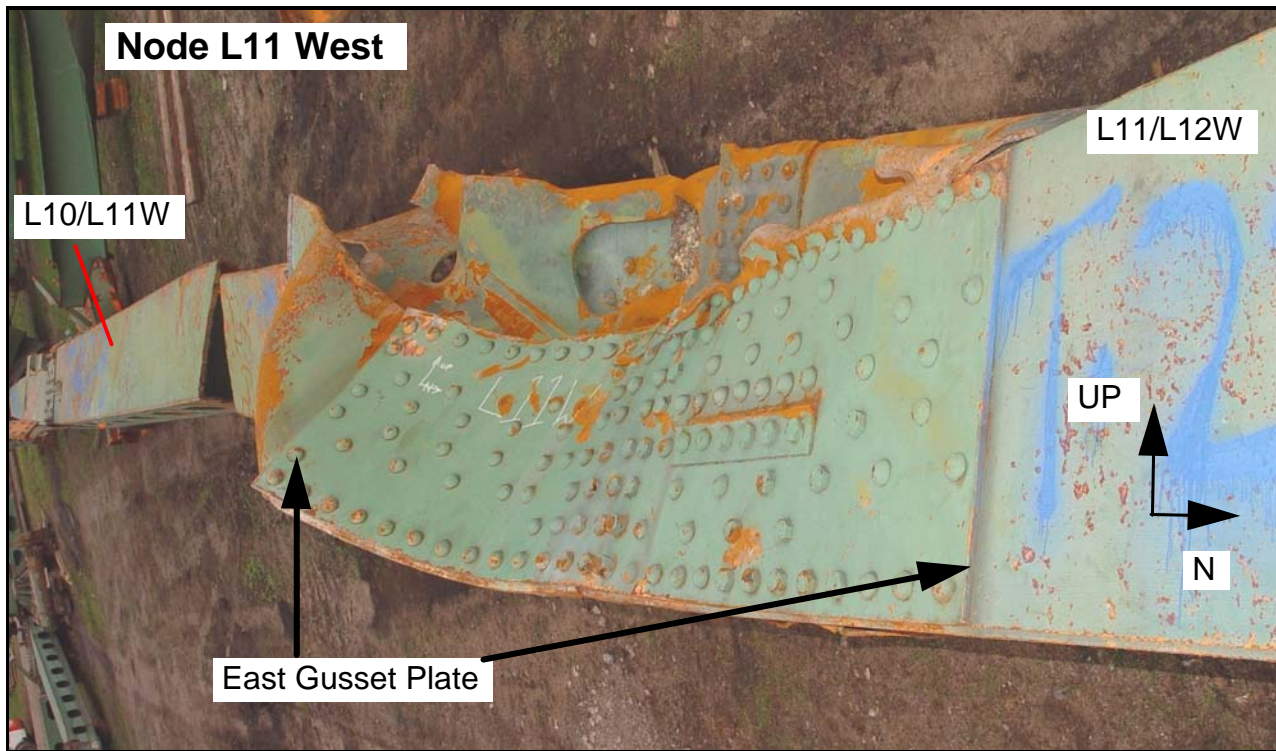
Both the east and west side plates of the lower chord members (L10/L11W and L11/L12W) remained attached to each other through intact portions of the gusset plates at node L11 West (see figure 6). The west side plate of lower chord member L10/L11W was fractured near and adjacent to the west gusset plate for node L11 West. (See Materials Laboratory Report No. 08-004 for additional information on a portion of this fracture.) Fractures in the gusset plates separated the diagonals (U10/L11W and L11/U12W) and the vertical (U11/L11E) from the lower chord members.

Figure 6. View of the lower chord members of node L11 West, viewed looking south, with the east gusset plate on top.

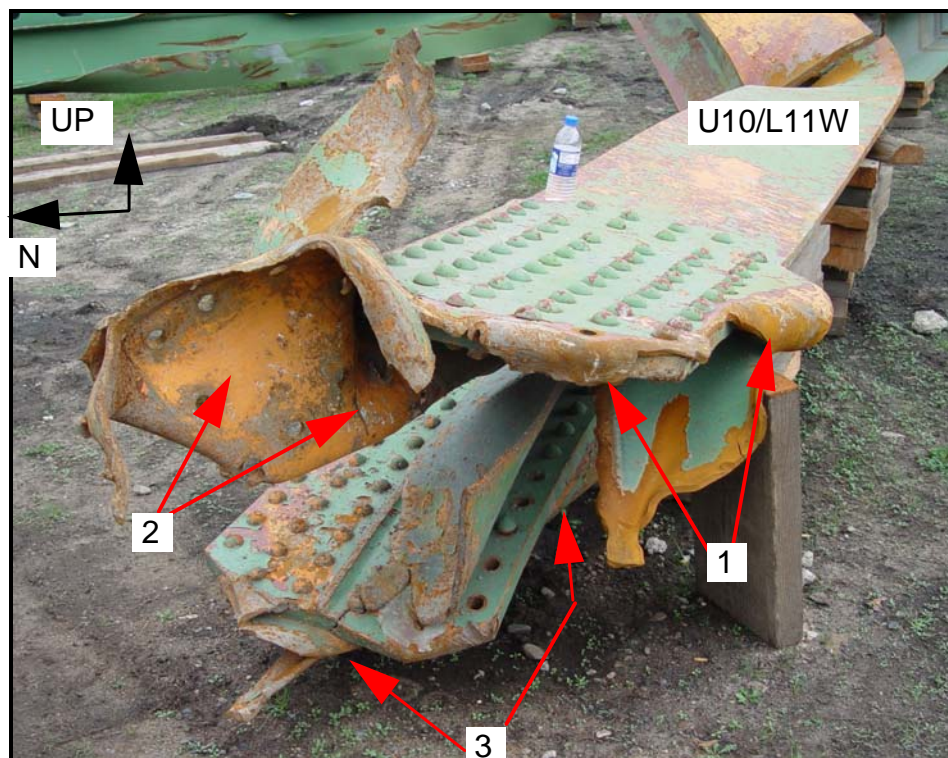
- The west gusset plate in the area between the tension diagonal and the lower chord was fractured just above the top row of rivets in the lower chord, consistent with a bending fracture as the west flange of the tension diagonal translated west relative to the lower chord. The fractured gusset plate was bent over the lower end of the west flange of the tension diagonal, as indicated by arrows "1" in figure 7. The west gusset plate was not fractured in the area between the tension diagonal and the vertical member U11/L11W, as shown by arrows "2" in figure 7.
- The east gusset plate in the area between the tension diagonal and the lower chord was fractured at the top of the lower chord. The fractured east gusset plate was peeled from the lower end of the east flange of the tension diagonal, as indicated by arrows "3" in figure 7.

Figure 7. Lower (L11W) end of tension diagonal U10/L11W, with the west flange of the diagonal facing up. View is looking primarily up and slightly east. The folded west gusset plate (arrows "1"), the intact portion of the west gusset plate between the diagonal and the vertical (arrows "2"), and the peeled east gusset plate (arrows "3") are visible.

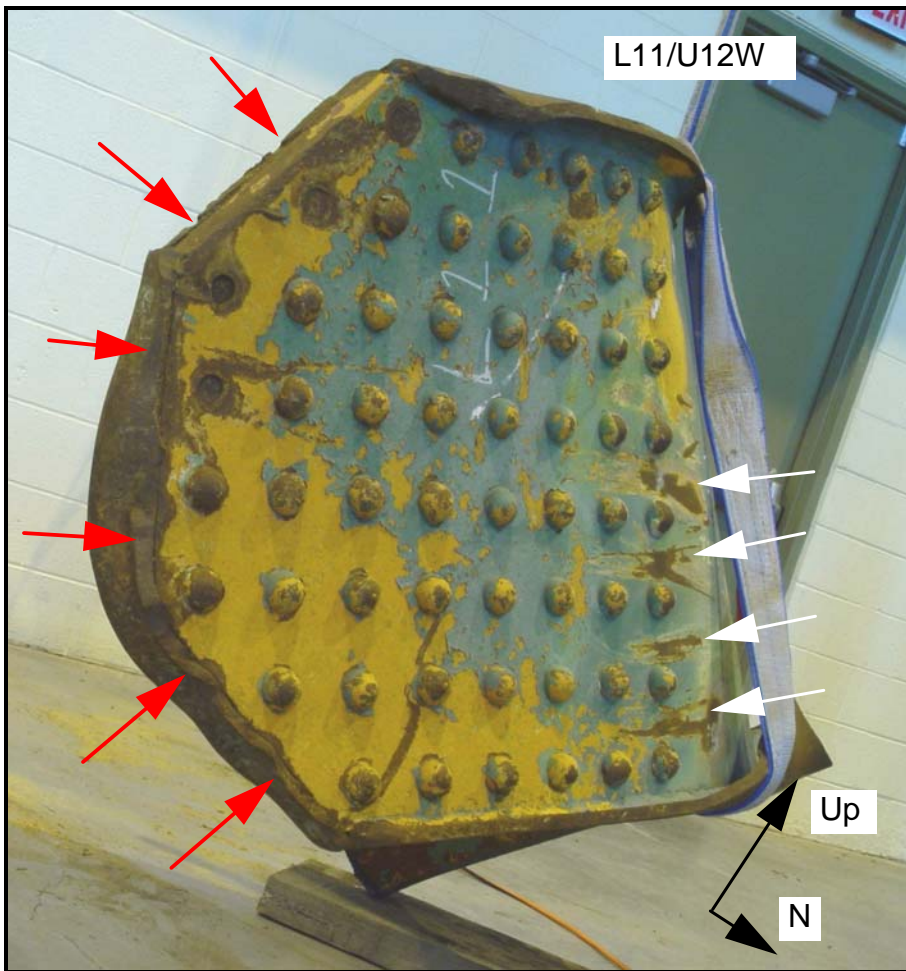
Examination of the fractured and deformed gusset plates in areas between the compression diagonal L11/U12W and the lower chord member L11/L12W and between the compression diagonal and vertical member U11/L11W indicated that the lower end of this diagonal translated west relative to the remainder of the node, with the east side plate penetrating through the node and the west side plate passing on the west side of the node. Scrape marks and damage patterns on the lower end of the compression diagonal were consistent with this motion. Figure 8 shows the scraping damage on the west side plate of compression diagonal L11/U12W.

Figure 8. Inside surface of the lower (L11W) end of the west side plate of compression diagonal L11/U12W, showing scraping marks on the inside surface (white arrows) and the west gusset plate folded over the lower end of the side plate (red arrows).
