NATIONAL TRANSPORTATION SAFETY BOARD

MATERIALS LABORATORY FACTUAL REPORT

Report No. 11-034

Place : New York, New York
Date : March 12, 2011
Vehicle : 1999 Prevost H3-45 56-Passenger Motorcoach
NTSB No. : HWY11MH005
Investigator : Jennifer L. Morrison, HS-20

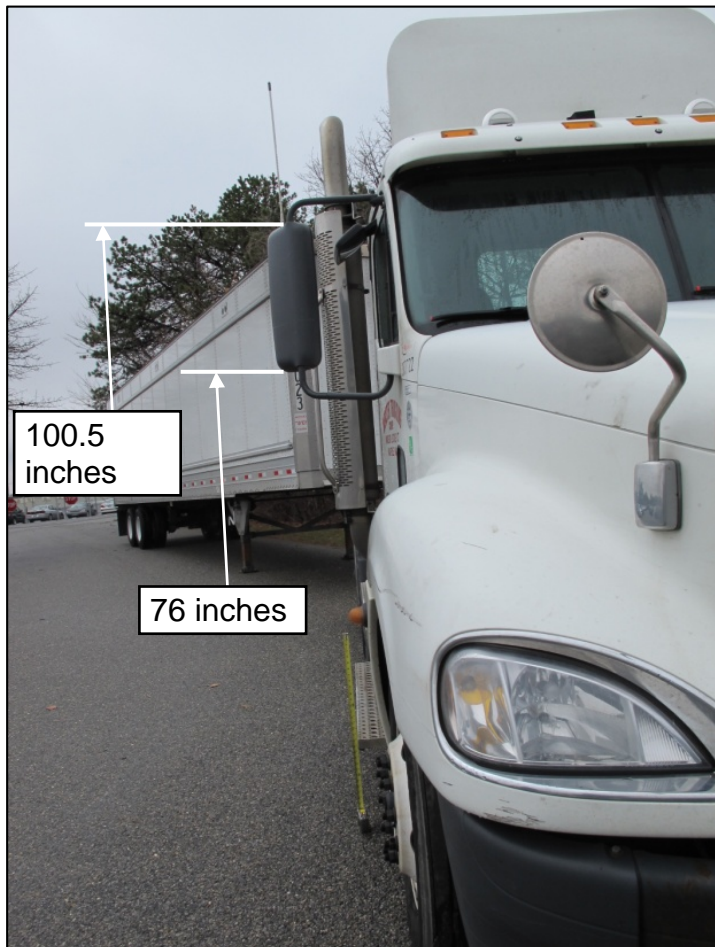
A view looking along the side of the tractor is shown in figure 2. On the right side of the tractor, the side-view mirror mounted to the door extended the furthest from the centerline of the tractor. The outer edge of the mirror was 57.8 inches from the tractor centerline. The handle on the muffler was the next furthest out at approximately 53 inches from the centerline. The outer edge of the lower step was 50.3 inches from the centerline. As shown in figure 2, the lower edge of the side-view mirror was located 76 inches above the ground, and the upper edge of the side-view mirror was located 100.5 inches above the ground.

Figure 2. View along the right side of the tractor looking toward the rear. Measurements from the ground up to the top and bottom edges of the side-view mirror are indicated.

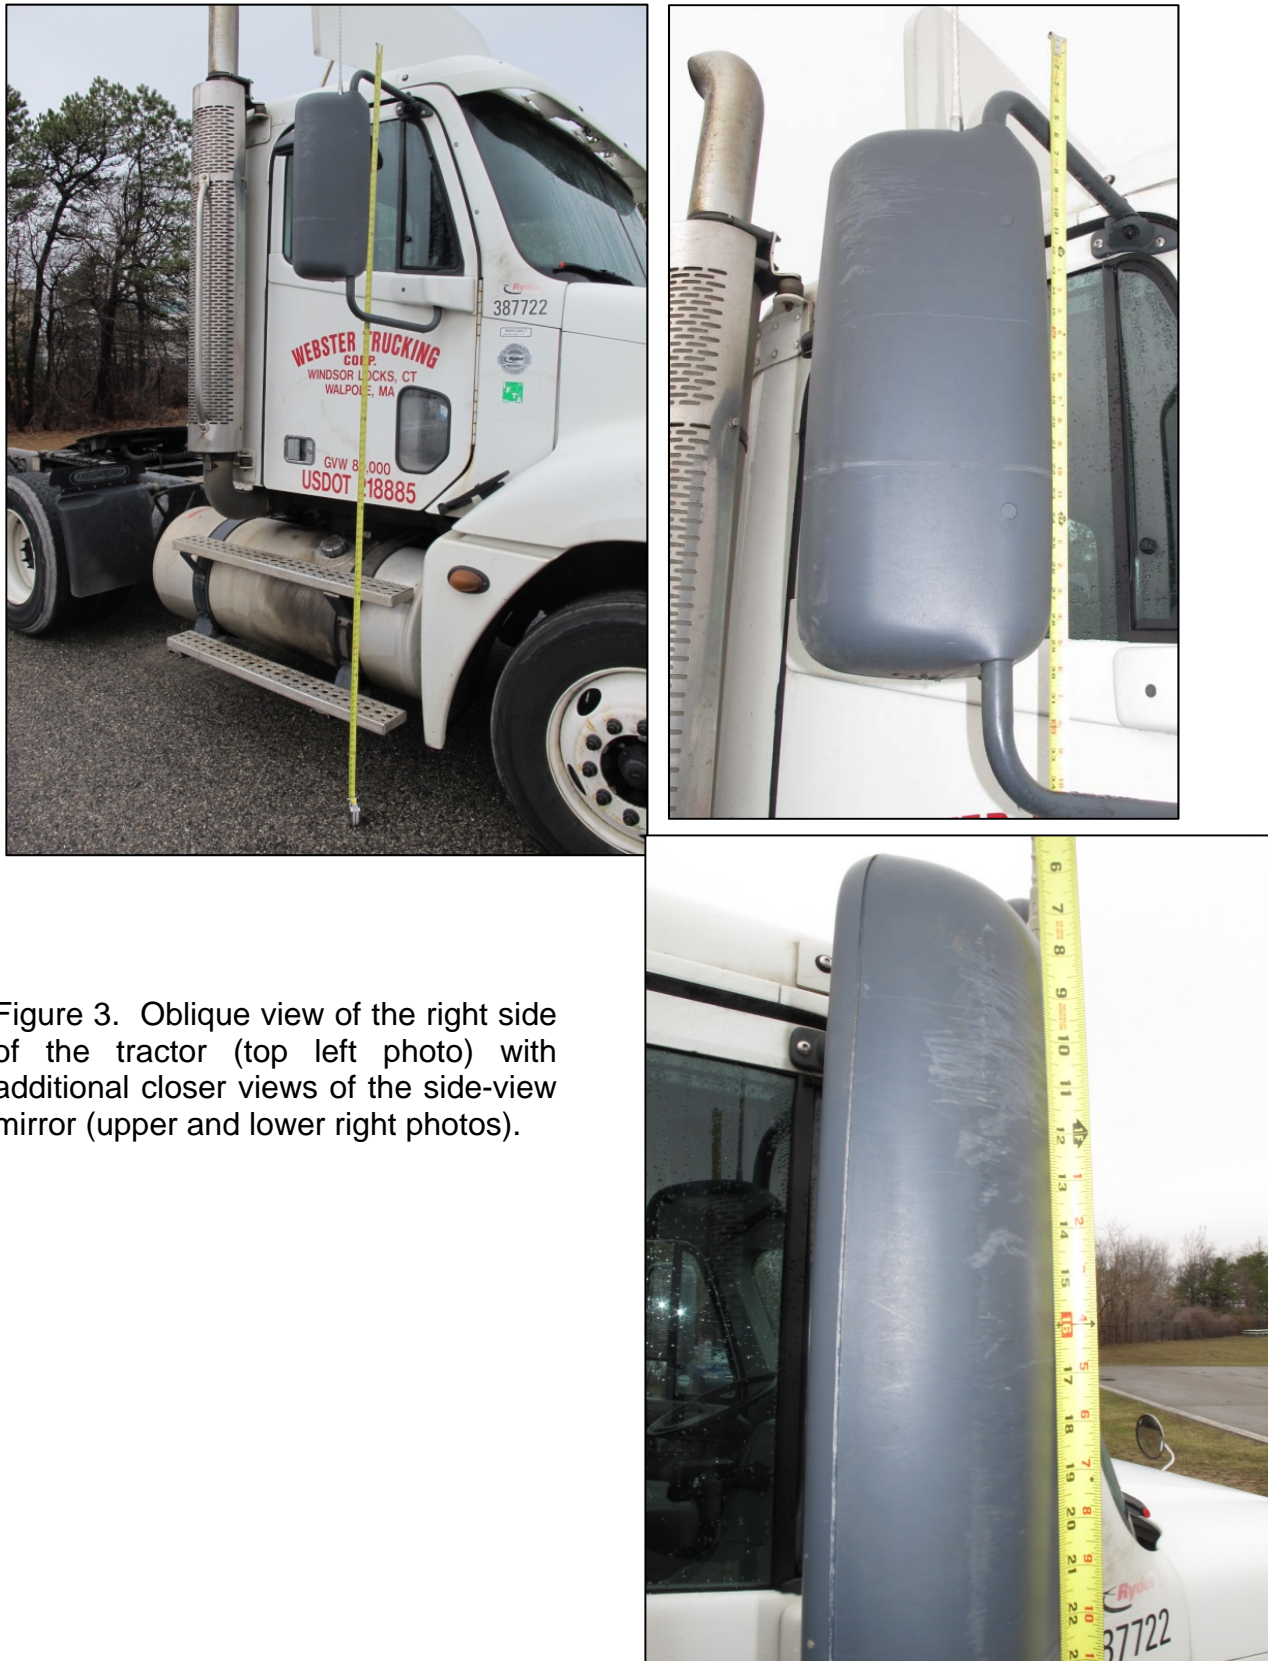
Additional views of the right rear-view mirror are shown in figure 3. Multiple scrape marks were observed on the outer edge of the rear view mirror. One mark approximately 8 inches above the lower end of the mirror extended around the mirror housing, had a consistent width, and appeared deeper around the curved edges of the mirror housing consistent with contact with an object wrapped tightly around the mirror. Other marks were generally less prominent and more varied and irregular consistent with sliding contact. The mirror was black in color, but a light green color was observed in the area of the sliding contact marks including areas near the top of the mirror shown in the lower right photo in figure 3.

Figure 3. Oblique view of the right side of the tractor (top left photo) with additional closer views of the side-view mirror (upper and lower right photos).

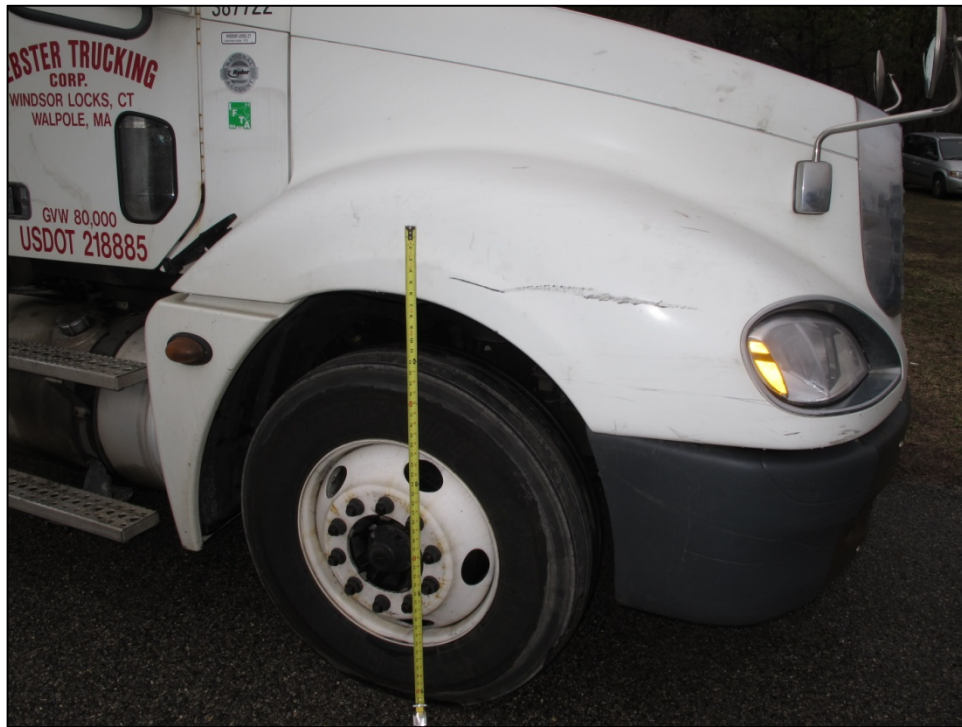
A black mark measuring 22 inches long was observed on the fender above the right front wheel as shown in figure 4. The black mark was located between 47 and 48 inches above the ground.

Figure 4. Black mark on the fender above the right front wheel of the tractor.

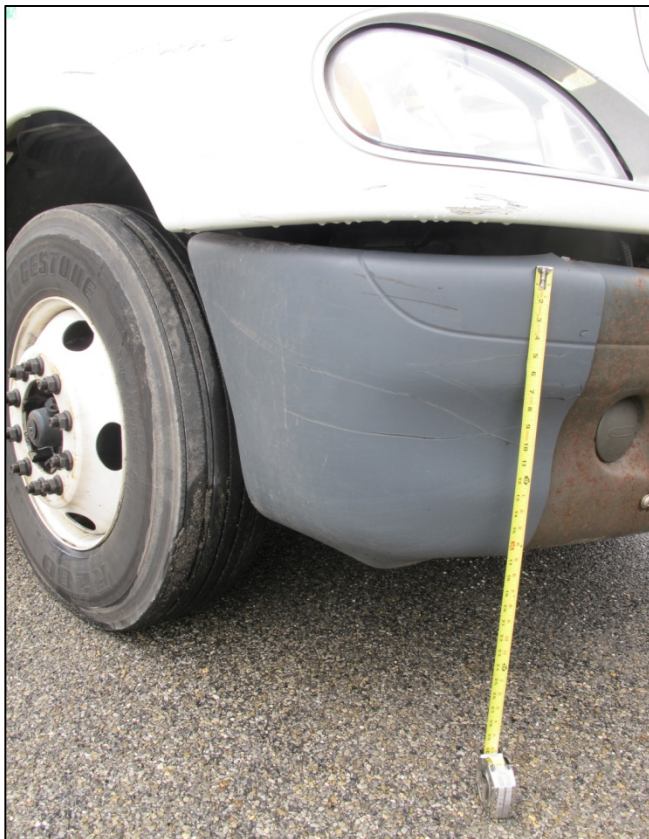
Sliding contact marks were observed on the right side of the front bumper. The marks were located between 22.5 inches and 32.5 inches from the ground. The marks were oriented in varying angles relative to the horizontal plane and some intersected each other. The marks on the right side of the bumper were continuous around to the front face of the bumper.

Figure 5. View of sliding contact marks on the right side of the front bumper of the tractor.

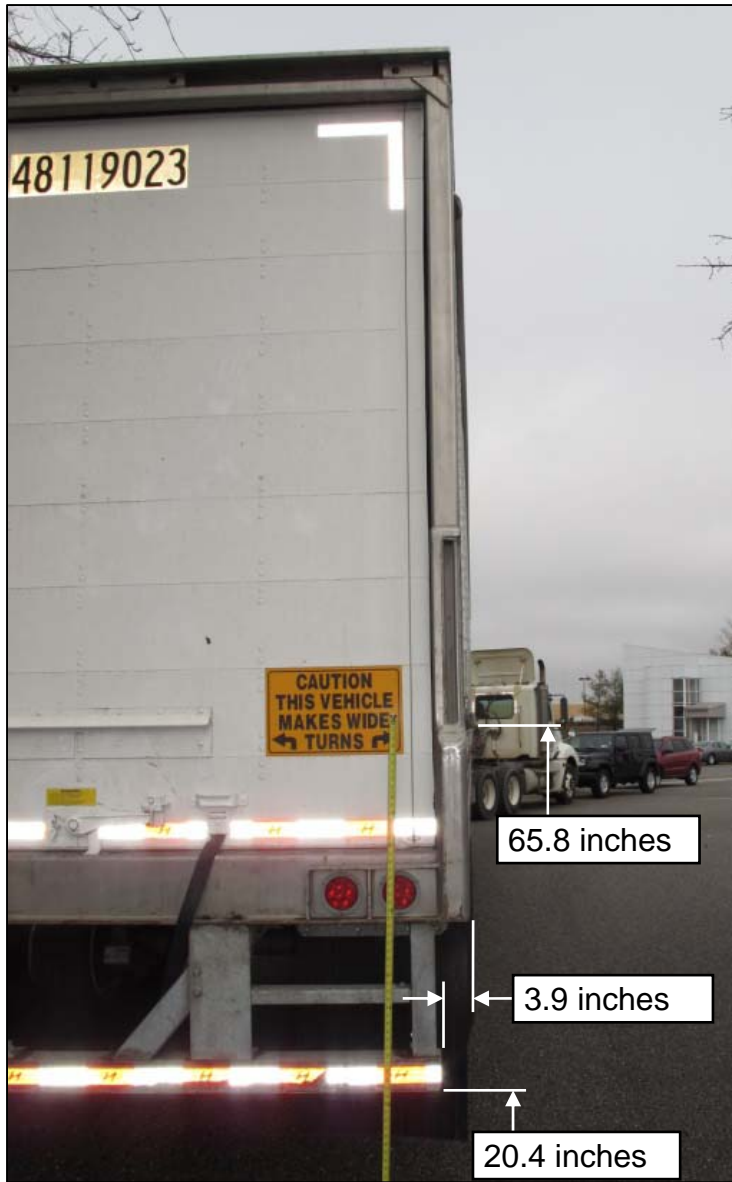
Views of the right rear side of the trailer are shown in figures 6 and 7. The trailer had an underride guard located 20.4 inches above the ground. The horizontal piece of the guard was 4.1 inches high. The trailer was wider than the underride guard. The right side of the underride guard was 3.9 inches inboard of the right side of the trailer as shown in figure 6. The underride guard was not painted. A red and white reflective adhesive strip was attached to the rear face.

Figure 6. View looking forward along the right side of the trailer. Distances from the ground up to the lower surface of the underride guard and the lower corner of the longitudinal stringer are indicated. The side of the trailer extended 3.9 inches beyond the underride guard as indicated.

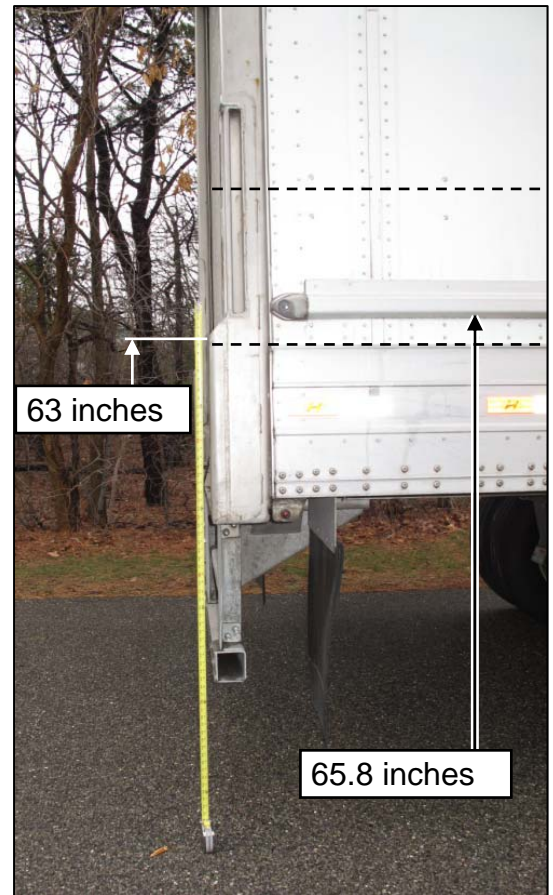
Dashed lines in figure 7 indicate the approximate height from the ground corresponding to the upper and lower surfaces of a left side-view mirror on a 1999 Prevost H3-45 motorcoach. No evidence of sliding contact, metal transfer, or paint transfer was observed during a close visual inspection of the area between the dashed lines in figure 7, including the surfaces of the longitudinal stringer as shown in figure 8.

At the rear of the trailer, the rear face of the rear door frame was in line with the vertical plane of the rear face of the underride guard up to 63 inches above the ground as shown in figure 7. The rear face of the rear door frame angled forward above 63 inches from the ground, and above 65.3 inches from the ground, the rear face was 2.3 inches forward of the rear face at the lower portion of the frame.

Figure 7. View of the lower rear end of the trailer. Distances from the ground up to a corner feature on the rear face and to the lower corner of the longitudinal stringer are indicated. Dashed lined indicate approximate height corresponding to the upper and lower surfaces of a left side-view mirror on a 1999 Prevost H3-45 motorcoach.

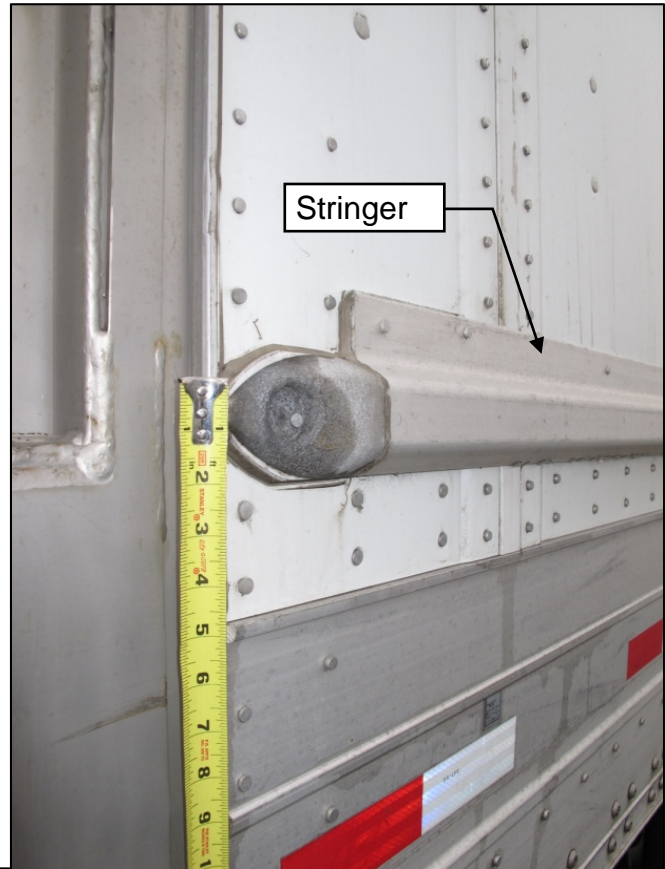
The trailer had 2 stringers per side that ran longitudinally along the right and left sides of the trailer. The stringers had a semi-hexagon shape and extended 1.5 inches out from the side of the trailer (see figure 8). The lower corner of the lower stringer was located 65.8 inches above the ground as shown in figures 6 and 7. The lower corner of the upper stringer was located 139.9 inches above the ground. The vertical face of each stringer was 1.4 inches wide.

Figure 8. Oblique view of the rear end of the lower stringer on the right side of the trailer.

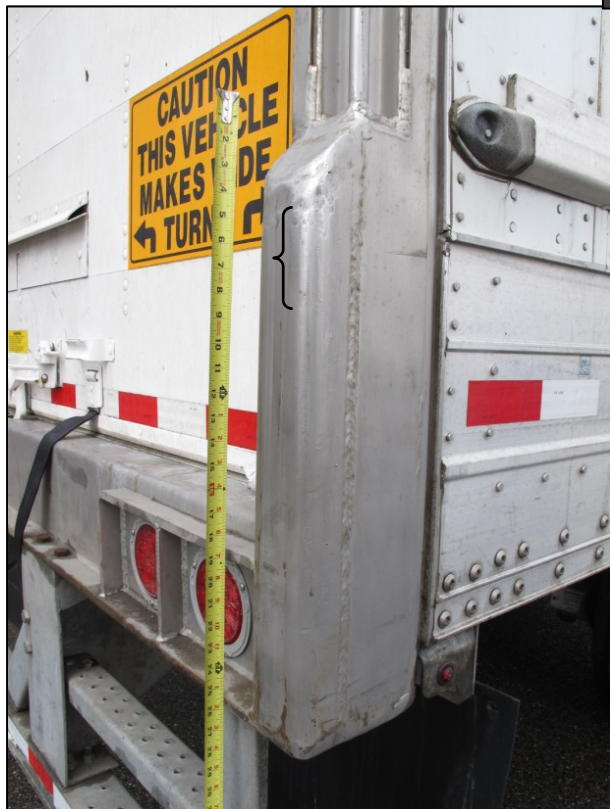
An oblique view of the right rear corner of the trailer is shown in figure 9. An unlabeled bracket in figure 9 indicates the approximate height from the ground corresponding to a side-view mirror support arm and bracket on a 1999 Prevost H3-45 motorcoach. No evidence of sliding contact, metal transfer, or paint transfer was observed during a close visual inspection of the corner in the vicinity of the unlabeled bracket shown in figure 9.

Figure 9. Oblique view of the right rear corner of the trailer. An unlabeled bracket indicates the approximate height corresponding to a side-view mirror support arm and bracket on a 1999 Prevost H3-45 motorcoach.

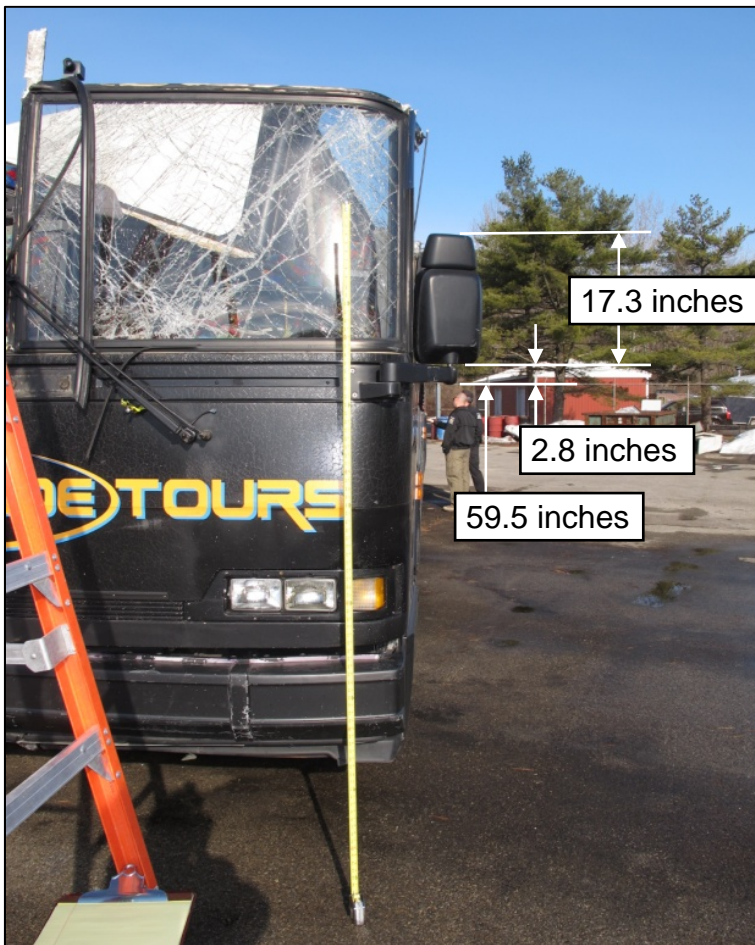
On the left side of the motorcoach, the side-view mirror was the feature that extended the farthest from the plane of the left side of the motorcoach. The left side-view mirror housing extended up to 9 inches outboard from the plane of the driver's side window. (On the exemplar motorcoach, the left side-view mirror extended up to 10.5 inches outboard from the plane of the driver's side window.). As indicated in figure 11, the 2-part mirror was 17.3 inches high, and the lower surface of the mirror was 2.8 inches above the lower surface of the support arm. The lower surface of the support arm at the point intersecting the axis of the mirror attachment hardware was measured on the exemplar motorcoach, and as indicated in figure 11 was 59.5 inches above the ground.

Figure 11. View looking along the left side of the motorcoach toward the rear while the motorcoach was on jackstands. The indicated distance of 59.5 inches from the ground to the bottom of the side-view mirror support arm is as measured on an exemplar Prevost H3-45 motorcoach.

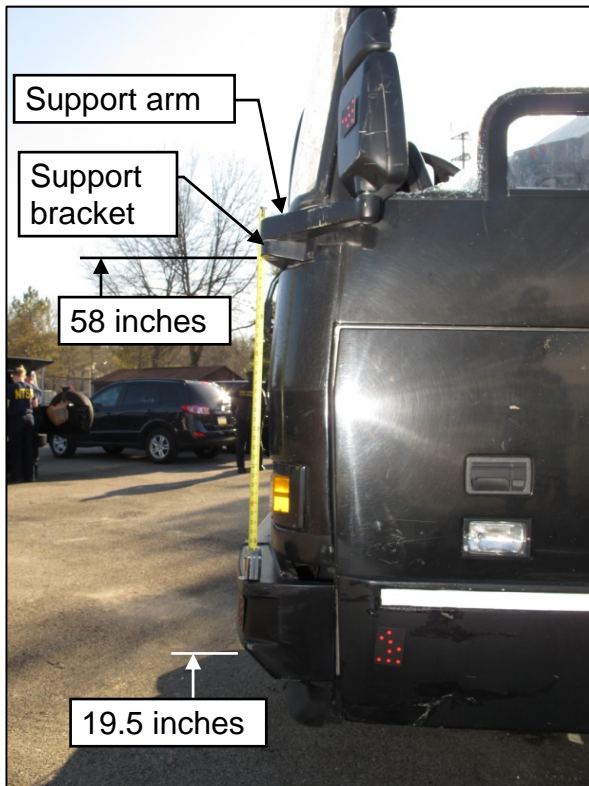
Views looking along the left side and along the front of the motorcoach are shown in figures 11 and 12. The photograph in figure 11 was taken with the motorcoach on jackstands, and the photo in figure 12 was taken after air was applied to the suspension system. As indicated in figures 12 and 13, the left side-view mirror was attached to a support arm that was connected to a support bracket attached to the front side of the bus.

Figure 12. Side view looking toward the right along the front of the bus. Distances from the ground to the point on the front bumper and to the lower surface of the side-view mirror support bracket are as measured from an exemplar Prevost H3-45 motorcoach.

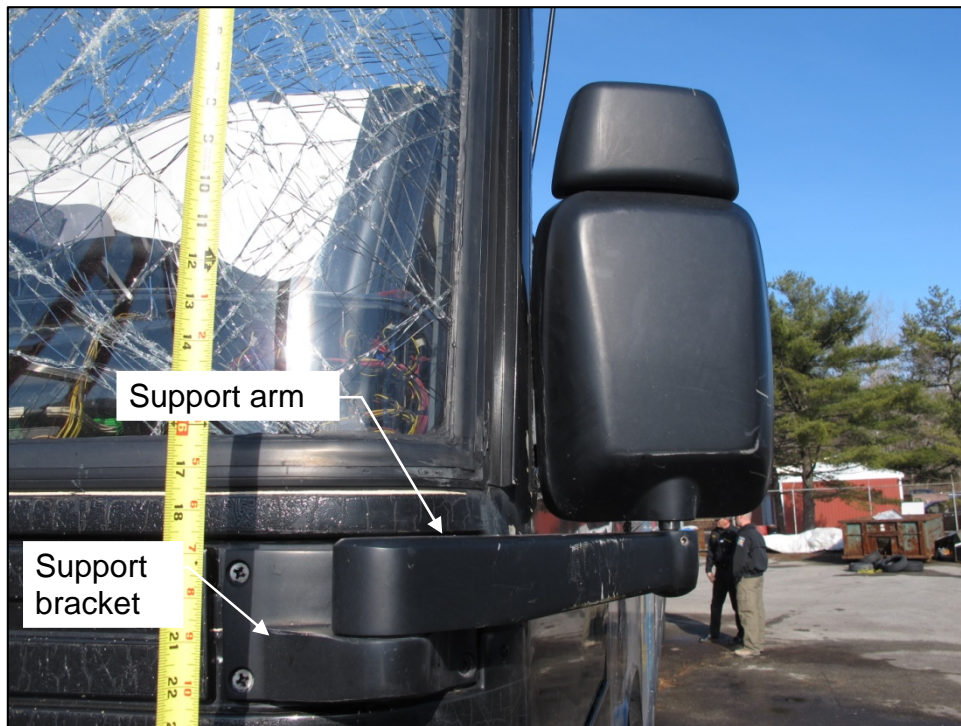
A close view of the left side-view mirror, support arm, and bracket are shown in figure 13. The support bracket and the support arm were painted black and showed no evidence of marks or missing paint on the bracket or on the support arm above the support bracket. As shown in figure 14, multiple contact marks were present on the

Figure 13. Close view of the left side-view mirror, support arm, and bracket.

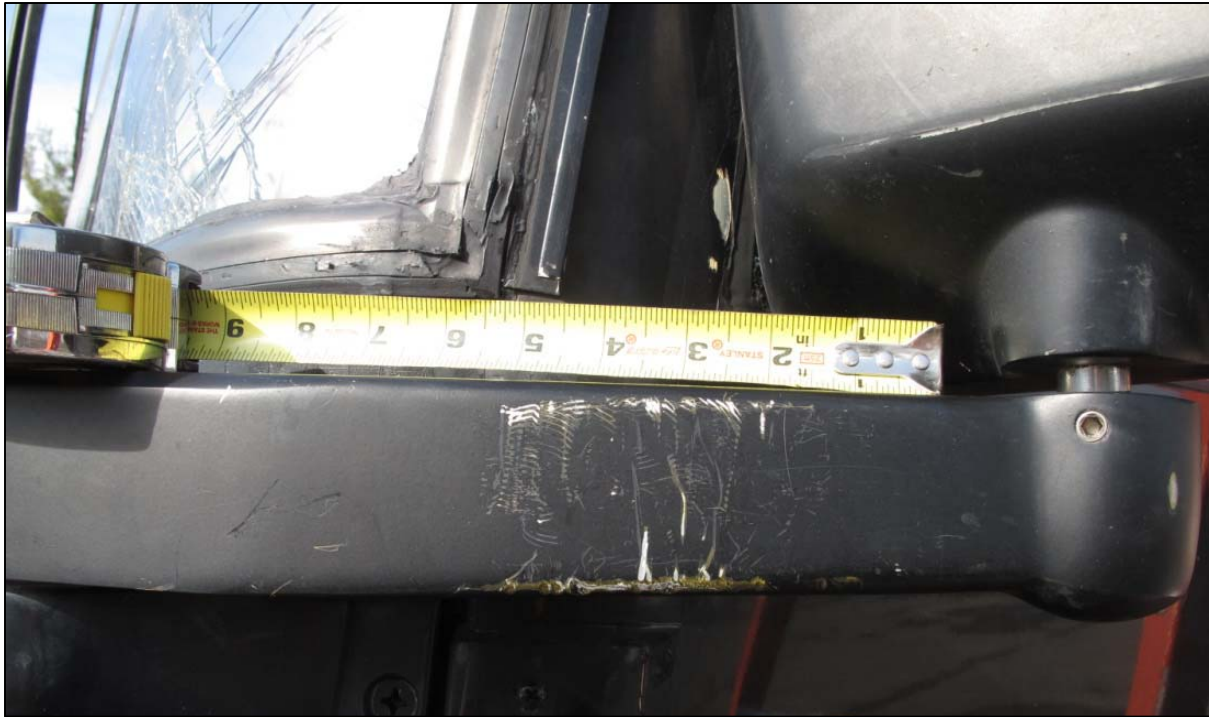
outboard face of the support arm with missing paint and primer layers at a location closer to the mirror end of the support arm. The marks included a number of regularly-spaced parallel lines with heavier marks near the upper and lower corners of the support arm. A similar pattern was observed on the inboard face of the support arm as shown in figure 15.

Figure 14. View of the outboard face of the left side-view mirror support arm.

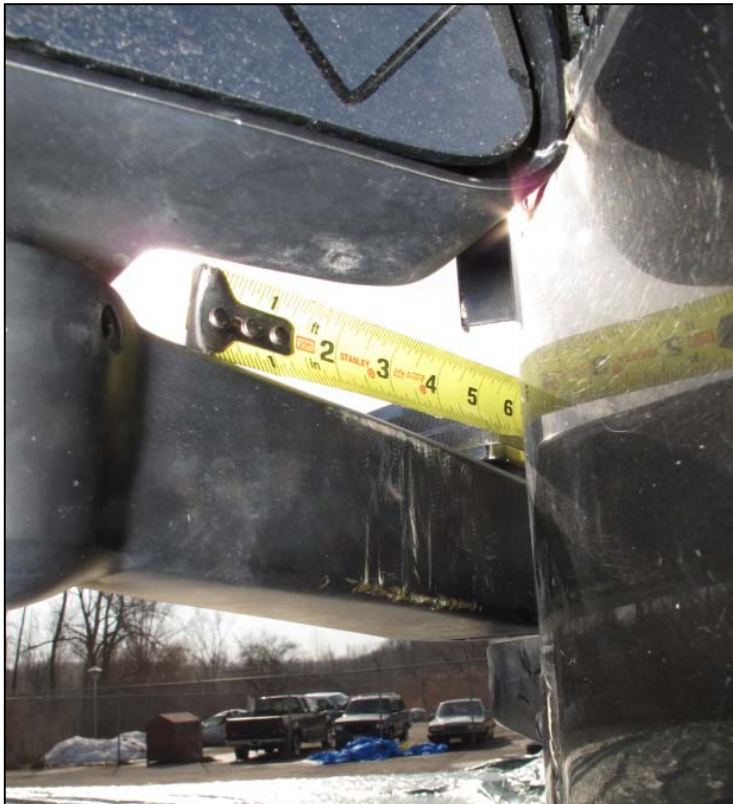
Figure 15. View of the inboard face of the left side-view mirror support arm.

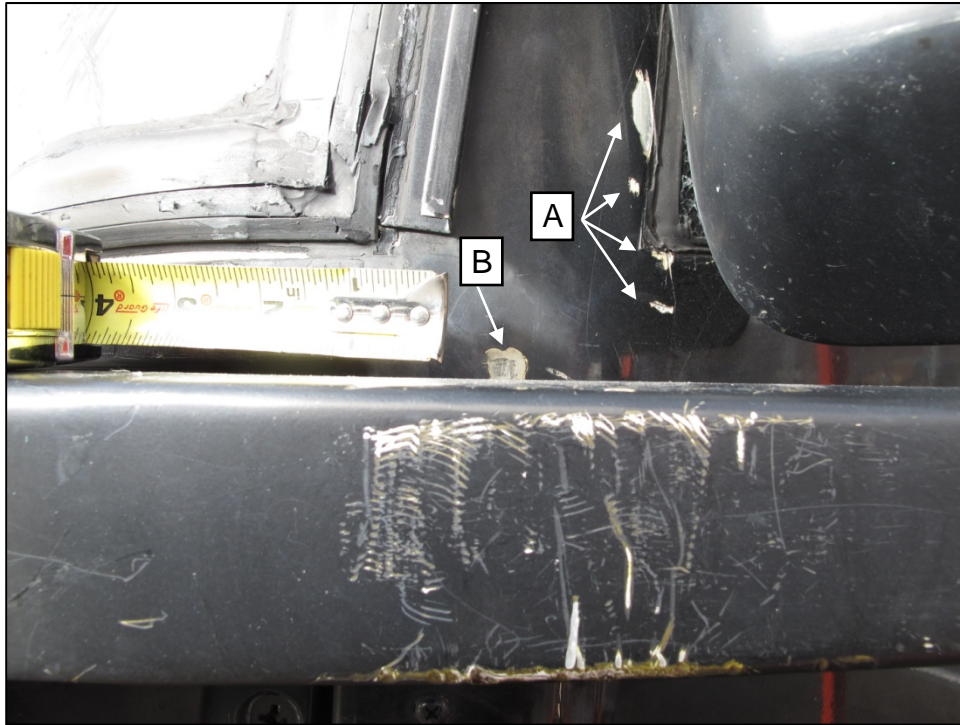
Contact marks with missing paint layers were observed on the side of the motorcoach in the vicinity of the left side-view mirror. Several of the marks are shown in figure 16 labeled A and B. The marks labeled A in figure 16 corresponded to the position of the inboard edge of the side view mirror housing with the support arm rotated inboard. Similar marks (not shown) were also observed closer to the top of the mirror. As shown in figure 16, mark B was located inboard of the area of regularly-spaced marks on the side-view mirror support arm at a height near the top surface of the support arm. A closer view mark B is shown in figure 17. The mark did not correspond to contact with any feature on the motorcoach at the time of the examination.

Figure 16. Areas of contact damage on the side of the motorcoach in the vicinity of the left side-view mirror.

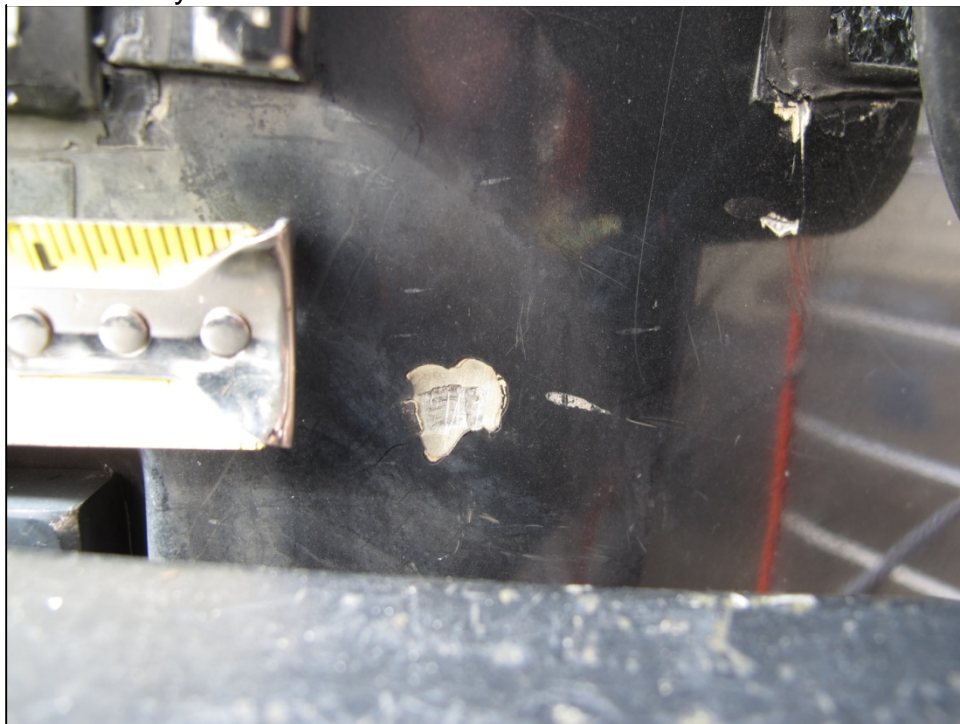
Figure 17. Closer view of contact damage labeled B in figure 16.

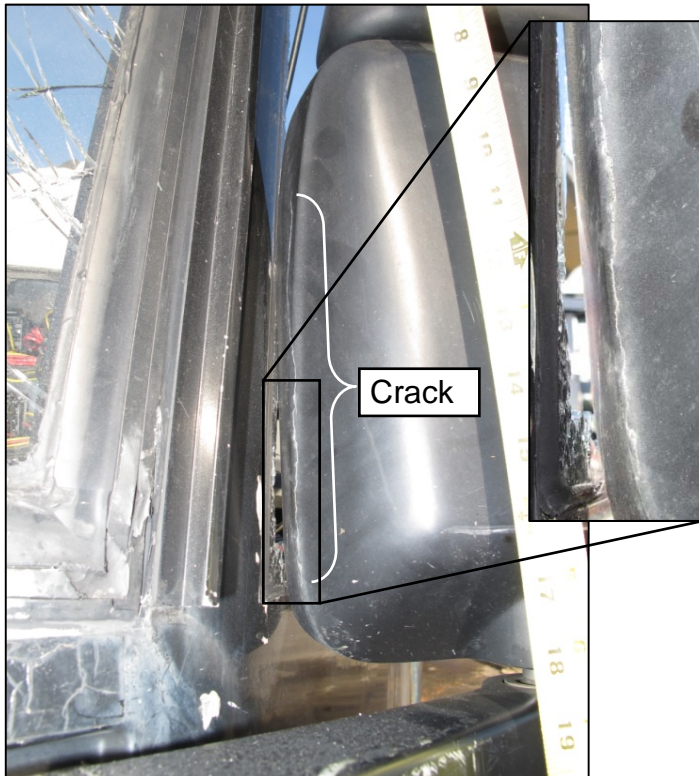
A close view of the inboard edge of the front face of the left side-view mirror is shown in figure 18. A vertical crack was observed on the inboard side of the mirror housing. White deposits were observed at higher concentrations along the edges of the crack and in the crack opening, particularly near the lower end of the crack as shown in the detail in figure 18. The mirror face of the left side-view mirror had a spall fracture at the lower inboard edge as indicated in figure 19. A horizontal crack was also observed at the lower inboard edge of the mirror housing as shown in figure 19. The location of the horizontal crack corresponded to the location of the lowest contact mark among the marks labeled A in figure 16.

Figure 18. Close view of the inboard side of the left side-view mirror viewed looking rearward where a vertical crack was observed in the mirror housing as indicated. The detail view shows a closer view of the lower end of the crack with accumulated white deposits along the crack surfaces.

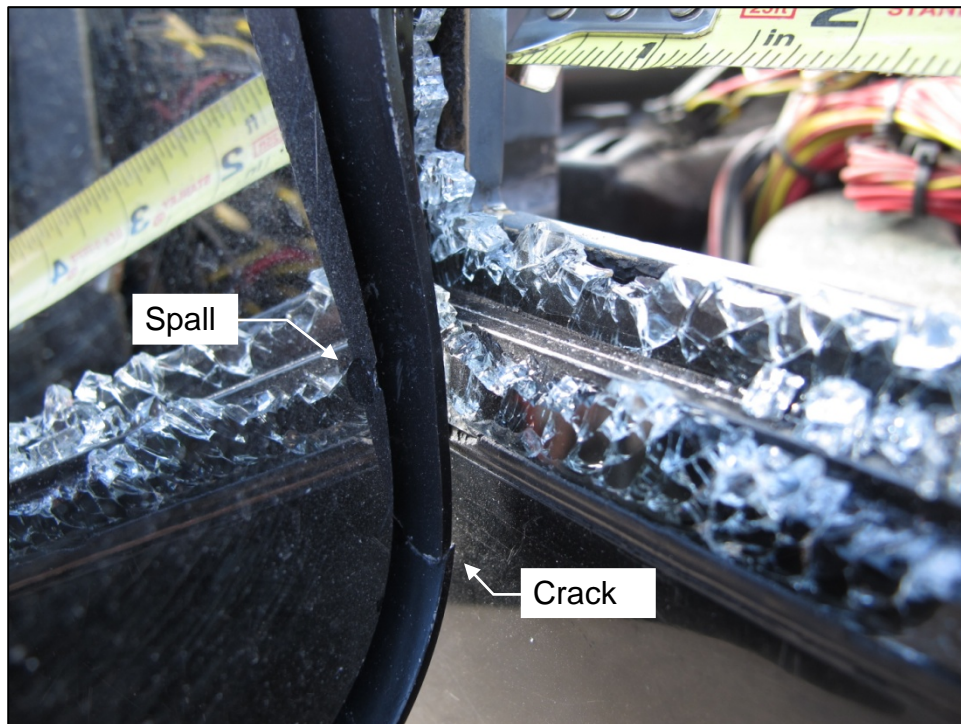
Figure 19. Close view of the inboard lower edge of the left side-view mirror viewed looking forward showing a horizontal crack in the housing and a spall crack at the edge of the mirror.

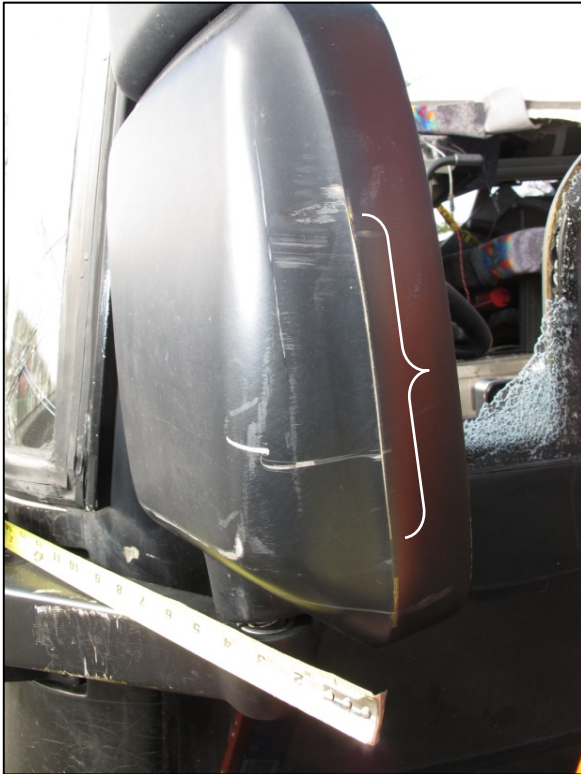
The outboard edge of the lower part of the left side-view mirror as viewed looking transverse to the length of the motorcoach is shown in figure 20. The outboard edge of the left side-view mirror showed multiple sliding contact marks along its front and outboard face as shown in figures 20 and 21. The corner between the front and outboard faces was missing paint in the area indicated by a bracket in figure 20. The area corresponded to the location where the mirror extended furthest from the plane of the side of the motorcoach. Multiple sliding contact marks were observed within and above the region indicated by the bracket in figure 20. These sliding contact marks were deepest on the front face at the corner between the front and outboard edges.

Figure 20. Left side-view mirror as viewed looking transverse to the length of the motorcoach. An unlabeled bracket indicates where paint was missing at the corner between the front and outboard faces.

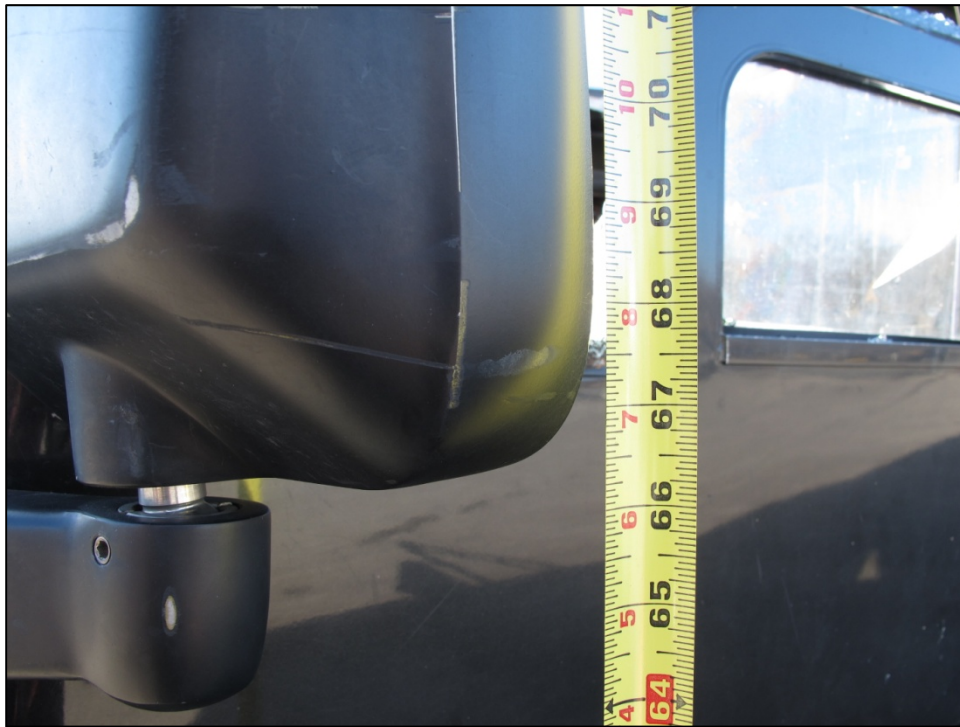
Another sliding mark was observed at the lower corner of the left side-view mirror below the bracket shown in figure 20. A close view of the sliding contact mark at the lower corner of the left side-view mirror is shown in figure 21. At the corner between the front and outboard faces of the mirror, the mark was approximately 1 inch wide, and material appeared to be rolled over the front edge of the corner. On the forward face, the mark was approximately 1.3 inches long in the transverse direction and was approximately parallel to the ground. On the outboard face, the mark extended across approximately 2/3 of the face in the longitudinal direction.

The tape measure in figure 21 shows the distance from the ground on the accident motorcoach after air pressure had been applied to the suspension system. However, the left side-view mirror on the exemplar motorcoach with the suspension at the normal operating condition was 4 inches lower than the accident motorcoach with the damaged suspension system. Based on measurements on the exemplar motorcoach, the position of the sliding contact mark shown in figure 21 is expected to be approximately 63 to 64 inches from the ground under normal operating conditions.

Figure 21. Close view of sliding contact marks at the lower corner of the outboard edge of the left side-view mirror.

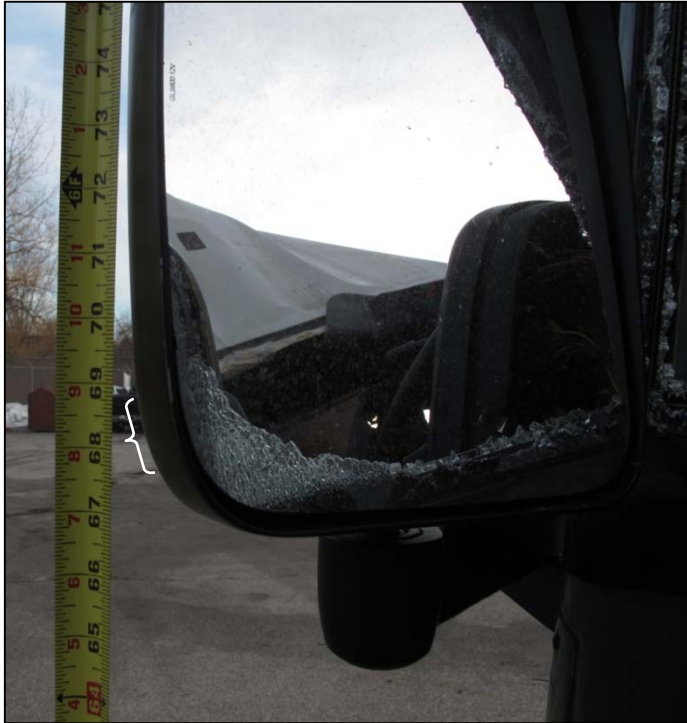
In figure 22, the lower portion of the left side-view mirror is shown from a view looking forward along the left side of the motorcoach. The broken driver's-side window is shown reflected in the mirror. As in figure 21, the ruler shown in figure 22 shows the distance from the ground after air pressure had been applied to the suspension system. A bracket in figure 22 indicates the approximate location of the sliding contact mark on the lower outboard corner of the mirror. The outboard edge of the side-view mirror was curved as shown in figure 22, and the height at which the outboard edge was furthest from the side of the bus was 73 inches from the ground in the accident motorcoach with air pressure on the suspension, a height that would correspond to 69 inches on the exemplar motorcoach.

Figure 22. View showing curvature of the outboard edge of the left side-view mirror as viewed looking forward. The measure at right shows height from the ground after air pressure was applied to the suspension, heights that are approximately 4 inches higher than the exemplar motorcoach.

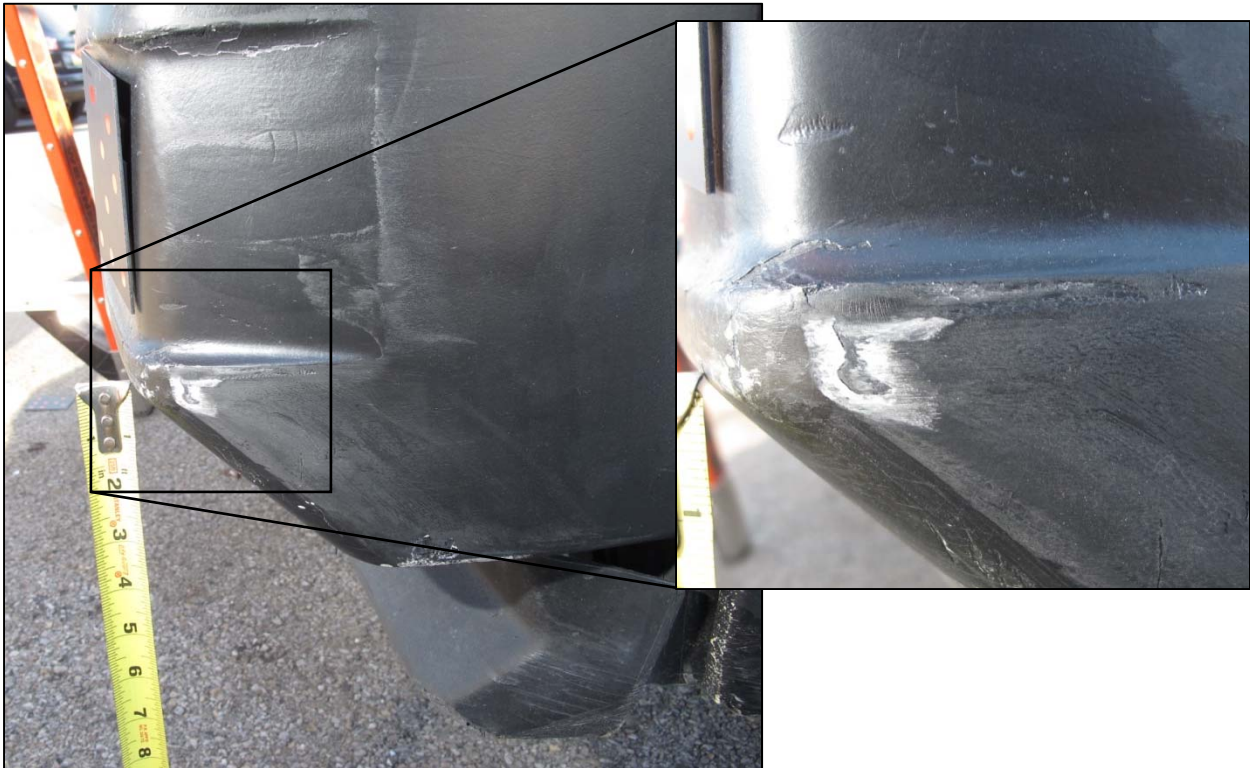
A close view of the left side of the front bumper of the motorcoach at the lower front corner is shown in figure 23. The left side of the bumper adjacent to the corner showed a sliding contact mark with white paint transfer on the surface.

Figure 23. Close view of a sliding contact mark at the left corner of the front bumper showing white paint transfer. On an exemplar motorcoach, the location at the end of the tape measure was 19.5 inches above the ground.
