# NATIONAL TRANSPORTATION SAFETY BOARD

MATERIALS LABORATORY FACTUAL REPORT

Report No. 11-049

Place : San Bruno, California  
Date : September 9, 2010  
Vehicle : Pacific Gas & Electric Natural Gas Transmission Pipeline  
NTSB No. : DCA10MP008  
Investigator : Ravindra Chhatre, RPH-20

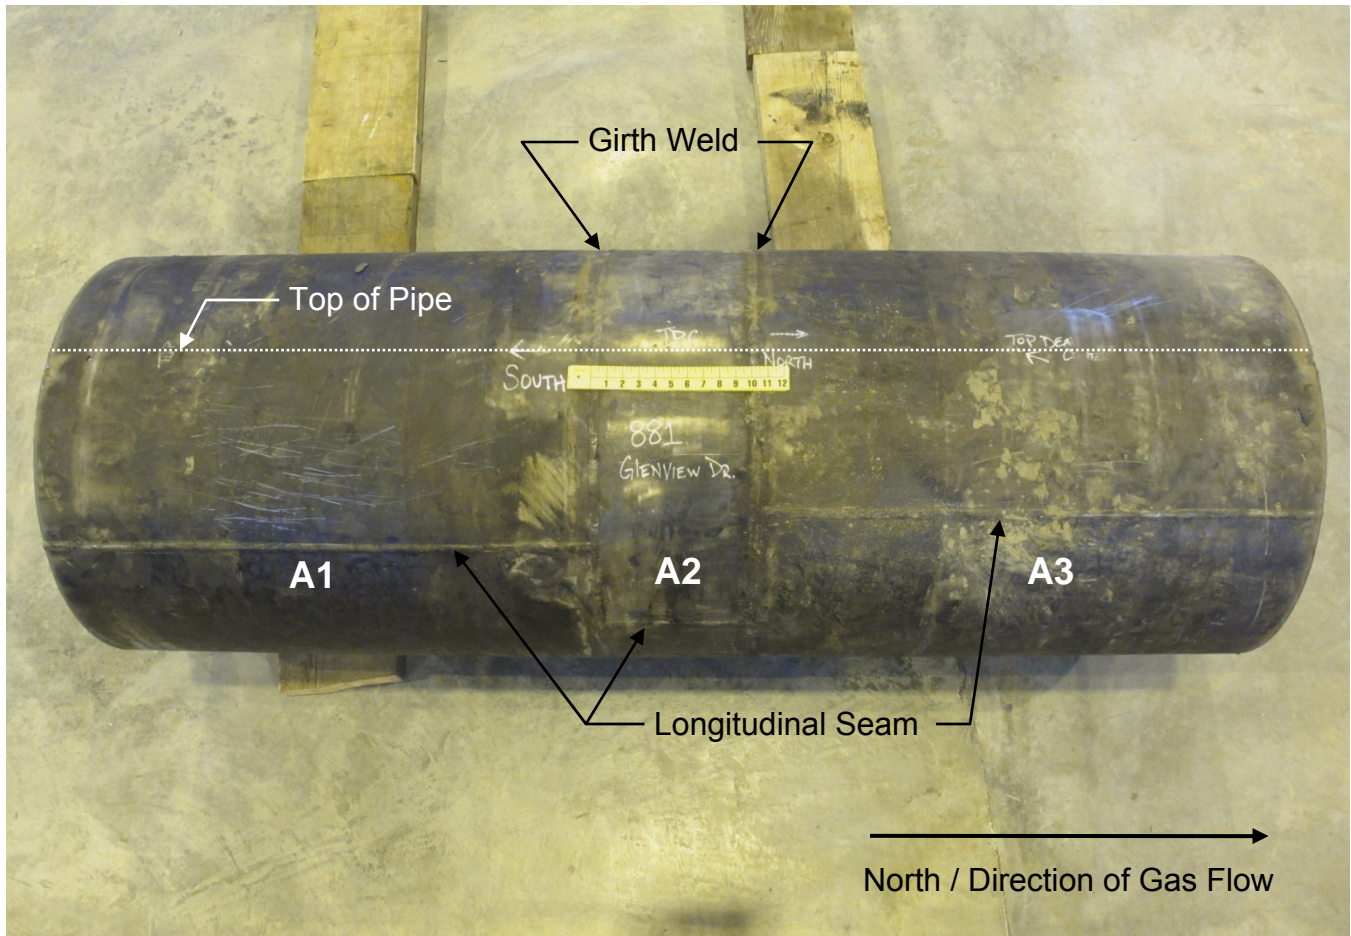
The pipe was received in the condition shown in Figure 1. The pipe was covered by a protective asphalt coating, which was chipped off in the field using brass hammers and scrapers prior to shipment, except for two 1-foot by 1-foot sections on the bottom. Top dead center, the north/south orientation of the pipe, and the direction of gas flow were labeled in the field. The two 1-foot by 1-foot sections of coating were chipped off at the Ashburn facility using a brass hammer and a metal scraper. There were no visual indications of deformation or corrosion on the outer or inner diameter surface of the pipe. After visual examination, the outside of the pipe was grit blast using olivine blast media to near-white (SSPC-SP 10/NACE No. 2). For convenience, the three lengths of pipe were labeled A1, A2, and A3 in the typical direction of gas flow (south to north). The 10-inch length for which no internal seam was detected during camera inspection was labeled A2, the length of pipe upstream from A2 was labeled A1, and the length of pipe downstream from A2 was labeled A3. The girth welds joining the lengths of pipe were labeled A1/A2

**Figure 1:** Overview of the as-received pipe from Line 132, Segment 180, 881 Glenview Drive.

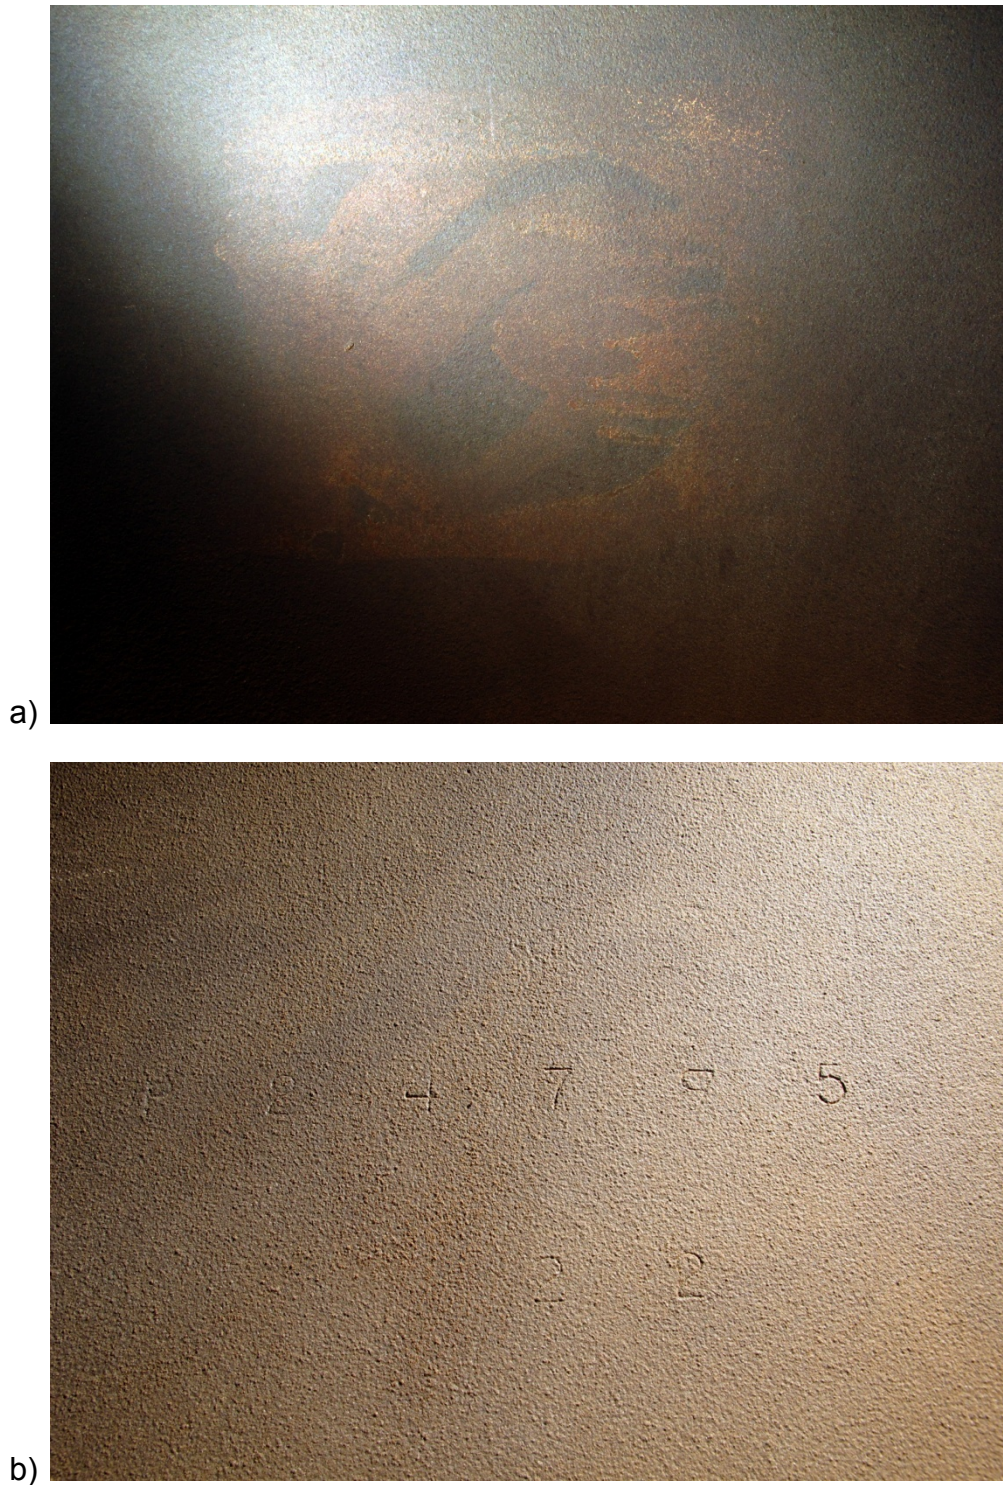
The pipe's outer and inner surfaces were examined for identifier markings. There were no observable stamp, stencil, or paint marks on the outer diameter surface of A1, A2, or A3 (the outer surface was examined for stencil and paint marks prior to abrasive blasting). The number "31" followed by other indiscernible numbers was painted on the inner diameter surface of A1 and A2, consistent with partial joint footage markings (not shown).<sup>1</sup> A painted symbol, similar to a "6" or "9" was observed on the inner diameter surface of A1, as shown in Figure 2a. The alphanumeric code "P24795" and the number "22" were stamped on the inner diameter surface of A3, as shown in Figure 2b, approximately 20 inch from girth weld A2/A3. Pacific Gas & Electric Co. (PG&E) was unfamiliar with these markings or their meaning (PG&E, 2011a, b).

**Figure 2:** Pipe markings found on inner diameter surface; a) painted symbol inside A1, similar to a “6” or “9”; b) stamp inside A3 reading “P24795” and “22”.

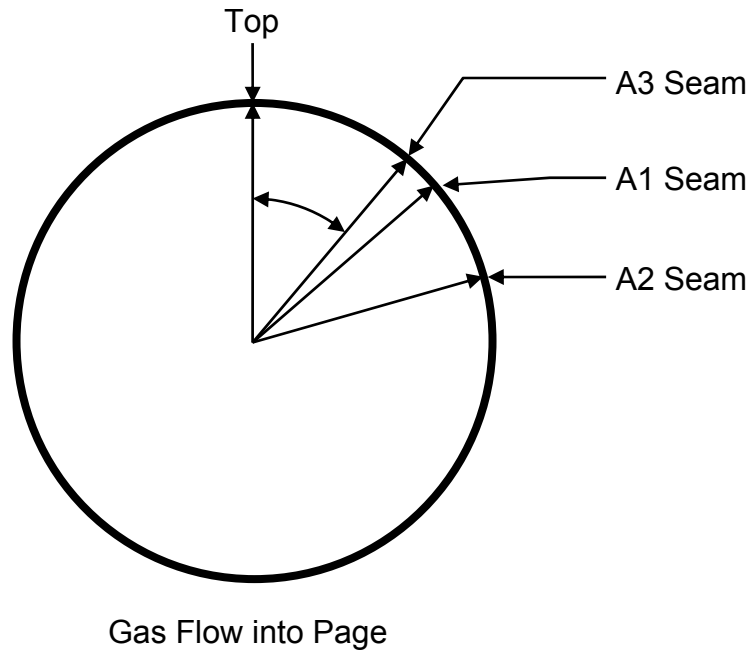
Longitudinal seam welds were visible on the outer and inner surfaces of the three lengths of pipe. Except near the ends, the weld caps were rounded, of uniform width and height, and exhibited little to no visible ripple pattern, consistent with a double submerged arc welding (DSAW) process. The distance of each weld from the top along the outer circumference of the pipe was measured by steel tape and is listed in Table 1. The circumference of each length of pipe and the distance of its corresponding seam from the top were used to calculate the angle between the top of the pipe and the seam. The angles were 49°, 74°, and 40°, defined clockwise relative to the typical direction of gas flow, for A1, A2, and A3, respectively. The angle values are listed in Table 1 and shown schematically in Figure 3.

**Figure 3:** Schematic of pipe viewed in the typical direction of gas flow illustrating the orientation of the longitudinal seams relative to the top of the pipe.

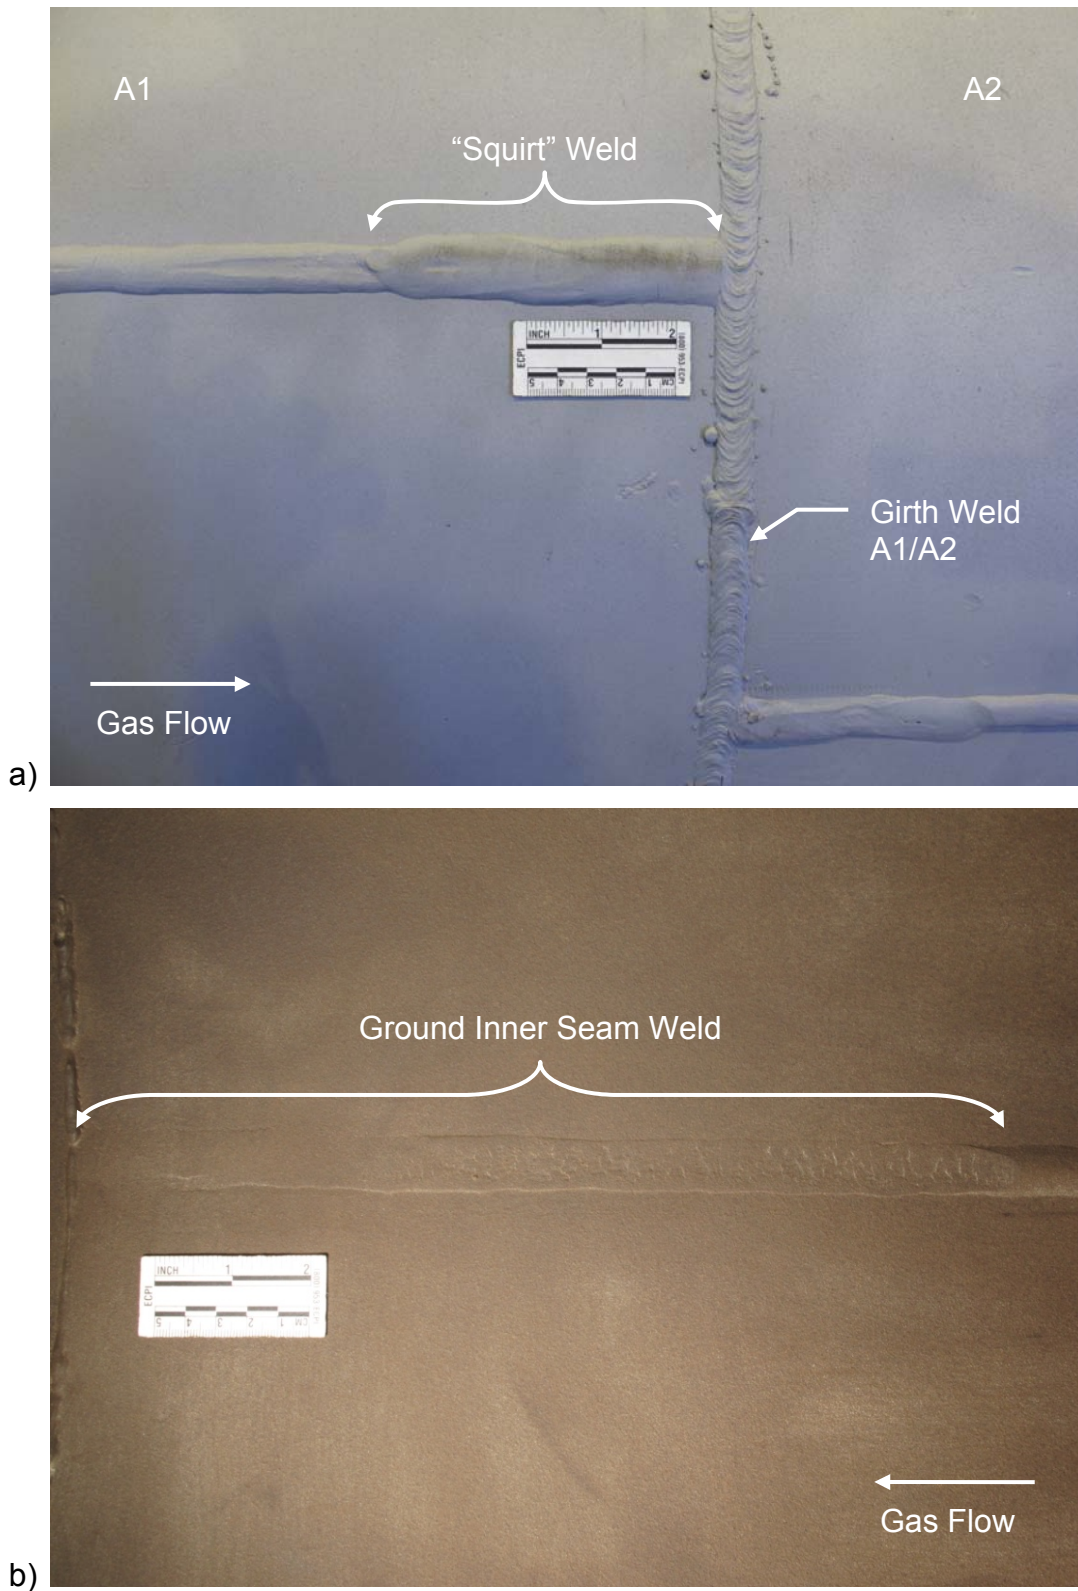
The outer and inner seam welds on A1 were of uniform width and height except near girth weld A1/A2. The outer seam weld became irregular in shape starting 4.6 inch from the girth weld, consistent with a “squirt” weld,<sup>3</sup> as shown in Figure 4a. The inner seam weld was ground flush with the inner diameter surface of the pipe starting 12 inch from the girth weld, as shown in Figure 4b.

**Figure 4:** Photographs of DSAW longitudinal seams on A1 near girth weld A1/A2; a) outer seam; b) inner seam.

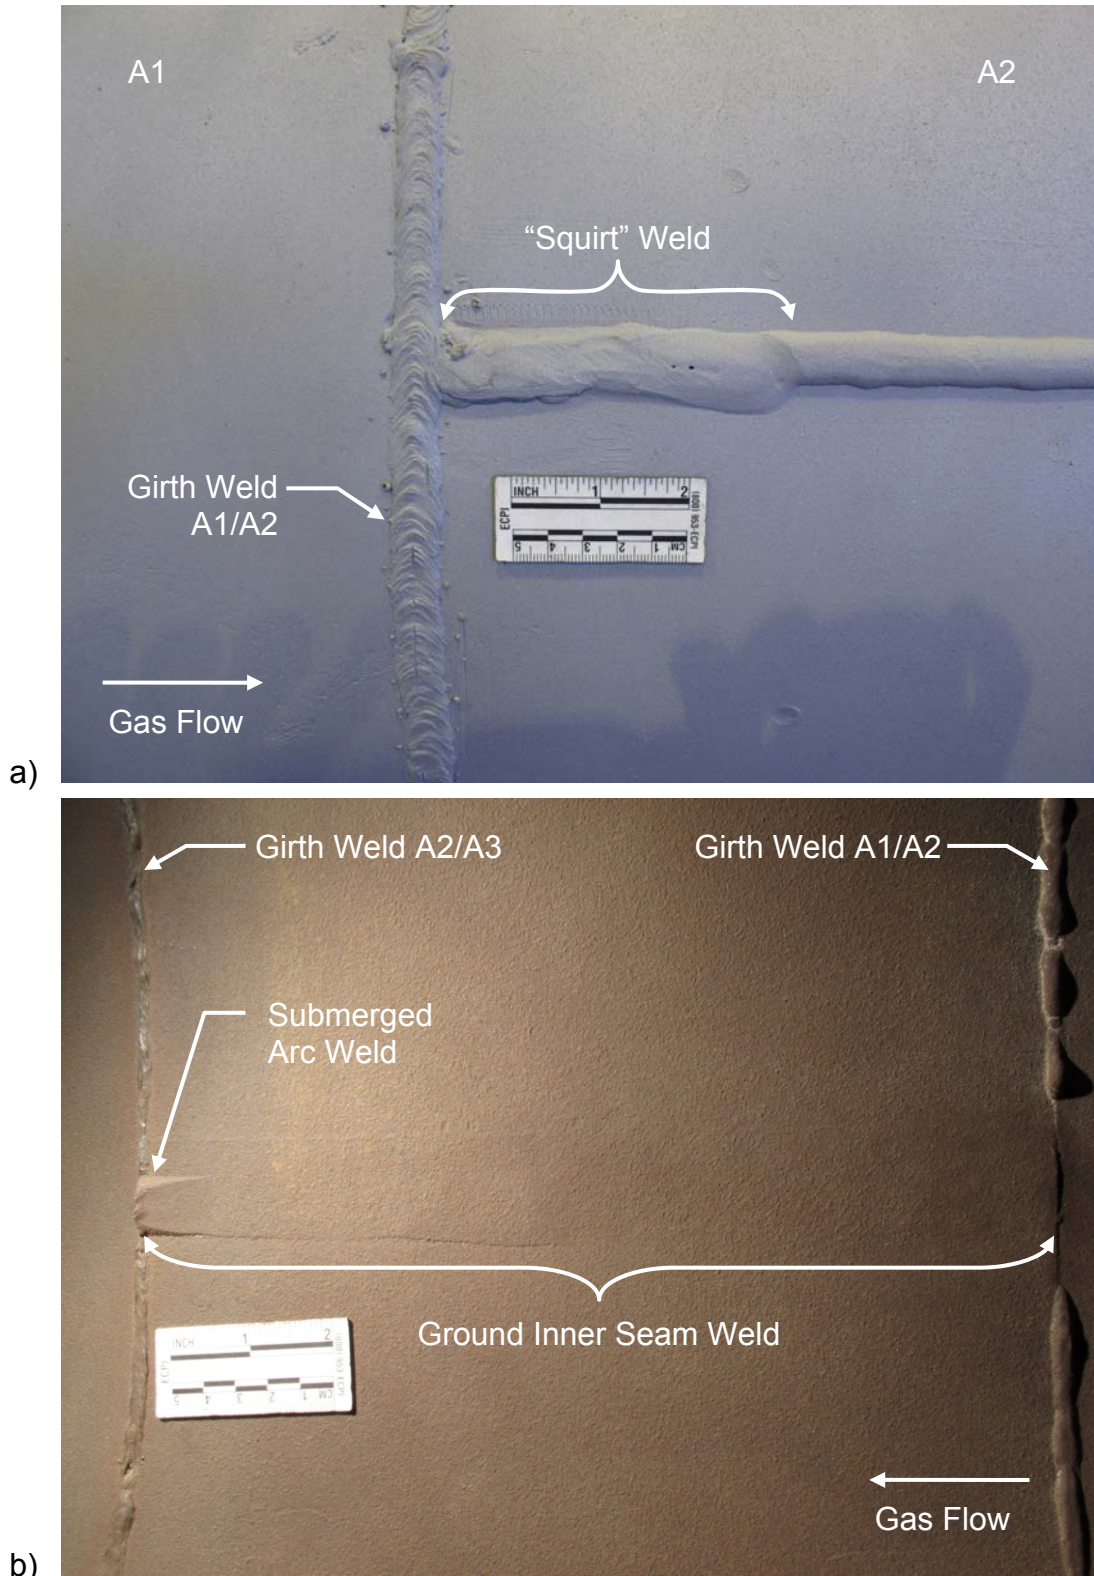
The outer and inner seam welds on A2 were of similar appearance. The outer seam weld was of uniform width and height, except near girth weld A1/A2. Starting 4.2 inch from the girth weld, the seam weld became irregular in shape, consistent with a “squirt” weld, as shown in Figure 5a. The inner seam weld was ground flush with the inner diameter surface over the entire 10-inch length of the pipe, except for a 1-inch length near girth weld A2/A3, where the weld was partially ground, as shown in Figure 5b.

**Figure 5** Photographs of DSAW longitudinal seams on A2; a) outer seam near girth weld A1/A2; b) inner seam between girth welds A1/A2 and A2/A3.

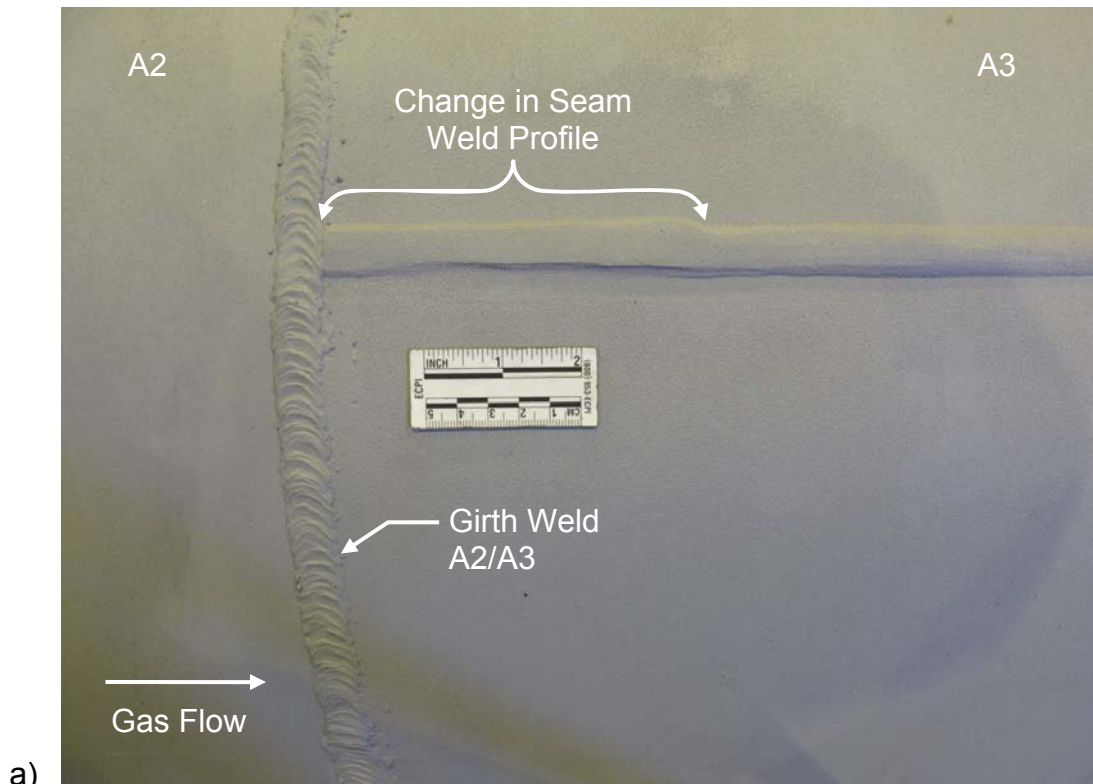
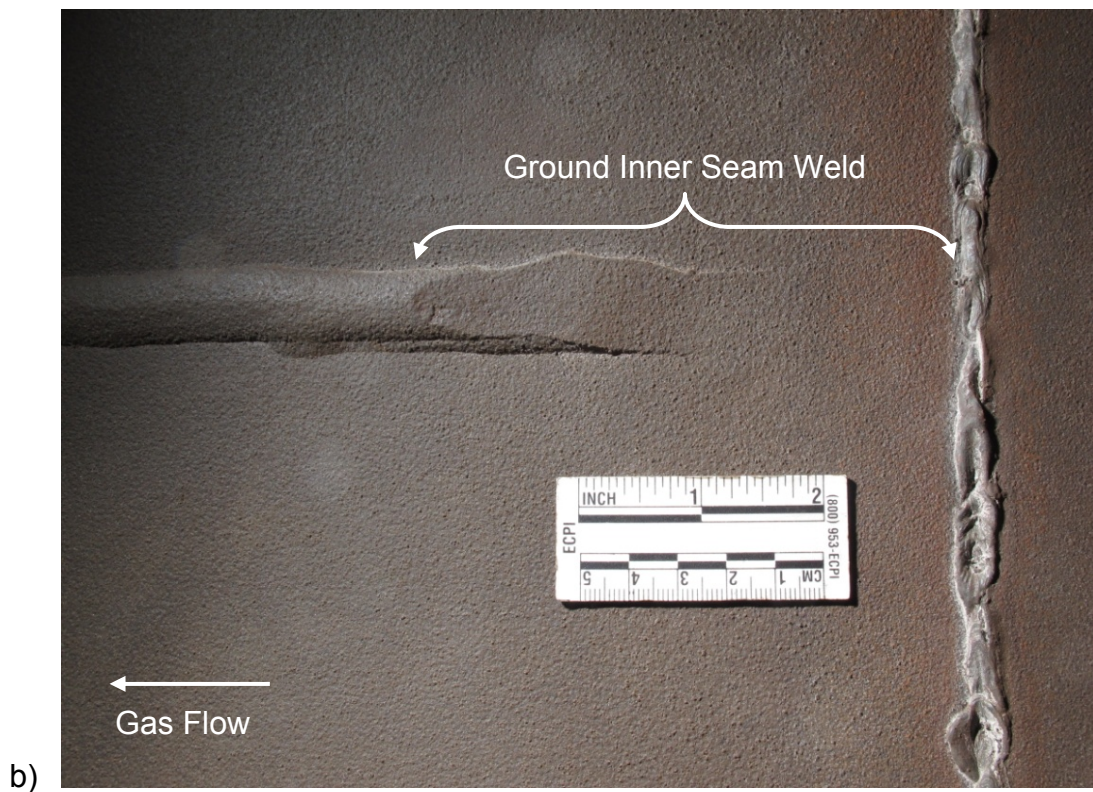
The outer and inner seam welds on A3 were of uniform width and height, except near girth weld A2/A3. The profile of the outer seam weld changed shape starting 5.2 inch from the girth weld, as shown in Figure 6a, but did not have the irregular appearance of a “squirt” weld, as compared with A1 and A2. The inner seam weld was ground flush with the inner diameter surface starting 4.5 inch from the girth weld, as shown in Figure 6b. The length of each notable outer and inner seam weld feature is summarized in Table 1 for A1, A2, and A3.

**Figure 6:** Photographs of DSAW longitudinal seams on A3 near girth weld A2/A3; a) outer seam; b) inner seam.

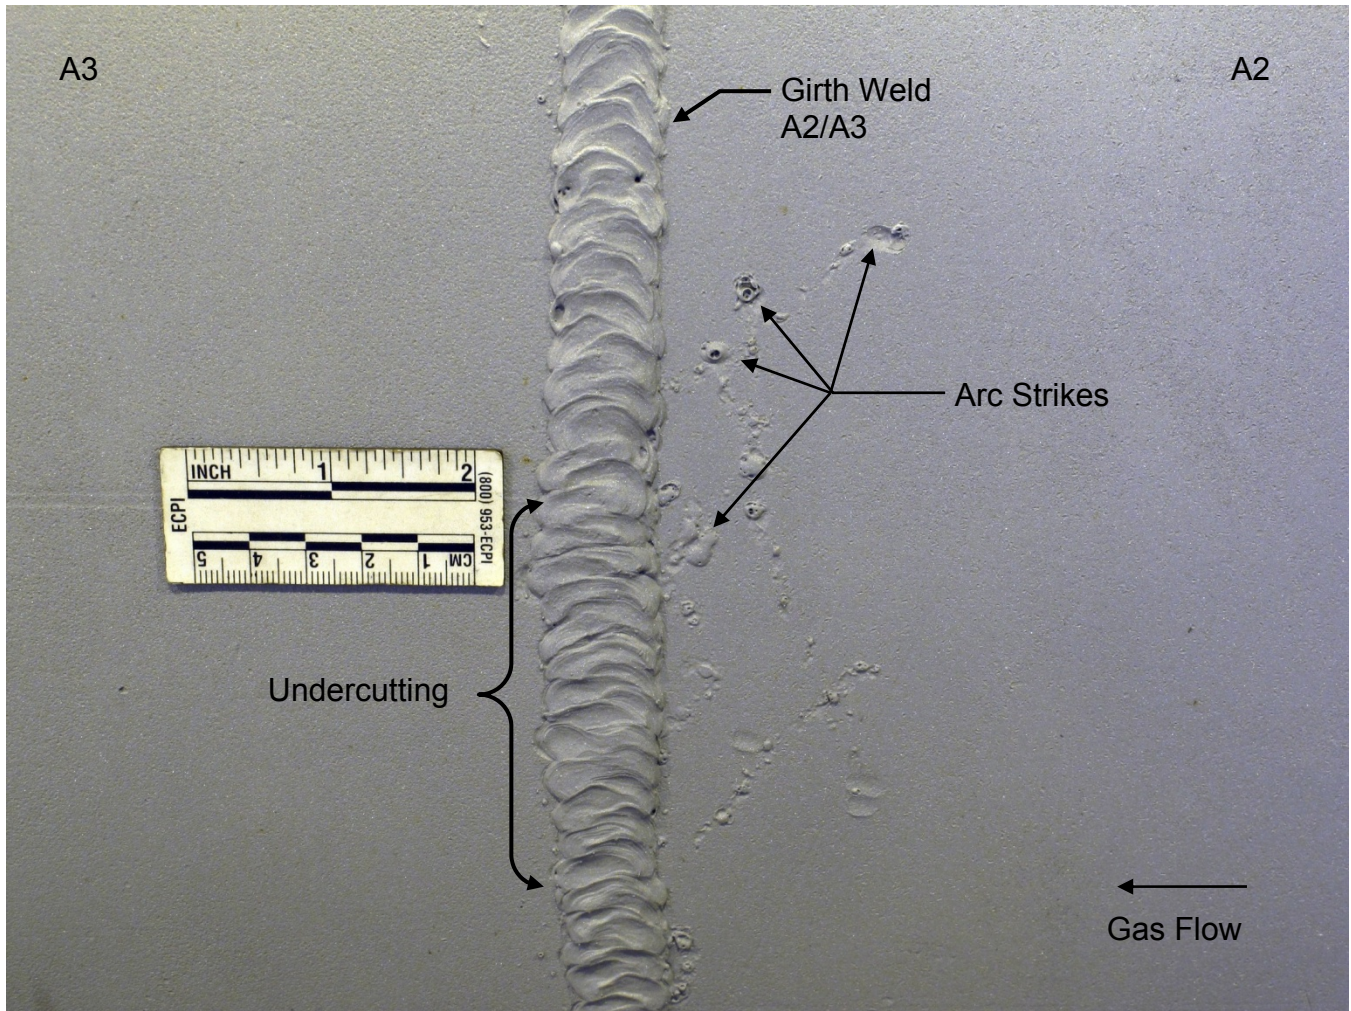
Various weld discontinuities were observed on the girth welds.<sup>4</sup> Arc strike clusters were observed at approximately six locations, distributed around the outer circumference of girth weld A1/A2. Each cluster contained multiple individual arc strikes. Approximately six arc strike clusters of similar appearance were also observed on girth weld A2/A3. Undercutting was observed on the outer circumference of girth weld A2/A3 along an 8-inch length, a second separate 8-inch length, and a 12-inch length. High/low offset was observed along some regions that exhibited undercutting. Figure 7 shows undercutting

**Figure 7:** Photograph of outer surface of girth weld A2/A3 showing undercutting and arc strikes.

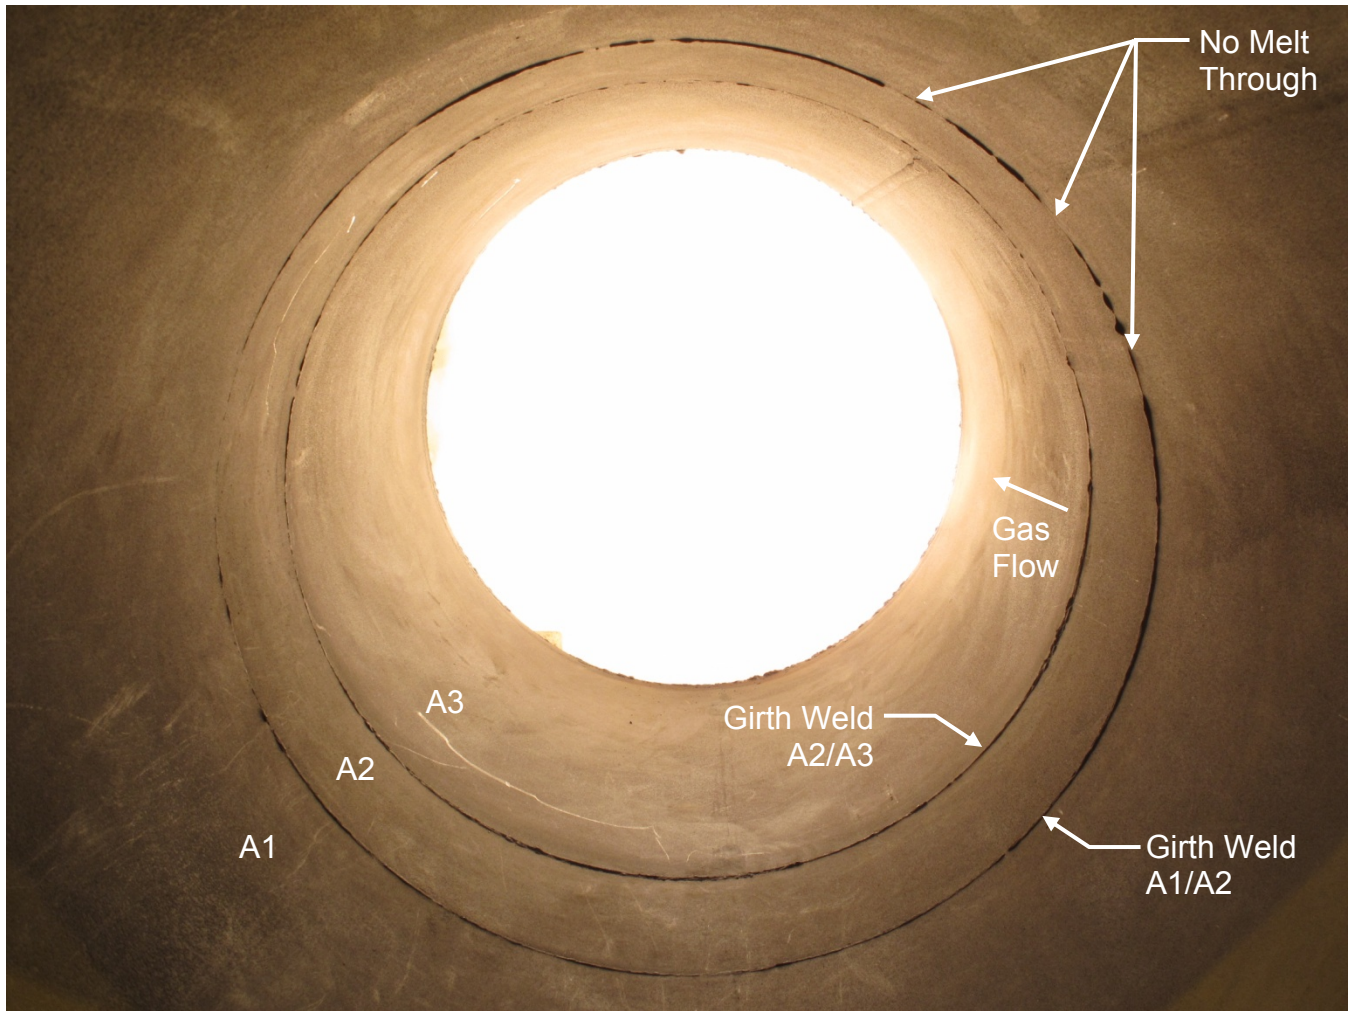
and arc strikes on girth weld A2/A3. Figure 8 shows the inner surface of the pipe with the girth welds in profile. Both girth welds exhibited occasional spot-sized regions (0.75 inch or less) where weld metal did not melt through the inner diameter surface. In addition, girth weld A1/A2 exhibited three such locations 2 inch in length between 0° and 90°. Girth weld A2/A3 exhibited a 12-inch long region of internal concavity (i.e., weld suck back) between 180° and 240°, as shown in Figure 9a, and a 2-inch lack of fusion defect (API, 1956) between 30° and 60°, as shown in Figure 9b.

**Figure 8:** Interior view of the pipe showing the full inner circumference of the girth welds in profile.

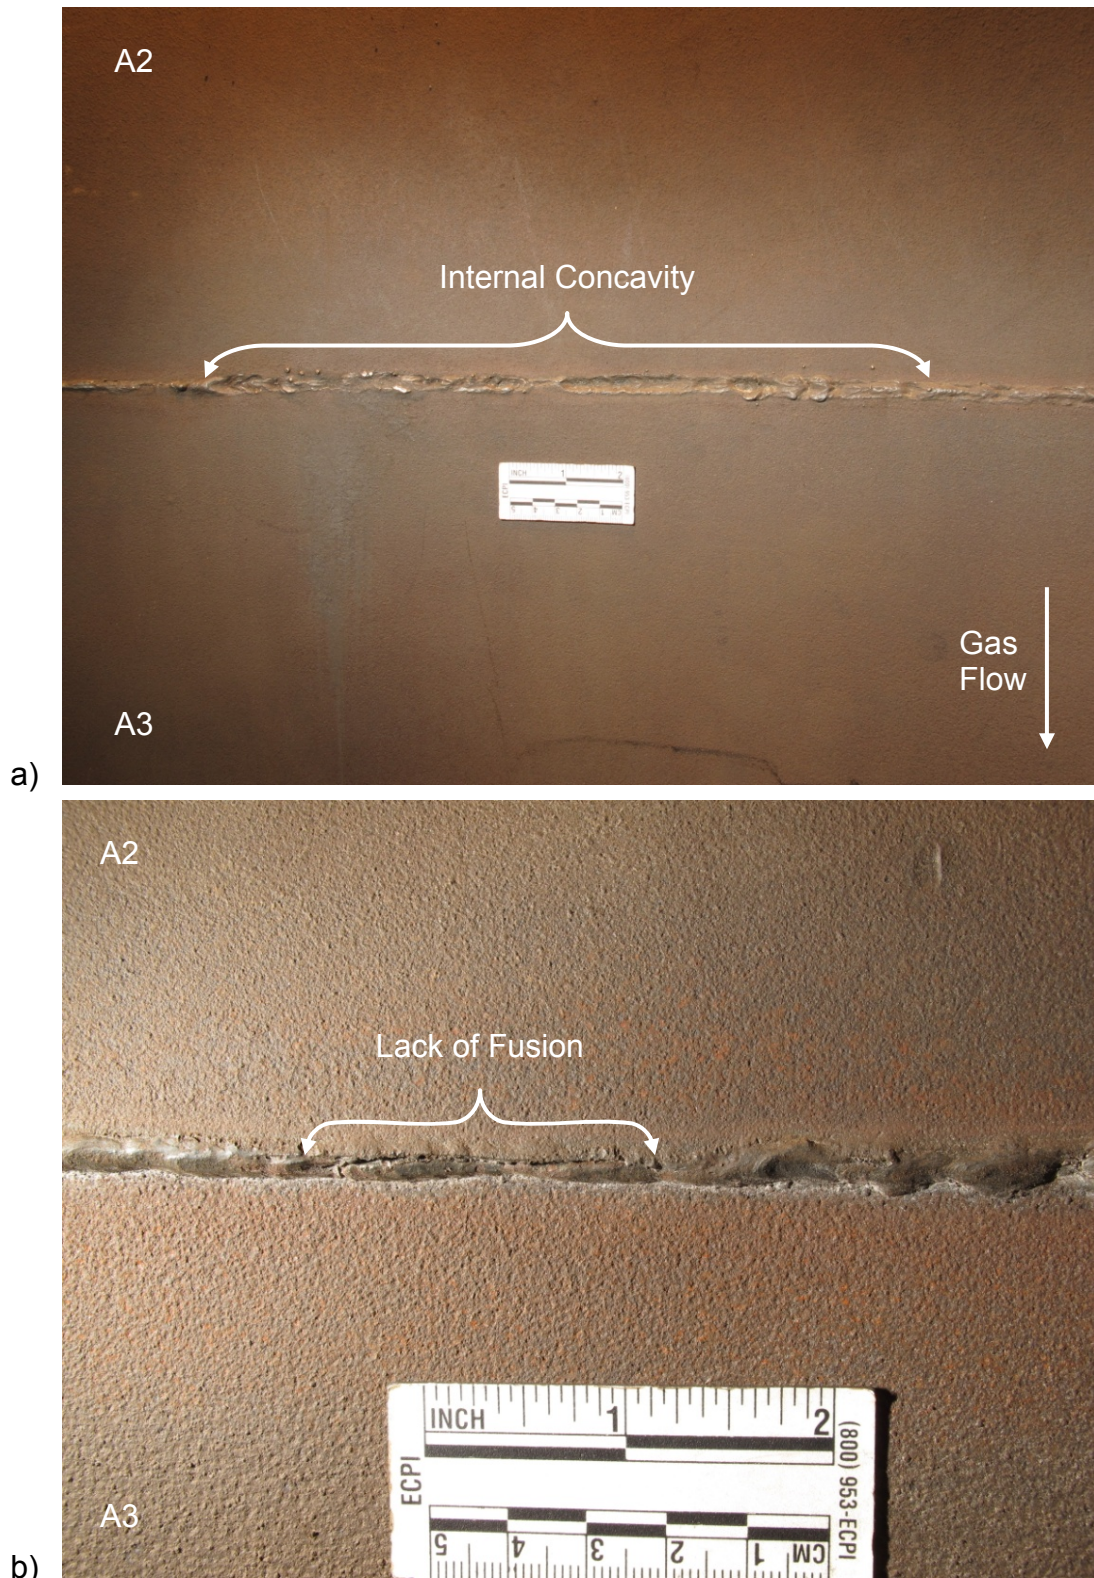
**Figure 9:** Visible weld discontinuities on the inner diameter surface of girth weld A2/A3; a) internal concavity between 180° and 240°; b) lack of fusion defect.

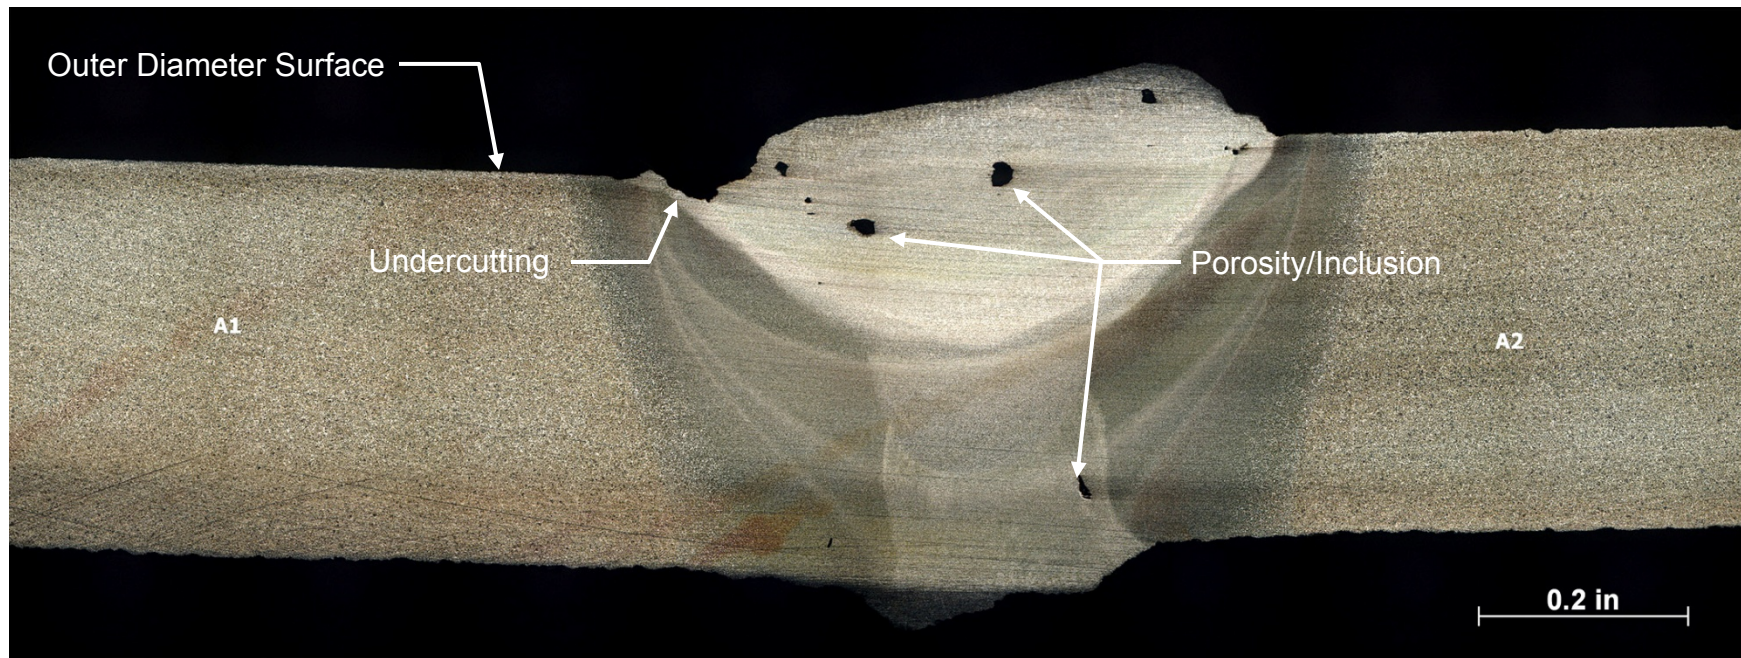
Girth weld A1/A2 was sectioned through a region with an undercutting discontinuity on the A1 side of the weld. Multiple porosity/inclusion discontinuities were visible in the weld as well. A 3° angle was measured between the A1 and A2 pipe walls on the cross section macrograph in Figure 10.

**Figure 10:** Cross section of girth weld A1/A2, etched using a solution of 4% nitric acid in ethanol.

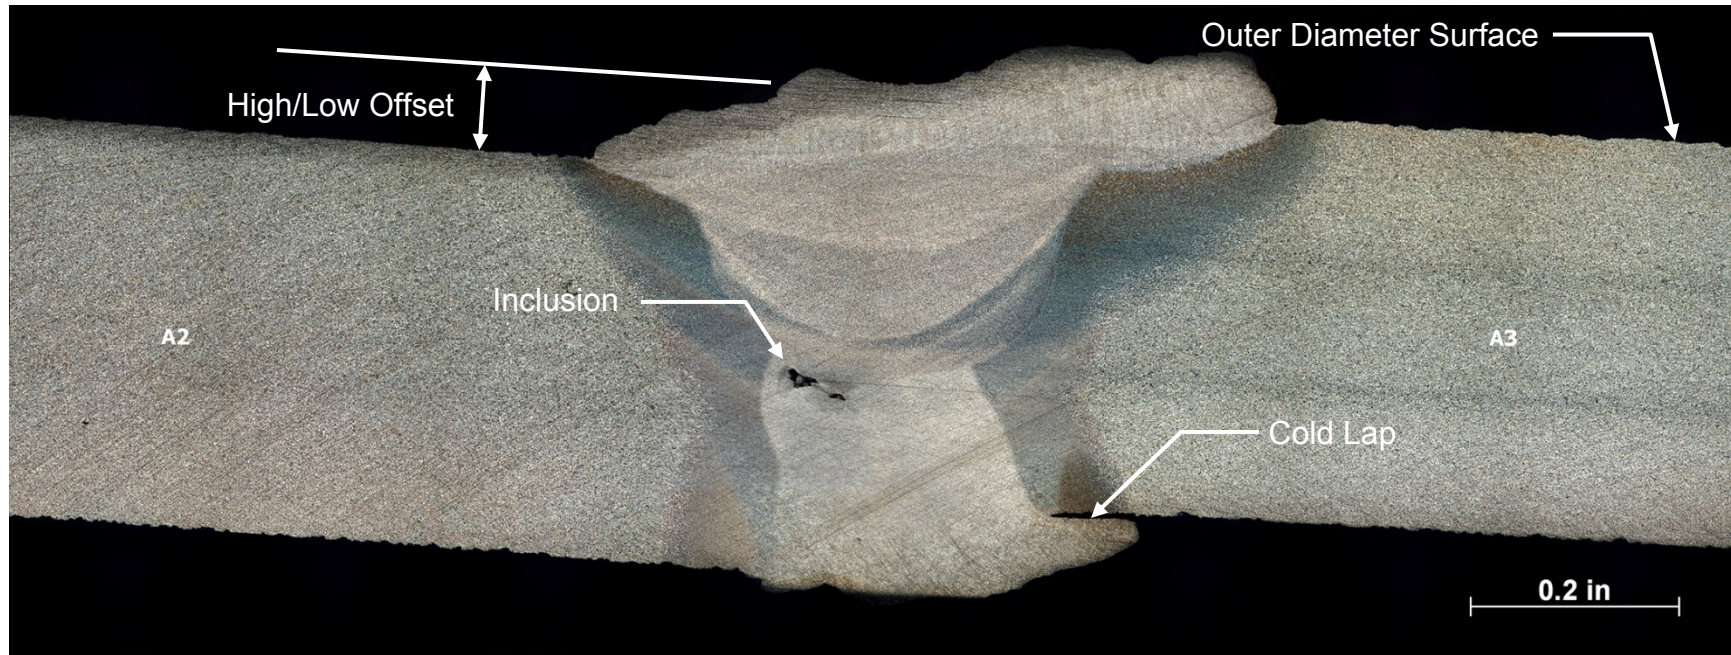
The region where girth weld A2/A3 was sectioned exhibited high/low offset, as shown in Figure 11. The offset was 0.088 inch, exceeding the maximum offset of 0.062 inch allowed for pipe of the same diameter according to API Std. 1104 (API, 1956). An inclusion discontinuity was visible in the weld. Cold lap was visible on the inner diameter surface on the A3 side of the weld where weld metal had not fused to the base metal.

**Figure 11:** Cross section of girth weld A2/A3, etched using a solution of 4% nitric acid in ethanol.

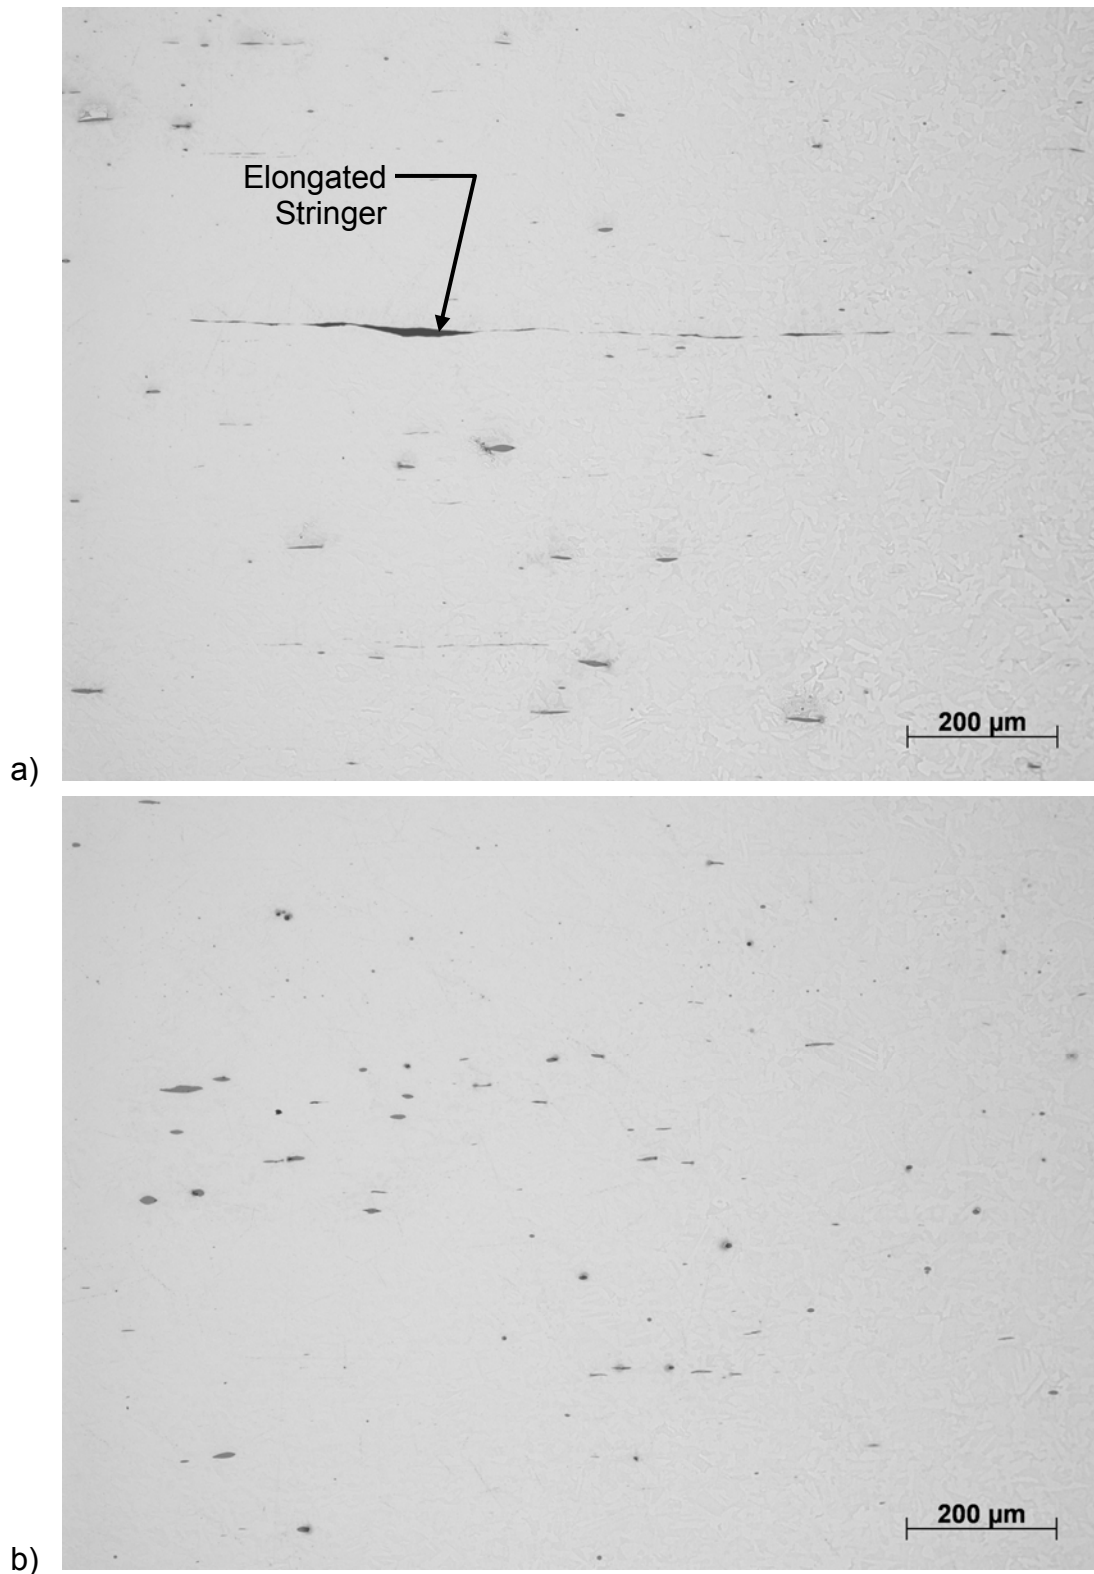
The rolling direction of A2 was determined by evaluating the orientation and relative length of manganese sulfide inclusions (stringers) on longitudinal and transverse metallographic cross sections. The samples were mounted, ground, and polished according to standard metallographic procedures (ASTM, 2001). Elongated stringers were observed in the longitudinal direction, as shown in Figure 12a, consistent with plate rolled in the longitudinal direction. By contrast, the stringers, when viewed in the transverse plane, were flattened but not elongated, as shown in Figure 12b.

**Figure 12:** Metallographic cross sections of A2; a) longitudinal cross section; b) transverse cross section.

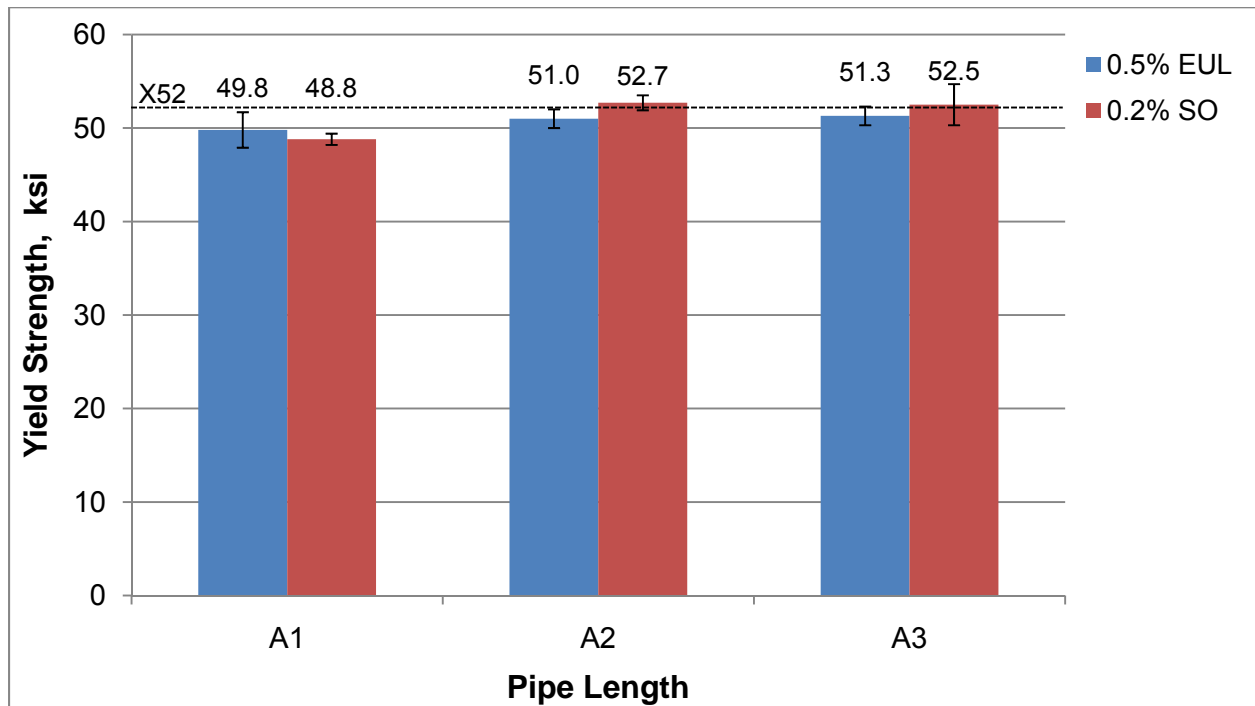
Tensile test data were compared to mechanical property requirements from PG&E pipe specifications (PG&E, 1948a, b). Material codes for pipe on material procurement orders for the 1956 relocation project corresponded to X52 DSAW pipe,<sup>5</sup> the same grade as in the above mentioned materials specifications (NTSB, 2011a, b). Table 3 lists the mean and one standard deviation for 0.5% EUL yield strength, 0.2% SO yield strength, tensile strength, and elongation. According to the 0.5% EUL method, the mean yield strength of A1, A2, and A3 fell below the specified minimum yield strength (SMYS) requirement for X52 pipe by 2.2 ksi, 1.0 ksi, and 0.7 ksi, respectively. According to the 0.2% SO method, A2 and A3 met the SMYS requirement and A1 fell below the requirement by 3.2 ksi. Figure 13 graphically represents the 0.5% EUL and 0.2% SO yield strength data. A dashed line is plotted on the graph representing the X52 SMYS. All lengths of pipe exceeded PG&E specification requirements for minimum tensile strength of 72.0 ksi and minimum elongation of 22%. Complete mechanical property data are presented in Appendix A and the test lab report is contained in Materials Laboratory Report 11-059 (NTSB, 2011c).

**Figure 13:** Yield strength data for A1, A2, and A3. The yield strength was measured by the 0.5% extension under load (EUL) method and the 0.2% strain offset (SO) method. The specified minimum yield strength was 52.0 ksi.
