NATIONAL TRANSPORTATION SAFETY BOARD

MATERIALS LABORATORY FACTUAL REPORT

Report No. 11-055

Place : Marshall, Michigan
Date : July 25, 2010
Vehicle : 30-inch diameter crude oil pipeline
NTSB No. : DCA10MP007
Investigator : Matt Nicholson, RPH-20

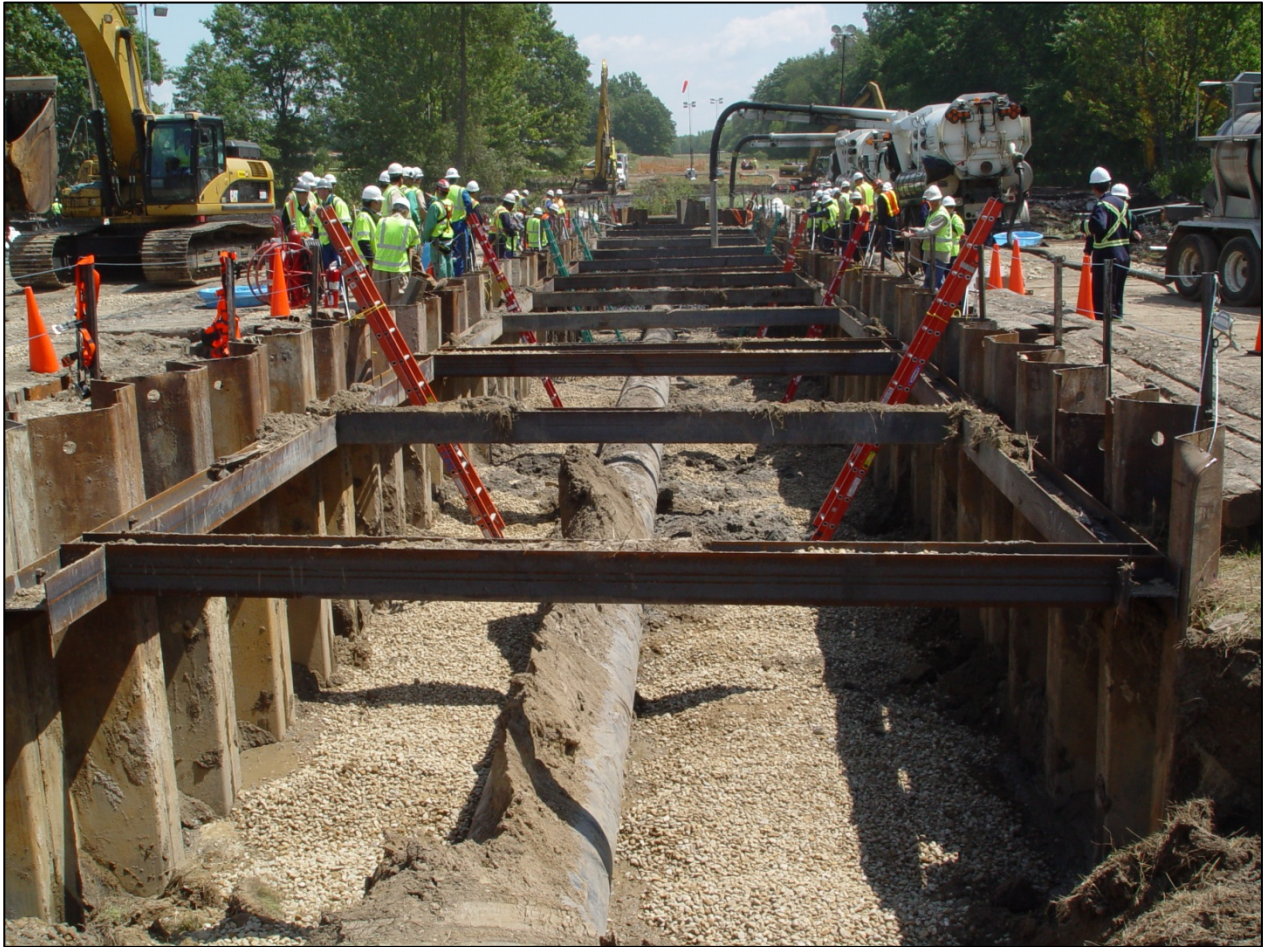
Figure 1. Overall view of the pipeline within the trench dug at the accident scene as viewed facing east.

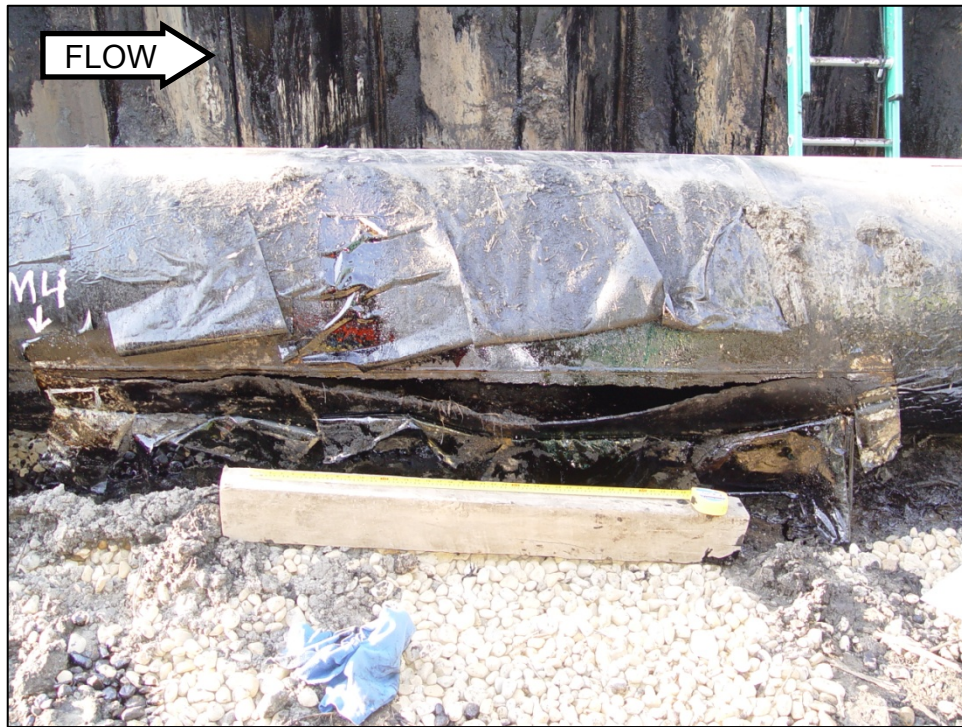
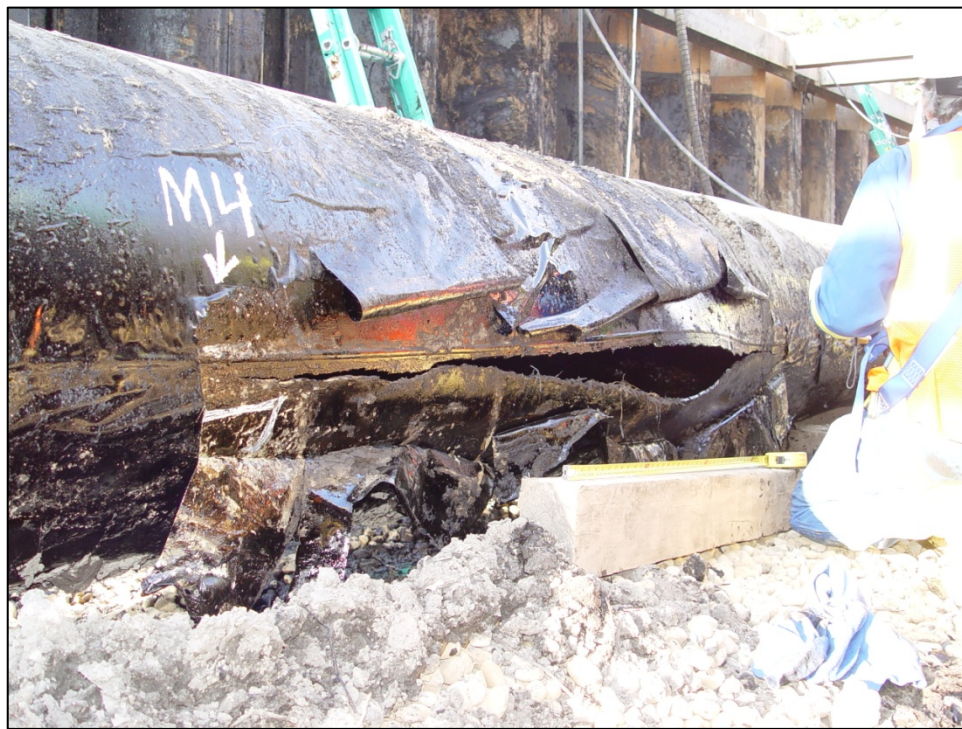
A trench was dug at the accident scene to expose the ruptured pipe joint and an additional 50 feet upstream and downstream of the ruptured joint. The pipe was supported by cradles as it was excavated. An overall view of the exposed pipeline in the trench is shown in figure 1. Views of the rupture as it was observed in the trench at the accident site are shown in figure 2. The rupture measured 6 feet 8.25 inches long. The upstream end of the rupture was located 24 feet 5.75 inches downstream of GWD217720. The longitudinal seam in joint 217720 was located 99.5 degrees clockwise⁵ from top dead center. The rupture was located 0.5 to 1.5 inches clockwise from the center of the longitudinal seam. The crack opening displacement between

Figure 2. Views of the pipe in the trench showing the rupture location.

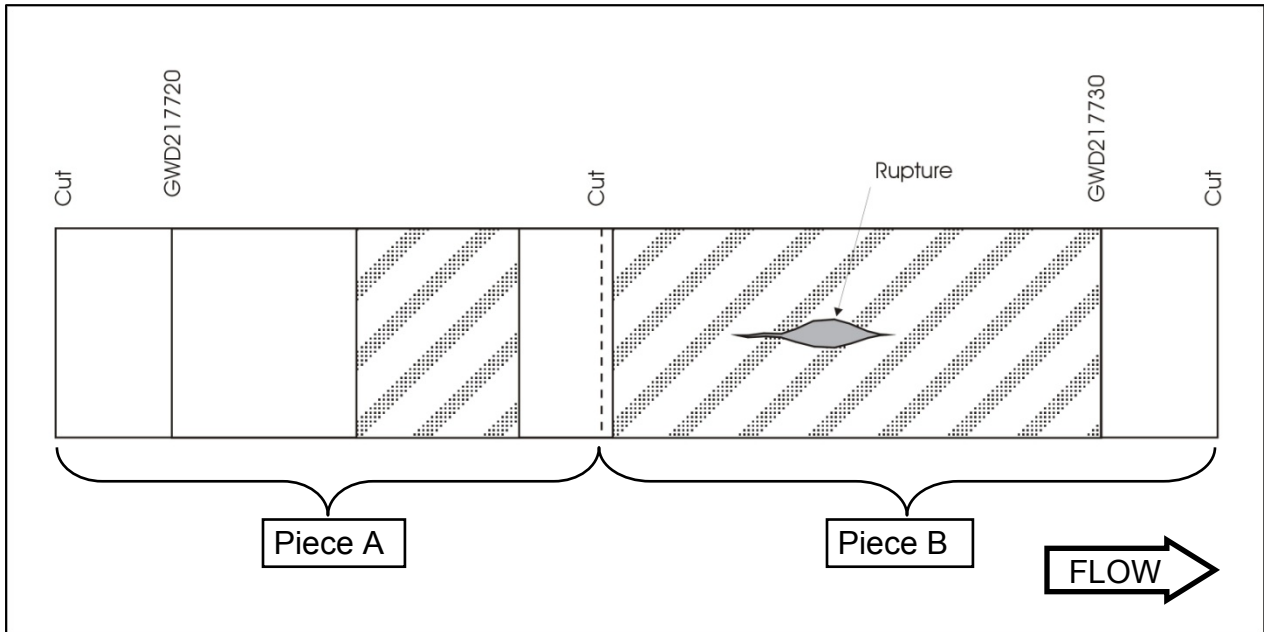
A review of ILI data from 2005 and 2009 was conducted on-scene. ILI data showed lengths of pipe within joint 217720 that had indications of crack-like features and/or metal loss generally located near the longitudinal seam. The lengths of pipe where ILI features were noted are shown as shaded areas in figure 3.

Figure 3. Schematic view of pieces A and B showing locations of girth welds, cuts, ILI features (diagonal shaded areas), and the rupture.

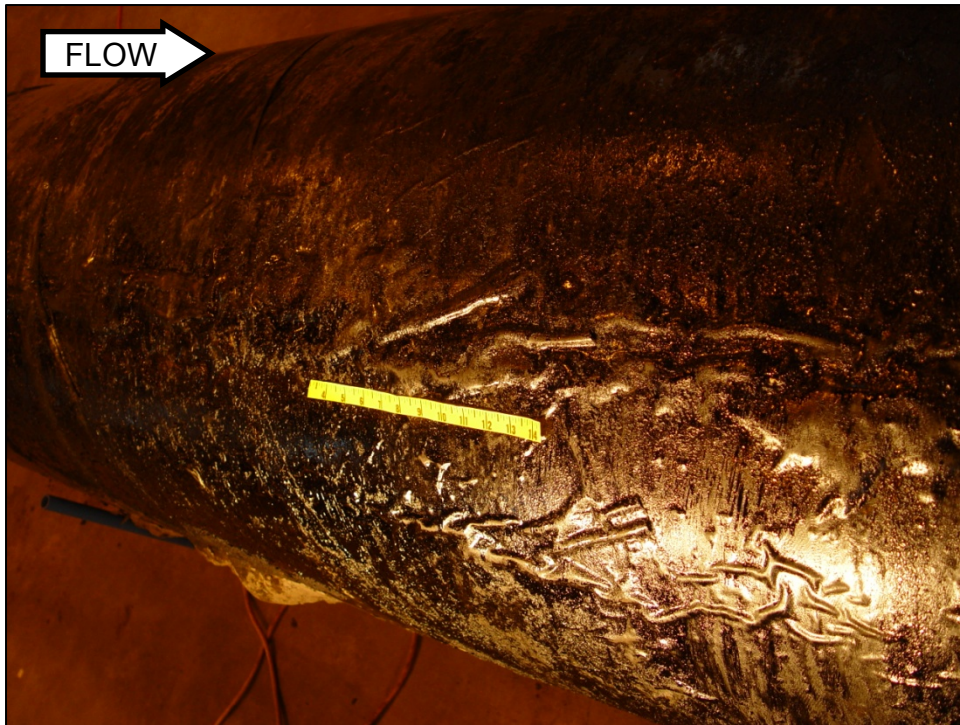
Views of typical coating features are shown in figures 5 to 8. Longitudinally-oriented wrinkles were observed in the coating mostly near the 3 o'clock and 9 o'clock positions. Wrinkling was most severe at the 3 o'clock side near the longitudinal seam for joint 217720 at positions starting approximately 9 feet from girth weld GWD217720 up to girth weld GWD217730. A view of wrinkles at the 3 o'clock position on piece B is shown in figure 5. Wrinkled areas generally had a soft feel when pressed inward. In many areas, the coating also showed bulging at the upstream edge of the tape overlap generally near the 3 o'clock to 5 o'clock positions such as shown in figure 6.

Figure 5. 3 o'clock position on the pipe piece B showing wrinkles in the coating.

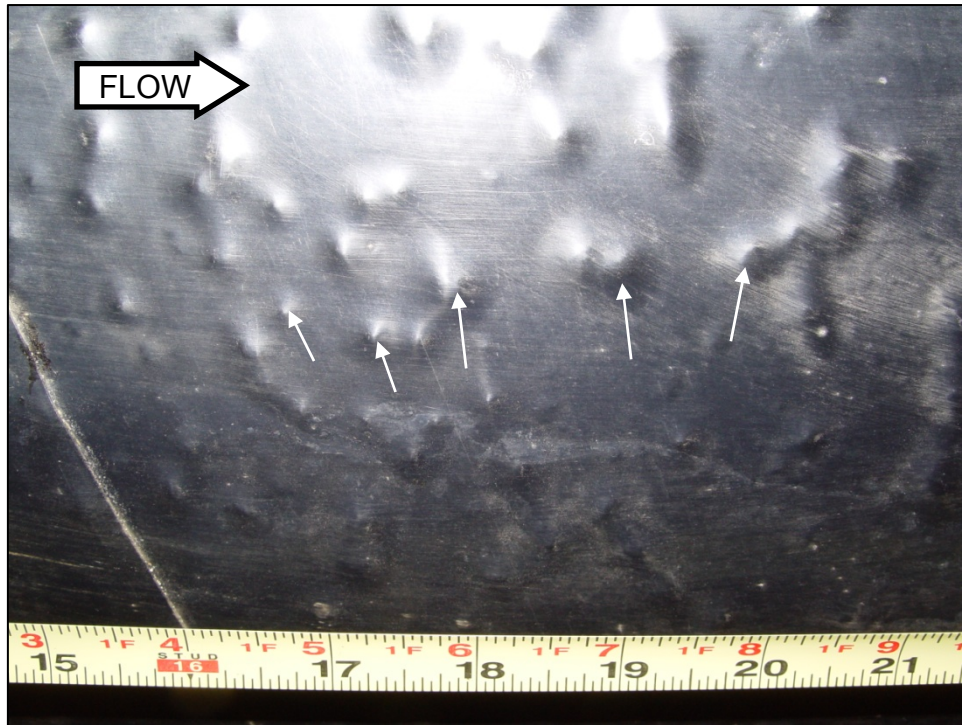
Isolated round bulges in the coating were also observed primarily from the 3 o'clock position clockwise to the 10 o'clock position. These areas were generally firm to the touch when pressed inward. The nodules were generally larger with more space between nodules at the lower quadrant of the pipe with typical diameters ranging from approximately 0.25 inch to 0.5 inch, as shown in figure 7. At the side and upper quadrants, the nodules were spaced closer together and were approximately 0.25 inches or less in diameter. The nodules were generally smaller and less prominent from 8:30 o'clock to 12 o'clock and were minimal from 12 o'clock to 3 o'clock, as shown in figure 8.

Figure 7. View of typical nodule features observed at the lower portion of the pipe. Arrows point to several of these nodules.

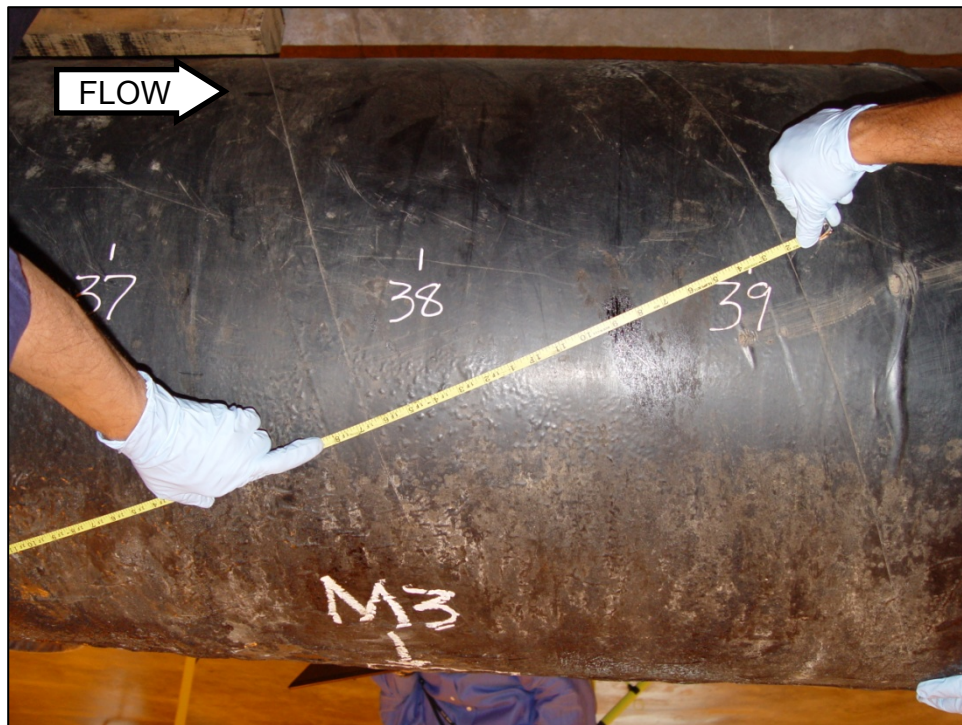
Figure 8. 12 o'clock position on pipe piece B showing relatively smooth coating features with smaller bulges near the 1 to 2 o'clock positions.

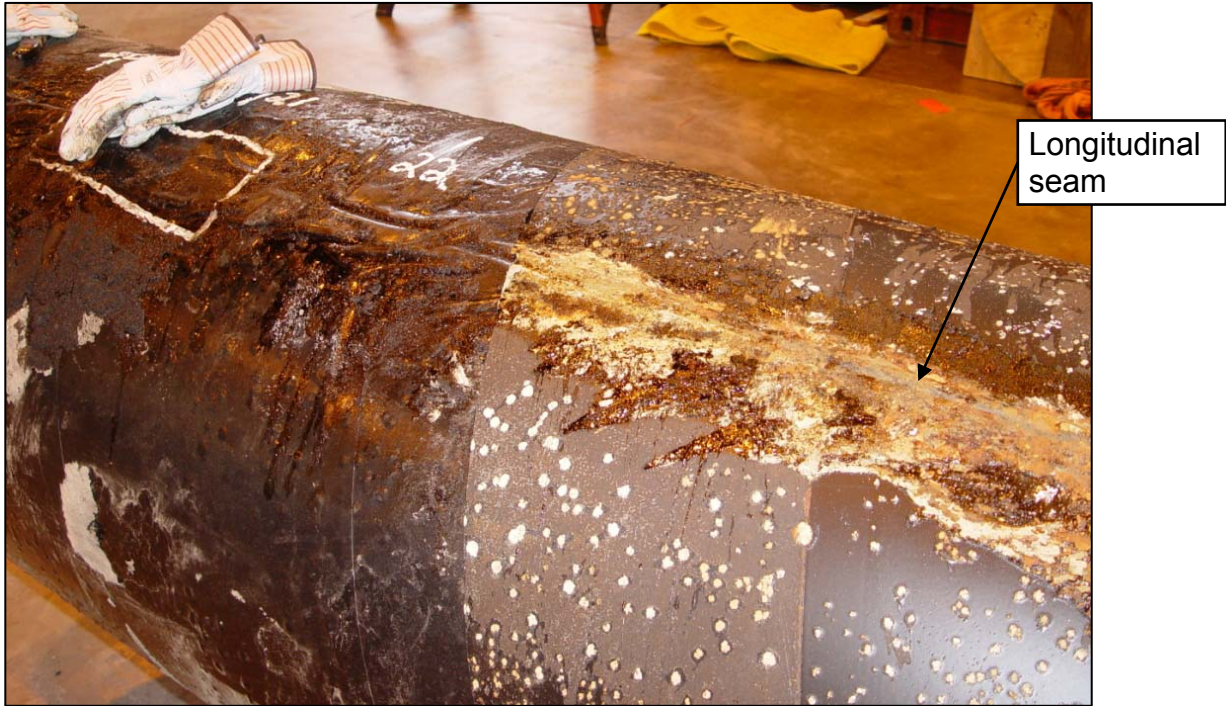
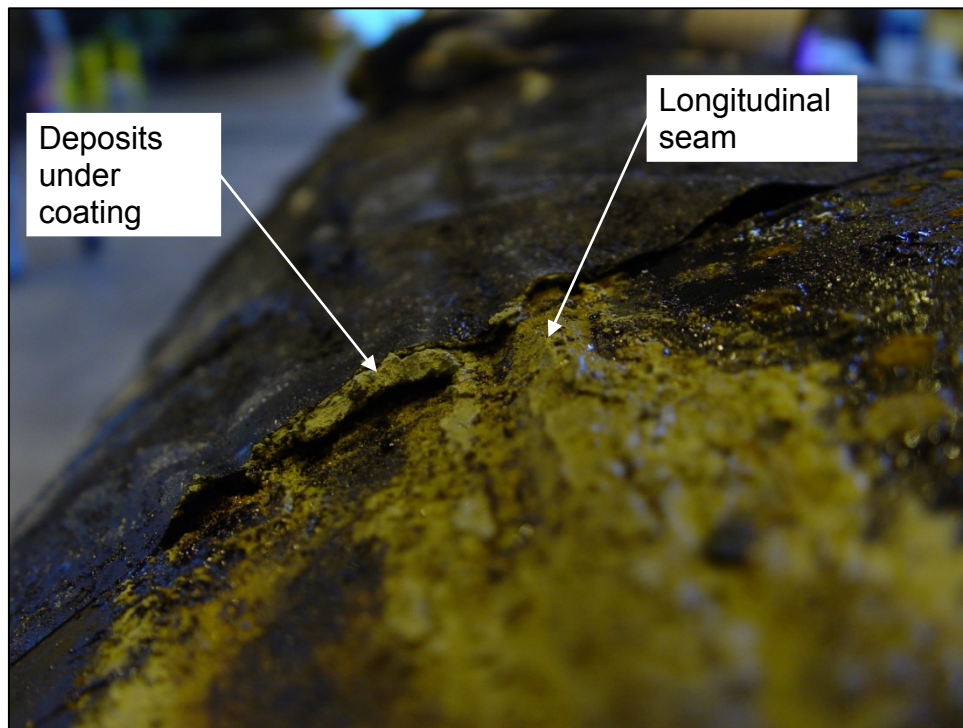
figure 9. In areas where nodules were observed, a powdery white material was observed. A view of the coating partially removed is shown in figure 10 with nodule material adhered to the pipe surface and to the removed coating material. When the nodule material was cleaned from the surface of the pipe, shallow areas of metal loss were observed.

Figure 9. Views of corrosion deposits on and near the longitudinal seam of piece B upstream of the rupture location.

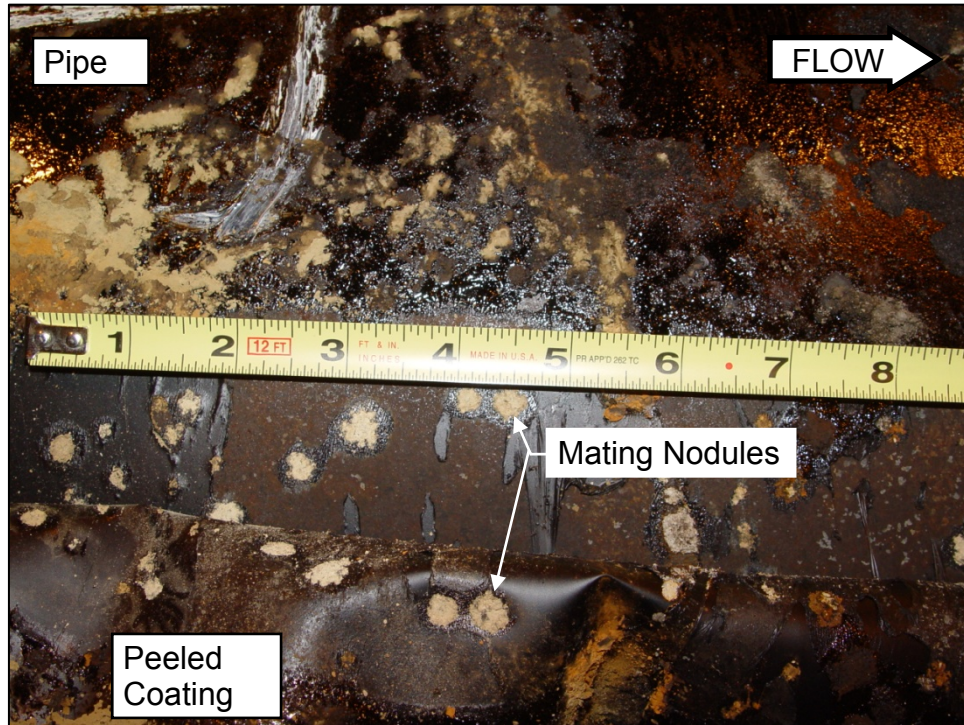
Figure 10. View of corrosion nodules as coating was peeled from the pipe surface near the rupture area.

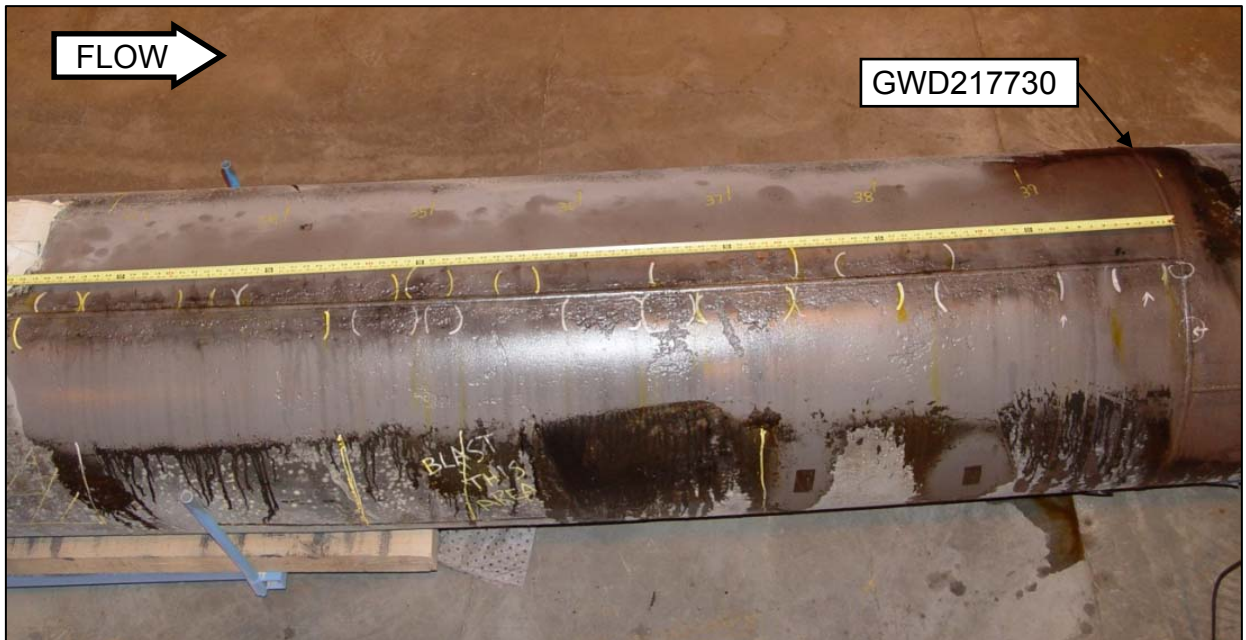
Nondestructive examination of the cleaned pipe external surfaces was completed by Eastern NDT, Hopewell, Virginia. Areas of the pipe surfaces that had been grit-blasted were examined using magnetic particle inspection (MPI). Clusters of longitudinally-aligned parallel crack indications were observed in areas of corrosion adjacent to the longitudinal seam in joint 217720, features associated with stress-corrosion cracking (SCC). Cracks were detected both clockwise and counterclockwise from the longitudinal seam in 17 areas downstream of the rupture to the girth weld as shown in figure 11. Areas where cracks were detected were denoted using parenthesis marks that were drawn on the surface of the pipe at either end of the clusters. The crack clusters did not necessarily have a continuous crack within the regions indicated. Clusters of crack indications were also detected in areas of corrosion at the clockwise side of the longitudinal seam upstream of the rupture at locations from 21 feet to 23.5 feet from the upstream girth weld. In piece A, clusters of crack indications were detected in three areas from 10.5 feet to 13.5 feet from the upstream girth weld also in areas of corrosion on the clockwise side of the longitudinal seam. Close views of several areas where clusters of crack indications were observed are shown in figures 12 and 13. Longitudinally-oriented faint crack indications were also detected within the weld bead in girth weld GWD217730 in areas shown circled in figure 11.

Figure 11. Overall view of the pipe with coating removed and abrasively cleaned showing areas of crack indications detected near the longitudinal seam downstream of the rupture location on joint 217720. Areas where crack indications were observed are bounded by parenthesis marks, and areas of faint indications on GWD217730 are circled.

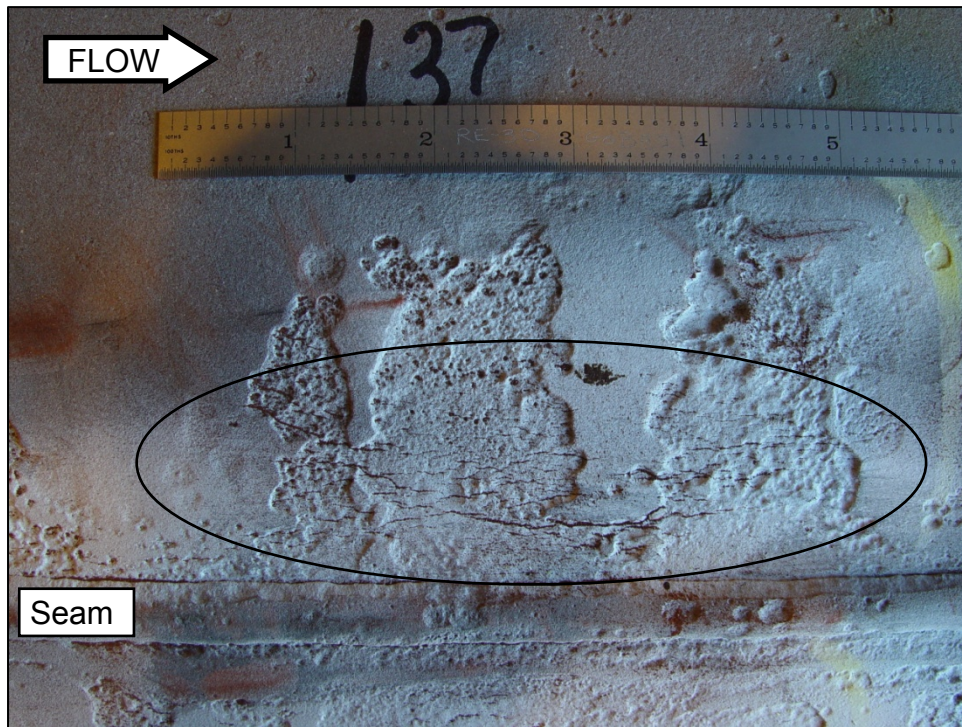
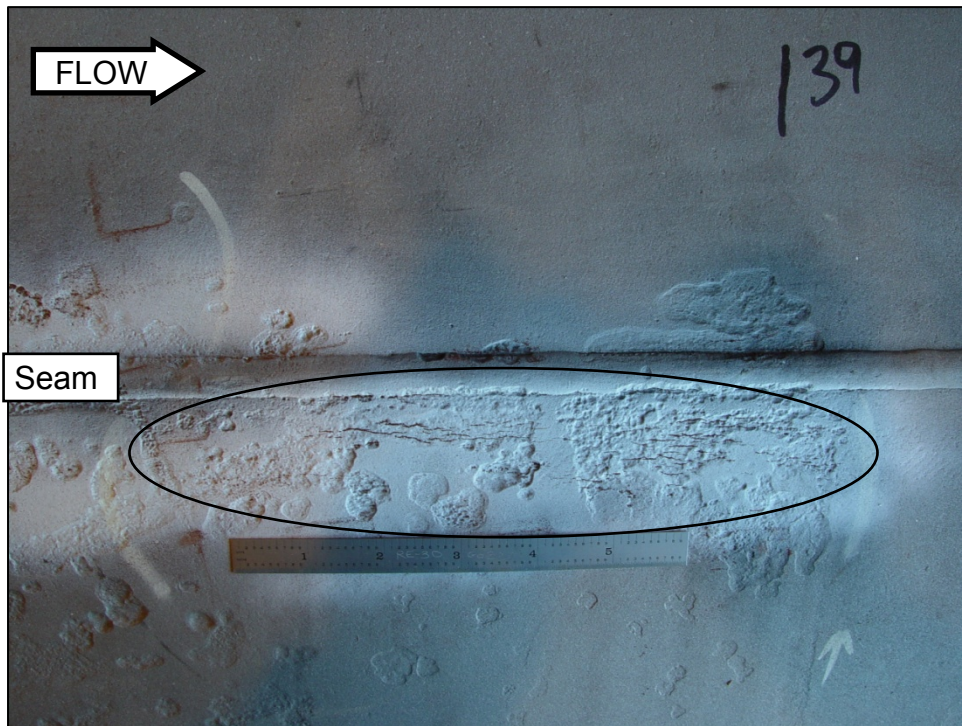
Figure 12. Views of clusters of crack indications at two locations on joint 217720 downstream of the rupture location. Crack clusters were located within the circled areas.

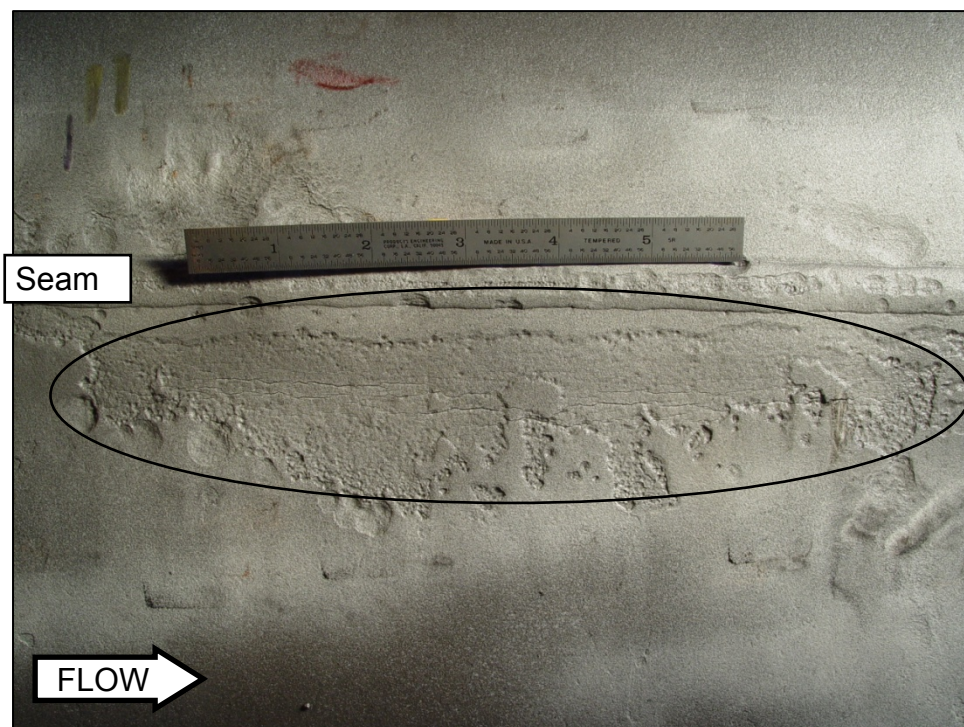
Figure 13. Close view of a crack cluster on piece A located between 11 and 12 feet downstream of girth weld GWD217720. Crack clusters were located within the circled area.

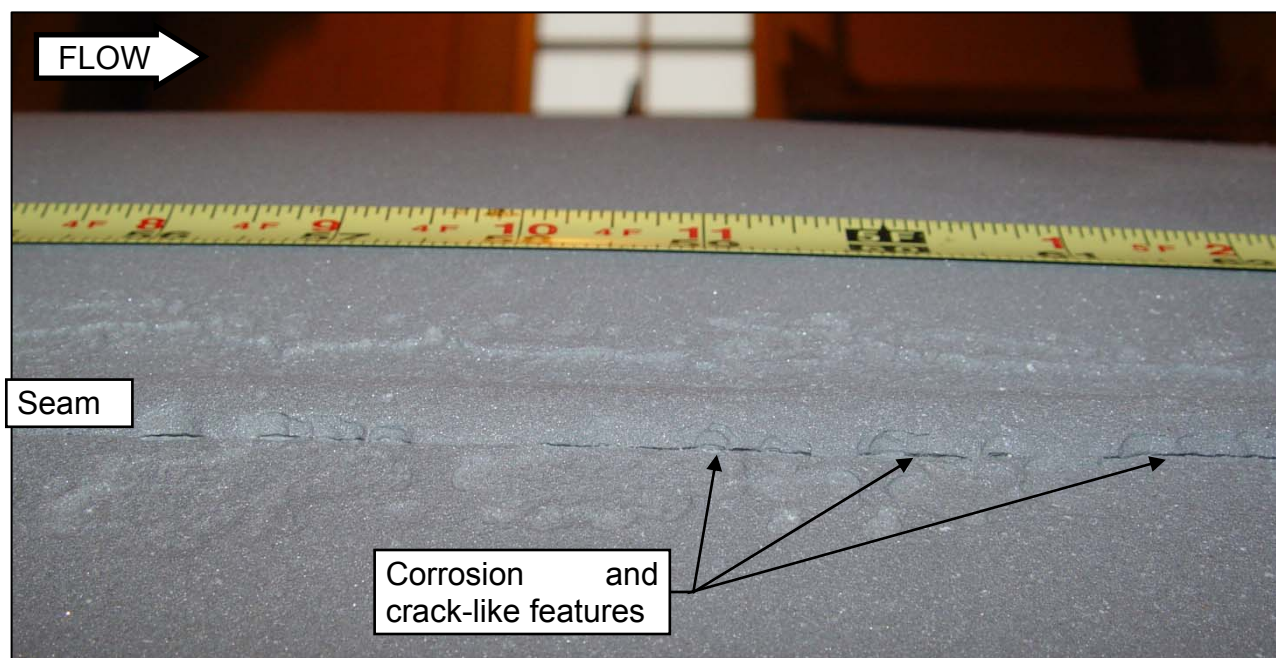
No crack indications were detected using MPI near the longitudinal seam in joints 2177210 or 217730, and no crack indications were detected in areas of the pipe wall inspected away from the longitudinal seam. However, crack-like features and corrosion were visible at the weld toes for the longitudinal seam in joint 217730. According to the ASNT Level III-certified inspector conducting the MPI, these features at the weld toes are not typically detected or noted as indications during MPI. Figure 14 shows an oblique view of the longitudinal seam where corrosion and crack-like features are visible at the toe of the weld on the clockwise side of the weld.

Figure 14. Oblique view of the longitudinal seam in joint 217730 showing typical corrosion and crack-like features at the toe of the weld.

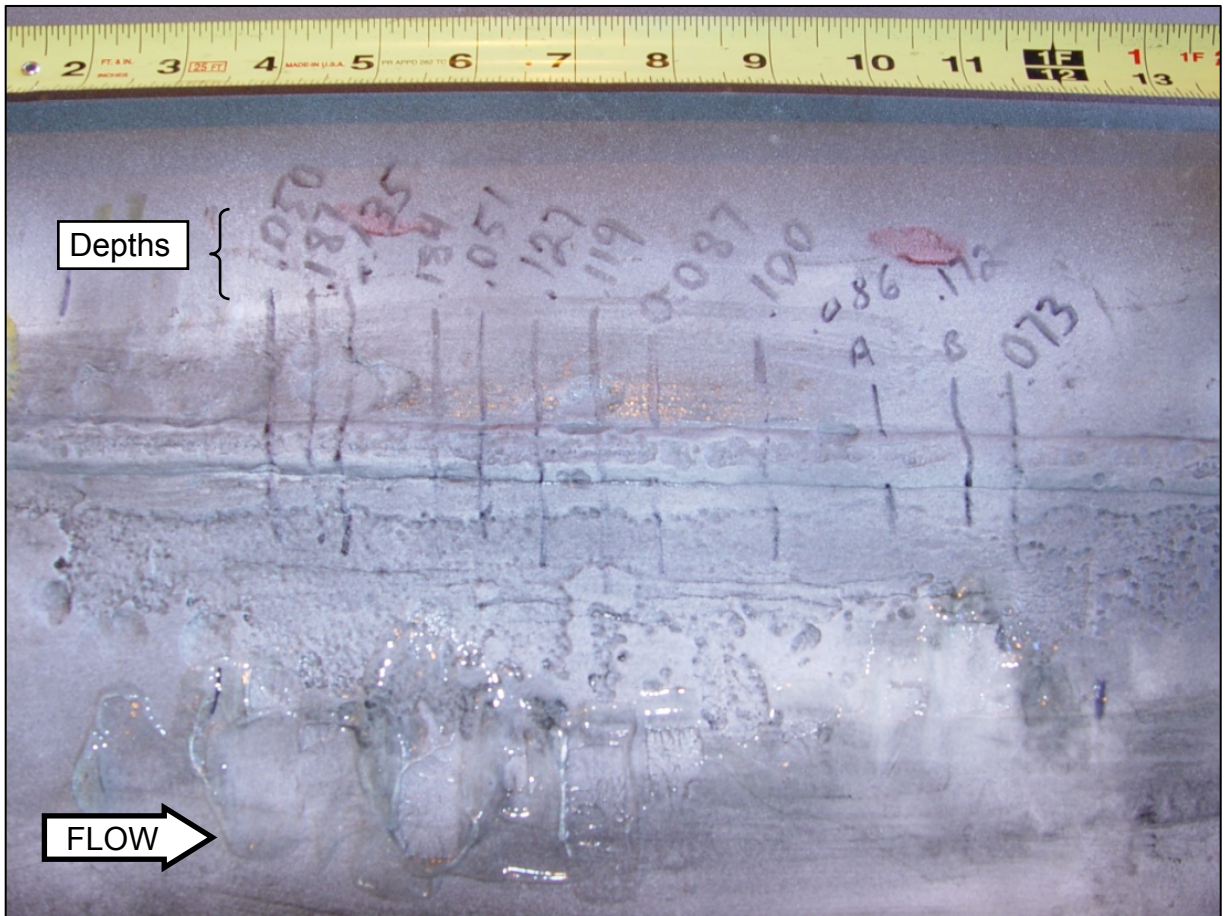
Several locations with stronger crack indications from the MPI were selected for inspection using an NDT Systems, Inc. (Huntington Beach, California) Avenger ultrasonic flaw detector to estimate crack depths. Results of this inspection for the area shown in figure 13 are shown in figure 15. Crack depths measured to the nearest 0.001 inch were marked with permanent marker on the surface of the pipe as shown in figure 15. The deepest crack penetration was estimated to be 0.187 inch in the area shown in figure 15, which was located clockwise from the longitudinal seam between approximately 11 feet 0 inches and 11 feet 11 inches from GWD217720. Areas shown in figure 12 (shown as viewed before testing) had maximum detected crack penetration values of 0.184 inch in the area of the upper photo and 0.183 inch in the area of the lower photo. The area shown in the upper photo in figure 12 was located counterclockwise from the longitudinal seam between approximately 36 feet 11 inches and 37 feet 4 inches from GWD217720. The area shown in the lower photo in figure 12 was located clockwise from the longitudinal seam between approximately 38 feet 4 inches to 39 feet 1 inch from GWD217720.

Figure 15. View of area shown in figure 13 after inspection using an ultrasonic flaw detector to estimate crack depths. Depth indications in units of inches are marked directly on the pipe surface with a line pointing to the location where the depth reading was obtained.

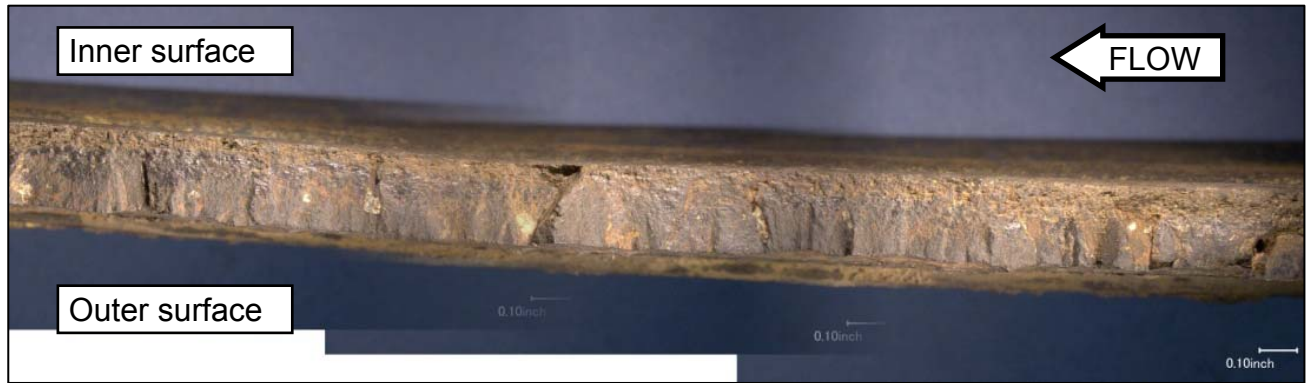
Fracture features were cleaned progressively using trichloroethylene, acetone, and a solution of Alconox detergent in hot water and gentle scrubbing with a soft-bristle brush. A close view of the fracture surface after this cleaning procedure is shown in figure 18. Black oxide was observed on the flat fracture features consistent with oxidation in an oxygen-poor environment such as a preexisting crack.

Figure 18. Close view of the fracture surface after cleaning with solvents and Alconox/water solution. Image is stitched together from 3 individual images using Stream Enterprise software by Olympus, Center Valley, Pennsylvania.

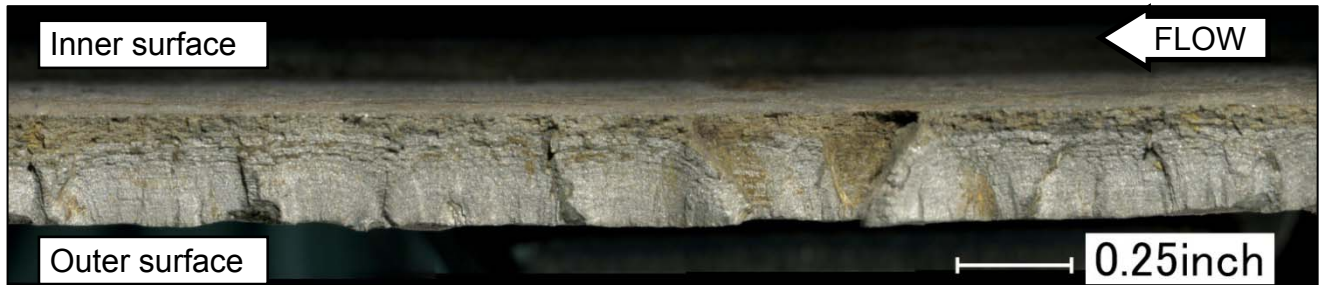
Close views of the fracture surface and the adjacent outer surface on piece B4-1c-ii in the area of deepest crack penetration after oxide removal are shown in figures 20 and 21. A closer view of the area of deepest penetration is shown in figure 22. Flat fracture features with curving arrest lines and boundaries were observed extending across up to approximately 81 percent of the wall thickness across the fracture face. The total wall thickness at this location as measured across the fracture face was 0.217 inch. Transgranular fracture features in planes perpendicular to the wall surfaces emanated inward from corrosion pits at the exterior surface consistent with preexisting cracks such as near-neutral-pH SCC or corrosion-fatigue.^{9,10,11} The extent of preexisting crack propagation in the area of deepest penetration is indicated with a dashed line in figure 22. The remainder of the fracture surface across the remaining 19 percent of the fracture face had matte gray rough fracture features on a slant plane consistent with overstress fracture.

Figure 20. Close view of the fracture surface at the area of deepest crack penetration after cleaning with oxide-removing chemicals.

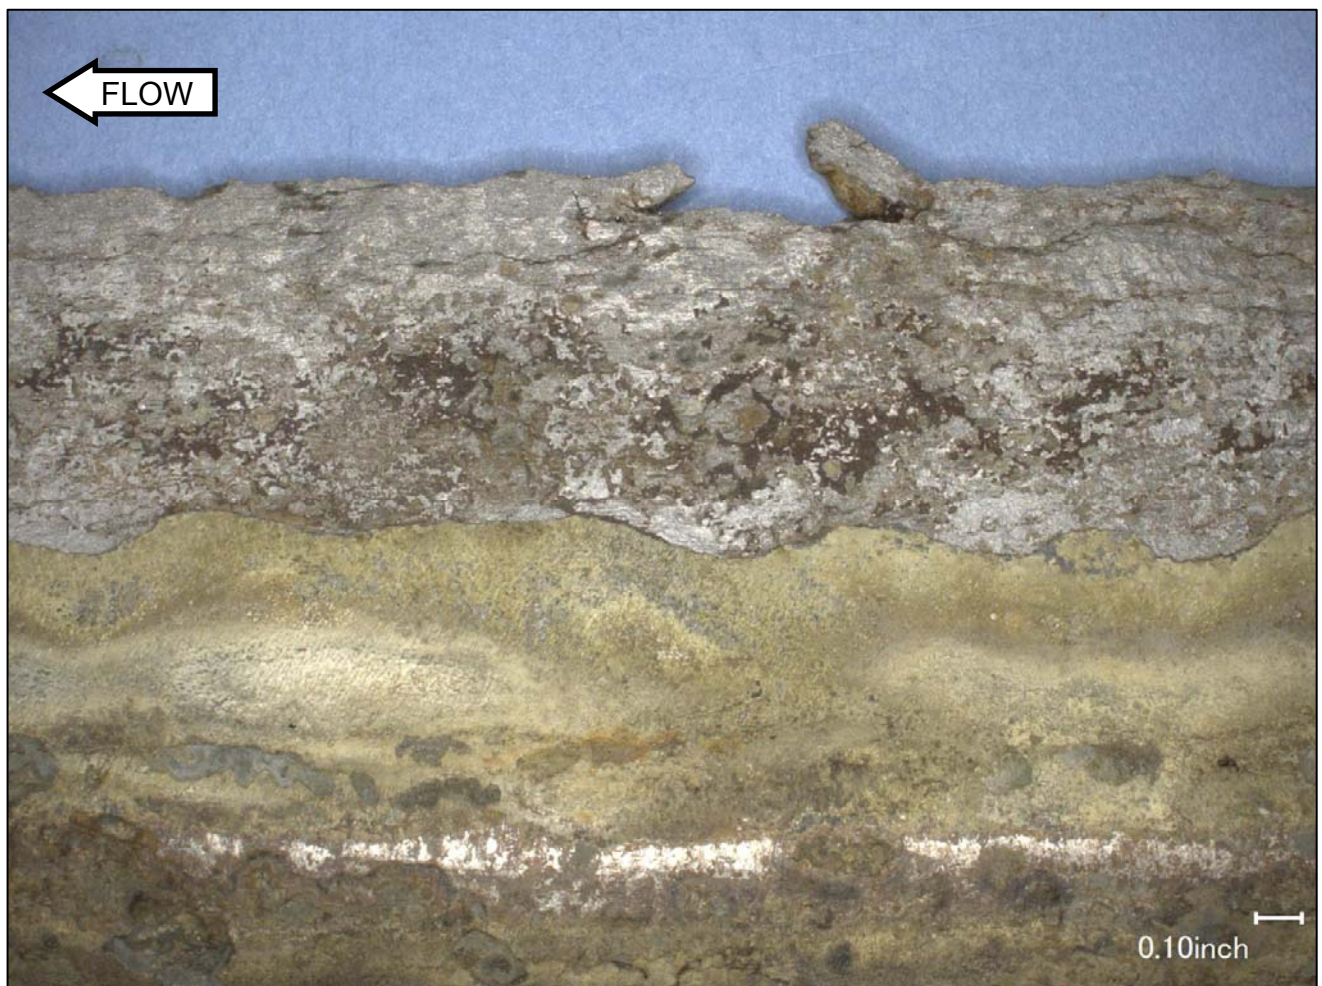
Figure 21. View of exterior surface of the pipe at the area of deepest crack penetration after cleaning with oxide-removing chemicals.

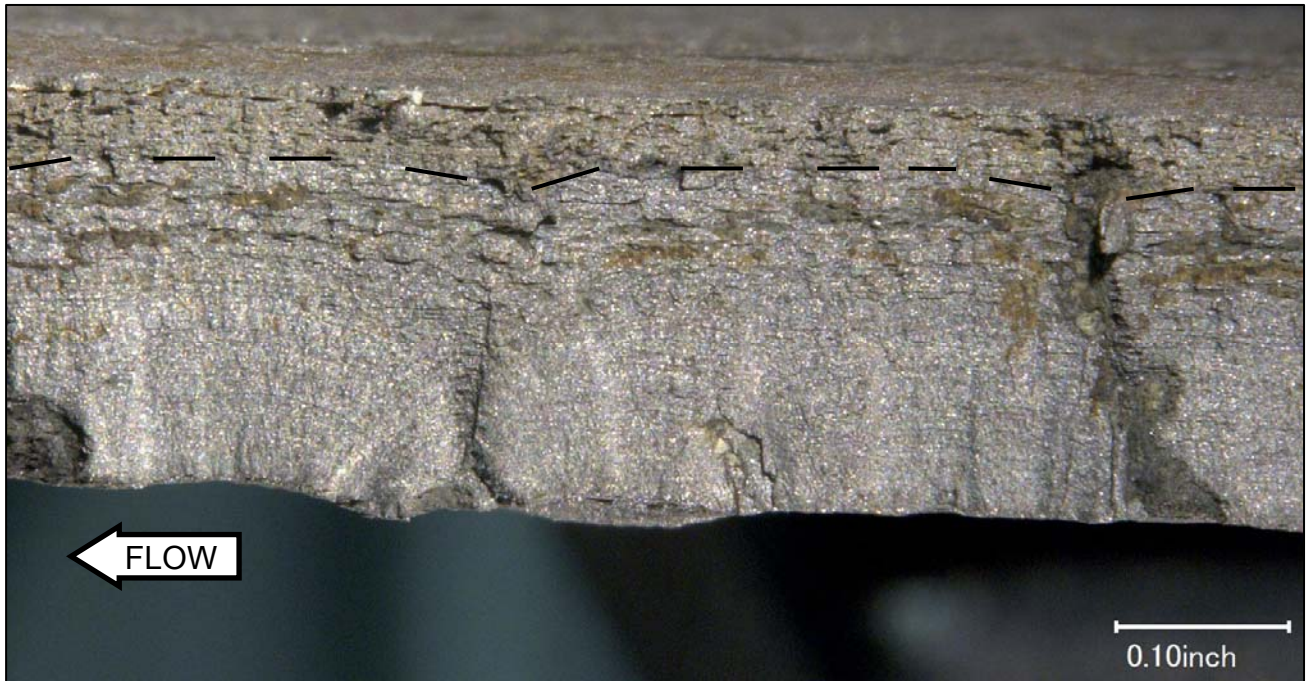
Figure 22. Close view of the fracture surface in the area of deepest crack penetration. A dashed line indicates the extent of the preexisting crack penetration.

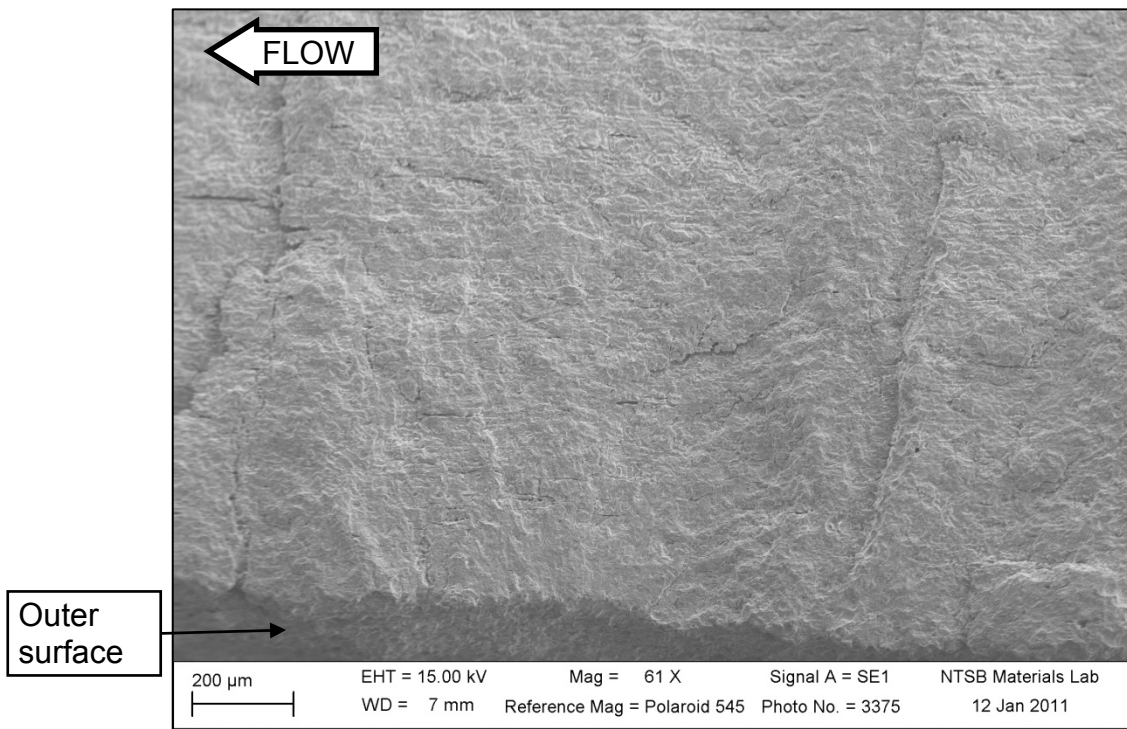
The fracture surfaces of piece B4-1c-ii were examined using SEM, and views of the fracture surface near the area of deepest preexisting crack penetration are shown in figures 23 through 26. Fine crack arrest features such as those shown in figures 24 and 25 were typically observed within approximately 0.015 inch of the crack origins. Further from the origins, broad crack arrest features were observed such as those shown in figure 26. Crack arrest features are indications of preexisting cracks and can be associated with SCC or corrosion-fatigue. Microstructural features were also observed on the fracture surface and were oriented in planes generally parallel to the pipe inner and outer surfaces. Areas where the fracture intersected pearlite in the microstructure appeared brighter and rougher than areas corresponding to ferrite. These features

Figure 23. Overall SEM view of an origin area near the area of deepest penetration.

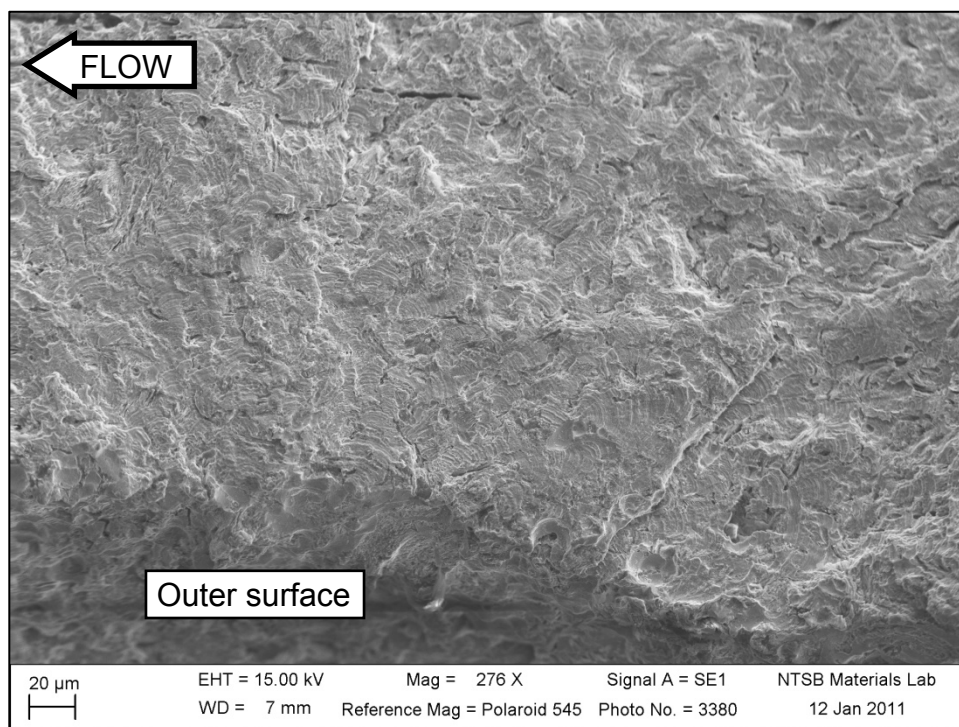
Figure 24. Close view of crack arrest features near the origin of the crack shown in figure 23.

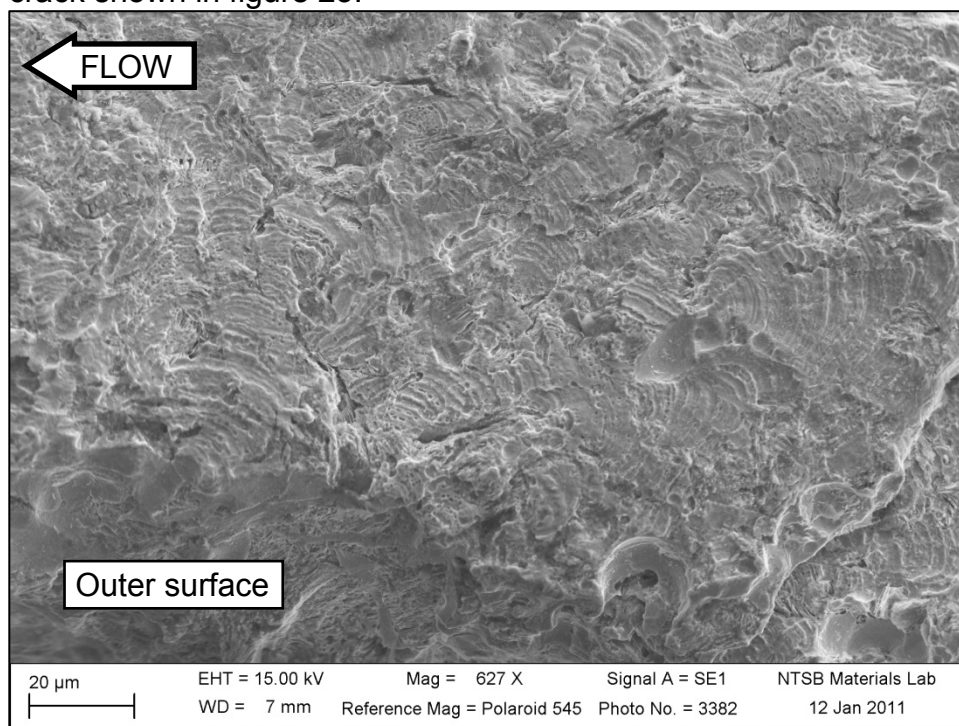
Figure 25. Closer view of crack arrest features at the origin shown in figure 24.

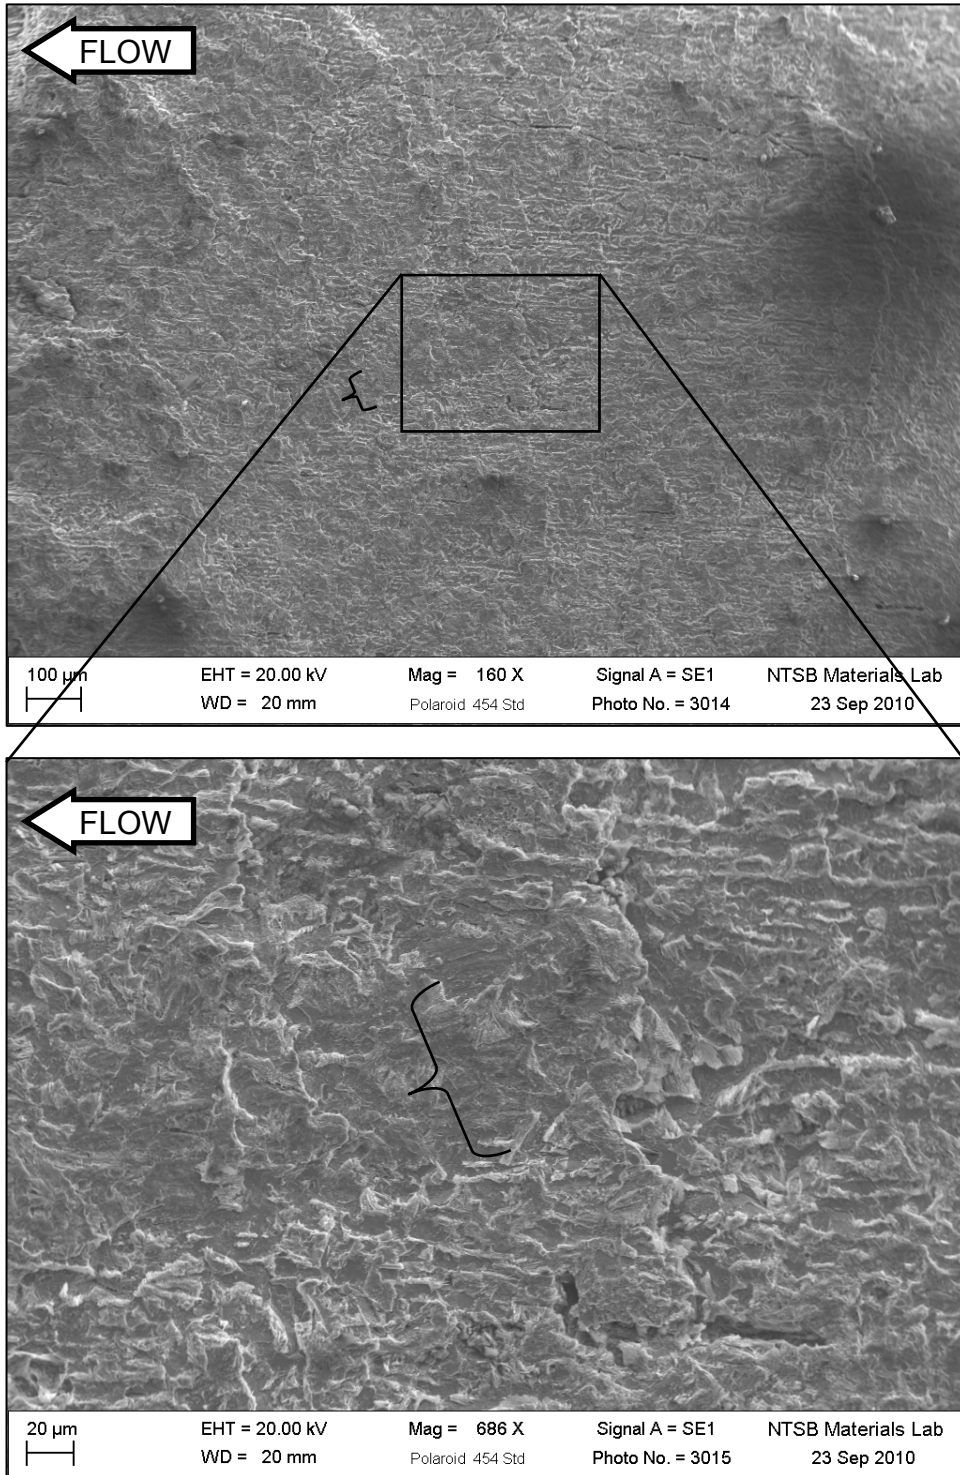
appeared on the fracture surfaces as alternating bands of brighter and darker areas that were oriented with the long direction of the bands parallel to the axis of the pipe.

Figure 26. Views of broad crack arrest features further from the origin at a site near the area of deepest penetration. Brackets indicate the location of this feature appearing as a darker curving area on the fracture surface.
