NATIONAL TRANSPORTATION SAFETY BOARD

MATERIALS LABORATORY FACTUAL REPORT

Report No. 11-055

Place : Marshall, Michigan
Date : July 25, 2010
Vehicle : 30-inch diameter crude oil pipeline
NTSB No. : DCA10MP007
Investigator : Matt Nicholson, RPH-20

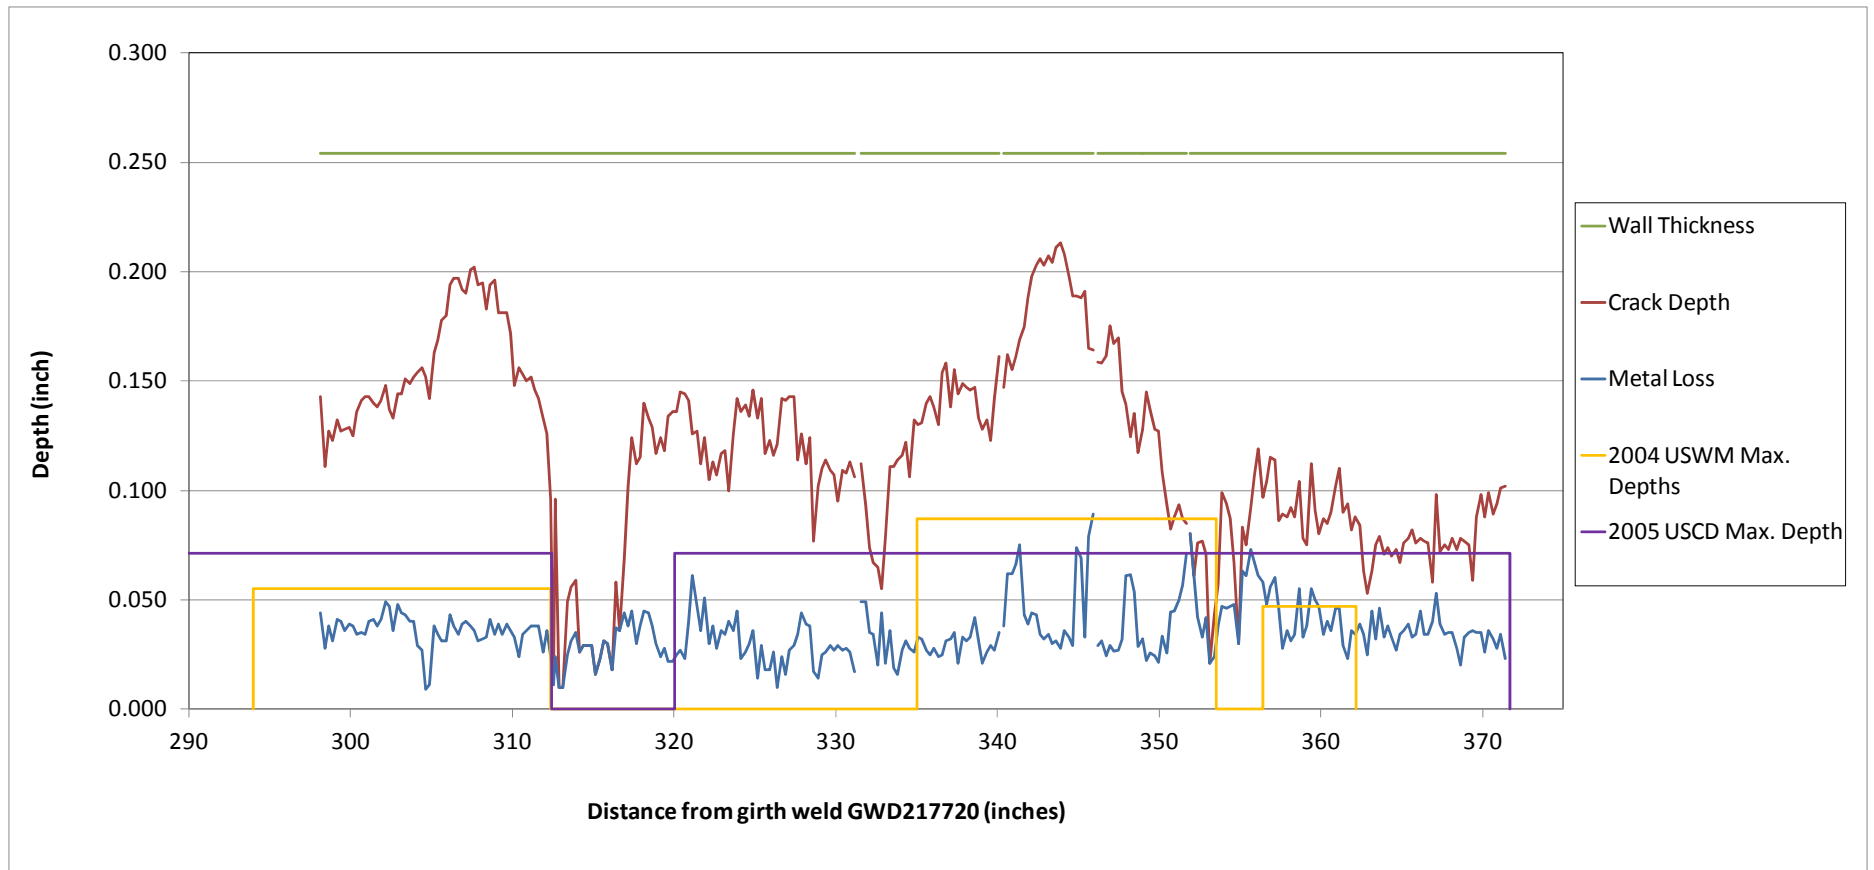
Results of the crack depth and external metal loss measurements are shown in the graph in figure 27. As shown in the graph, the maximum depth of penetration of the crack relative to the approximate original exterior wall surface was 0.213 inch at a location approximately 344 inches away from GWD217720. Figure 27 also shows results from the 2004 ultrasound wall measurement (USWM) and 2005 ultrasound crack detection (USCD) in-line inspection (ILI) tools. For more details regarding the ILI data, see section D.15 of this report.

Figure 27. Crack profile data for the rupture at the area of deepest crack penetration showing metal loss depth and crack penetration depth along the length of the rupture at $\frac{1}{4}$ -inch increments. Breaks in the data indicate locations where cuts were made. Metal loss depth and crack penetration depth are referenced to the estimated original wall exterior surface as determined using an average of micrometer measurements in adjacent areas that appeared free from corrosion features. The wall thickness in this plot represents the wall thickness determined from the micrometer measurements. The yellow and purple lines indicate results from the 2004 ultrasound wall measurement (USWM) and the 2005 ultrasound crack detection (USCD) in-line inspection (ILI) tool inspection reports, respectively, showing locations and maximum depths for features reported in this area. (Additional details of the ILI inspections are included in Section D.15 of this report.)

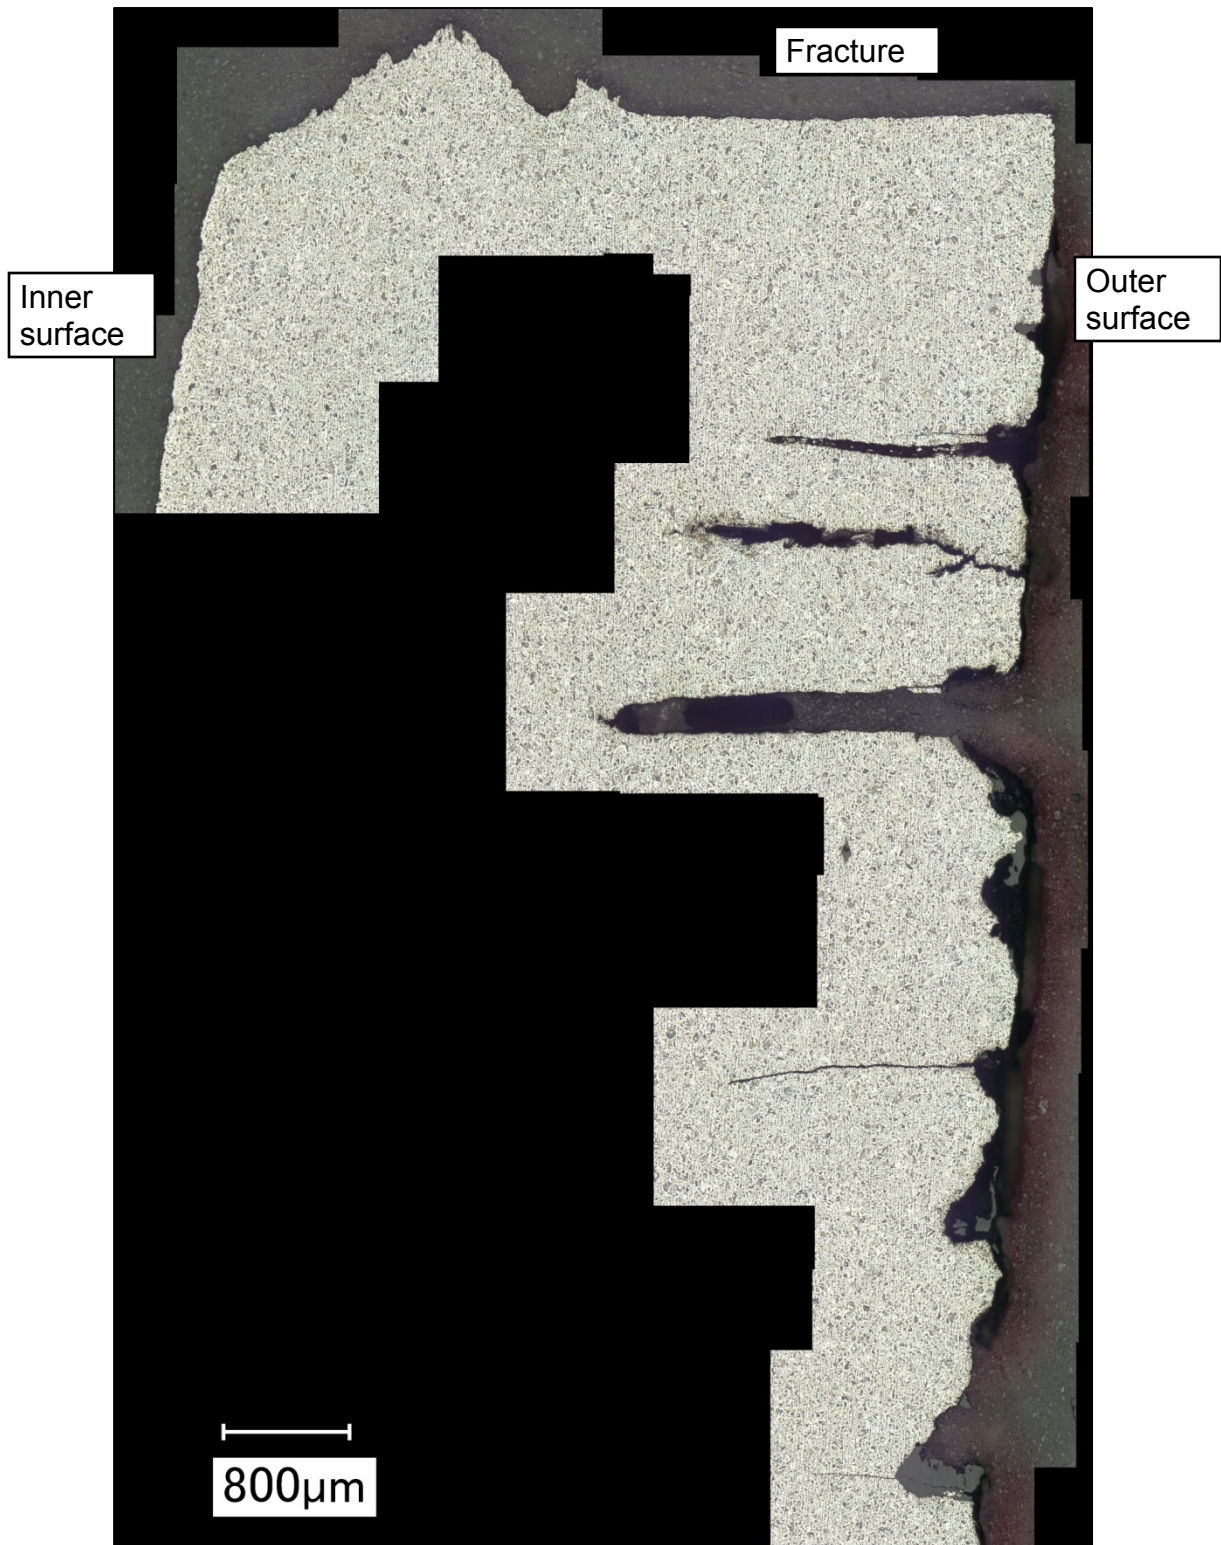
indicated by MM1 and MM2 in figure 19. Polished cross-sections were etched using 2 percent Nital etchant. Views of typical crack features in the mounted cross-sections are shown in figures 28 and 29. Multiple closely-spaced cracks with transgranular propagation paths and limited crack branching were observed, features consistent with near-neutral-pH SCC or corrosion-fatigue. The deepest of the secondary cracks shown in figure 28 extended through approximately 43 percent of the wall thickness.

Figure 28. Montage of a polished and etched transverse cross-section (mount MM1) showing the fracture surface and multiple secondary cracks.

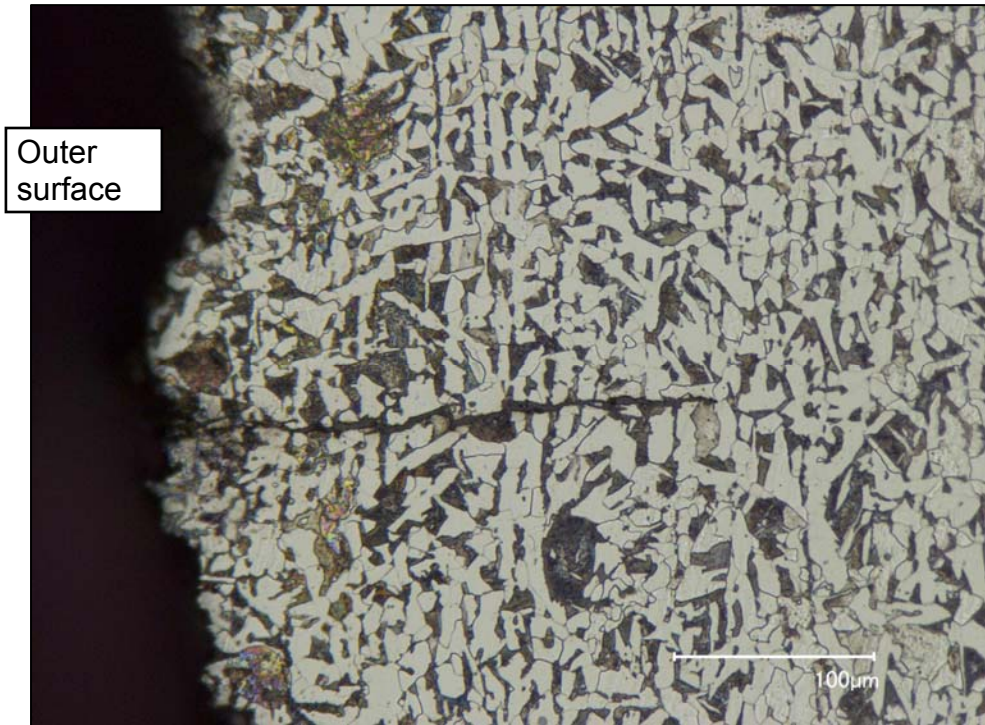
Figure 29. Close view of one of the smaller secondary cracks in a polished and etched transverse cross-section (mount MM2).

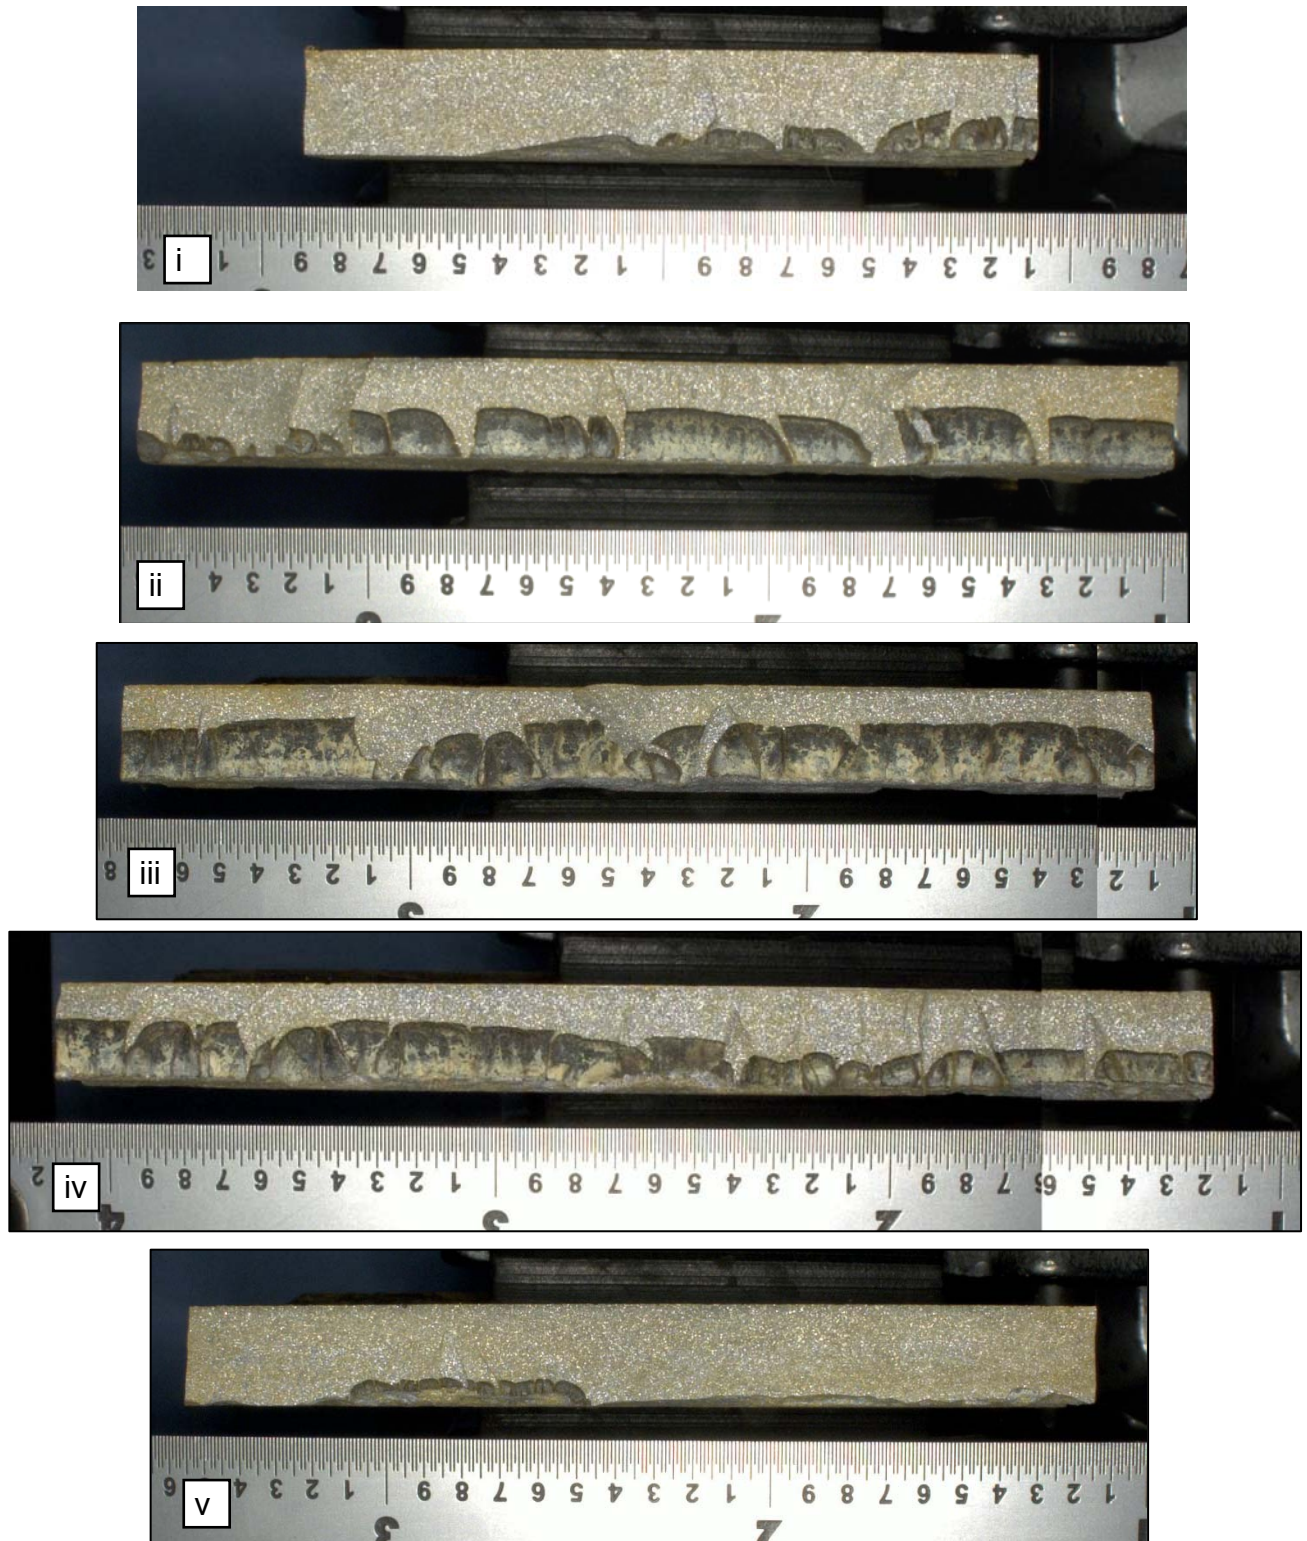
Overall views of the fracture surfaces are shown in figures 34 to 36. Each fracture surface showed dark areas with curving boundaries consistent with preexisting cracking such as SCC or corrosion-fatigue. Cracks emanated from multiple origins at the outer surface. The maximum depth of crack penetration was 69 percent, 50 percent, and 45 percent of the wall thickness in lab fractures from samples A1d2, B2b2, and B2d2, respectively.

Figure 34. Overall views of lab fracture surfaces of samples A1d2i-v. The ruler is adjacent to the outer surface in each photo, and the pipe flow direction is from left to right.

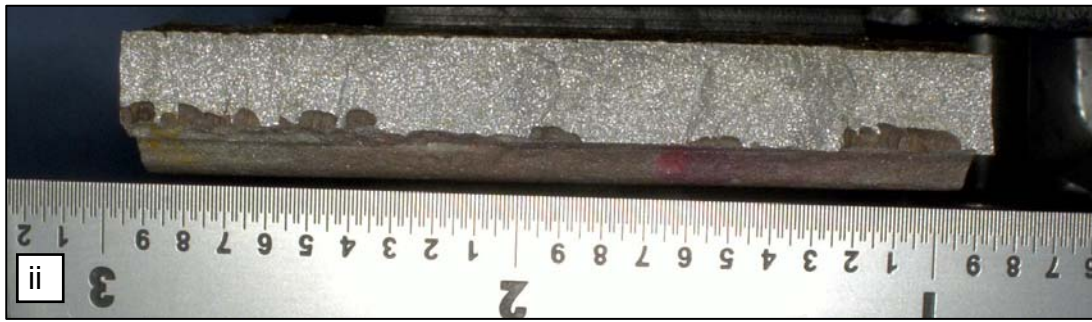
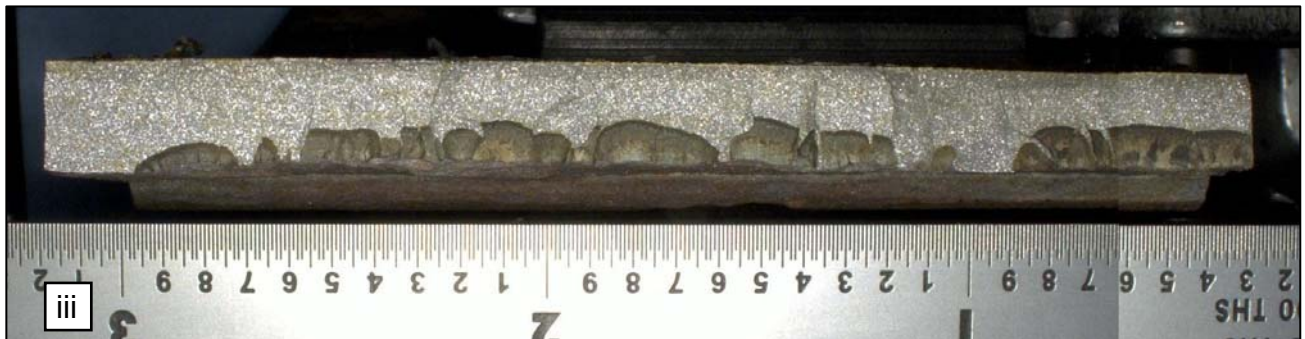
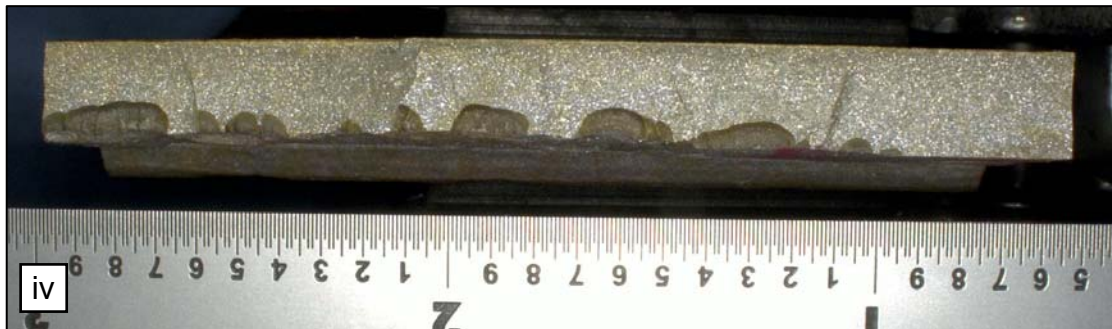
Figure 35. Overall views of lab fracture surfaces of samples B2b2ii-iv. The ruler is adjacent to the outer surface in each photo, and the pipe flow direction is from left to right.

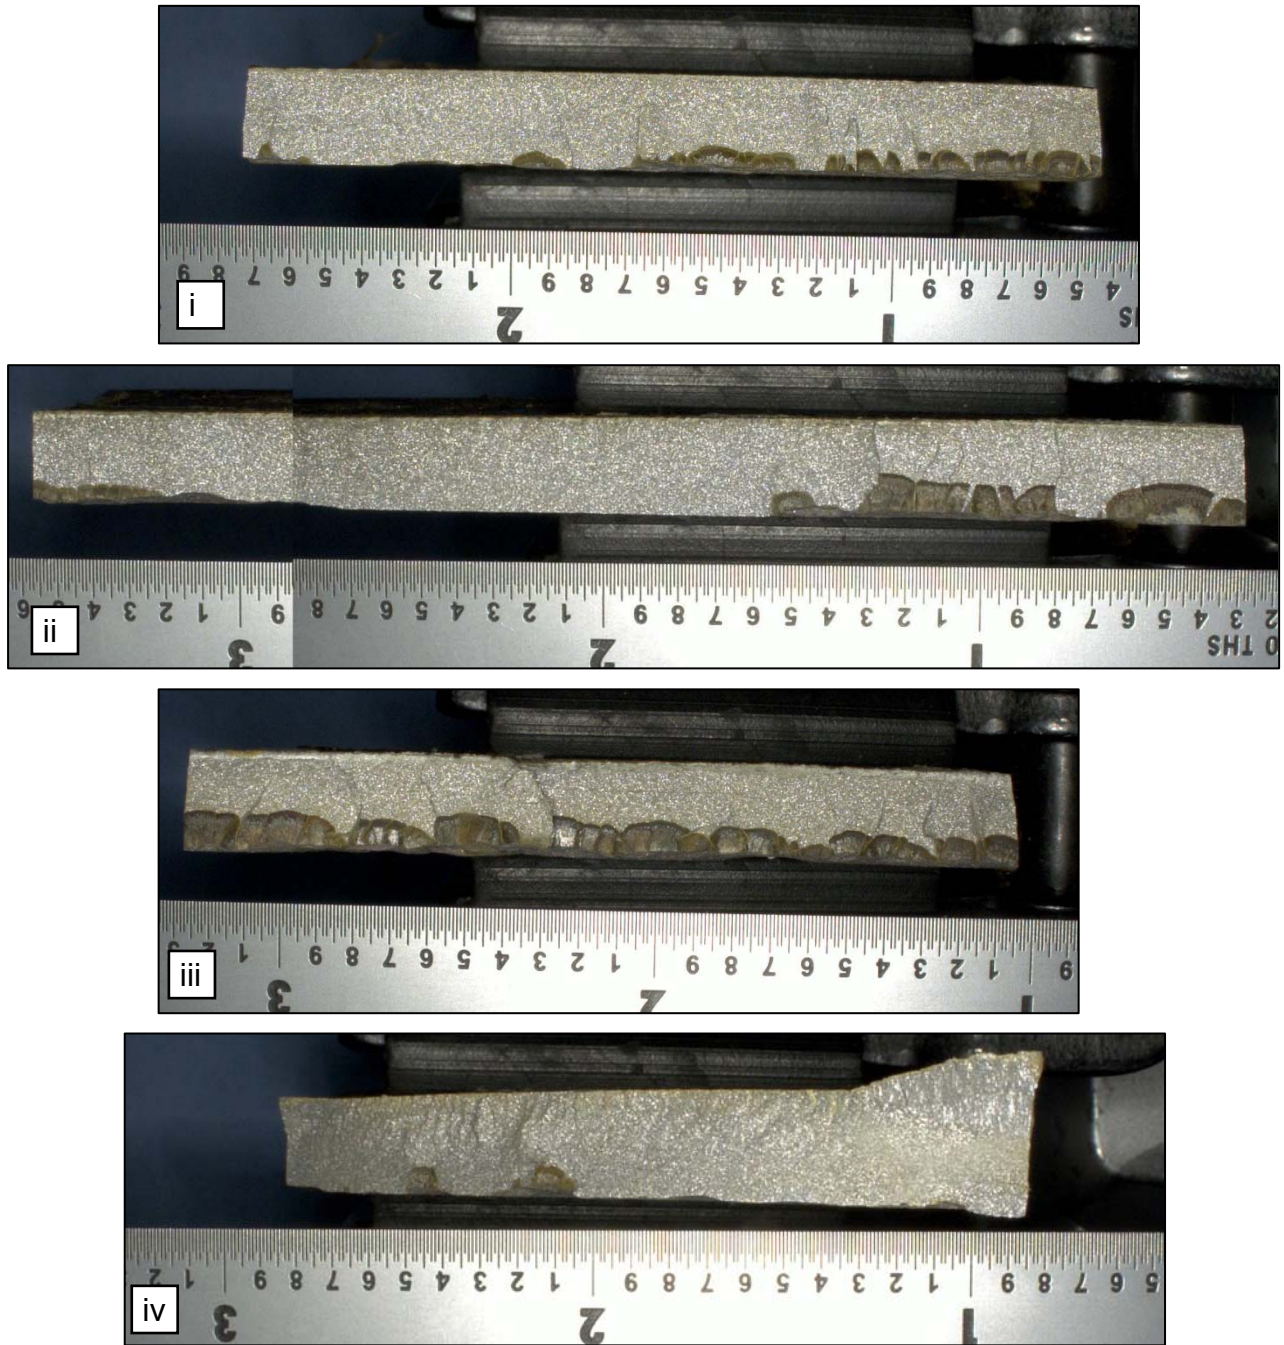
Figure 36. Overall views of lab fracture surfaces of samples B2d2i-iv. The ruler is adjacent to the outer surface in each photo, and the pipe flow direction is from left to right.

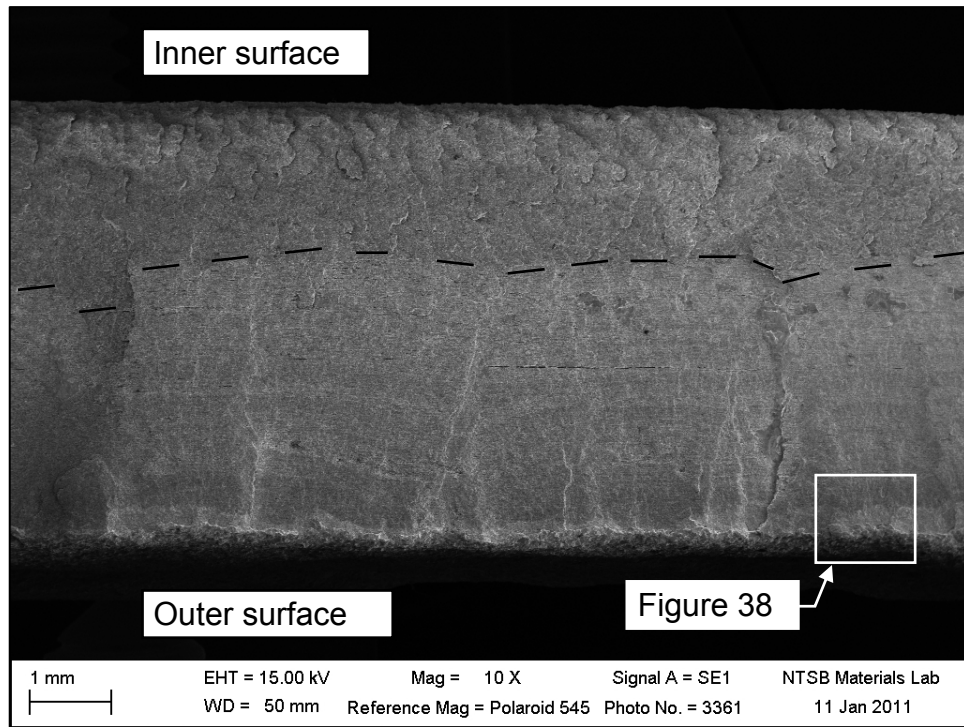
Figure 37. Overall view of deepest crack features in piece A1d2iii. A dashed line indicates the crack boundary.

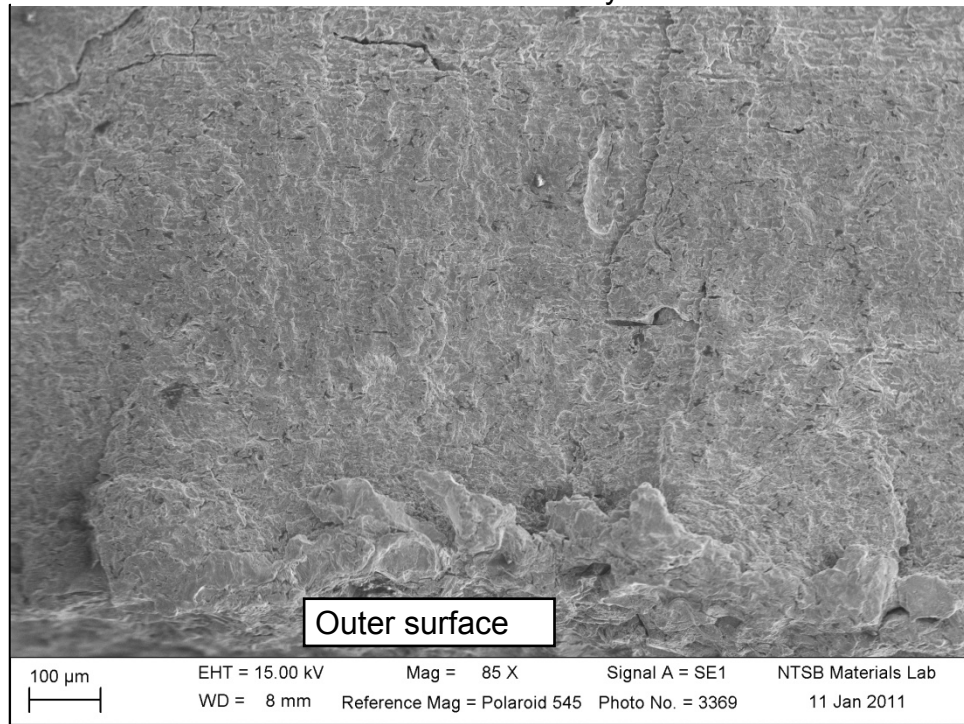
Figure 38. Closer view of the crack origin in the area indicated in figure 37.

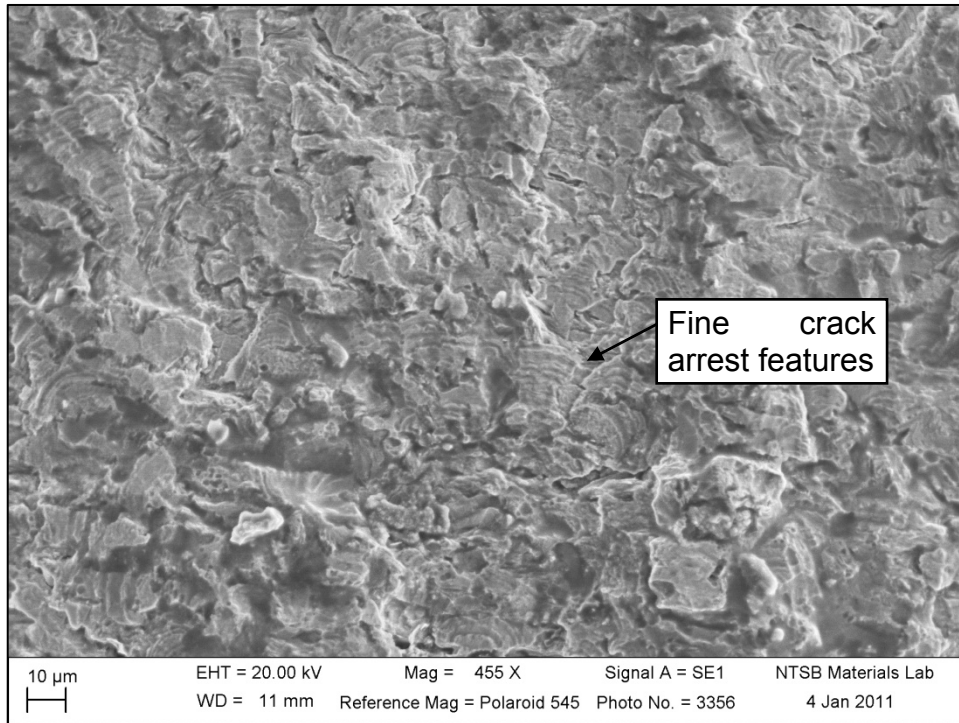
Figure 39. SEM view of fine crack arrest features observed within approximately 0.032 inches of an origin area on piece A1d2iii.

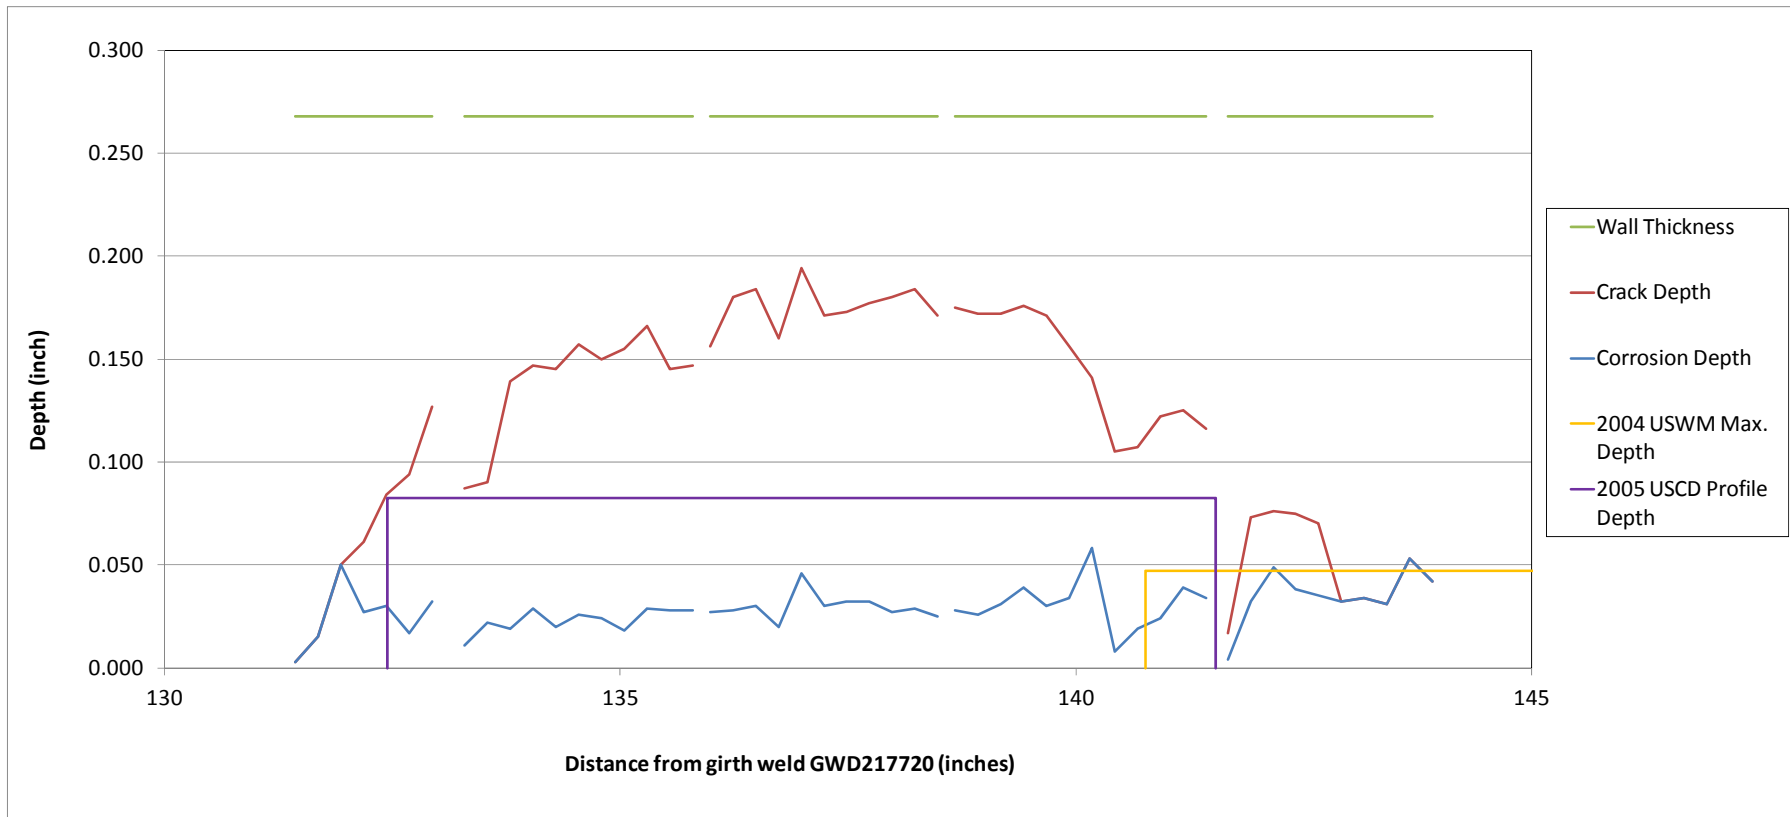
Figure 40. Crack profile data for the lab fractures from sample A1d2 showing metal loss depth and crack penetration depth along the length of the rupture at $\frac{1}{4}$ -inch increments. Breaks in the data indicate locations where cuts were made. Metal loss depth and crack penetration depth are referenced to the estimated original wall exterior surface as determined using an average of micrometer measurements in adjacent areas that appeared free from corrosion features. The wall thickness in this plot represents the wall thickness determined from the micrometer measurements. Results from the 2004 ultrasound wall measurement tool (USWM) and the 2005 ultrasound crack detection tool (USCD) in-line inspection (ILI) data for features intersecting the profiled crack. The line for the 2004 USWM data represents the location and maximum depth of that feature, which continues beyond 145 inches. The line for the 2005 USCD depth represents the profile depth provided at Enbridge's request during Enbridge's remaining strength assessment of the line using the 2005 USCD inspection report. (Additional details of the ILI inspections are included in Section D.15 of this report.)

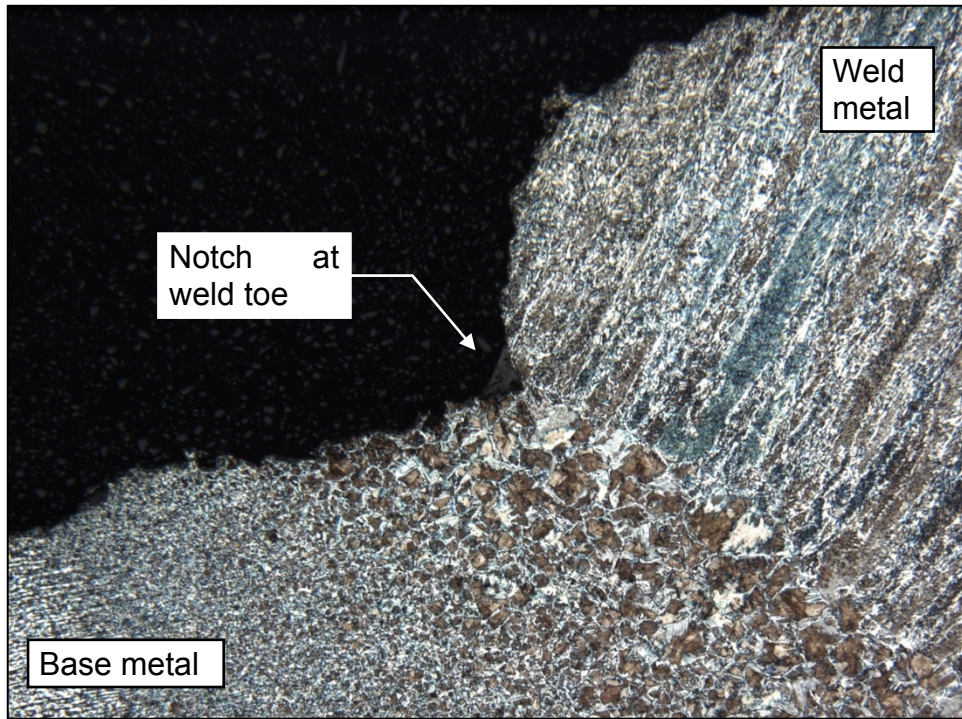
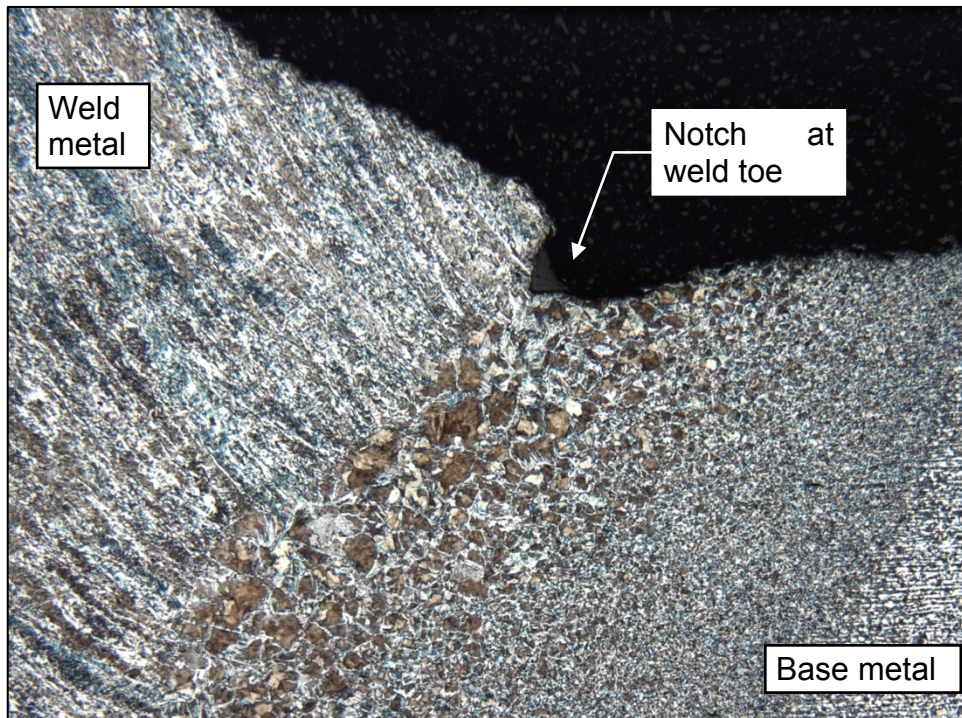
Figure 42. Views of etched specimen MM3 showing metallographic features at the weld toes of the longitudinal seam in joint 217730.

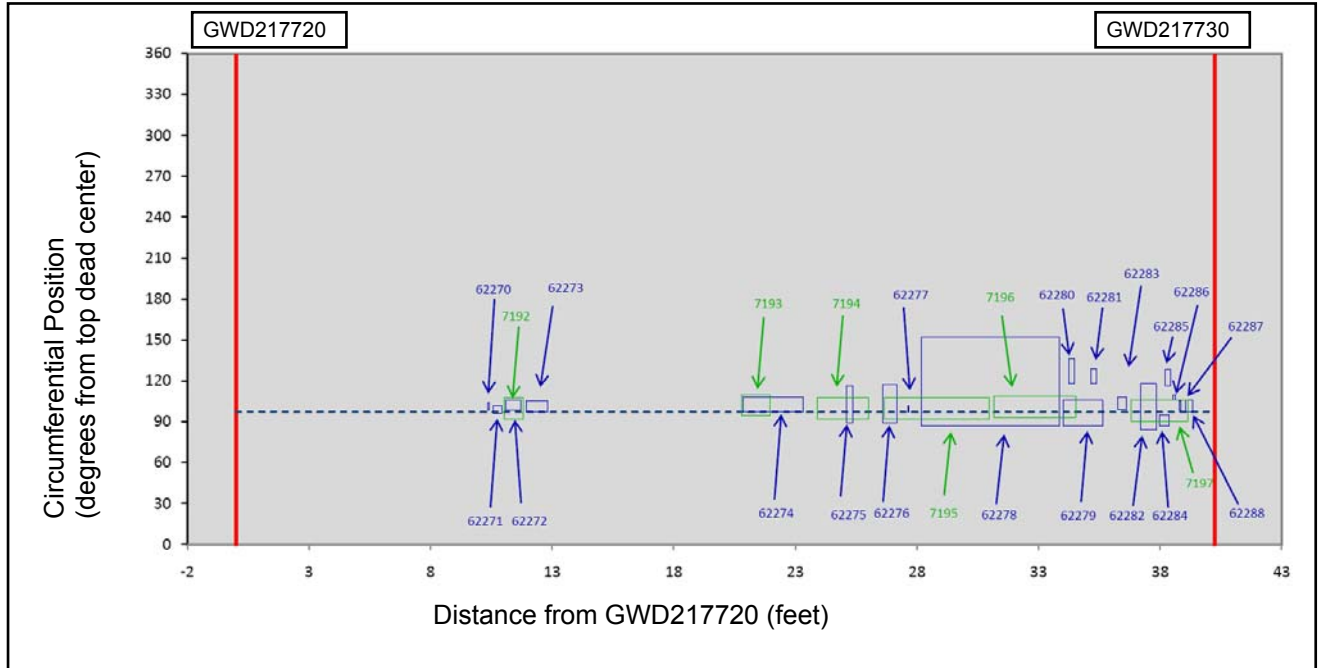
USWM feature shown in figure 46. The feature with the lowest RPR in joint 217720 was feature 62278 located 28.2 feet from GWD217720. Feature 62278 measured 68.03 inches long and 17.05 inches wide with a peak depth of 27 percent of the local wall thickness and had an RPR of 0.925. One other feature (number 62279 located 34.24 feet from GWD217720) also had an RPR of less than 1.0 at 0.935. Both features were also analyzed using an effective area method, and in that calculation, the effective area RPR's were 1.056 and 1.049 for features 62278 and 62279, respectively. The deepest feature was feature 62279, located 34.03 feet from GWD217720, with a depth of 30 percent of the local wall thickness.

Figure 46. Plot of inspection data for joint 217720 showing locations of crack-like features from the 2005 USCD tool (green boxes) and locations of metal loss from the 2009 USWM tool (blue boxes). Red lines indicate girth weld locations, and a dashed blue line indicates the location of the seam weld.
