# NATIONAL TRANSPORTATION SAFETY BOARD

MATERIALS LABORATORY FACTUAL REPORT

Report No. 11-056

Place : San Bruno, California  
Date : September 9, 2010  
Vehicle : Pacific Gas & Electric Natural Gas Transmission Pipeline  
NTSB No. : DCA10MP008  
Investigator : Ravindra Chhatre, RPH-20

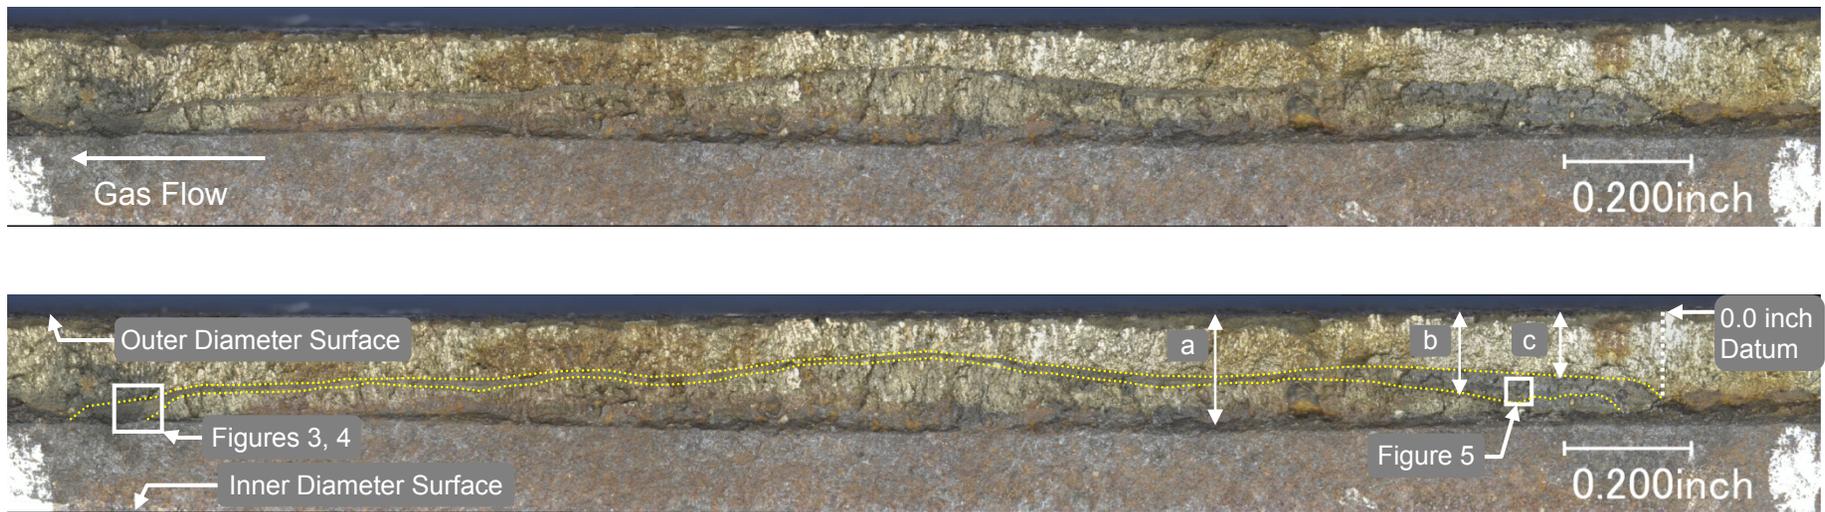
The CW fracture face of the P1 longitudinal seam showed the same features that were previously documented on the CCW face, except that features consistent with fatigue were identified in areas that were not interpretable on the CCW face. A macrophotograph of the CW fracture face of the P1 longitudinal seam at the initiation site is shown in Figure 2. The image on the bottom has two yellow dashed lines superimposed on it that bound areas where features consistent with fatigue were observed by scanning electron microscope (SEM). SEM micrographs taken at various locations inside the area bounded by the yellow-dashed lines are shown in Figures 3 through 5. Features consistent with striations are indicated in each of the figures.

**Figure 2:** Clockwise fracture face of the initiation site located in P1. The lower yellow line follows the crack boundary after progression by overstress. The upper yellow line follows the crack boundary after progression by overstress and fatigue. Features consistent with fatigue fracture were located between the two dashed yellow lines. Intact wall thickness measurements were made approximately every 0.10 inch for; a) the weld depth; b) intact wall thickness after progression of the crack by overstress; and c) intact wall thickness after progression of the crack by overstress and fatigue.

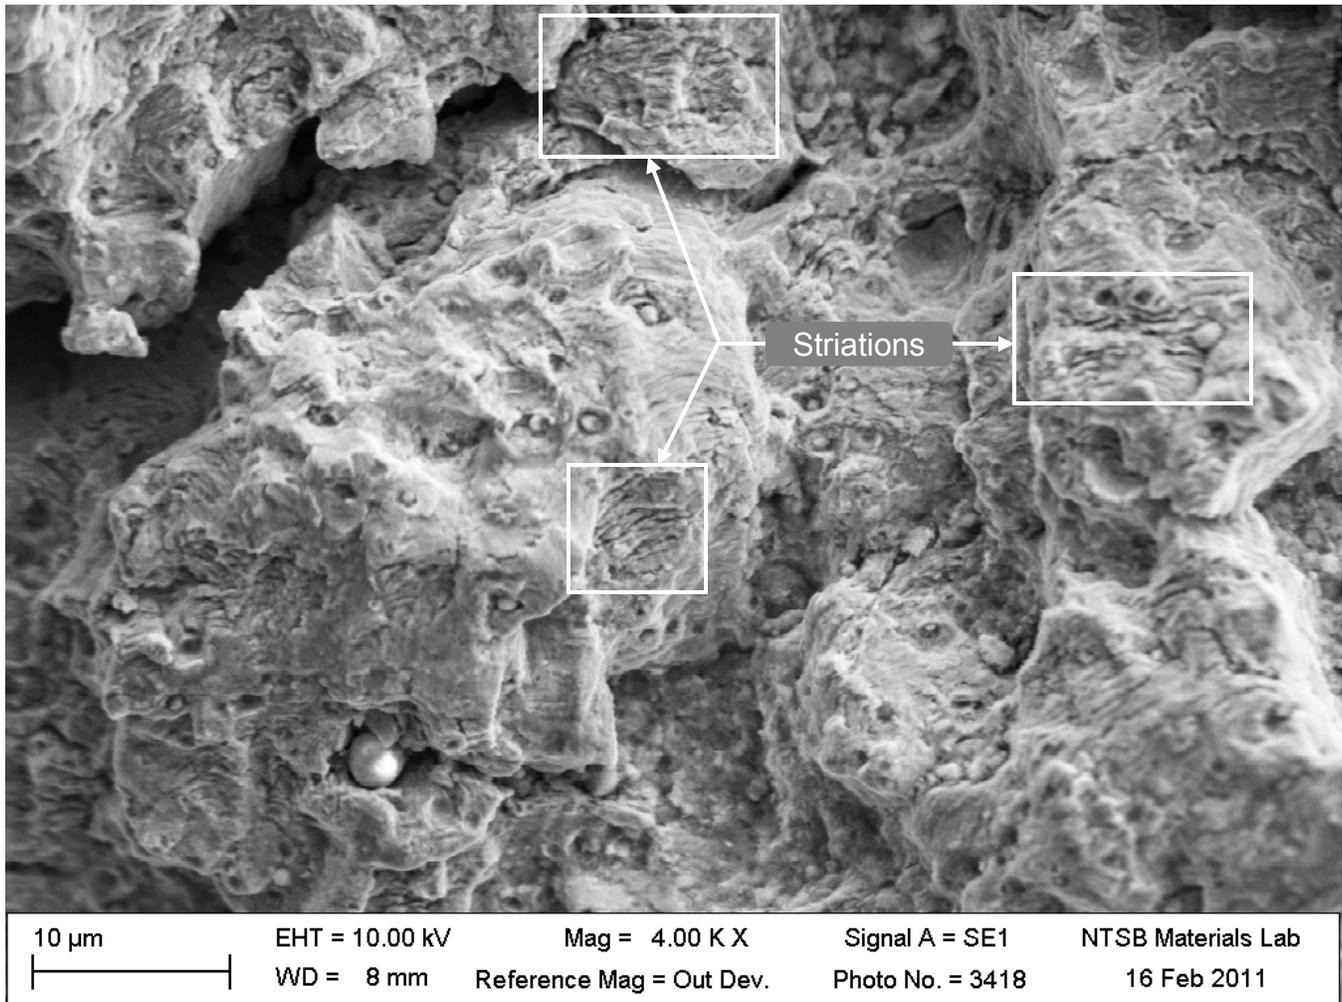
**Figure 3:** SEM micrograph of the P1 CW longitudinal seam weld fracture within the area bordered by the two yellow-dashed lines in Figure 2. Striated features were observed on the fracture surface, consistent with fatigue.

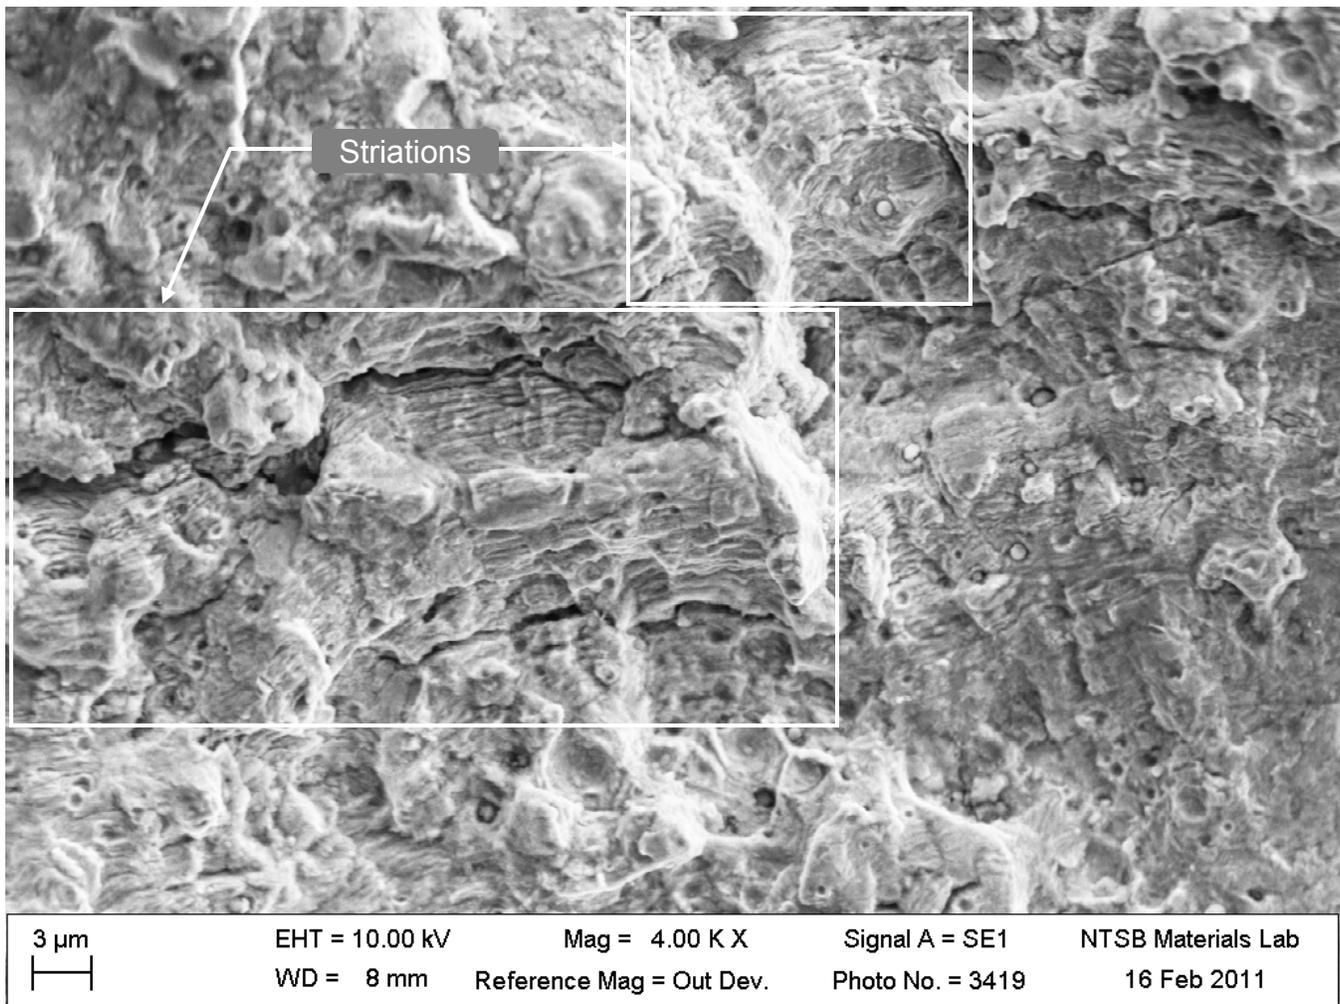
**Figure 4:** SEM micrograph of the P1 CW longitudinal seam weld fracture within the area bordered by the two yellow-dashed lines in Figure 2. Striated features were observed on the fracture surface, consistent with fatigue.

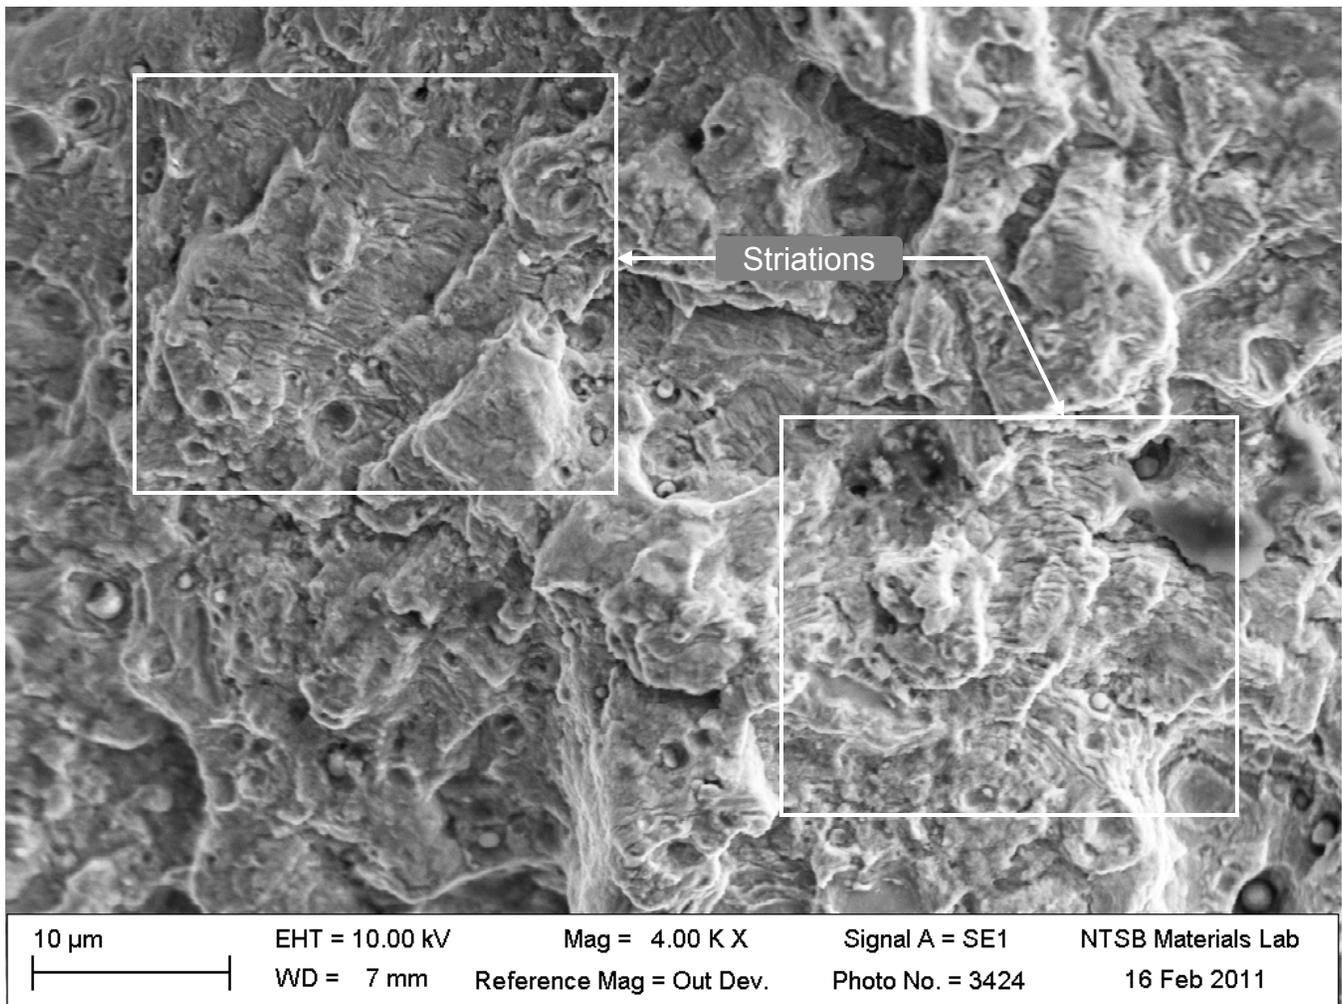
**Figure 5:** SEM micrograph of the P1 CW longitudinal seam weld fracture within the area bordered by the two yellow-dashed lines in Figure 2. Striated features were observed on the fracture surface, consistent with fatigue.

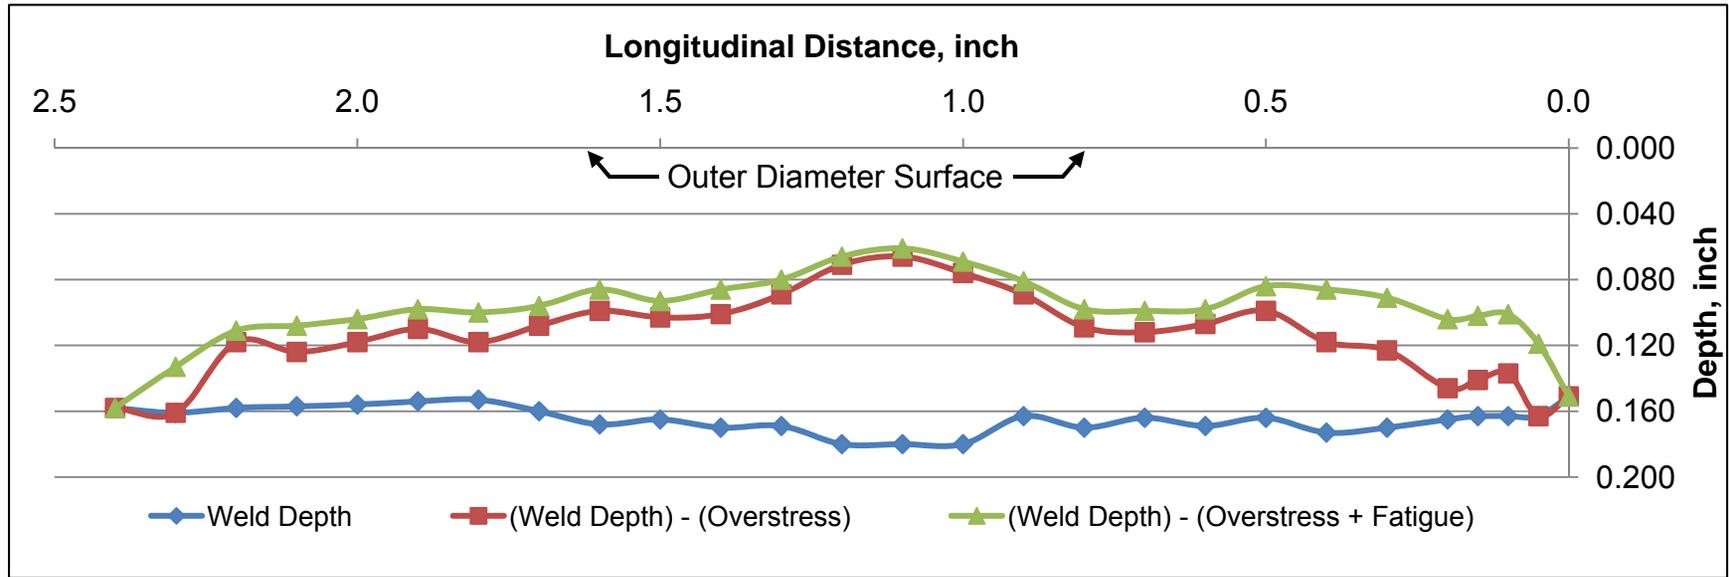
The longitudinal position of deepest crack penetration was at 1.0 inch–1.2 inch, coinciding with the location where the initial wall thickness was at its maximum. The intact cross sectional wall area was calculated from the data in Appendix A for all three cases as a piecewise sum of trapezoidal area measurements along the seam (i.e., trapezoidal integration rule). The cross sectional area of the initial intact wall was 0.397 inch<sup>2</sup>, the cross sectional area of the intact wall after crack progression by

**Figure 6:** Depth measurements at the crack initiation site along the P1 CW longitudinal seam. Depth measurements are referenced with respect to the outer surface of the pipe; weld depth (blue diamonds), intact wall thickness after crack progression by ductile overstress (red squares), and intact wall thickness after crack progression by overstress and fatigue (green triangles).

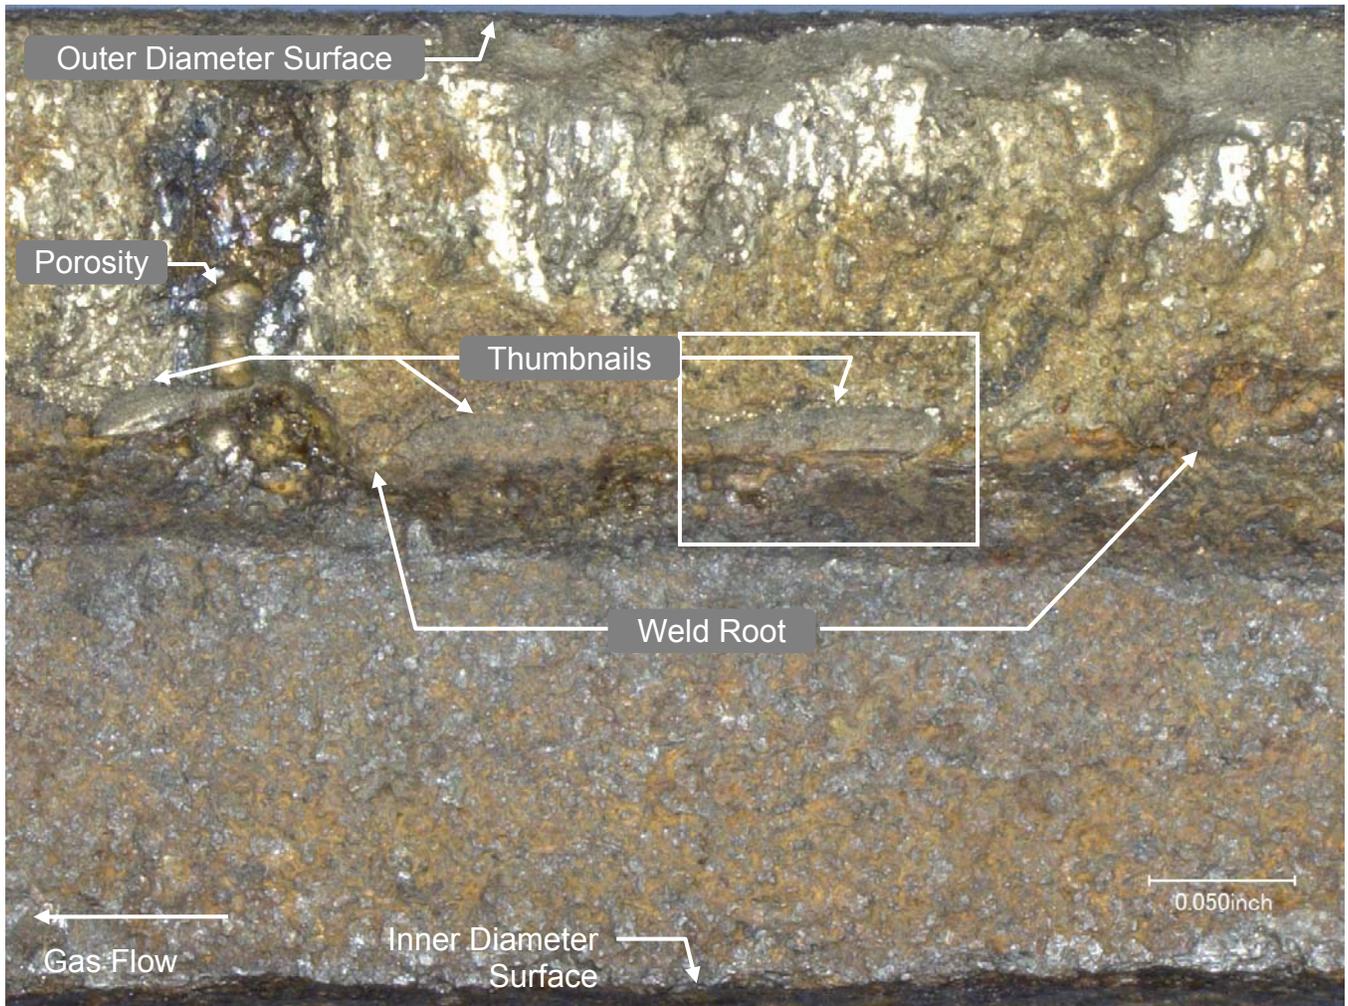
Occasional thumbnail-shaped features were observed along the length of the P1 longitudinal seam at the root of the weld fracture surface. Several thumbnail features on the CW side of the seam fracture, starting at the initiation site and continuing approximately 1.5 inch upstream, were examined by SEM and were found to exhibit fractographic features consistent with fatigue. Several of the thumbnail features are shown in Figure 7. The thumbnails ranged from 0.060 inch to 0.075 inch in the longitudinal direction and 0.015 inch to 0.017 inch in the through-thickness direction. One of the thumbnails, indicated by the box in Figure 7, is shown in an SEM micrograph in Figure 8. In turn, the fracture surface inside the box in Figure 8 is shown in greater detail in Figure 9. Striations, consistent with fatigue, are indicated by the rectangle.

**Figure 7:** Optical macrograph of the P1 longitudinal seam, CW side of the seam, just upstream of the initiation site where thumbnail features were observed along the root of the weld.

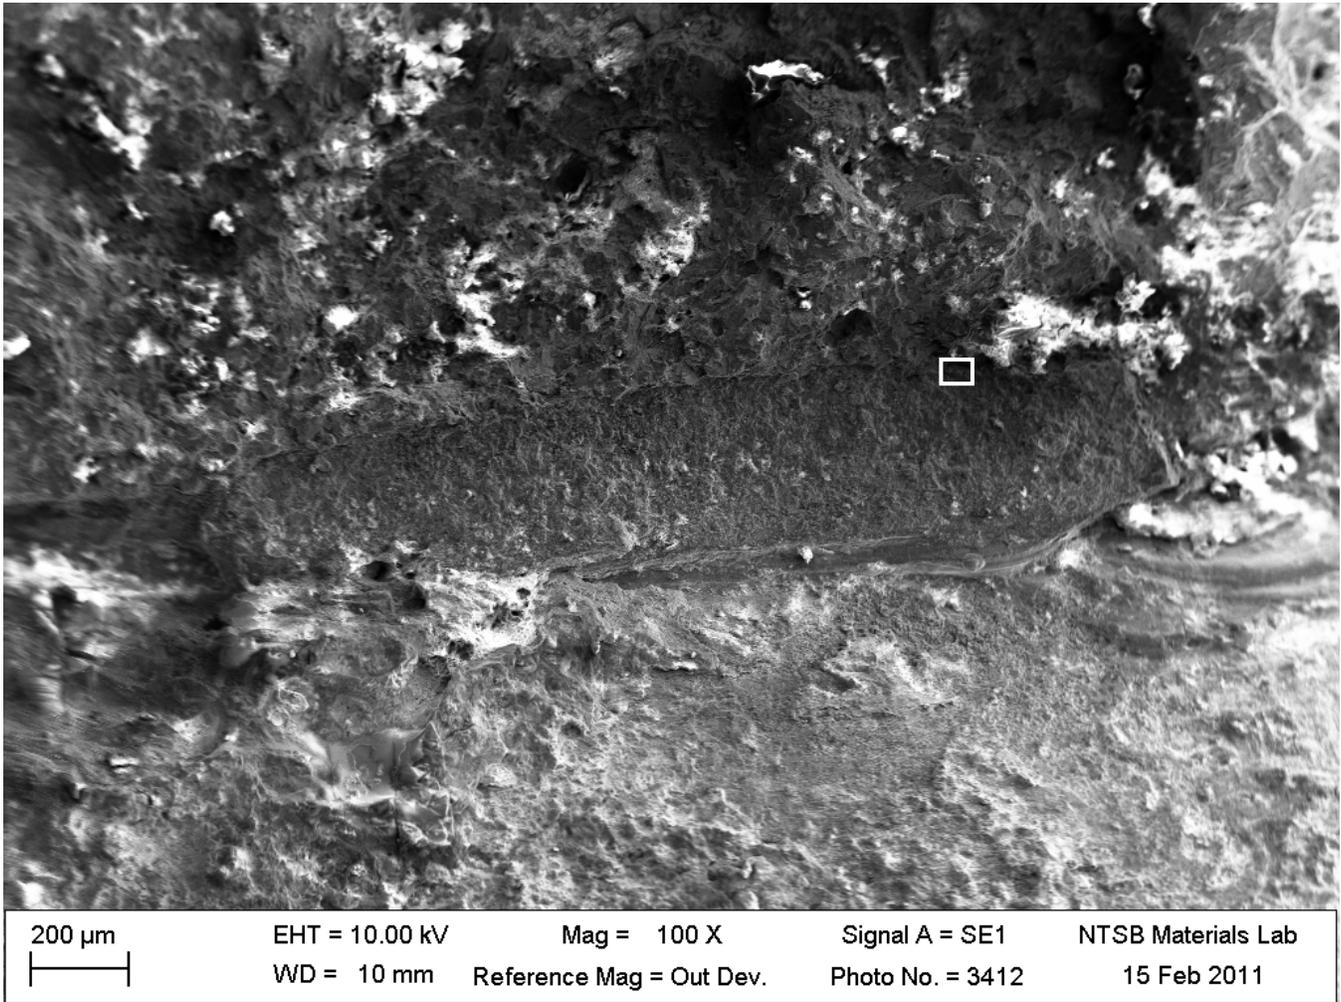
**Figure 8:** SEM micrograph of the thumbnail feature indicated by the box in Figure 7.

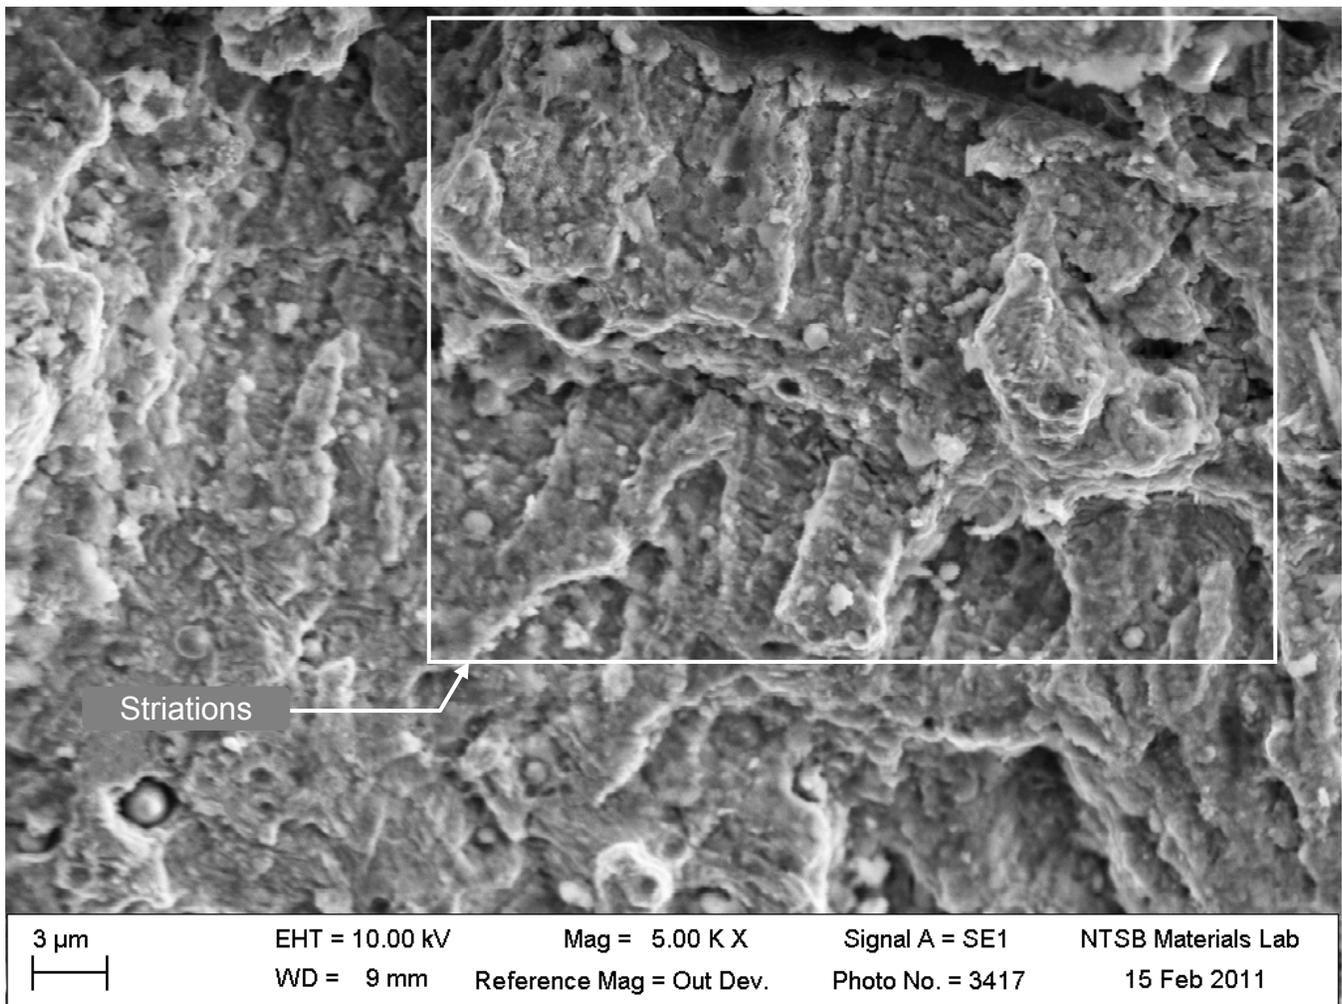
**Figure 9:** SEM micrograph of the P1 CW fracture face in a thumbnail feature at the root of the weld. Striations are indicated by a rectangle in the figure. The location of the micrograph is indicated by the box in Figure 8.

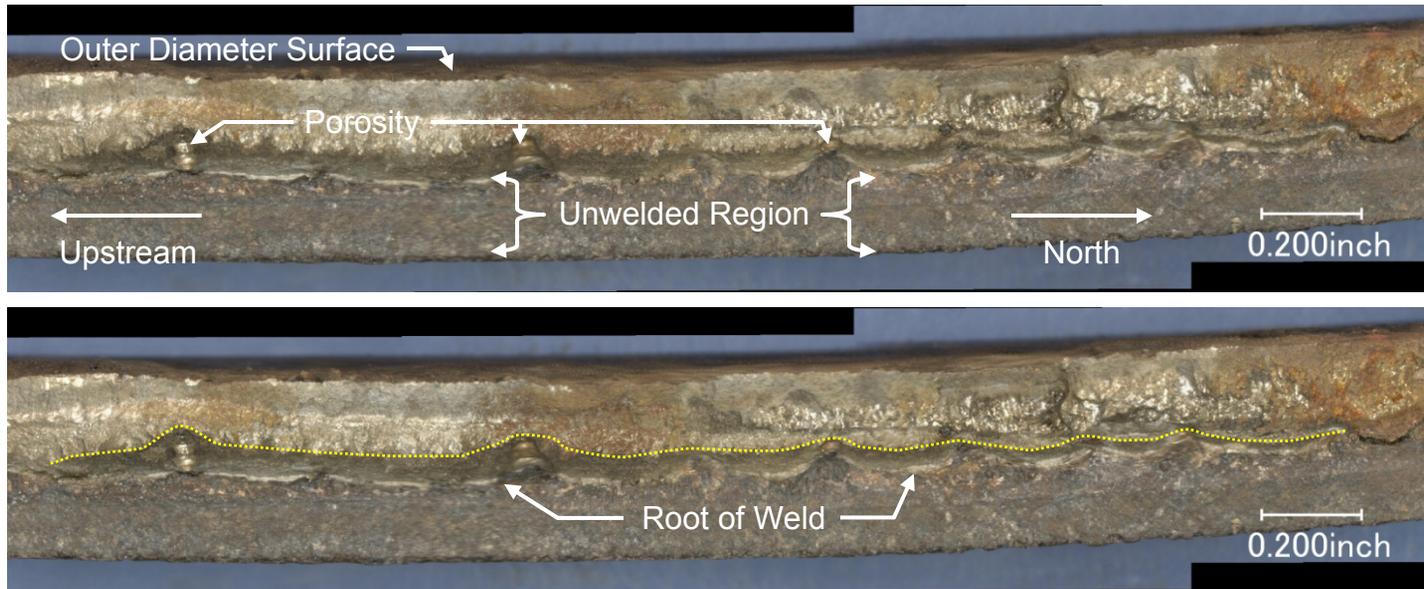
**Figure 10:** Region of ductile fracture originating from the root of the weld along the P2 CCW longitudinal seam. The region extended from 29.4 inch to 32.2 inch, with respect to the upstream end of P2 (girth weld C2). The dark-colored ductile fracture boundary is indicated by the yellow-dashed line in the bottom image.

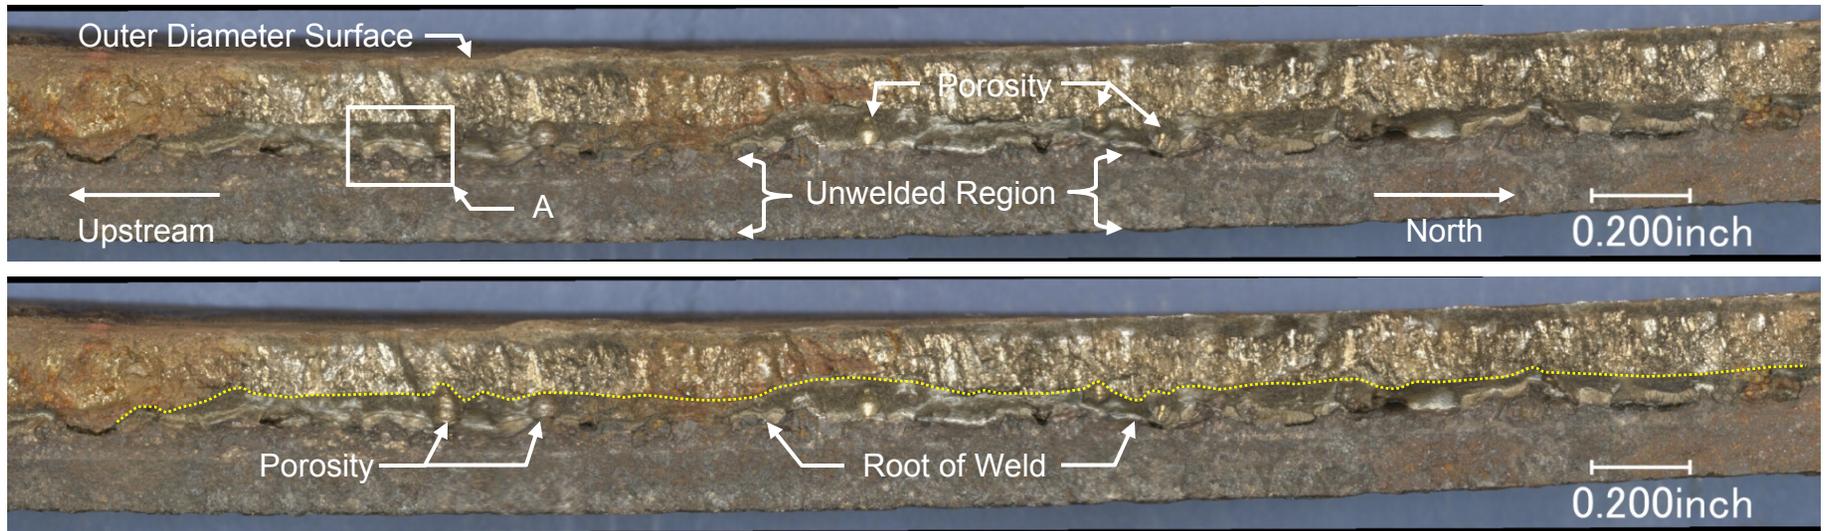
**Figure 11:** Region of ductile fracture originating from the root of the weld along the P2 CCW longitudinal seam. The region extended from 32.3 inch to 35.9 inch, with respect to the upstream end of P2. The ductile fracture boundary is indicated by the yellow-dashed line in the bottom image. An SEM image of region A is shown in Figure 13.

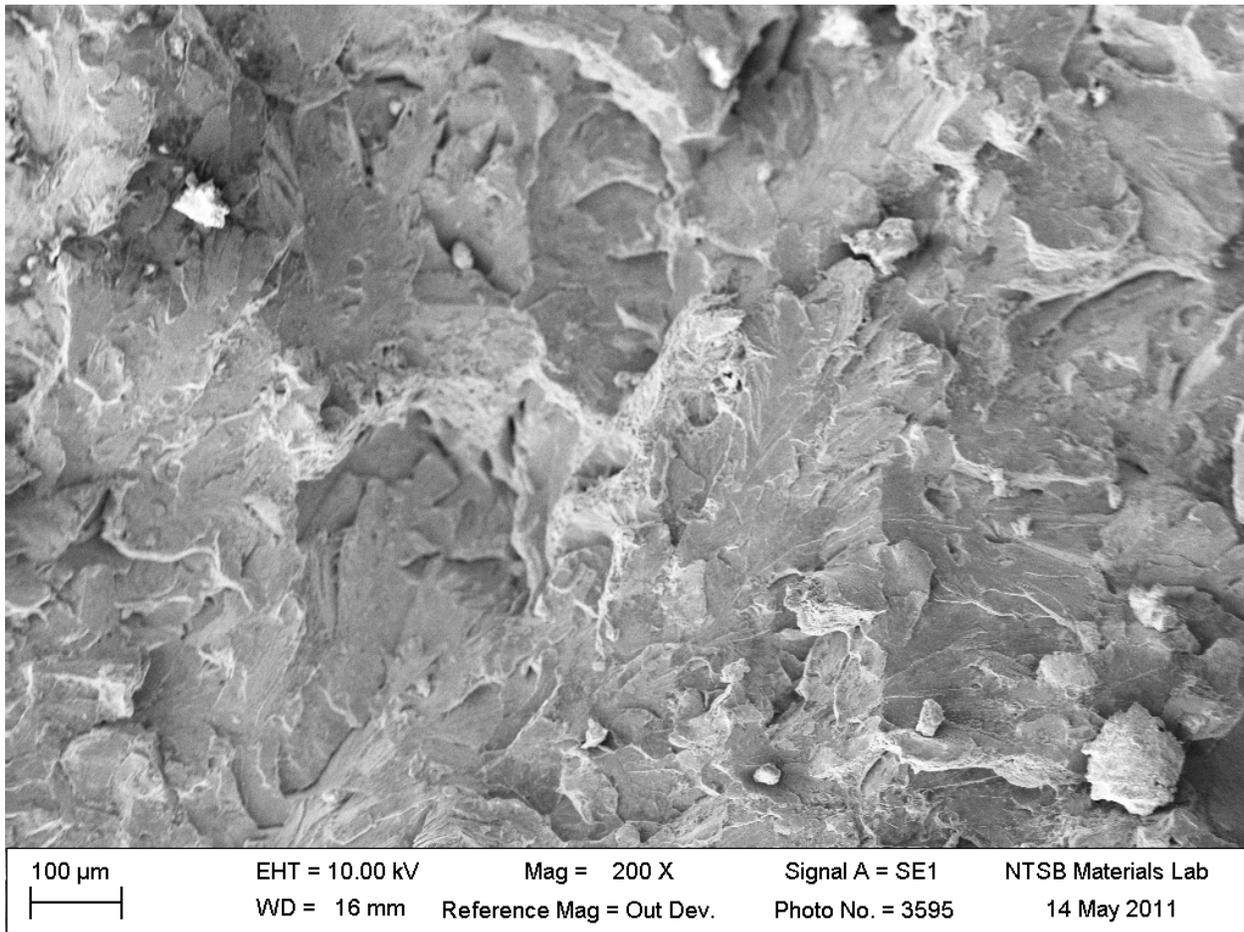
**Figure 12:** SEM micrograph of quasi-cleavage fracture approximately 34 inch from the upstream end of P2 along the CCW longitudinal seam.

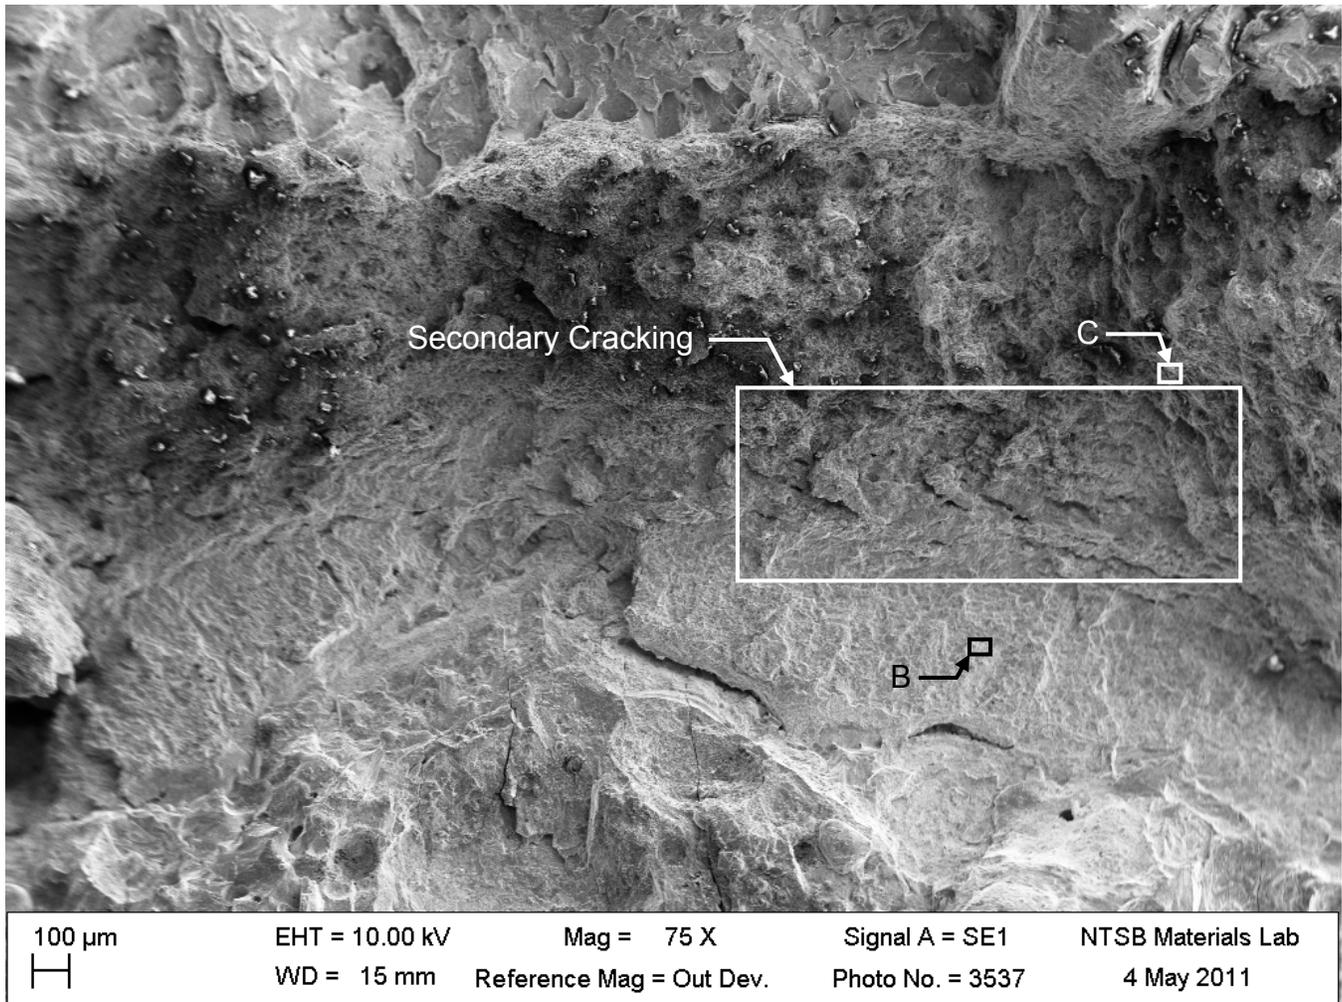
**Figure 13:** SEM micrograph of a ductile fracture region along the P2 CCW longitudinal seam at the area labeled A in Figure 11. Higher magnification micrographs of regions B and C are shown in Figure 14.

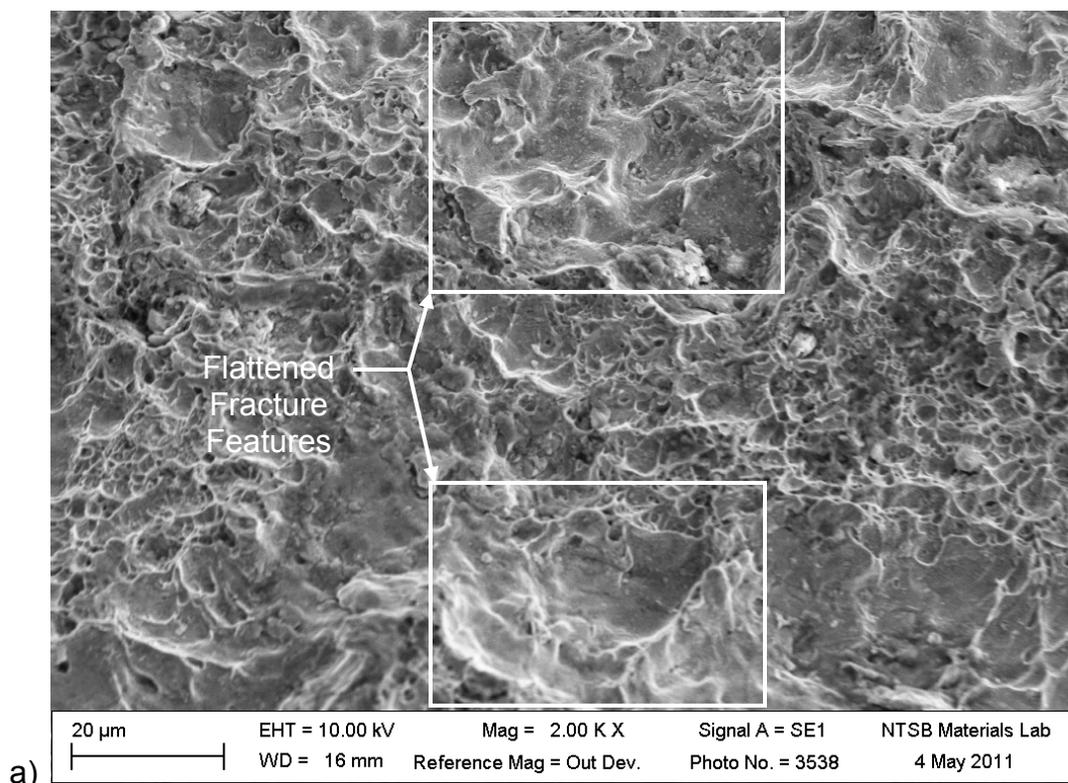
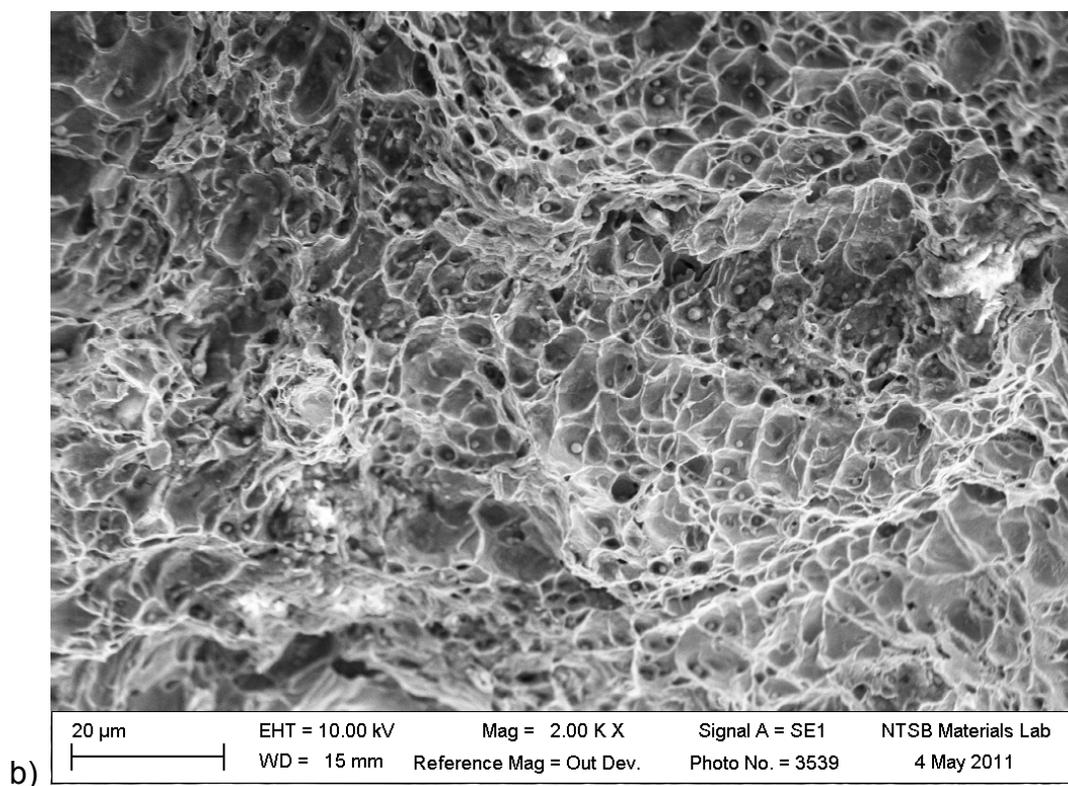
**Figure 14:** Higher magnification SEM micrographs from the regions indicated in Figure 13 along the P2 CCW longitudinal seam; a) Region B showing flattening of dimple features; b) Region C showing dimple features but little to no flattening.

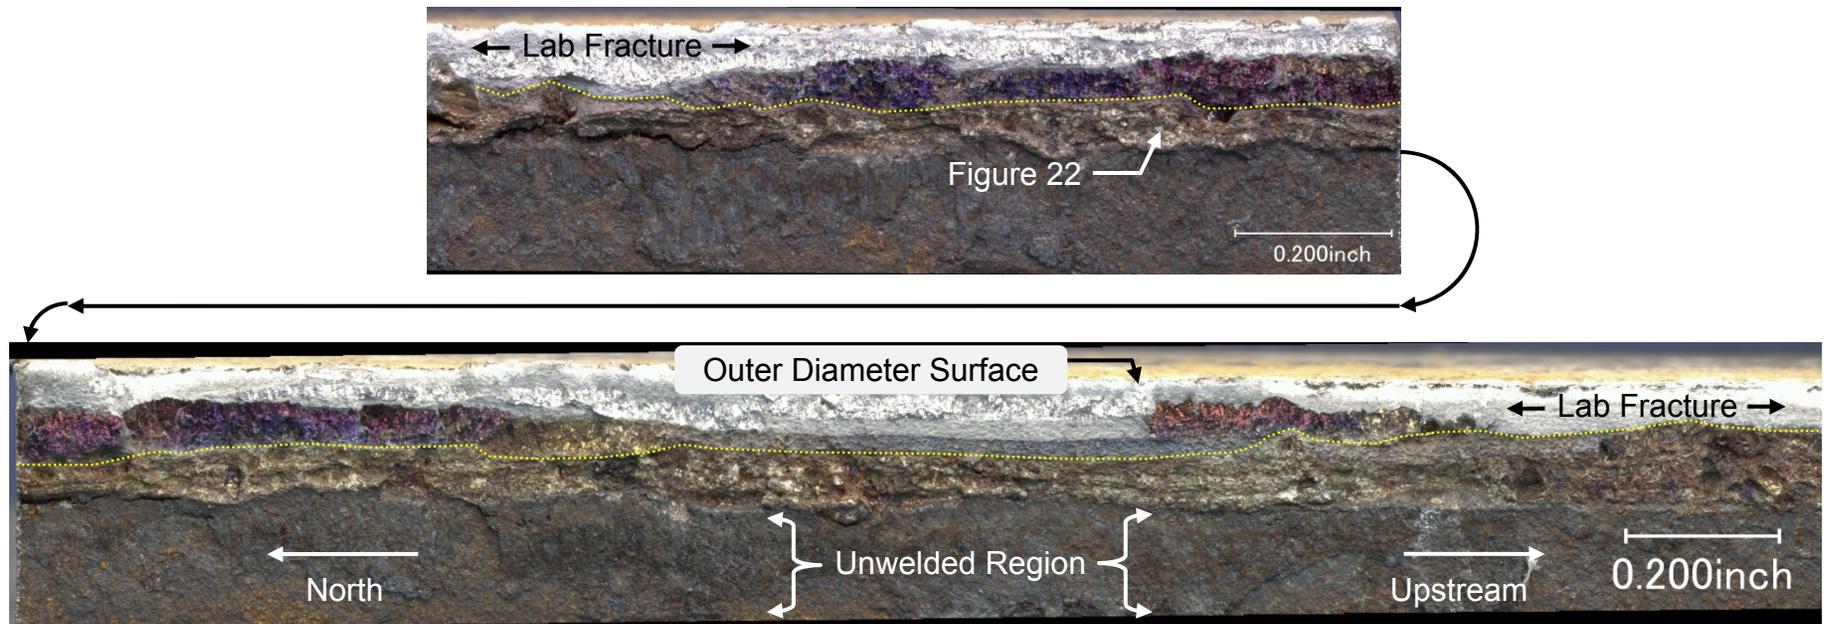
lab-fractured regions exhibited surface features consistent with a mixture of quasi-cleavage fracture and ductile fracture. The lab-fractured surfaces were identified by their silver color, typical of a fresh fracture. An example can be seen in Figure 15 adjacent to the outer diameter surface.

The ductile fracture region originating from the root of the weld in Figure 15 was examined by SEM after treatment with acetate tape. Features observed fell into one of three categories: 1) well-adhered corrosion product; 2) dimple features consistent with ductile fracture; or 3) square etch pits and step/terrace features consistent with corrosion. An example of the last is shown in Figure 22. Moving from the ductile fracture region towards the outer diameter surface, the fracture morphology changed to a specular appearance, consistent with quasi-cleavage fracture, and a blue/purple tint as previously described. The remaining silver-colored region was a result of the lab fracture and had a mixed appearance, with some regions containing features consistent with ductile fracture and other regions containing features consistent with quasi-cleavage fracture.

**Figure 15:** P3 CW longitudinal seam where features consistent with ductile fracture and corrosion were observed extending from 19.5 inch to 23.1 inch from the upstream end of P3. The right side of the top image continues on the left side of the bottom image, where a bandsaw cut was made. The lab-fractured regions had a silver color, typical of a fresh fracture.

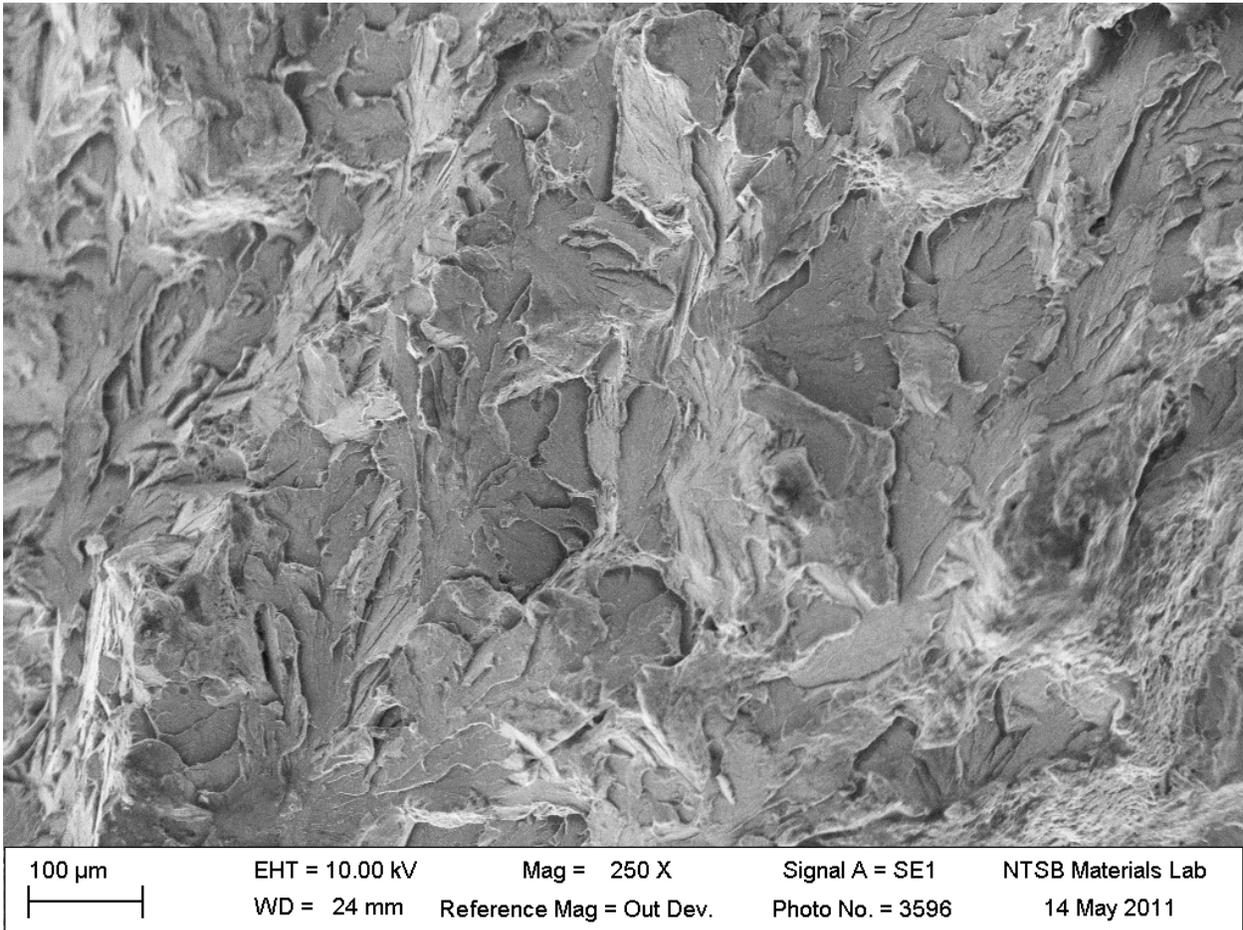
**Figure 16:** SEM micrograph of quasi-cleavage fracture approximately 31 inch from the upstream end of P3 along the CW longitudinal seam.

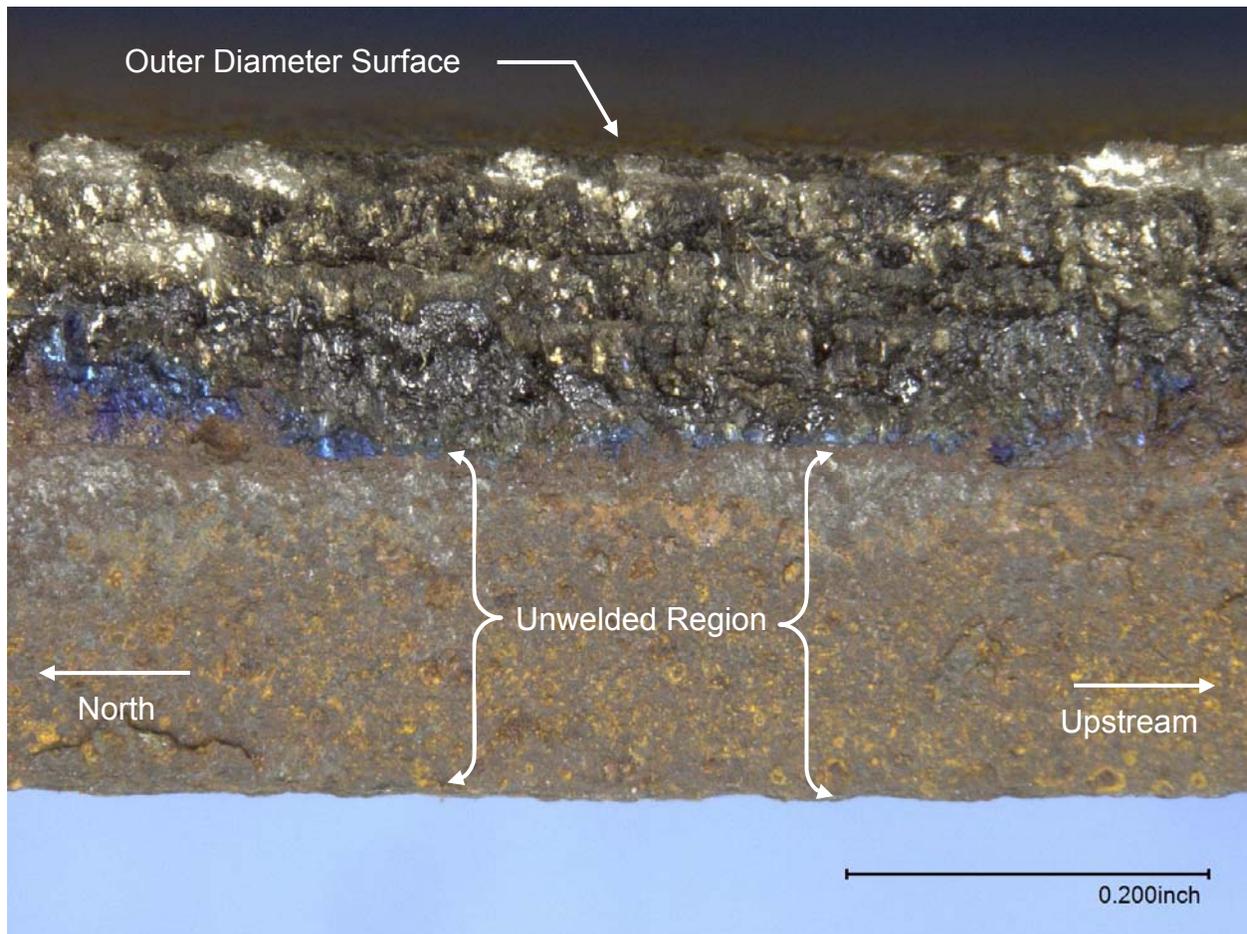
**Figure 17:** Photograph of the P3 CW fracture surface at approximately 8 inch from the upstream end. The fracture surface was covered by a black substance, consistent with charred asphalt. The appearance of the fracture surface was consistent with quasi-cleavage fracture, segmented by thin bands of ductile fracture.

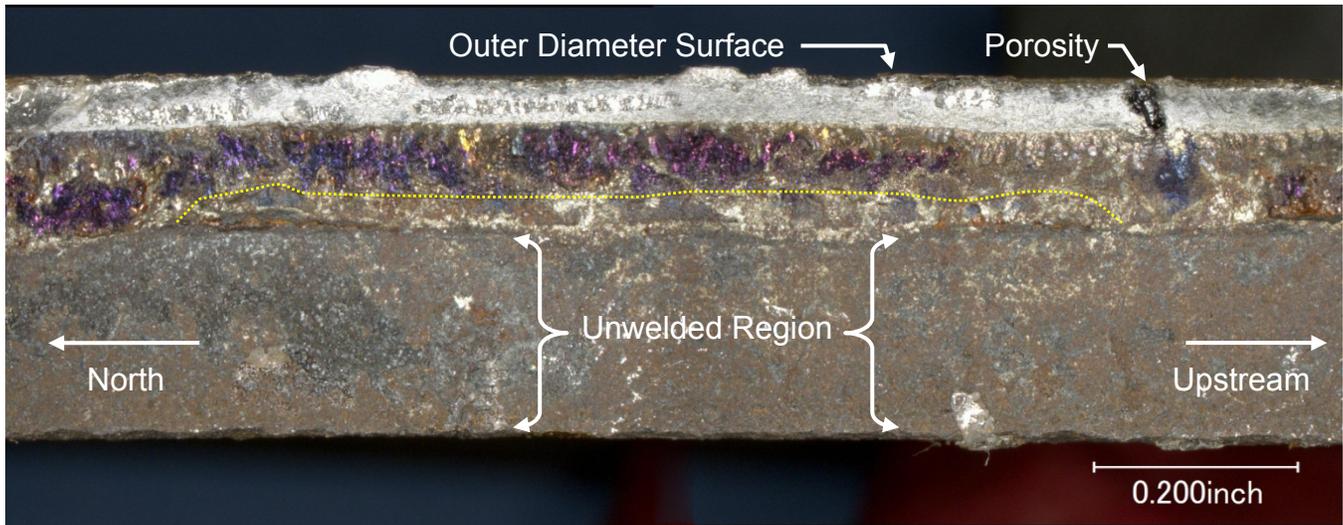
**Figure 18:** P3 CW longitudinal seam where features consistent with ductile fracture were observed extending from 10.3 inch to 11.3 inch from the upstream end of P3.
