# NATIONAL TRANSPORTATION SAFETY BOARD

MATERIALS LABORATORY FACTUAL REPORT

Report No. 11-056

Place : San Bruno, California  
Date : September 9, 2010  
Vehicle : Pacific Gas & Electric Natural Gas Transmission Pipeline  
NTSB No. : DCA10MP008  
Investigator : Ravindra Chhatre, RPH-20

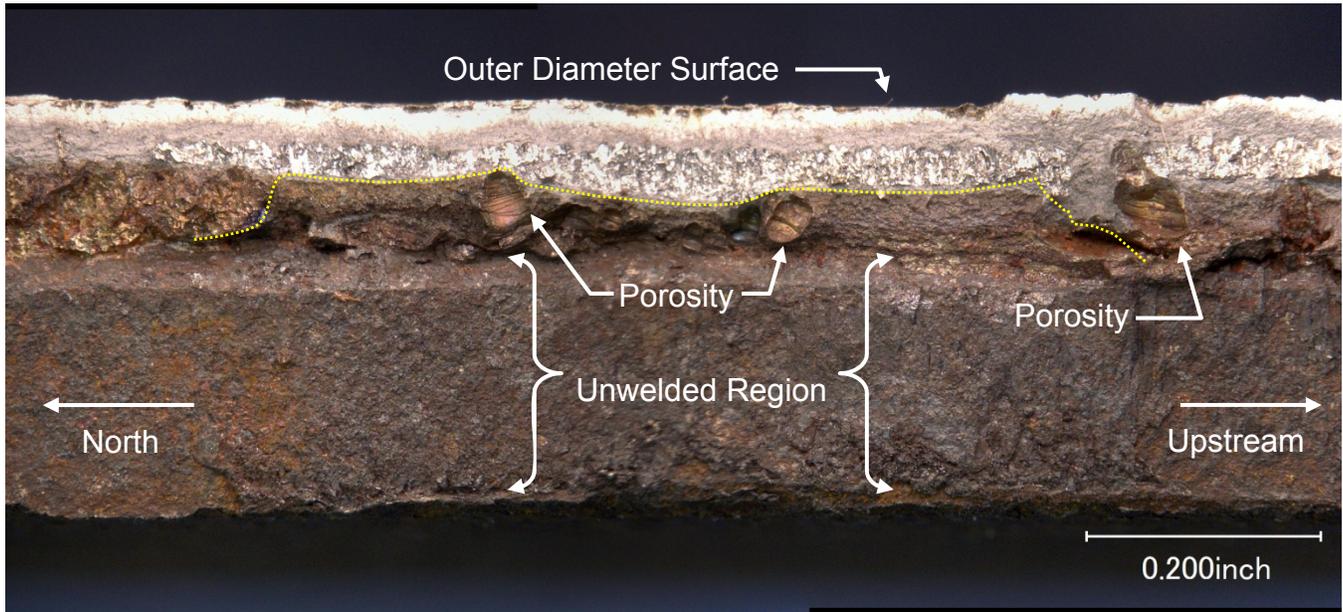
**Figure 19:** P3 CW longitudinal seam where features consistent with ductile fracture were observed extending from 23.1 inch to 24.0 inch from the upstream end of P3.

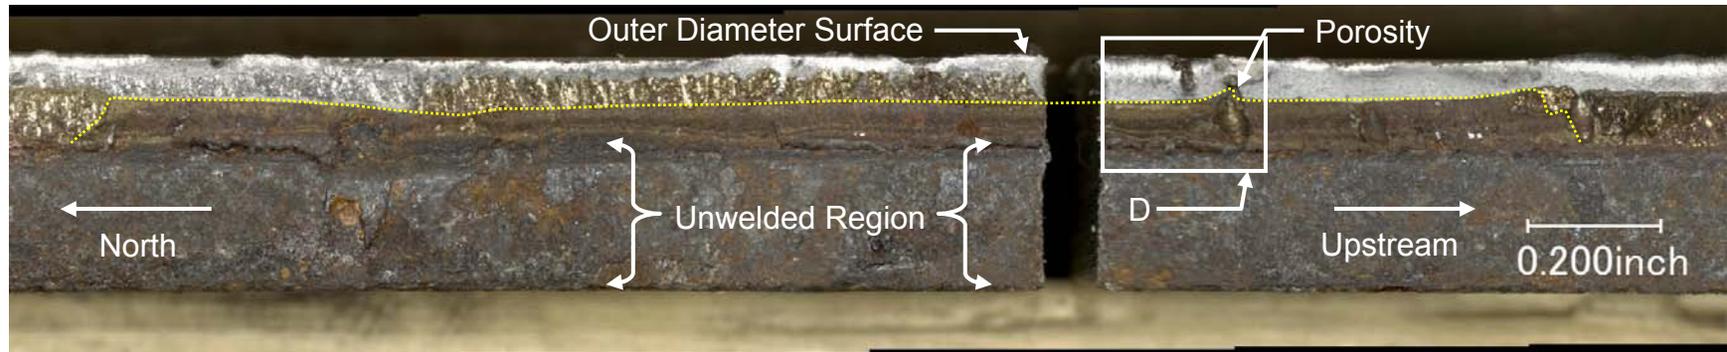
**Figure 20:** P3 CW longitudinal seam where features consistent with ductile fracture were observed extending from 31.7 inch to 33.9 inch from the upstream end of P3. A higher magnification optical image of the region labeled D is shown in Figure 23.

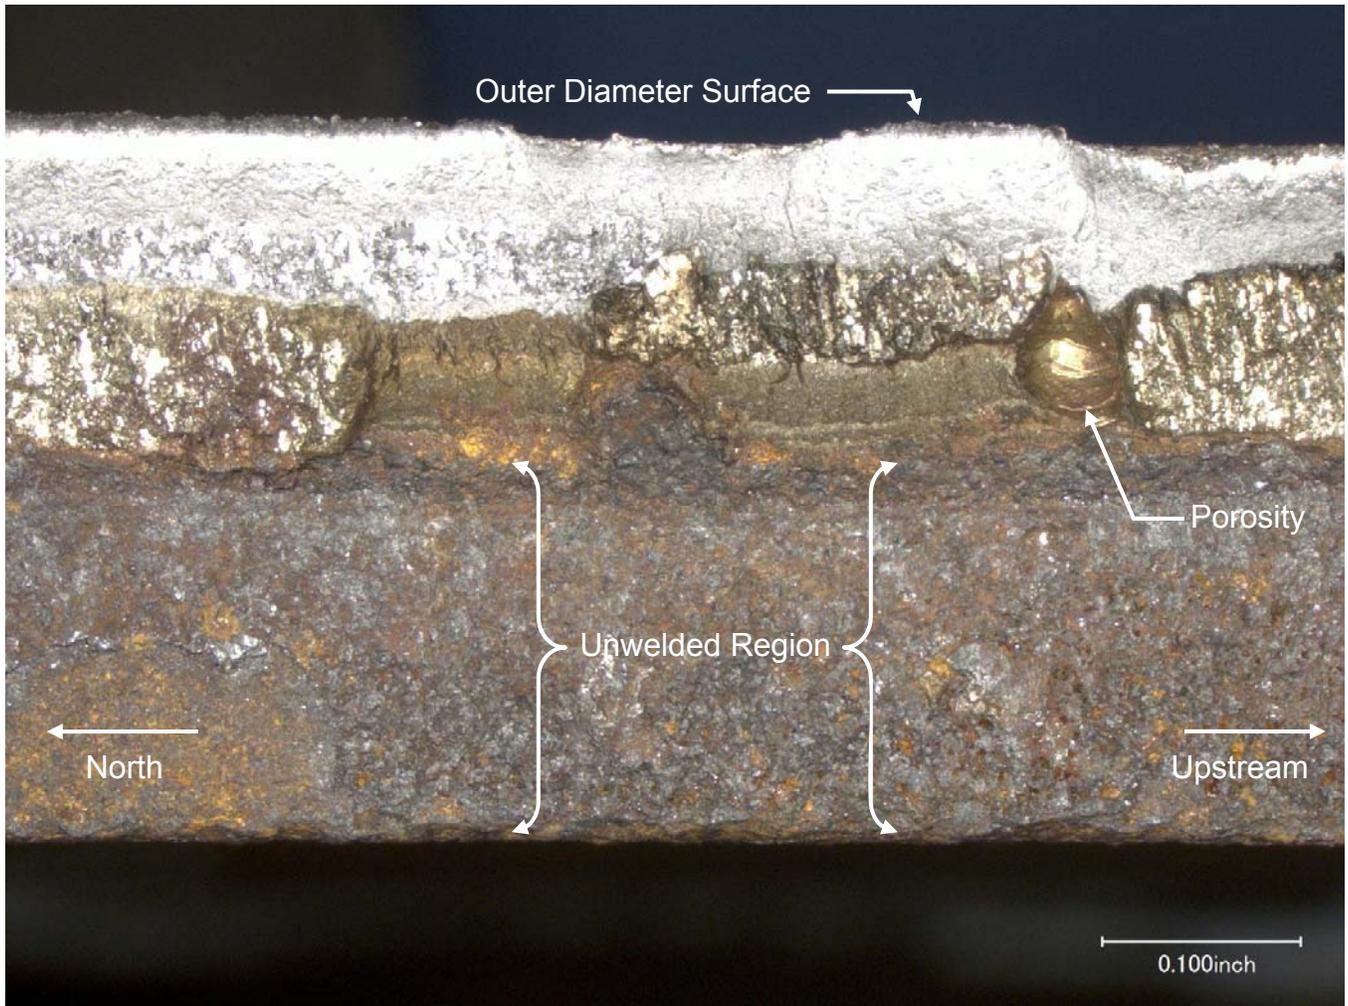
**Figure 21:** P3 CW longitudinal seam where features consistent with ductile fracture were observed extending from 40.3 inch to 40.7 inch from the upstream end of P3.

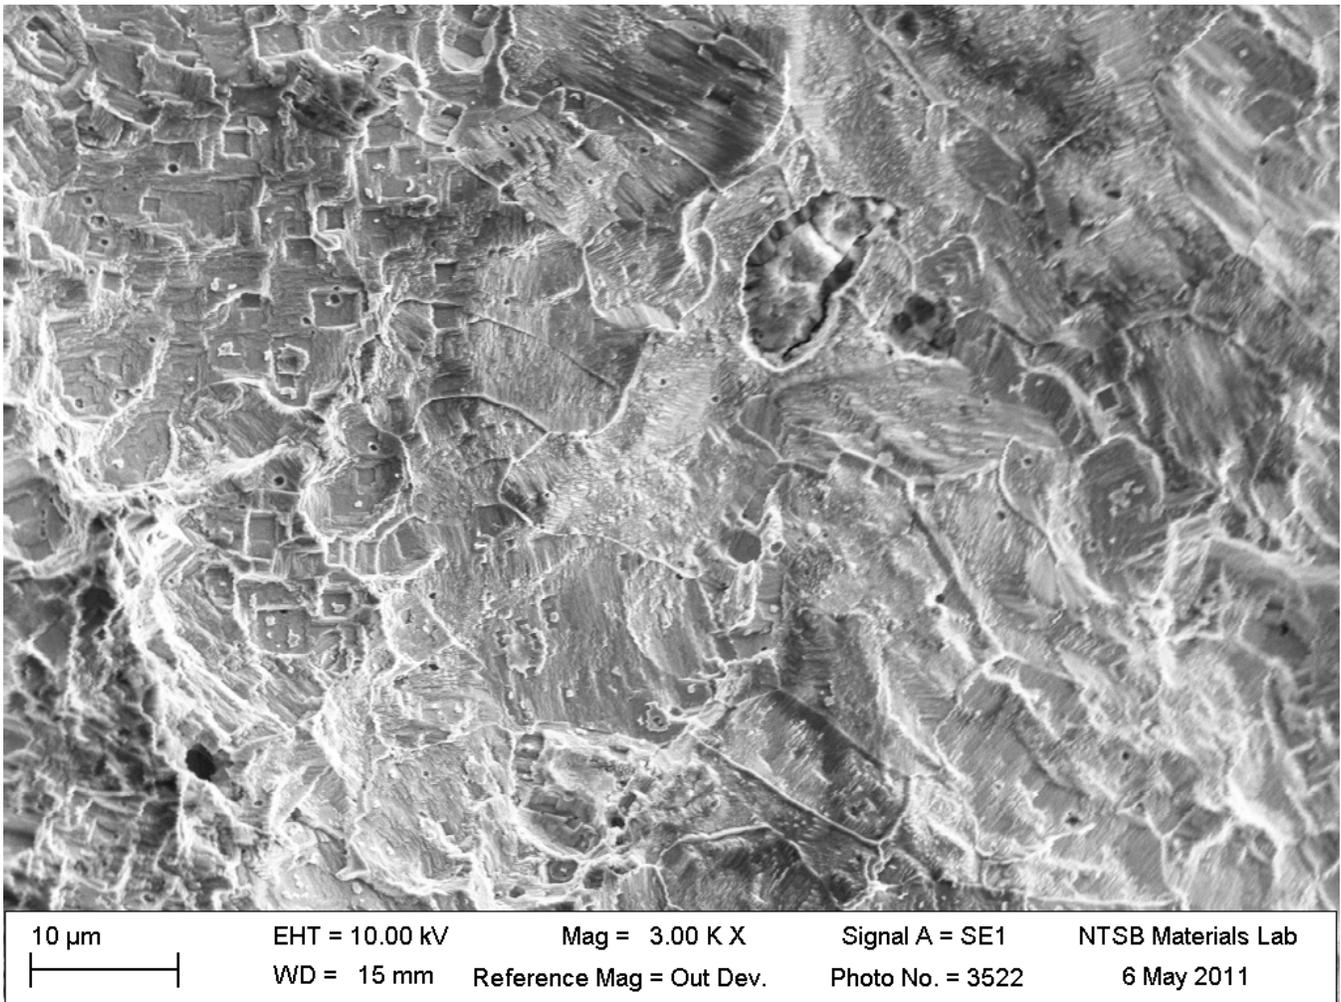
**Figure 22:** Etch pits and step/terrace features consistent with corrosion on the P3 CW fracture surface.

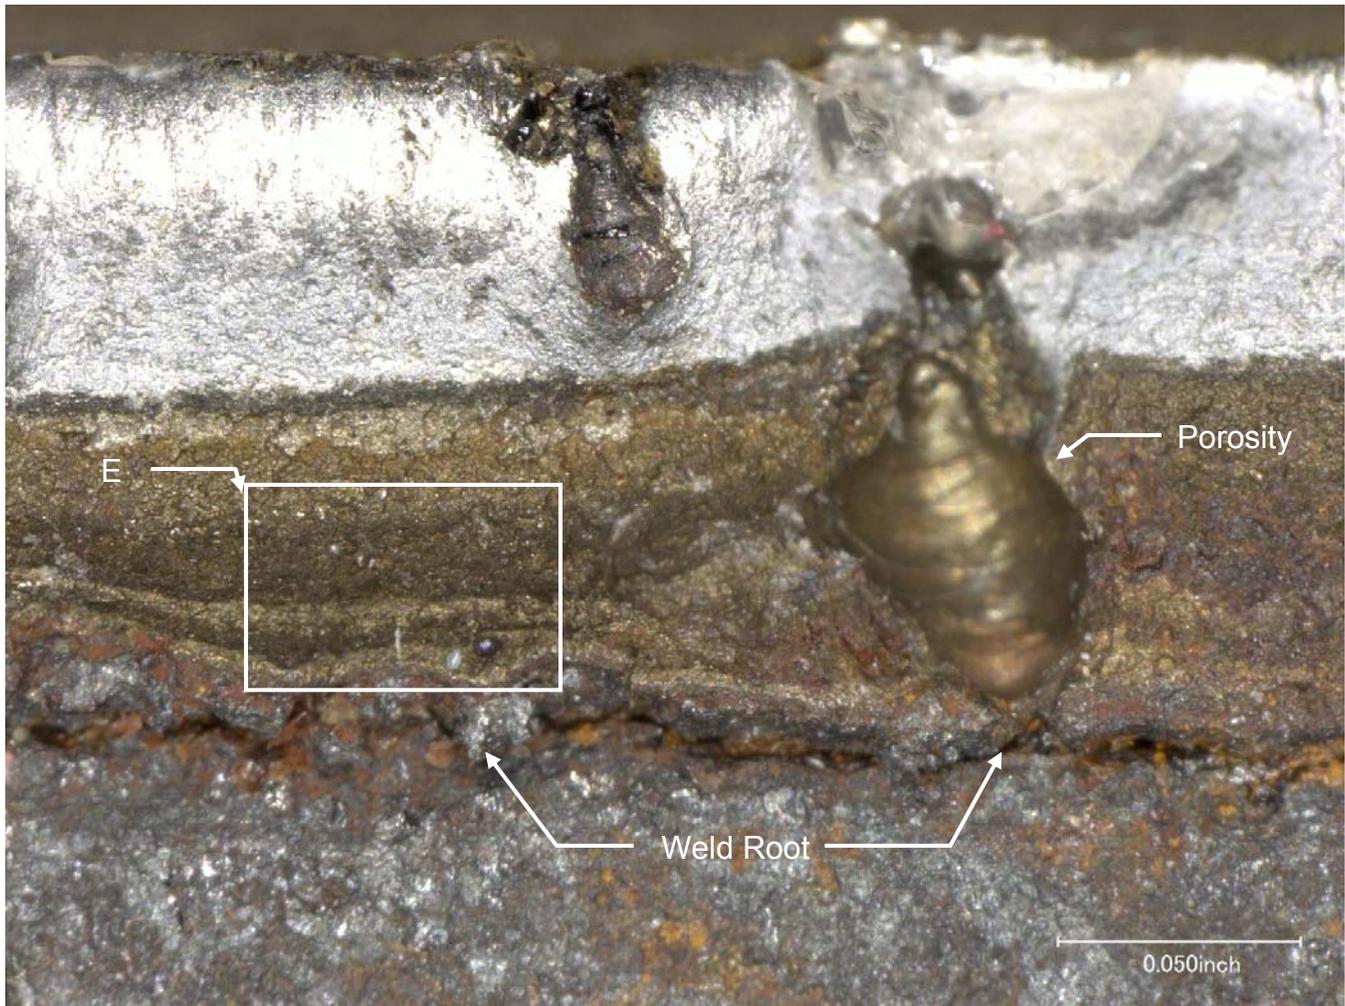
The region from 31.7 inch to 33.9 inch was examined at higher optical magnification and by SEM. Figure 23 shows a higher magnification image of the region labeled D in Figure 20. Alternating light-colored and dark-colored bands were observed

aligned approximately with the longitudinal direction. The bands were of a comparatively close spacing near the weld root and of an increased spacing moving away from the weld root.

**Figure 23:** Higher magnification view of the region labeled D in Figure 20. Alternating light- and dark-colored bands were observed in the ductile fracture region. The region labeled E was examined by SEM, as shown in Figure 24.

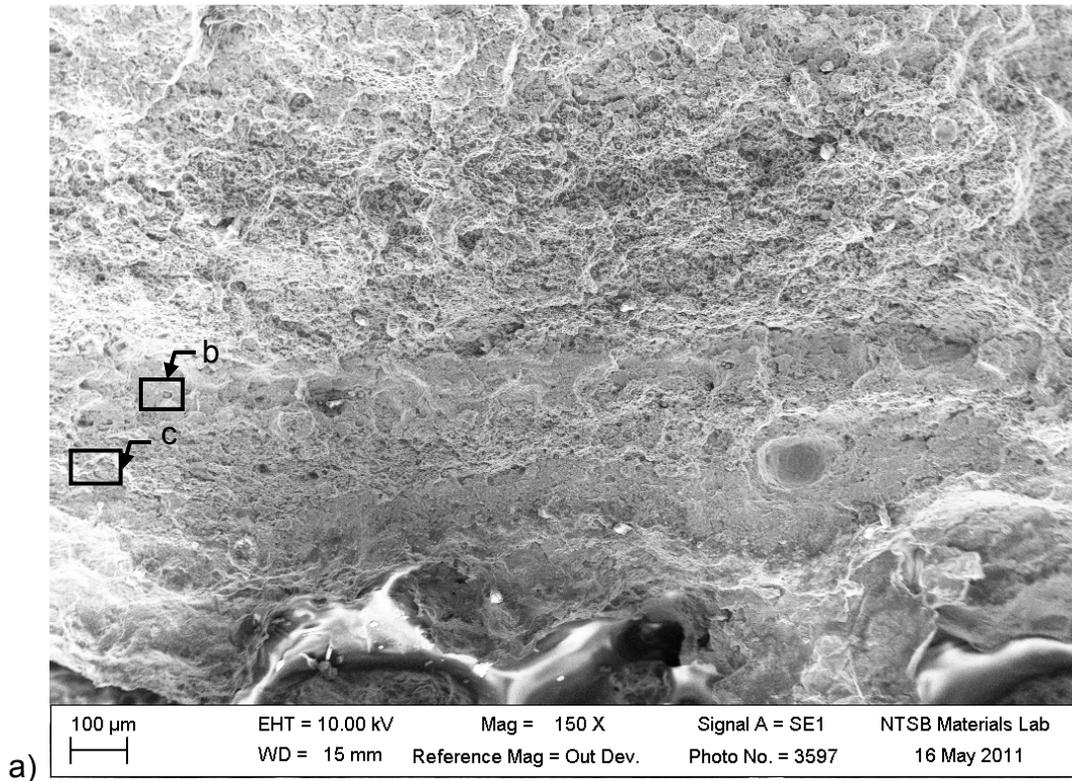
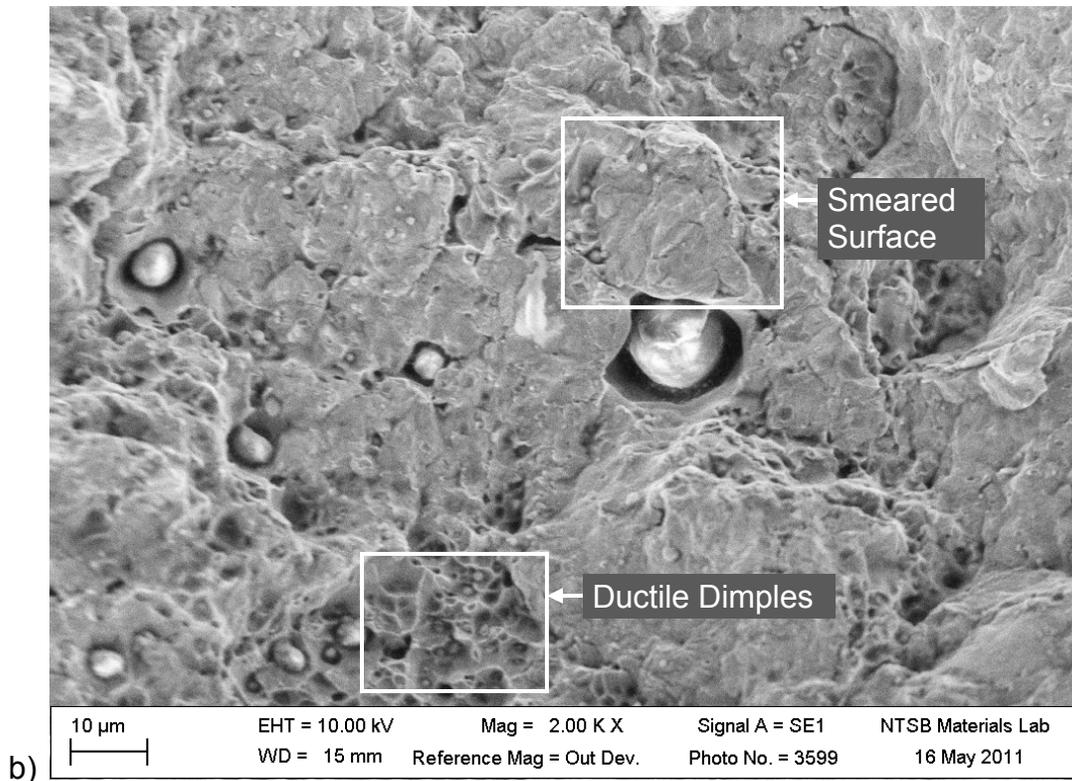
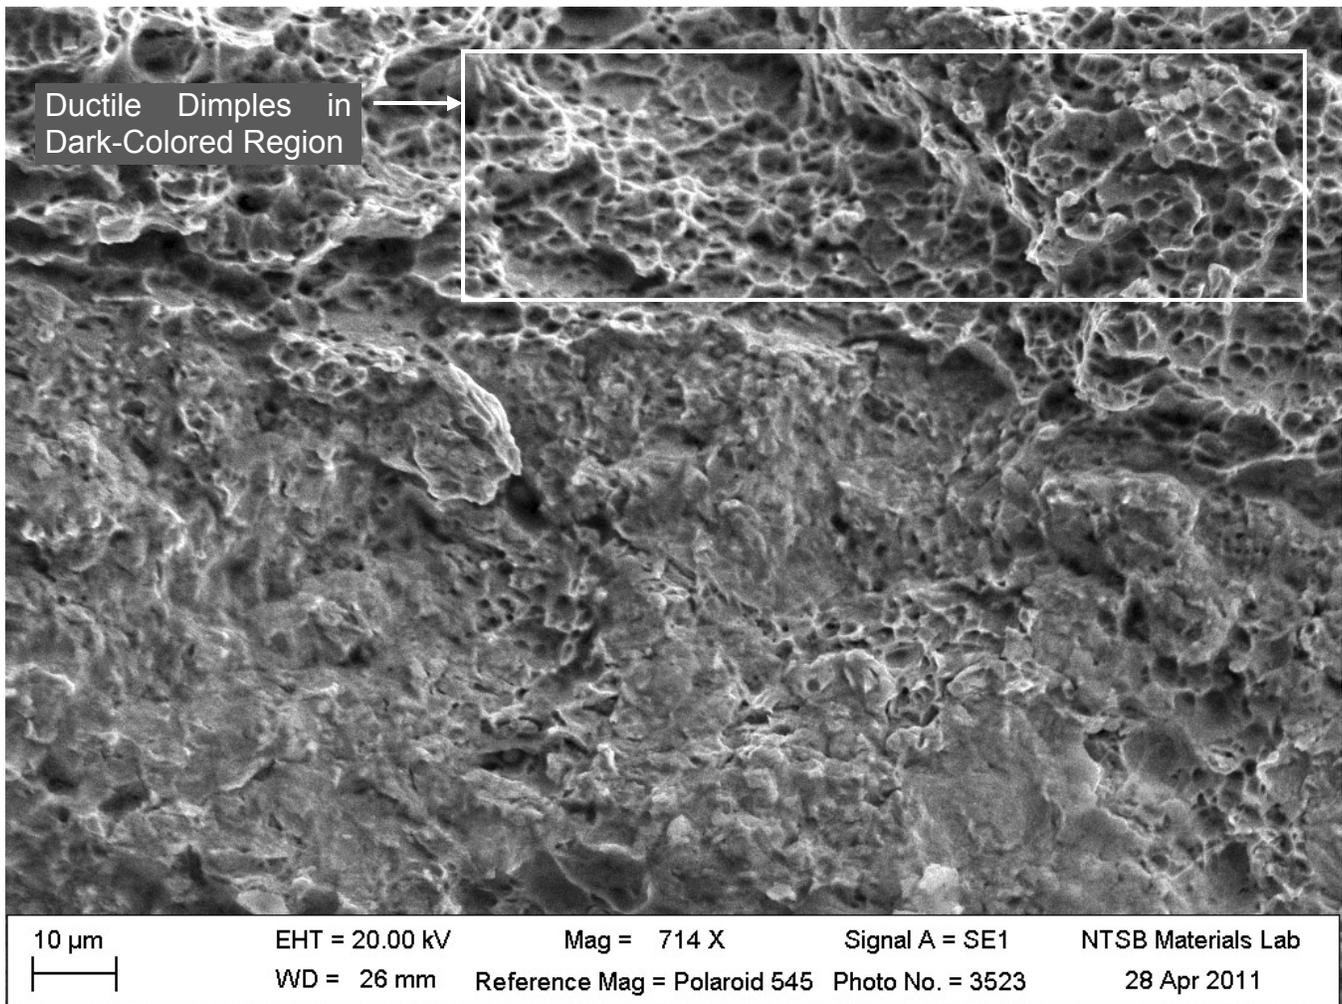
Examination by SEM indicated that the alternating light/dark bands were due to a change in the morphology of the fracture surface. Figure 24a shows an SEM micrograph of the region labeled E in Figure 23. A higher magnification micrograph is shown in Figure 24b (box b in Figure 24a). The fracture surface had an appearance consistent with a smeared fracture surface, with occasional observable dimple features. Figure 23c (box c in Figure 24a) shows the morphology of the dark-colored region, where ductile dimples had not been deformed. Similar light/dark banding was observed from 40.3 inch to 40.7 inch, as shown in Figure 21.

**Figure 24:** a) SEM micrograph of the region labeled E in Figure 23; b) higher magnification image from the region indicated in part a). The fracture surface in the light-colored region was smearred with occasional dimples.

**Figure 24 (cont.):** c) the fracture surface in the dark-colored region consisted solely of ductile dimples.

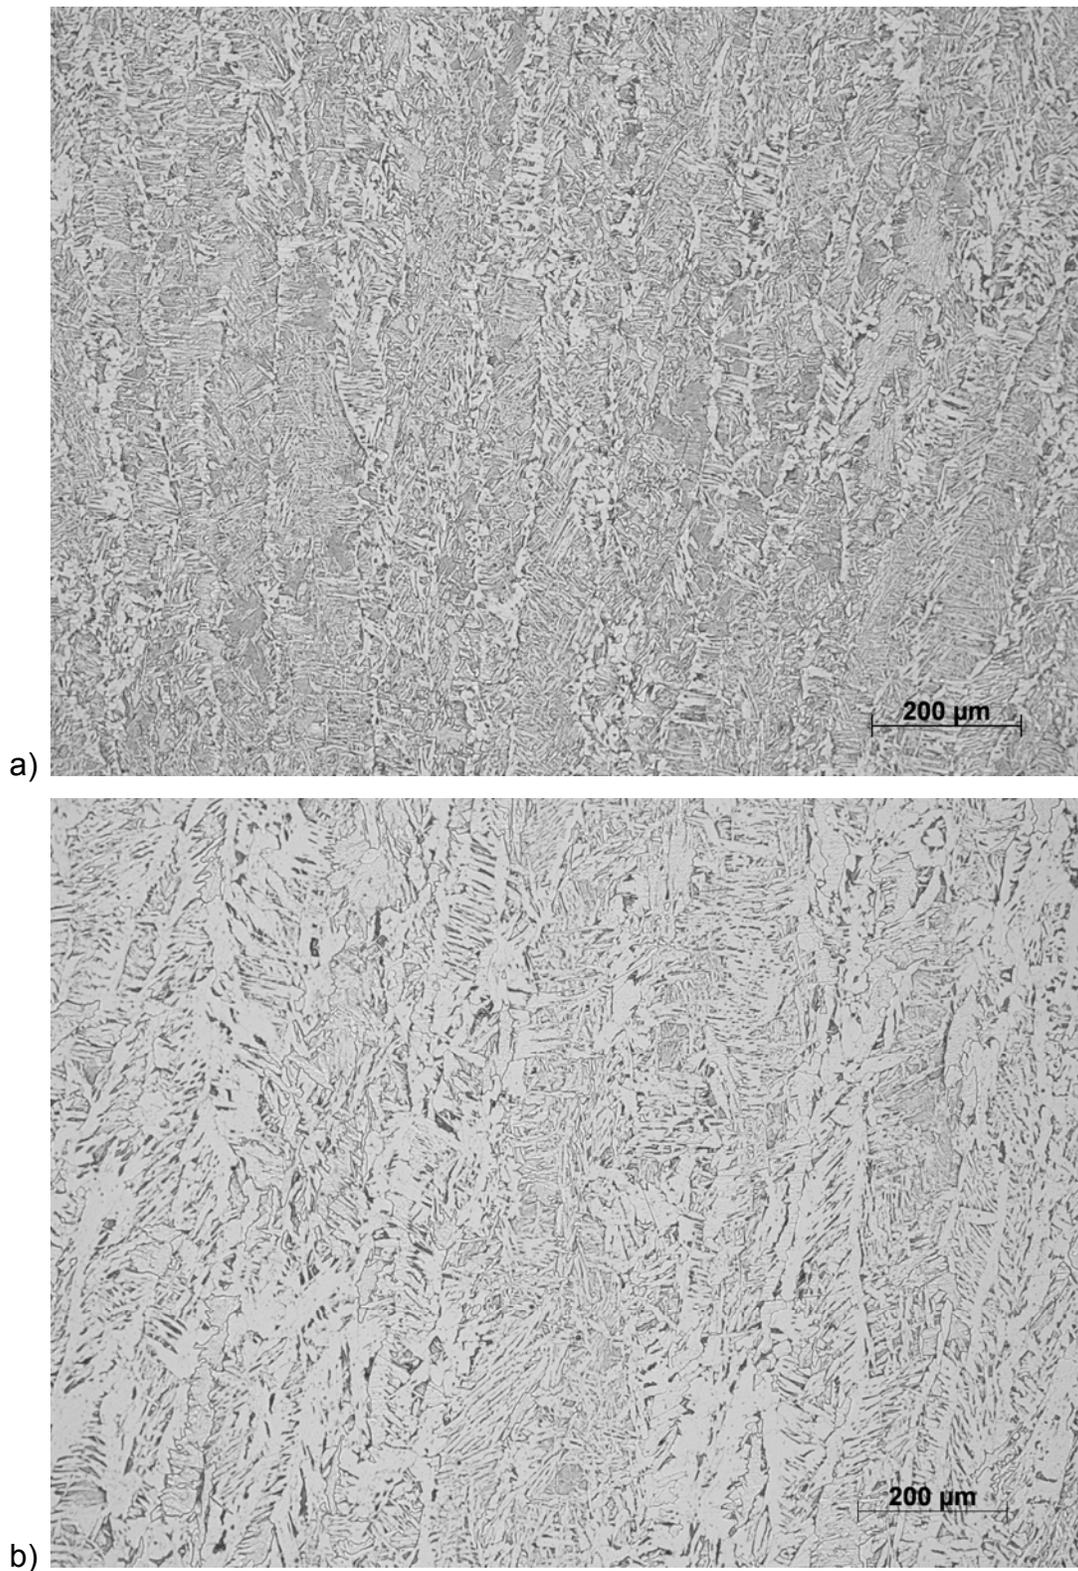
The longitudinal seam weld microstructure of LS, P6, and LN were compared with the weld microstructure of P1, P2, and P3. Figure 25a shows the weld microstructure observed on a cross section of the LS longitudinal seam, which was typical of the microstructure observed on P6 and LN, as well. Figure 25b shows the weld microstructure observed on a cross section of P1, which was typical of P2, and P3, as well. The LS longitudinal seam weld had a much finer microstructure than the weld along the P1 longitudinal seam, consistent with a different rate of heat input and total heat input.

**Figure 25:** Micrographs of representative weld microstructure on cross sections from; a) LS longitudinal seam; b) P1 longitudinal seam. The micrographs were 100X original magnification. The sample was etched using a solution of 2% nitric acid in ethanol.

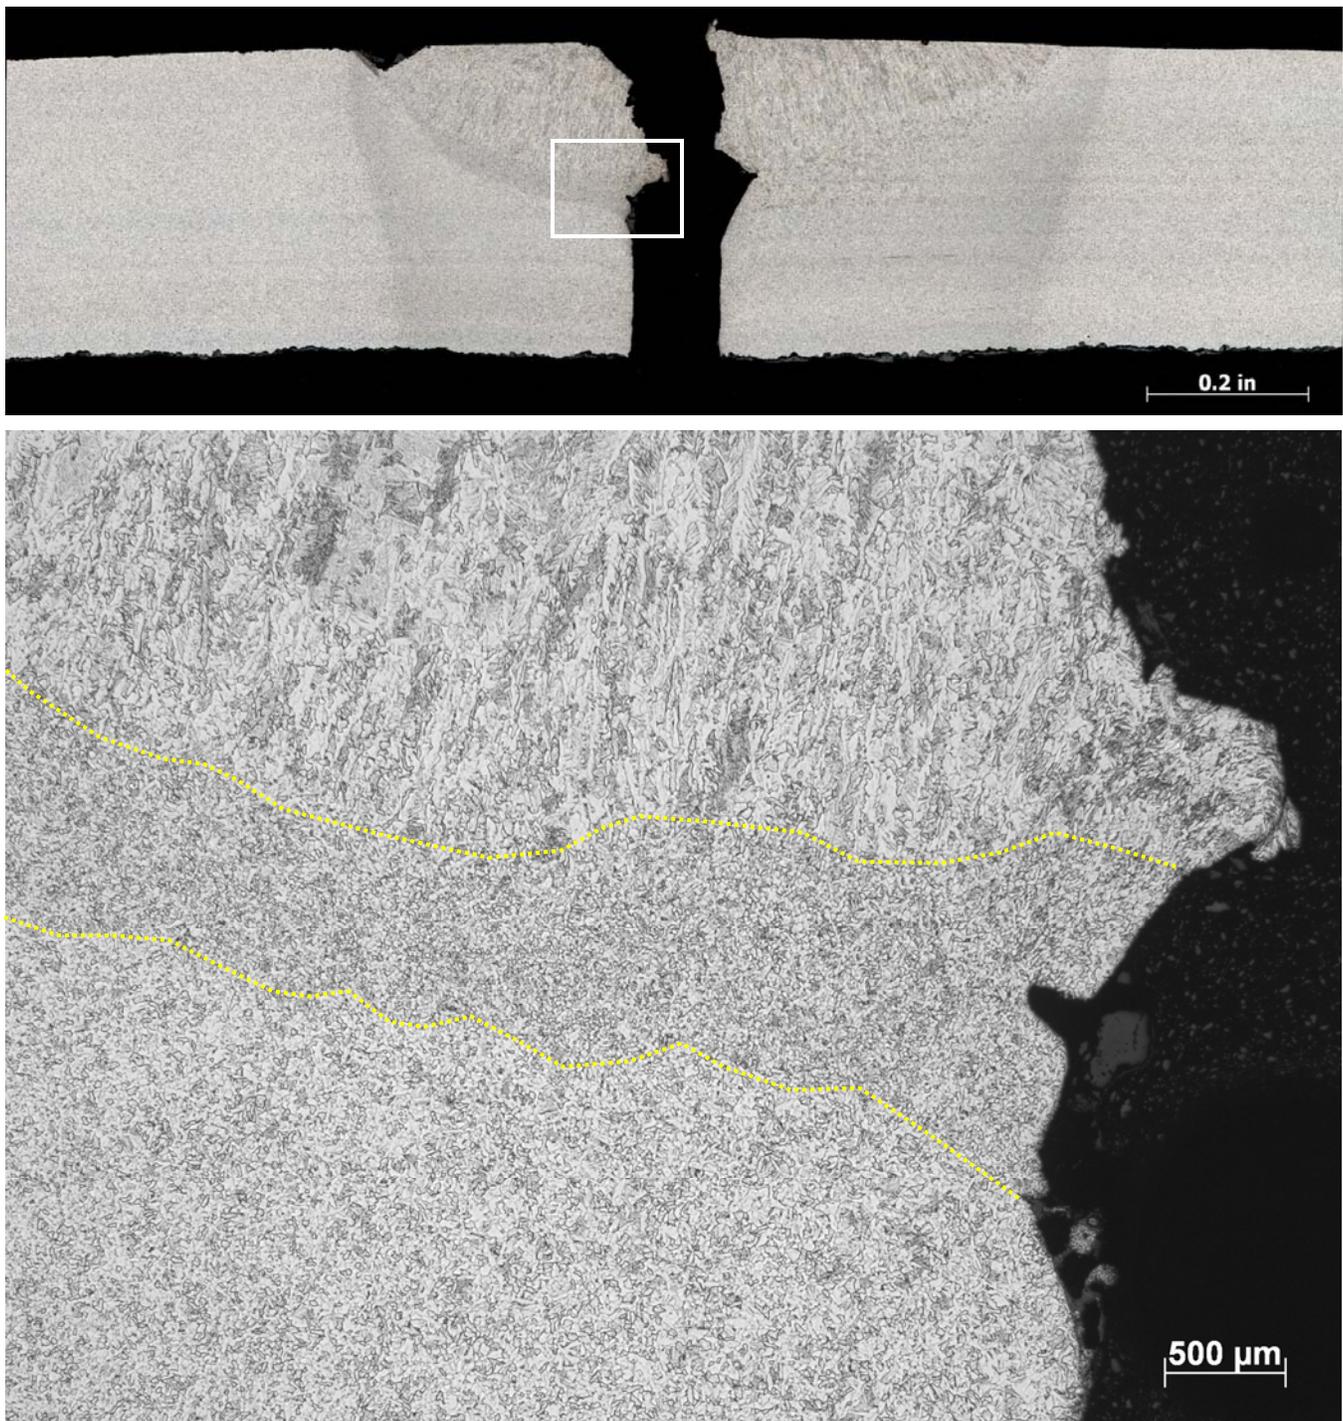
gradually transitioned to the grain-refined HAZ, which in turn transitioned to the base metal region. One side of the P2 longitudinal seam did not exhibit a coarse-grained HAZ, but rather had a highly grain-refined region where a coarse-grained HAZ was observed on other welds, as shown in Figure 27. The refined grain structure was consistent with the remnants of a previous welding pass.

**Figure 27:** One side of the P2 longitudinal seam did not exhibit a coarse-grained HAZ at the base of the weld but, instead, a highly grain-refined region, consistent with the remnants of a previous welding pass. The region indicated by the rectangle in the top image is shown in greater detail in the bottom image. The grain-refined region is bound by two yellow-dashed lines.
