NATIONAL TRANSPORTATION SAFETY BOARD

MATERIALS LABORATORY FACTUAL REPORT

Report No. 11-096

Place : Red Oak, Iowa
Date : April 17, 2011
Vehicle : BNSF 9159 East (coal train) and BNSF 9470 East (maintenance of way equipment train)
NTSB No. : DCA11FR002
Investigator : Michael Hiller, RPH-10

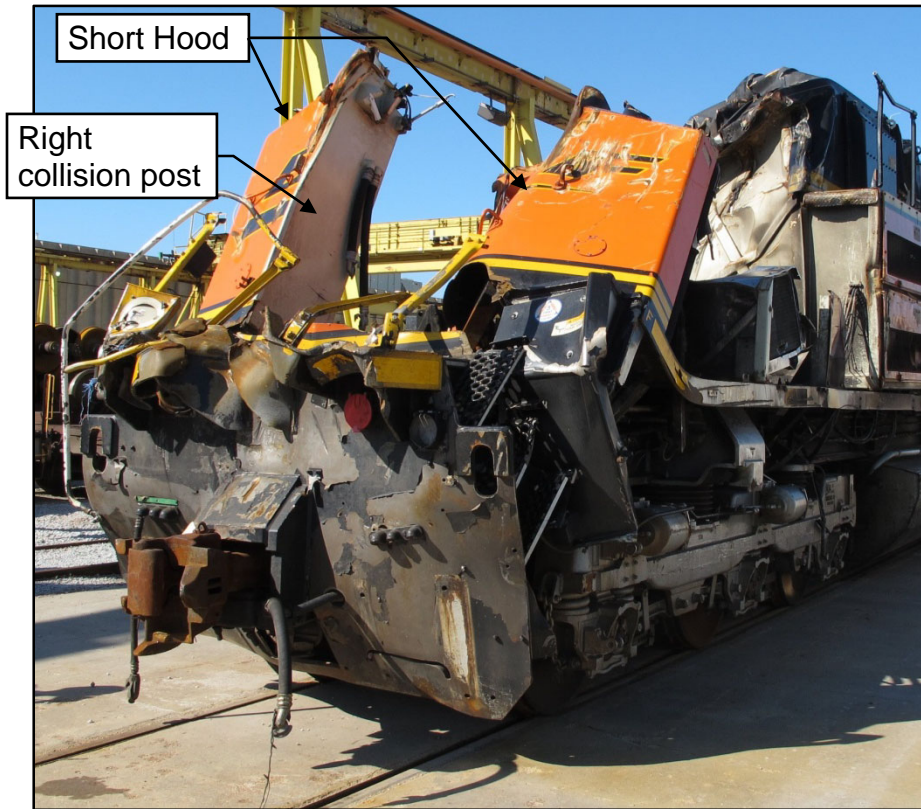
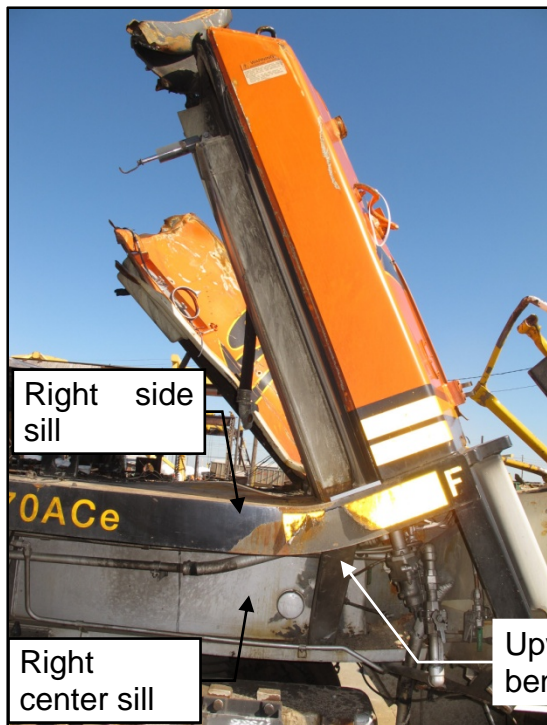
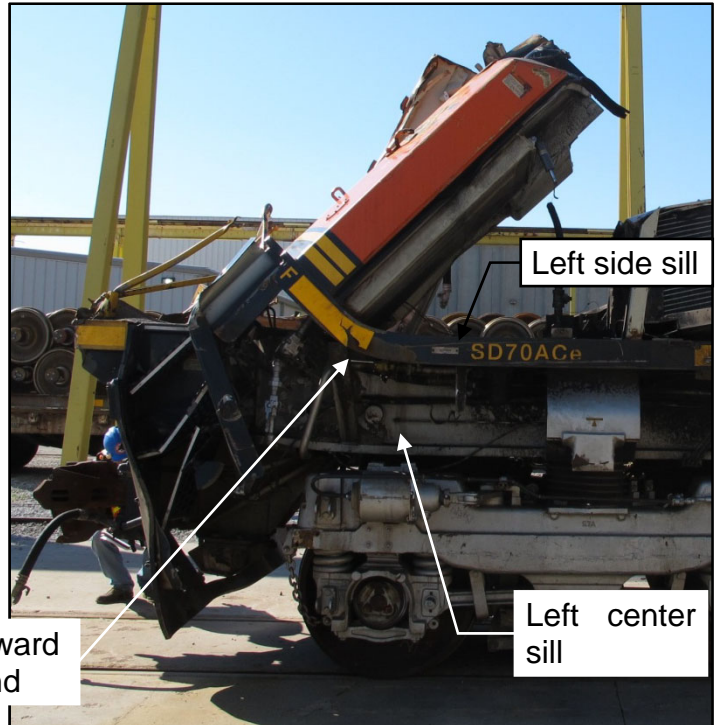
Overall views of the short hood of the accident striking locomotive are shown in figure 1. The short hood including the collision posts were deflected rearward. The collision posts remained attached to the top plates. Deflection of the collision posts occurred as the top plates fractured, welds between the top plates and the center sills and center plate fractured, and the top plate and side sills bent upward. Arrows in figure 1 indicate locations where the side sills and top plates bent upward. Figures 2 and 3 show closer views of the fractures and deformation at the lower end of the right collision post. Figures 4 and 5 show closer views of the fractures and deformation at the lower end of the left collision post.

Figure 1. Overall views of the front of the striking locomotive showing short hood and collision post deflection with bending deformation to the top plates and side sills.

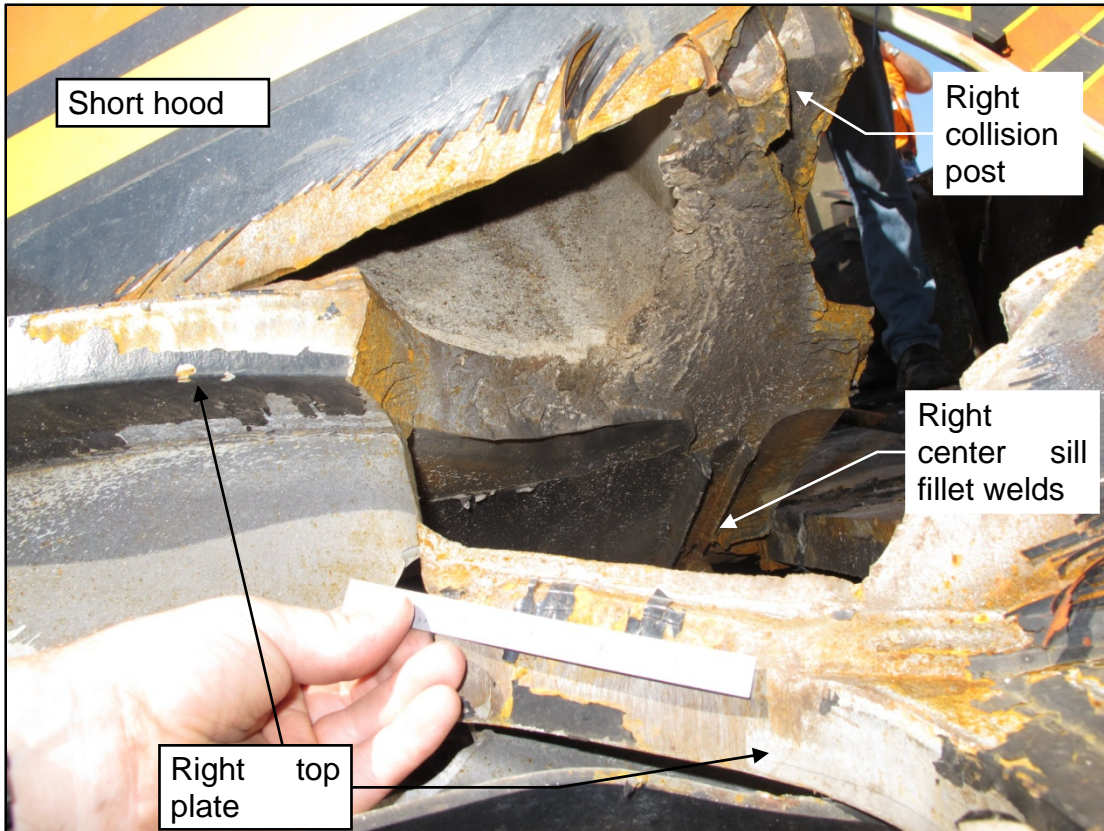
The right top plate was fractured near the forward end of the collision post as shown in figure 2. The fracture surface showed matte gray fracture features with areas of orange-colored post-fracture oxidation. Radial features emanated from an area near the forward end of the collision post consistent with fracture propagating front to rear. The fracture propagated nearly in the short transverse plane directly under the collision post from the upper side to the lower side of the top plate along a length of 11 inches. A secondary fracture curving from the longitudinal to the transverse plane emanated from the fracture under the collision post and turned back toward the front edge of the top plate approximately 6 inches outboard of the collision post.

The fillet welds between the right top plate and the right center sill were fractured near the original surface plane of the center sill as shown in figure 2. Fracture features showed smeared patterns consistent with shear fracture with no indications of weld anomalies. The weld sizes as measured on the fracture surfaces were 5/8 and 1/2 inch for the outboard and inboard fillet welds, respectively.

Figure 2. Close view of fractures at the lower end of the right collision post.

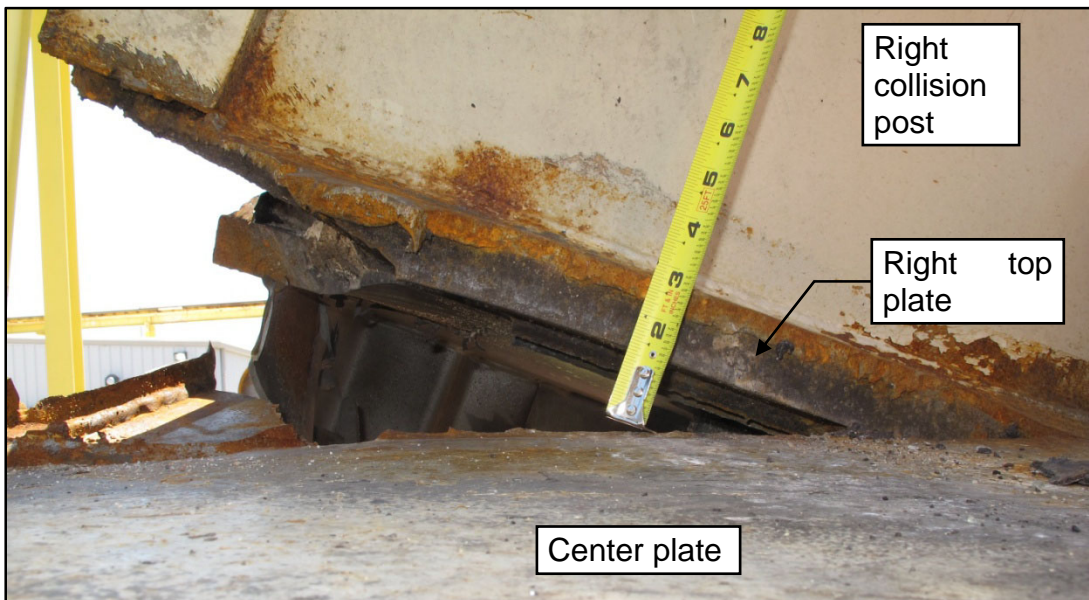
A view of the fracture surface of the weld between the right top plate and the center plate is shown in figure 3. The fracture features were covered with orange oxide, consistent with post-fracture oxidation. The fracture surface was rough and irregular consistent with overstress fracture. The weld depth as measured on the fracture surface was somewhat variable measuring approximately 7/16 inch deep with a variation of approximately $\pm 1/16$ inch.

Figure 3. Side view of the lower end of the right collision post looking outward.

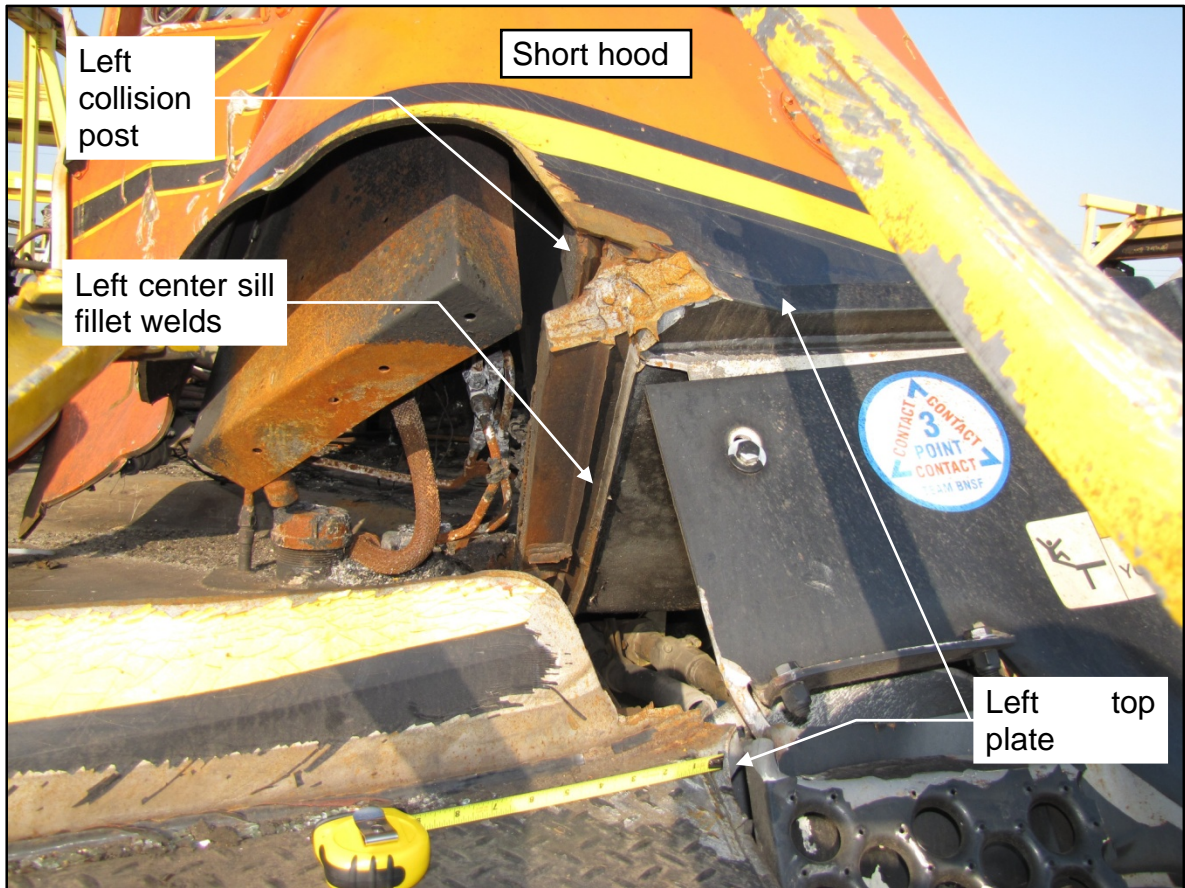
The left top plate was fractured in a plane nearly perpendicular to the longitudinal direction at the forward end of the left collision post as shown in figure 4. Fracture

features were rough with orange-colored post-fracture oxidation, features consistent with overstress fracture. Radial marks emanated from the upper side of the top plate, indicating the fracture propagated through the top plate starting from the top surface.

The fillet welds between the right top plate and the right center sill were fractured near the original surface plane of the center sill as shown in figure 4. Fracture features showed smeared patterns consistent with shear overstress fracture with no indications of weld anomalies. The weld sizes as measured on the fracture surfaces were 3/4 and 3/8 inch for the outboard and inboard fillet welds, respectively.

Figure 4. Close view of fractures at the lower end of the left collision post.

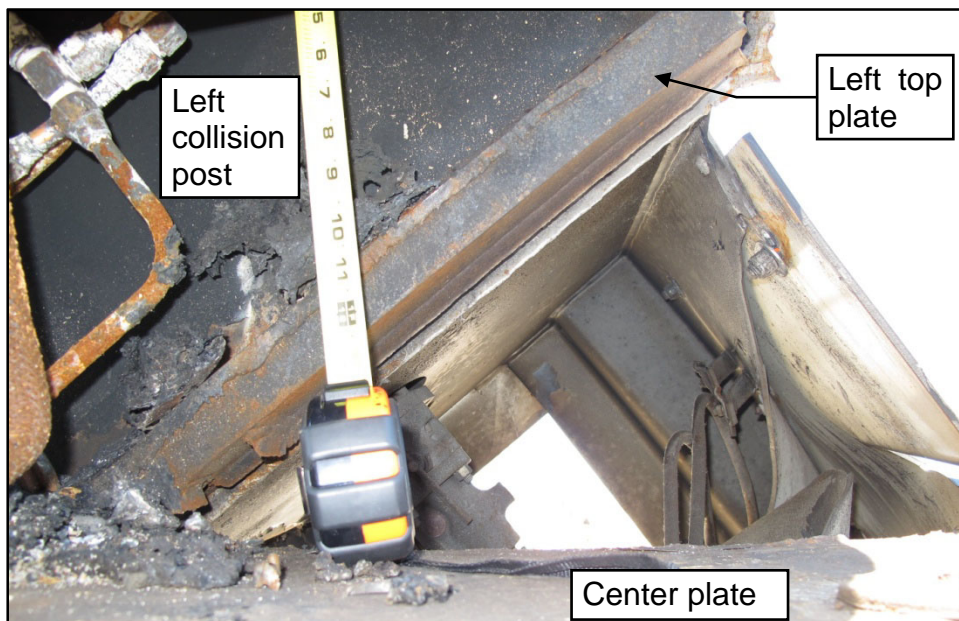
A view of the fracture surface of the weld between the left top plate and the center plate is shown in figure 5. The fracture surface and surrounding surfaces were covered with black sooty deposits, and portions of the fracture surface were covered with orange oxide, consistent with exposure to fire and post-fracture oxidation. The fracture surface had smeared features consistent with overstress shear fracture. The weld depth as measured on the fracture surface was somewhat variable measuring approximately 1/4 to 3/8 inch deep.

Figure 5. Side view of the lower end of the left collision post looking outward.

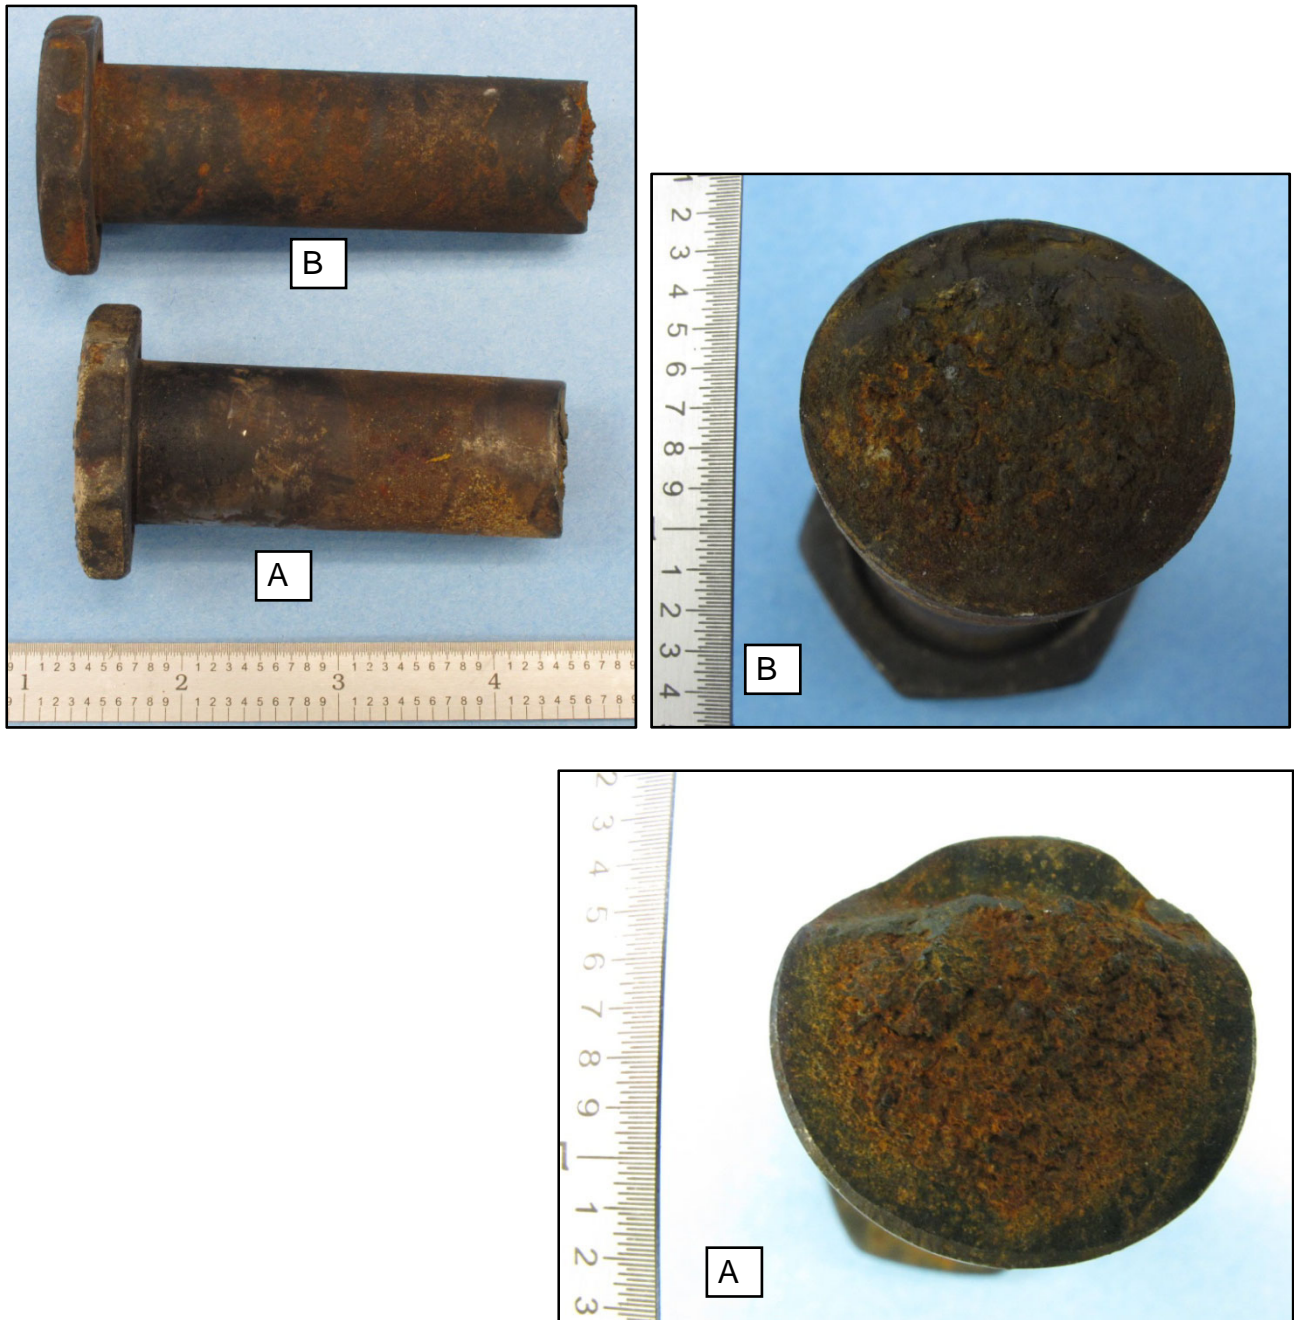
The two forward cab retention pins were fractured, and overall views of the fractured retention pins are shown in figure 6. The pins were arbitrarily labeled "A" and "B" as shown in figure 6. The original position of the pins relative to the left or right side of the cab was not determined. A view of the right lug through which the right pin was inserted is shown in figure 7.

Both pins had part number "8146747" and manufacturer mark "GB" formed on the head. Pin A had paint visible on parts of the head. Portions of the original gray ground surface was visible around $\frac{3}{4}$ of the circumference of the shank within 1.1 inches of the head. The remainder of pin A had black and orange oxides and sooty deposits on the remainder of the surfaces. On pin B, painted areas were visible on the head, and the paint appeared heat tinted to a reddish brown color. The remainder of the surfaces showed orange and black oxides and sooty deposits.

The shank diameter of pins A and B measured 0.999 inch and 1.001 inch, respectively, both within the range of allowable dimensions specified in the engineering drawing for EMD part number 8146747 bolts. Pins A and B were fractured in the shank at 2.66 inches and 3.18 inches from the underside of the head, respectively. Views of the fracture surfaces are shown in figure 6. Fracture features on both pins were similar. The fracture surfaces were relatively smooth around the edges and rough in the middle.

Small shear lips were visible around the edges, and an overall change in fracture plane was observed at one side of the fracture. All features were consistent with overstress fracture of surface-hardened steel under a bending load.

Figure 6. Side view and views of the fracture surfaces of the two fractured retaining pins arbitrarily labeled “A” and “B”.

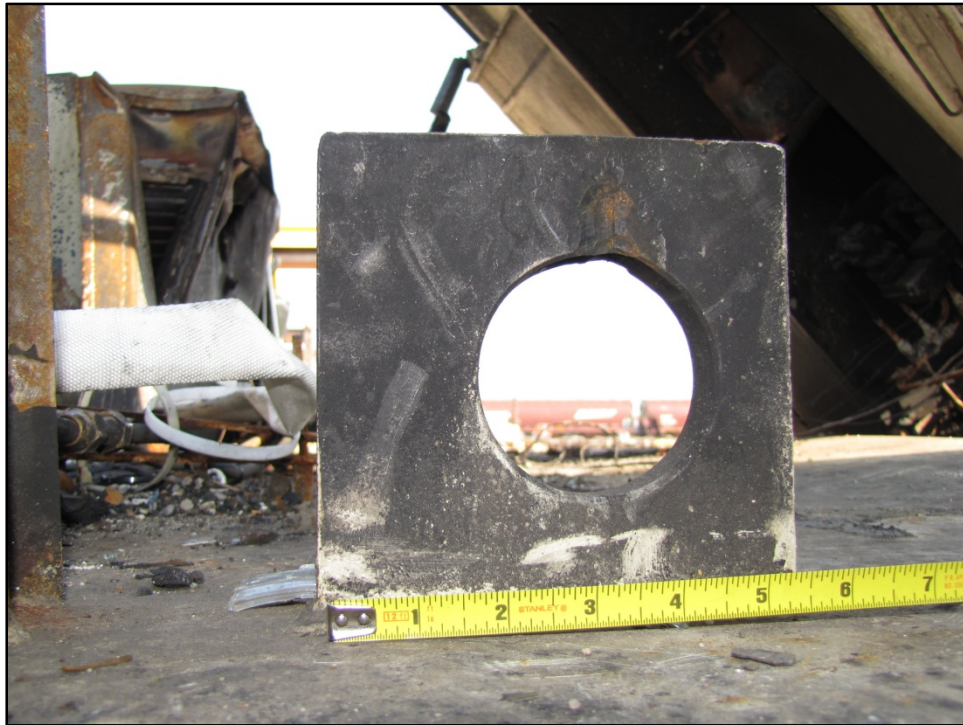
Figure 7. Lug attached to the top plate at the right forward cab retention joint.
