NATIONAL TRANSPORTATION SAFETY BOARD

MATERIALS LABORATORY FACTUAL REPORT

Report No. 13-018

Place : Ellicott City, Maryland
Date : August 21, 2012
Vehicle : CSX Transportation coal train U183-18
NTSB No. : DCA12MR009
Investigator : Richard Hipkind, RPH-10

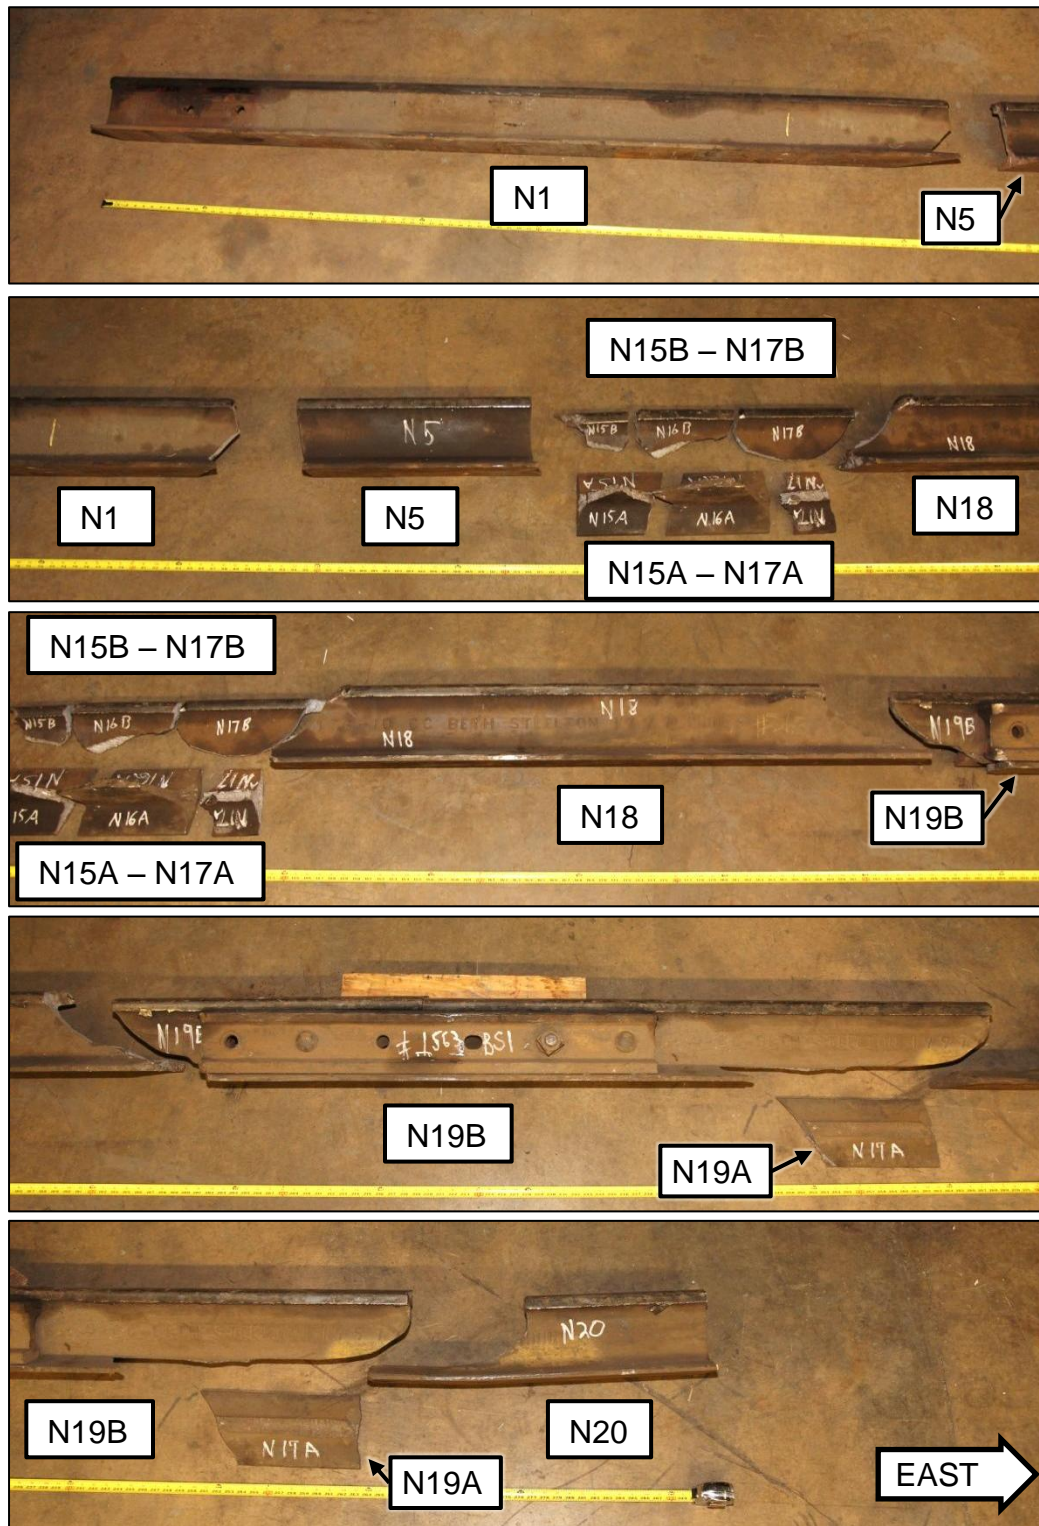
Overall views of the 12 submitted rail pieces are shown in figure 1. The pieces were from the north rail at the derailment site. The pieces were labeled N1, N5, N15A to N17A, N15B to N17B, N18, N19A and B, and N20. Based on the rail reconstruction conducted on-scene, the pieces were numbered with numbers increasing from west to east. The numbers were preceded by an N for the north rail. In cases where the rail was fractured in the web, the base portion was labeled with an A, and the head portion was labeled with a B.

The pieces are shown in figure 1 in their relative positions based on the rail reconstruction. Mating fractures for the east end of piece N1, both ends of piece N5, and the west ends of pieces N15A and B were not observed in the recovered pieces. The remaining fractures all had mating sides. The west end of piece N1 was a cut end that was part of a rail joint that was found intact after the accident and was disassembled on-scene. The east end of piece N20 was cut on-scene after the accident to facilitate shipping and examination of the west end of piece N20. No weld joints were observed in the submitted pieces. The joint bars in piece N19B had been applied to repair a defect detected during an internal rail inspection conducted in July, 2012.

Figure 1. Overall views of the gage side of the submitted rail pieces.

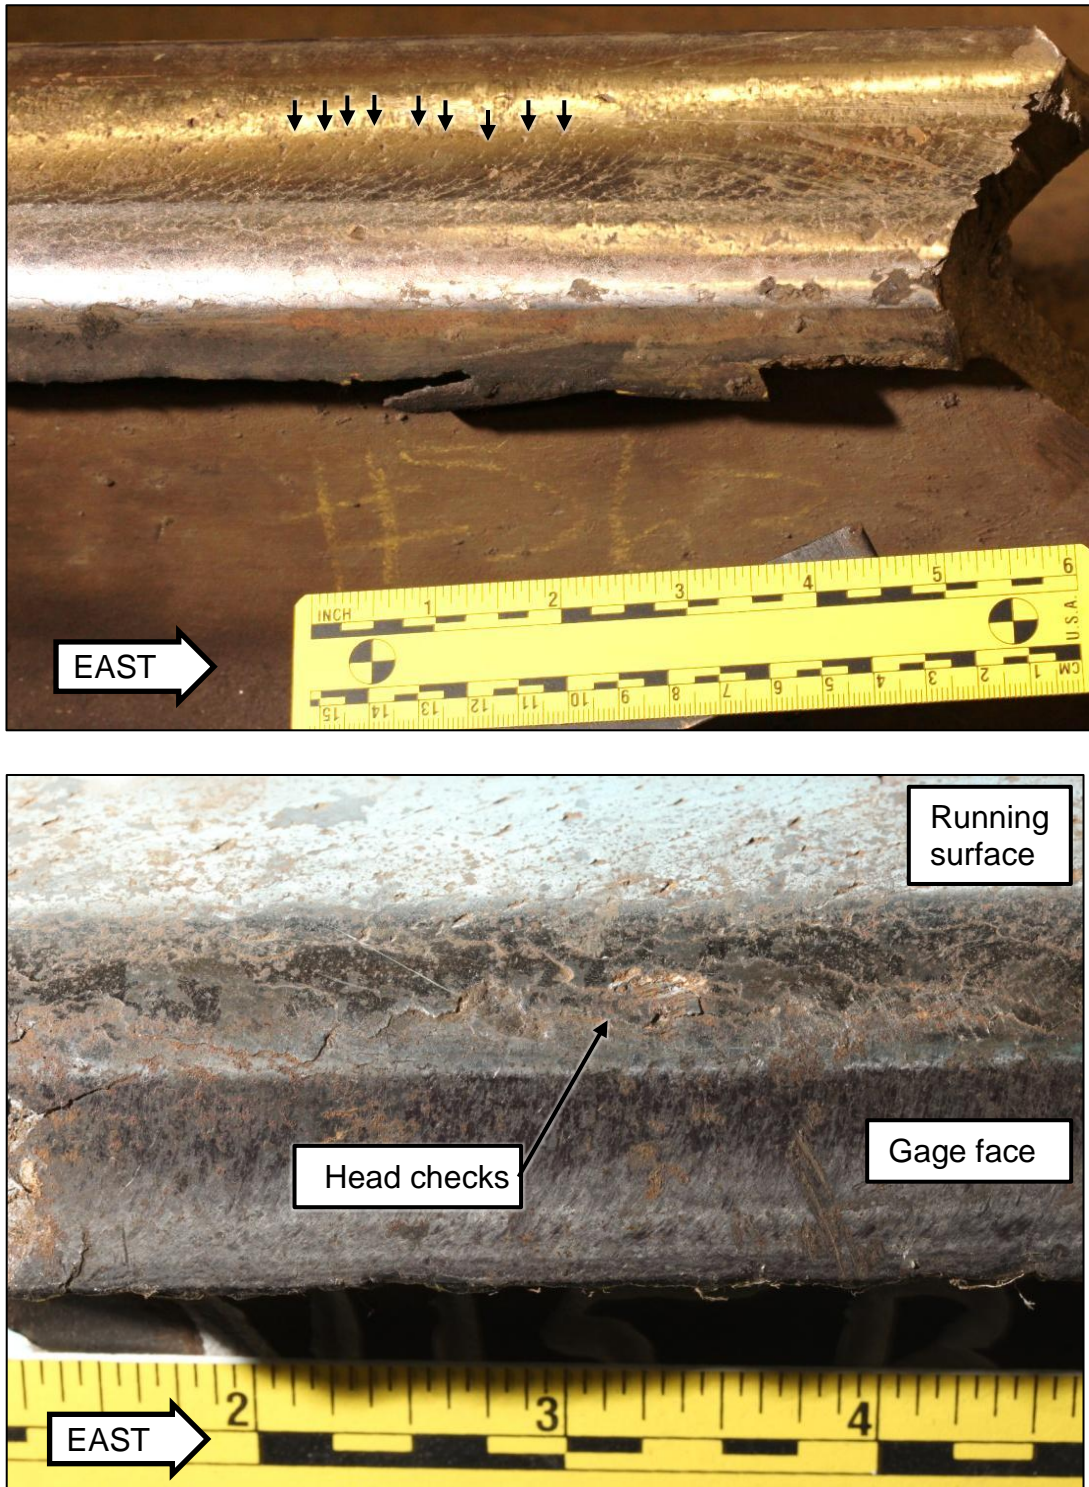
Views of typical features observed on the running surface of the rail are shown in figure 2. Surface cracks associated with rolling contact deformation were observed on the gage side of the running surface. Unlabeled arrows in the upper image in figure 2 indicate many of these surface crack features. Head checks² were generally observed at the gage corner of the head as shown in the lower image in figure 2.

Figure 2. Views of the rail surface on two of the pieces showing rail surface conditions observed on the rail pieces. Unlabeled arrows in the upper image point to some of the cracks associated with surface rolling contact deformation as observed on the running surface near the gage corner.

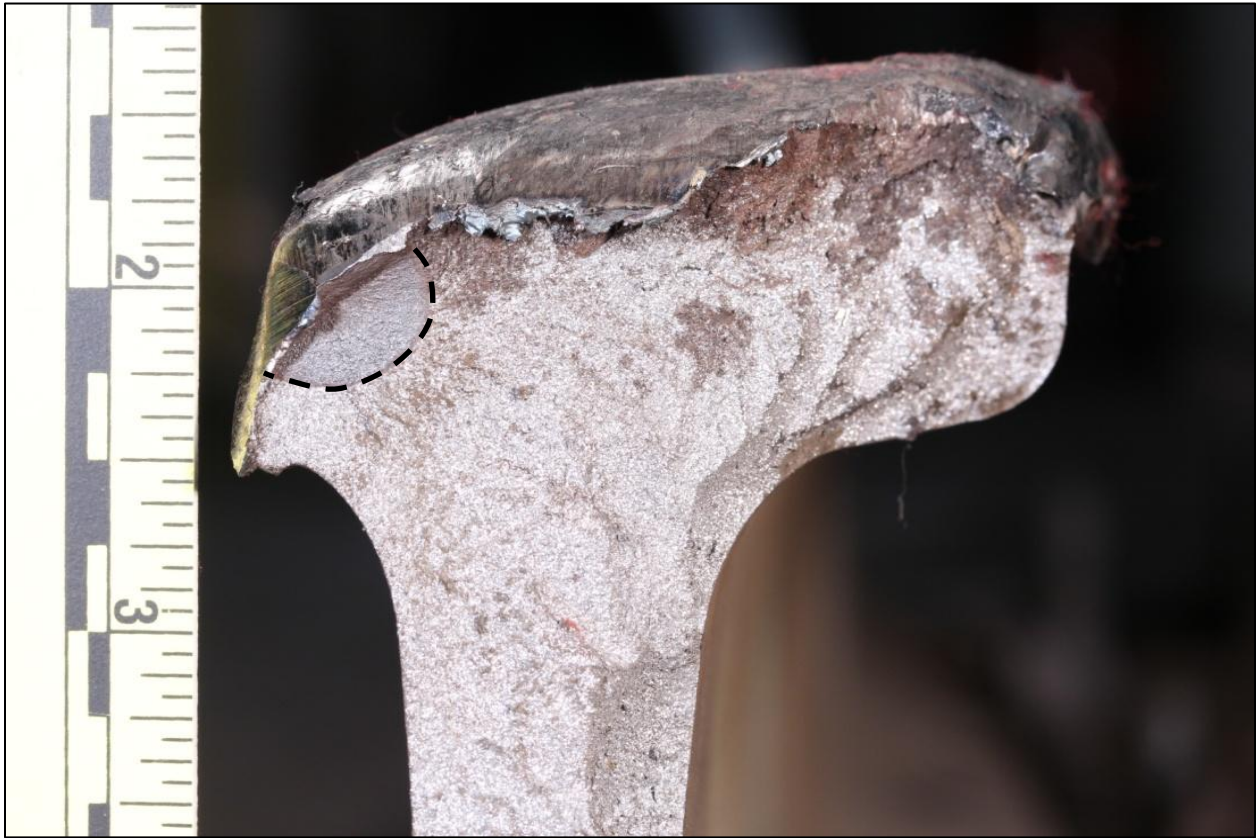
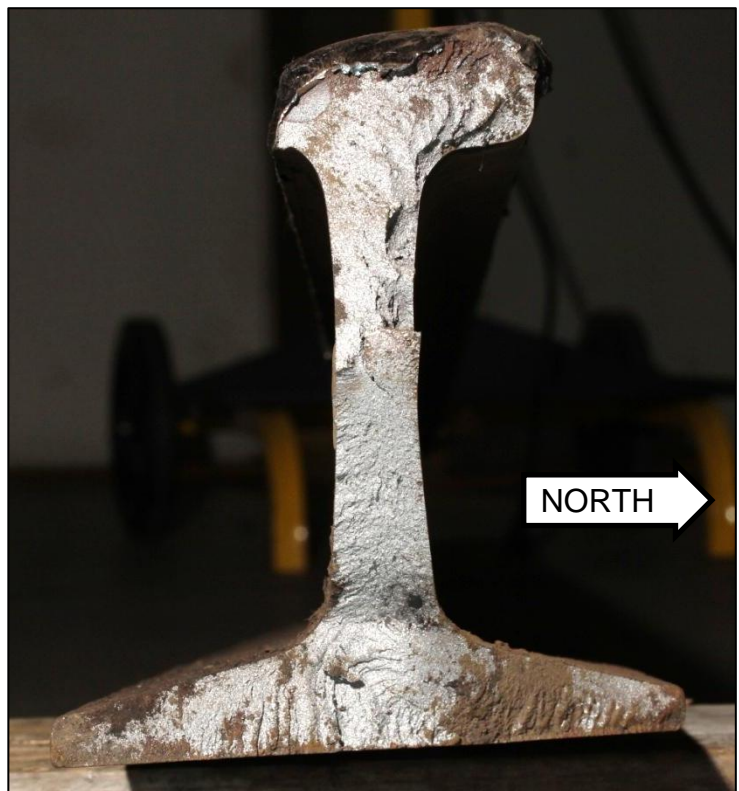
Views of the fracture surface at the east end of rail piece N1 are shown in figure 3. The upper and gage sides of the head were deformed and curled over the fracture surface consistent with trailing rail end deformation.³ A dark area with relatively flat fracture features and a smooth curving boundary was observed at the gage side of the head, features consistent with a transverse detail fracture.⁴ A dashed line in the upper image in figure 3 indicates the boundary of the detail fracture. The origin area of the detail fracture was obliterated by the trailing rail end deformation, but the shape of the boundary was consistent with a detail fracture emanating from the gage corner area. The size of the detail fracture covered approximately 9 percent of the remaining head area.

Figure 3. Views of the fracture surface at the east end of piece N1. A dashed line in the closer view of the head indicates the boundary of a detail fracture emanating from the gage corner.

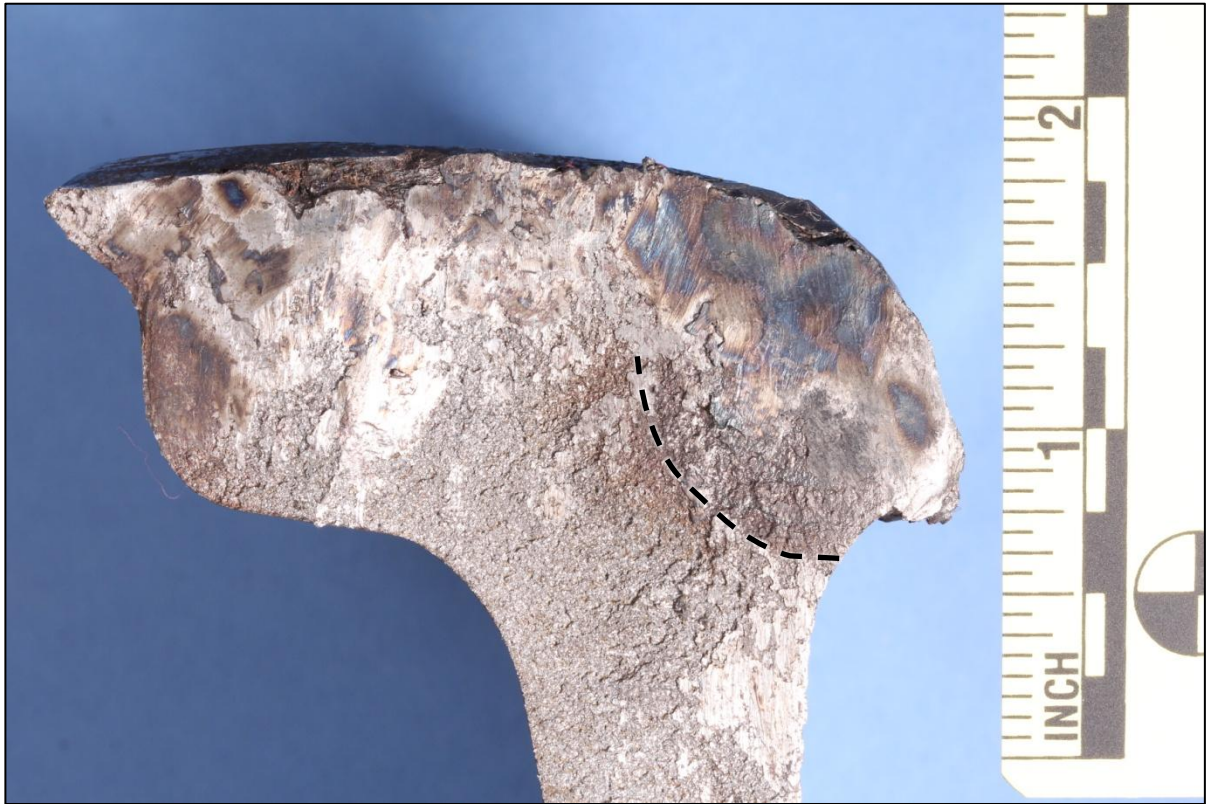
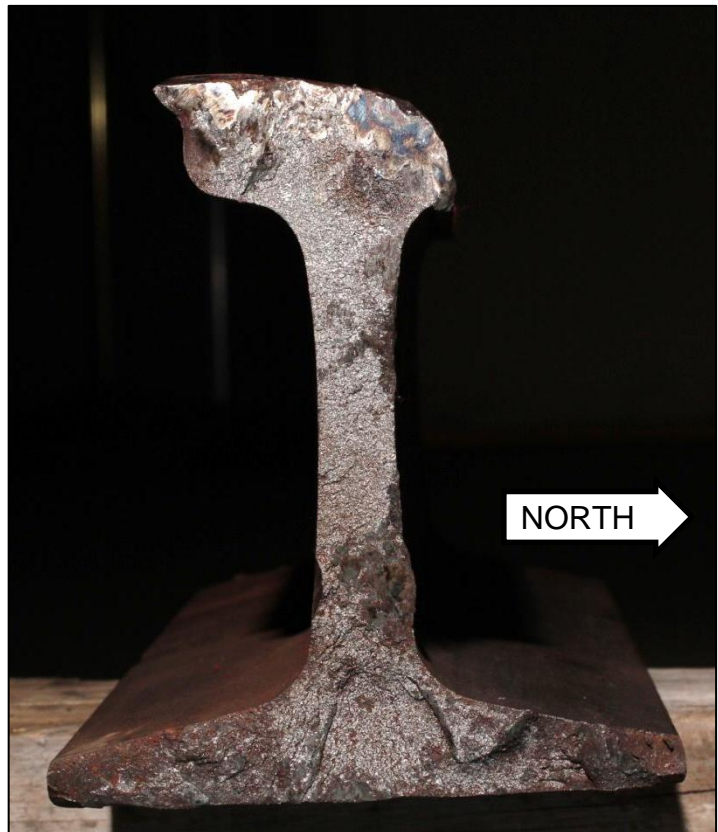
Fracture surfaces at the west and east ends of piece N5 are shown in figures 4 and 5, respectively. The head area including the gage corner of both pieces had post-fracture damage that obscured many of the fracture features. However, areas of dark oxide were observed on both pieces and portions of curving crack arrest boundaries were observed, consistent with transverse detail fractures at each end of piece N5. Dashed lines in the upper images in figures 4 and 5 indicate the approximate boundaries of the detail fractures. The fracture surface within the detail fracture at the west end of piece N5 appeared relatively rough near the boundary, consistent with

Figure 4. Views of the fracture surface at the west end of piece N5. A dashed line in the closer view of the head indicates the boundary of a detail fracture emanating from the gage corner.

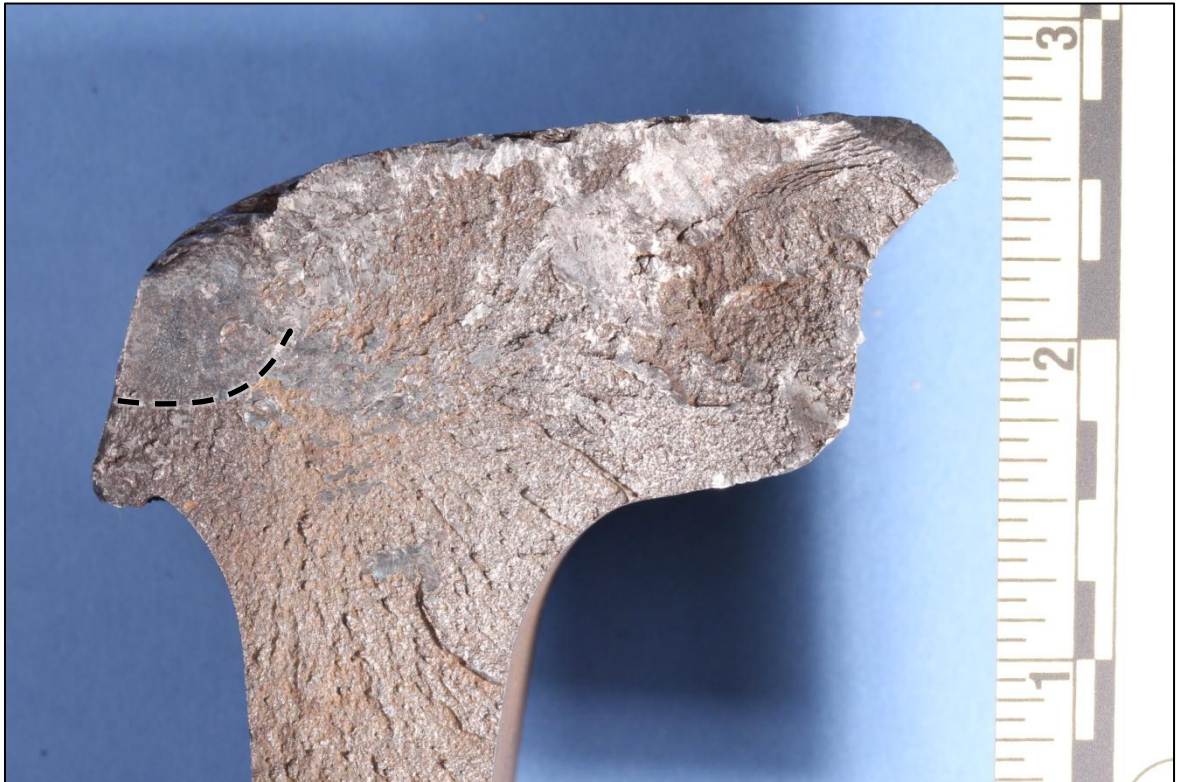
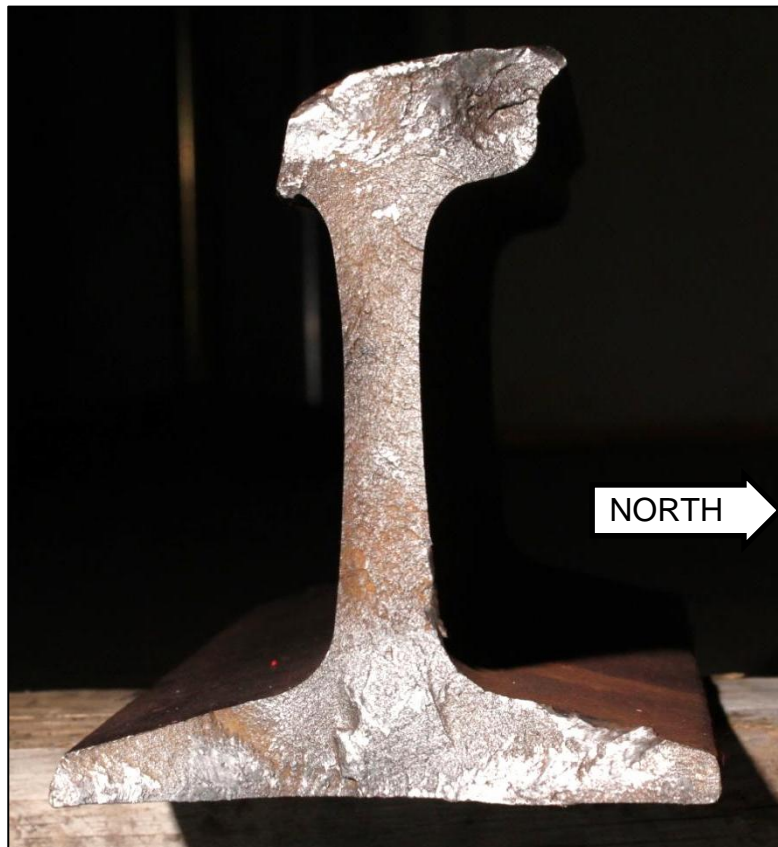
relatively rapid crack growth. Both fracture surfaces showed rubbing damage at the upper portion of the head fracture, and some receiving rail end deformation⁵ was observed at the running surface at the west end of piece N5. The overstress portions of the fractures at both the east and west ends of piece N5 appeared rubbed consistent with fracture surface recontact in the overstress regions. The transverse defects covered approximately 24 percent of the remaining head at the west end of piece N5 and 10 percent of the remaining head area at the east end of piece N5.

Figure 5. Views of the fracture surface at the east end of piece N5. A dashed line in the closer view of the head indicates the boundary of a detail fracture emanating from the gage corner.

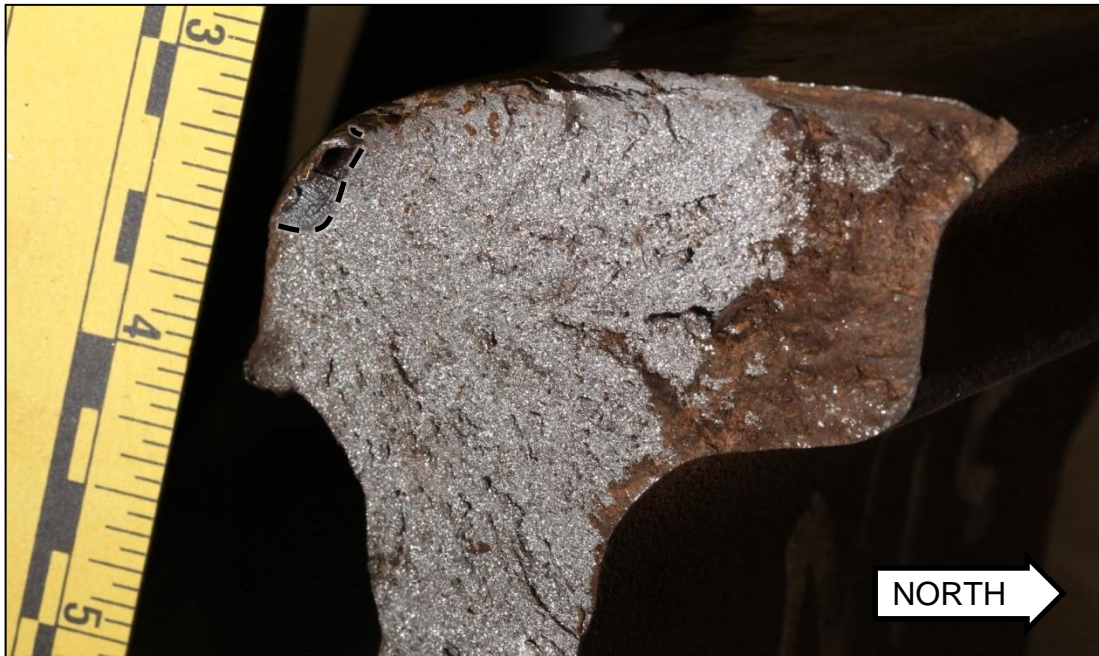
The fracture at the west end of piece N15B was angled between the transverse and horizontal planes. The fracture had uniform rough features consistent with overstress fracture. No evidence of a preexisting crack was observed, and no rail end deformation was observed. The fracture at the east end of piece N15B is shown in figure 6. A transverse detail fracture was observed in the gage corner as shown in figure 6, where the curving boundary of the detail fracture is indicated with a dashed line. The detail fracture covered approximately 2 percent of the remaining head area. The field side of the fracture was covered with reddish brown dirt.

Figure 6. View of the fracture surface at the east end of piece N15B. A dashed line indicates the boundary of a detail fracture emanating from the gage corner.

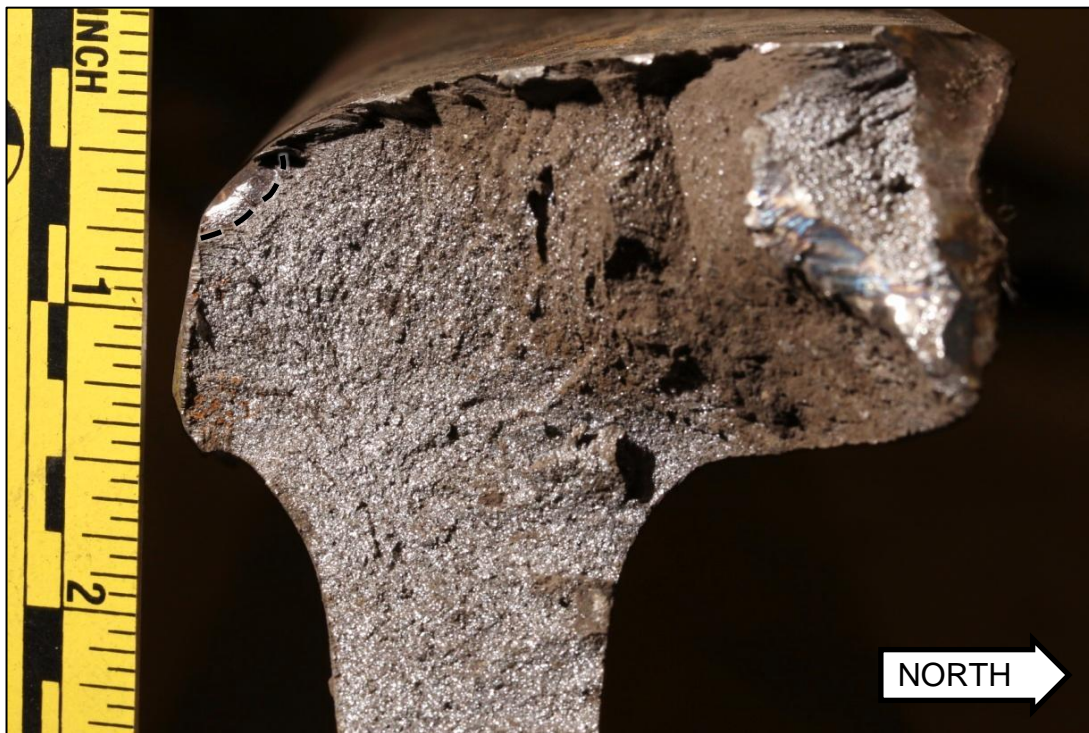
The fracture at the east end of piece N18 is shown in figure 7. An open head check was observed in the gage corner, and the start of transverse detail fracture growth from the area of the open head check was observed. A dashed line in figure 7 indicates the area of the open head check and transverse detail fracture growth. The size of the detail fracture was approximately 1 percent of the remaining head area (including the area of the open head check). The field side of the fracture was covered with reddish brown dirt.

Figure 7. View of the fracture surface at the east end of piece N18. A dashed line indicates the boundary of a detail fracture emanating from an open head check at the gage corner.

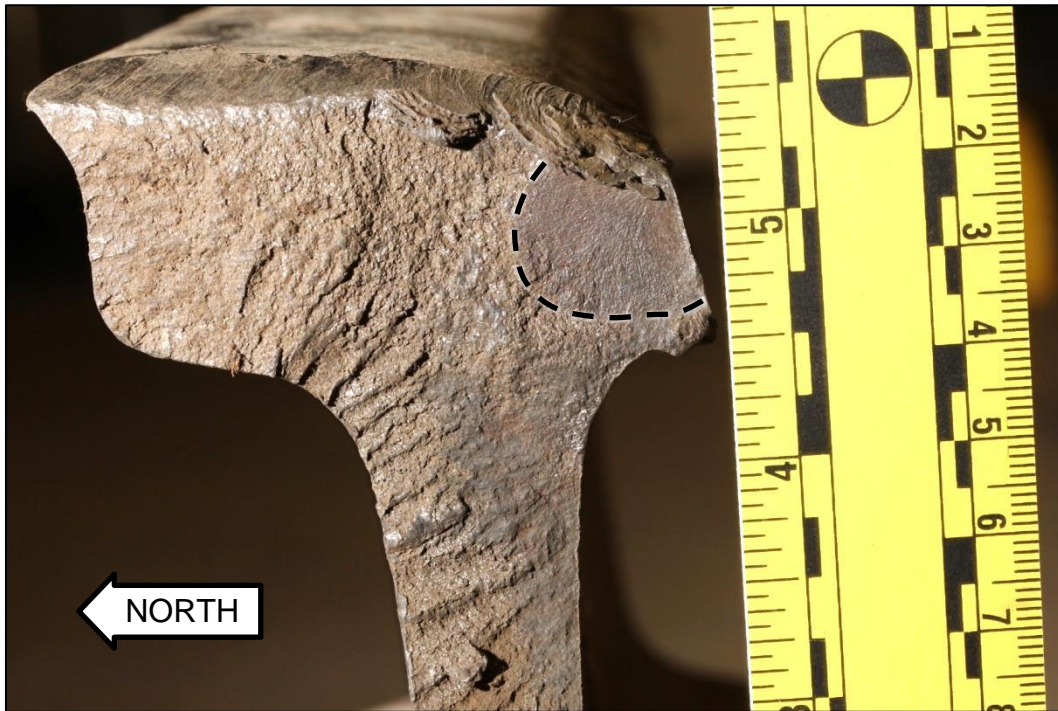
The west end of piece N19 mated to the east end of piece N18. The fracture surface was covered with dirt and showed post-fracture damage. Evidence of flange contact was observed on the upper surface of the joint bar on the gage side of piece N19. The fracture at the east end of piece N19 mated to the fracture at the west end of piece N20 shown in figure 8.

A portion of the fracture surface at the west end of piece N20 had features consistent with a detail fracture as shown in figure 8. A dashed line in figure 8 indicates the boundary of the detail fracture. Receiving rail end deformation was observed at the running surface and gage corner at the upper side of the head, and the origin area of the detail fracture was obliterated by the receiving rail end deformation. However, the mating side of the fracture at the east end of piece N19 showed the detail fracture emanated from an origin at an open head check at the gage corner. The detail fracture covered approximately 15 percent of the remaining head area.

Figure 8. View of the fracture surface at the west end of piece N20. A dashed line indicates the boundary of a detail fracture emanating from the gage corner.

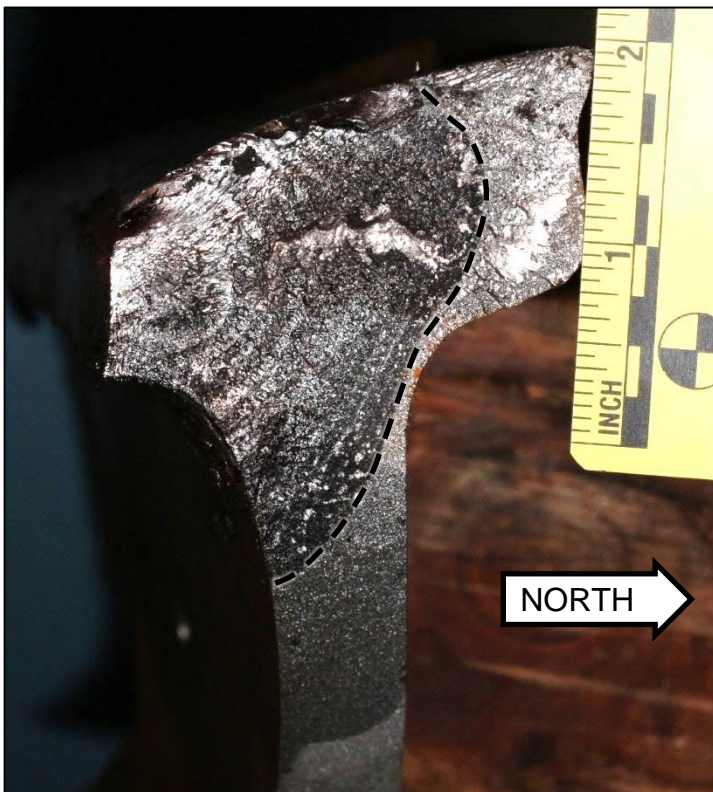
The joint in piece N19 was partially disassembled to facilitate examination of the fracture surfaces. The two bolts east of the repaired defect were removed, and the remaining two bolts were loosened, allowing the east portion of piece N19 to be removed from the joint bars. A view of the fracture surface with the repaired defect is shown in figure 9. A dashed line in figure 9 indicates the boundary of a detail fracture observed on the fracture surface. The detail fracture covered 73 percent of the remaining head area and extended out of the head into the web. The detail fracture originated at an open head check at the gage corner of the head.

Figure 9. View of the fracture surface of the repaired defect in piece N19 after the joint bars were removed. A dashed line indicates the boundary of a detail fracture emanating from the gage corner.

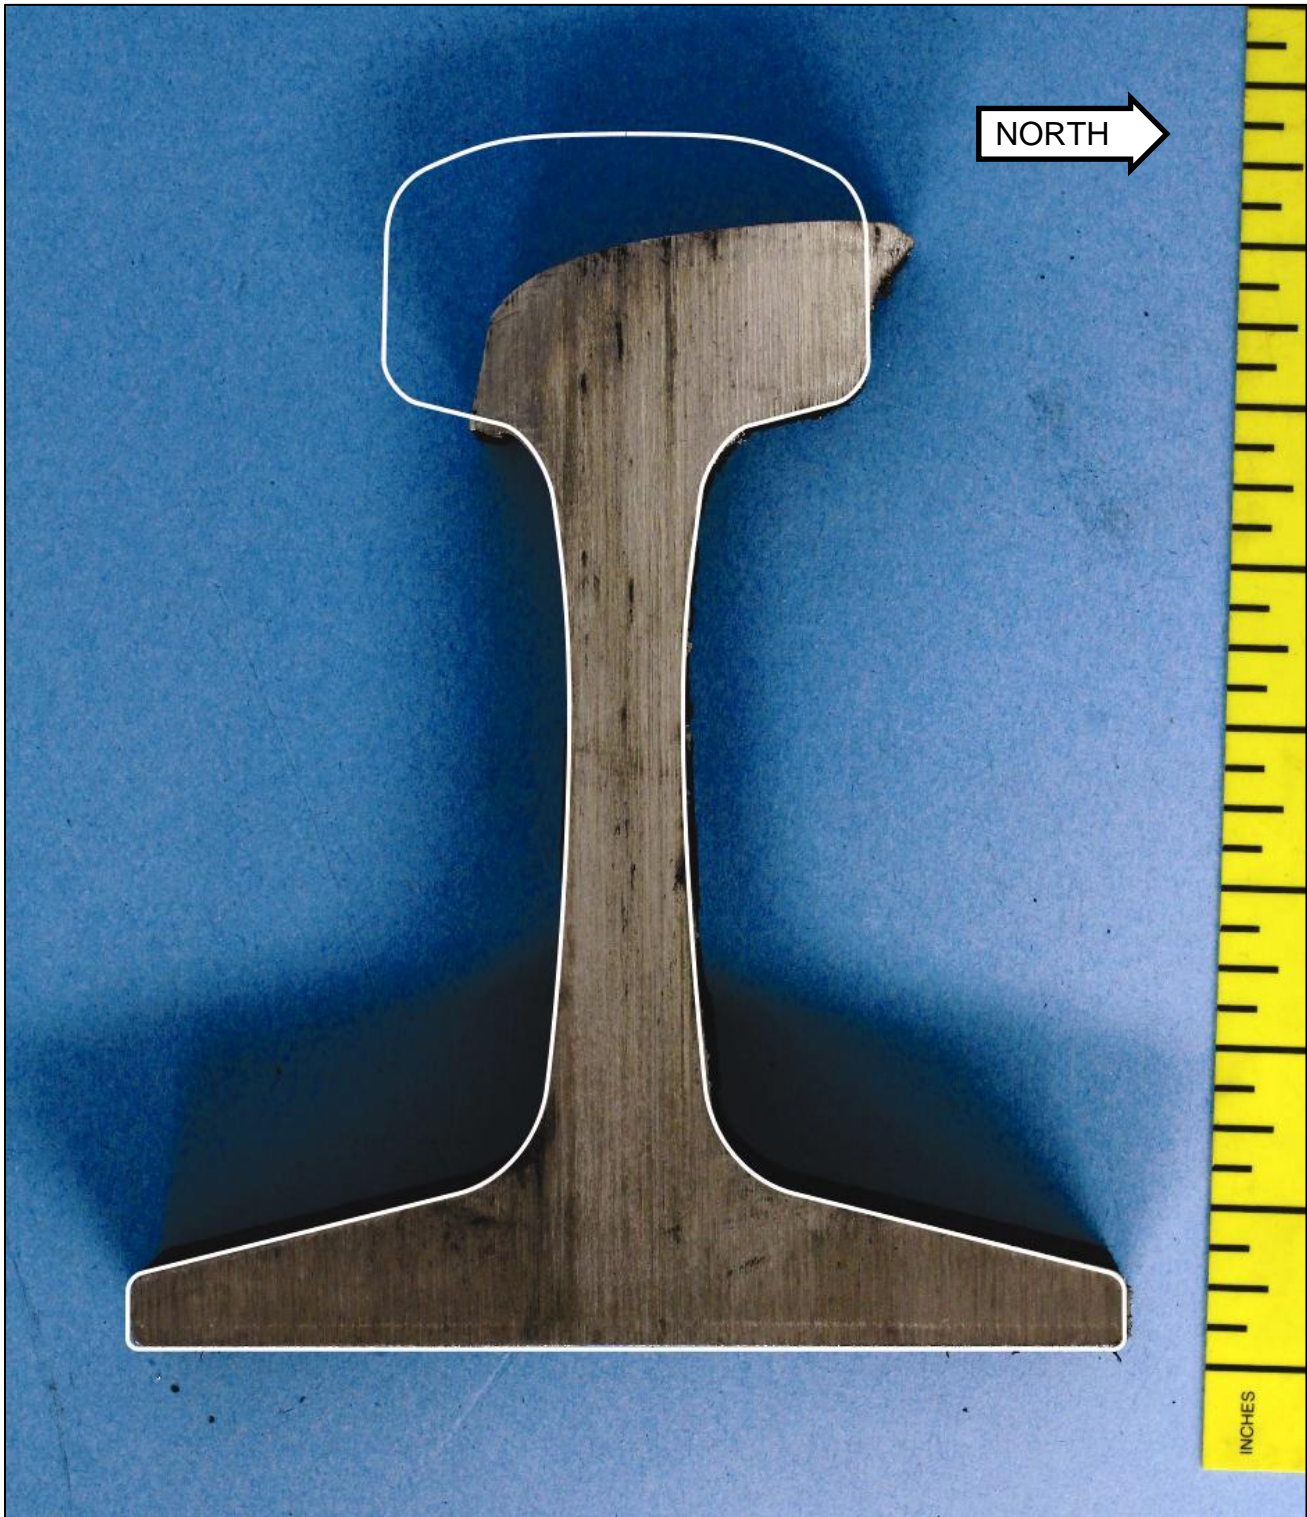
Three transverse cuts were made in piece N5. Two of the cuts were made approximately 1 inch away from the fracture surfaces at each end of the piece. The third cut was made parallel to the cut near the west end to produce a 1-inch thick cross-section. A view of the transverse cross-section after cutting is shown in figure 10. For reference, an outline representing the cross-section of a new 136-pound rail is also shown in figure 10. The remaining head area was measured in the image shown in figure 10 and compared to the head area of the new 136-pound rail. The remaining head area in the accident rail represented 57 percent of the new head area, which corresponds to a 43 percent head loss.

The rail height, as measured at the middle of the running surface, was 6.793 inches on the pieces cut from piece N5. The height of a new 136-pound rail is 7.313 inches. By calculation, the vertical head loss for the accident rail was 0.520 inches. According to CSX engineering requirements for main track, 136-pound rail is to be scheduled for removal when the vertical head loss has reached 0.625 inch. The engineering requirements list a minimum rail height (wear limit) of 6.688 inches.

The width of the head was measured at a location 0.63 inches below the running surface. The head width at that location was 2.320 inches. The head width for new 136-pound rail is 2.938 inches. By calculation, the gage side wear for the accident rail was 0.618 inch. According to CSX engineering requirements for main track, 136-pound

rail is to be scheduled for removal when the side wear has reached 0.625 inch as measured at 0.63 inches below the running surface. The engineering requirements list a minimum rail head width (wear limit) of 2.313 inches.

Figure 10. View of the rail cross-section (as-cut surface) near the west end of piece N5. The outline represents the cross-section of a new 136 pound rail.

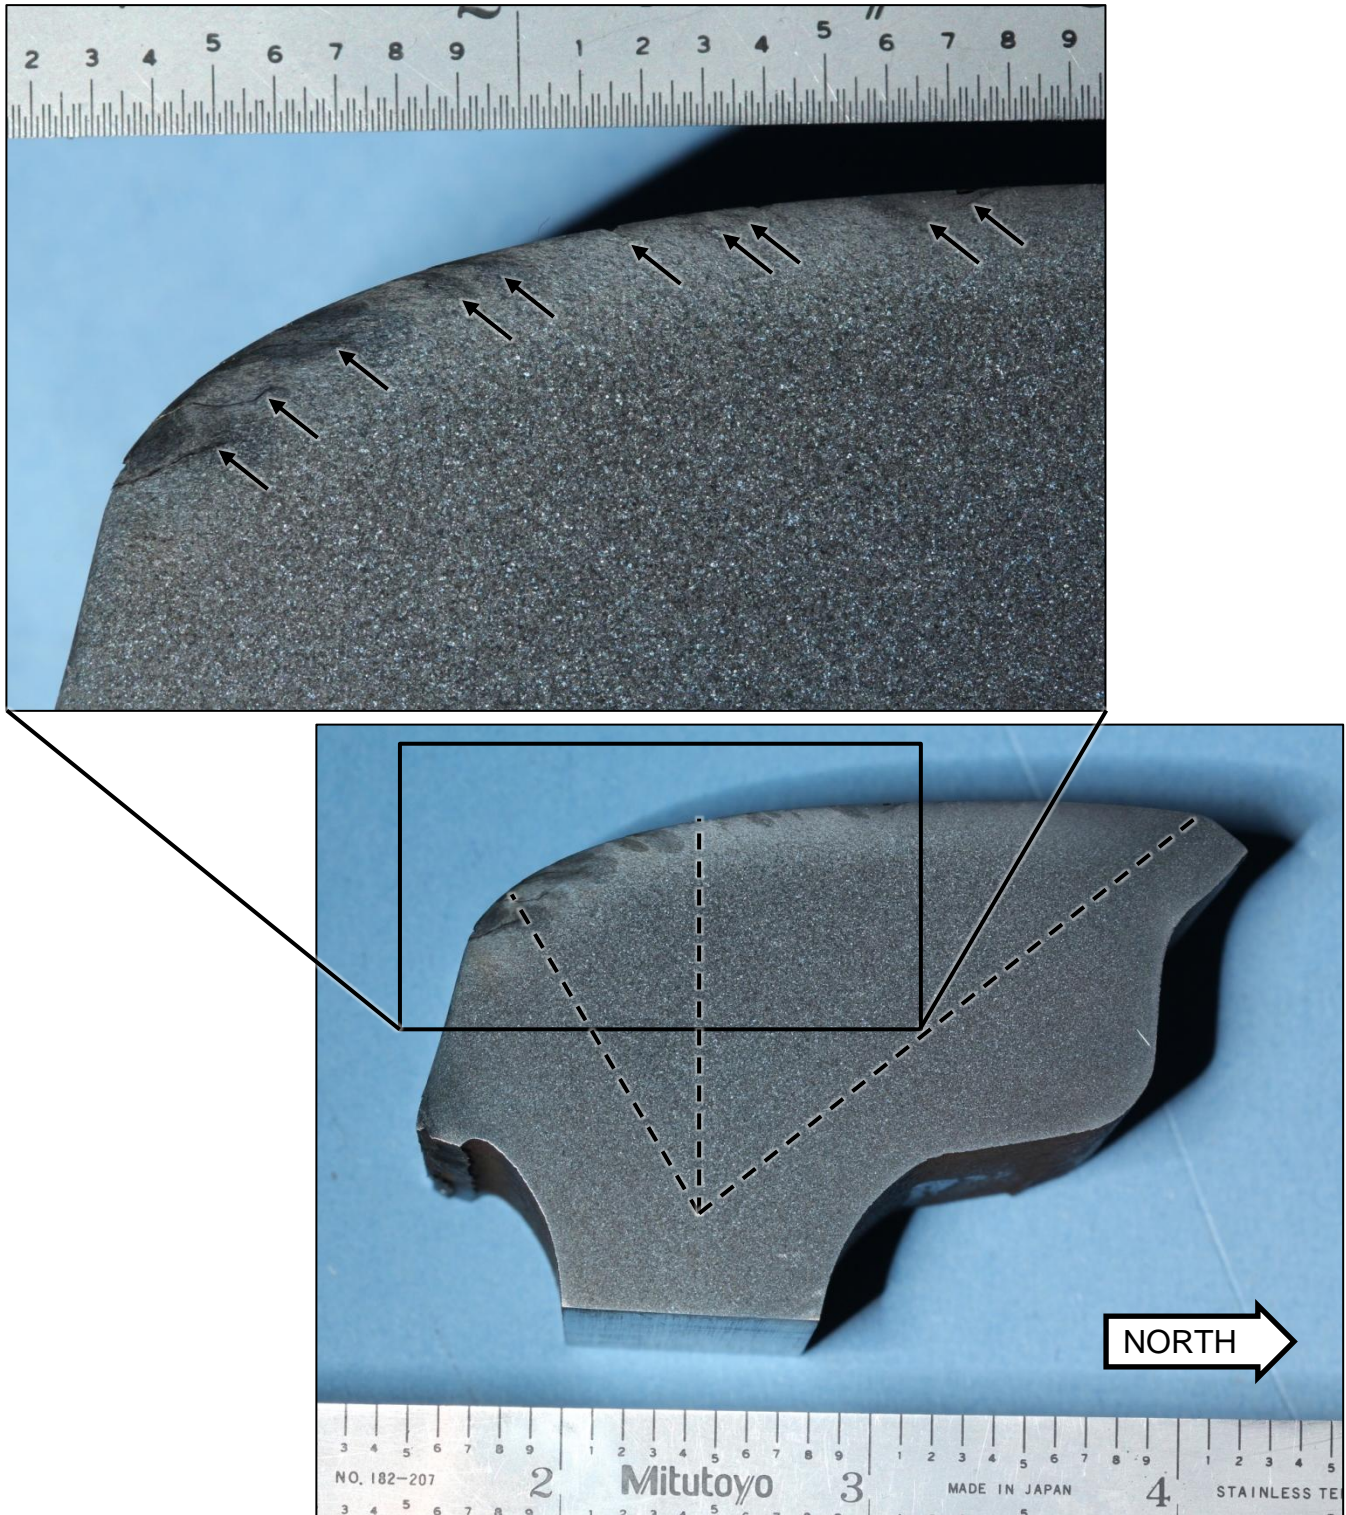
The rail cross-section removed from piece N5 (the piece shown in figure 10) was cut below the head to remove the head portion from the rest of the piece. Then the head portion was polished and etched with Nital, and the result is shown in figure 11. The microstructure observed on the polished and etched cross-section was pearlite, consistent with standard rail steel. Cracks were observed emanating from the surface at the gage corner and at the gage side of the running surface as indicated with unlabeled arrows in figure 11. These cracks were associated with the head checking and surface rolling contact deformation.

Hardness was conducted on the polished and etched cross-section of the head shown in figure 11. According to the 1997 AREMA specifications for standard rail steel,⁷ hardness was to be measured at 7 points on the rail head. Three of the points were located 0.375 inch vertically from the top center and 0.375 inch diagonally from the field and gage corner surfaces of a new rail head. The remaining four points were located 0.125 inch from the vertical sides of the head with two on the field side and two on the gage side. On each side, the lower point was located 0.125 inch above the lower

surface of the head, and the other was located 0.875 inch below the top of the rail. All specified locations for hardness except the two points at 0.125 inch away from the field side of the head were missing due to wear on the accident rail head. Hardness was measured at the two locations specified for the field side of the head. The upper point was located relative to the original head surface, accounting for wear in the accident piece. The hardness of the upper point was 23.2 HRC. The hardness at the lower point was 28.5 HRC. Three additional hardness measurements were conducted between the upper and lower points at approximately 0.125 inches from the field side, and hardness measured at those points were 30.6 HRC, 31.2 HRC, and 30.2 HRC. The average of the 5 hardness measurements was 28.7 HRC. According to the 1997 AREMA specifications, the minimum specified tensile strength for standard rail steel was 140,000 pounds per square inch, which corresponds to an approximate hardness of 31 HRC.

Figure 11. Views of polished and etched cross-sections of the head piece sectioned from rail piece N5. Arrows in the detail image indicate small cracks associated with head checks and surface rolling contact deformation. Dashed lines indicate locations of Knoop hardness traces conducted on the head.

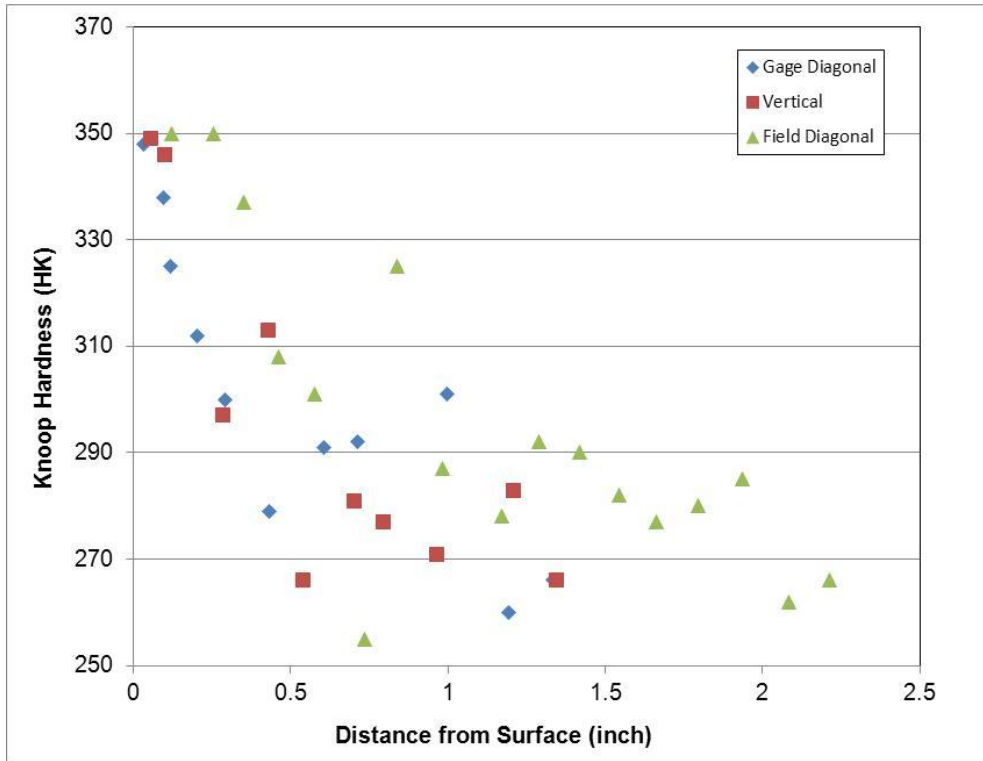
Knoop hardness measurements were also conducted on the head along traces spanning from the field and gage corners and vertically from the surface to a point where the lower end of the head intersected the web centerline (see figure 11). A chart showing the Knoop hardness readings is presented in figure 12. The chart shows a general trend of decreasing hardness from adjacent to the rail head surface to the middle of the head. Near the surface, hardness measured 35 HRC (350 HK). Near the point where the head met the web centerline, hardness values measured with the Knoop test machine corresponded to a Rockwell hardness of 23 HRC.

Figure 12. Chart showing Knoop hardness measurements measured along lines shown in figure 10.

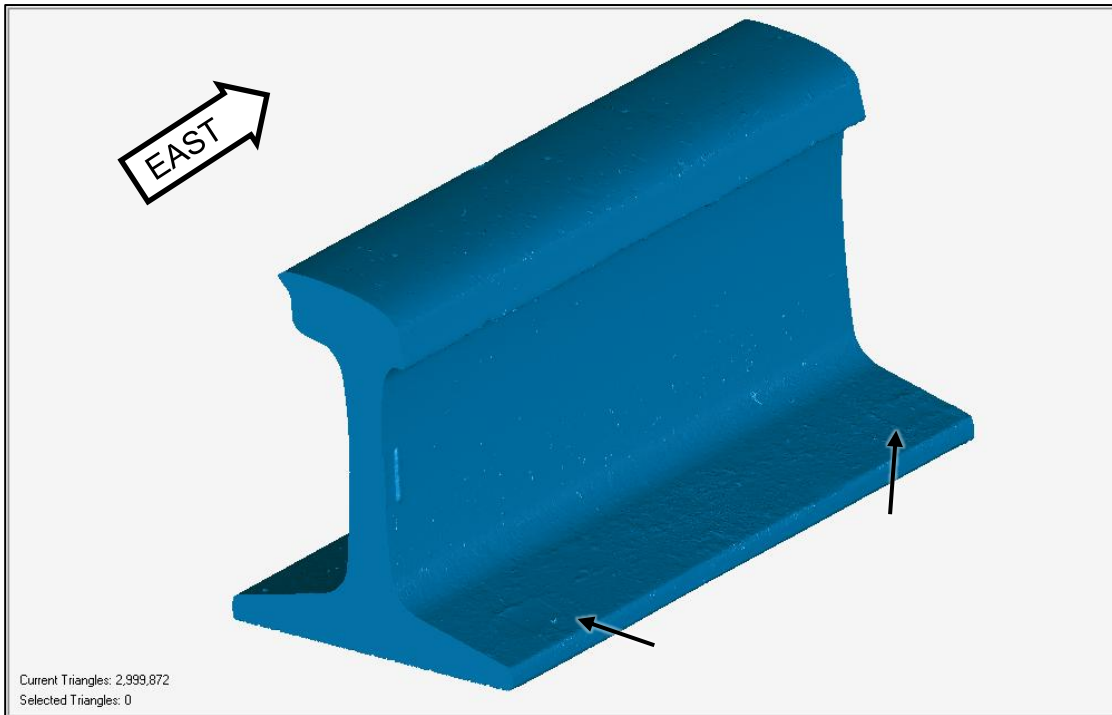
The remaining portion of piece N5 (after the ends were cut off) was scanned using a Faro QUANTUM FaroArm coordinate measurement device fitted with a Faro Laser ScanArm.⁸ A cloud of data points representing the surface of the rail piece was collected using Geomagic Studio software.⁹ The data was processed by making the point spacing uniform with a target number of points set at 3 million points. Next, the bottom plane was defined based on points collected from the table upon which the scanned piece was sitting, and the points collected from the table were removed. Then surfaces with 4 million triangles were created from the points. Next, a surface representing the bottom of the rail was created in the plane of the table and merged with the rest of the model. Then holes were filled using a curvature fill. Most of the holes were in the fillet area at the gage side of the rail and in the radius between the side of the base and the flat surface created to represent the rail bottom. The ends of the scanned piece were trimmed flat in the transverse plane, and the resulting openings at the ends of the piece were filled flat. Finally, the model was oriented with the positive X axis aligned along the rail to the east and the positive Z axis aligned with the up direction. An image of the resulting model of piece N5 is shown in figure 13, and a 3-dimensional portable document file (3D PDF) model is included in the electronic copy of

this report as Appendix A.¹⁰ Arrows in figure 13 indicate marks observed on the base of piece N5 corresponding to contact locations for rail anchors.

Figure 13. Laser scan representation of the piece N5 after fractured ends and a transverse cross-section piece were cut from the ends. Arrows indicate location of anchor contact marks on the base.
