# NATIONAL TRANSPORTATION SAFETY BOARD

MATERIALS LABORATORY FACTUAL REPORT

Report No. 13-037

Place : Paulsboro, New Jersey  
Date : November 30, 2012  
Vehicle : Freight Train FC4230  
Operator ; Consolidated Rail Corp. (Conrail)  
NTSB No. : DCA13MR002  
Investigator : Cy Gura, RPH

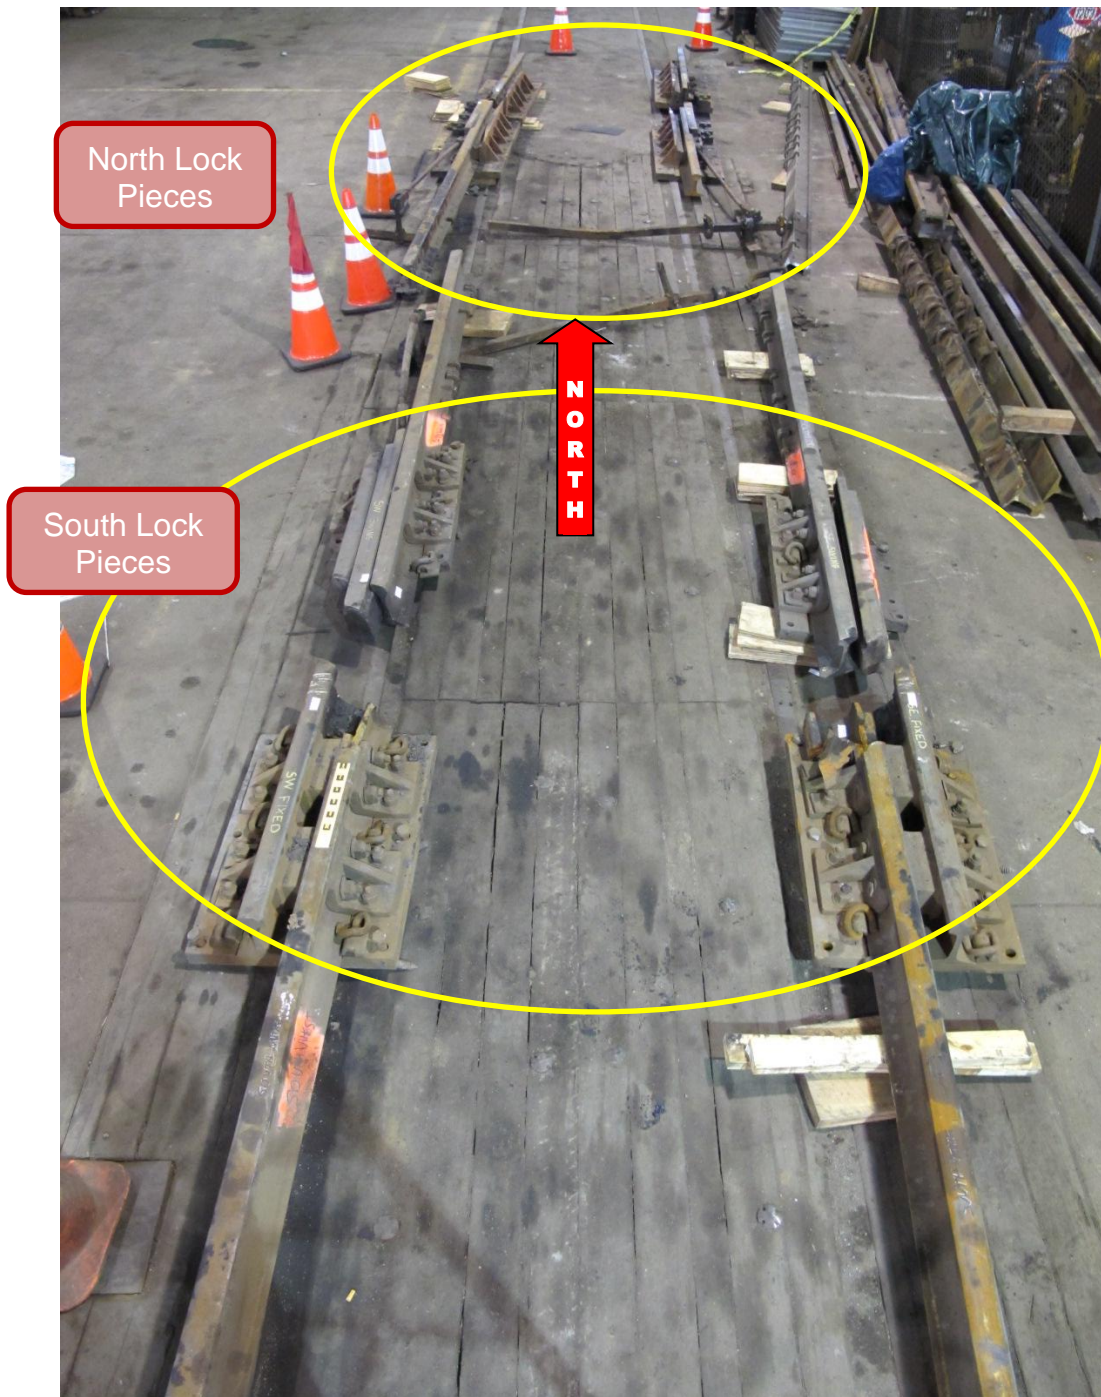
The examined bridge and mating land-side components are displayed in figure 1 and arranged in their approximate original bridge closed relative positions. All of the recovered bridge deck-level locking components were examined including approximately 10 to 15 feet of running rail on either side of the bridge to land interface.

Figure 1. Overall view of the examined lock pieces relatively arranged as if on the bridge.

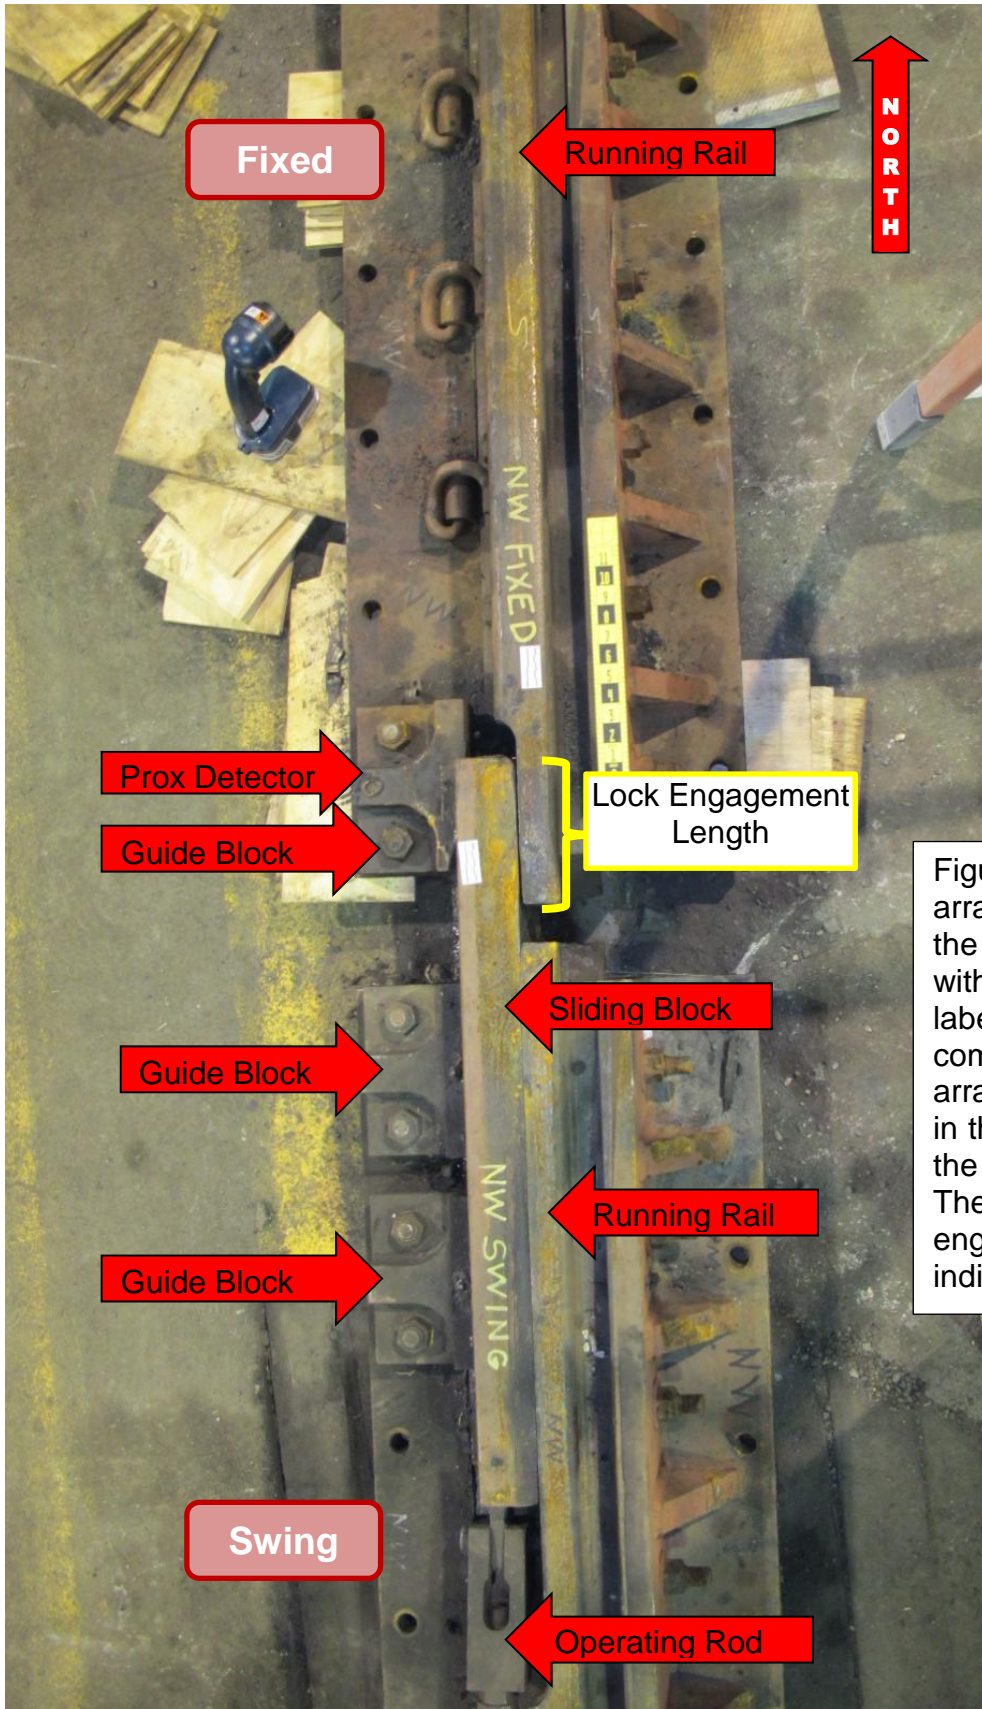
At the north end, four specialty blocks (two per rail) guided the field sides of the slide blocks on the swing span and two blocks (one per rail) formed the field sides of each slot on the fixed land side, see figure 3. The field side heads of the running rail are trimmed to accommodate the shape of the slide blocks. The approximate length of engagement of the sliding block into the fixed side slot is also indicated in figure 3. Proximity detectors were mounted on brackets attached to the fixed side guide blocks for both east and west rails. The centerlines of proximity detectors located 6.5 inches north of the ends of the fixed running rails. Gage side wheel flange guards were incorporated into the support structures of both the swing and fixed side mechanisms.

Figure 3. Image showing the arrangement of components at the north side of the bridge with many of the components labeled. West rail shown. The components have been arranged with the sliding block in the locked position engaging the fixed side components. The approximate lock engagement length is also indicated.

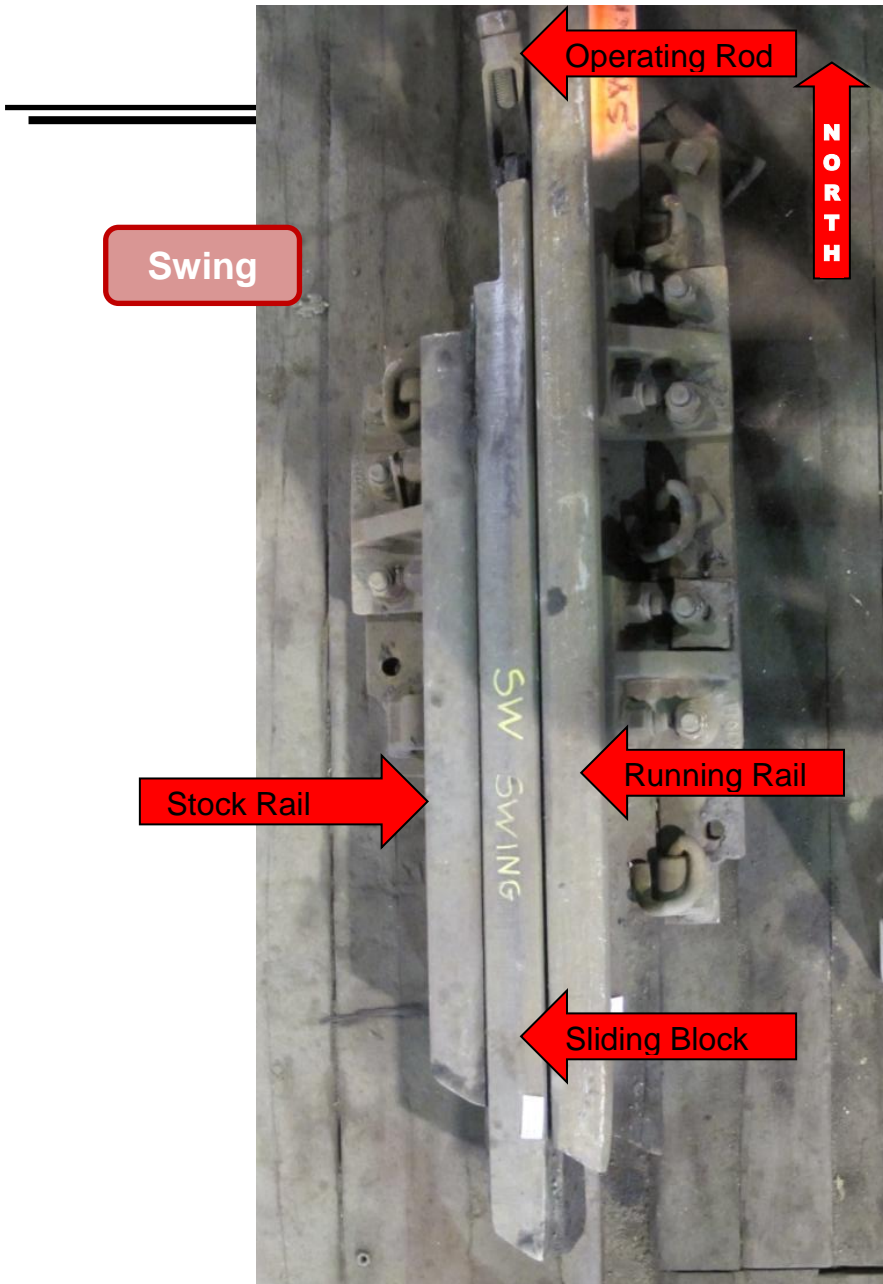
For the south end lock mechanisms, the bottom flanges of short sections of stock rails were butted against the bottom flanges of the running rail adjacent to the gap on both the swing span and land side to form the slot for the sliding blocks, see figure 4. The south sliding blocks were machined so as to ride in the web area pockets formed by the running rail profile and the short stock rail sections. The approximate length of engagement of the sliding block into the fixed side slot is also indicated in figure 4. The south end proximity detectors were located in the webs of the fixed stock rail sections. The detector centerlines were located about 5 inches south of the northern tips of the stock rail sections. Due to the near proximity of the bridge pivot to the south edge of the bridge, the southern bridge to land interface components were heavily angled to accommodate the short pivot radius.

Figure 4. Images showing the arrangement of components at the south side of the bridge with many of the components labeled. West rail shown. The swing side components have been arranged with the sliding block in the extended locked position but not engaging the fixed side components (shown below). The approximate lock engagement length is also indicated.

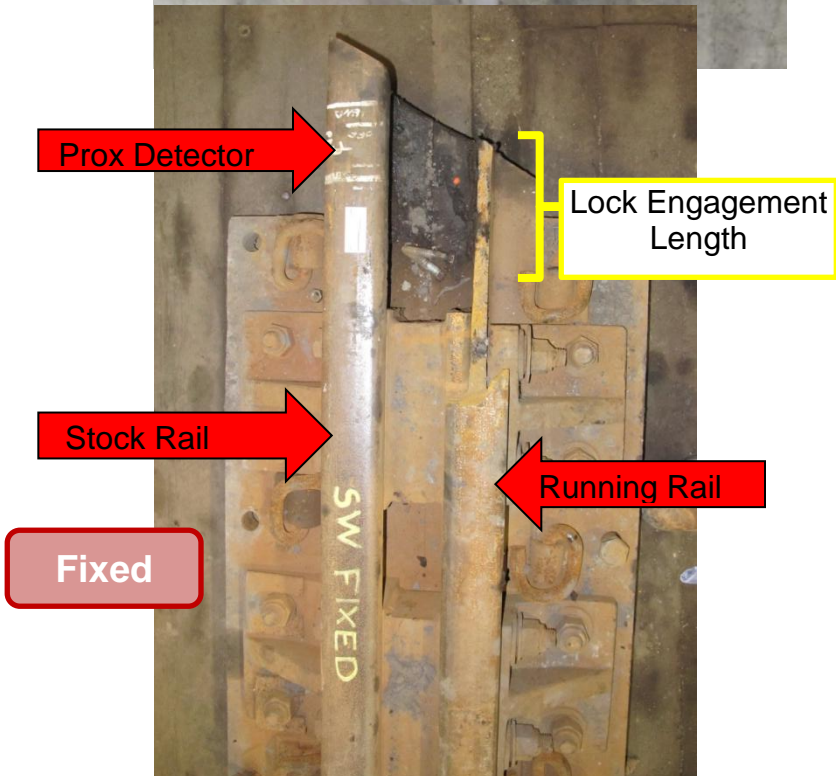
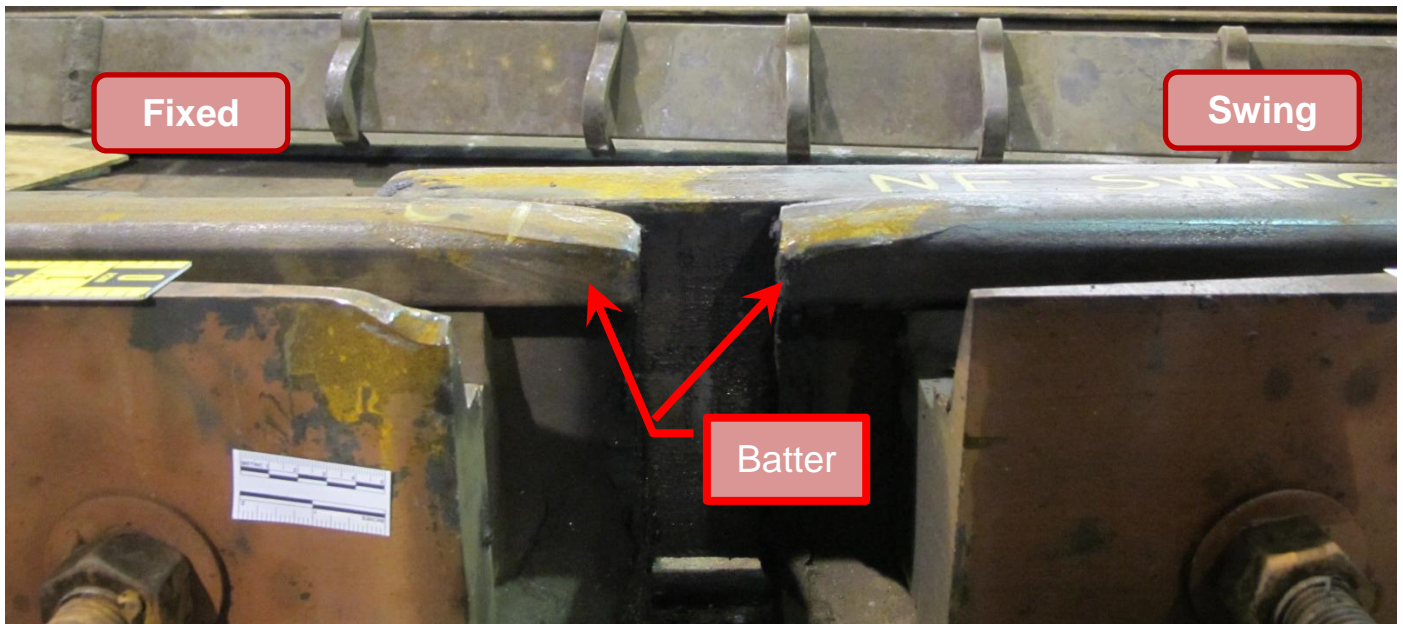
Figure 5. Side view looking east at the rail end battering on the running rail at the at the north bridge end gap. East rail shown, also typical of the west rail.

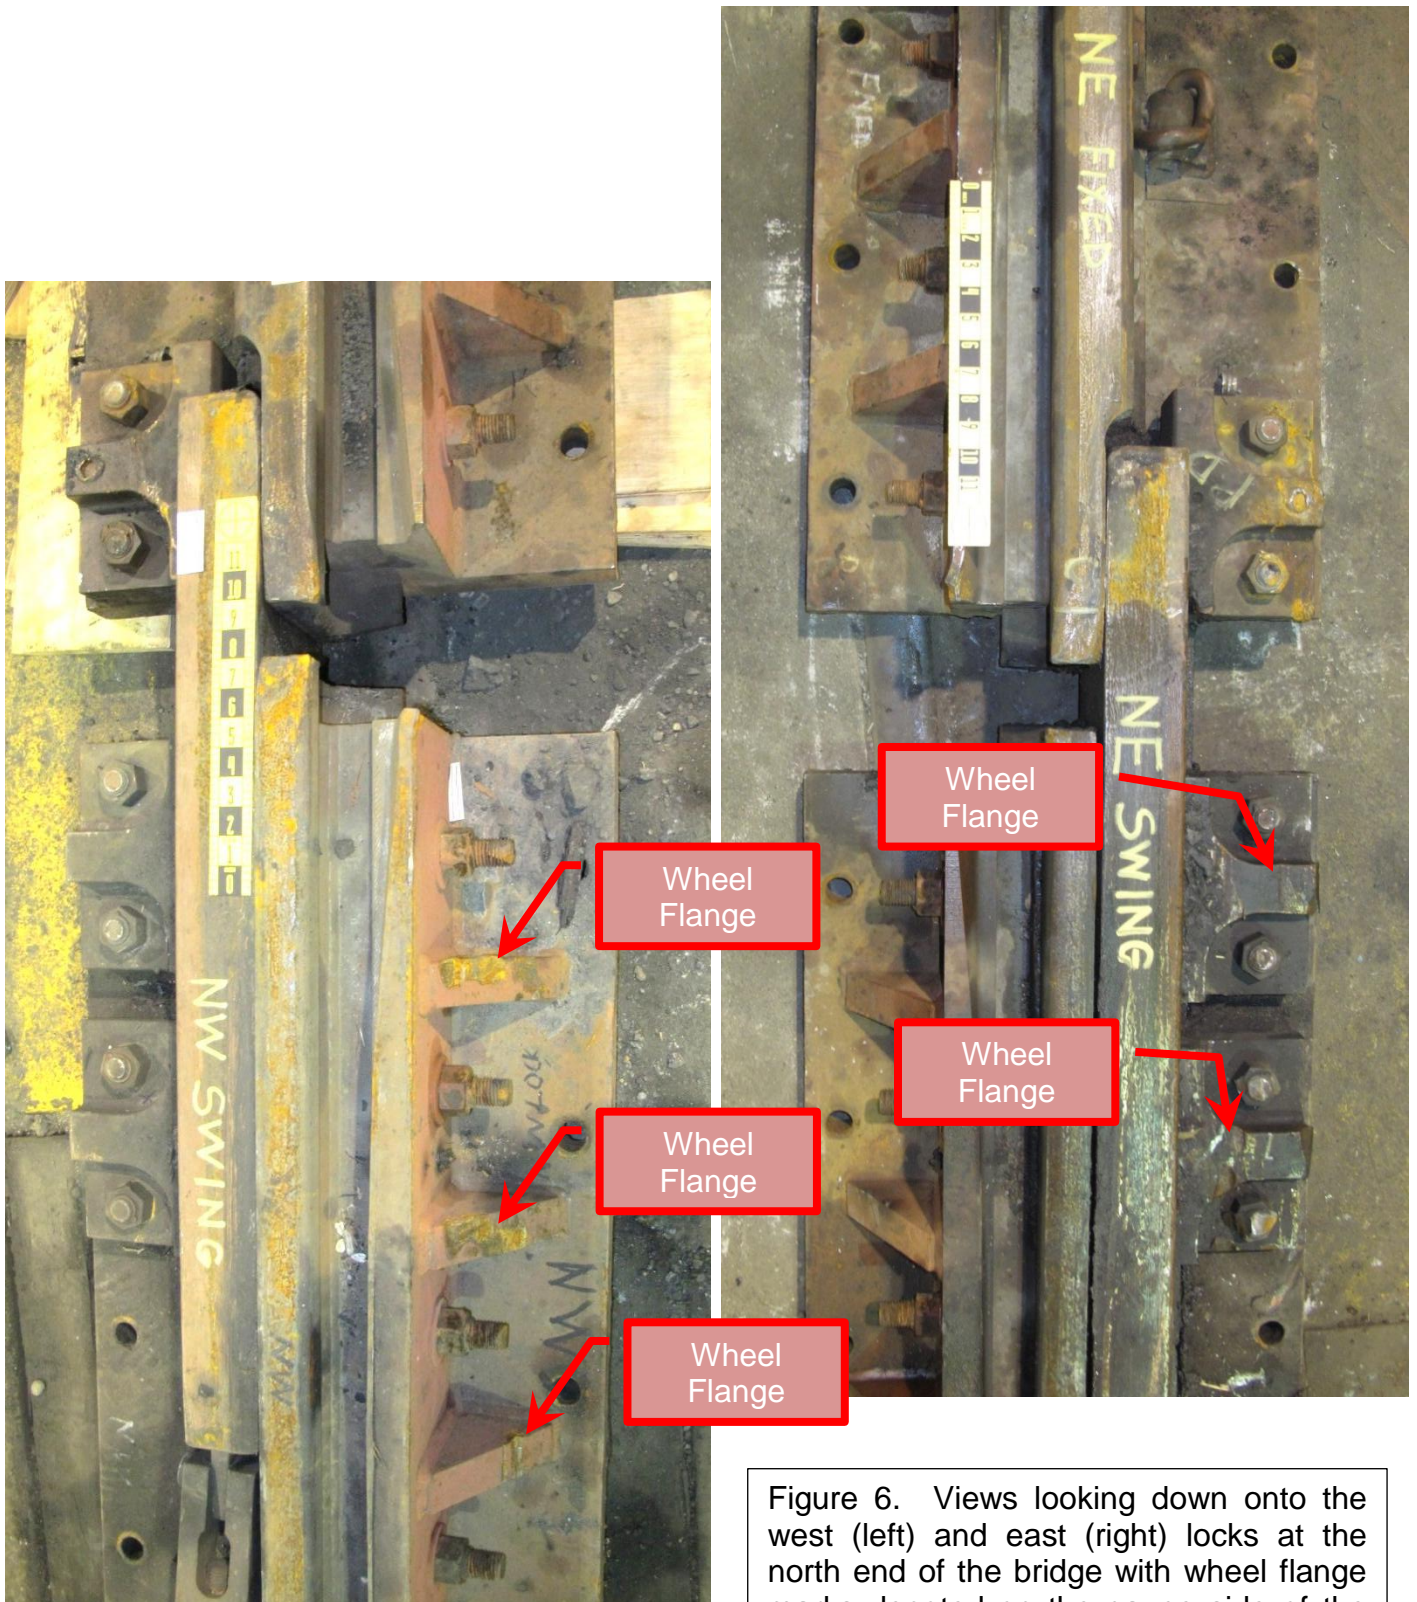
The north ends of the slide blocks were undamaged as were the mating areas of the fixed side slot components. Multiple marks and dents consistent with wheel flange impacts were noted on the swing span components including the gauge side wheel flange guard at the northwest rail and on top of the field side guide blocks of the northeast rail. Wheel flange marks are denoted in figure 6 for both the west and east sides.

Figure 6. Views looking down onto the west (left) and east (right) locks at the north end of the bridge with wheel flange marks denoted on the gauge side of the west rail and field side of the east rail.

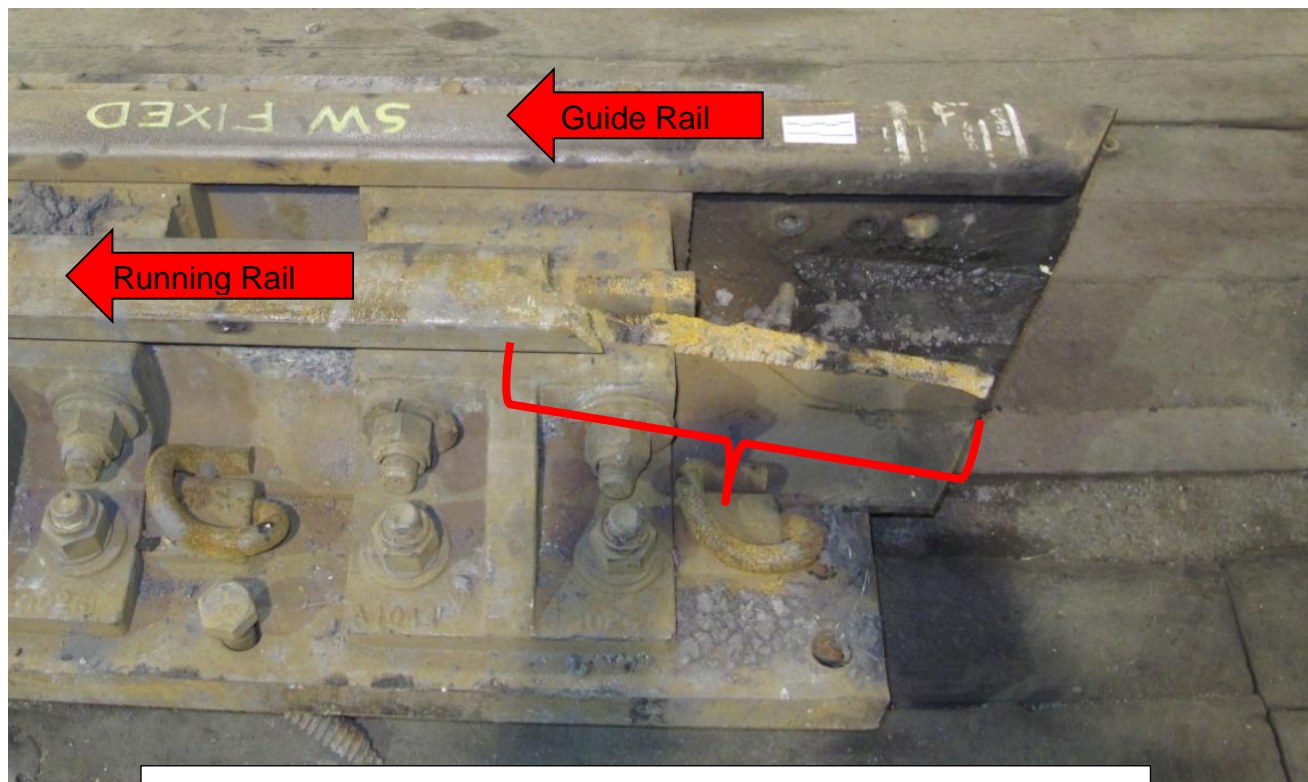
The fixed southwest running rail was fractured through the web for approximately 18 inches, see figure 7. Conrail representatives indicated that the rail was originally found intact but was fractured during recovery from the bridge. The separated piece reportedly fell into the waterway and was not recovered. The remainder of the southwest swing and fixed locking mechanism was intact with little apparent damage.

Figure 7. View of the fractured end of the running rail on the fixed south side west rail. View looking west.

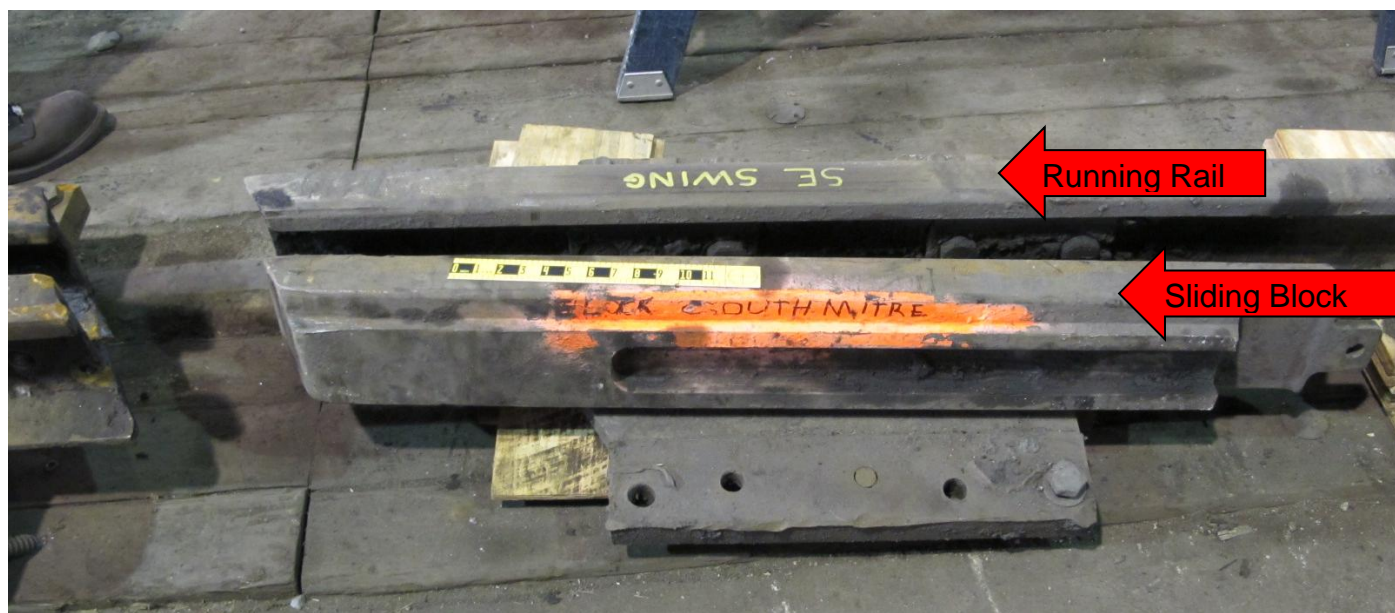
In contrast, the southeast locking components showed significant damage. On the swing span, the slide block and guide rail were separated from the swing side bed plate. The slide block was reportedly found some distance south on the land. The guide rail was not recovered. The bolts holding the guide rail were separated and one sheared bolt remained in the bed plate, see figure 8. The operating rod for the southeast rail slide block was also separated and not recovered.

Figure 8. View of the south side east rail lock showing extensive damage to the bridge side components including; separation of the guide rail section with fracturing of the attaching bolts and release of the sliding block. View looking west.

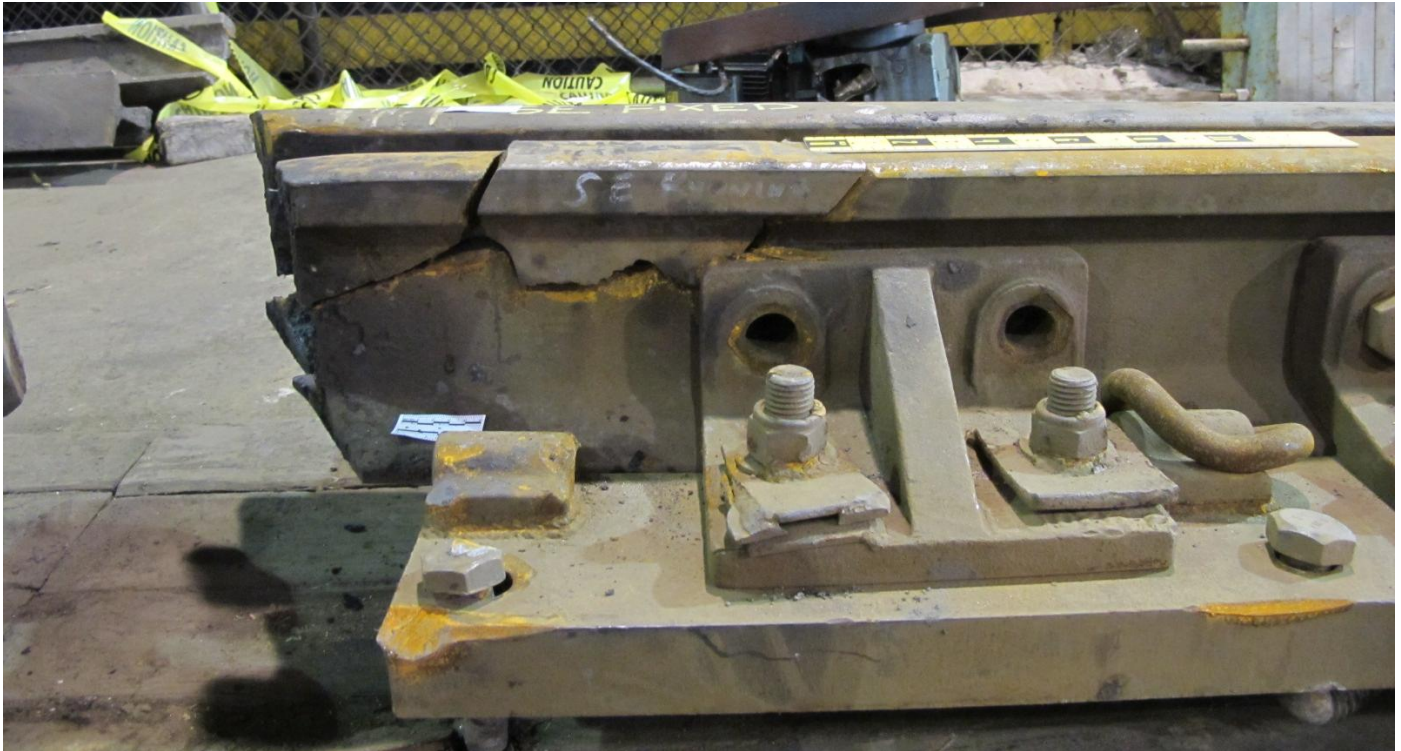
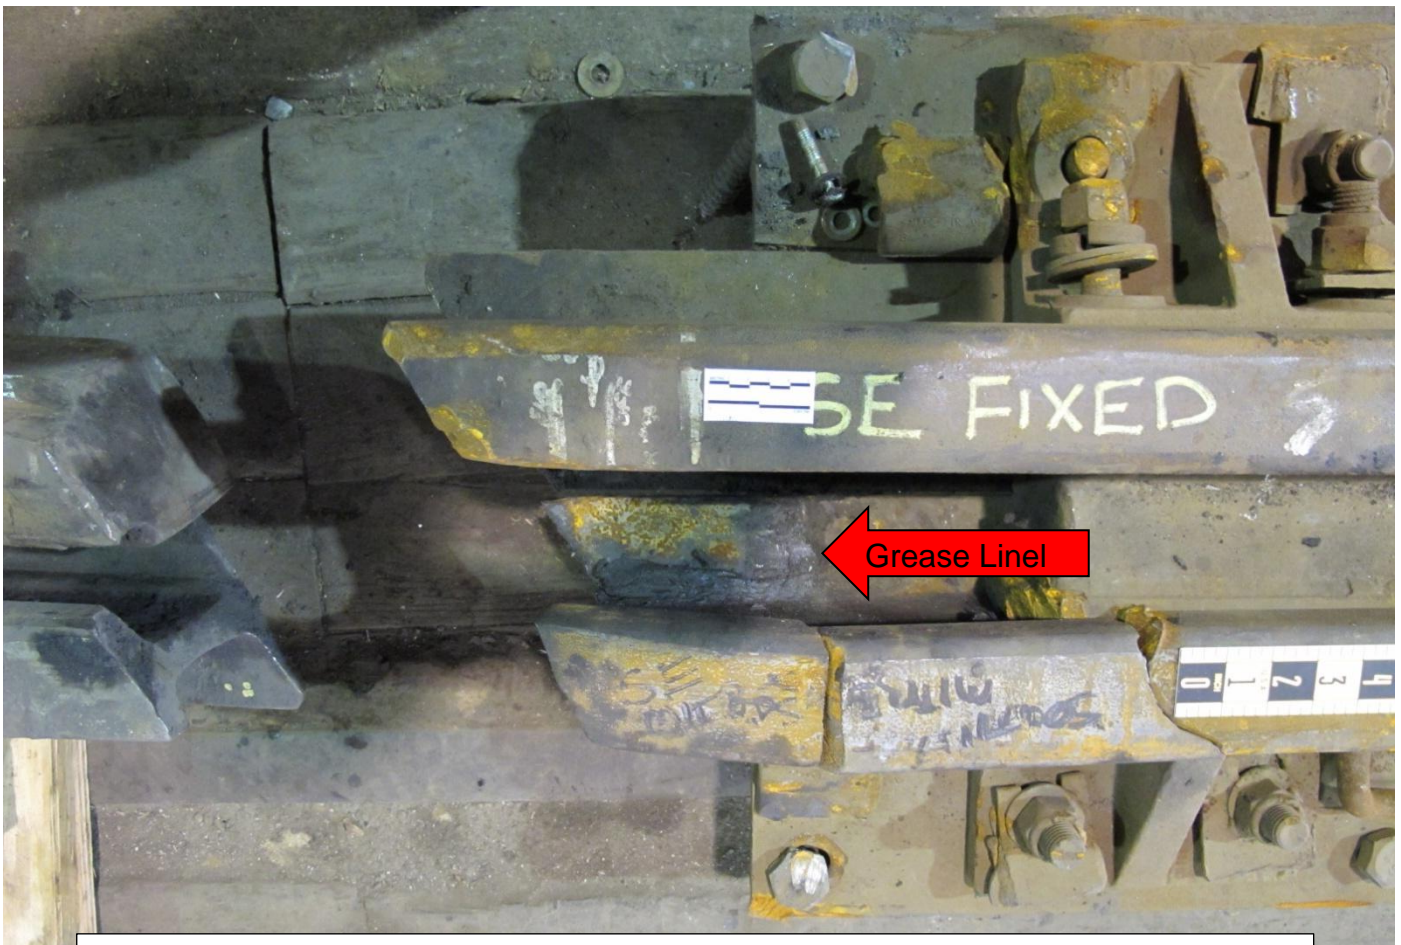
The north end of the fixed southeast running rail was fractured through the web and head separating two pieces as shown in upper view figure 9. The fractures were overstress with features indicating bending loads to the gage side of the rail. The north head fracture was located at the grease indicated south tip of the slide block in the locked position as shown in lower view of figure 9. Dents were apparent on the base flange side fractures consistent with wheel impacts after fracturing, see figure 10.

Figure 9. Upper view shows a side view looking east at the fractures in the fixed east running rail, south side adjacent to the gap. Lower view shows the same fractures from above relative to the grease line in the locking slot.

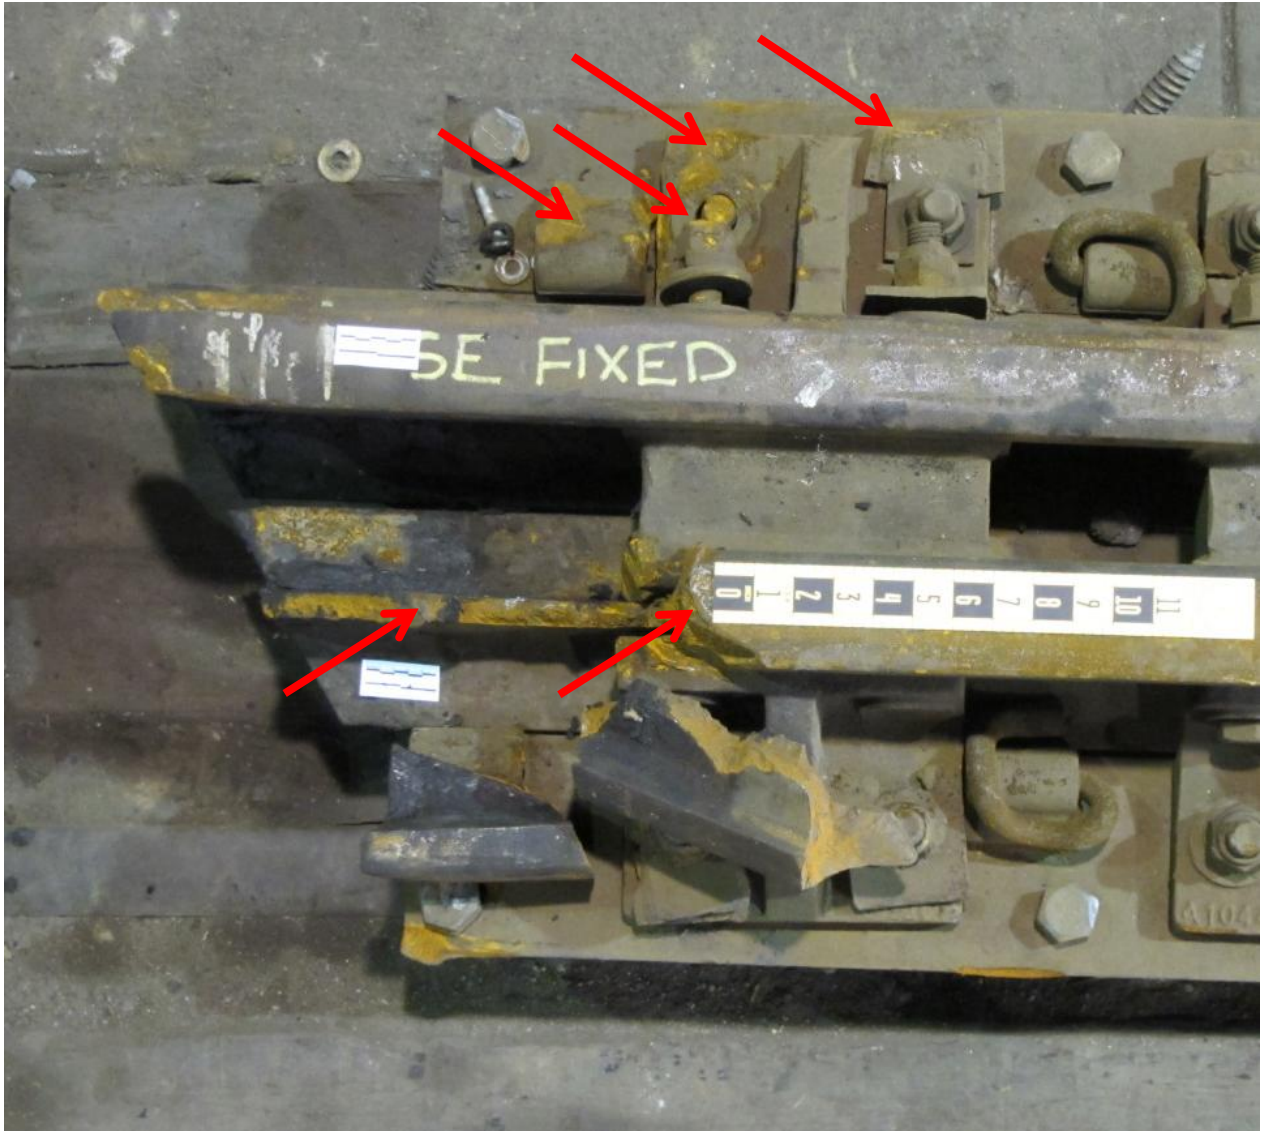
Figure 10. The fractured south side, east running rail with areas of wheel impact damaged denoted by arrows.

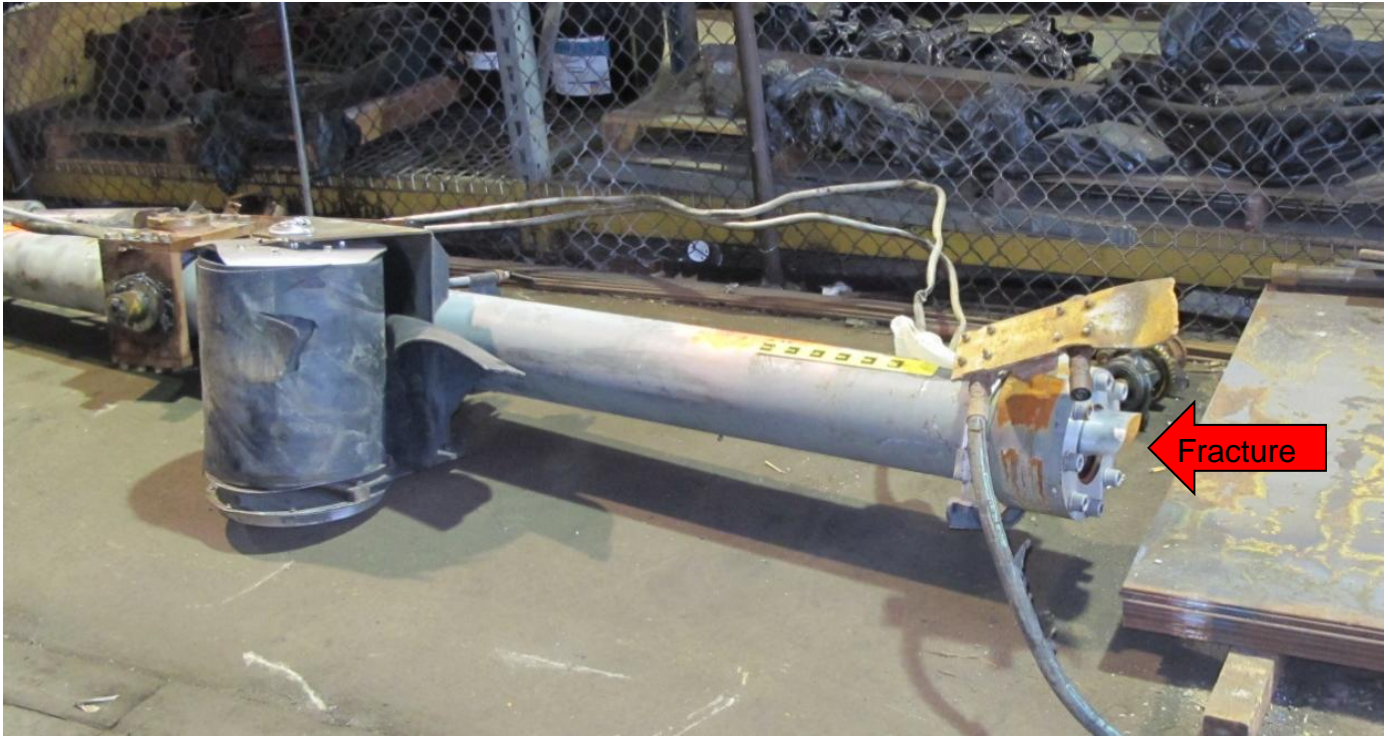
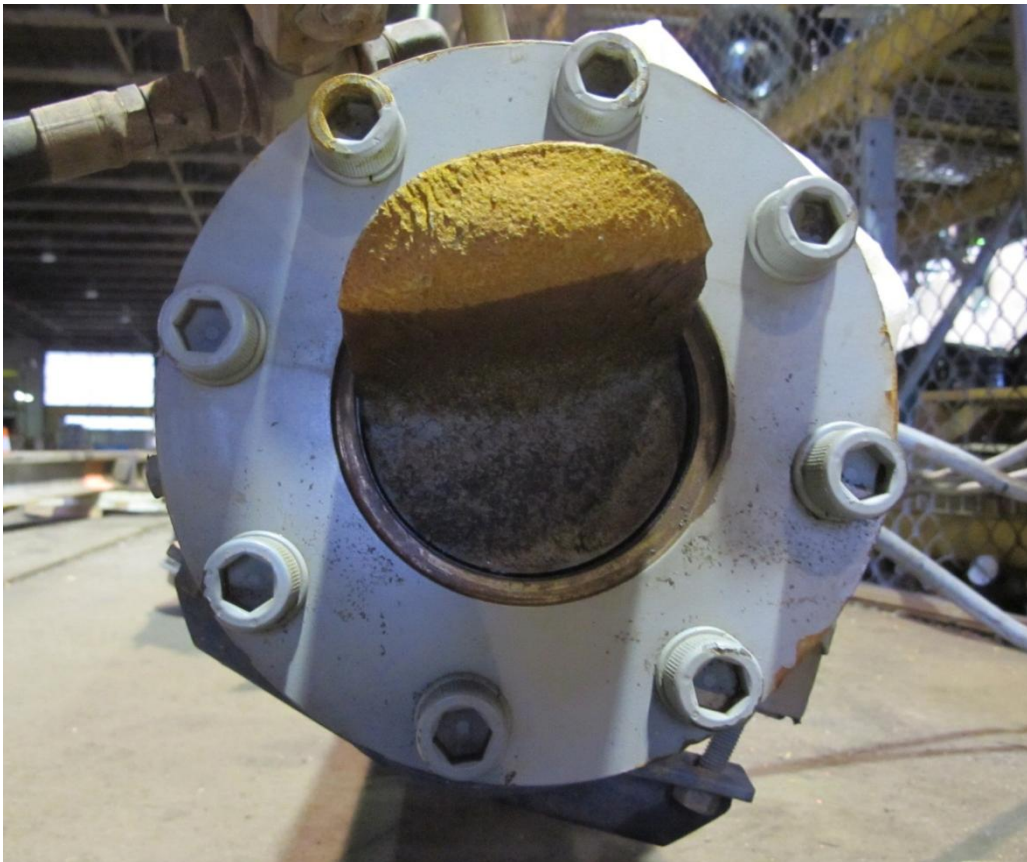
The end of the piston shaft for the hydraulic cylinder that actuates the swing mechanism was fractured near the end as shown in the upper view of figure 11. Examinations of the fracture, shown in the lower view of figure 11, revealed features consistent with a bending overstress separation. No indications or preexisting corrosion or progressive cracking was apparent.

Figure 11. Overall view of the swing actuating hydraulic cylinder above with a closer view of the fracture below.
