NATIONAL TRANSPORTATION SAFETY BOARD

MATERIALS LABORATORY FACTUAL REPORT

Report No. 12-036

Place : Chesterfield, New Jersey
Date : February 16, 2012
Vehicle : Mack dump truck
NTSB No. : HWY12MH007
Investigator : Steven Prouty
Office of Highway Safety

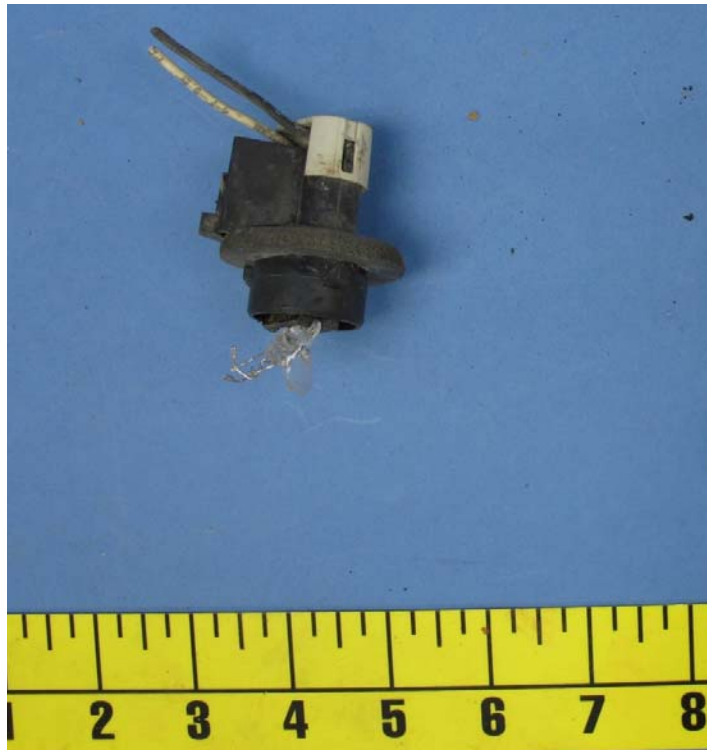
Figure 1. Photograph of VEH-007 (Right front clearance/turn signal).

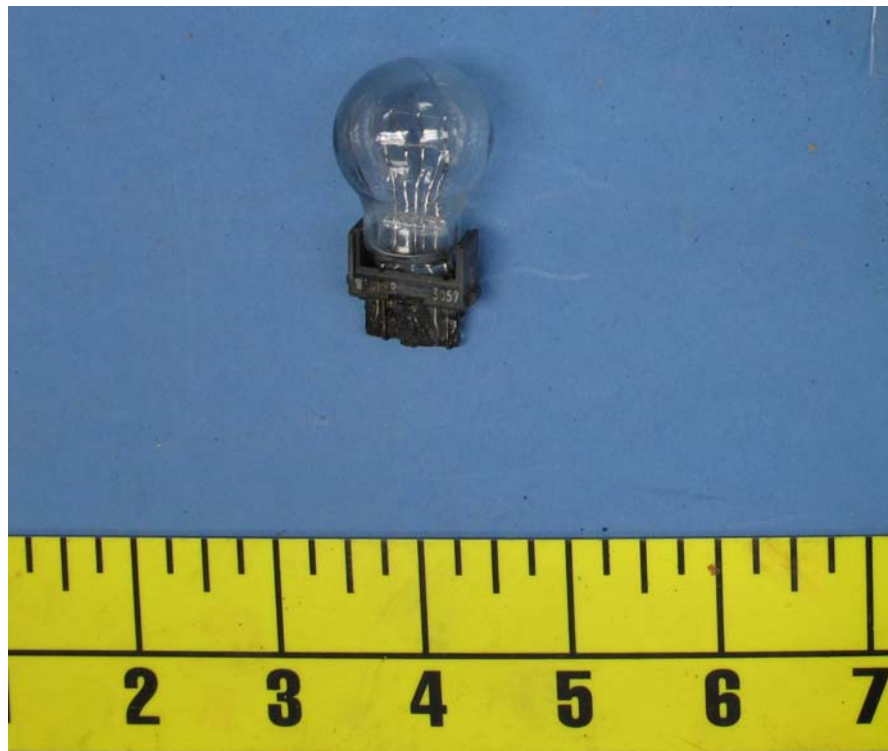
Figure 2. Photograph of VEH-005 (Left front clearance/turn signal).

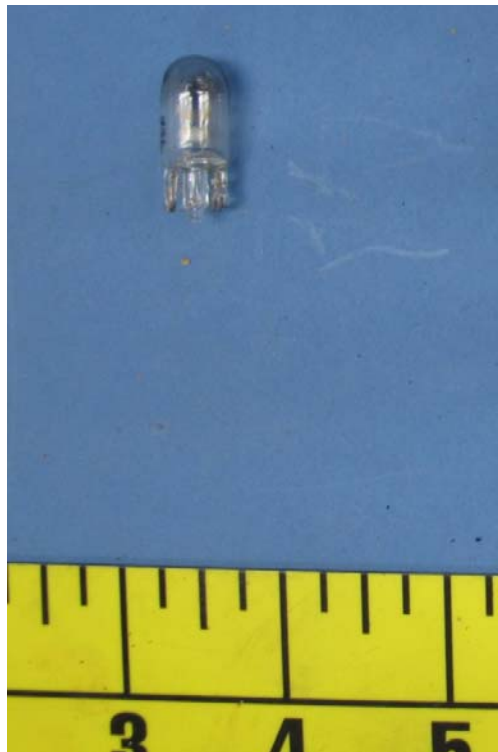
Figure 3. Photograph of VEH-006 (left front marker lamp).

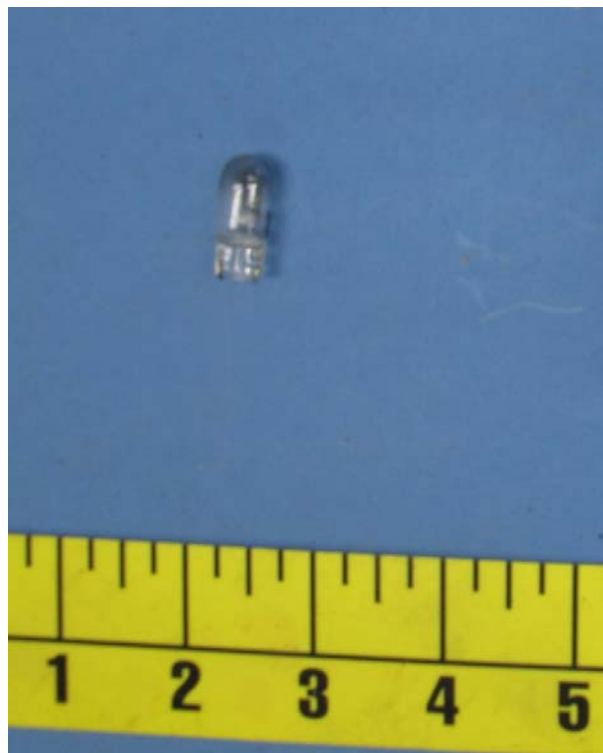
Figure 4. Photograph of VEH-008 (right front marker lamp).

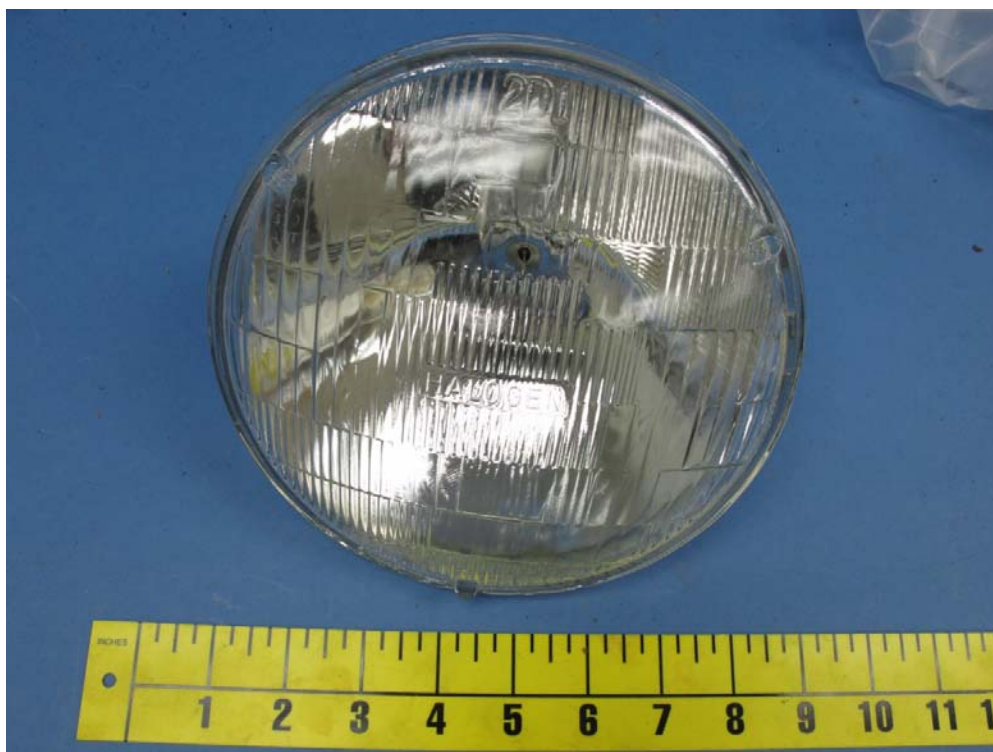
Figure 5. Photograph of left headlamp.

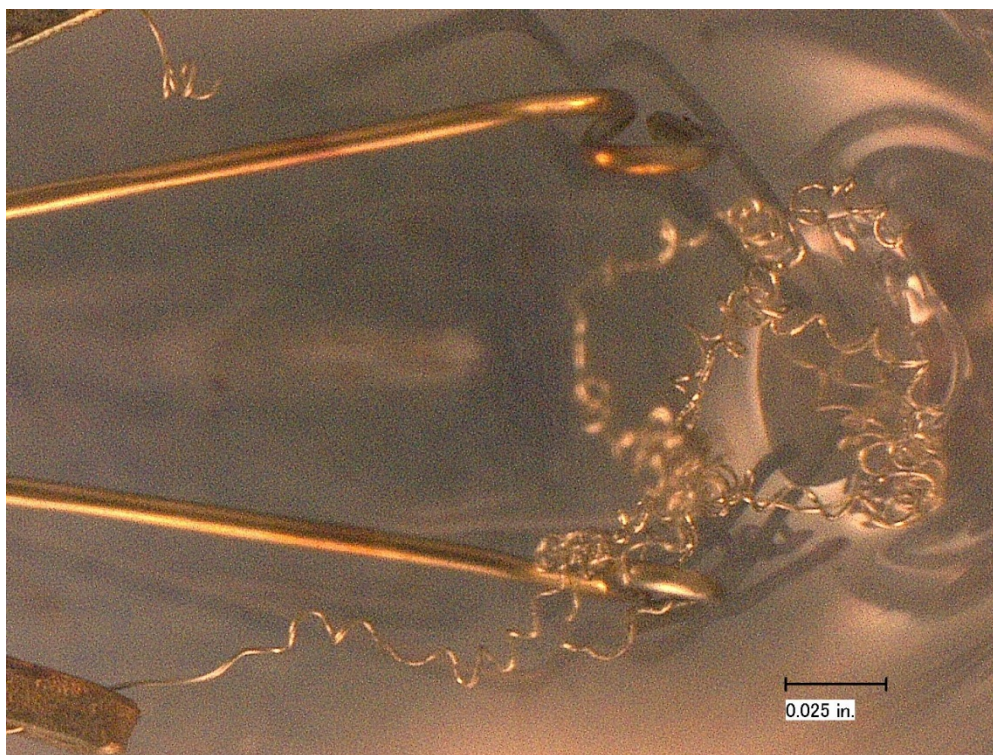
Four light bulbs and the left headlamp from the accident dump truck were submitted to the NTSB Materials Laboratory for filament examination. VEH-005 and the headlamp were two-filament halogen light bulbs. VEH-006 and VEH-008 were single filament halogen bulbs. The glass globe from VEH-007 was broken, as shown in Figure 1 and none of the filament material remained so no examination was performed. Photographs of the other four bulbs are shown in Figures 2-5. The intact light bulbs were x-rayed to determine the condition of the filament inside. Radiographs of the filaments from VEH-005, VEH-006, and the headlamp showed that all of the filaments were intact (unbroken) and no signs of filament stretching were found. VEH-008 had a broken filament and was found to have stretching of the filament as shown Figures 6 and 7. For comparison, a radiograph of an unstretched filament (VEH-006) is found in Figure 8.

Figure 6. Photograph of stretch filament in VEH-008 (right front marker lamp).

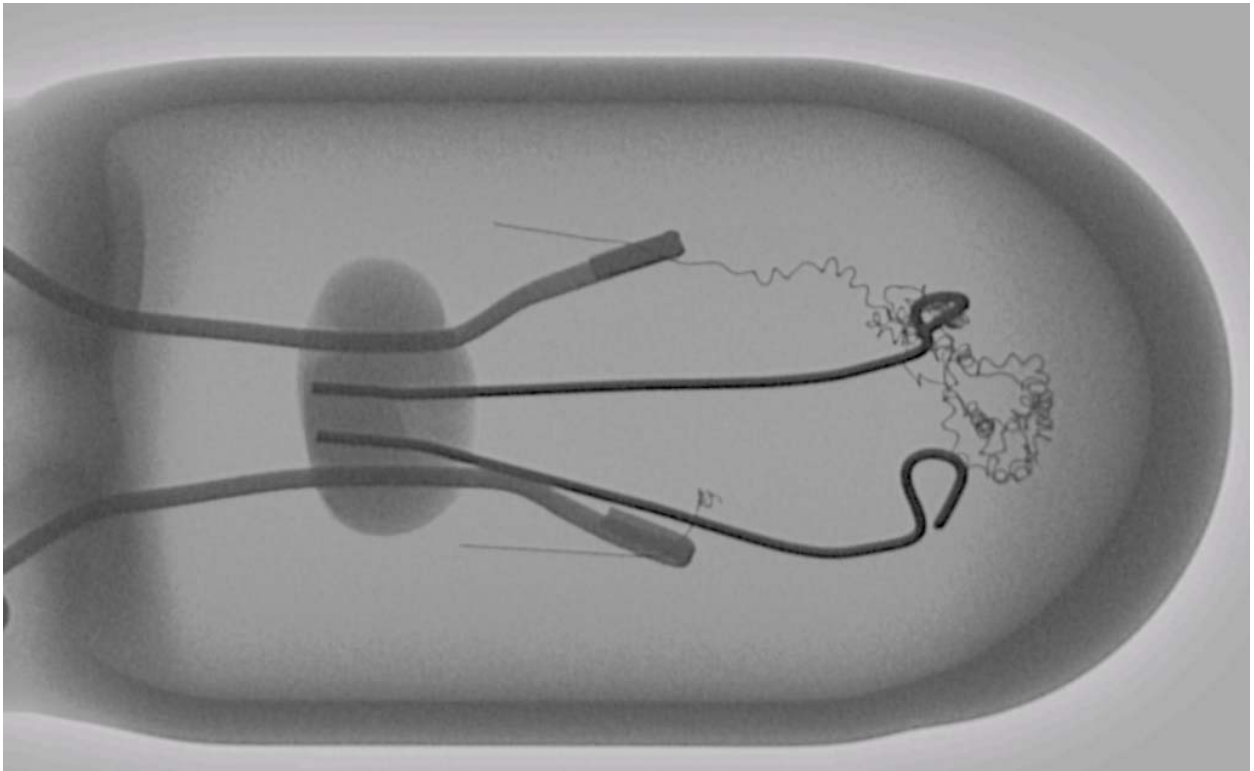
Figure 7. Radiograph of stretch filament in VEH-008 (right front marker lamp).

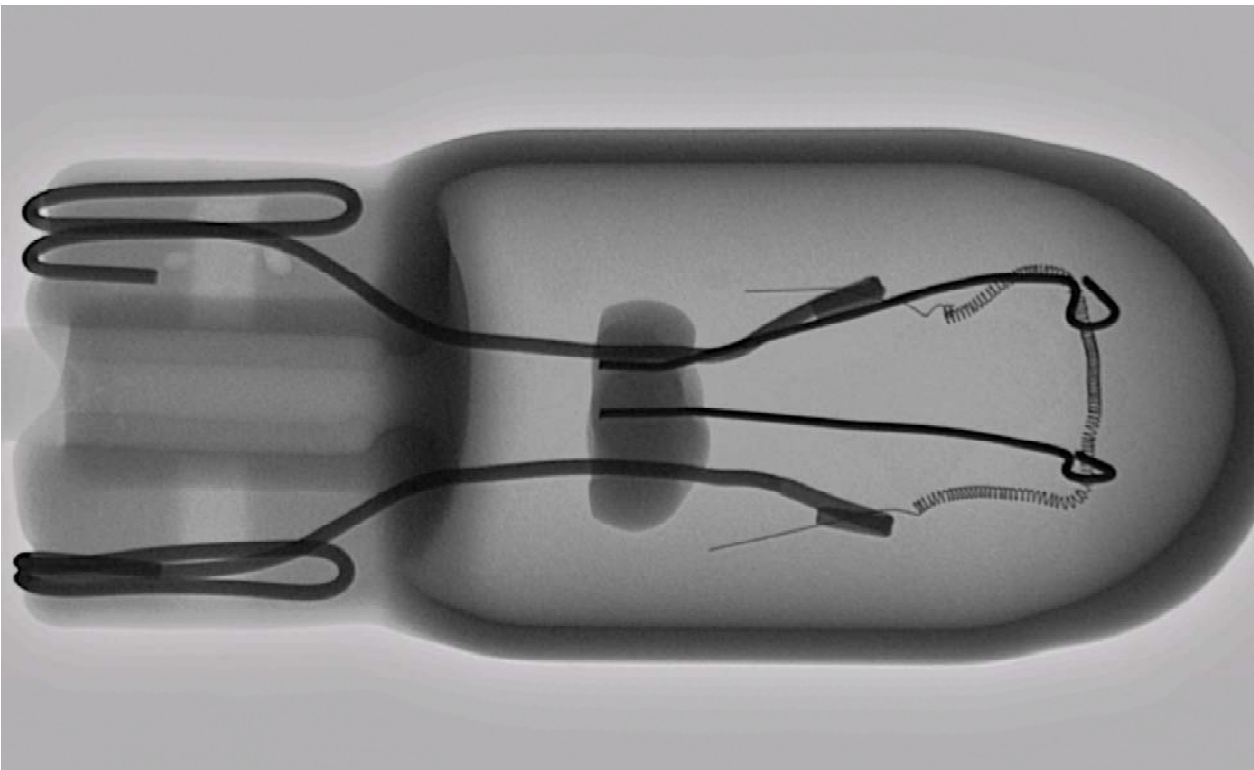
Figure 8. Radiograph of unstretched filament in VEH-006 (left front marker lamp).
