# NATIONAL TRANSPORTATION SAFETY BOARD

MATERIALS LABORATORY FACTUAL REPORT

Report No. 03-078

Place : Miami, Florida  
Date : May 25, 2003  
Vehicle : Cruise ship S/S Norway  
NTSB No. : DCA03MM032  
Investigator : Robert Ford

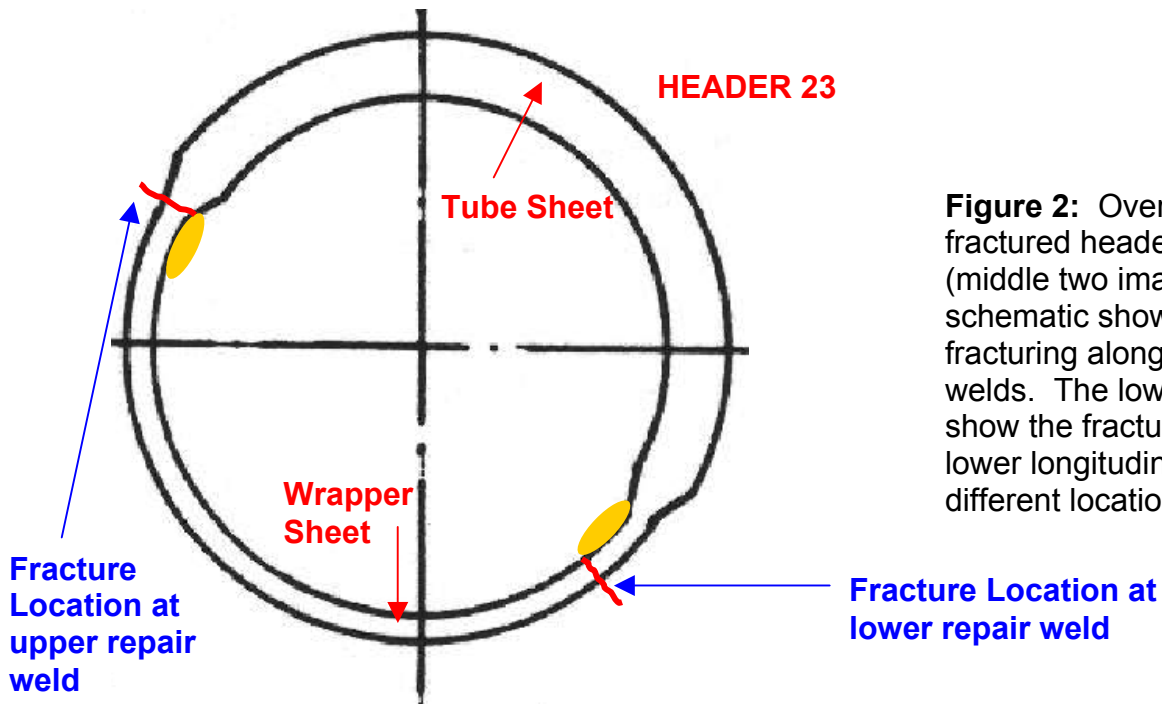
The middle images in Figure 2 show the fracture area on the header of boiler 23. The wrapper sheet fractured at the lower longitudinal weld for a length of approximately 8 feet and along the upper longitudinal weld for approximately 11 feet. Shear ligaments connected the two fractured regions along the welds. A view of the liberated and deformed portion of the header can be seen in the top image in Figure 4. The fracture surfaces of interest were cleaned by use of mineral spirits and a nylon brush prior to examination. Immediately following examination and documentation the fracture surfaces were covered with white grease for preservation.

The top schematic in Figure 2 shows the location where the fracturing occurred along the repair welds (orange regions in schematic). The repair welds were superimposed on the original longitudinal welds. The cylindrical portion of the header (the tube and wrapper sheets) is approximately 13.0 feet long, and the entire header including hemispherical caps is approximately 16.5 feet long. The repair welds were approximately 1.5 inches wide extending along almost the entire length of the original longitudinal weld seams, except 1 to 2 feet at both ends (top images in Figure 3).

**Figure 2:** Overall views of the fractured header from boiler 23 (middle two images). The upper schematic shows the location of fracturing along the longitudinal welds. The lower two images show the fracture surface of the lower longitudinal weld at two different locations.

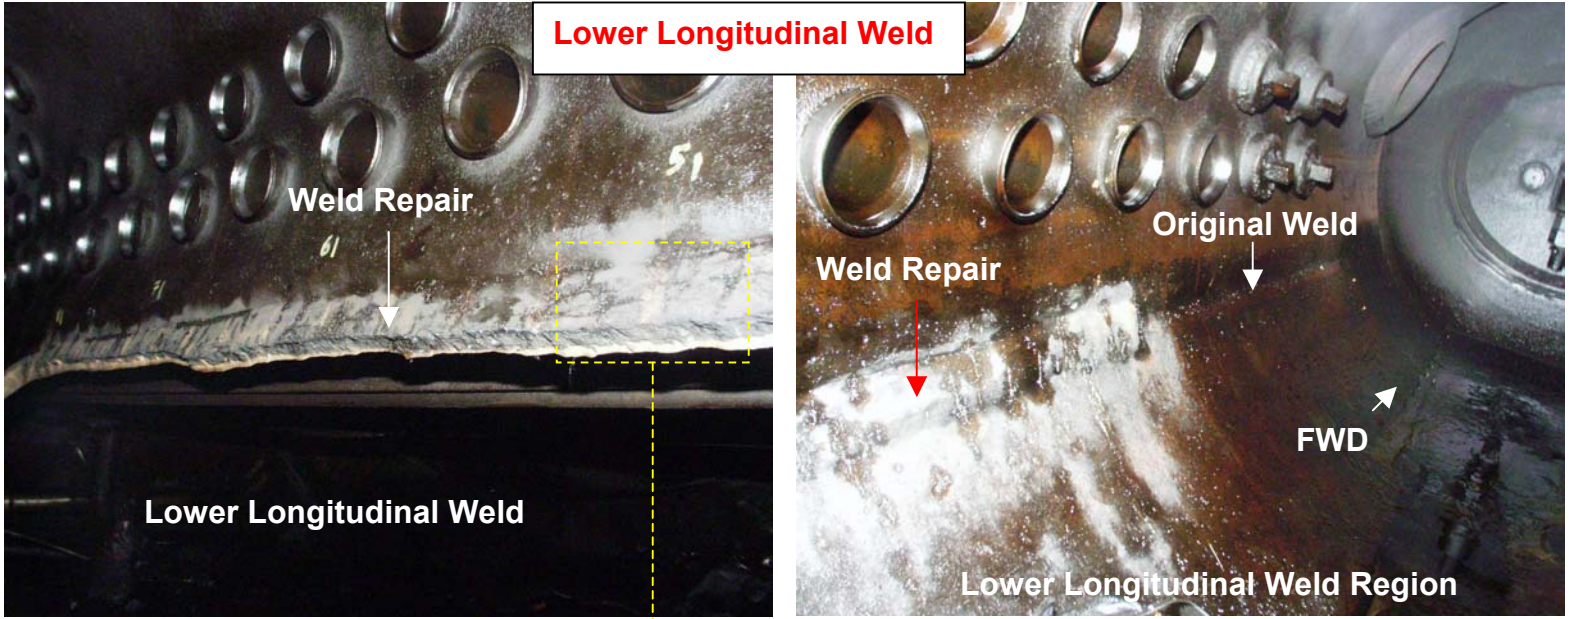
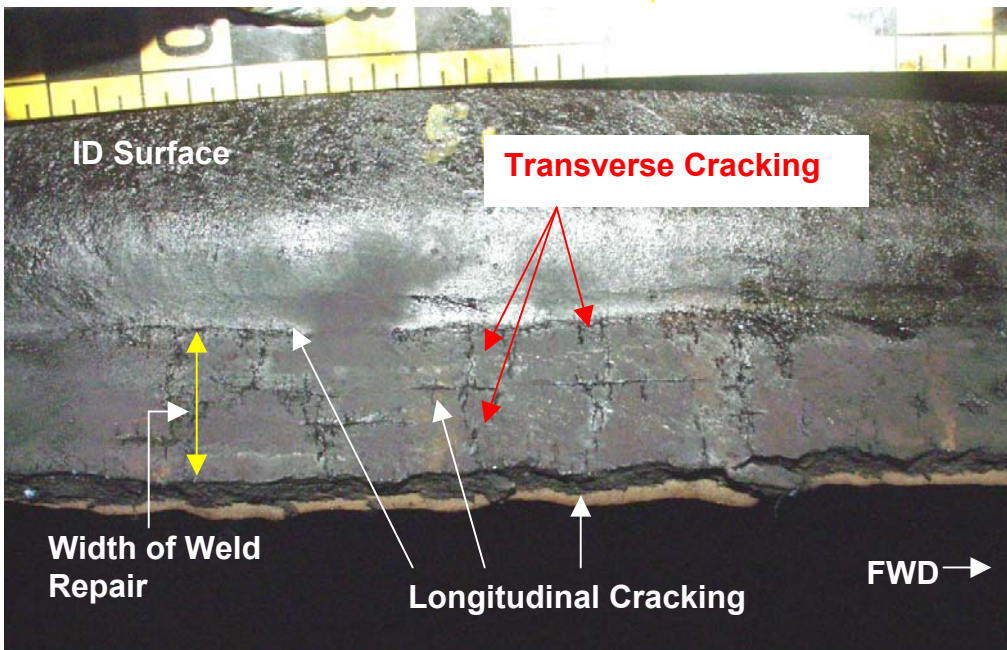
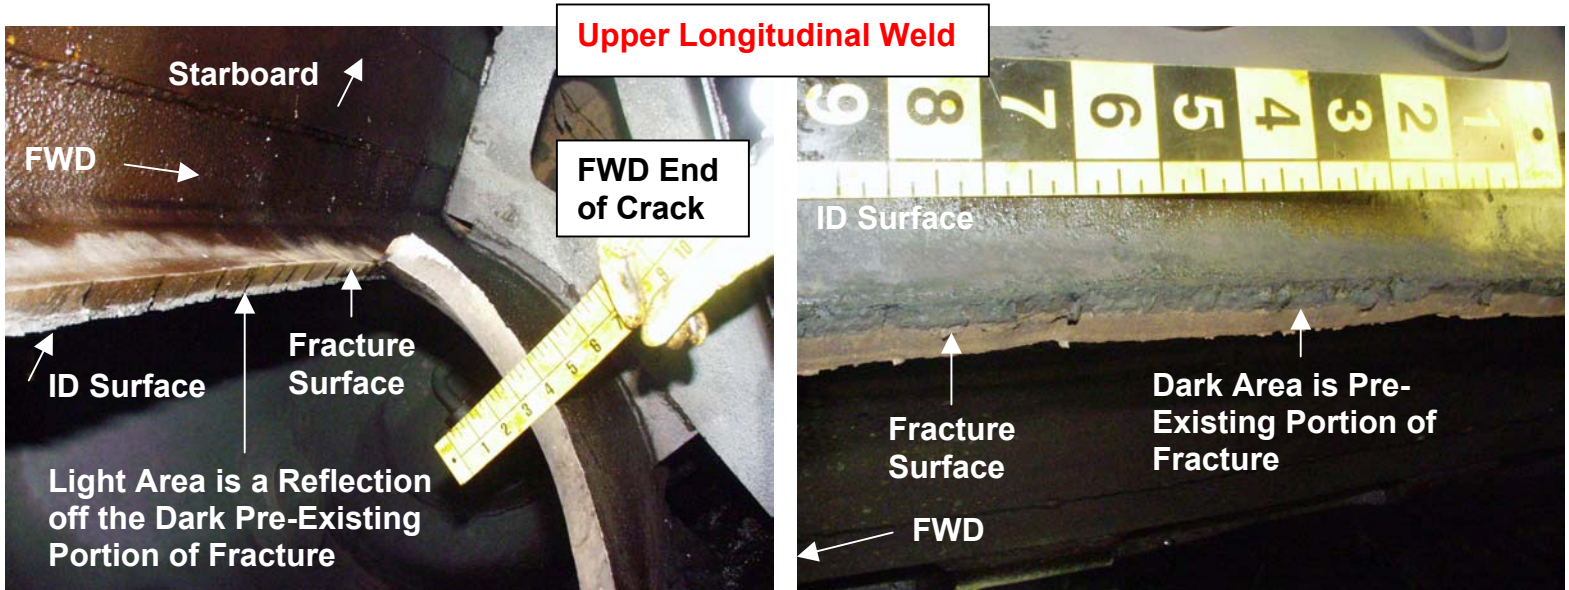
The fracture along the lower longitudinal weld extended along the edge of what appeared to be a weld repair region (lower four images in Figure 2, upper left image Figure 3, and middle image in Figure 3). The presence of repair welds on the ship's boilers was confirmed by examination of documents.<sup>2</sup> The documents indicate that cracks were observed in the original equipment manufacturer (OEM) longitudinal welds in the headers, water drums, and steam drums of all four of the ship's boilers, with the first detection occurring in December 1970. The documents further indicate that the boiler drums were periodically monitored by visual and NDT methods and cracks that were detected were removed by grinding. When cracks extended below the minimum allowable wall thickness they were ground off and the walls were built back up by weld repairs. The welding procedure was created by Deutsche Babcock, approved by the classification society (Bureau Veritas), and welding was performed by Lloyd Werft or its subcontractor at the shipyard. Weld repairs were performed while the ship was in drydock in Bremerhaven, Germany in both 1987 and 1990. Specific documents indicate that the OEM welds on the header of boiler 23 were weld repaired in 1990.<sup>a</sup>

Visual examination of the fracture surface on the tube sheet side of the lower longitudinal weld revealed the presence of pre-existing cracks (dark areas of fracture surface), which

extended from the inner diameter (ID) surface and propagated through approximately 60% of the wall thickness toward the outer diameter (OD) surface (middle image in Figure 3). The pre-existing crack region was nearly continuous throughout the length of the lower longitudinal fracture. However, at both ends of this fracture, additional isolated thumbnail-shaped regions indicative of fatigue were observed (lower images in Figure 2). The weld repair region contained both longitudinal and transverse cracks. The transverse cracks were between 0.5 and 2 inches long (middle image in Figure 3).

**Figure 3:** Additional optical views of the lower longitudinal weld in the fractured region (middle and top left image) and in an intact region near the forward manhole (top right image). The lower images show portions of the fracture at the upper longitudinal weld.

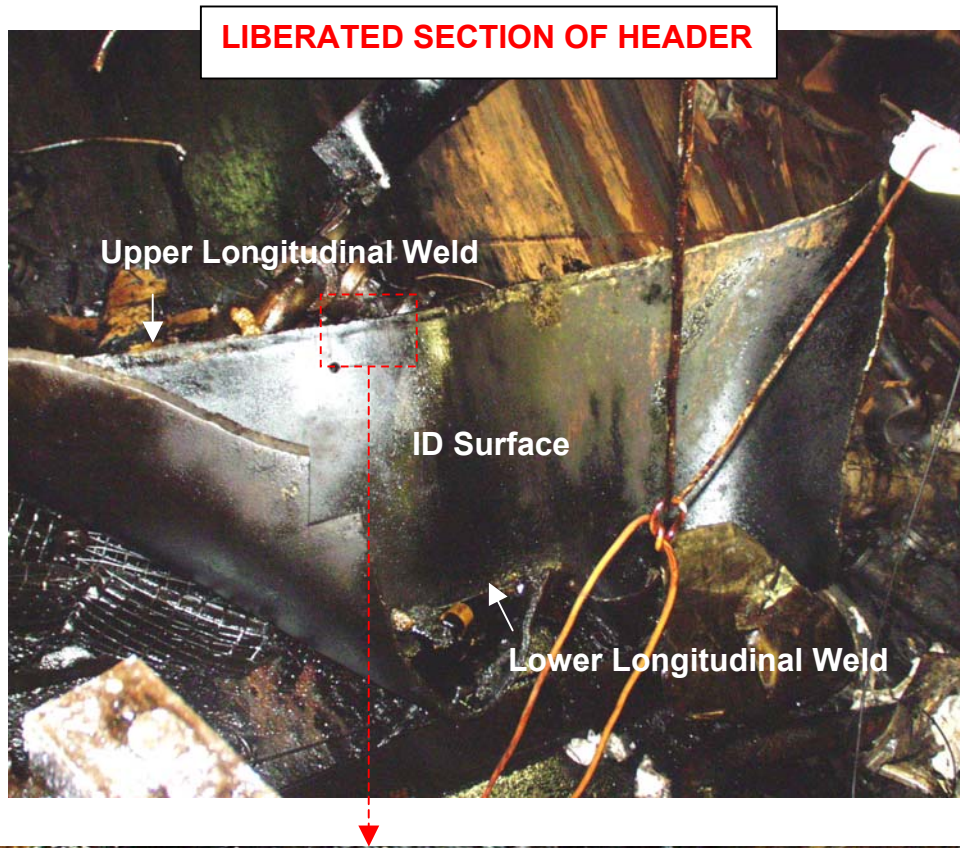
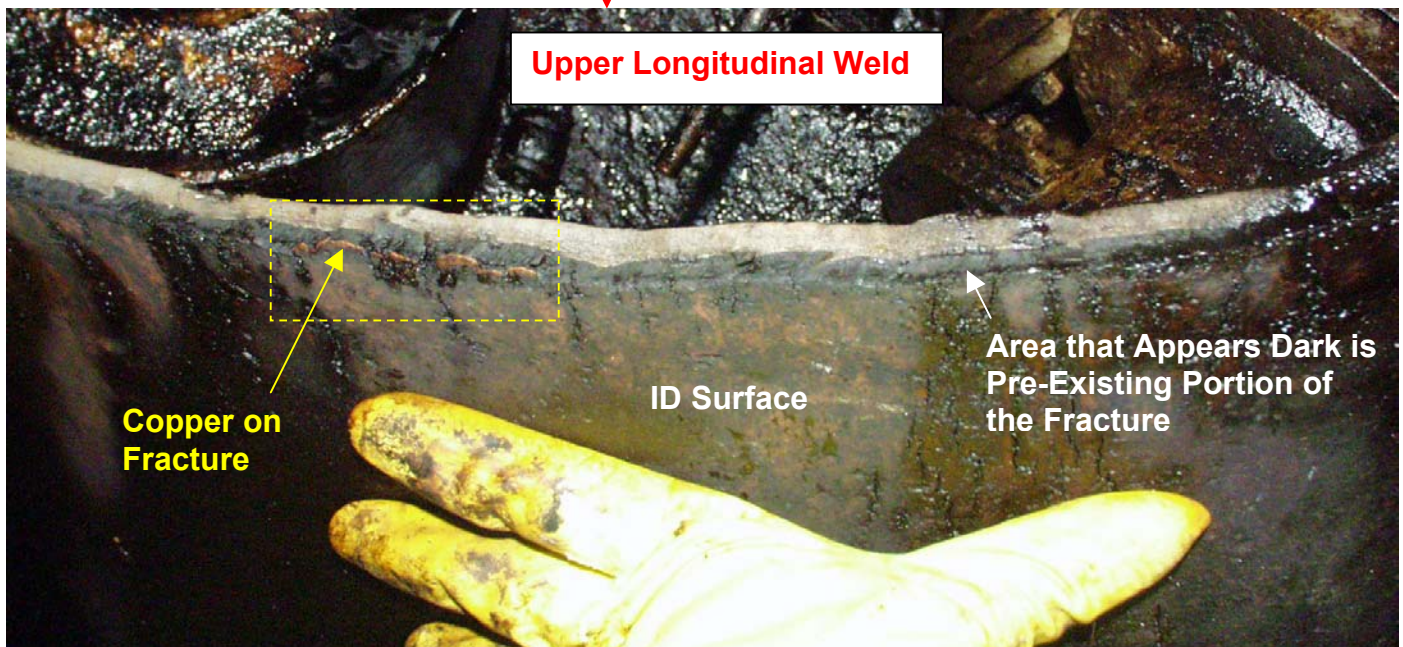
A view of the liberated section of the header can be observed in the top image in Figure 4. This section was found intact, but contained areas of heavy damage from collision with other objects and had a transverse tear near the middle of the lower longitudinal weld. A higher magnification view of a portion of the fracture surface of the upper longitudinal weld can be seen in the lower image in Figure 4. This section shows the presence of the pre-existing cracks (dark region of the fracture). It also shows the presence of copper nuggets covering the fracture surface near the ID side (described in more detail later).

**Figure 4:** Overall view of the liberated section of the header (top image) and higher magnification view of a portion of the fracture surface of the upper longitudinal weld (lower image).

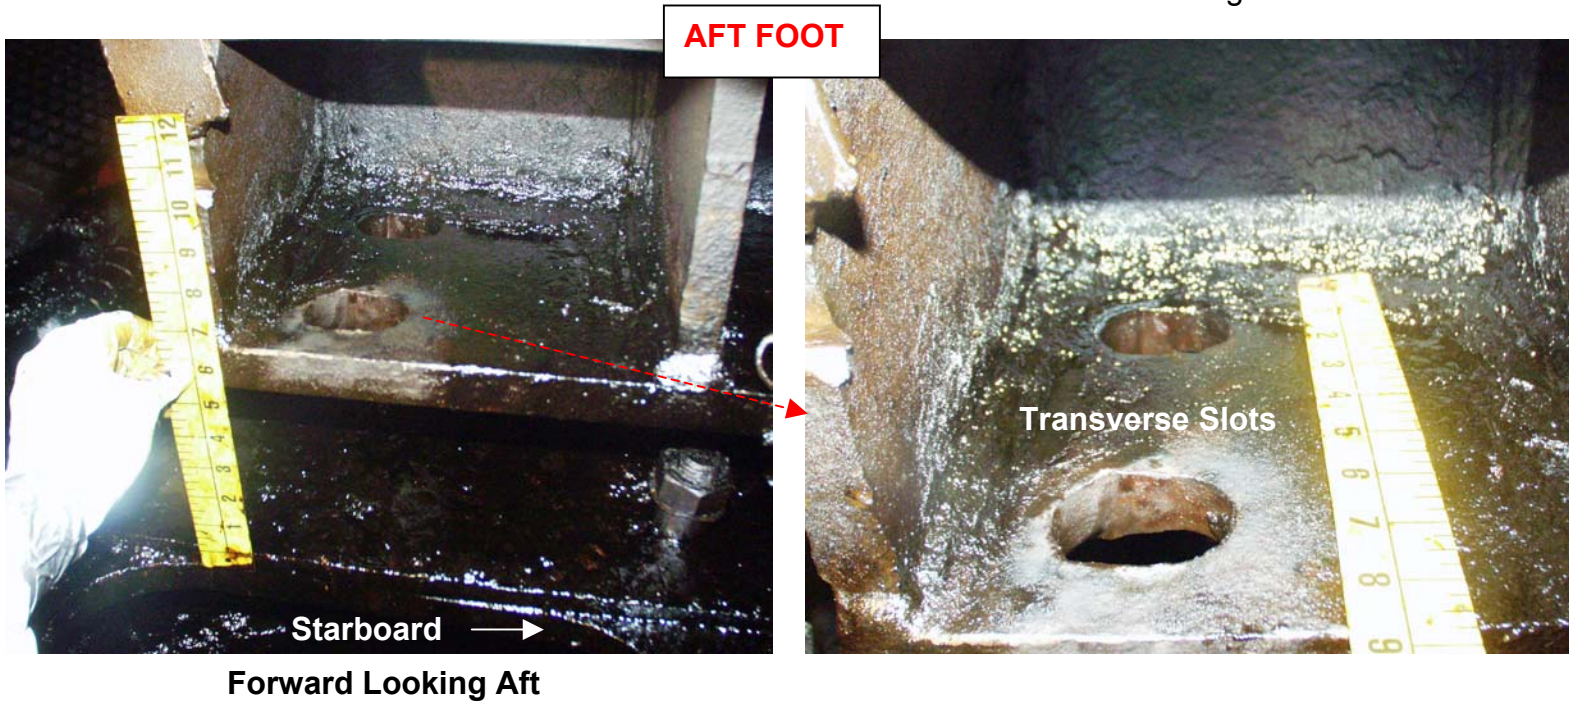
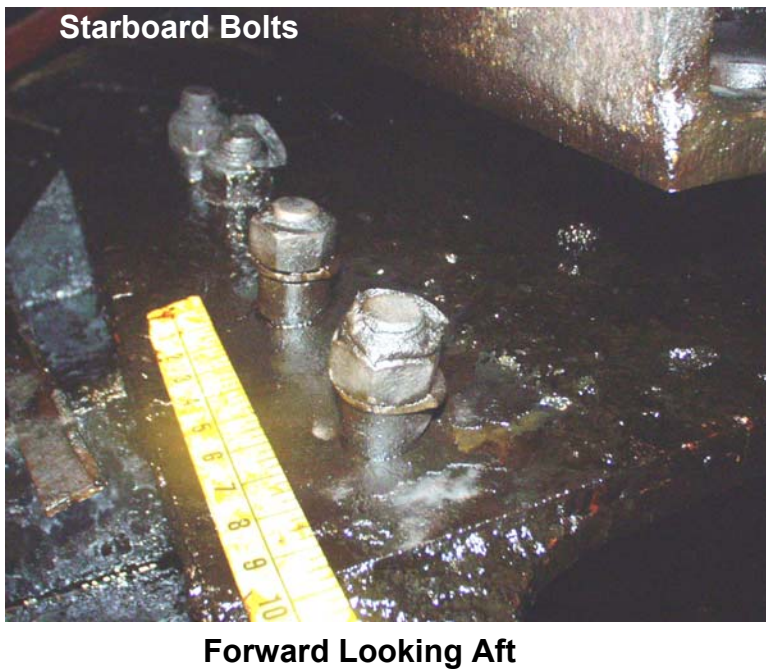
Examination of the header support feet revealed that both were lifted off their bases. The forward foot was approximately 6 inches off the base and the aft foot was approximately 5.5 inches off the base (upper left images in Figures 5 and 6). The aft foot had transverse slots and the forward foot had oblique slots (upper right images in Figures 5 and 6, respectively). The bolts on the bases were found to contain the nuts, washers, and sleeves (lower images in Figures 5 and 6). All washers were deformed upward consistent with the feet separating upward from the base. The floor plating below the ruptured area of the header was found to have been bent downward, likely a result of the steam release.

**Figure 5:** Views of the aft support foot slots (top two images) and starboard bolts (lower image) for header 23.

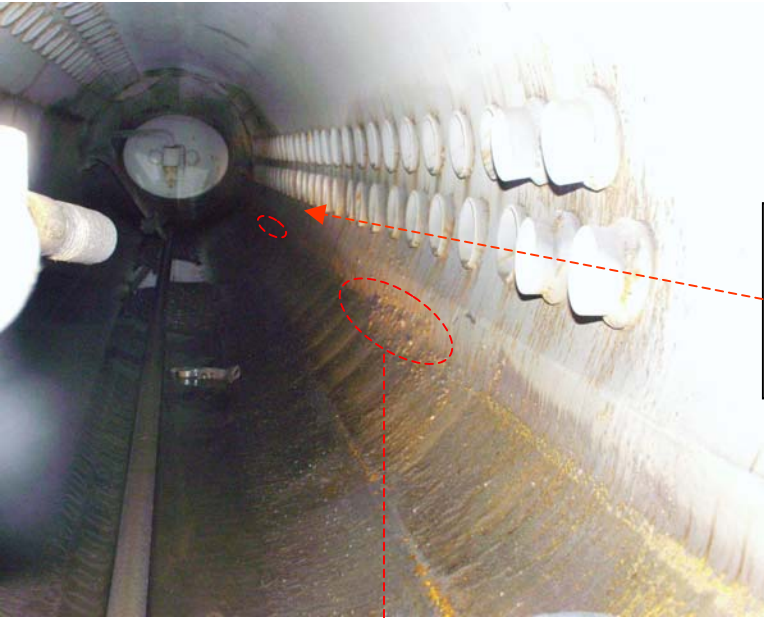
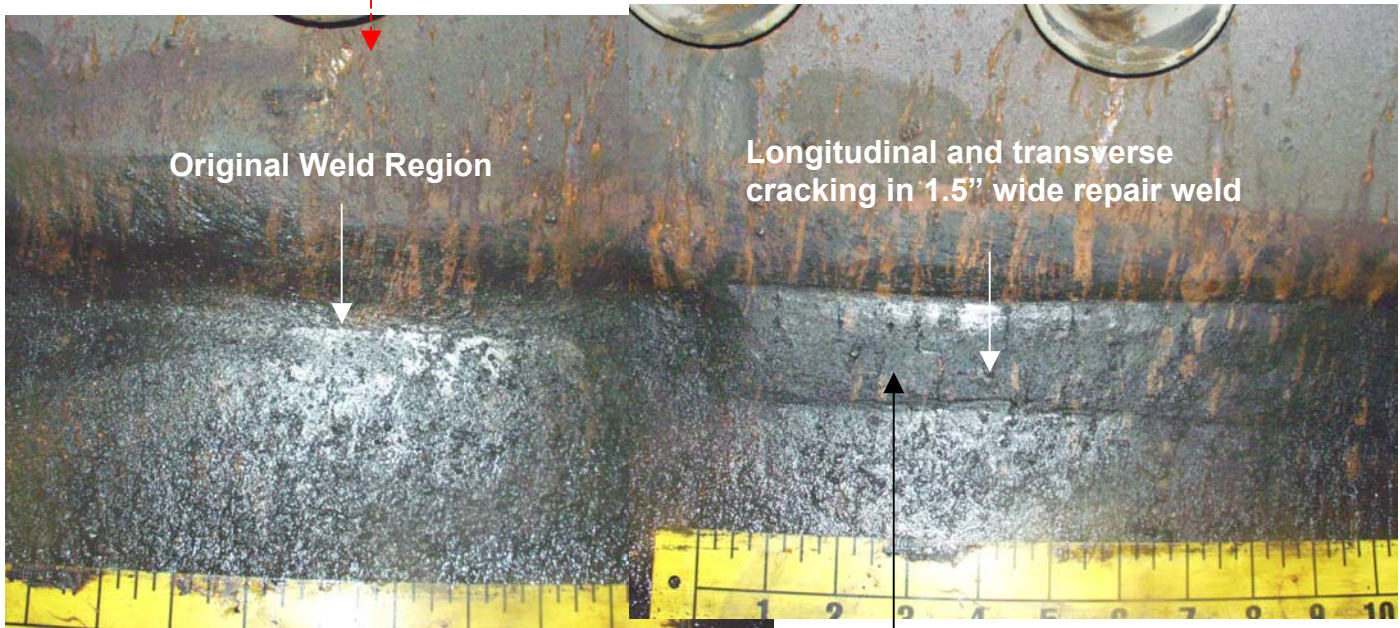
**HEADER FROM BOILER #22**

Visual examination of the interior of the headers from the other three boilers revealed that header 22 also showed the presence of repair welds (built-up regions along the OEM weld) in the lower longitudinal weld. One weld repair region was approximately 16 inches long in-line with tubes 7-10 from the forward end. The other repair area was approximately 12 inches long in-line with tubes 5-7 from the aft end (upper image in Figure 7). Both repair welds showed visual cracking in both the transverse and longitudinal directions (middle image in Figure 7). Repair welds were not found on the upper longitudinal weld of this header, but the inside diameter surface showed the presence of circular and linear blisters/pits near this weld (lower image in Figure 7).

**16 inch repair weld in-line with tubes 7-10 from forward end on lower longitudinal weld.**

**Longitudinal and transverse cracking in 1.5" wide repair weld**

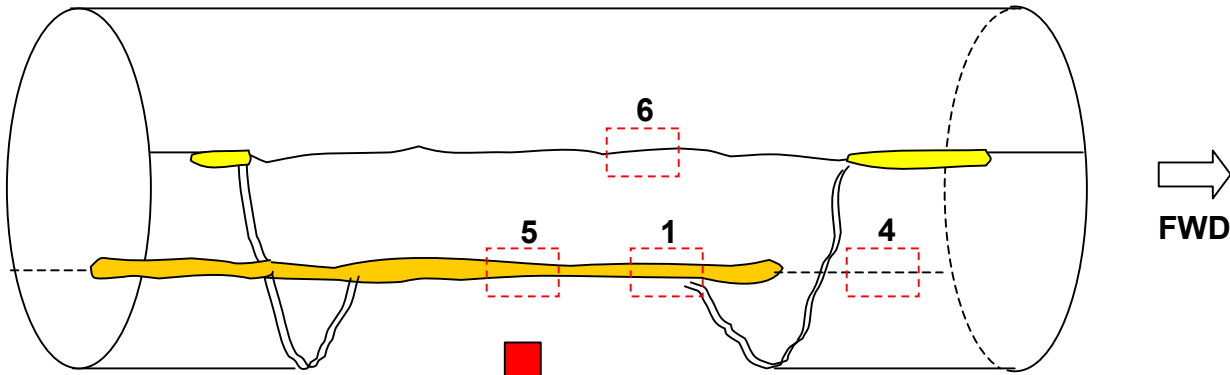
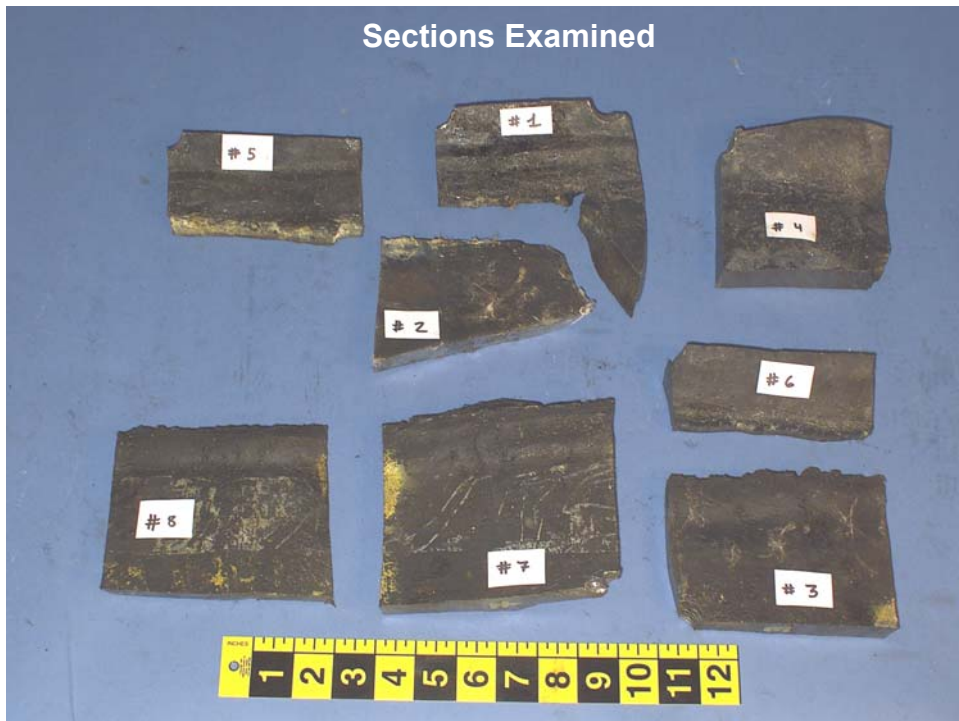
Header sections from boiler 23 from the cruise ship S/S Norway operated by Norwegian Cruise Lines (NCL). The sections examined were as follows (see Figure 9):

**Figure 9:** The upper image is a schematic of the fractured header from boiler 23. The numbered regions identify the sections removed from the header for analysis, which can be seen in the lower image.

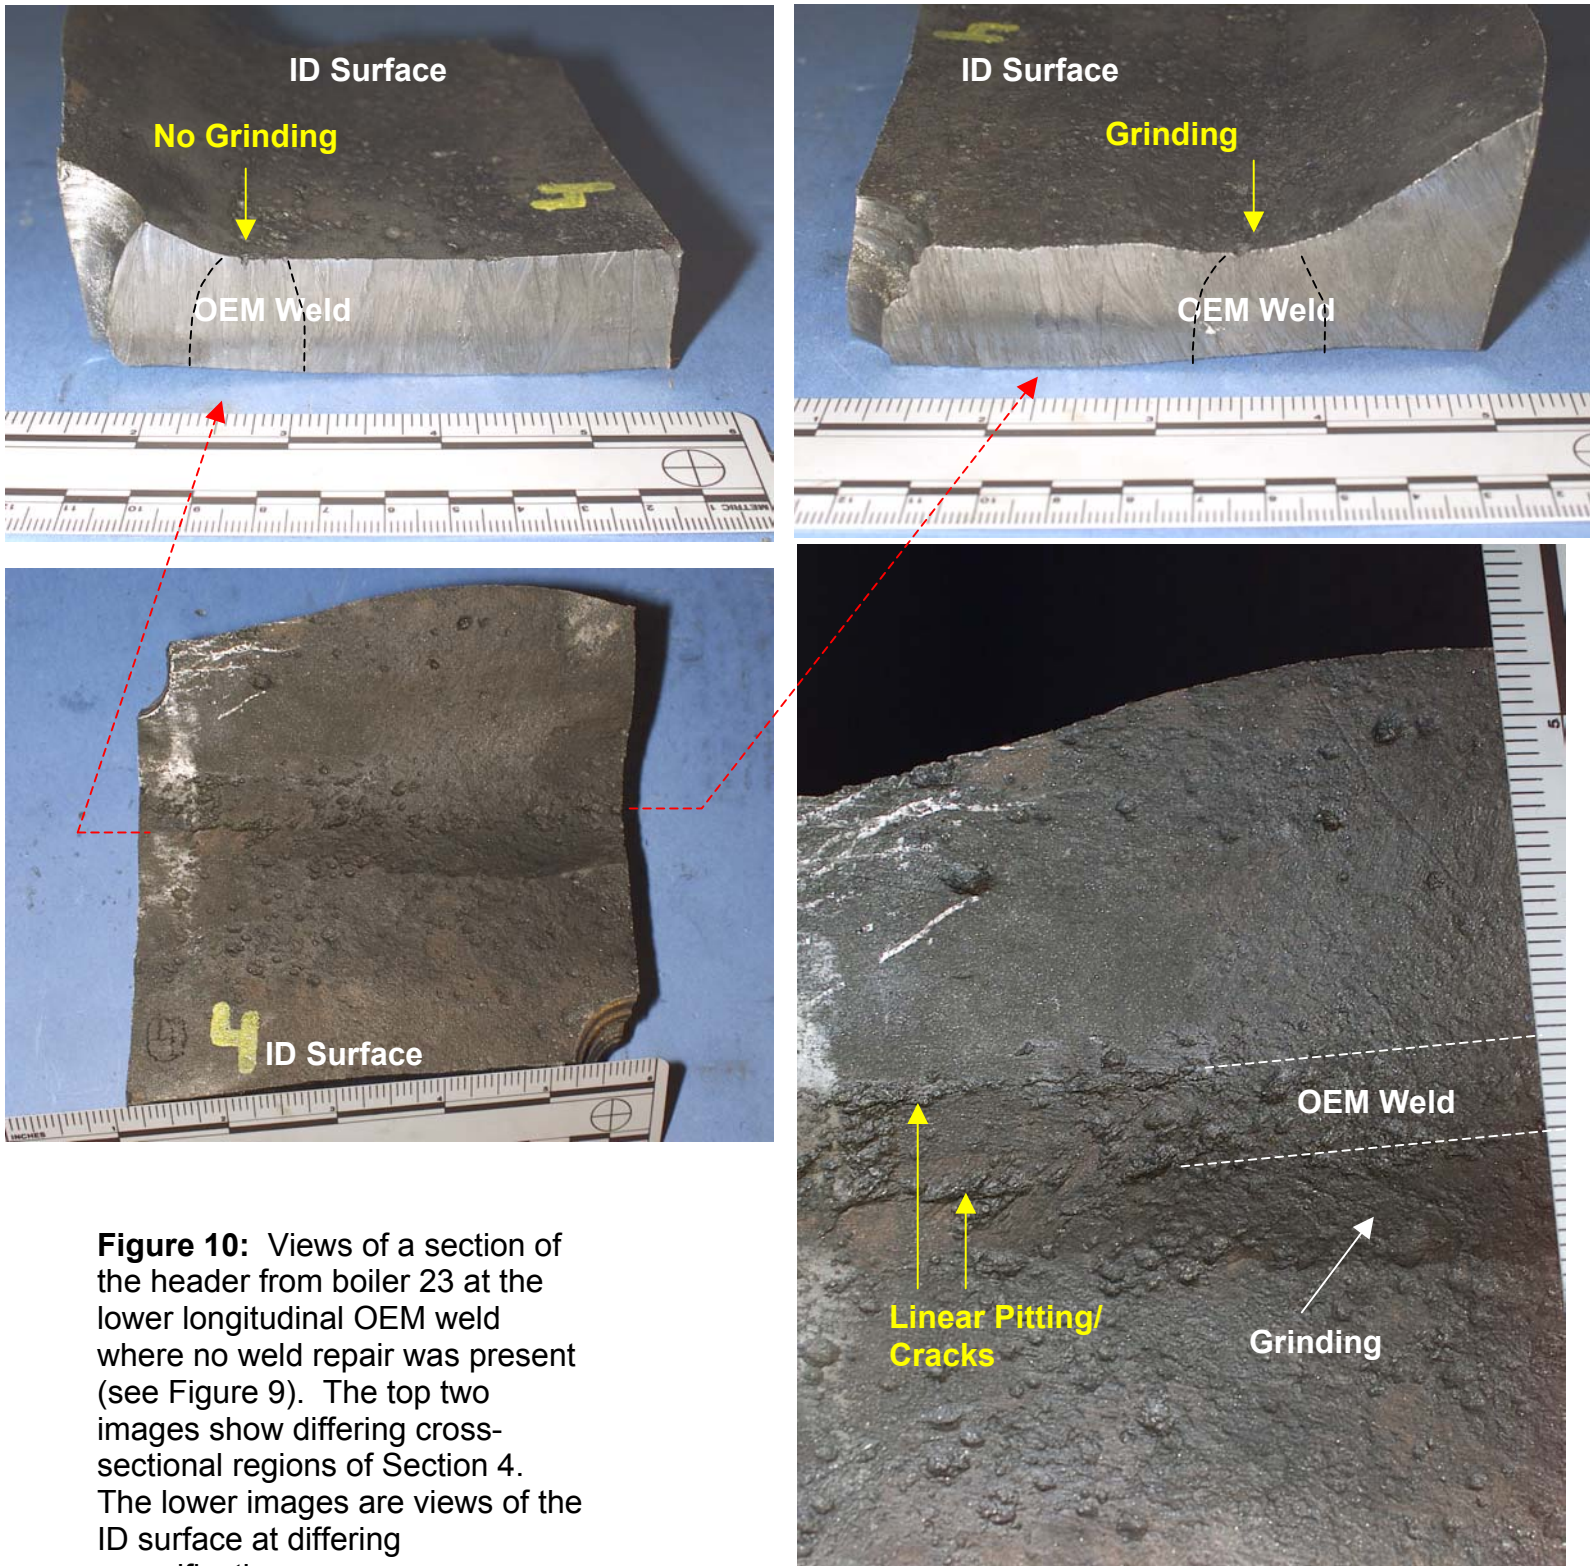
**SECTION 4-OEM Weld Region**

Section 4 was through the OEM portion of the lower longitudinal weld. Optical examination of Section 4 revealed that some portions of the ID surface had been ground at the original weld location, reducing the wall thickness in the weld area below other areas of the wrapper sheet (compare the top two images in Figure 10). The ID surface contained grinding marks in areas of reduced thickness and had overall general pitting, even on areas with grinding. Preferential longitudinal pitting and cracks were also observed on the ID surface on the portion of the weld with minimal grinding (lower right image in Figure 10). At the position where the grinding had removed the most material, the wall thickness was approximately 0.788 inch, which is below the minimum allowed thickness of 20.3 millimeters (0.799 inch) before weld repair is required<sup>5</sup>. In areas not affected by grinding,

Cracking was observed on the ID in both the wrapper sheet and the OEM weld region. The most significant cracking was at the weld interface up to 0.1 inch deep. In the wrapper sheet pitting/cracking was up to approximately 0.05 inch deep.

**Figure 10:** Views of a section of the header from boiler 23 at the lower longitudinal OEM weld where no weld repair was present (see Figure 9). The top two images show differing cross-sectional regions of Section 4. The lower images are views of the ID surface at differing magnifications.

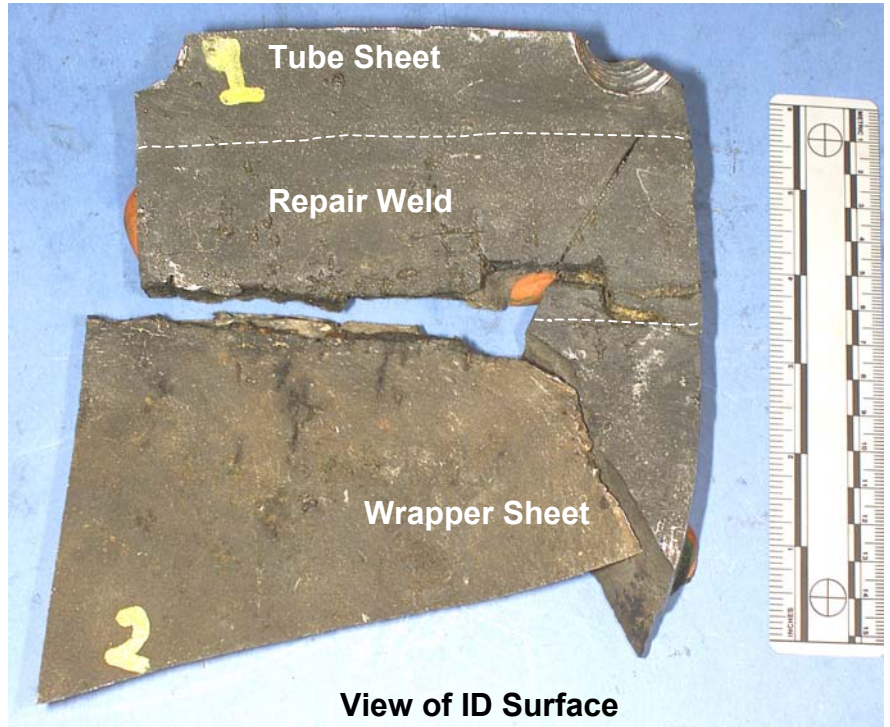
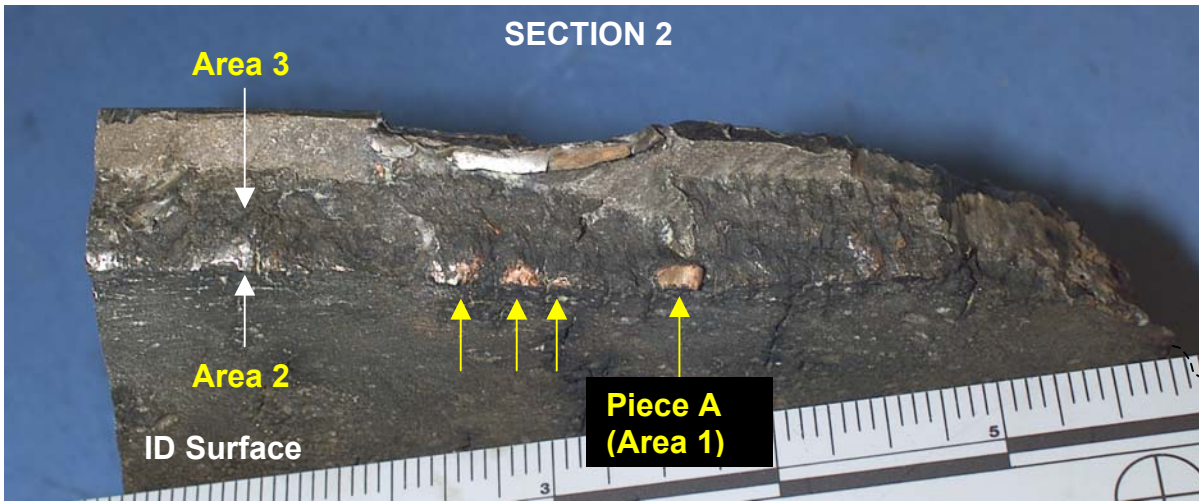
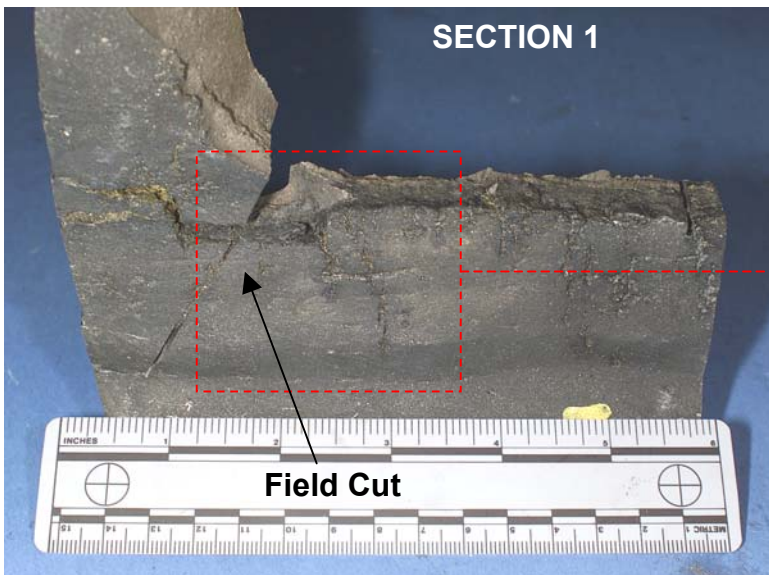
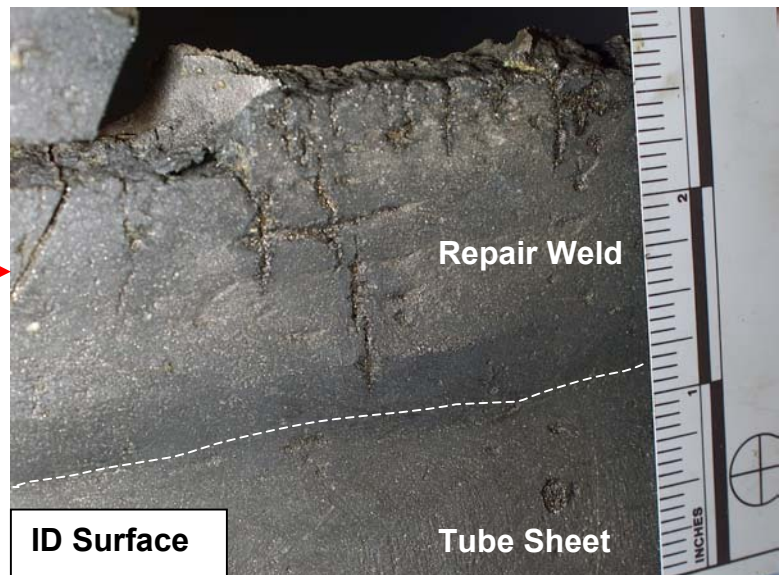
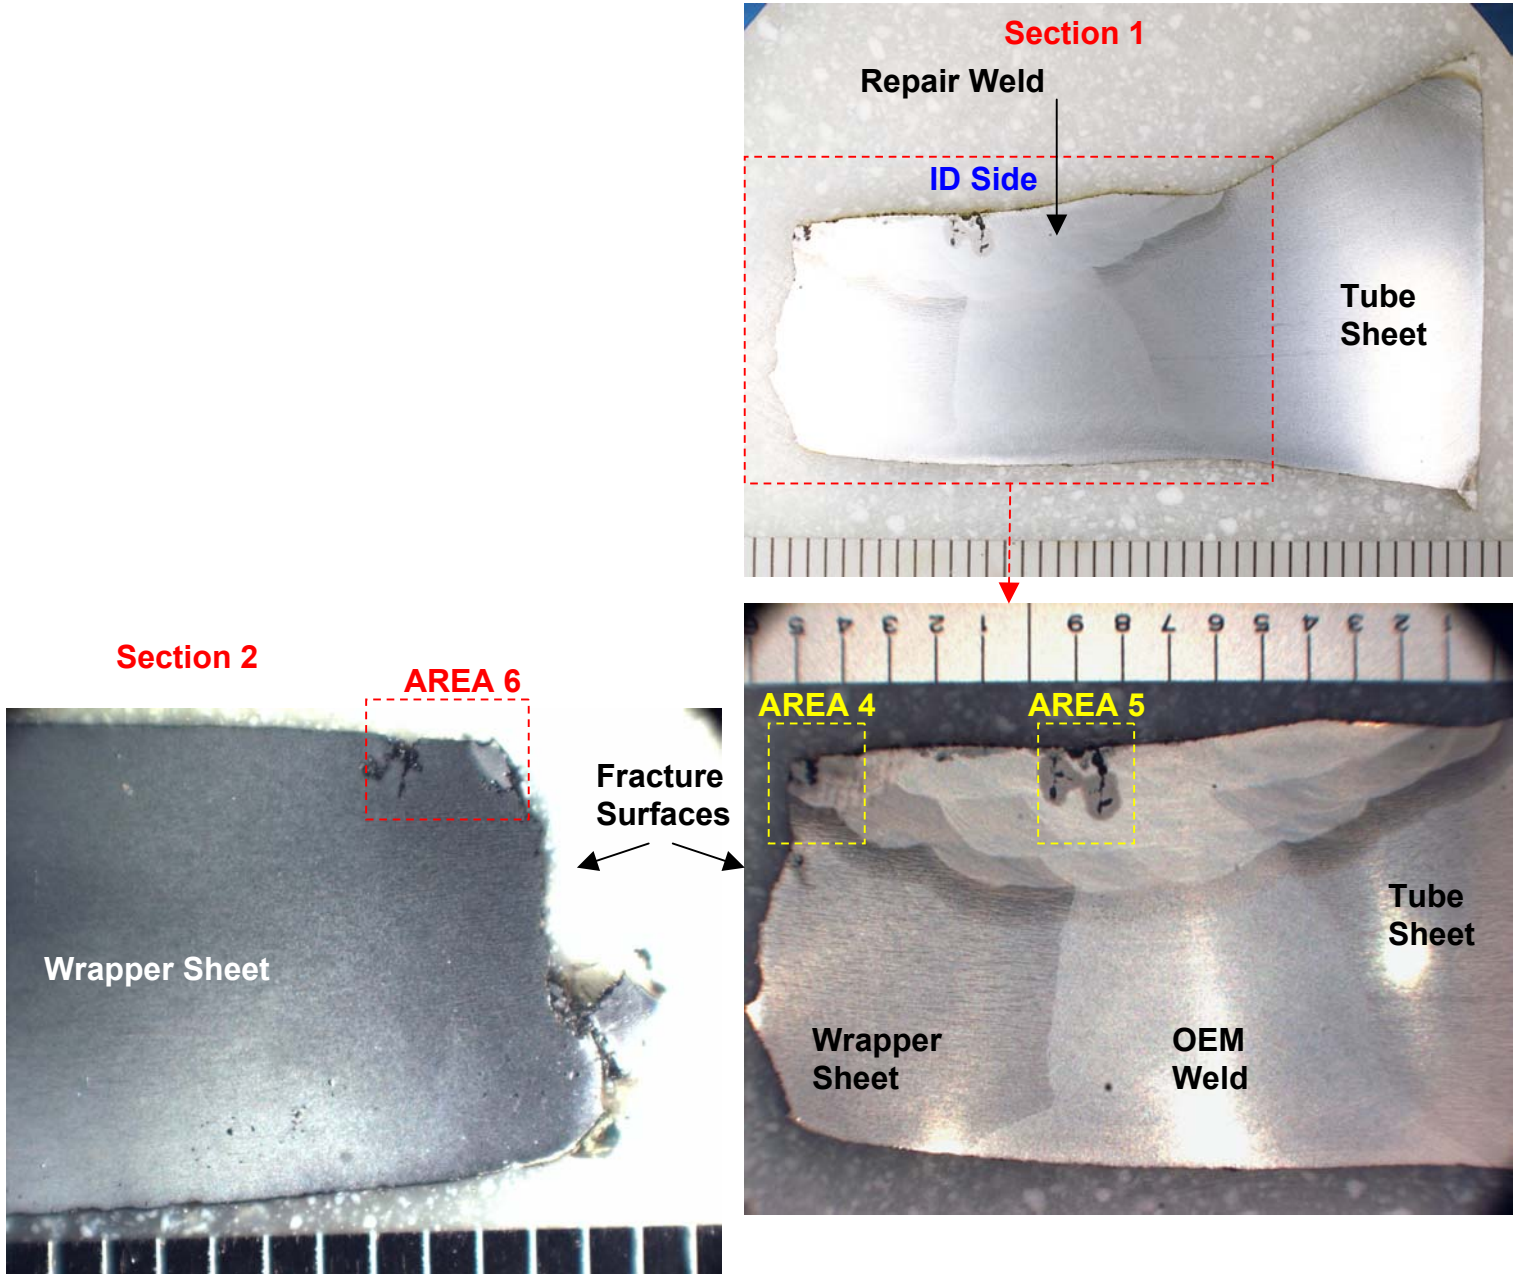
Cracking/pitting was observed on the transverse cross sections in the wrapper sheet up to 0.1 inch deep (bottom left image in Figure 13) and in the center of the repair weld up to 0.15 inch deep (right images in Figure 13). The fracture itself was through the starboard side of the repair weld approximately 0.1 inch away from the weld interface with the wrapper sheet (lower images in Figure 13).

**Figure 13:** Cross-sectional mounts at varying magnifications of mating Sections 1 and 2 in the lower longitudinal weld.

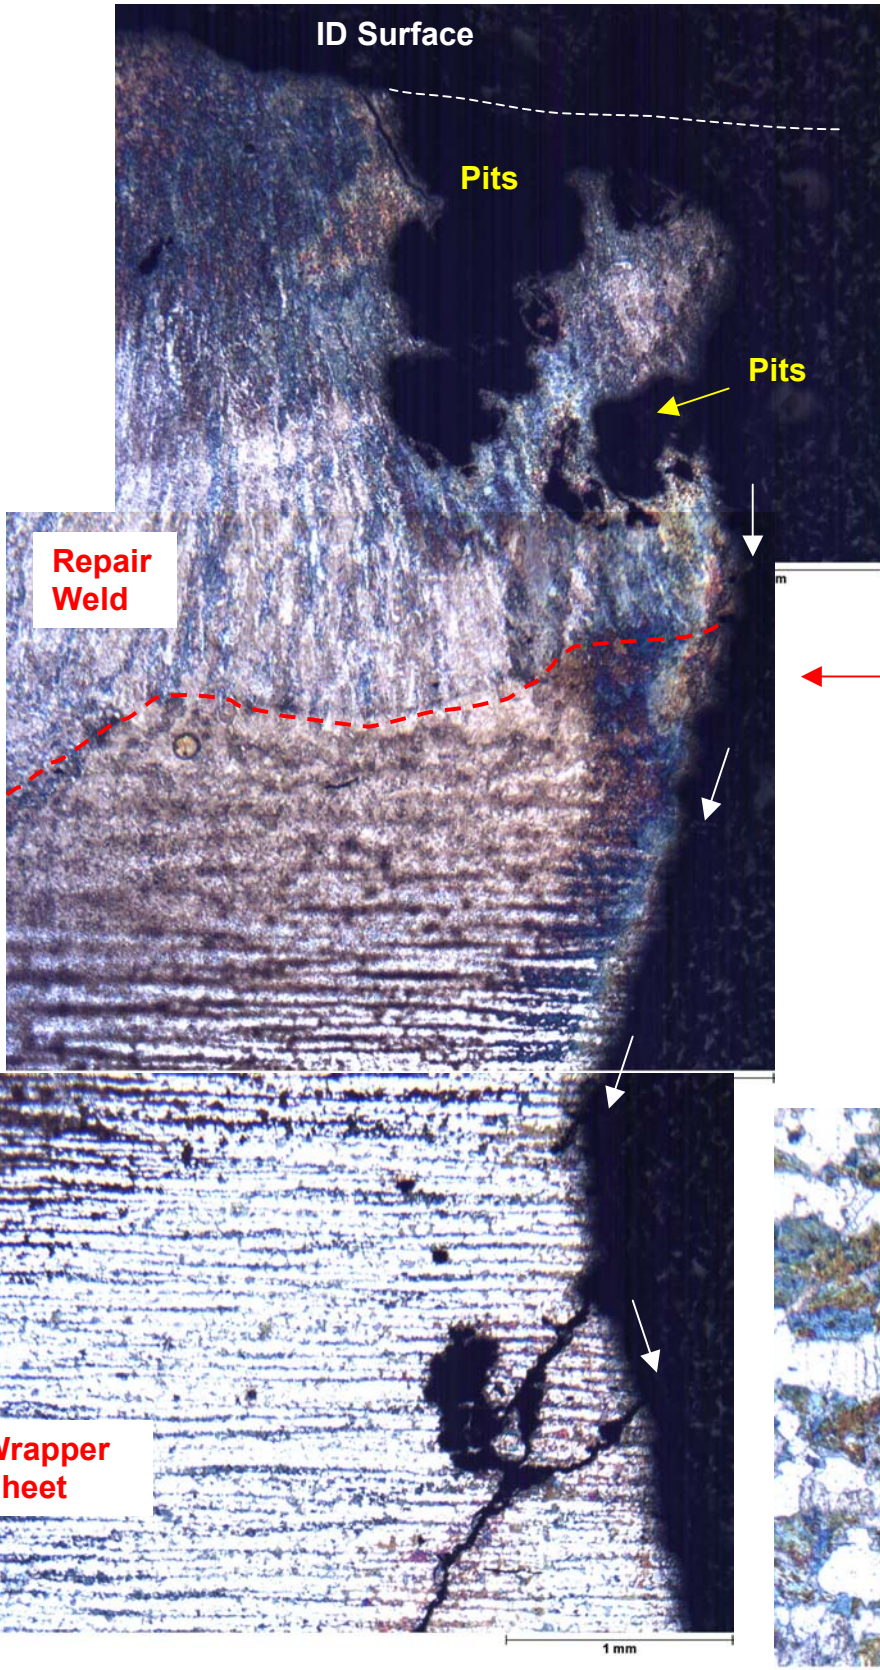
**AREA 4- Section 1**

From the metallographic mount it could be observed that the fracture initiated at the base of very large corrosion pits and then propagated through the repair weld and wrapper sheet in a transgranular manner (images in Figure 16). Additional large pits with crack-like features connecting them were observed in the wrapper sheet adjacent to the repair weld (top image in Figure 17) and in the repair weld itself (lower image in Figure 17).

**Figure 16:** Micrograph showing the edge of the repair weld at the fracture surface location (left image). The lower right image shows the fracture path in the wrapper sheet at a higher magnification.

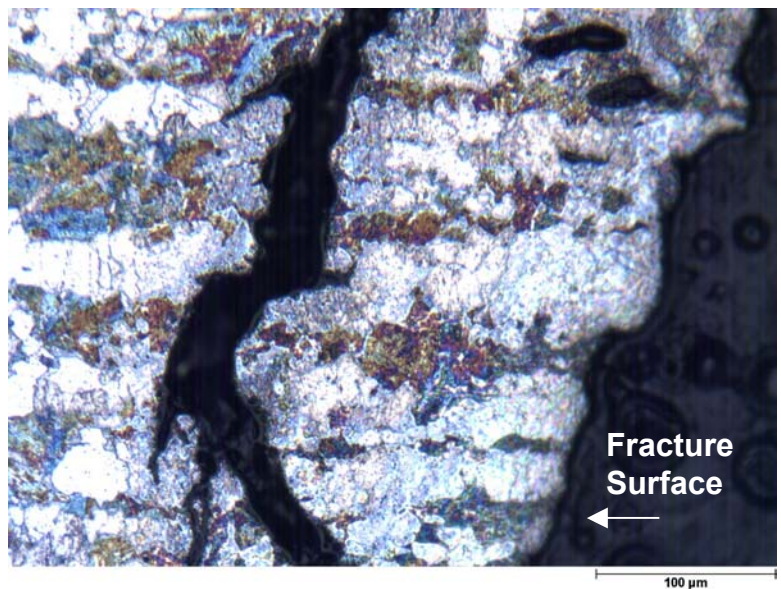
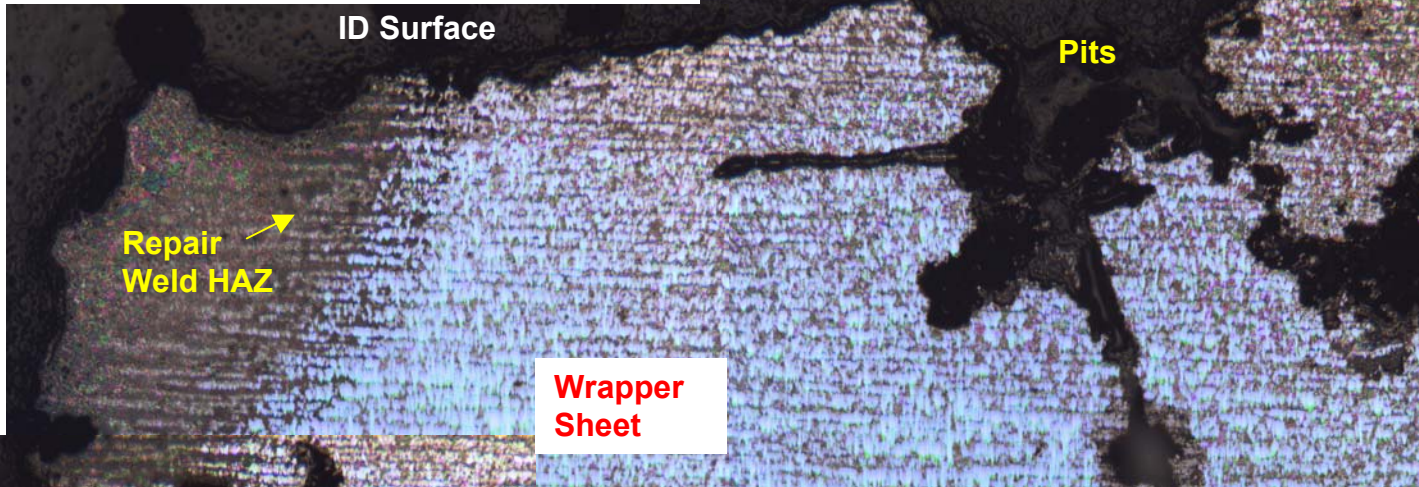
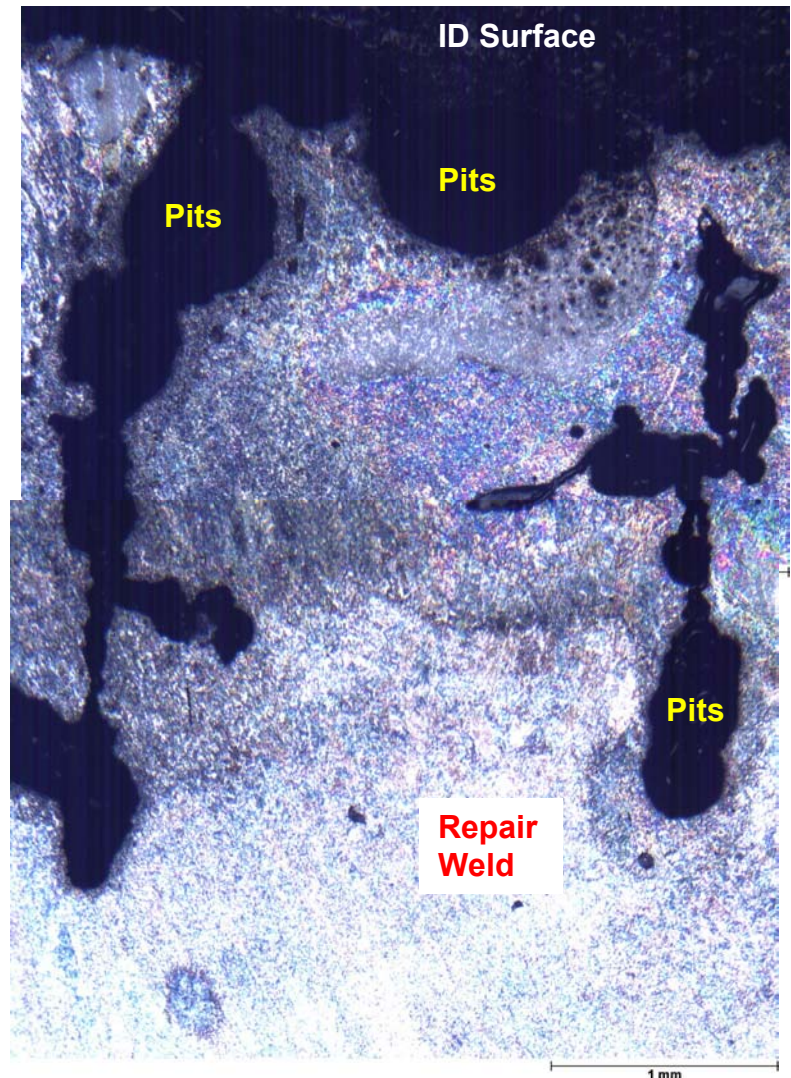
**Figure 17:** Micrograph showing the edge of the repair weld at the fracture surface location and the ID surface of the wrapper sheet (left image). The lower right image shows the pitting/cracking in the repair weld itself.
