# NATIONAL TRANSPORTATION SAFETY BOARD

MATERIALS LABORATORY FACTUAL REPORT

Report No. 03-078

Place : Miami, Florida  
Date : May 25, 2003  
Vehicle : Cruise ship S/S Norway  
NTSB No. : DCA03MM032  
Investigator : Robert Ford

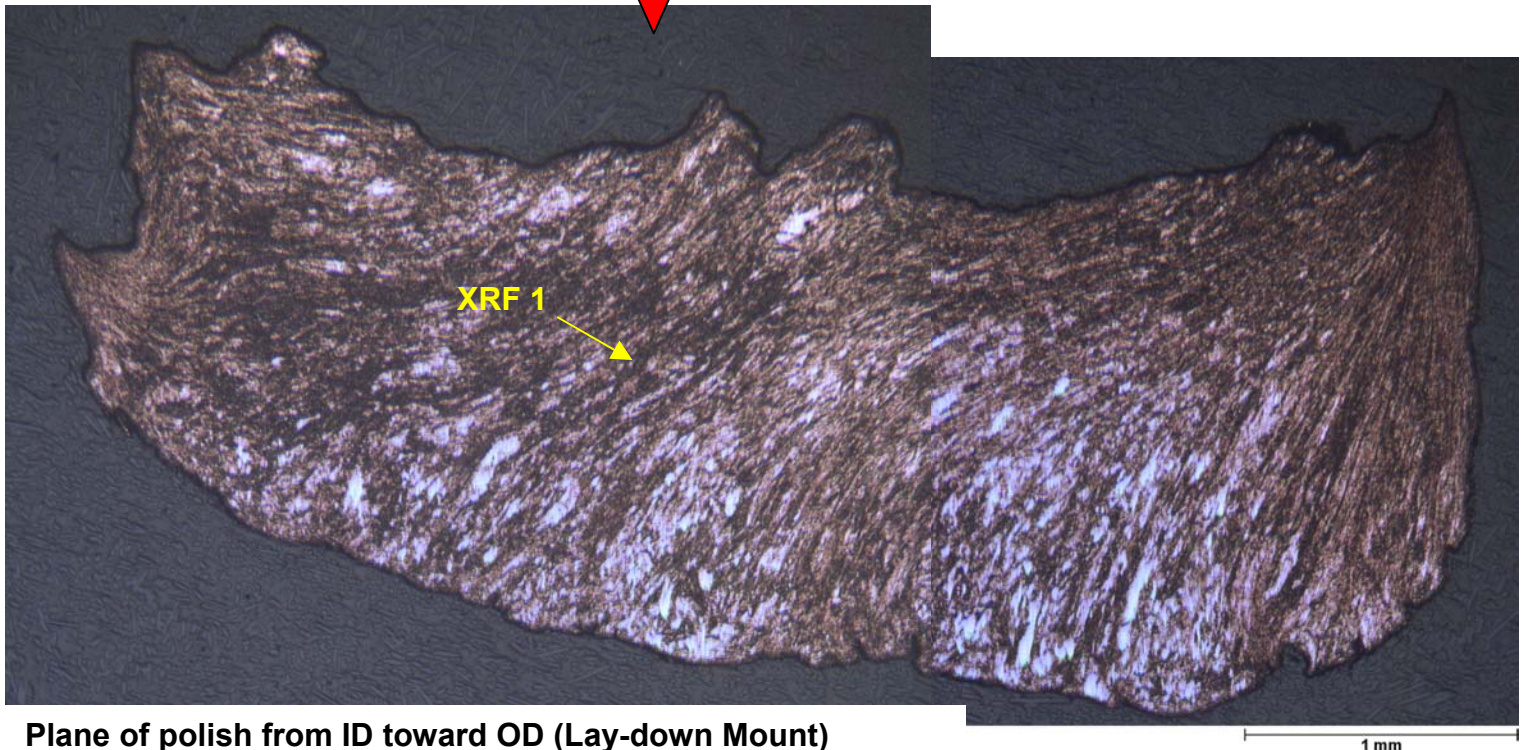
**Area 1- Piece A on Section 2**

**Figure 18:** SEM view of the underside of copper nugget Piece A that was flaked off from Section 2 (upper image). The lower image is a lay-down etched micrograph of the nugget microstructure.

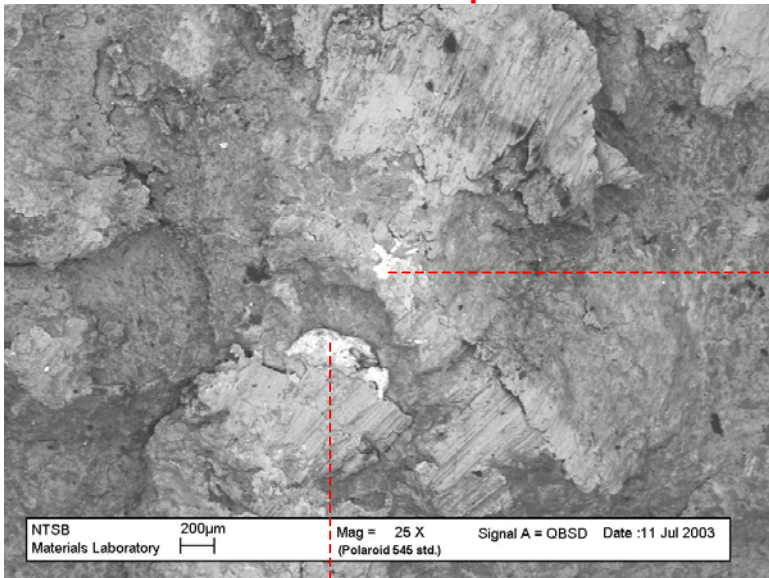
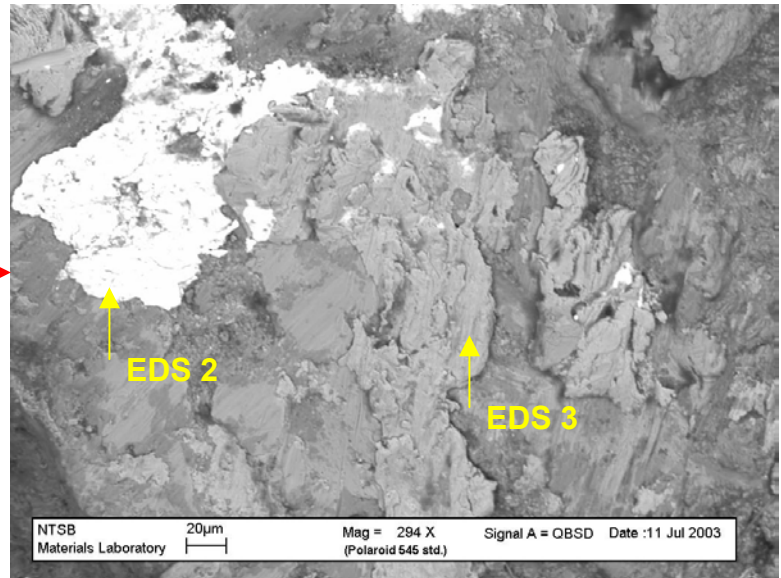
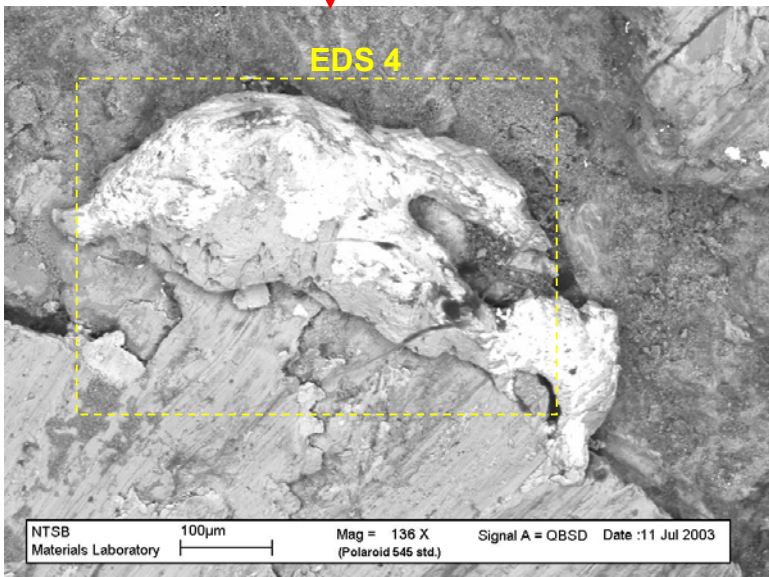
SEM examination and EDS analysis of selected areas on the fracture surface of Section 2 revealed that on the interior of the fracture (away from either the ID or OD surfaces) and at some of the locations along the ID surface deposits of almost pure copper were observed (lighter gray areas in Figure 20, EDS 3 in Figure 21). Deposits rich in lead (white regions in Figure 20- EDS 2 in Figure 21) were observed on top of portions of the copper deposits and, in some areas, directly on the fracture surface adjacent to the copper deposits. The lead and copper regions were separate and EDS analysis of multiple areas did not show any location where the copper and lead were mixed together. In the interior of the fracture the deposits appeared smeared on to the fracture. An overall EDS analysis of one of the interior smeared areas showed the presence of lead and copper, though still separate materials (lower image in Figure 20, EDS 4 in Figure 21).

**Figure 20:** Varying magnification SEM views of additional location along the fracture surface of Section 2. In these locations EDS readings were taken as shown in Figure 21.

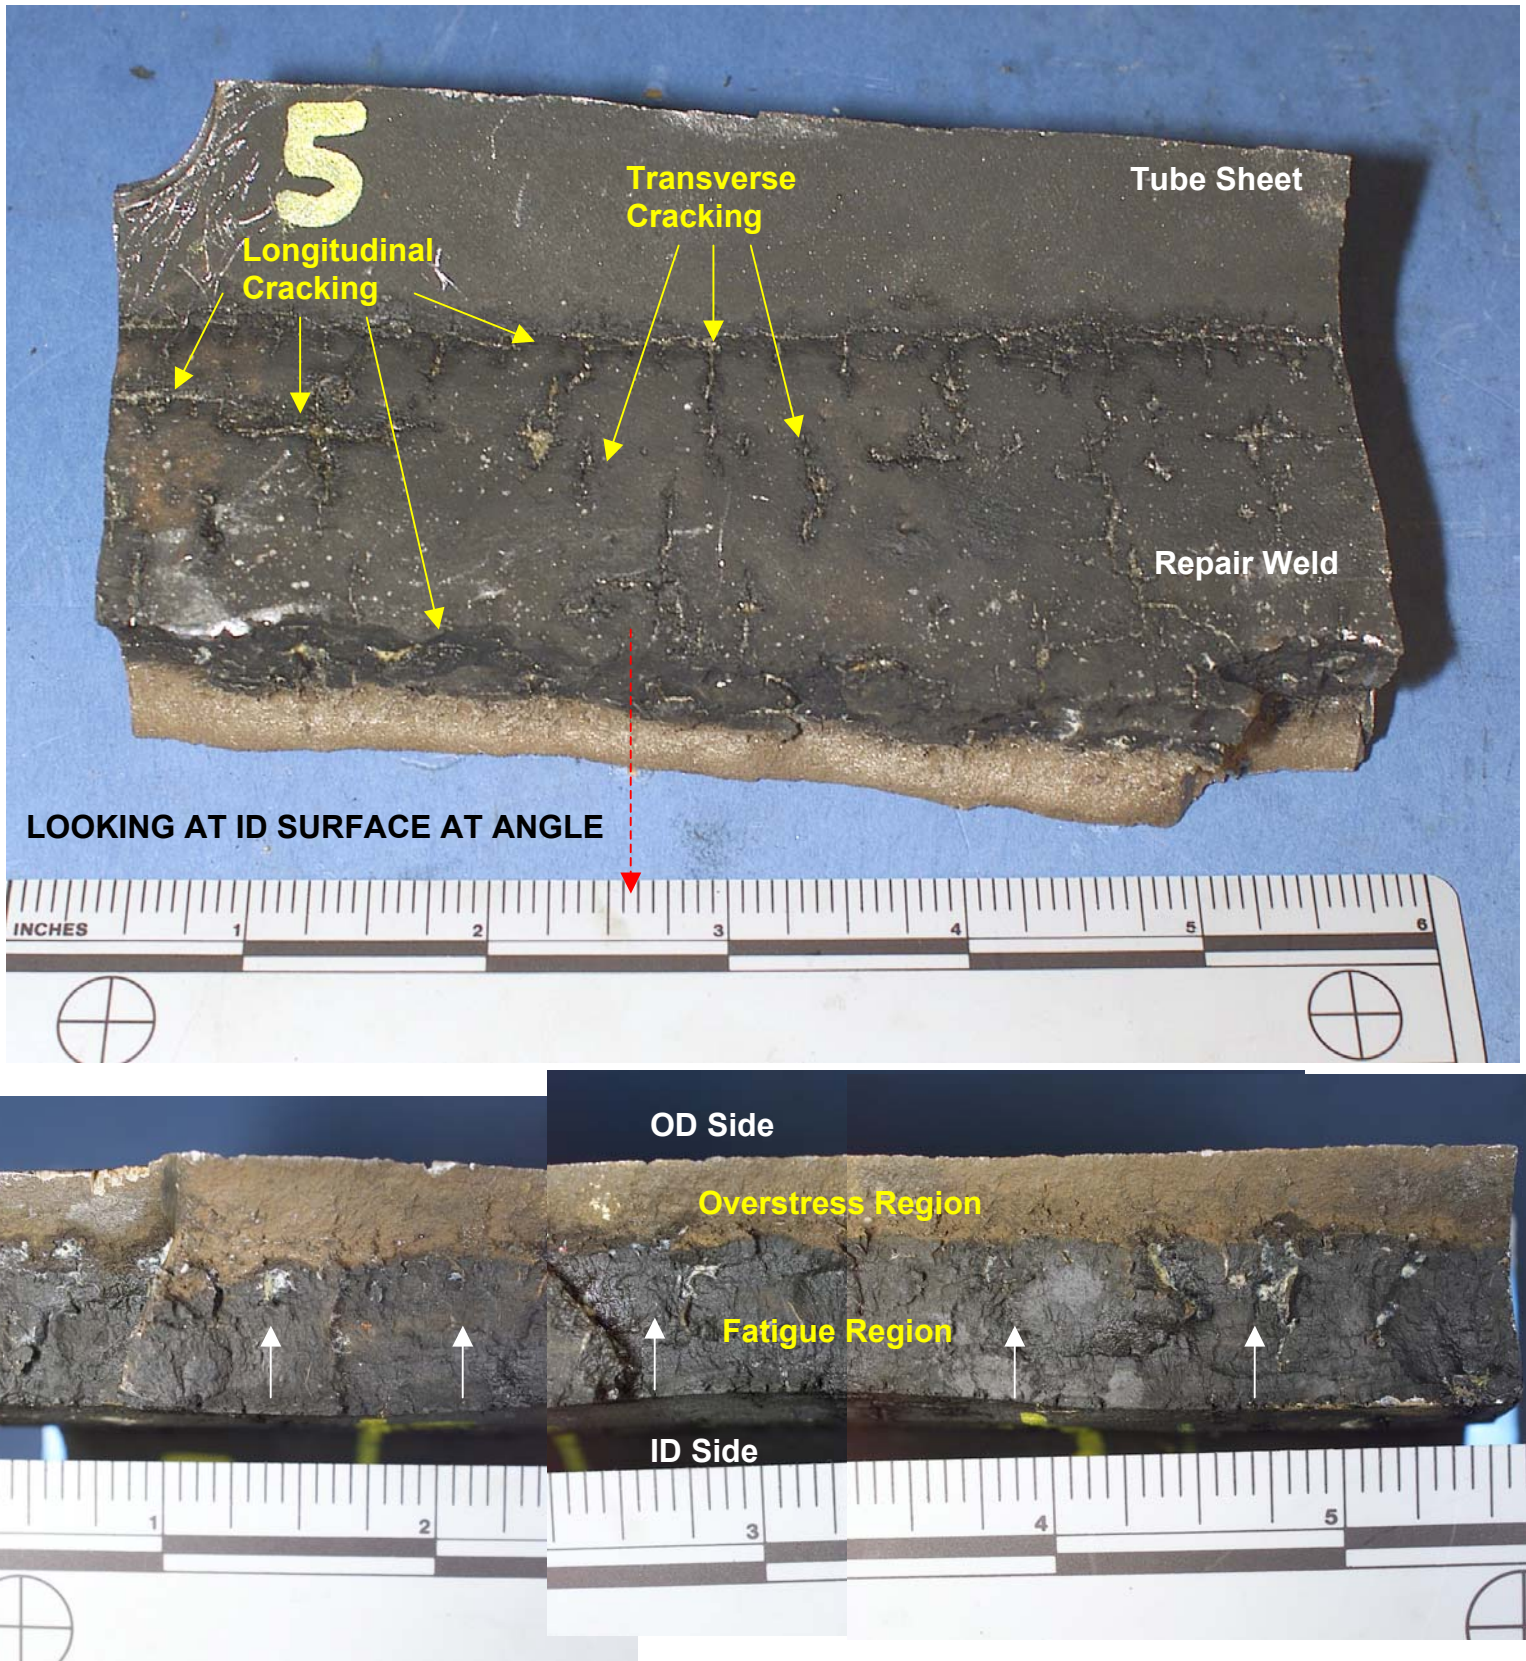
Section 5 was from the approximate middle of the length of the fracture along the lower longitudinal weld. The fracture on this section propagated along the starboard side of the repair weld (top image in Figure 22). The fracture was comprised of cracks on multiple longitudinal planes joining up to form a larger crack front. The fracture surface showed pre-existing cracks with multiple origins initiating from the ID surface and continuing to a depth between approximately 0.45-0.55 inch, in a section approximately 0.940 inch thick in the wrapper sheet removed from the fracture (lower image in Figure 22). At the fracture location the wrapper sheet was reduced to 0.8-0.85 inch thick by necking.

**Figure 22:** Views of the inner diameter surface (upper image) and fracture surface (lower montage) of Section 5 taken from the middle of the lower longitudinal weld of header 23.

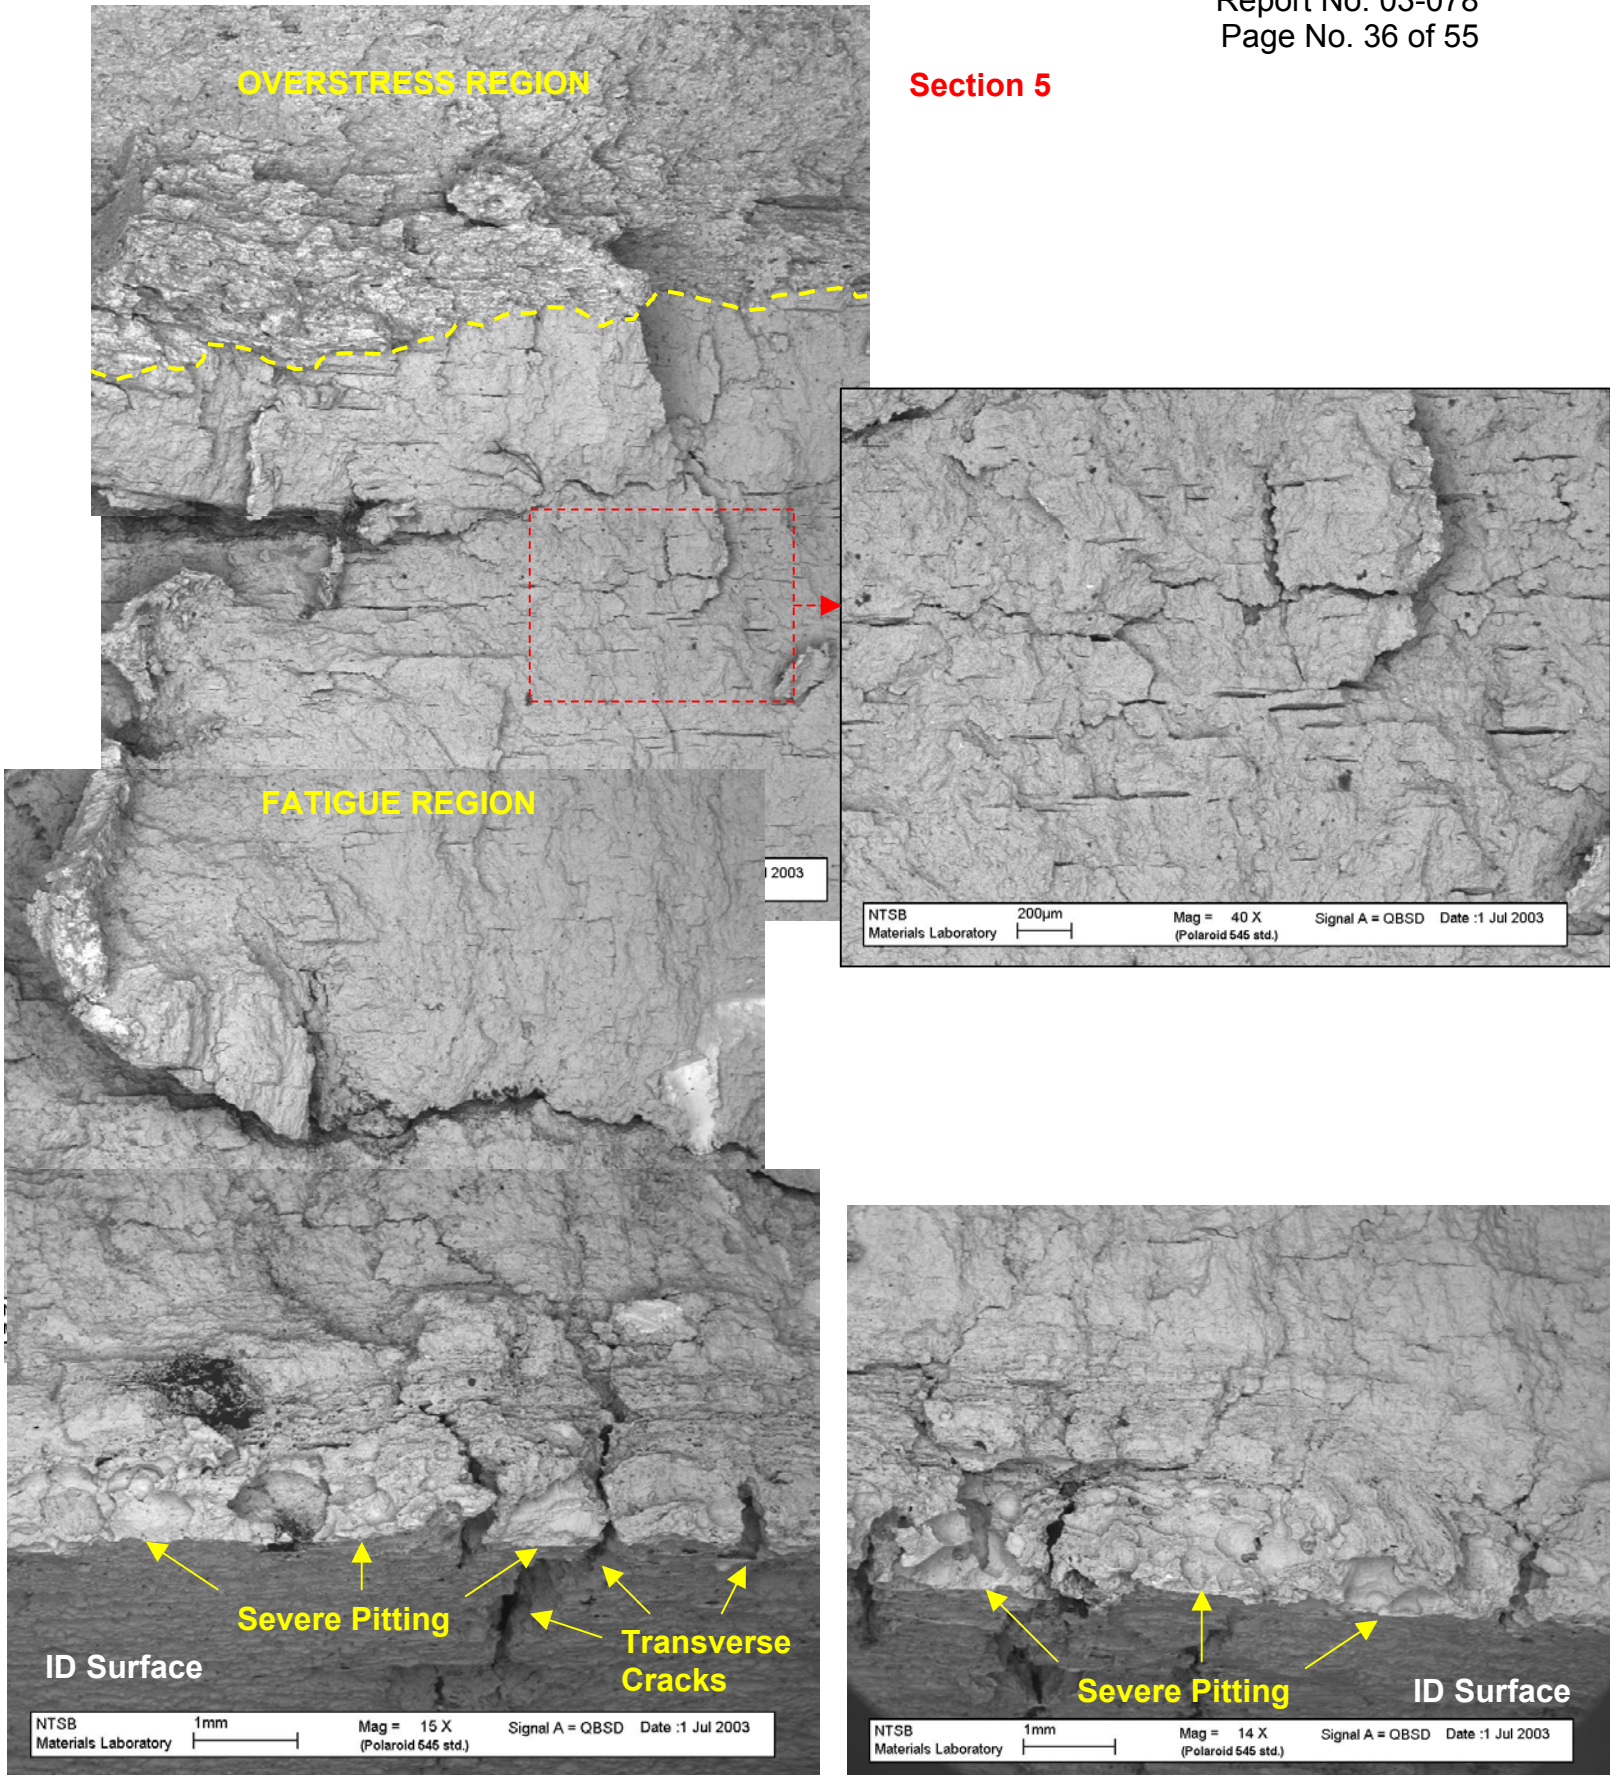
**Section 5**

SEM examination of the fracture surface revealed that the fracture near the ID surface was pitted (left and lower right images in Figure 23). From the pits thumbnail shaped fatigue arrest marks were observed propagating toward the OD. The arrest marks extended to a depth of approximately 0.1 inch. The fracture continued in a flat, transgranular manner to the final fatigue depth of approximately 0.45 to 0.55 inch. Beyond that point rough features with ductile dimples indicative of tensile overstress were observed. All along the fatigue fracture secondary micro-cracking was observed (left and top right images in Figure 23). SEM examination of the interior of one of the corrosion pits is shown in the top image in Figure 24. Within the pit very small circular deposits less than 0.0002 inch in diameter were observed (white spots). Compositional analysis of the white spots showed that they were composed primarily of copper, with the addition of iron, likely from the base metal (EDS 5- Figure 24). The fracture surface composition was primarily composed of iron, with traces of calcium, sulfur, phosphorus, silicon, aluminum, zinc, and oxygen (EDS 6- Figure 24).

**Figure 23:** Varying magnification SEM views of the fracture surface of Section 5 at multiple locations.

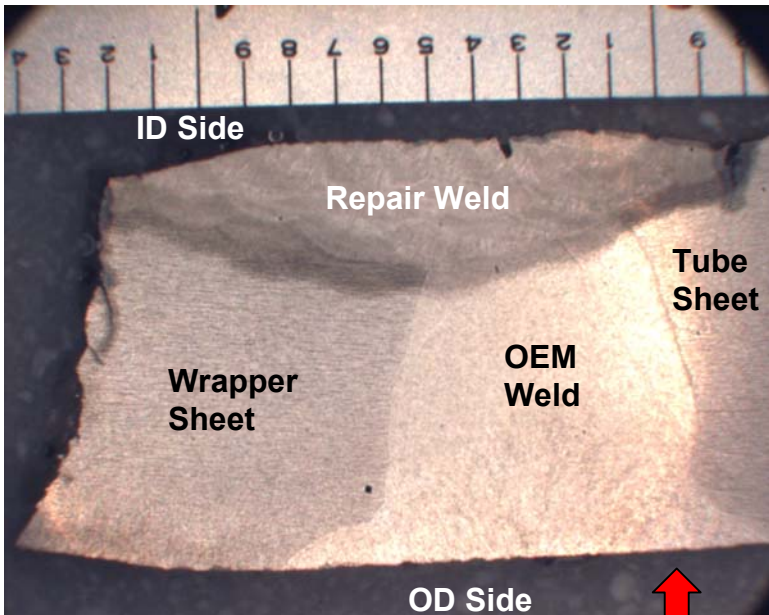
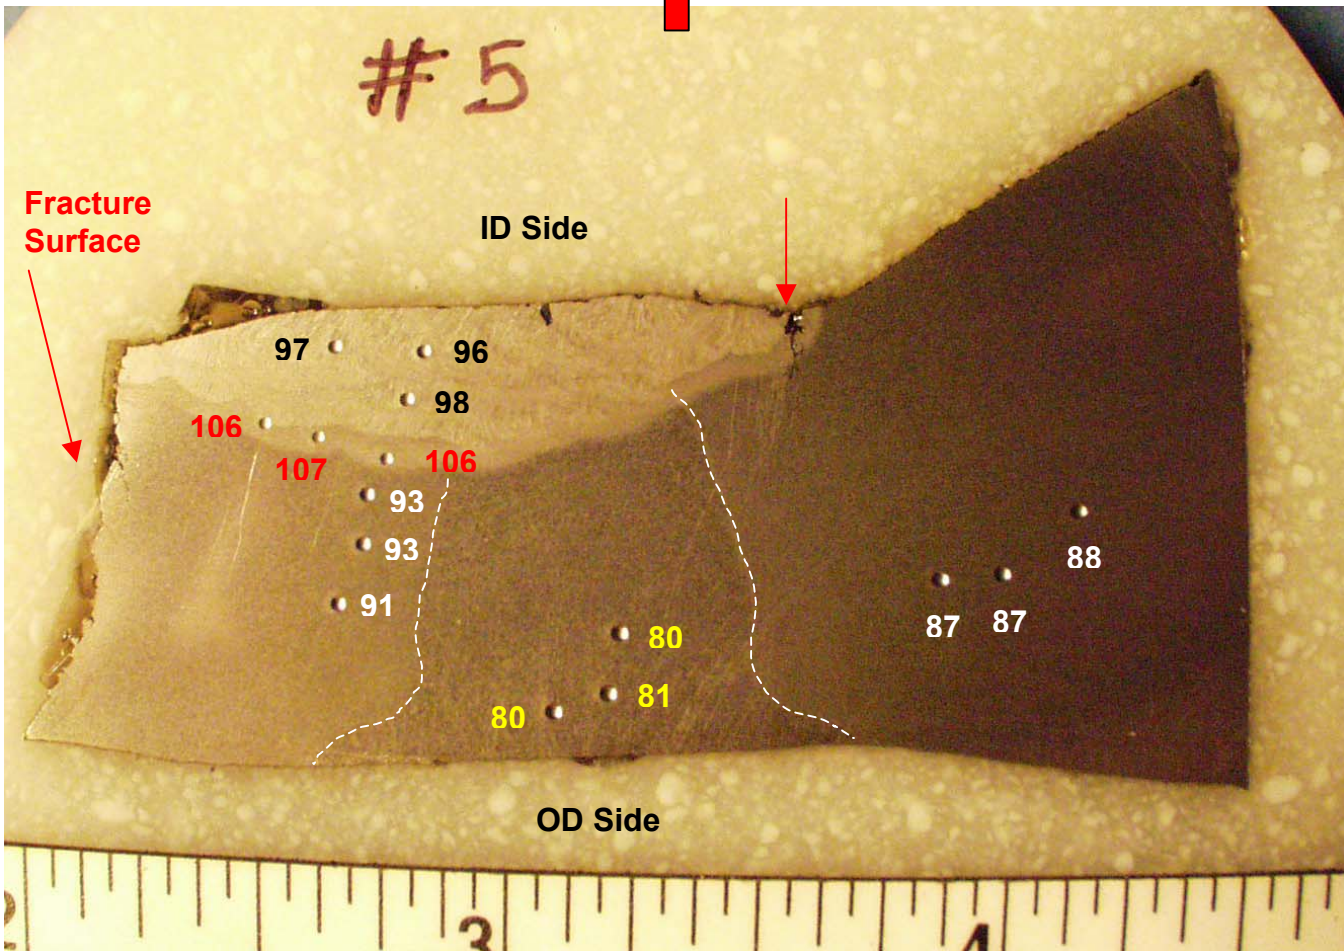
A transverse metallographic section through Section 5 confirmed the presence of a repair weld region on the original weld. The repair weld was slightly off-center of the OEM weld (images in Figure 25), compared to the location shown in Section 1 (images in Figure 13). In this mount longitudinal cracking was observed on the tube sheet (port) side of the repair weld to a depth of approximately 0.15 inch and in the center of the repair weld to a depth of

0.060 inch. The fracture propagated through the starboard side of the repair weld and in the wrapper sheet.

The back side of the metallographic mount was ground parallel to the face shown in Figure 25 until a flat plane through the mounted piece was created. This allowed macro-hardness measurements to be taken with metal-to-metal contact between the section and the hardness machine anvil. An average hardness of HRB 87 was obtained in the tube sheet, HRB 92 in the wrapper sheet, HRB 80 in the original OEM weld, HRB 97 in the repair weld, and HRB 106<sup>d</sup> in the repair weld HAZ. The hardness locations on the mount can be seen in the lower image in Figure 25. Since the original material specification was not known a hardness comparison could not be made with a specification. However, the hardness readings are typical for low carbon steel of the current composition (shown later).

**Figure 25:** Transverse cross-sectional mounts through Section 5 at varying magnifications and lighting conditions. The lower image also shows the value and location where Rockwell B readings were taken.

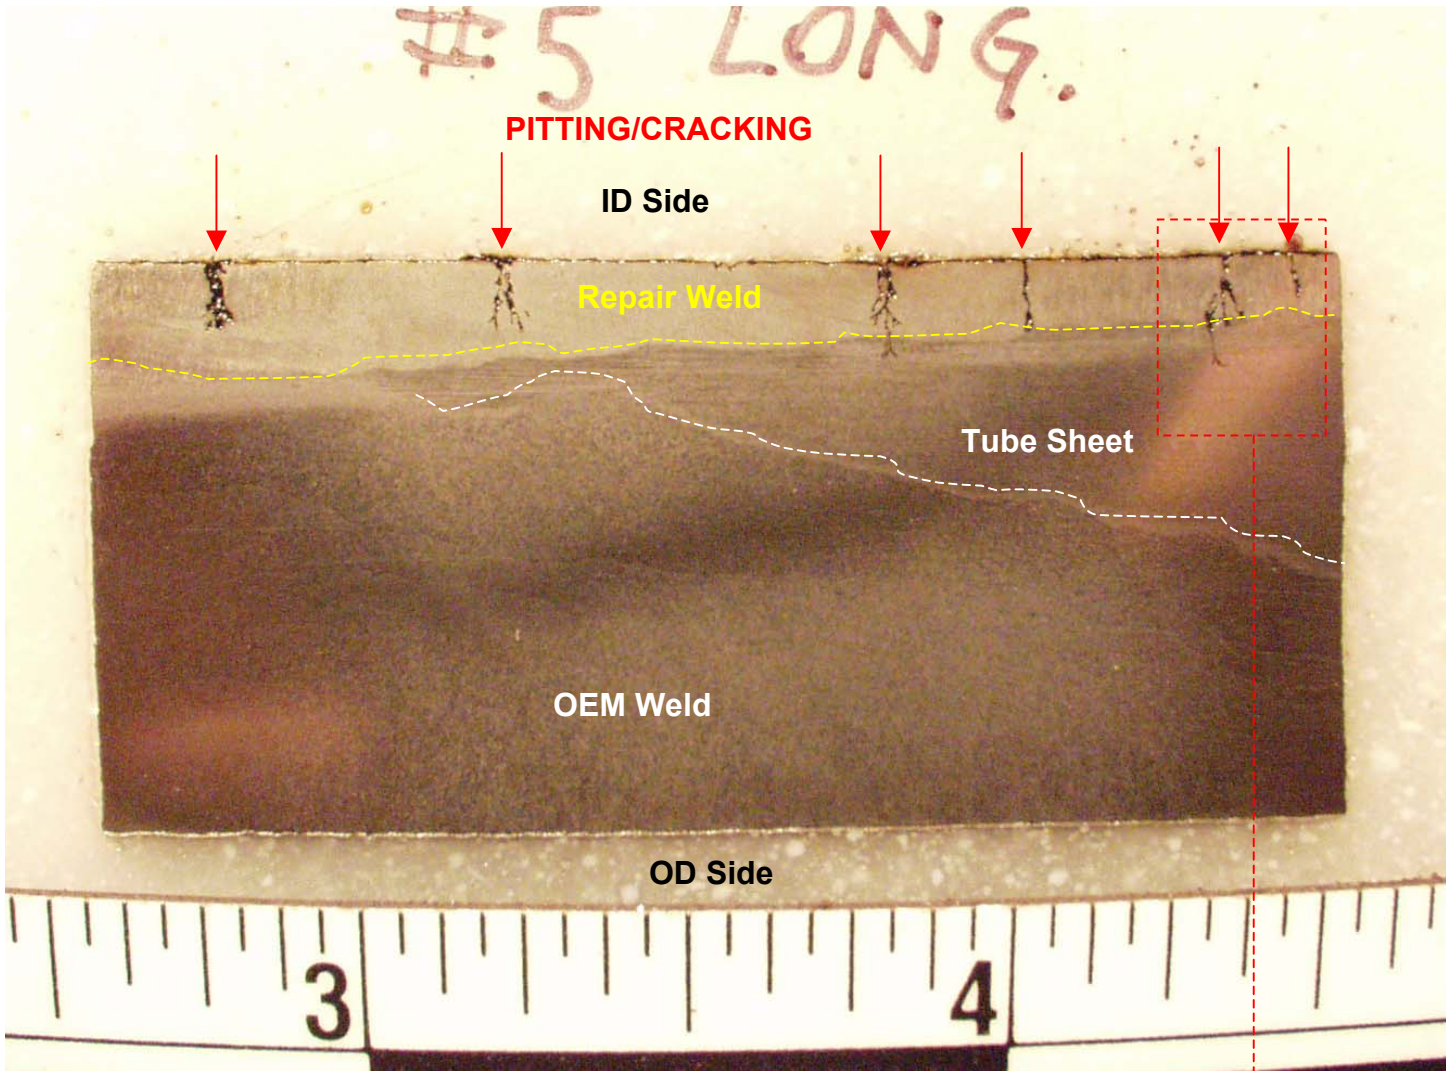
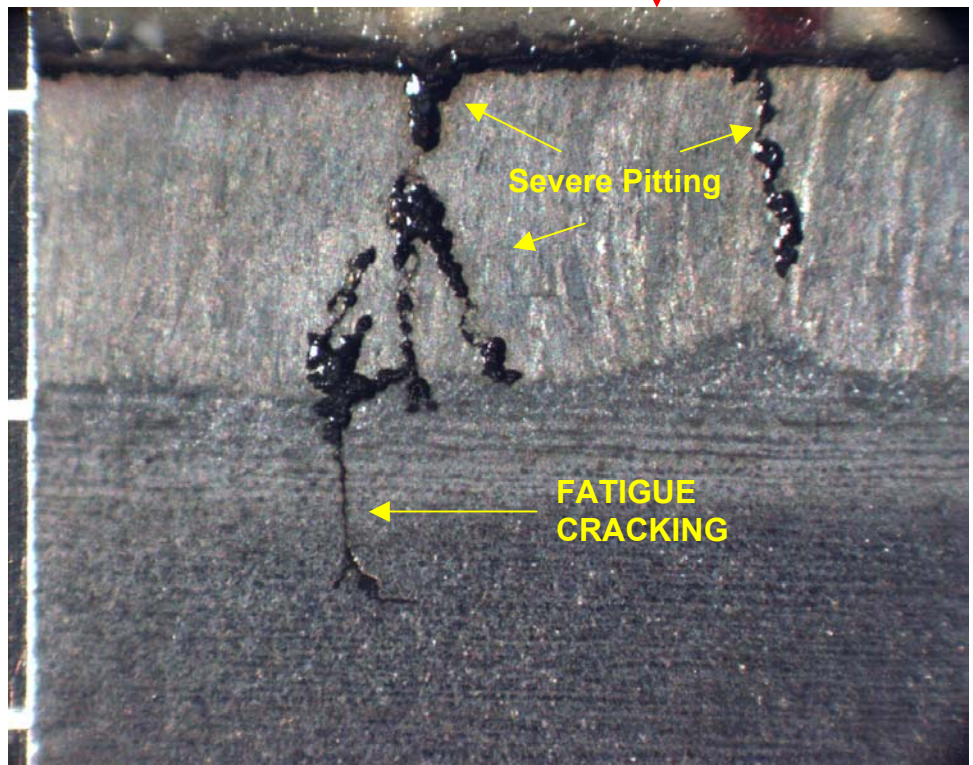
A longitudinal micrograph through the weld repair in Section 5 showed that in a 2 inch long section six transverse cracks were observed, with an average spacing of approximately 0.33 inch (images in Figure 26). At this location the transverse cracks ranged in depth from 0.12 to 0.2 inches. Two of the six cracks extended beyond the repair weld into the tube sheet. The cracks were perpendicular to the surface with significant pitting near the ID surface. When one of the cracks was opened up in the laboratory a dark thumbnail was observed. These features are consistent with fatigue cracks.

**Figure 26:** Longitudinal cross-sectional micrographs at varying magnifications through the longitudinal repair weld in Section 5.

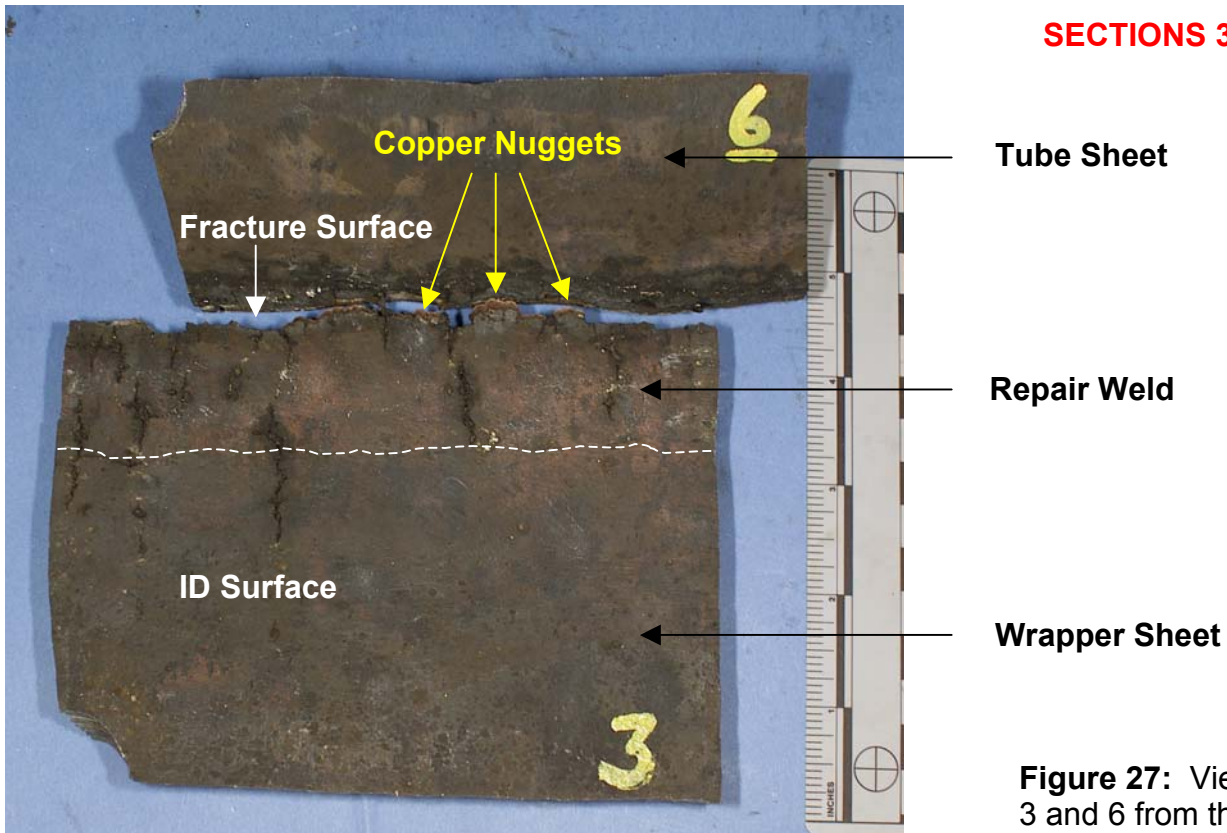
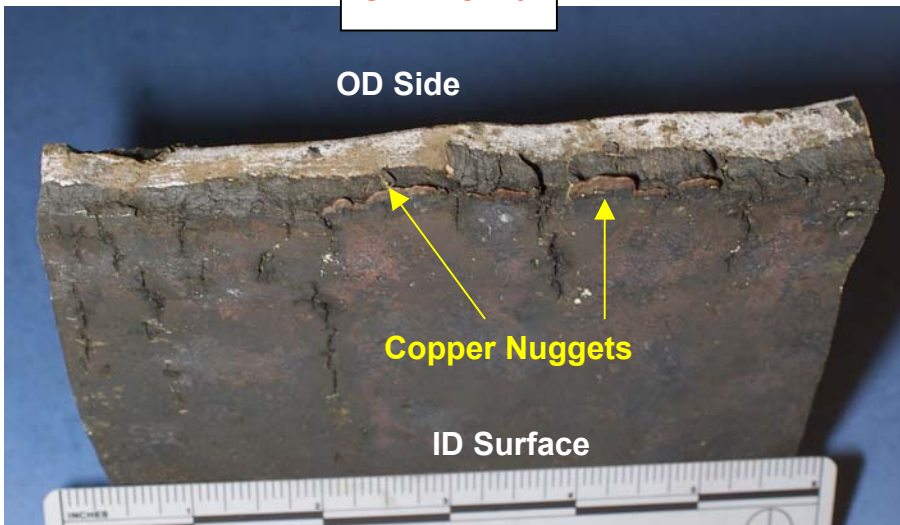
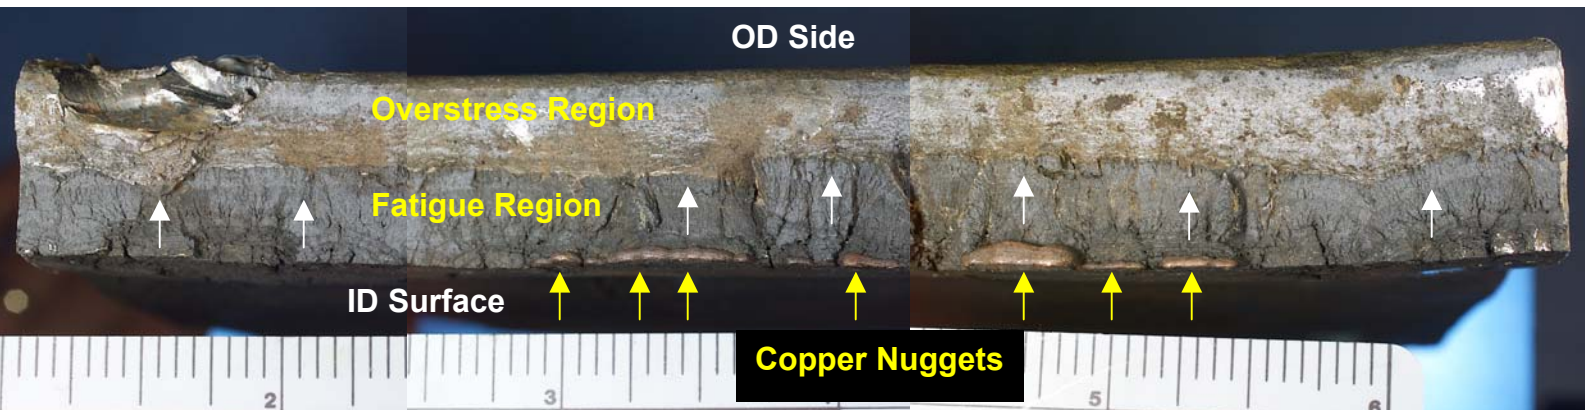
**SECTIONS 3 & 6**

Sections 3 and 6 were from the approximate middle of the length of the fracture along the upper longitudinal weld. Optical examination of these sections revealed that the fracture propagated along the starboard side of the repair weld (closest to the tube sheet). The fracture was comprised of cracks on multiple longitudinal planes joining up to form a larger crack front (top image in Figure 27).

**Figure 27:** View of mating Sections 3 and 6 from the upper longitudinal weld of the header (upper image). The middle image is a view of the ID surface and fracture surface at an angle from Section 3 (weld and wrapper sheet side). The lower image is a straight-on view of the fracture surface of Section 3. The yellow arrows indicate where copper nuggets were observed and the white arrows in the lower image show the direction of propagation of the cracks.

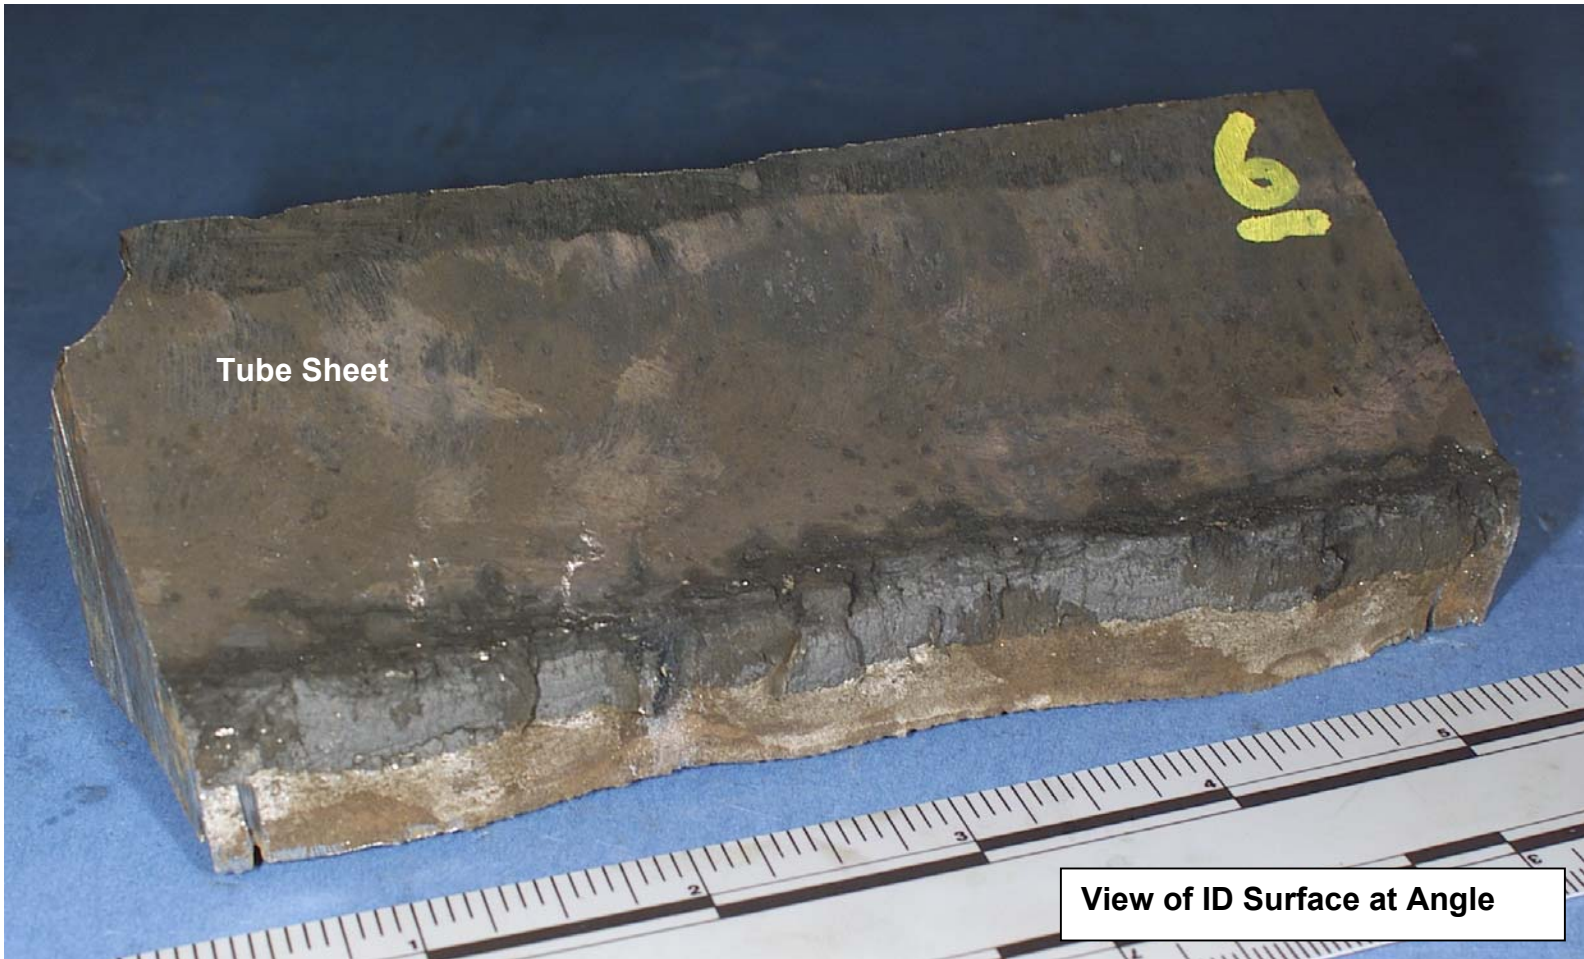
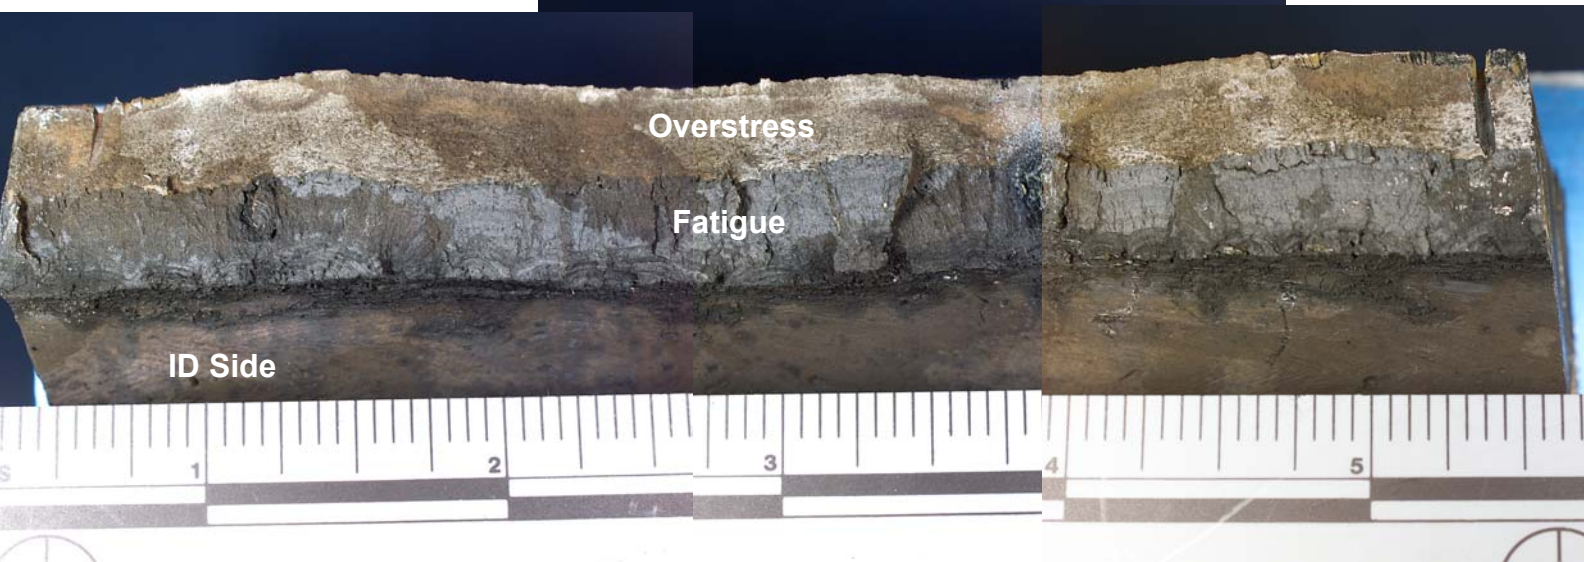
**SECTION 6**

**Figure 28:** Views of the tube sheet fracture on Section 6 taken from the upper longitudinal weld of header 23. The upper image is a view of the fracture surface and ID surface at an angle, while the lower image is a more straight-on view of the fracture surface.

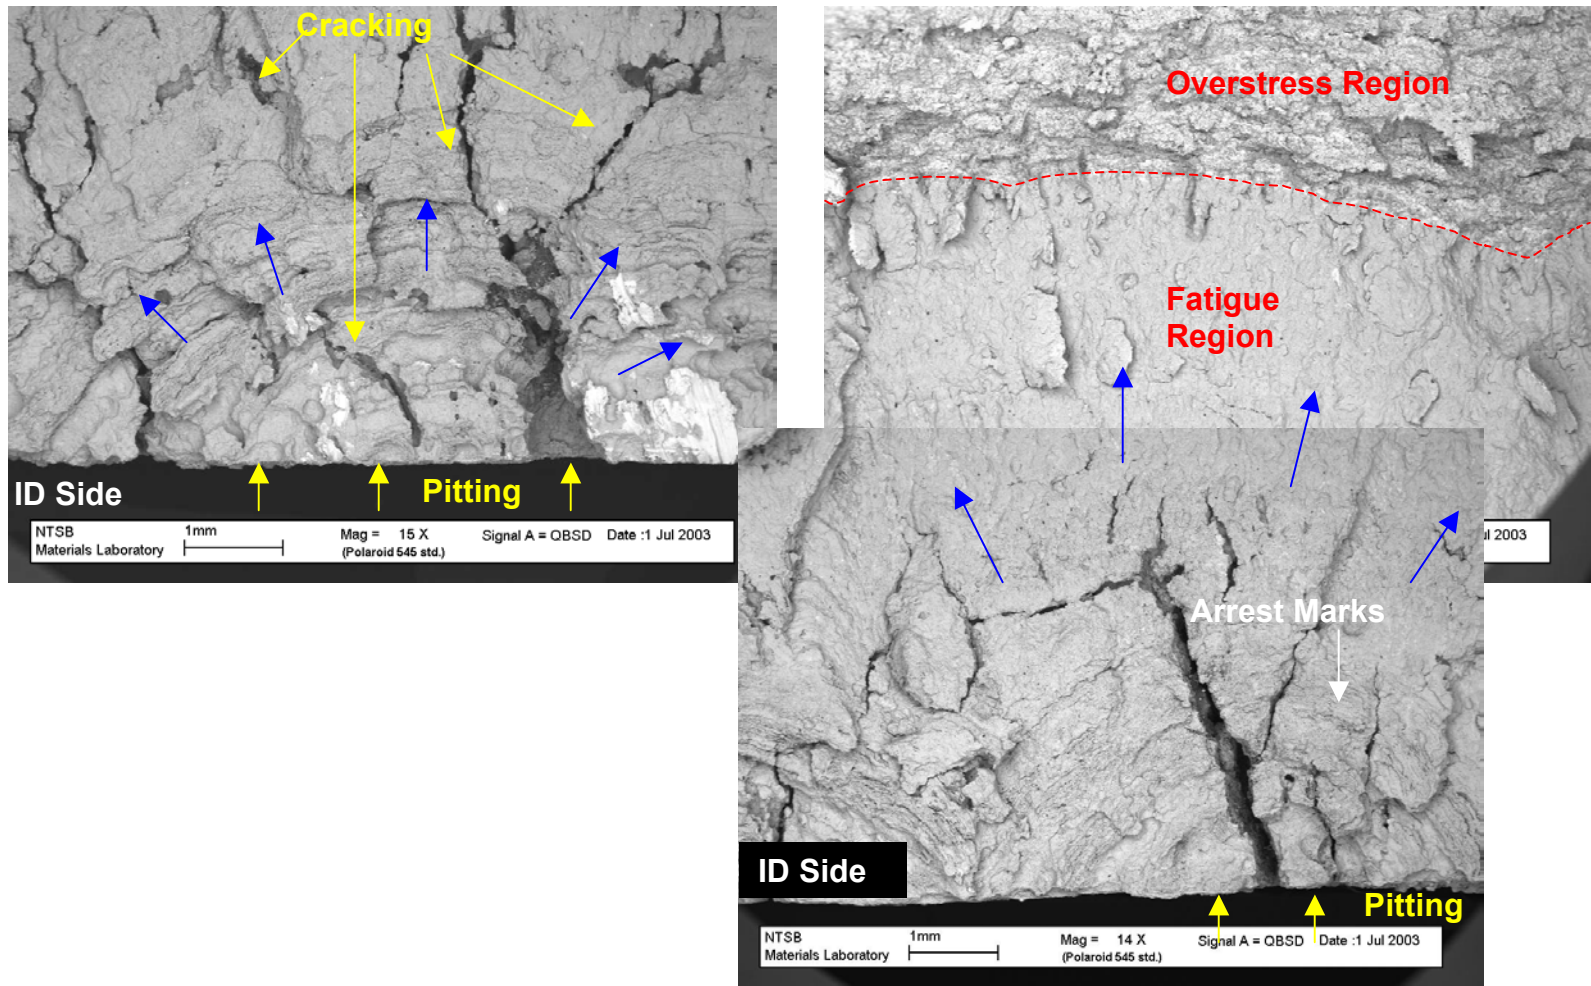
**SECTION 3**

SEM examination of both fracture halves revealed that the cracking initiated at the ID surfaces at the base of very large corrosion pits (images in Figure 29 and 30). From these regions visible semi-circular fatigue arrest marks were observed to a depth of

**Figure 29:** SEM images of the fracture surface of Section 3 near the ID surface.

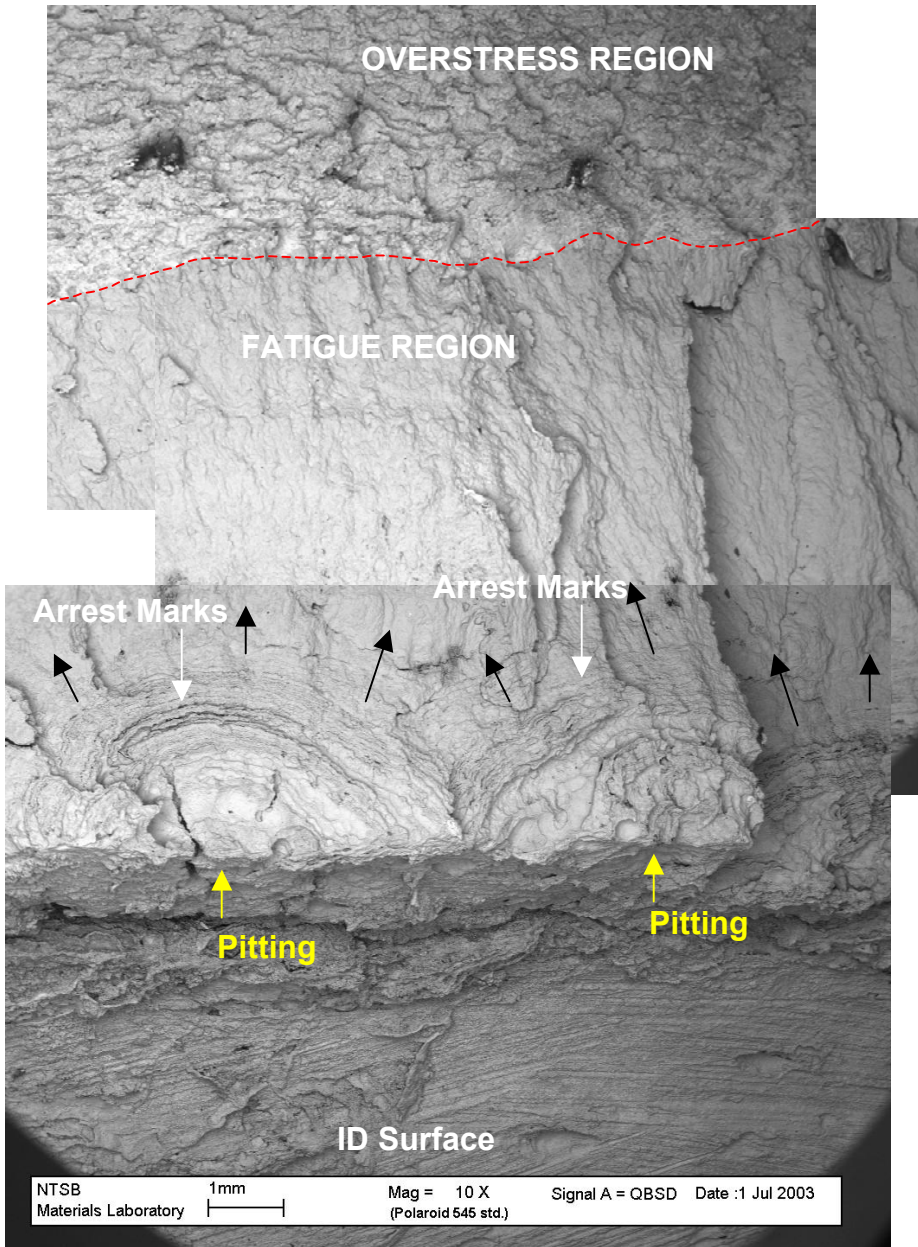
**SECTION 6**

**Figure 30:** SEM montage of a region of the fracture surface from Section 6 (upper image). The lower image is a view of one of the origin areas near the ID surface at higher magnification.
